DANISH MARITIME AUTHORITY

**MARINE ACCIDENT REPORT
DIVISION FOR INVESTIGATION OF MARITIME ACCIDENTS**

**Accident to seafarer HELGOLAND
Fall overboard on 16 November 2008**

The casualty report has been issued on 18 February 2009

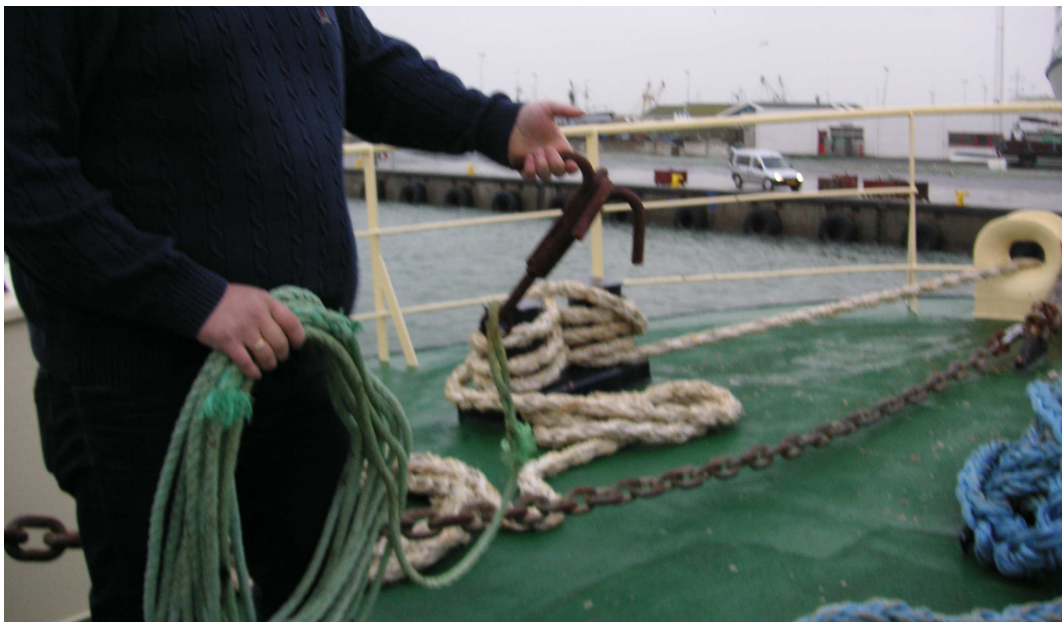
The skipper was steering into the sea at manoeuvring speed. Fisherman 1 was in starboard side holding the grapnel and the grapnel-line, and he threw the grapnel and got hold on the buoy-line, which was hauled to the deck. Fisherman 4 was also in starboard side of the forecastle approximately 2m forward fisherman 1. Fisherman 4 got hold in the buoy-line and began hauling it in.

A fisherman holding the grapnel and the grapnel line. Photo by the Investigation Division

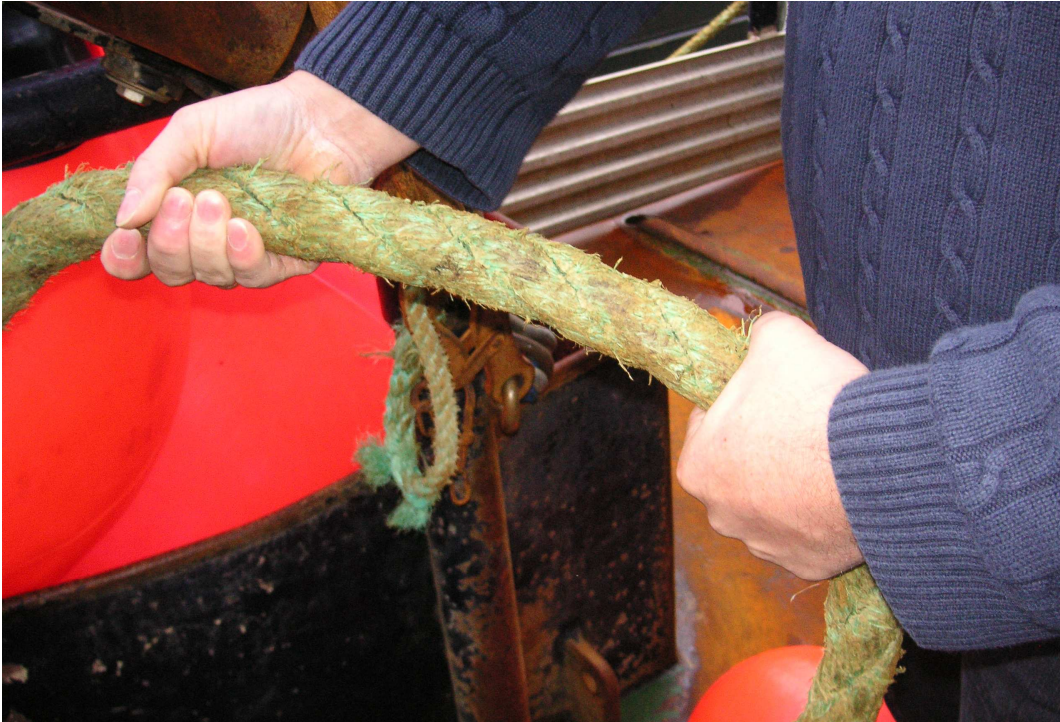
Gradually 10m slack of the buoy-line was hauled onto the deck, which was plentiful to have the buoy-line connected to the in-hauler line. The slack buoy-line was laying on the deck, and fisherman 4 was still holding on to the line.

A fisherman holding the buoy-line. Photo by the Investigation Division.

Suddenly the buoy-line tightened. Fisherman 4, who was standing approximately ½m from the railing, kept his hold in the line, and was therefore pulled – or thrown over board. Just at that moment fisherman 1 stood turned away while making the in-hauler line ready, so it could be connected to the buoy-line. He did not see the actual fall over board, but he heard the shout of fisherman 4, turned around and saw fisherman 4 hanging in the buoy-line. Fisherman 1 got hold in the buoy-line and kept it tight.

The fall over board was caused by an unexpected drive in the buoy-line, while the fisherman held the line. It is not possible with certainty to establish the cause to this drive or why the fisherman did not let go the line, when the drive occurred.

The drive could occur by an unexpected movement of the vessel in the high waves or it could have been by a sudden and forceful influence of the buoys or by a combination of the two.

- to work out risk assessments for the working processes concerning the shooting and the hauling of gear, so that they are always safe, e.g. by using lifejackets / lifeline during work on deck under certain weather conditions and possibly by enlargement of the height of railings, and
- to procure equipment suitable for rescue of a fallen over board person, and to see to that the crew is exercised in the use of the equipment. In this respect inspiration can be found in the pamphlet "*Rapport om bjergning af overbordfaldne fra fiskeskibe*" (Report on the rescue of fallen over board persons in fishing vessels) from the Danish Fishermen's Occupational Health Council, look at www.f-a.dk, publications.
