Summary
Investigation Report 612/08

Serious Marine Casualty

**Collision on the Kiel Canal
between
MV RMS SAIMAA and MV NORDIC DIANA
on 12 December 2008 at 0946**

1 December 2009

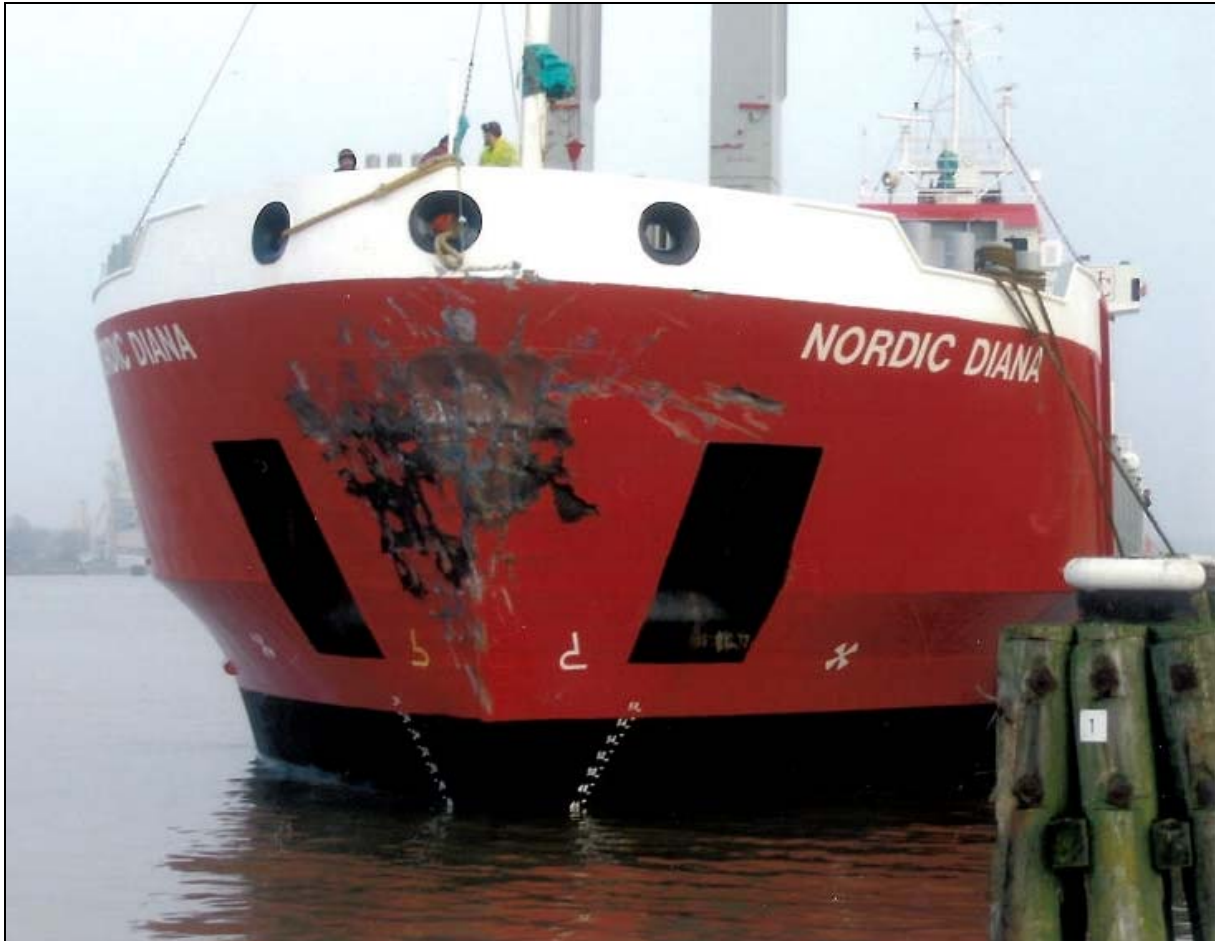
Figure 5: Damage to the MV NORDIC DIANA

There were no injuries and no environmental pollution.
The NORDIC DIANA had heavy deformations and cracks on the bow section.

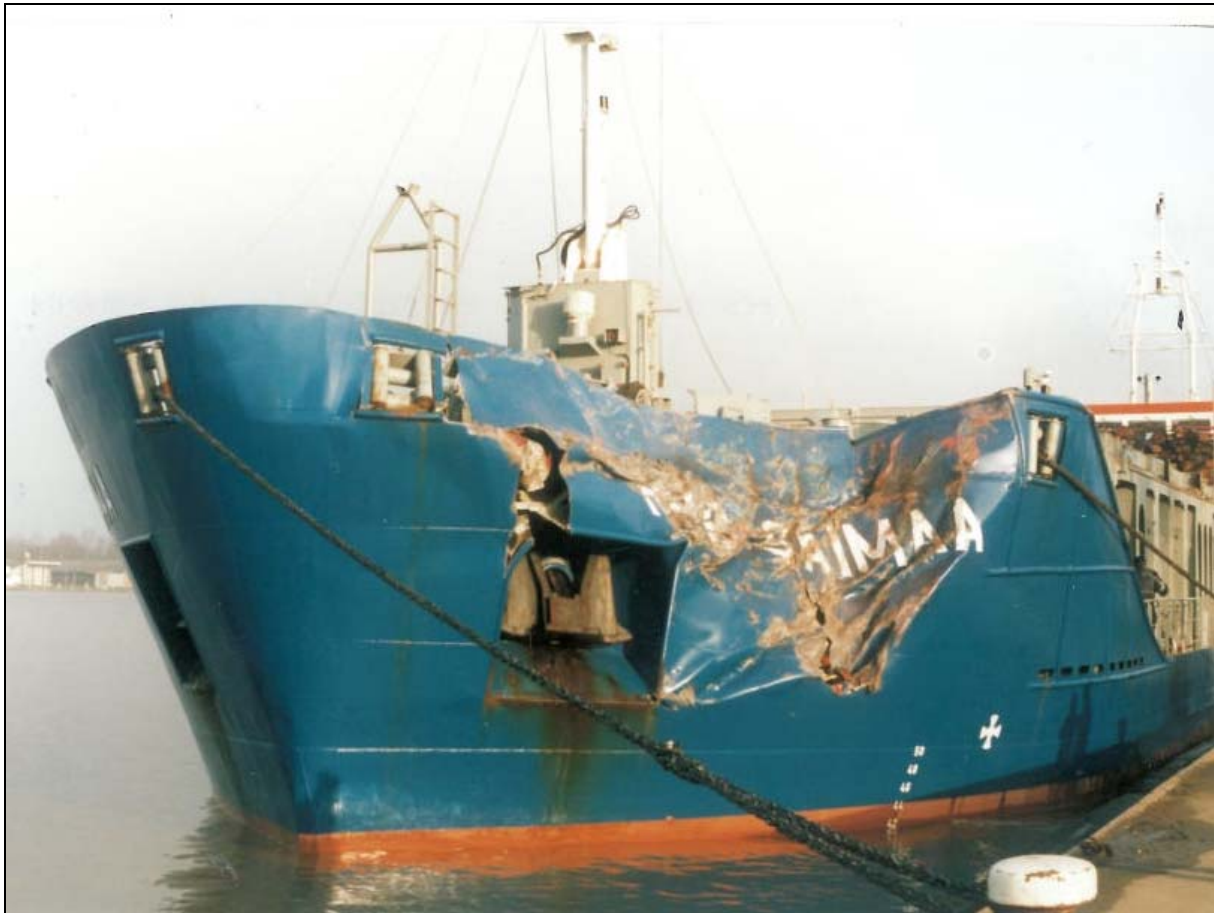
Figure 6: Damage to the RMS SAIMAA

The RMS SAIMAA was heavily dented on the port bow both above and below the waterline. This led to water ingress in the forepeak and in double bottom tank No. 2.

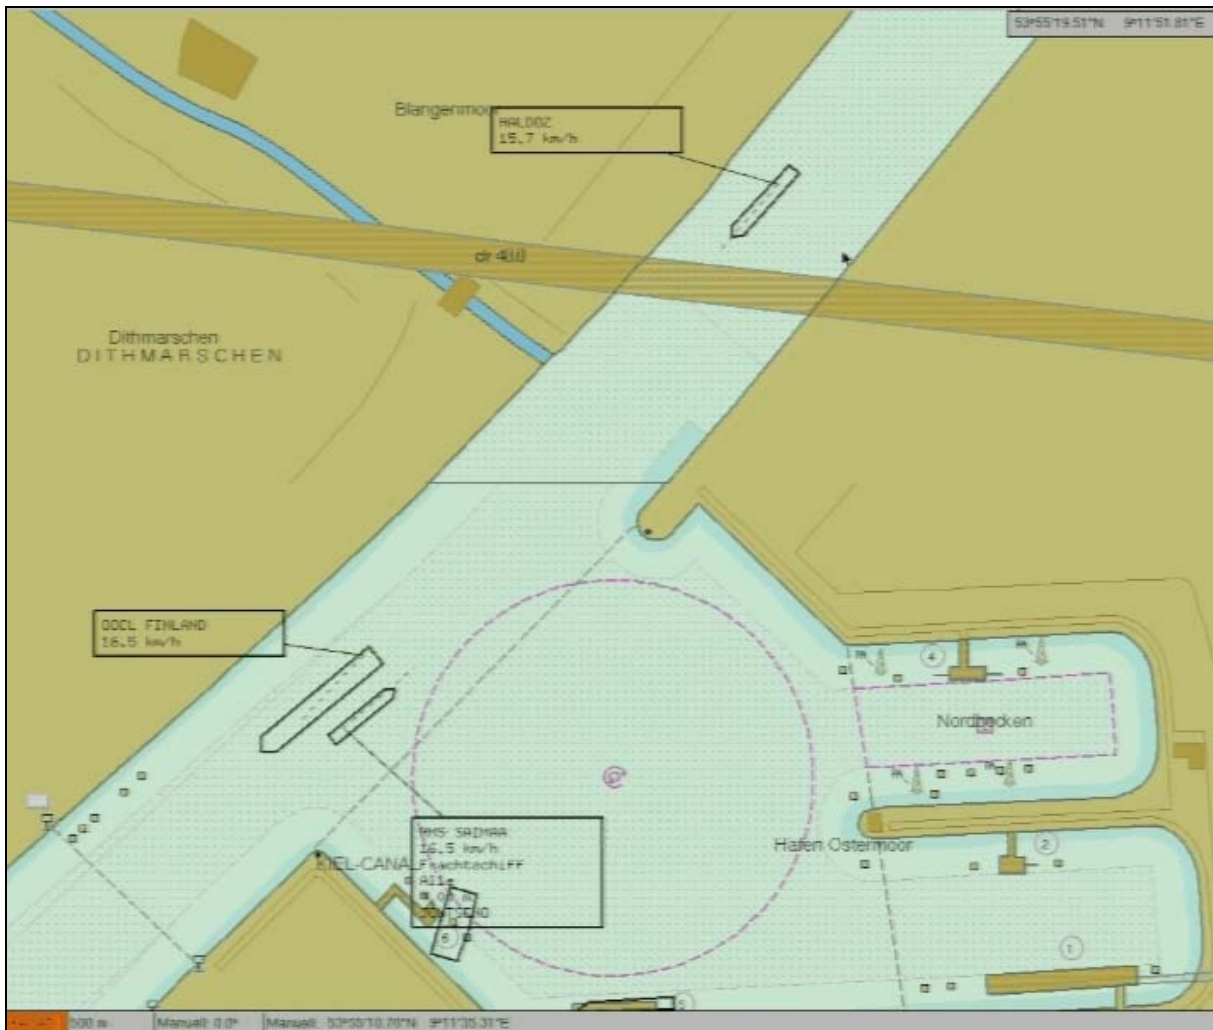
Figure 7: AIS display of the VTS at 0943

The following figures show the course of the voyage for both vessels up to the collision. Figure 7 shows the RMS SAIMAA passing the OOCL FINLAND sailing westwards.

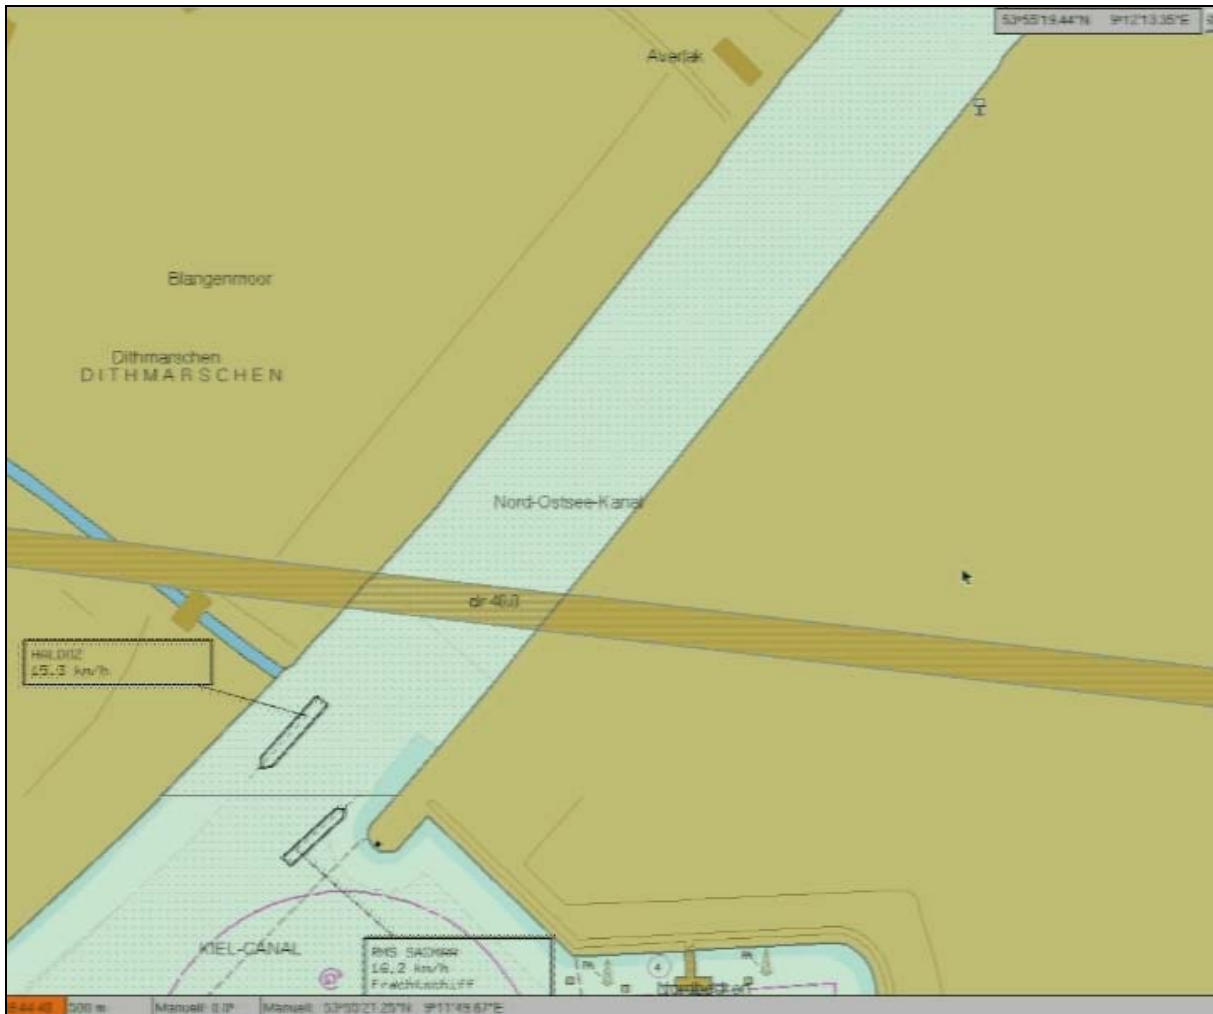
Figure 8: AIS display of the VTS at 0944

After the OOCL FINLAND, the HALDOZ is the second vessel to approach the RMS SAIMAA. Although the HALDOZ is keeping relatively far to the north, it seems that the RMS SAIMAA is continuing to move to the south and thus, as can be seen in Figure 8, ever closer to the tongue of land off Ostermoor port.

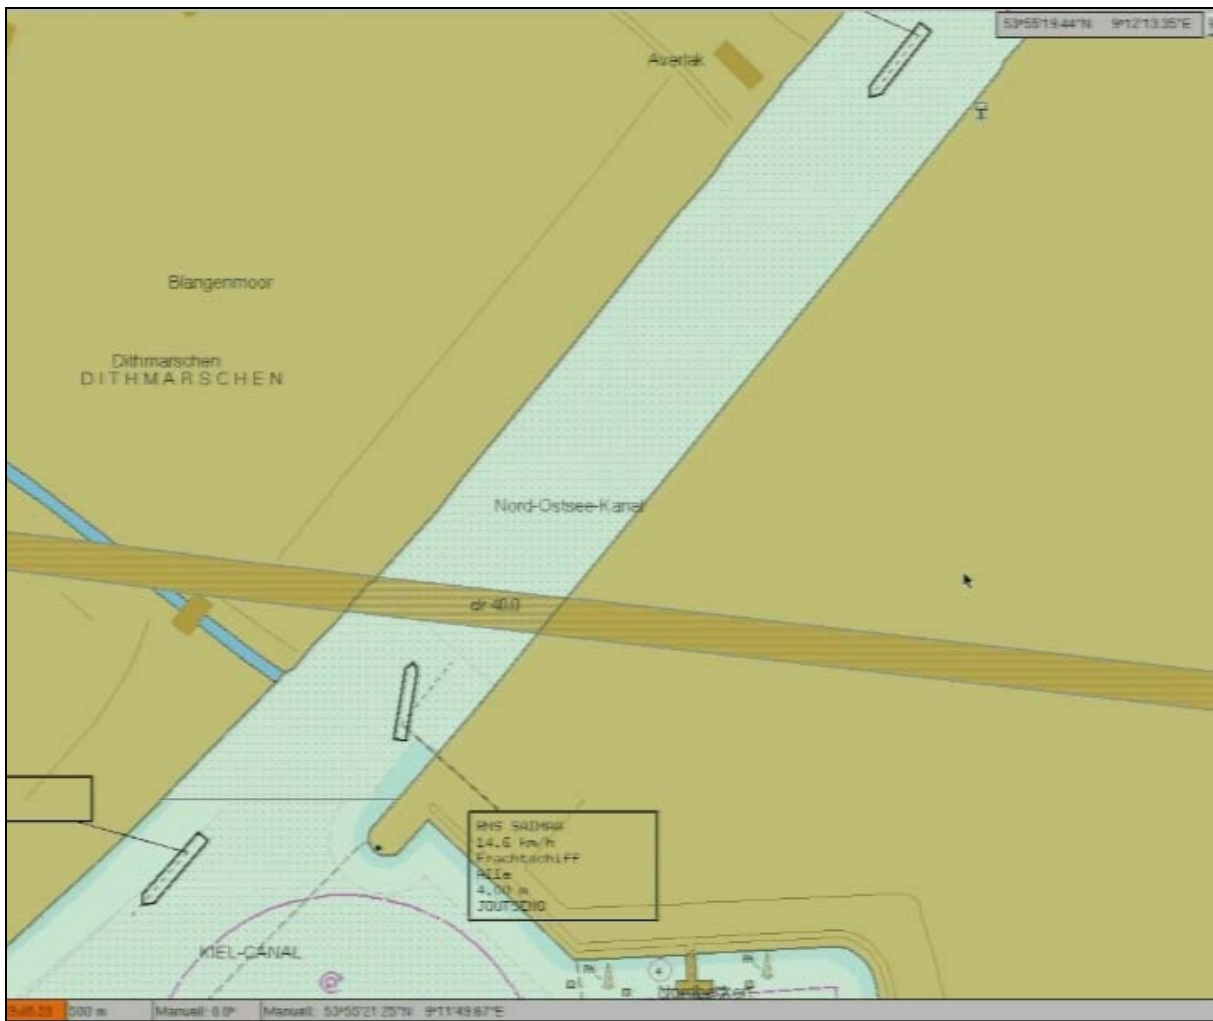
Figure 9: AIS display of the VTS at 0945

The records do not show the stern of the RMS SAIMAA coming into contact with the embankment on the southern side of the NOK. However, with her stern close to the southern bank, Figure 9 shows the vessel's clear tendency to begin to turn to port.

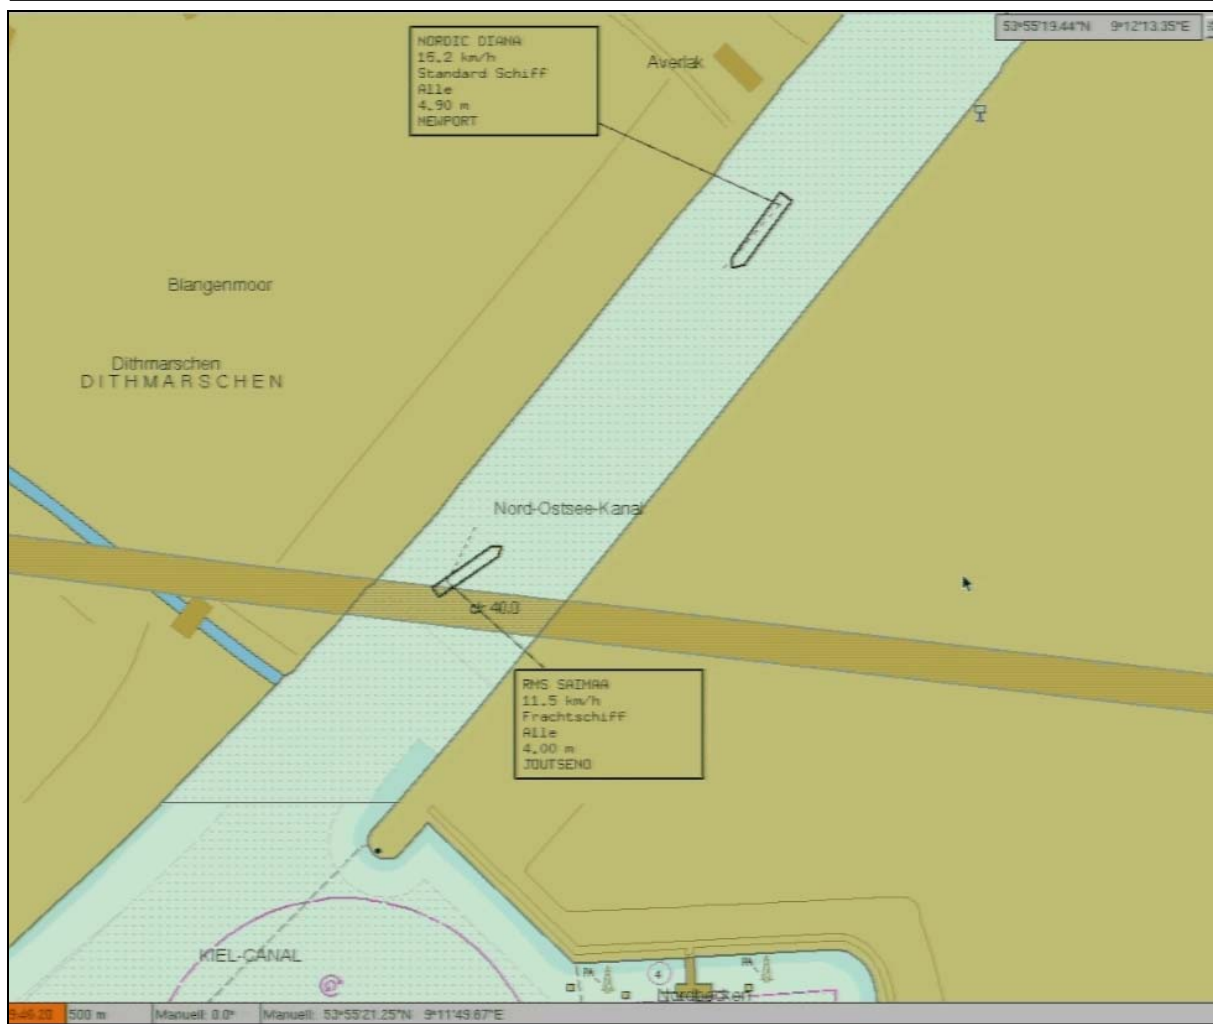
Figure 10: AIS display of the VTS at 0946

The records continue to show no contact between the RMS SAIMAA and the northern embankment. However, after a pronounced approach to the northern bank, Figure 10 shows the vessel's tendency to move to starboard back to the middle of the canal.

A comparison between the recordings of the VTS and the OOCL FINLAND (see Figs. 10 and 11) illustrates the value added by an integrated display. Through presentation of the vessel silhouettes on the nautical chart in the VTS, both the vessel's own position and the position of each other vessel are better identified and can be used by the ship's command when making decisions. This is particularly evident when the relationship to optical reference points is absent due to reduced visibility. Indeed, the pilot on the NORDIC DIANA knew that the RMS SAIMAA was situated under the viaduct because of the VHF traffic; however, he was not aware of her precise position on the canal and the resulting risks associated with the proposed port-by-port pass. His reasoning behind not reducing the vessel's speed in order to preserve the NORDIC DIANA's steer-ability is basically understandable. However, this is very critical in this situation because at that point he did not know where the RMS SAIMAA was located.

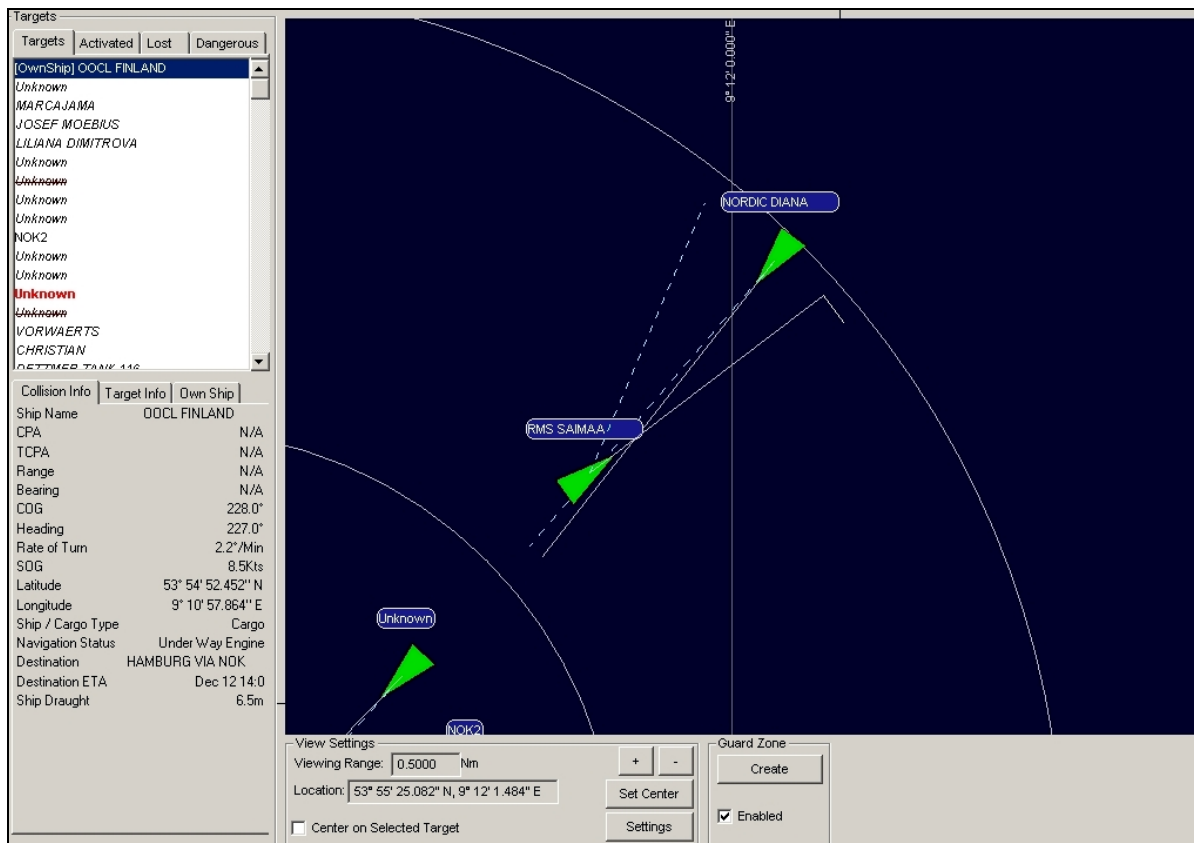
Figure 11: AIS data of the OOCL FINLAND

The following three screenshots show the two vessels involved in the collision. The data pertaining to the OOCL FINLAND are shown on the left side of Figure 11. The RMS SAIMAA and the NORDIC DIANA shortly before the collision are situated on the main image to the right. The rings have a distance of 0.5 nm.

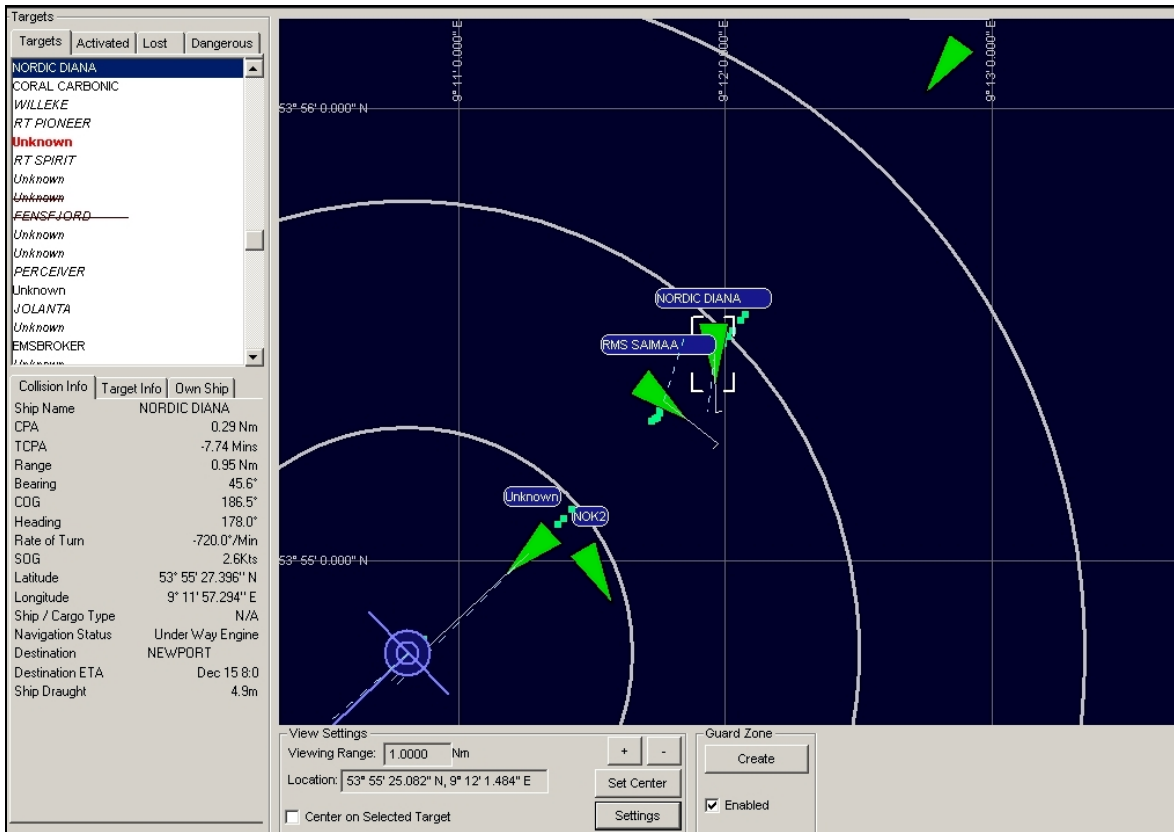
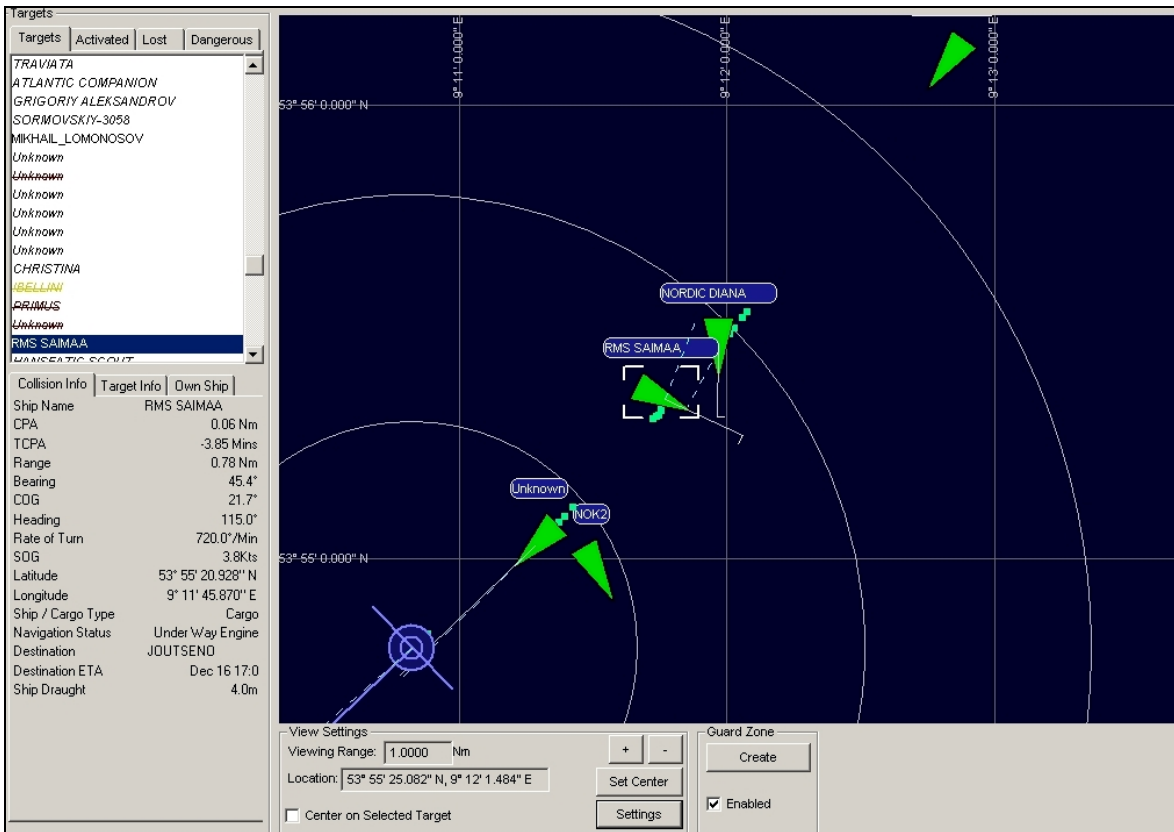
Figure 12 and Figure 13 show the data of each vessel involved in the collision at the same time shortly after the collision.

Various audio recordings show that the collision took place immediately beforehand. The turning movement of each vessel involved in the collision towards the south side of the canal can be seen clearly.
