## **Summary Investigation Report 617/08**

**Serious Marine Casualty**

**Collision of the cargo ship FREYA  
with the Gelbsand front light structure  
in the Elbe approach  
on 16 December 2008**

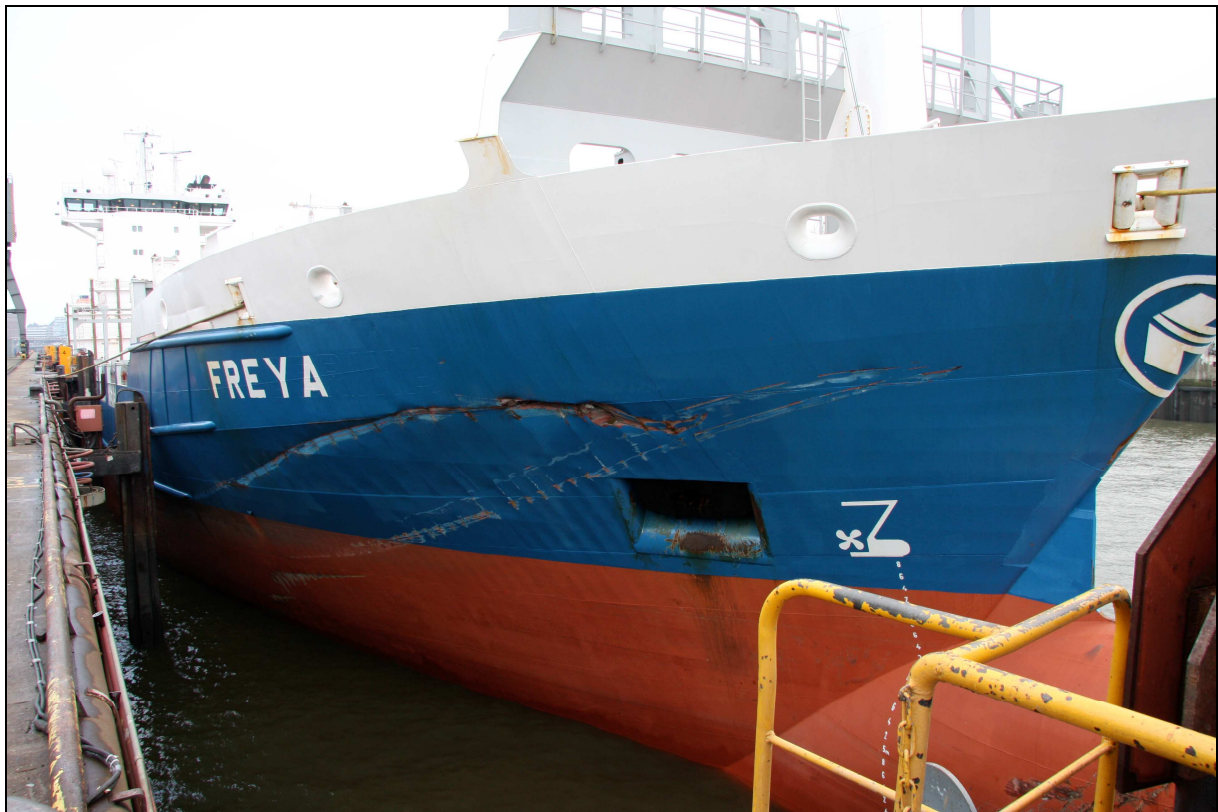
The impact tore several holes in the bow of the FREYA, one each above the waterline to port and to starboard (cf. Figures 3 to 5) as well as one bulbous bow just below the waterline (cf. Figure 6). Seawater filled the forepeak through the latter hole. Besides, there were extensive abrasions of the shell plating on both sides due to which frames were deformed partially.

Figure 3: Damaged starboard side of the FREYA

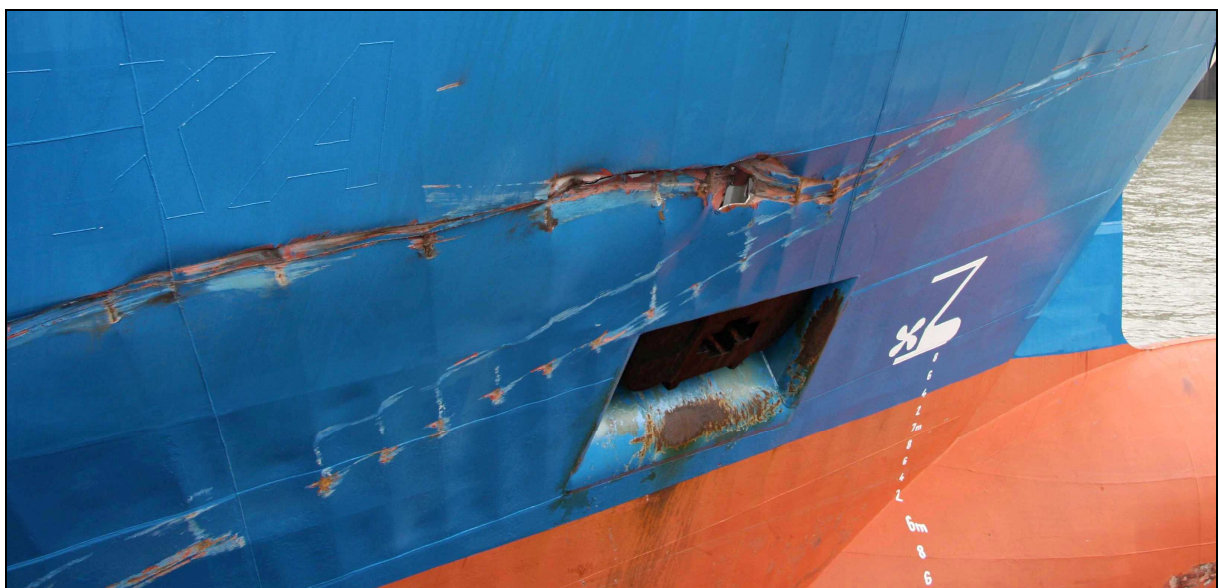
Figure 4: Details of the damage to the starboard side of the FREYA

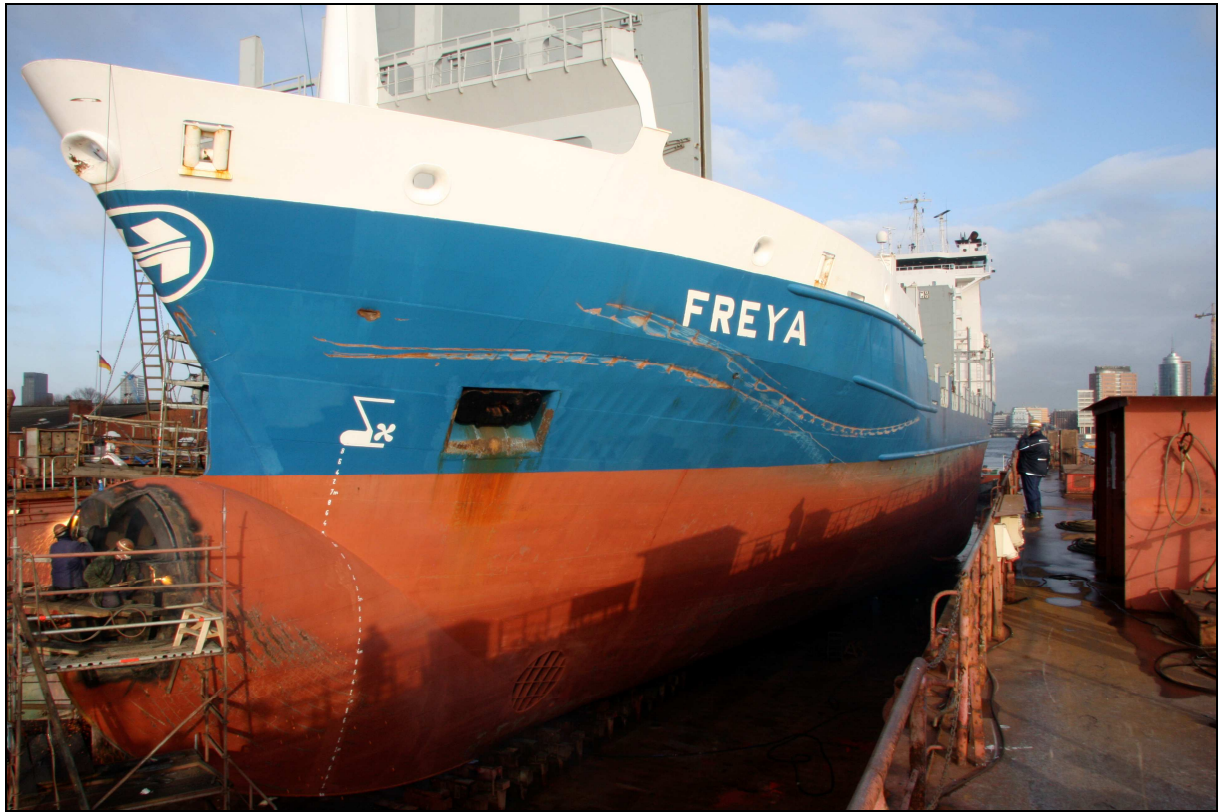
Figure 5: Damaged port side of the FREYA

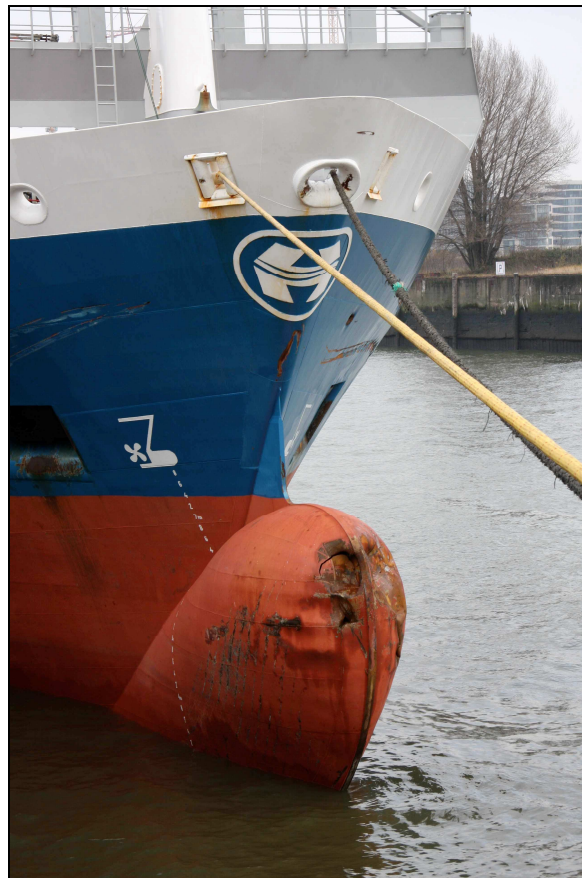
Figure 6: Damaged bulbous bow of the FREYA

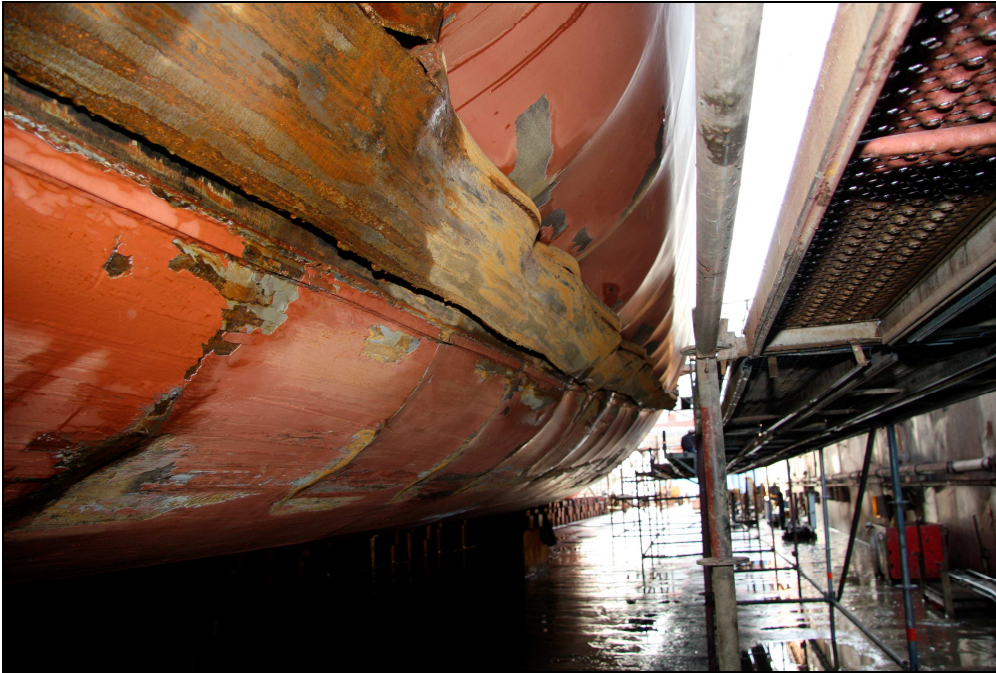
Even the rolling-chock and frames at the underwater hull were severely deformed due to the collision and torn apart to some extent (cf. Figure 7).

Figure 7: Damaged underwater hull of the FREYA

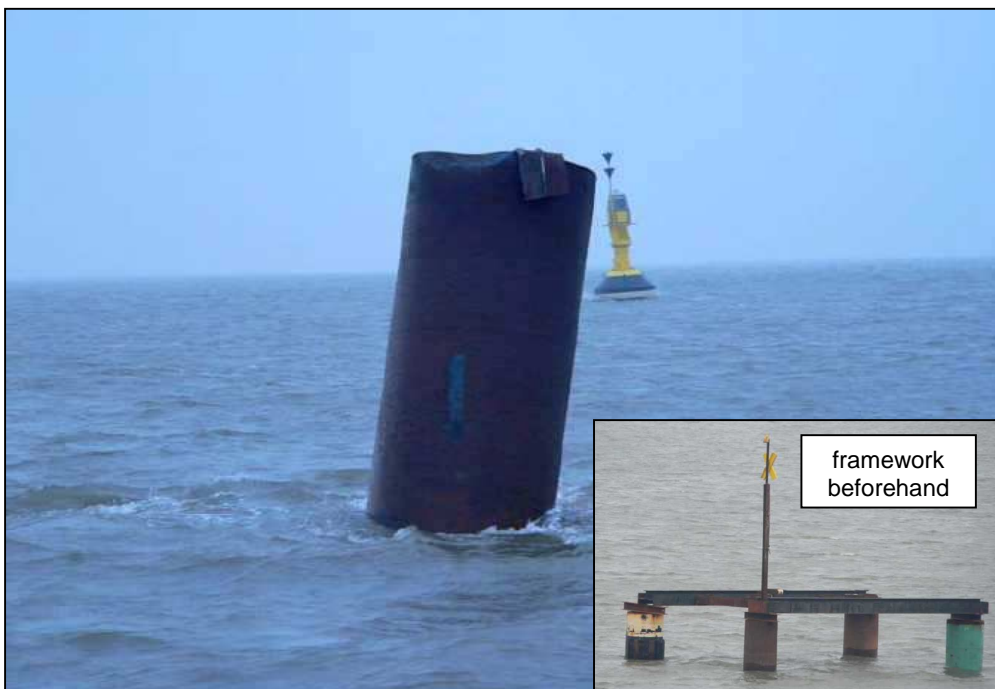
The FREYA also tore the guiding framework and the shank (diameter: 3 m) of the front range light being erected. Only one guide mooring post of the structure still protruded out of the water after the collision (compare Figure 8).

Figure 8: Damaged dolphin of the guiding framework

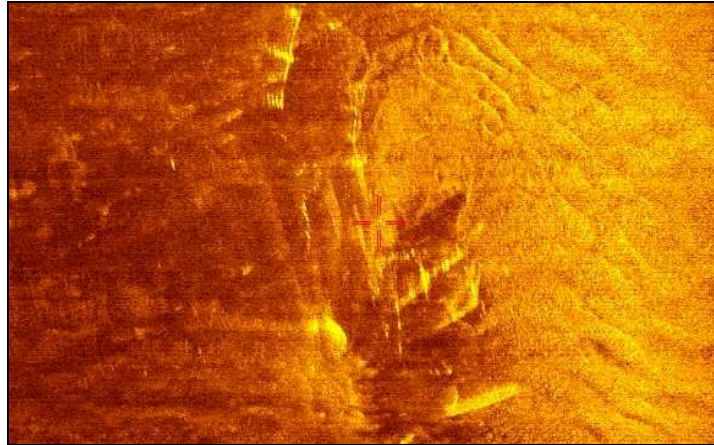
The VWFS ATAIR<sup>1</sup> of the Federal Maritime and Hydrographic Agency (BSH) could localize the wreckage components of the front light structure on 18 December 2008 with the help of a side scan. The wreckage (cf. Figure 9) stretched to an area of approximately 20 x 50 m. The maritime salvage operations of the wreckage debris lasted till 2 February 2009. Construction activities at the Gelbsand front light structure could be resumed only there after.

Figure 9: Side scan of the wreckage

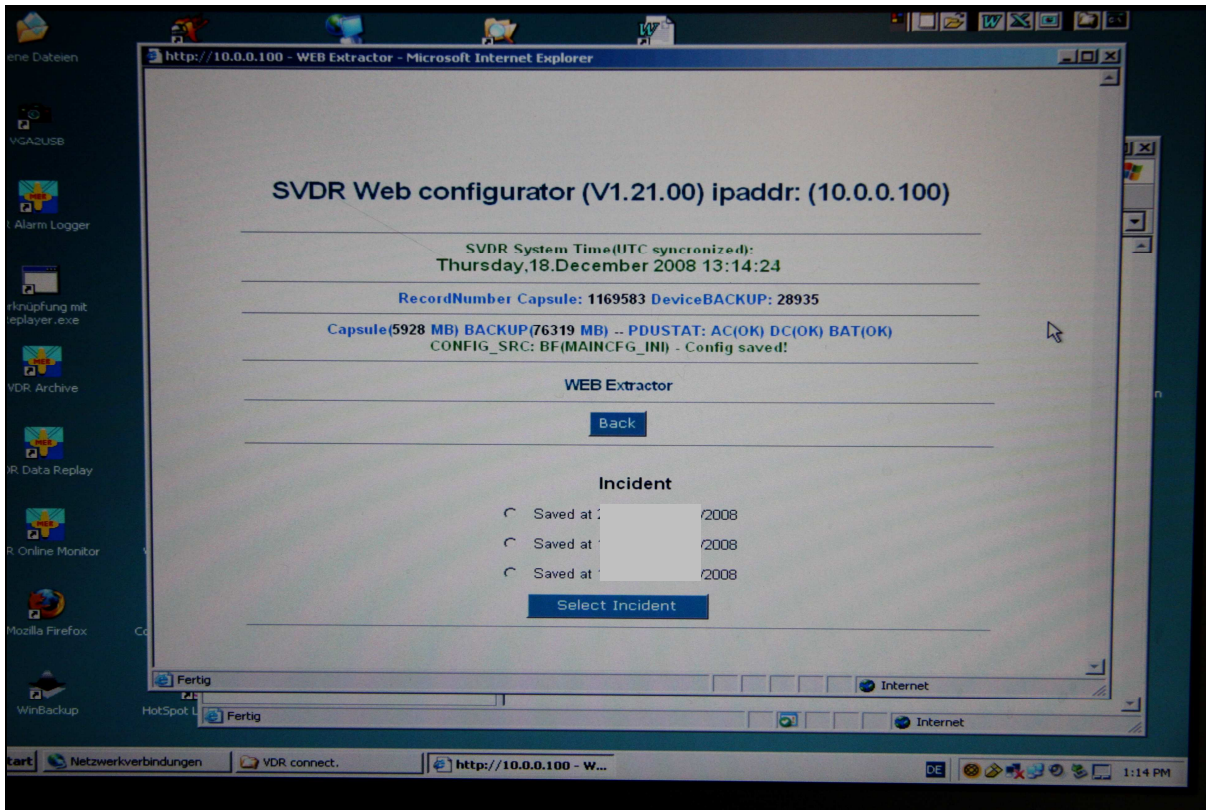
The S-VDR has a recording capacity of maximum three backups. As soon as all three backup save opportunities are full, at least one of the stored events must be deleted manually before the next backup can be executed. After the BSU employees arrived on board, it turned out that all three backup opportunities were occupied with

events that had taken place before the accident, so that the data of 16 December 2008 had not been secured (cf. Figure 12<sup>2</sup>).

Figure 12: Storage menu of the S-VDR for three full backups

As all the three backup opportunities were occupied at the time of the accident, and the backup disk was not manually cleared within 12 hours to enable recording of the accident in retrospect, no S-VDR recordings were available to BSU for investigating the collision.

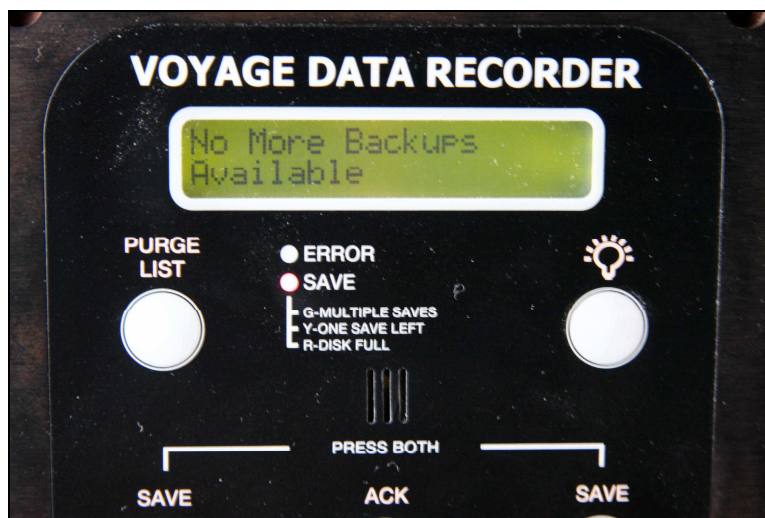
If a backup is conducted with all the backup save opportunities occupied, a corresponding message is displayed on the screen of the control panel, and the “SAVE” LED lights up in red in the steady mode (cf. Figure. 13).

Figure 13: Message display on the S-VDR screen

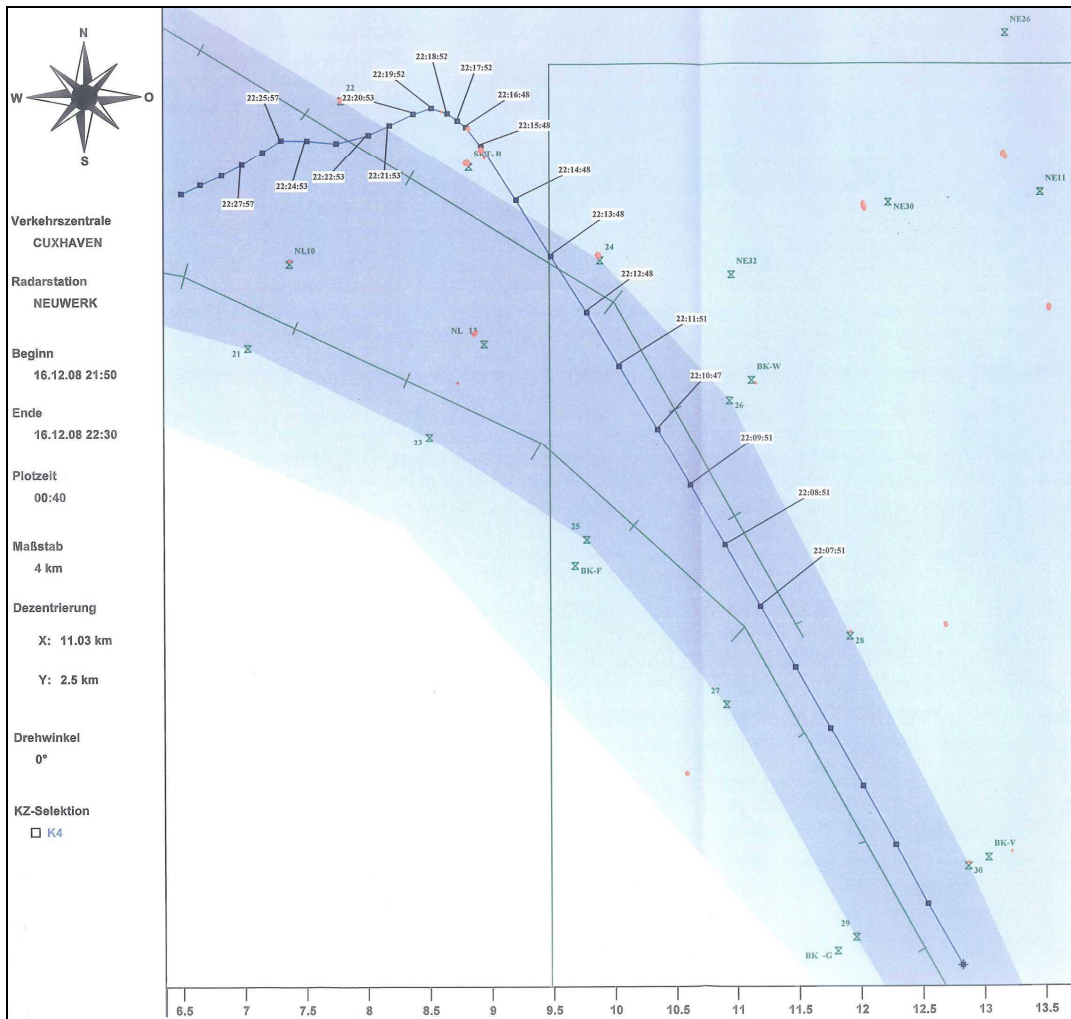
Figure 14: Radar image containing voyage course of the FREYA

It is clear from the voyage table as well as the radar image that even after passing buoy 24 at 2213, the FREYA initially maintained her speed of approximately 18 kts almost unchanged. The sudden drop in speed from 17.4 kts to 3.3 kts at the time of the accident (2216) is significant. The original course of exactly 330° was maintained almost right up to the collision.

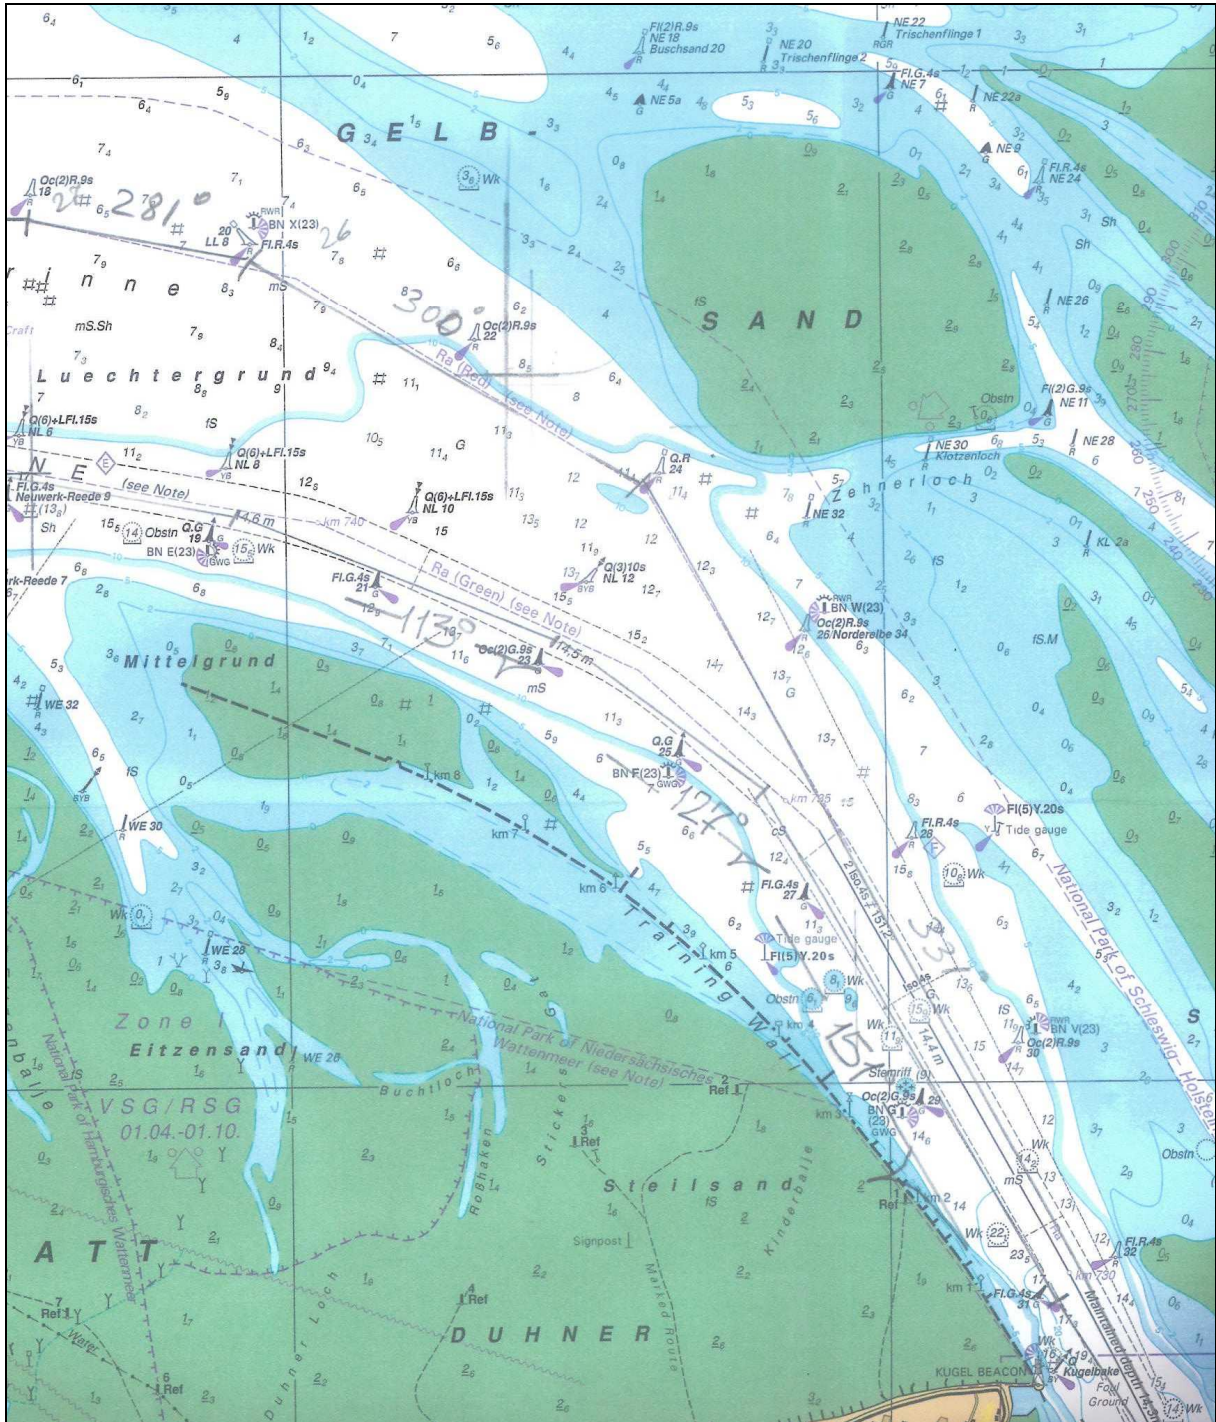
The route planning according to the nautical paper chart mostly followed the leading line displayed in the chart. This caused a problem because the chart had not been updated and hence it did not indicate the front light construction area as well as the restricted area.

Figure 15: Chart section BA 3619 with the entered courses of the FREYA

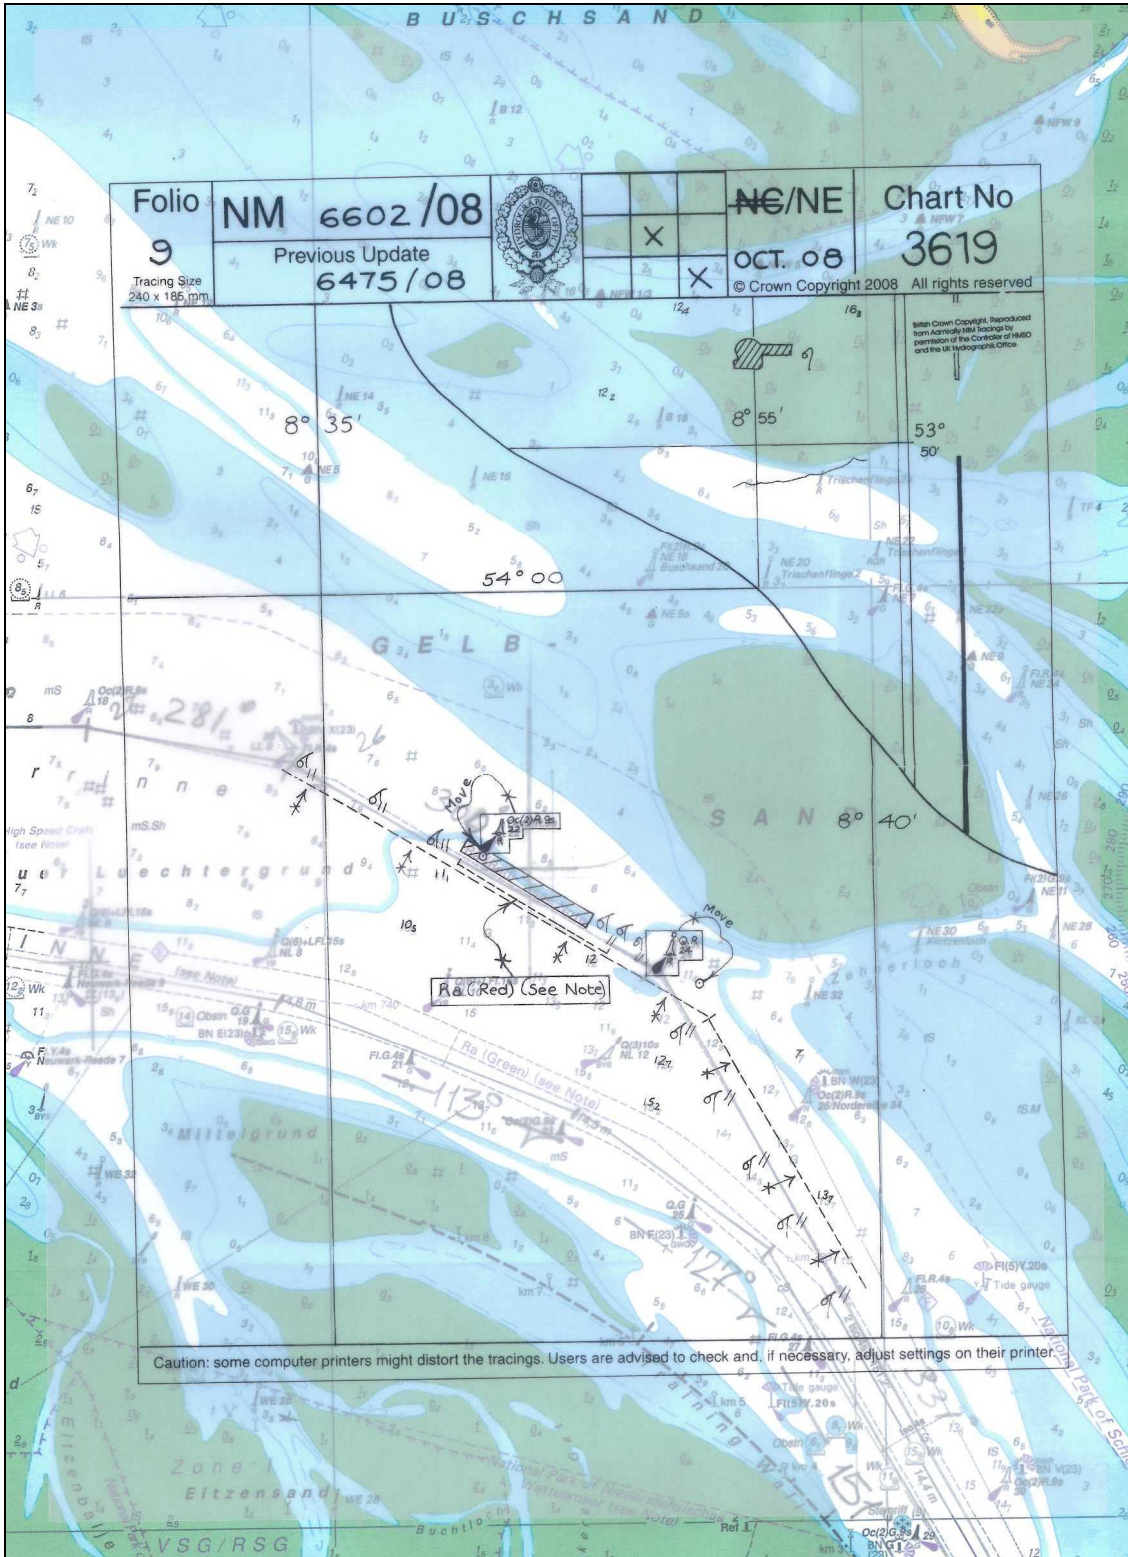
If the correction instructions had been available on the day of the accident, the absolutely essential adjustment of that days voyage planning would have been evident (cf. Figure 16).

Figure 16: Section from Chart BA 3619 containing the courses of the FREYA and correction sheet of the Notices for Mariners 6602/08
