**Bundesstelle für Seeunfalluntersuchung**  
**Federal Bureau of Maritime Casualty Investigation**  
Federal Higher Authority subordinated to the Ministry of Transport,  
Building and Urban Development

Investigation Report 015/09

**Very serious marine casualty**

**Capsize of the SY TAUBE with six fatalities  
off the Atlantic coast of Morocco  
on 20 January 2009**

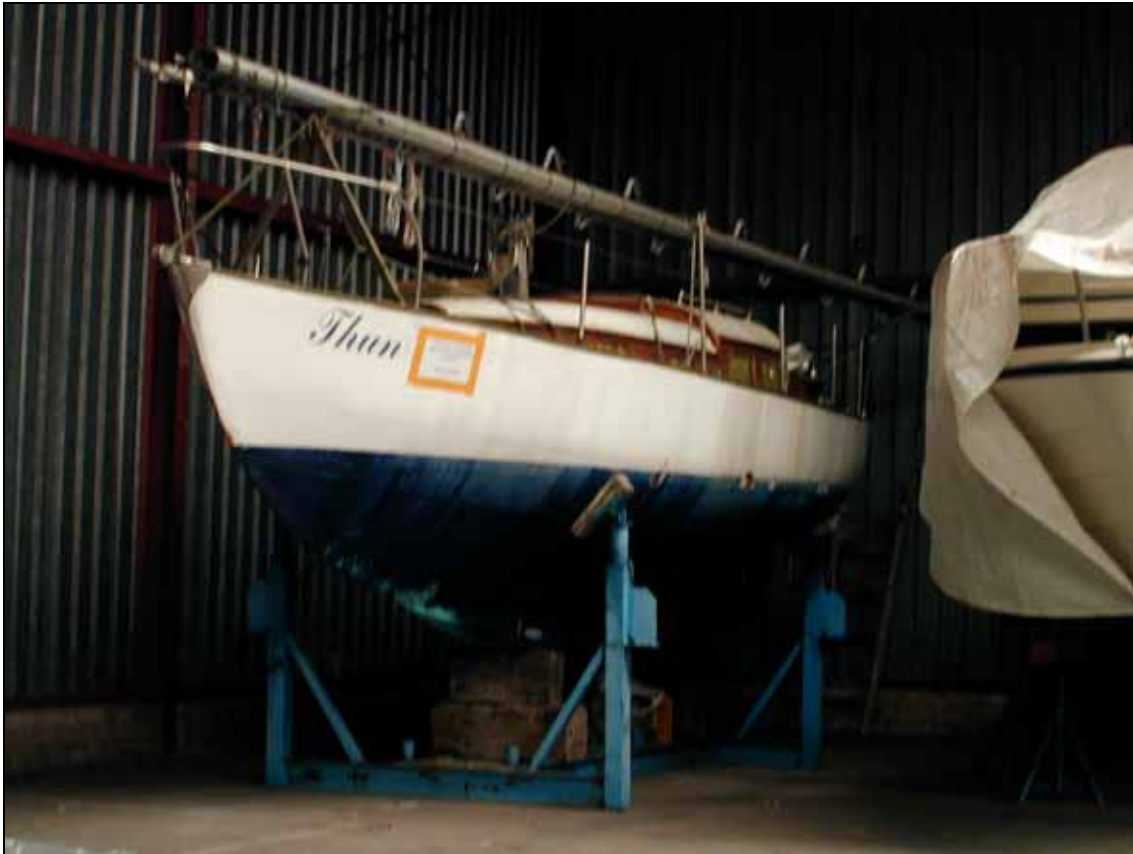
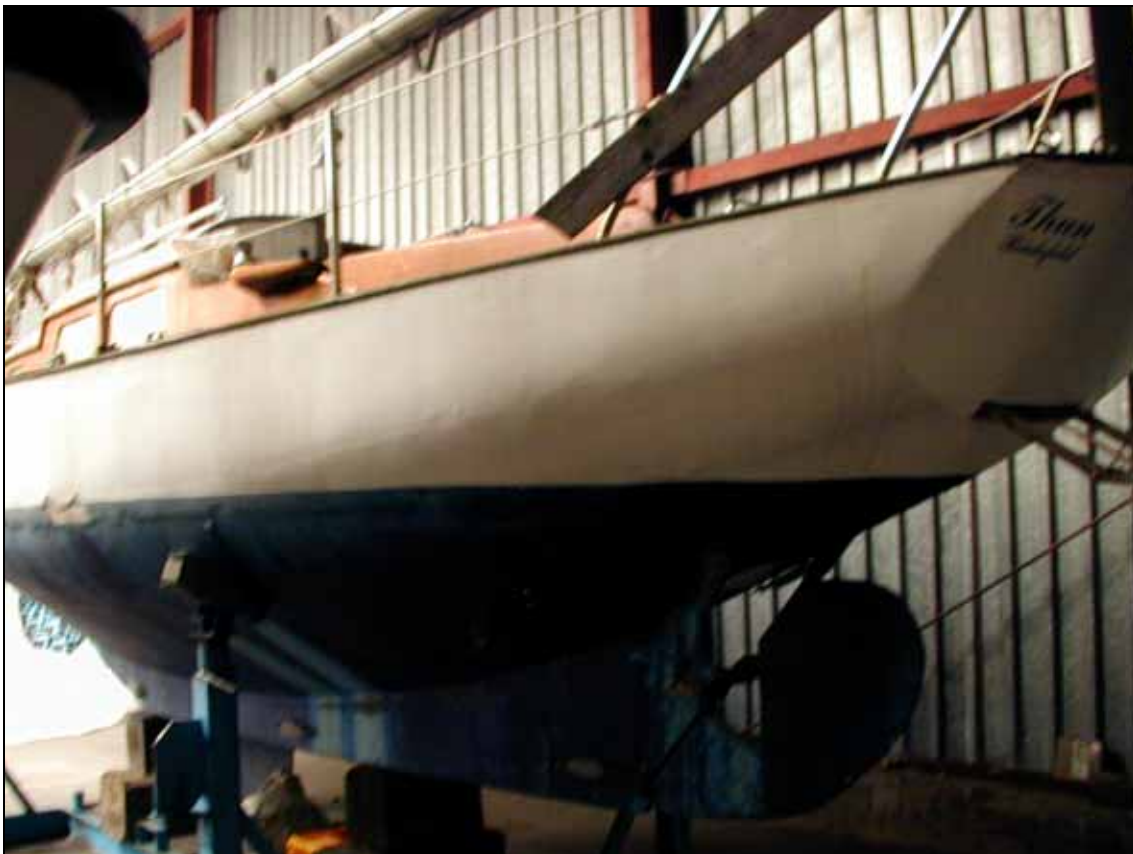
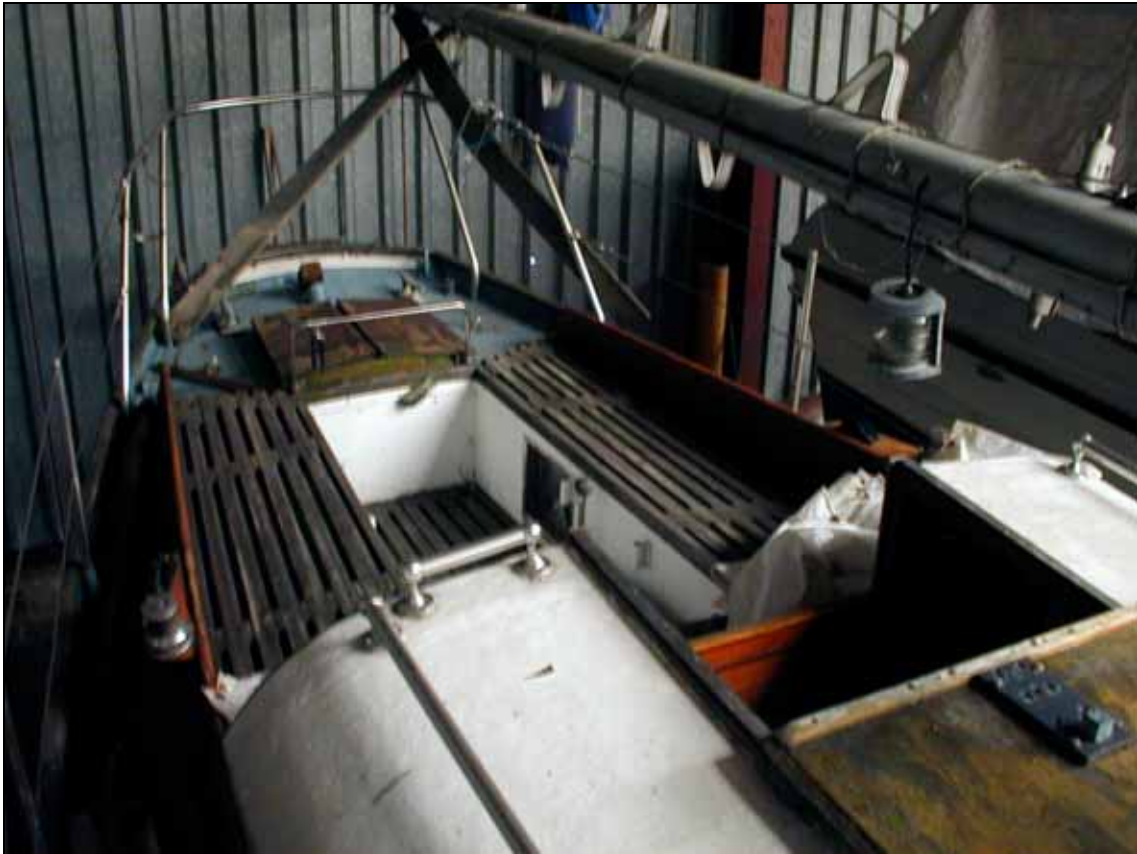
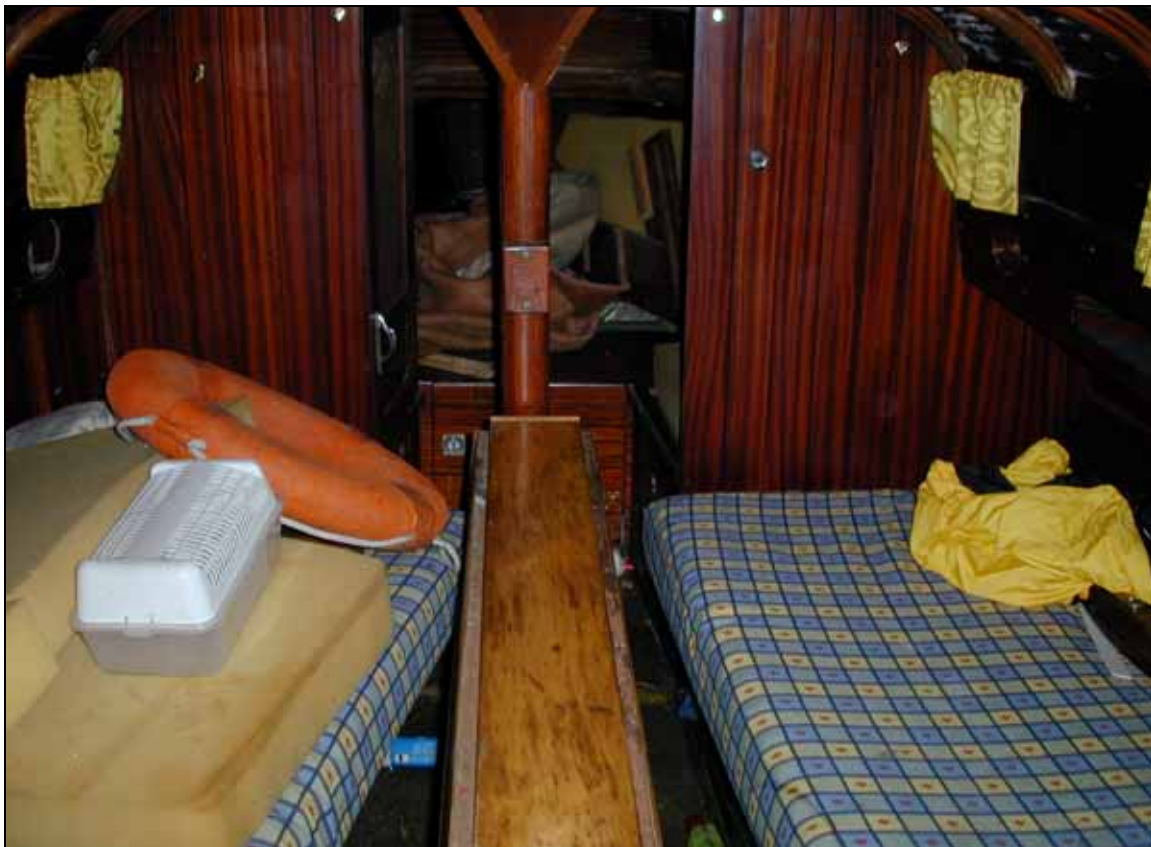
- Engine not running
- Centre board stuck in place
- Electrical system inoperable
- Hull is penetrated and has external damage
- Cracked fillers
- Rig damage and sail missing
- The yacht is not seaworthy

The repair of the TAUBE was carried out independently by members of the operating association. Work began on 20 August 2007. The original condition of the yacht is documented by the following photographs (Figs. 7 to 10).

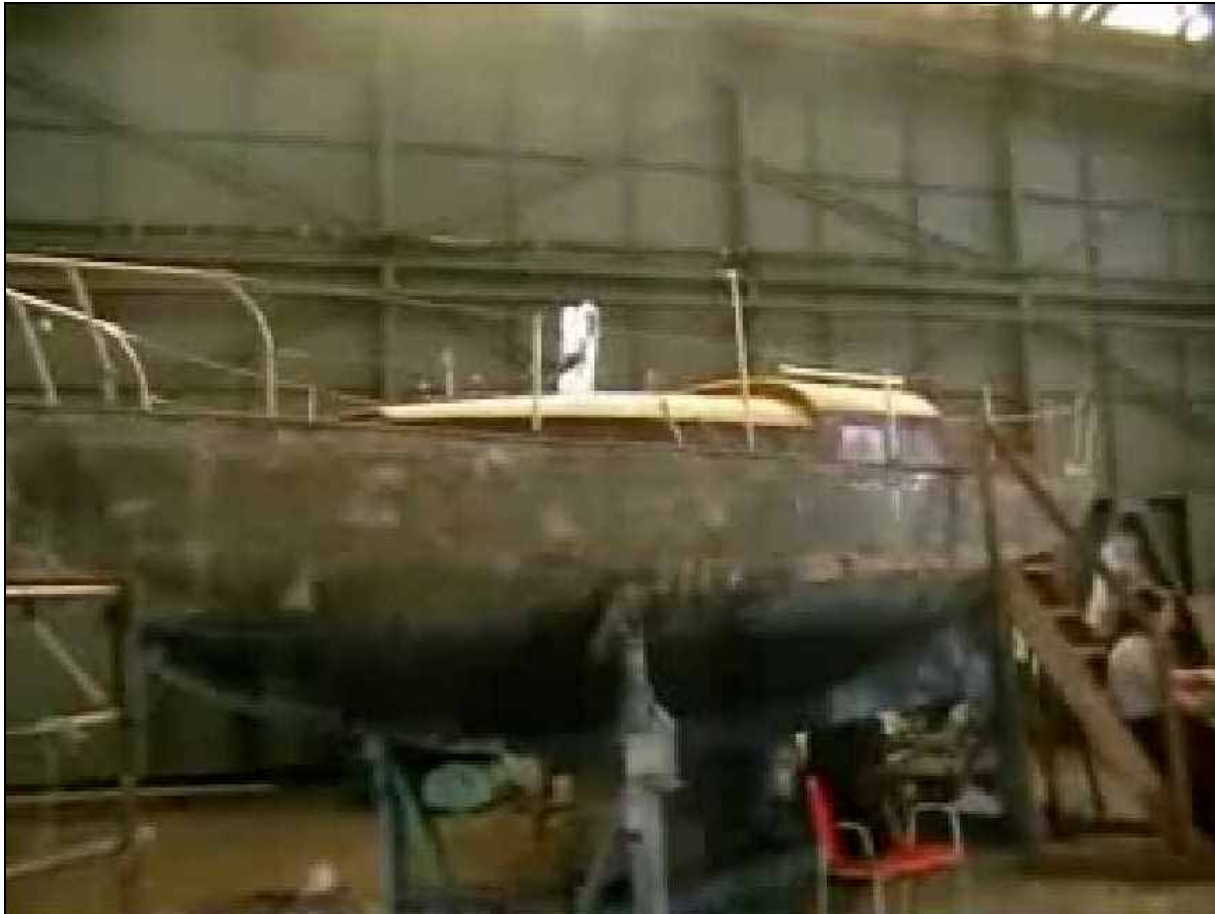
Figure 11: TAUBE during the restoration, video excerpt

The work was partly recorded on video. According to that, paint residues and rust were removed from the hull of the TAUBE and the deck (see Fig. 11).

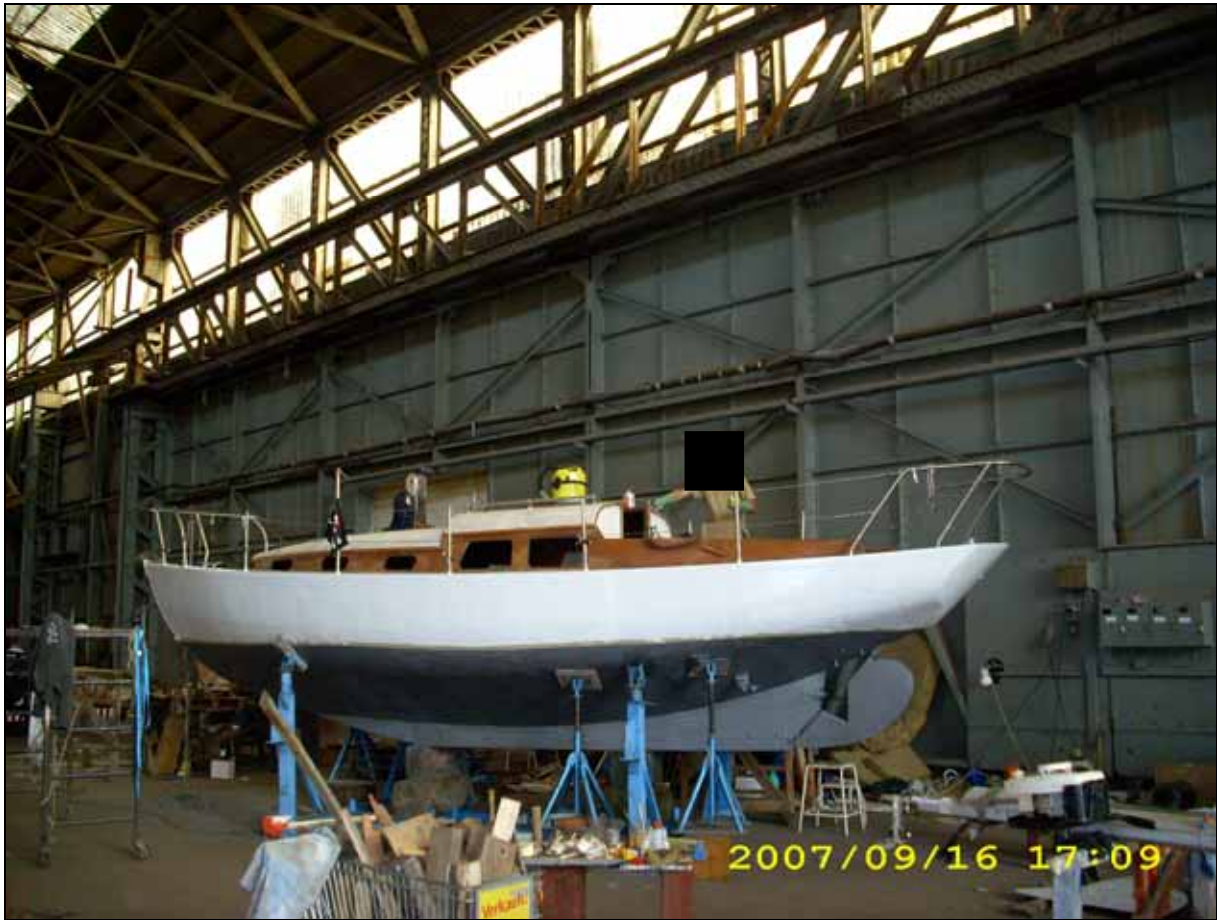
Figure 12: TAUBE during the restoration, painting the hull

The hull was sanded and then provided with a coat of paint. Rigging was removed before work began. The jib and mainsail were bought second hand by the operating association of the TAUBE from the pre-owners of the ex THUN. Inter alia, files were used on the heavily rusted centre board compartment to make the centre board operable again. By the middle of September 2007, the hull once again had a coat of paint (Fig. 12) and the centre board was operable again (Fig. 13).

Witnesses with relevant experience considered the overall work to be amateurish. Several futile attempts were reportedly made to dissuade the members of the association from putting their plans into practise or encourage them to work towards using the TAUBE only for coastal cruises on the Baltic Sea.

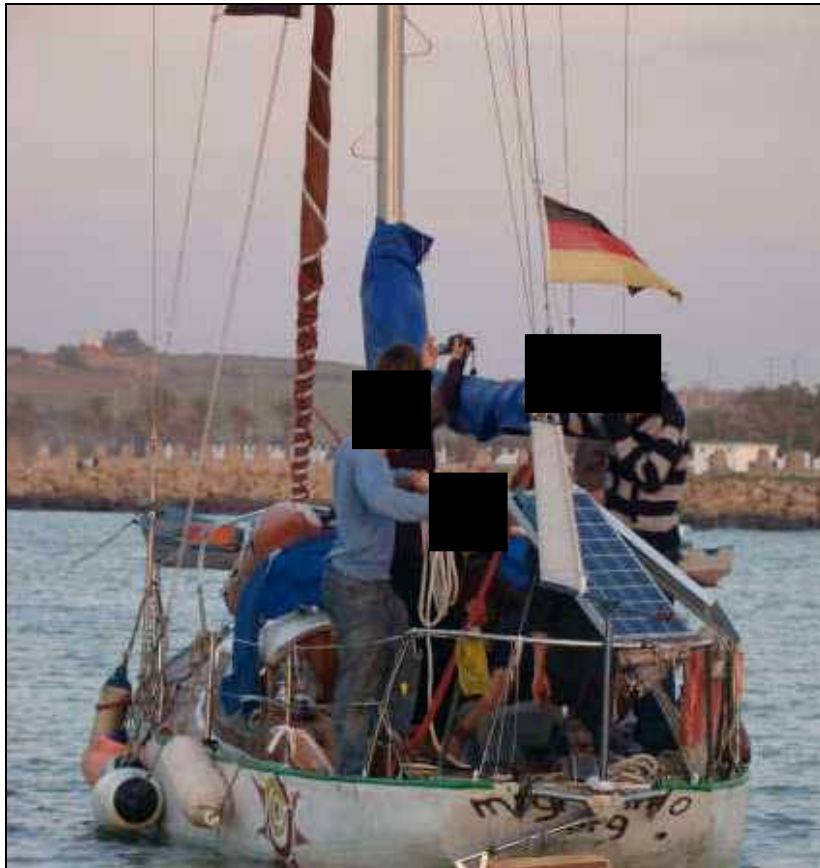
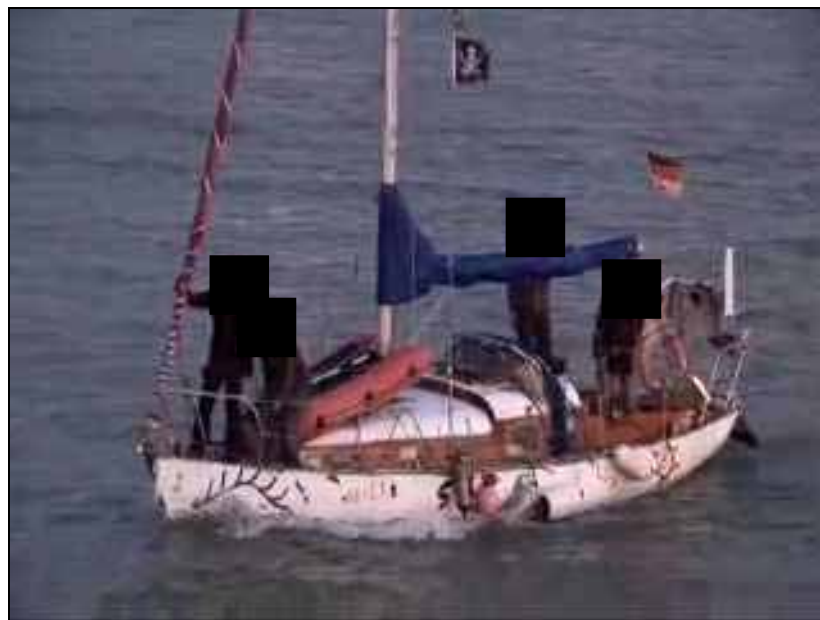
Estimates by the BSU indicate that the freeboard was no more than 50 cm. The filmshots also show the TAUBE dip into the light swell within the port's exit area.

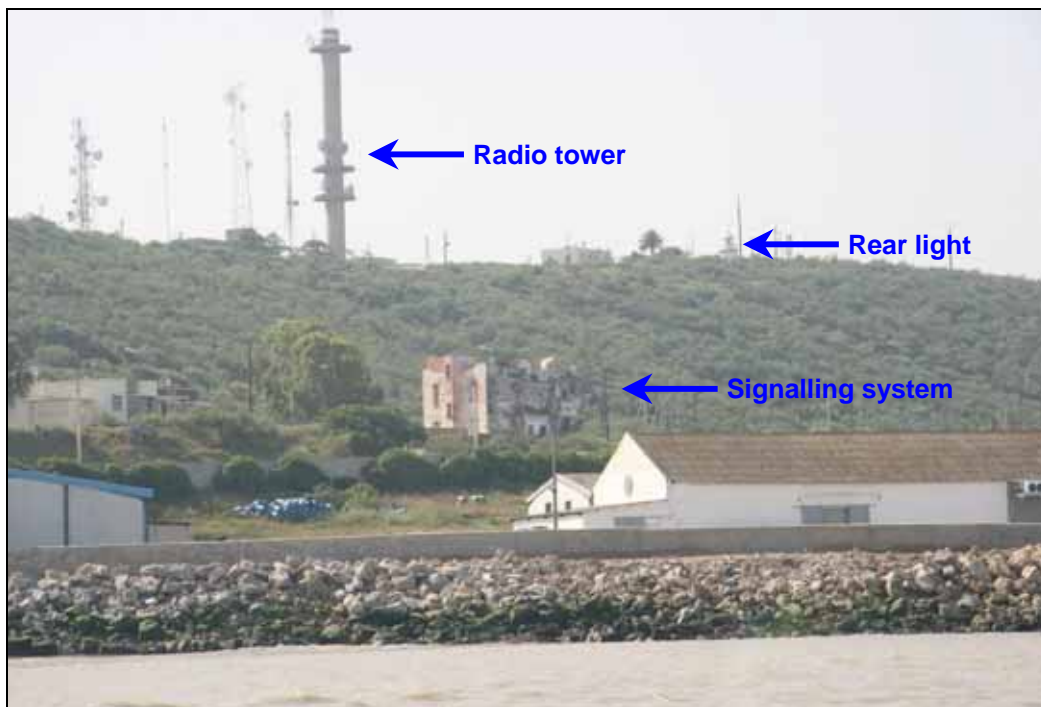
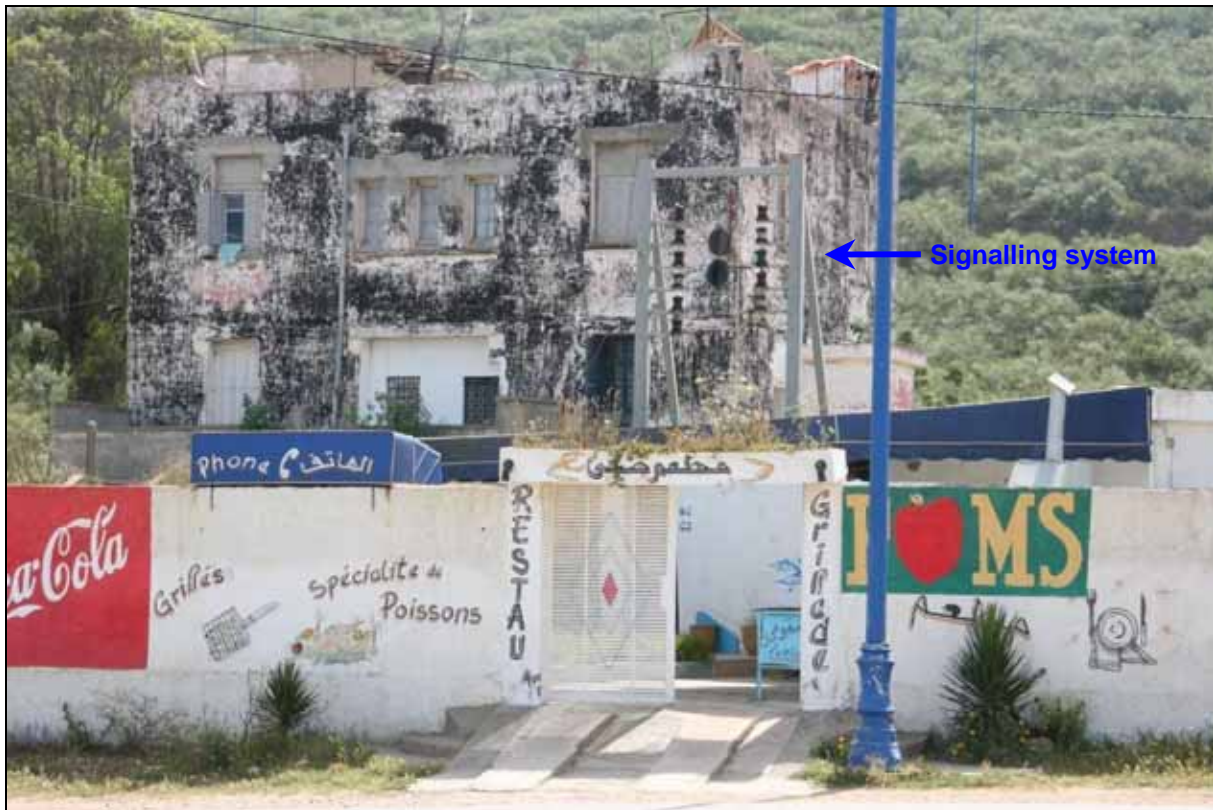
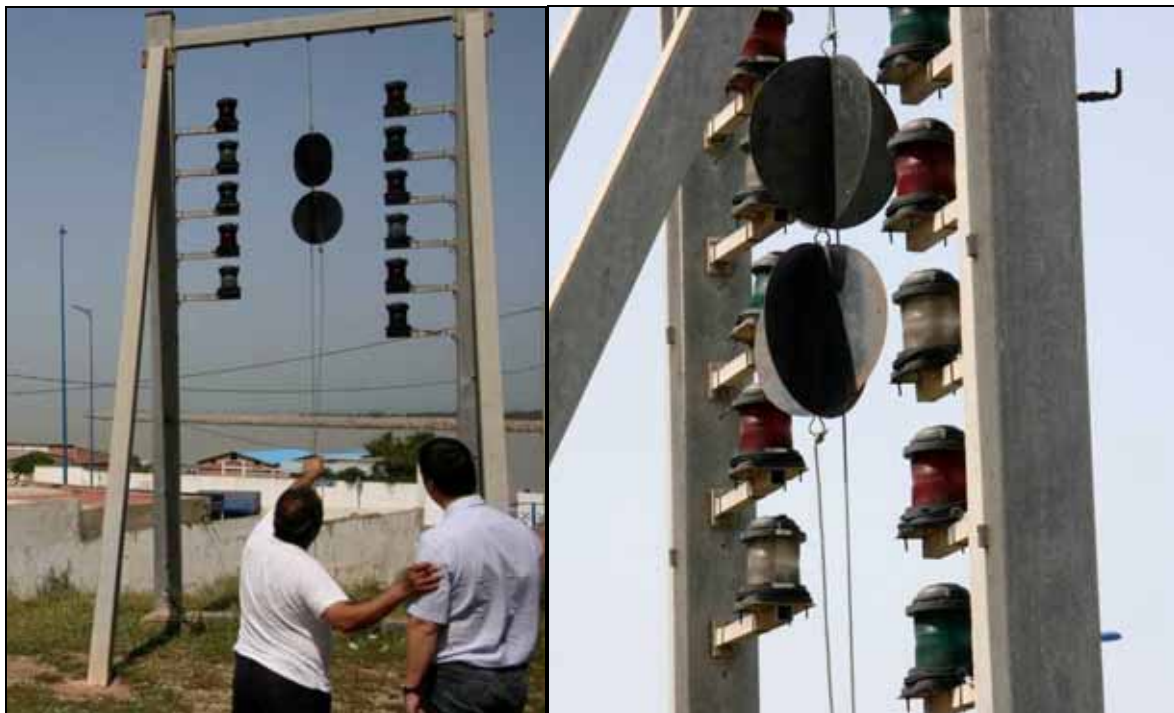
Even up close the port signalling system is difficult to make out against the backdrop of the port authority building situated behind it (Fig. 32 and 33).

The BSU assumes that the crew of the TAUBE was unable to discern the signalling system with the weather conditions prevalent on the day of the accident.

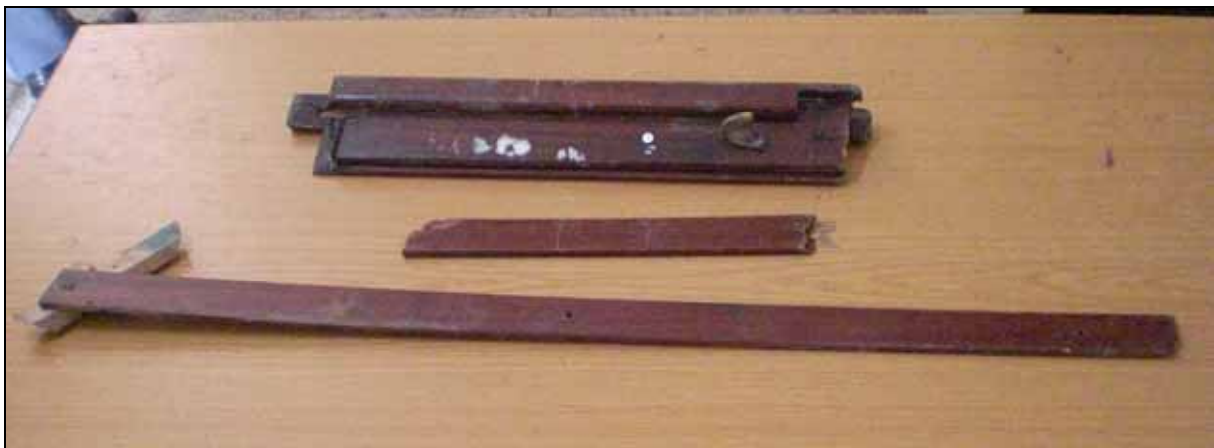
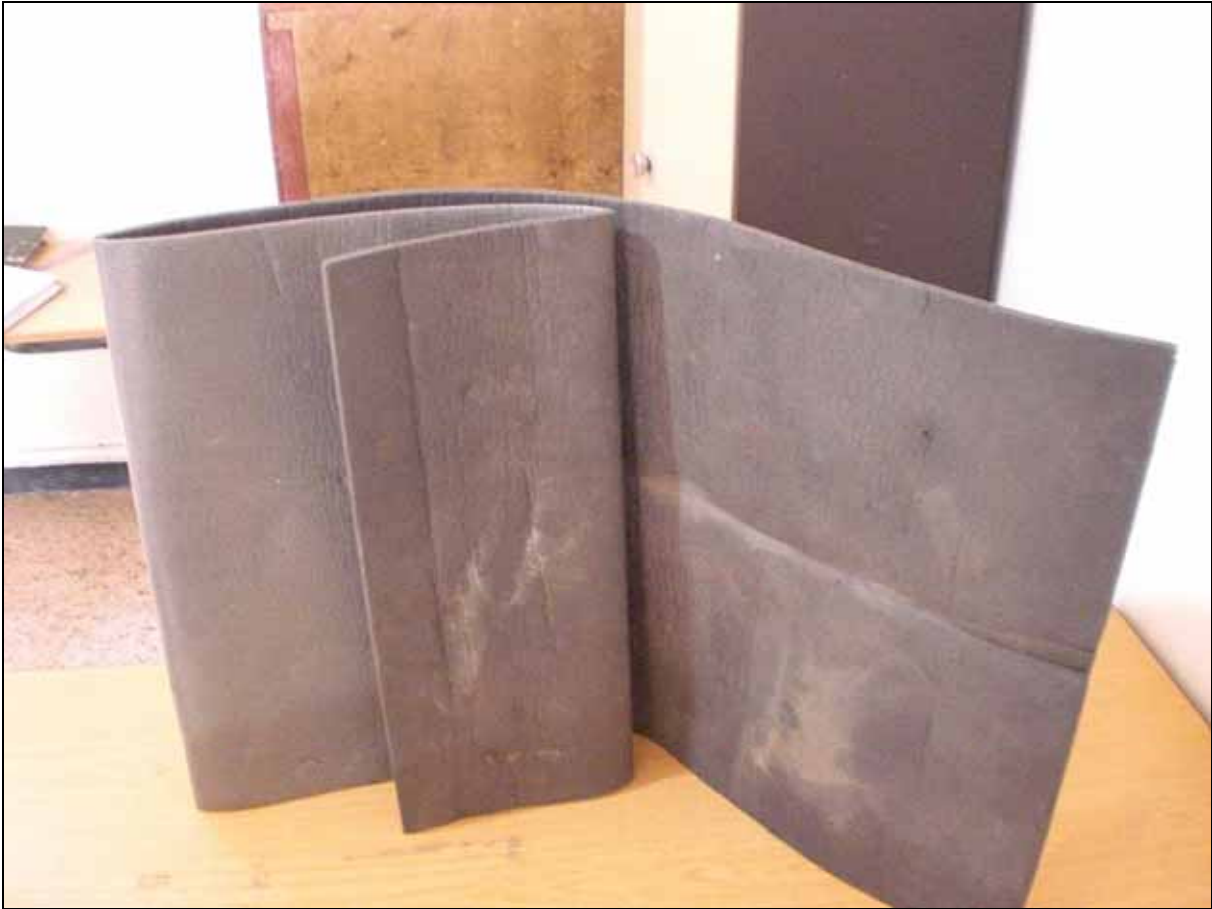
In the days following the accident, numerous items of equipment from the TAUBE, including the rubber dinghy, were washed ashore and taken into custody by the local police. In close collaboration with WSP Brunsbüttel and the BKA liaison officer in Rabat, the BSU was finally provided with details about these exhibits in November 2009. The exhibits consisted of a non-inflated life vest, a few wooden pieces, supposedly of the TAUBE (Fig. 33) and the sleeping pad used by the only survivor to swim ashore (Fig. 34).

These exhibits did not provide additional information to the investigators.
