Bundesstelle für Seeunfalluntersuchung
Federal Bureau of Maritime Casualty Investigation
Federal Higher Authority subordinated to the Ministry of Transport,
Building and Urban Development

Summary
Investigation Report 20/09

Collision on the Kiel Canal (NOK)
between HANSE VISION and BIRKA EXPRESS
on 12 January 2009 at 1424

1 March 2010

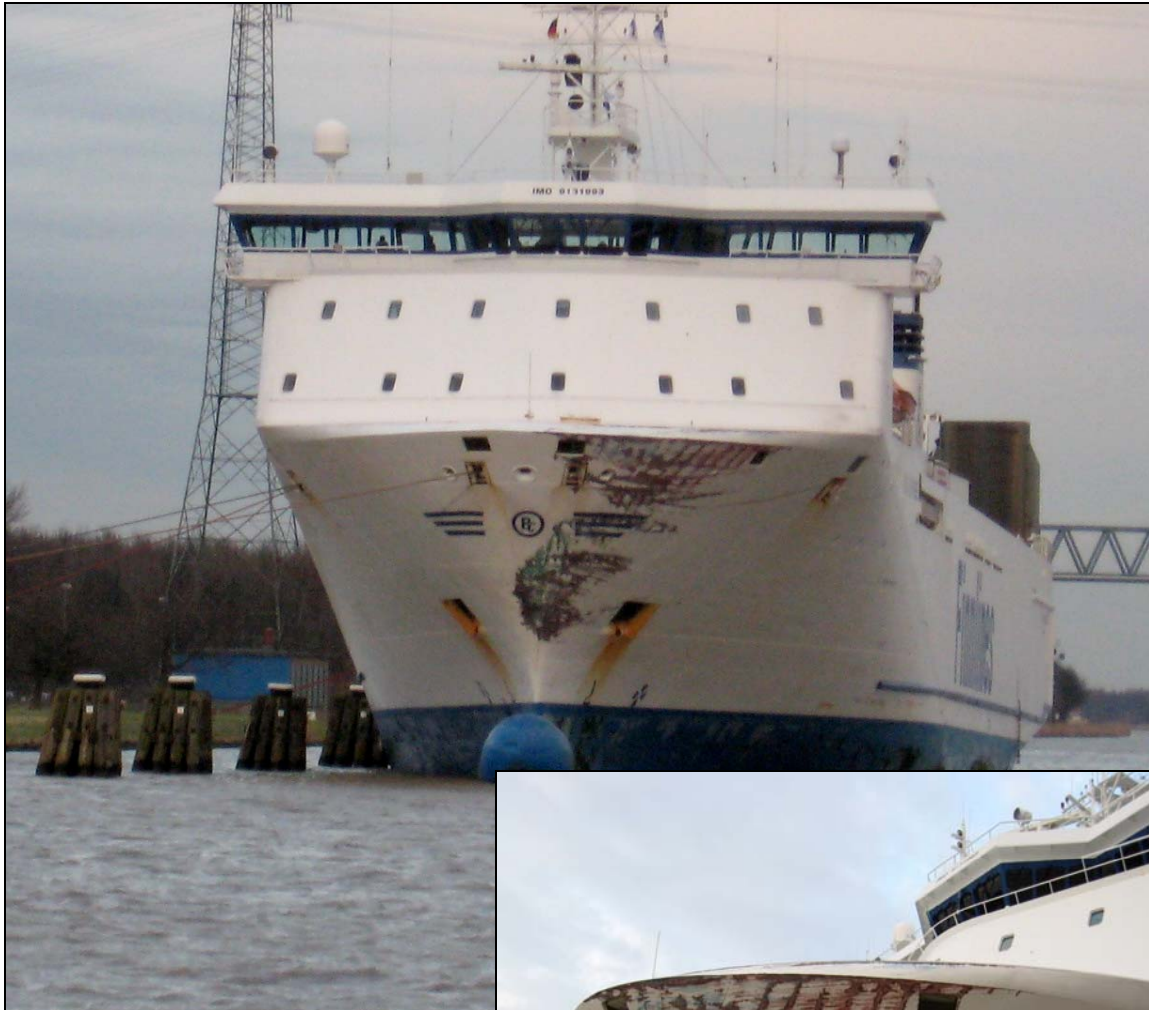
Figure 5: Damage overview

The BIRKA EXPRESS had heavy paint abrasions and deformations on the bow section.

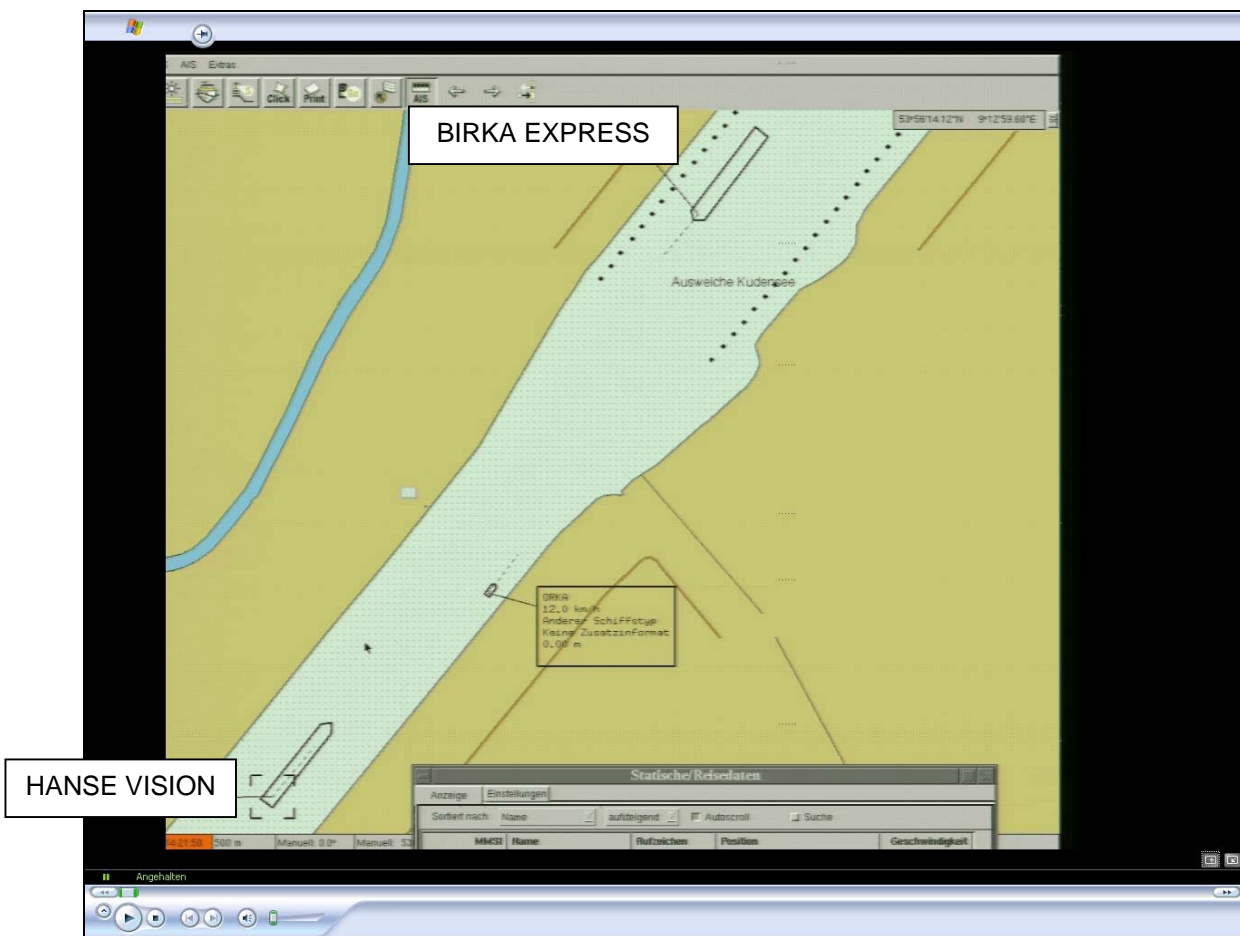
Figure 9: AIS display of the VTS at 142150

Figure 9 shows how the two vessels move towards each other. According to the numerical AIS data, graphically depicted in Figure 10, the BIRKA EXPRESS began to reduce her speed at 1421. At that time, she was located about 200 m from the siding area's western boundary. At about 1423, she increased her speed in order to improve the steering effect.

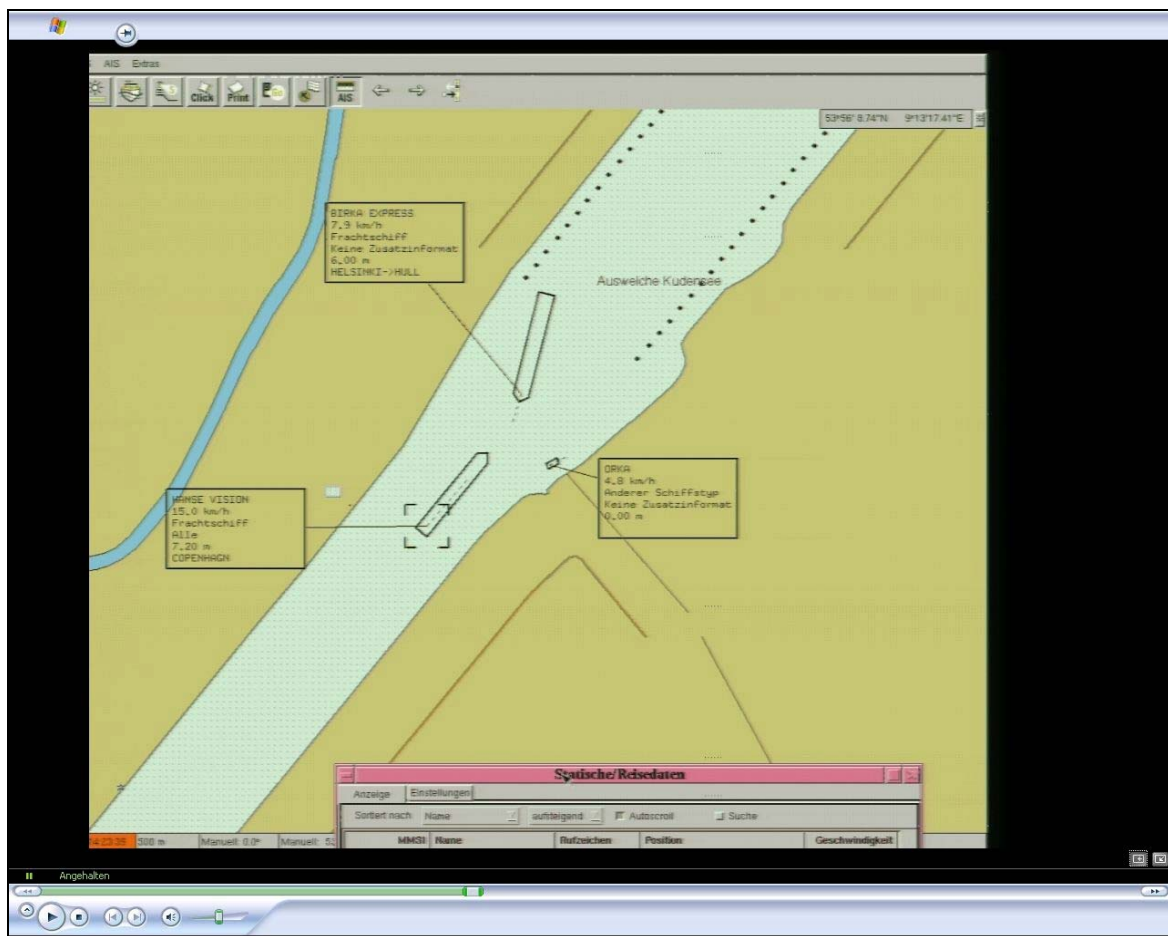
Figure 11: AIS display of the VTS at 142335

In Figure 11 we see clearly that the BIRKA EXPRESS was moving at 11 km/h when she passed the boundary of the Kudensee siding area. In the process, she began to turn to port.

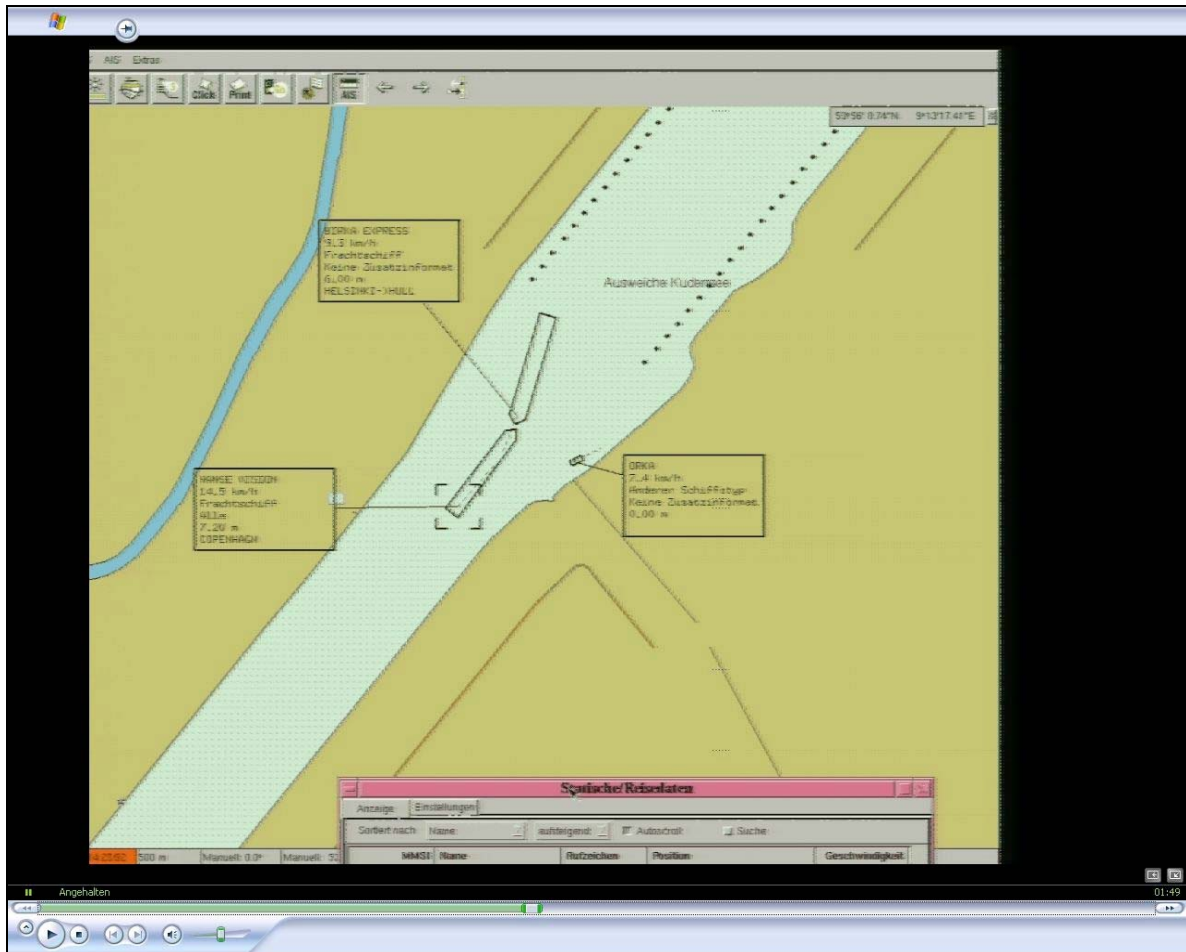
Figure 12: AIS display of the VTS at 142352

Figure 12 shows the time of the collision. The speed of the BIRKA EXPRESS was still 9.3 km/h and the HANSE VISION 14.5 km/h.

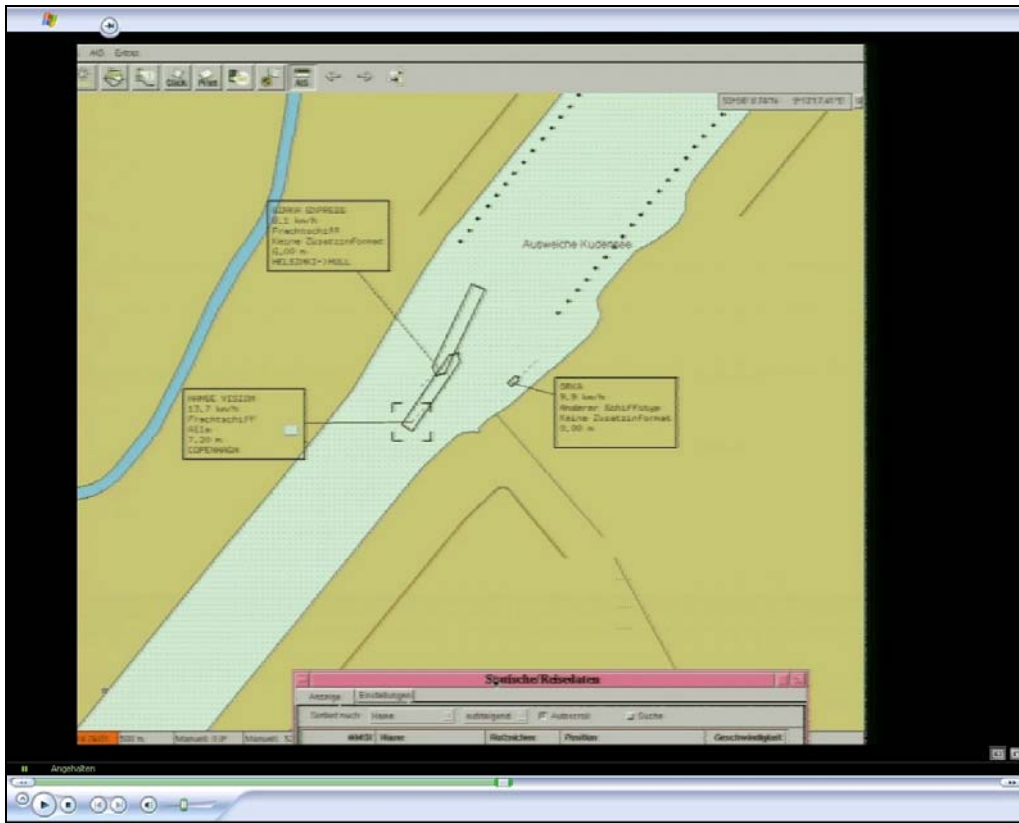
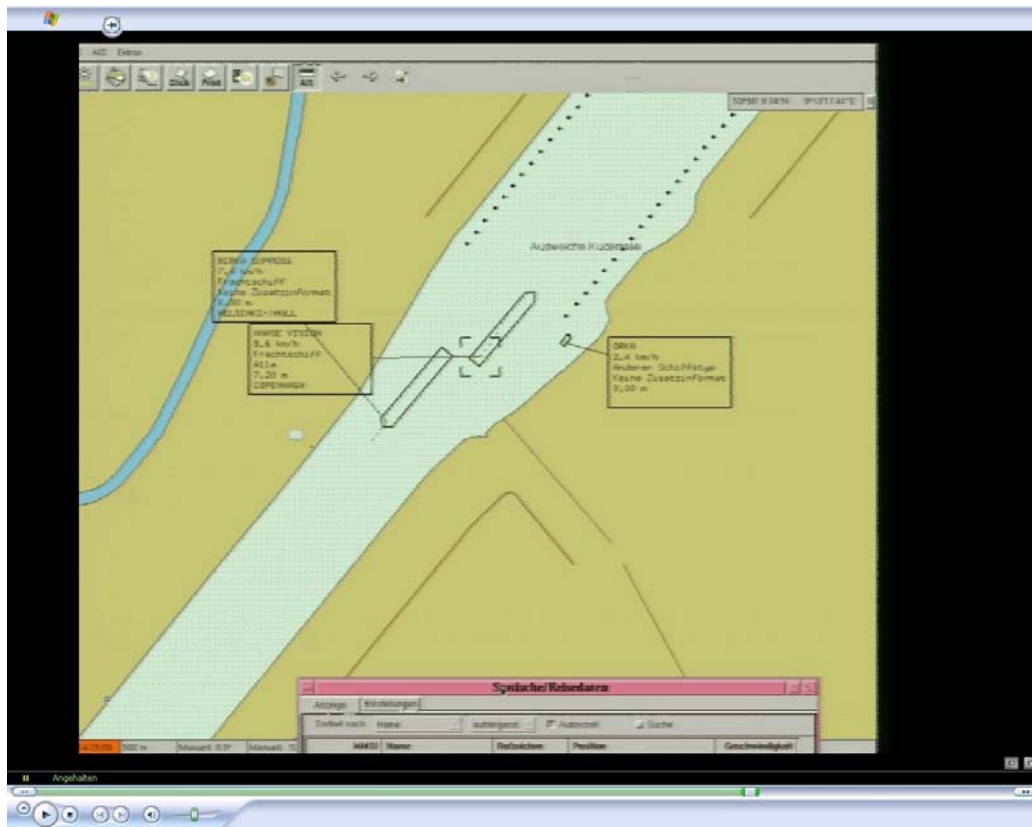
The following two figures show how each vessel passes the other on her port side.

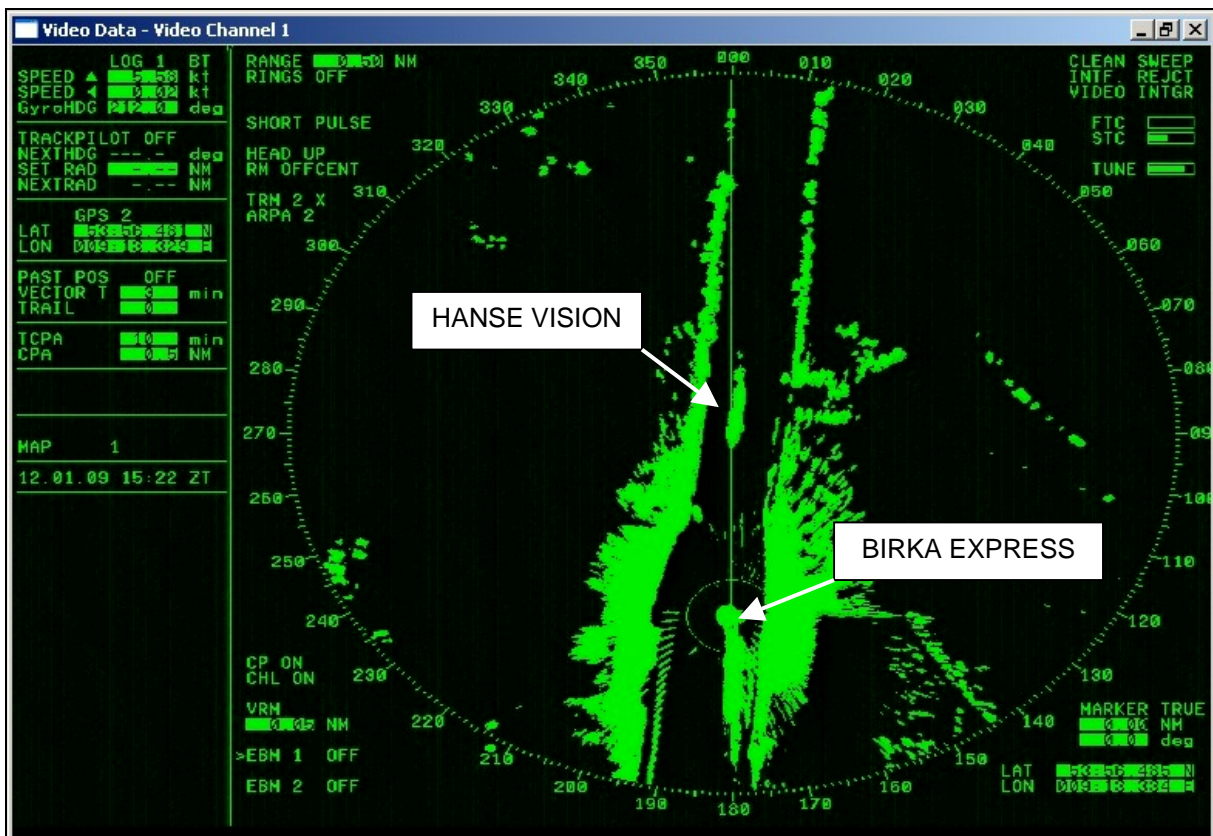
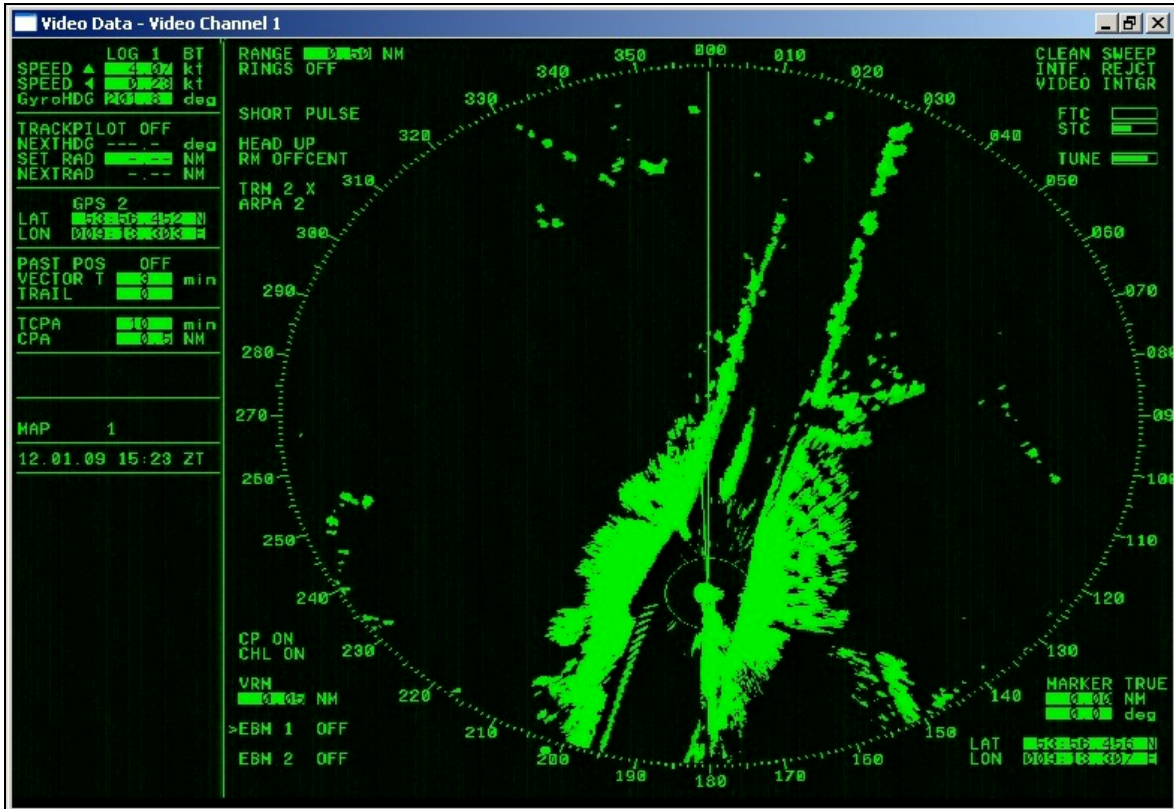
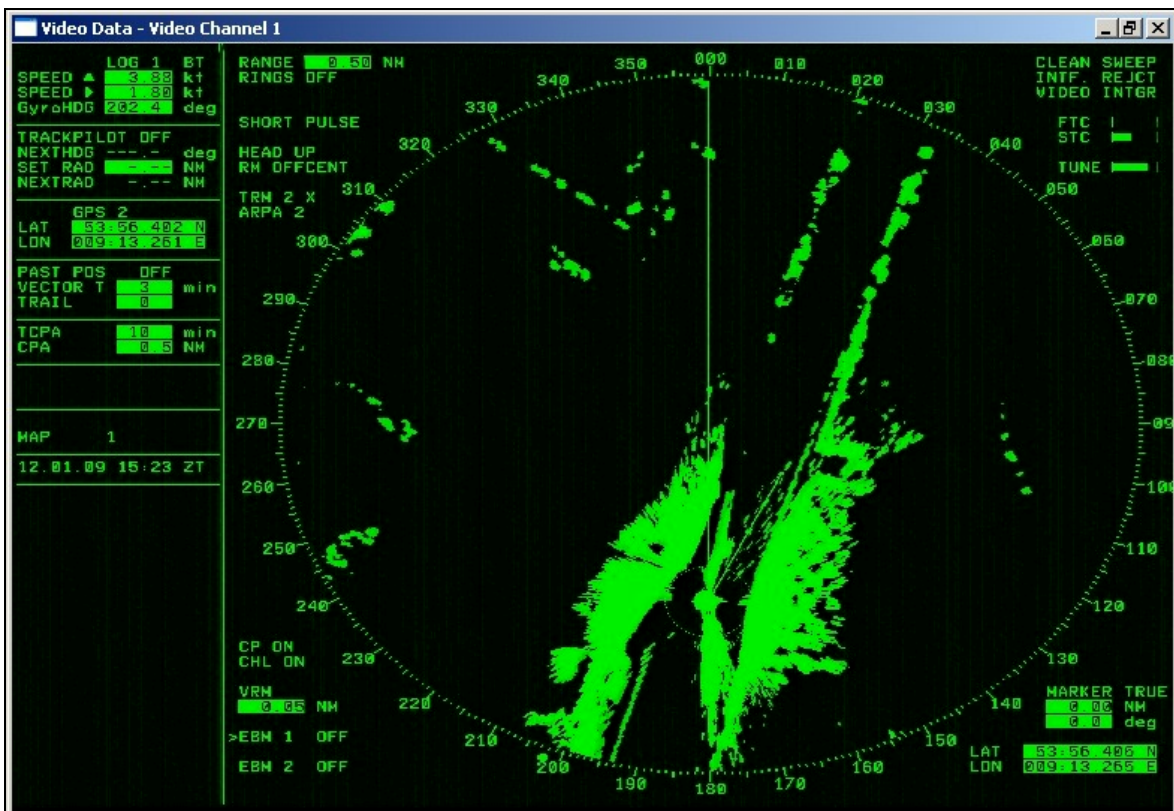
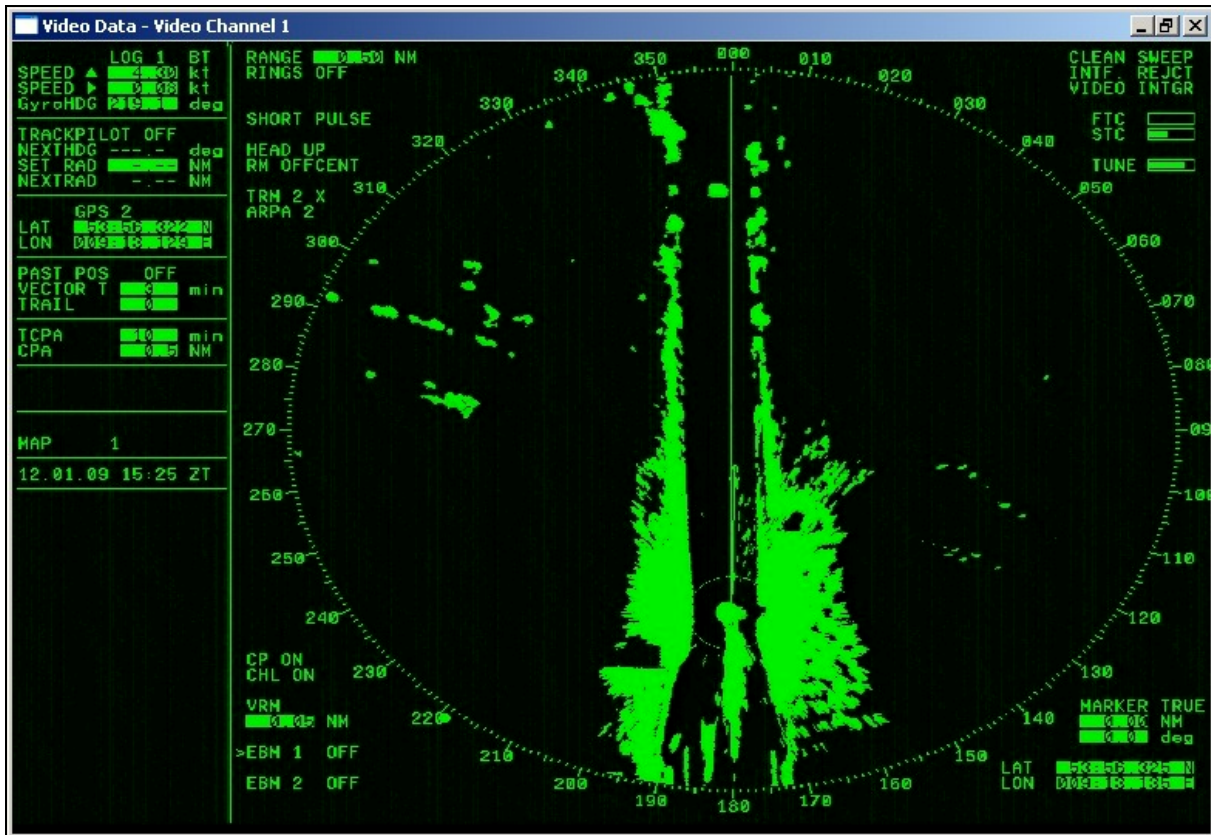
The AIS representation of the VDR is omitted here because it was not underlaid with a nautical chart; therefore, reference is made to the records of the VTS under para. 6.3. The following radar images further illustrate the course of the accident. Figure 15 shows the initial situation of each vessel at about 1422. In the figure below we see how the BIRKA EXPRESS reaches the siding area boundary at the end of the row of dolphins and begins to turn to port while the HANSE VISION approaches her.

The radar images confirm the manner in which the AIS records of the VTS represent the course of the accident.
