Summary
Investigation Report 07/10

Very Serious Marine Casualty

Foundering of the FV ORTEGAL UNO
on 13 January 2010
west of Ireland

1 November 2010

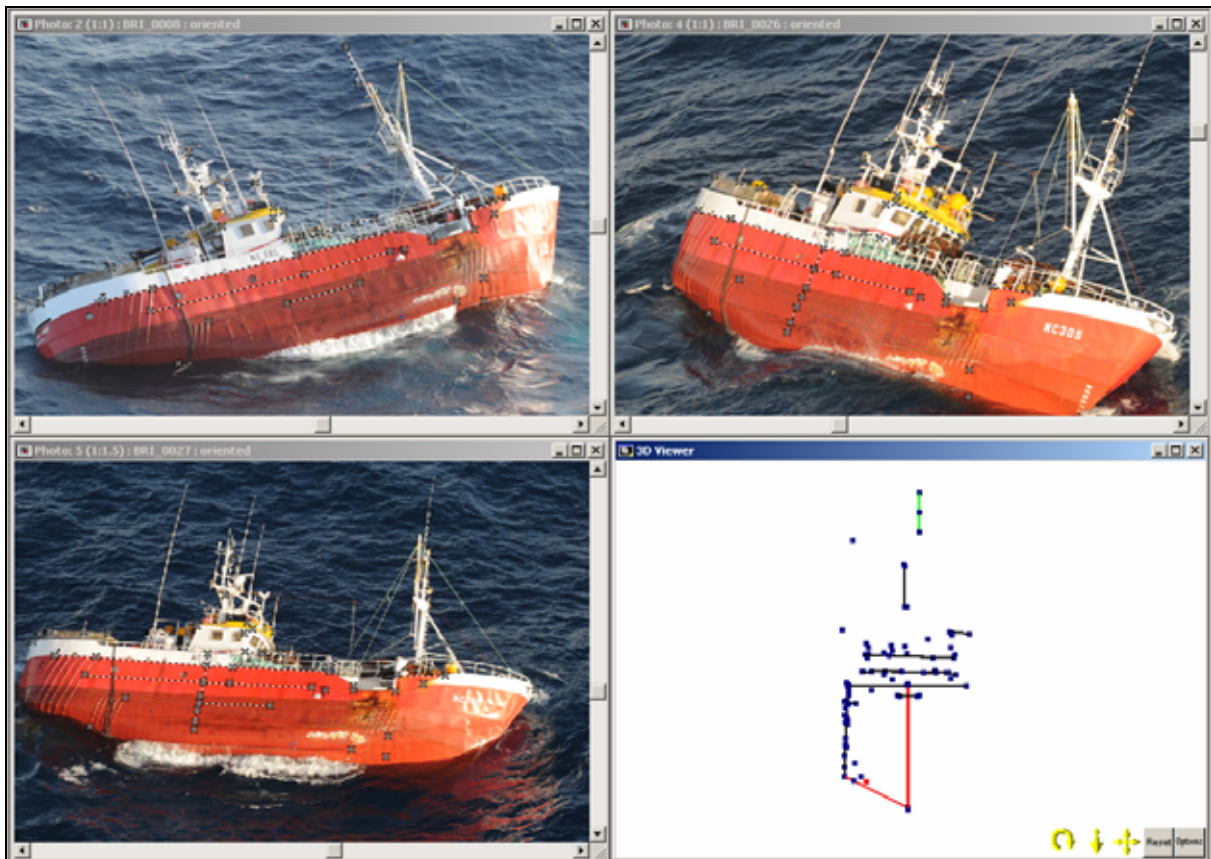
Figure 3: Measurement points on the hull

An appropriate number of identical points on the hull were measured to reconstruct the fishing vessel's position in the water (see Figure 3).

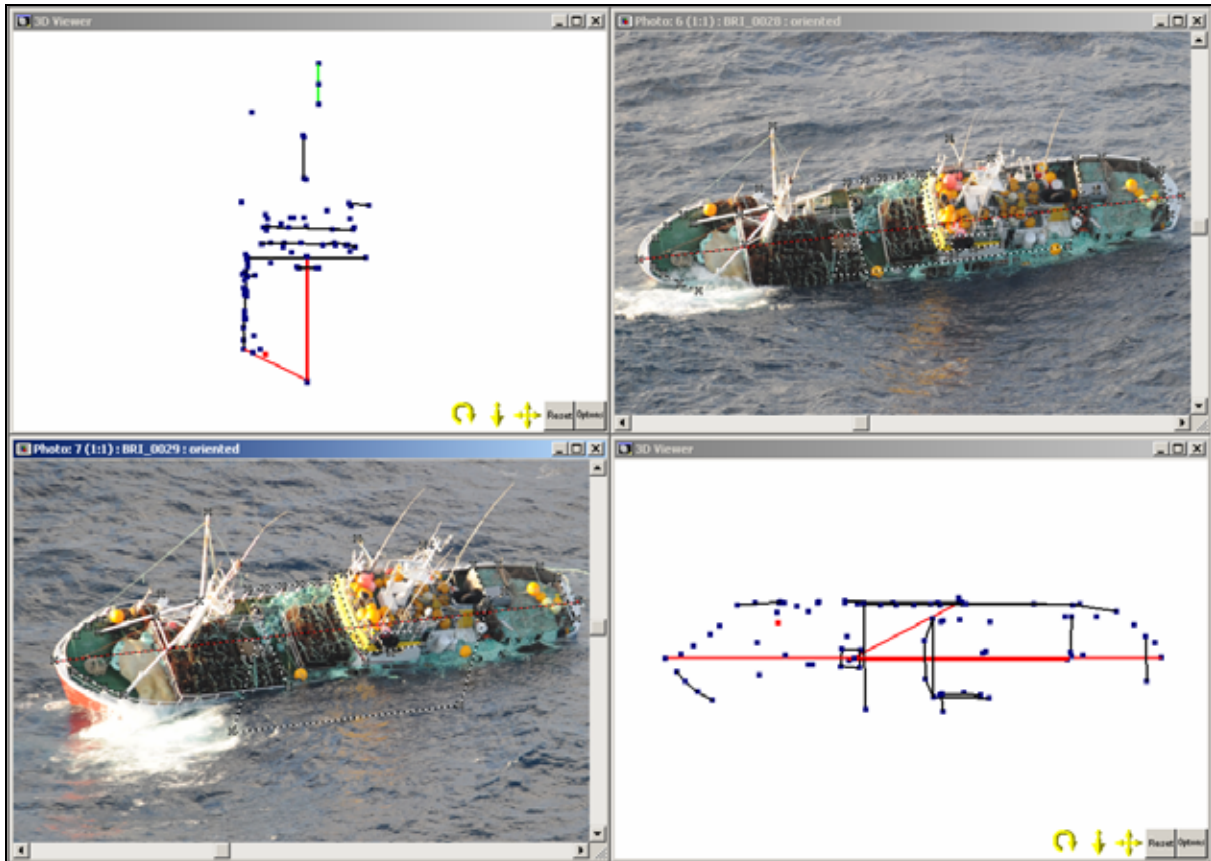
Figure 4: Shape and position of the hull

It was possible to determine the shape and position of the fishing vessel in relation to the water surface from the three-dimensional calculation of the visible side of the vessel and additional points on the port side (see Figure 4).

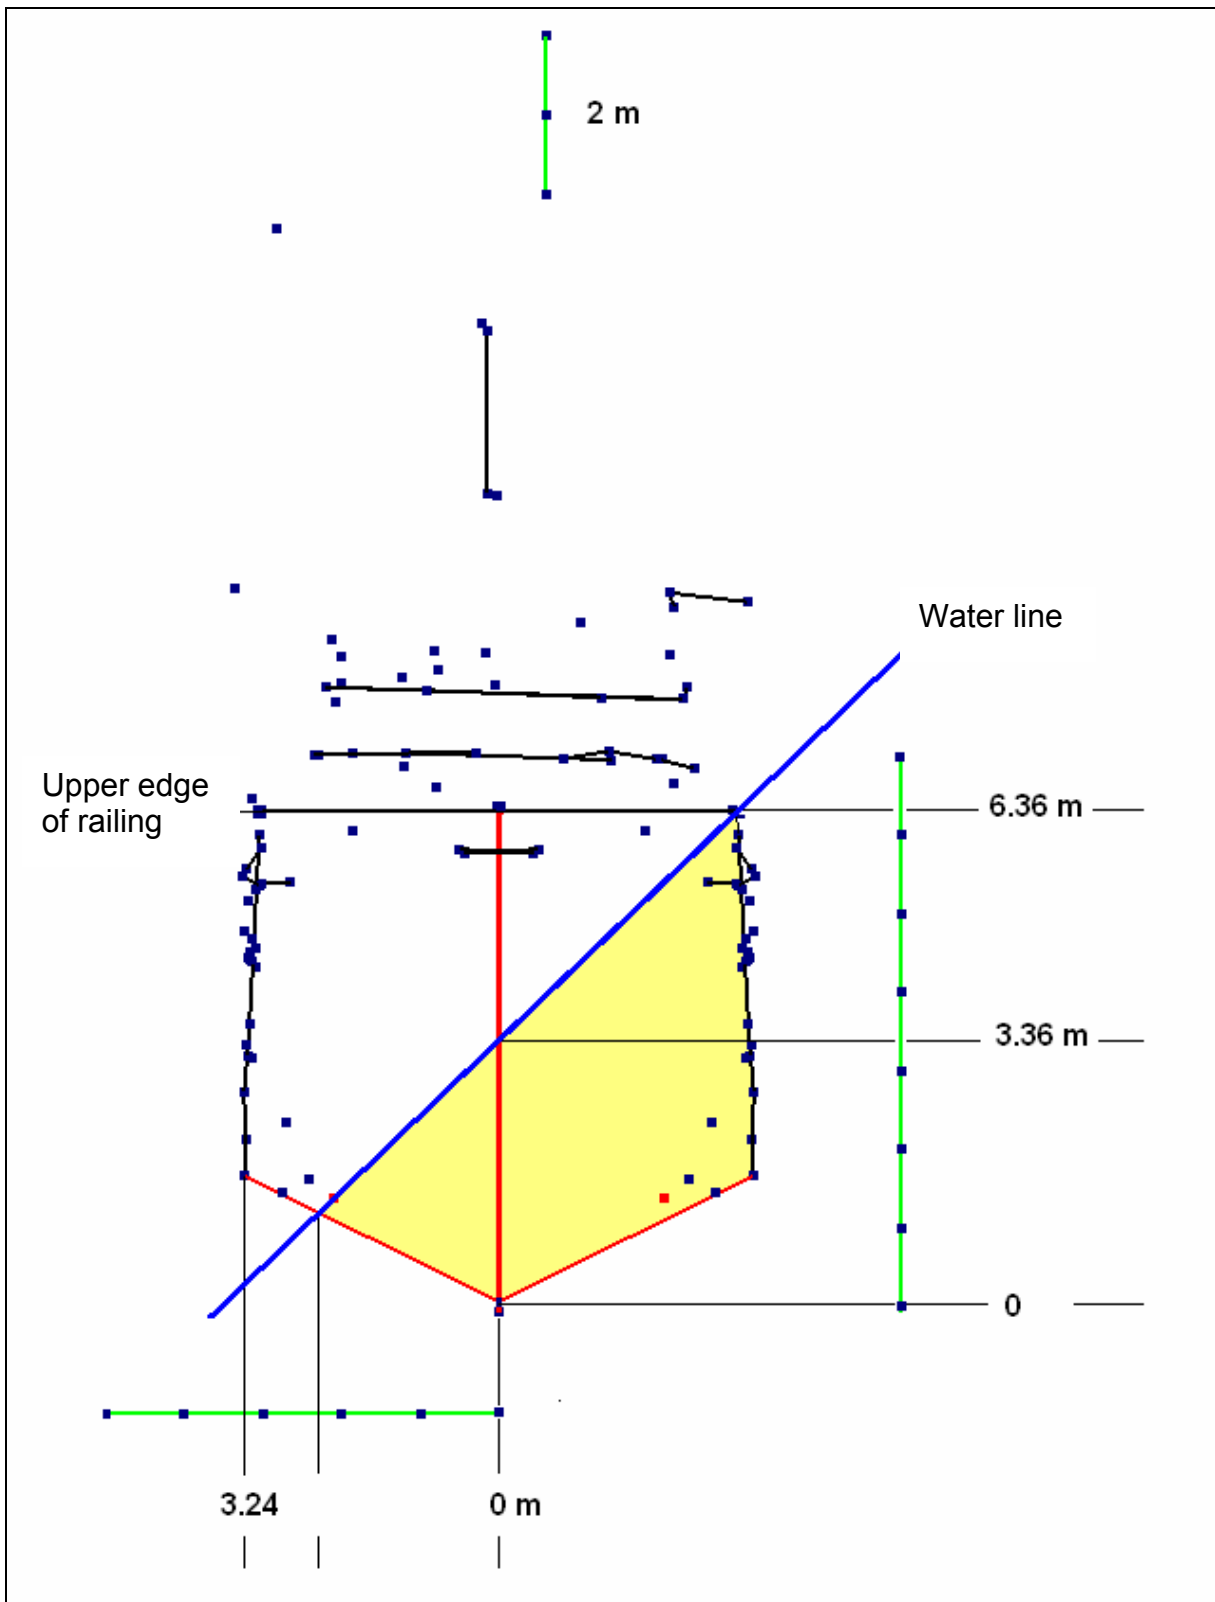
Figure 6: Front view (from bow to stern) with reconstructed port side

Evaluation of the digital images of the accident shows that the water reached the ORTEGAL UNO's port railing at the time they were taken. The water level was 3.36 m in midships at the time. Due to the swell and measurement uncertainty, this value may vary by +/- 0.20 m. The yellow area in Figure 6 shows the immersed part of the fishing vessel.

The water line runs 3 m below the upper edge of the railing through the centre of the vessel. A half beam of 3.24 m results in an angle = $\text{atan}(3.24/3) = 47.2^\circ$. The angle of the deck in relation to the waterline is therefore 42.8° .

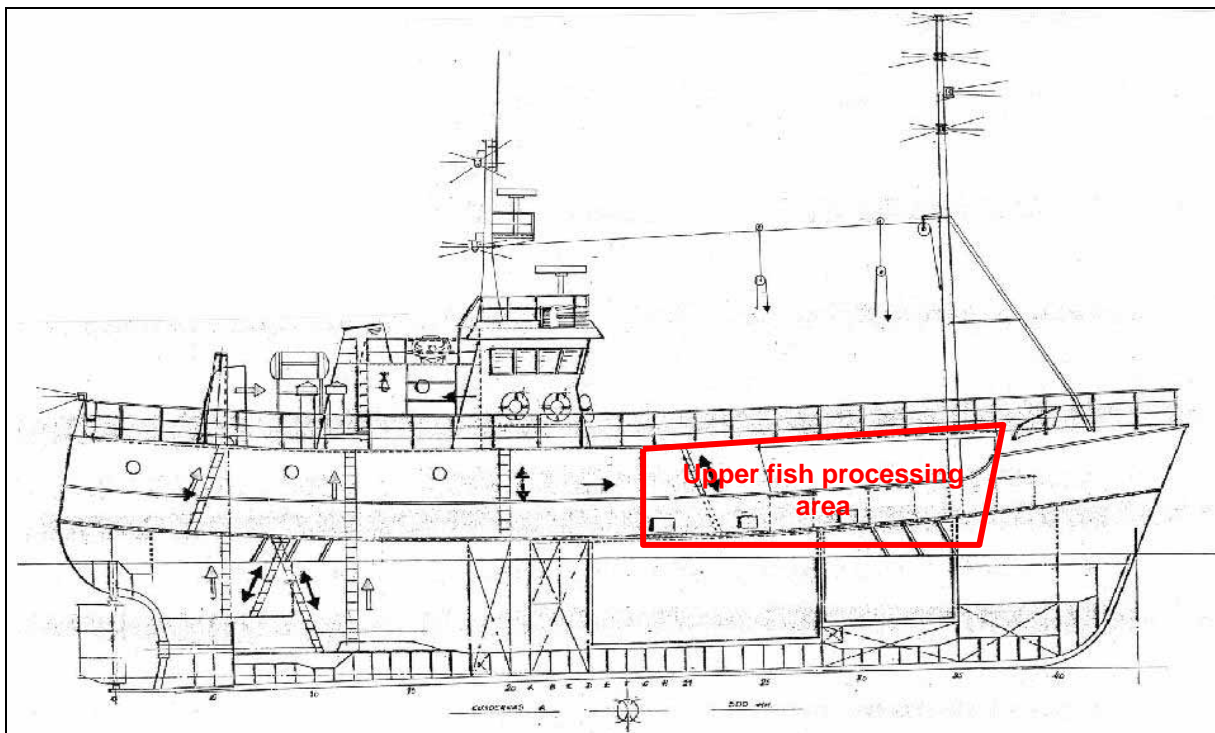
Figure 8: Side view of the vessel in her accident state as FV ORTEGAL UNO in 2010

Due to the insufficient stability of the vessel in heavy weather, the vessel was already rolling continuously with roll angles of up to about 30° when in an intact state and sailing in stern seas.

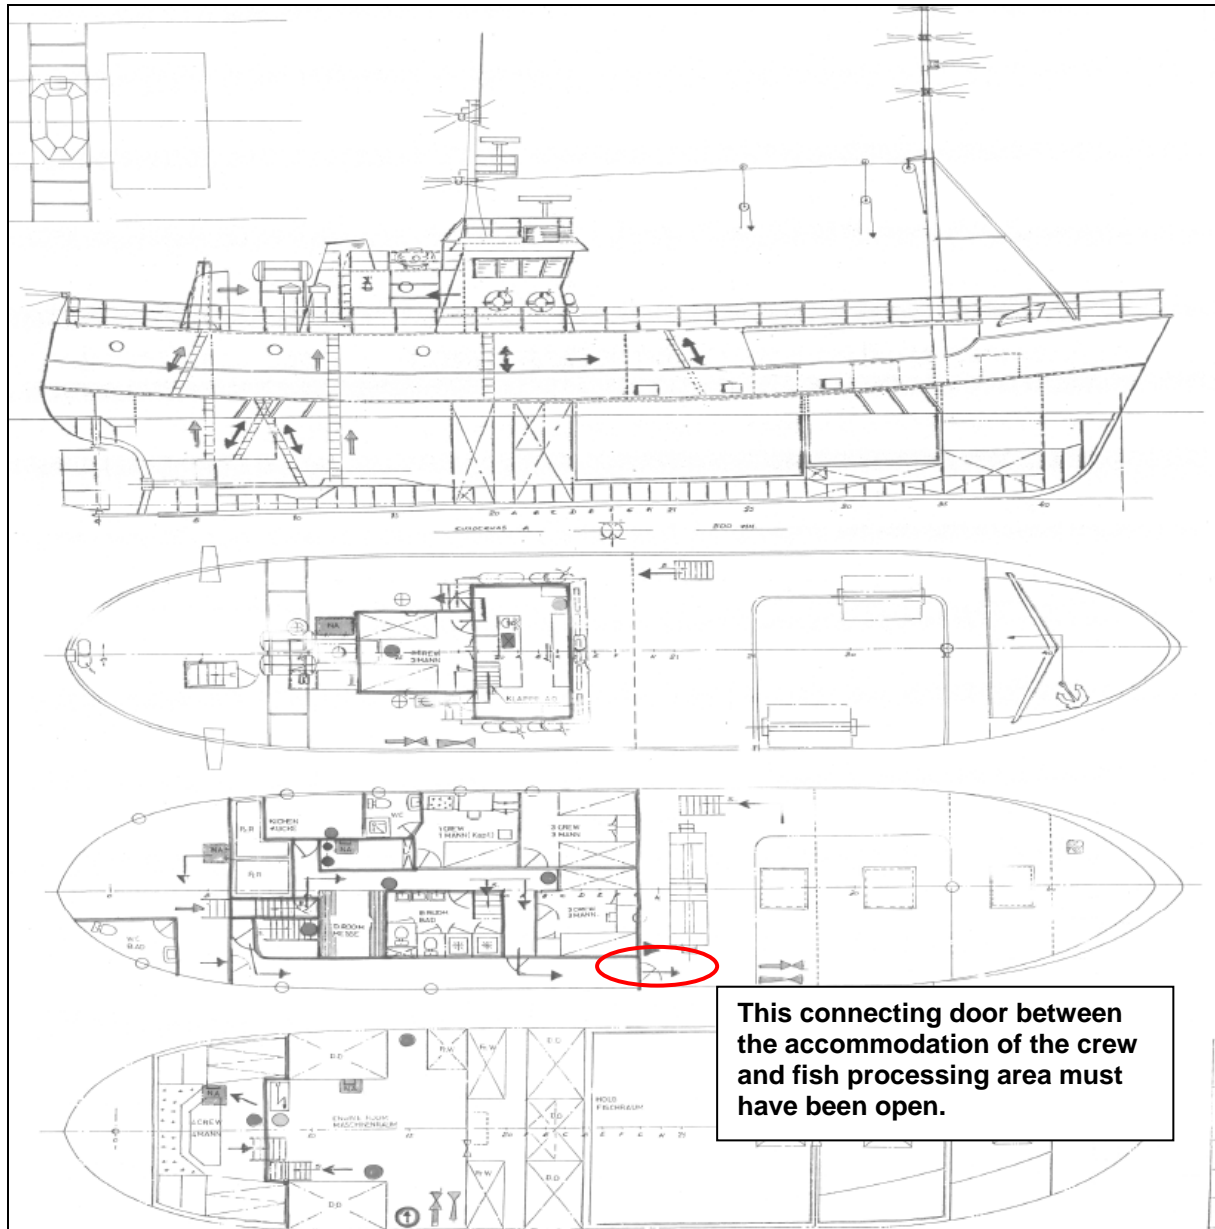
Figure 9: Excerpt of the general arrangement plan

However, the calculations have shown that the vessel would not have capsized with the amount of water in this area alone. The crew must have had the inner weathertight door (see Figure 9) between the upper fish processing area and superstructure open so that water entered the superstructure as the vessel rolled back to starboard in swell. In the process, the water that first entered the fish processing area ran into the superstructure. This must have occurred several times.

A watertight closure condition must be ensured in sea operation, i.e. corresponding openings on board are to be closed.

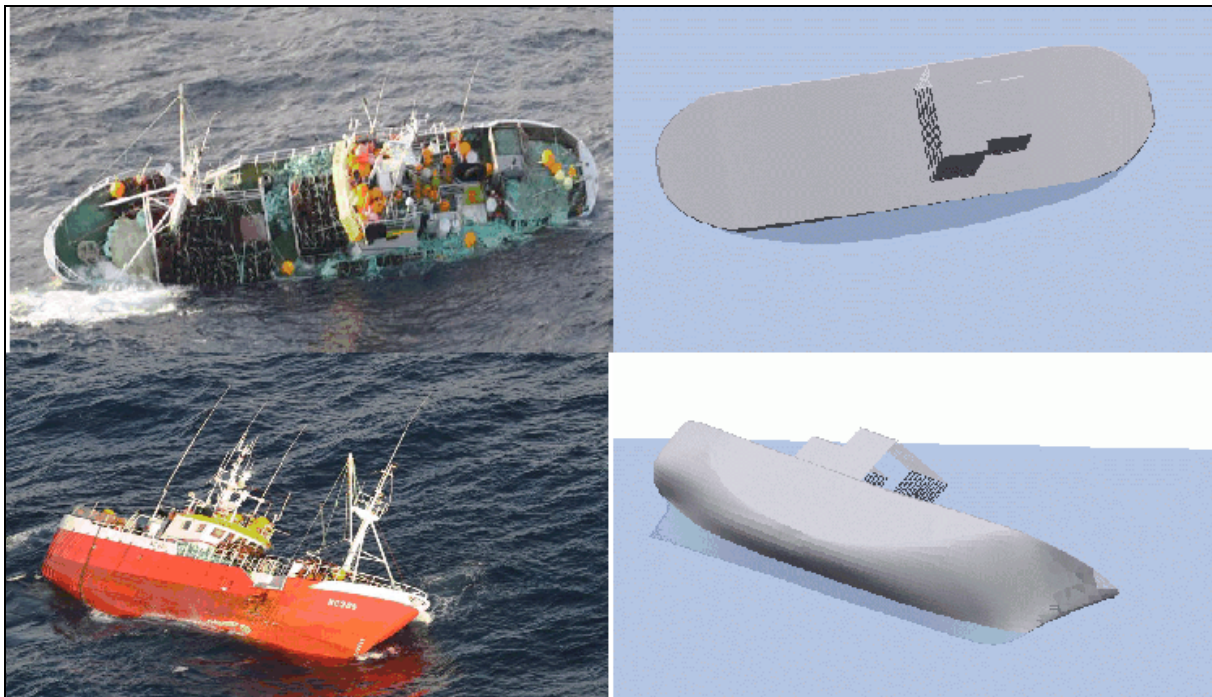
Figure 10: Comparison of the calculated and photographed equilibrium position for the presumed accident state of the ORTEGAL UNO

It was found that the cause of the accident stems directly from the various structural modifications on the vessel, which are improperly documented. During her last modification, the ORTEGAL UNO was fitted with an ice machine in order to be able to produce the amount of ice required to cool the catch. This also involved the preparation and approval of a new stability manual. Although, according to the statement of the skipper, the vessel did not have ice in the lower fish hold on departure as the ice machine was now available, in the corresponding stability case 25 tons of ice is scheduled for the cargo hold. Furthermore, in the accident situation the fishing gear was carried on the forecastle; however, in the loading condition of the stability manual this is scheduled for the main deck, which is lower. Although the vessel had consumed about a third of her bunker upon arriving at the fishing grounds, the loading condition in the stability manual prescribes a bunker filling of 100%. Therefore, based on the stability documents the vessel's centre of gravity was much higher than indicated, which led to the stability no longer complying with the applicable rules.

Structural modifications to the vessel must be properly documented and their influence on the stability of the vessel tested accordingly. In particular, it must be ensured that the structural condition of the vessel is consistent with the approved stability cases.

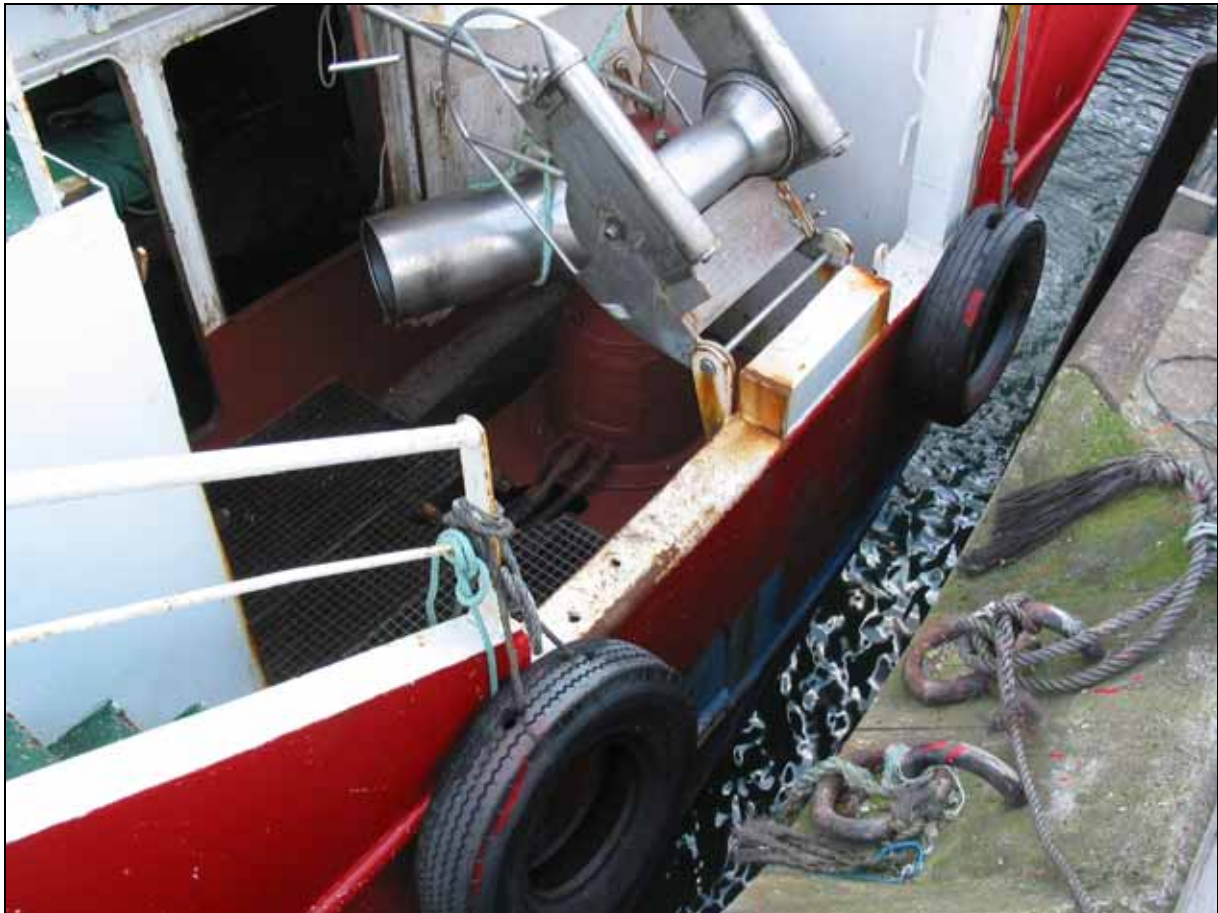
While deploying the fishing gear in heavy weather, the crew had the opening in the upper fish processing area on the starboard side open. This coupled with the rolling motion enabled water to enter the upper fish processing area.

Since the upper fish processing area was not equipped with wash ports, the water that entered the area could not clear, especially not after the vessel listed to port. The bilge pumps, which the skipper states are in this area, are not shown on the plans. Even if they were operational, it is likely that the intakes would be clogged by drifting working material and thus water could not be pumped out of the area.

That the upper fish processing area was not equipped with any water ports had a particularly catastrophic effect. This meant that water which entered this area was unable to clear. This ultimately triggered the accident. Wash ports are present on the approved plans of the vessel; however, they are not visible on various photos. This is a violation of the applicable safety rules according to EU Directive 97/70/EC; for if the upper fish processing area would have been regarded as closed, flooding of the area would have had to be considered when assessing stability. If it was regarded as open, it should have been equipped with wash ports.

Figure 11: Access to the upper fish processing area on the starboard side. The opening is behind the bulwark. The net is deployed through the smaller opening; the larger one is used to enter the fish hold.

It must be shown in accordance with Directive 97/70/EC that water can flow out of only partially enclosed areas through suitable wash ports or that the vessel can withstand flooding of the area.
