Bundesstelle für Seeunfalluntersuchung
Federal Bureau of Maritime Casualty Investigation
Federal Higher Authority subordinated to the Ministry of Transport,
Building and Urban Development

Investigation Report 231/09

Serious Marine Casualty

**Collision involving the AURORA and the
TRANSANUND
during an overtaking manoeuvre
on the Elbe
on 29 June 2009**

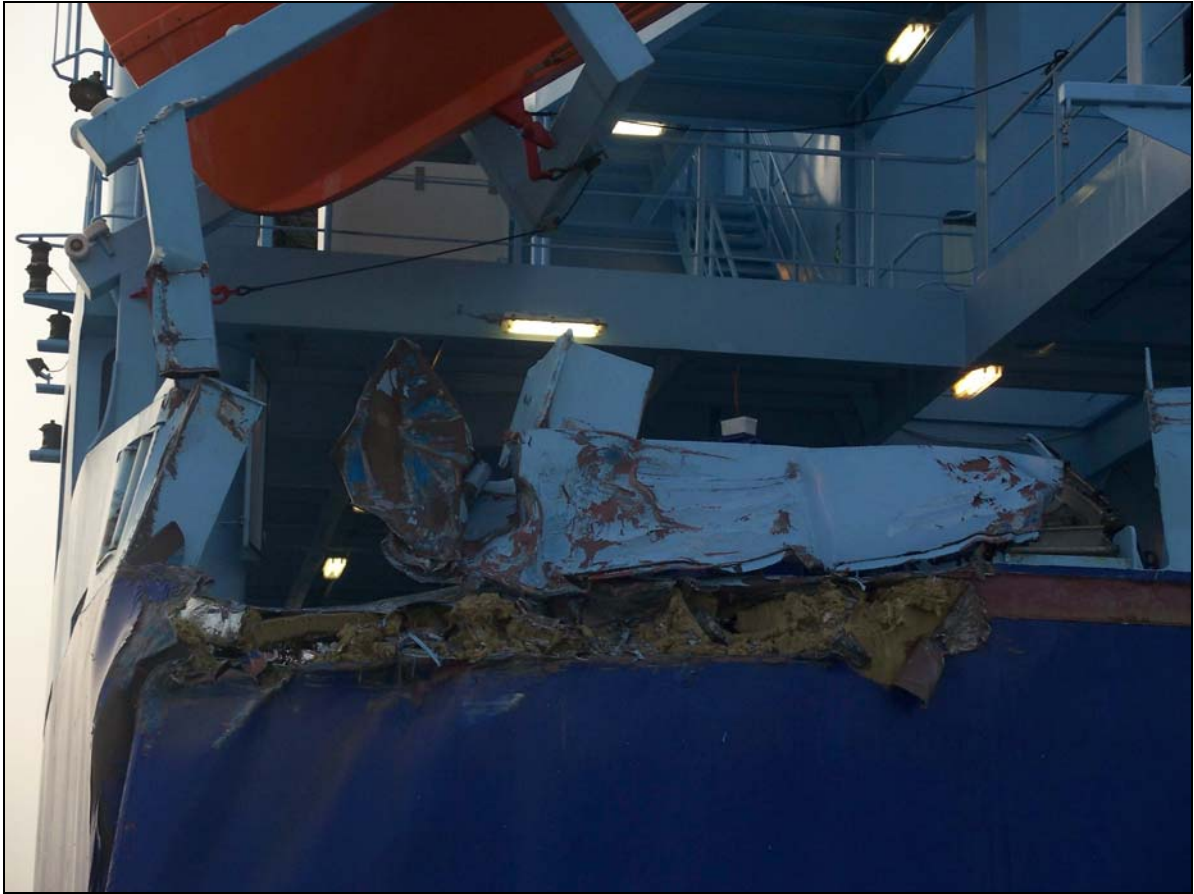
Both vessels sustained material damage above the water line due to the collision. The damage on the AURORA was located on the starboard side of the stern and on the free-fall lifeboat's launching device (Figure 4 and 5). The TRANSANUND was damaged on the port side in the area of the bow (Figure 6 and 7).

Figure 4: AURORA, damage at the stern

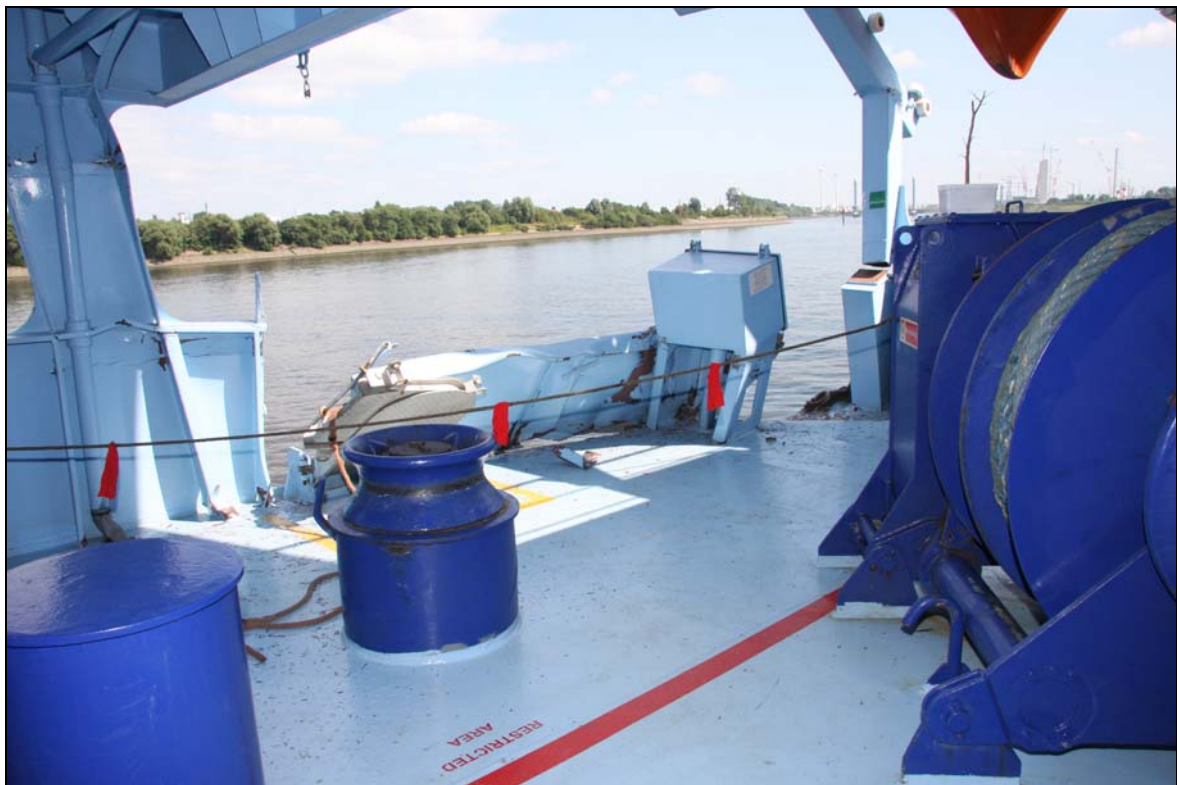
Figure 5: AURORA, damage to the stern and the free-fall lifeboat's launching apparatus

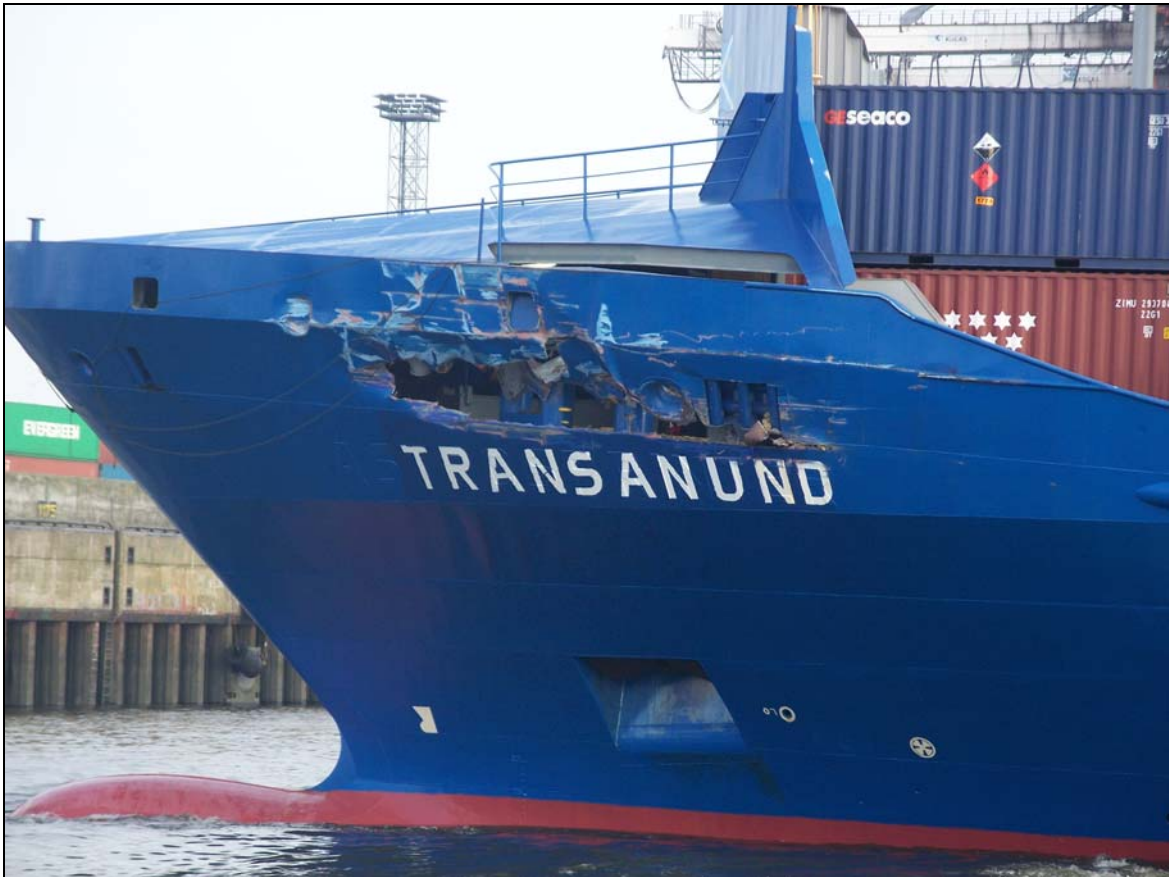
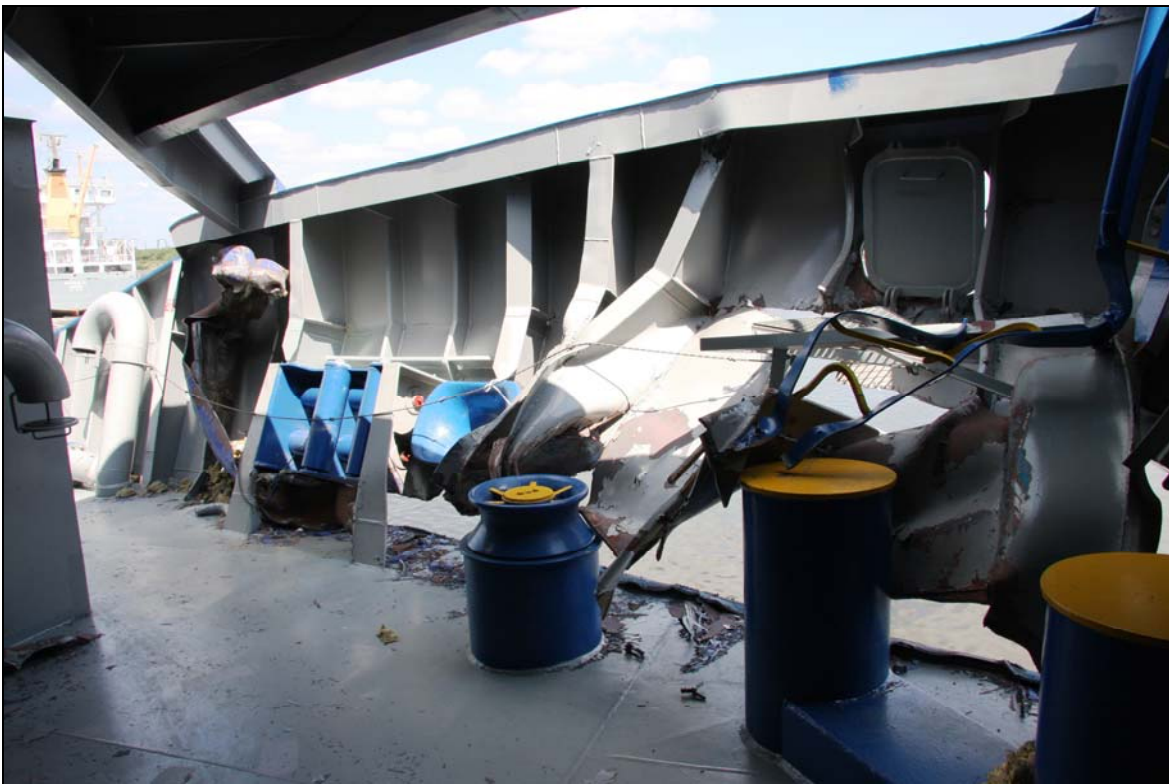
Figure 6: TRANSANUND, damage to the forecastle

Figure 7: TRANSANUND, damage to the forecastle

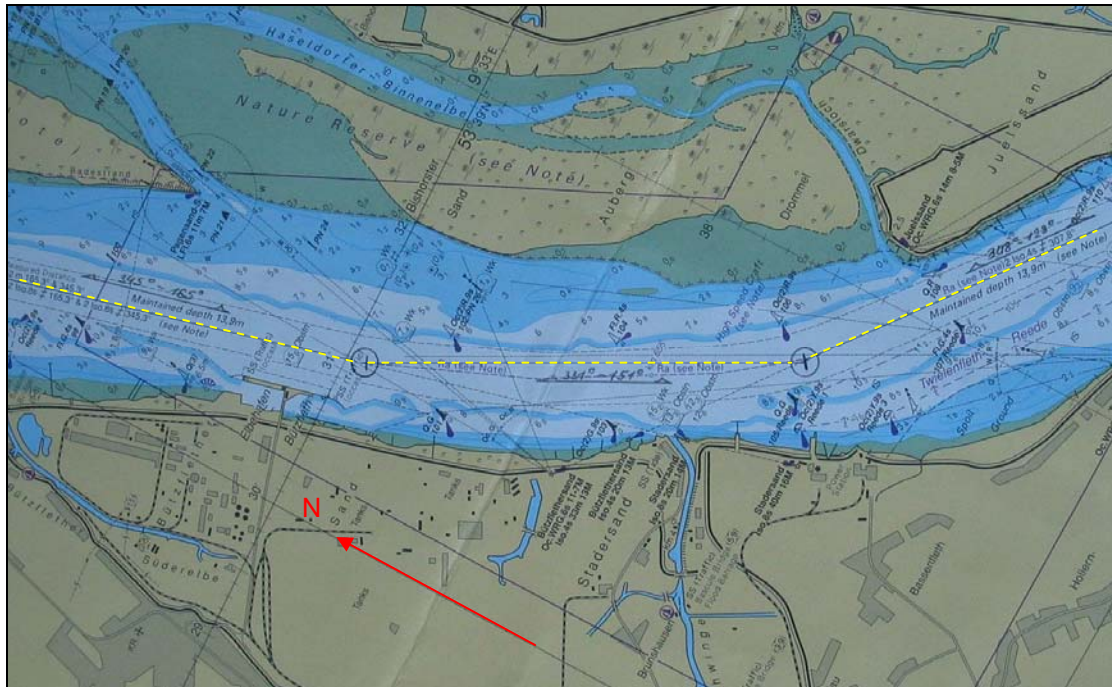
Figure 8: Excerpt of Nautical Chart 3267 UKHO from the AURORA with course line marked (photo)

On the AURORA, evidence to suggest that the course of the vessel was checked or recorded was found neither in the nautical chart nor in the submitted recordings. The position at 0400, the time of the change of watch, was not recorded.

Documentation of the course of the voyage, i.e. the entries in the nautical chart, bridge bell book or logbook of the AURORA, was inadequate. It did not provide a basis for tracing the course of the voyage.

The Federal Bureau of Maritime Casualty Investigation recommends that the ship's command and the operator of the AURORA review the accident within the scope of their safety management. Thereby the principles of watch duty, the conduct during restricted visibility and in waters with a large amount of traffic as well as navigating with pilot advice should particularly be addressed.

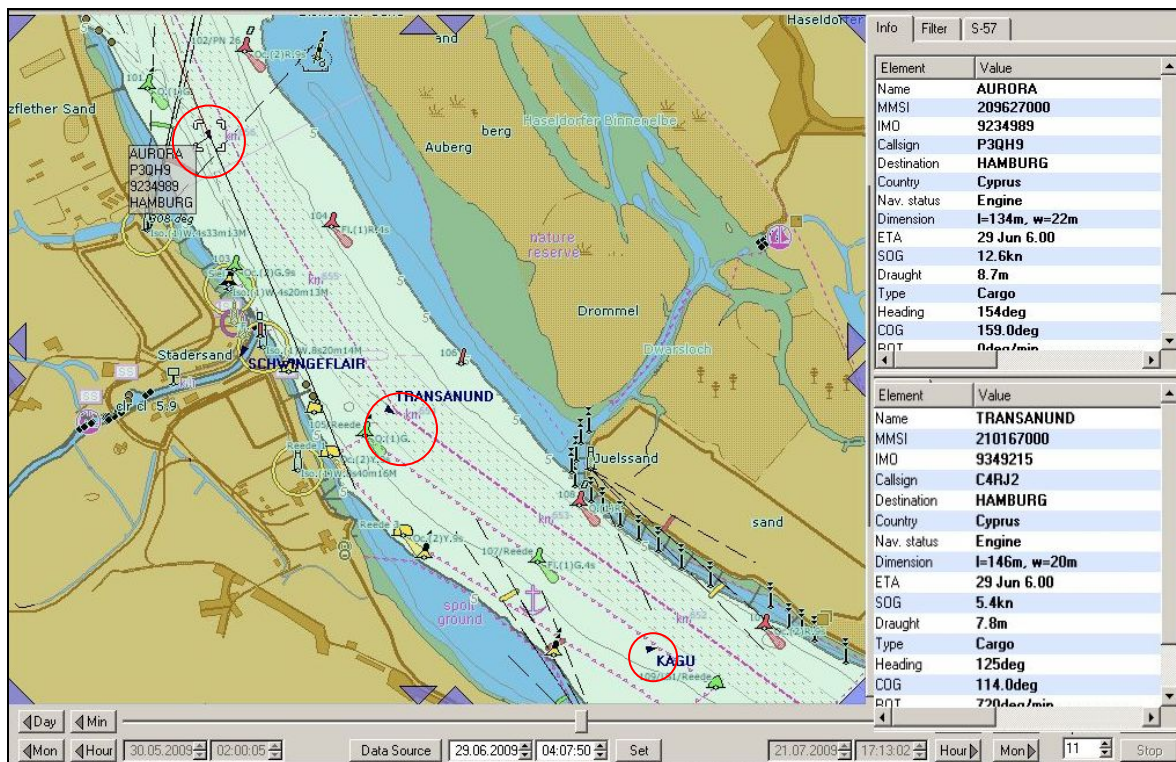
The description of the overtaking manoeuvre starts with the picture of the traffic situation at 040750 (figure 9). The KAGU was just leaving the Twielenfleth roadstead. The TRANSANUND was abeam of buoy 105 in the proximity of the radar reference line.

Figure 9: Traffic situation⁸ at 040750 with the AURORA, TRANSANUND and KAGU⁹

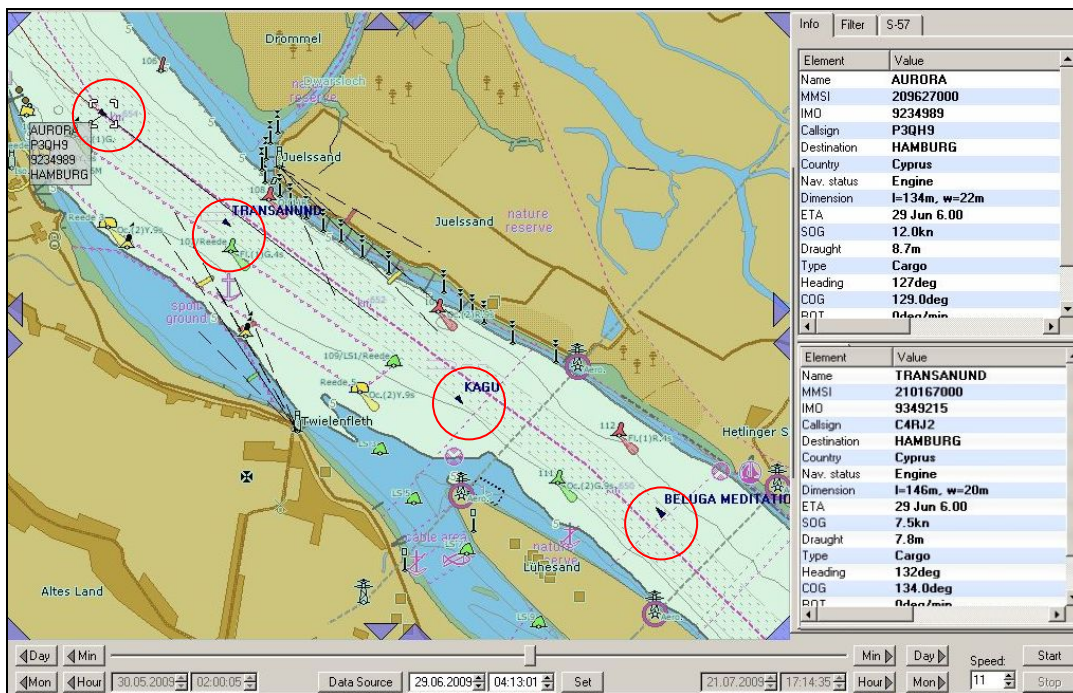
At 0413 (see Fig. 10), the pilot of the AURORA called the TRANSANUND over VHF. The pilot of the AURORA expressed his intention to overtake the TRANSANUND. Following that, the master of the TRANSANUND agreed to move right across to the green side, i.e. that he intended to sail directly along the green buoys. Furthermore, the look-out on the starboard side of the TRANSANUND was instructed to keep watch for the green buoys. At that point, buoy number 109 was about 7.5 cbl or 1,400 m away and the distance to the BELUGA MEDITATION was about 1.8 nm. The AURORA was about 0.6 nm away from the TRANSANUND.

Figure 10: Traffic situation at 041301 with the oncoming BELUGA MEDITATION

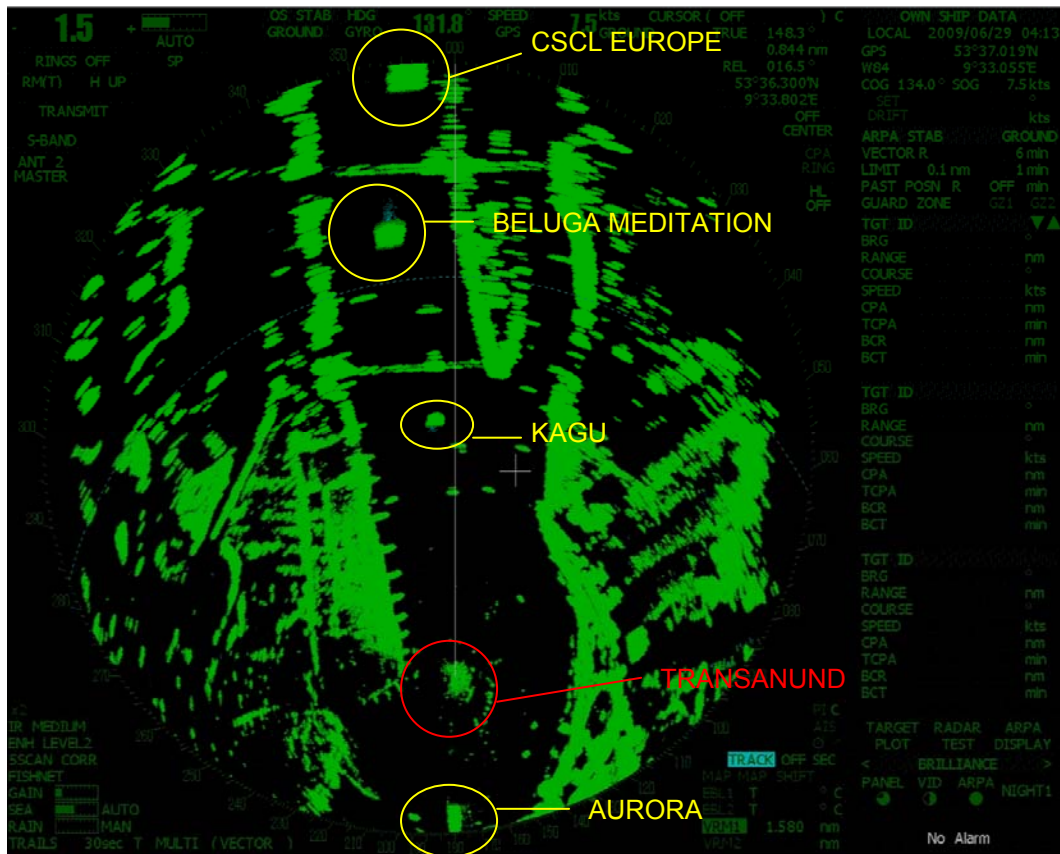
The VDR radar recording reveals that the buoy 109 was taken ahead by TRANSANUND at least since 0410. The head line and the vector for the course over ground then showed in the direction of the buoy 109 up to 0416 that means the TRANSANUND steered a compass course of 132°. The course over ground was on average 133°. The true track in this section of the Elbe is 128°.

Figure 11: Radar picture from the TRANSANUND at 041341¹⁰

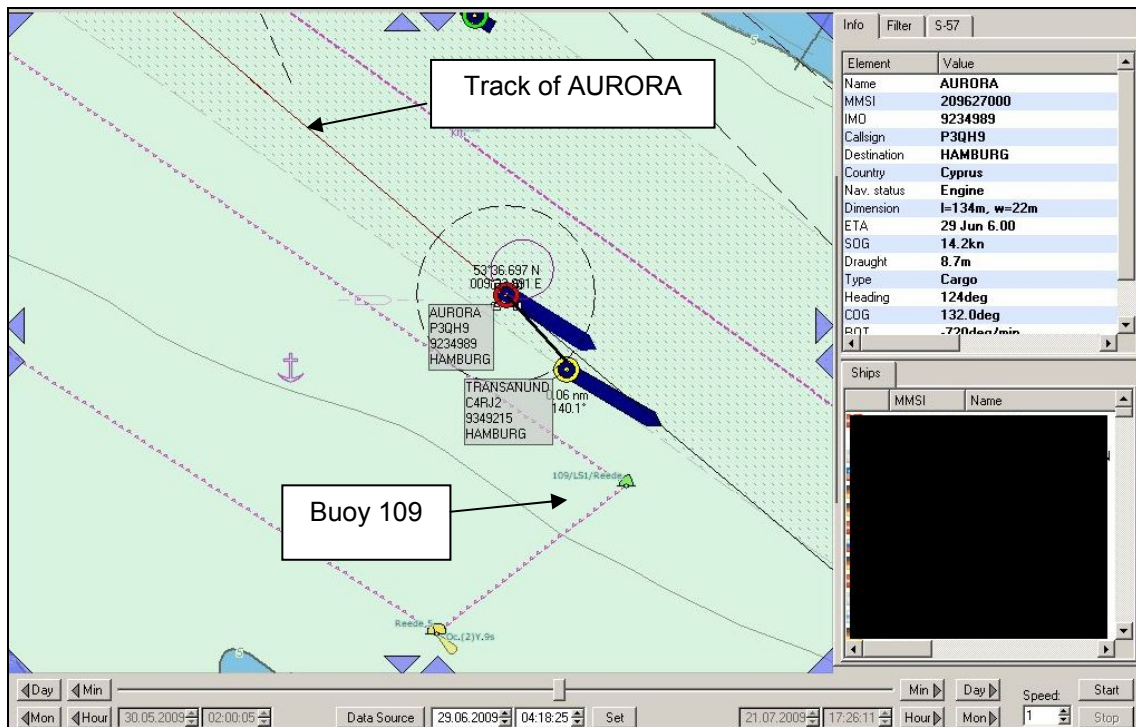
Figure 17: Situation at 041825

At 0418 (s. figure 17) the AURORA still had a southerly moving tendency. The TRANSANUND in contrast got slightly to the north.

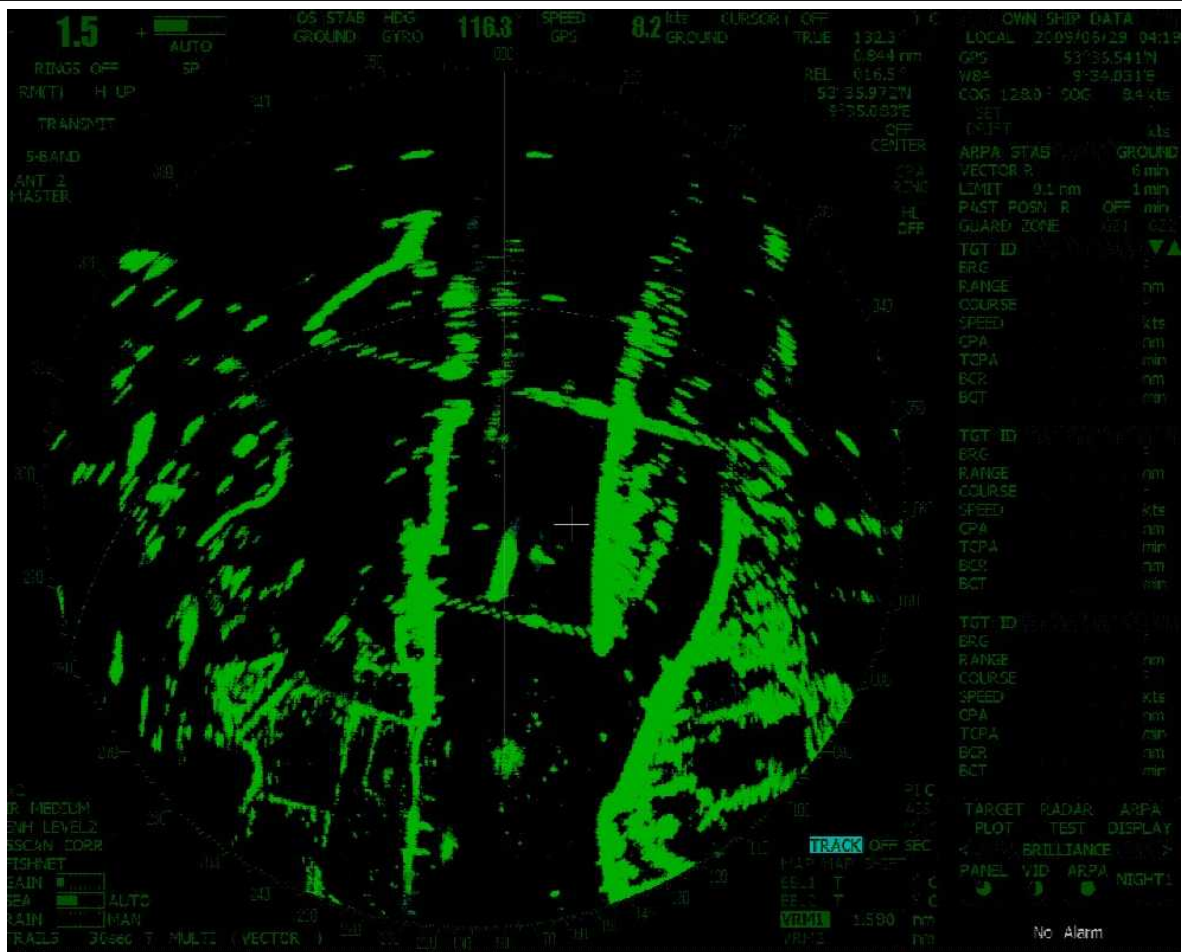
Figure 19: Radar picture from the TRANSANUND at 041925, AURORA abeam of the TRANSANUND, TRANSANUND beginning to turn to port

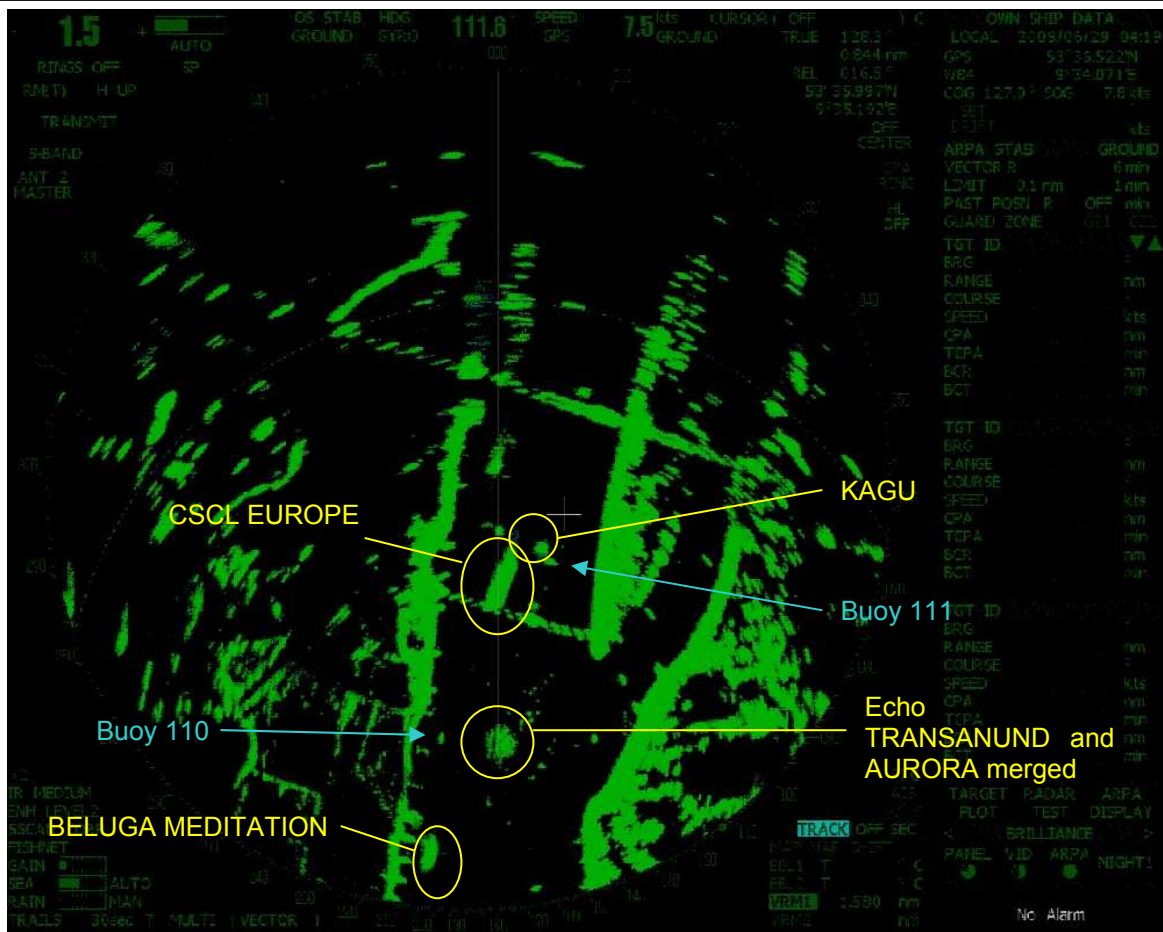
Figure 20: Radar picture from the TRANSANUND at 041940, further turn to port by the TRANSANUND

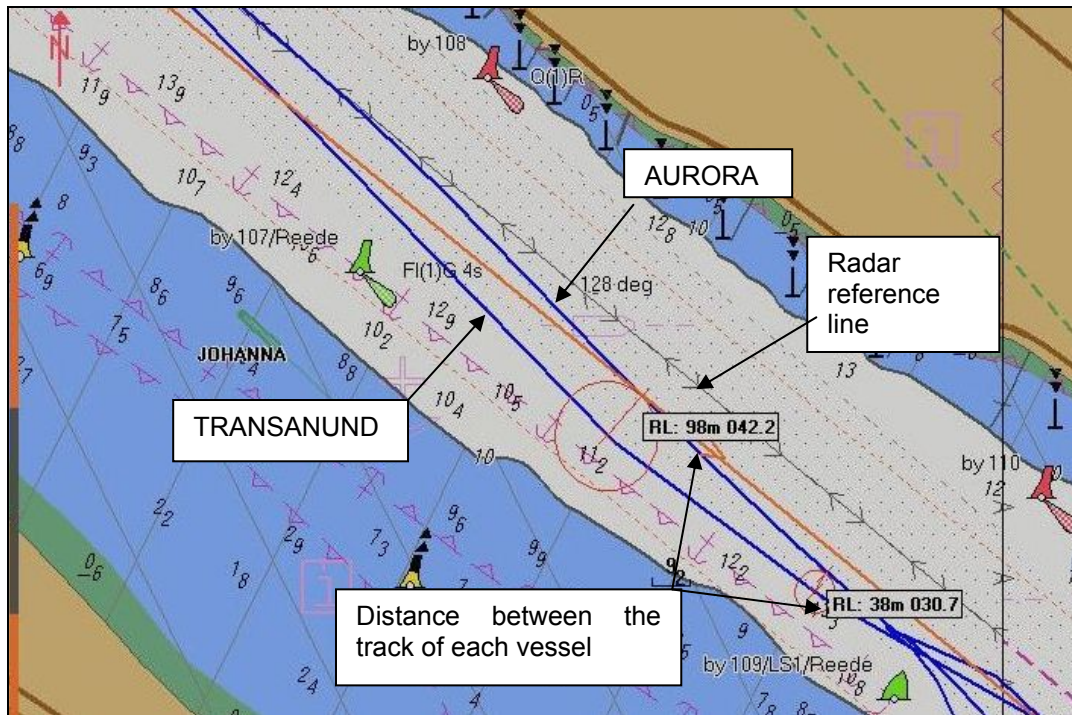
The course of the TRANSANUND and the AURORA according to the recording of the ECDIS of the TRANSANUND is shown in Figure 23. This shows that after passing buoy number 105, the TRANSANUND continuously steered for the right edge and after reaching it kept almost there. However, the AURORA continuously steered a course that took the vessel closer and closer to the TRANSANUND. On the AURORA, there was no way of graphically presenting the log files (s. figure 25) later on stored in the nautical chart system, i.e. the data for the course of the voyage. Therefore, the screen was photographed (Figure 24).

Figure 23: Track¹³ of the AURORA and TRANSANUND at about 0412

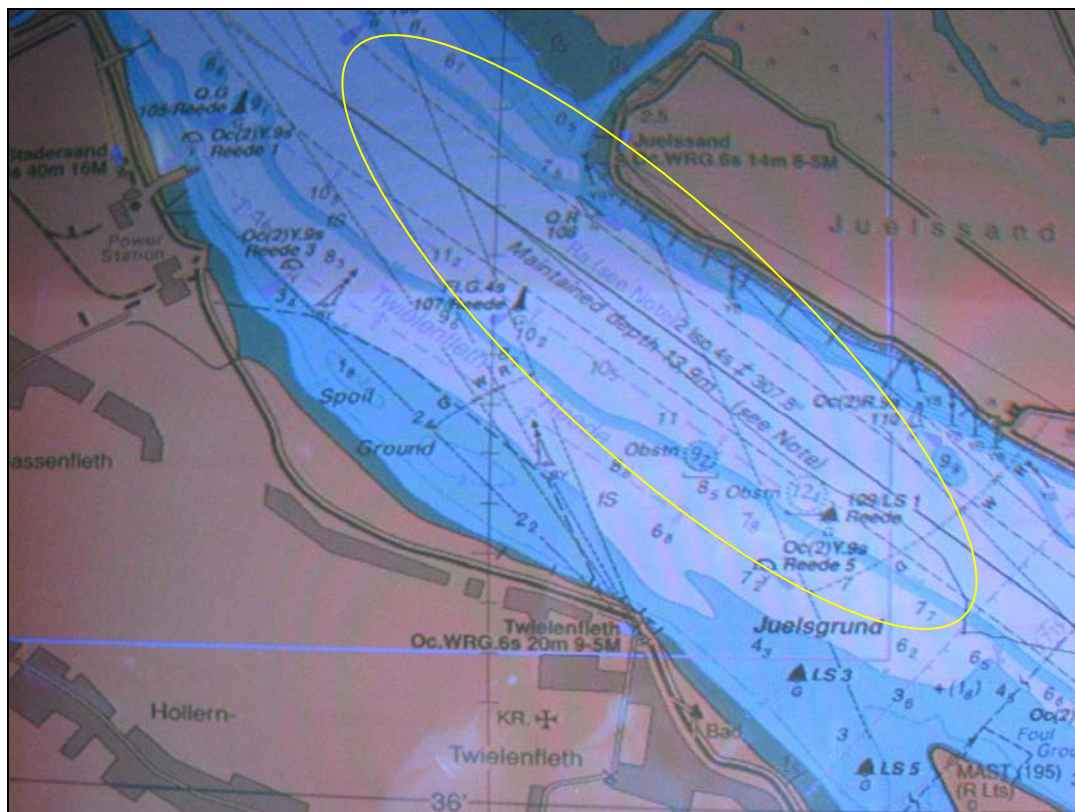
Figure 24: AURORA, electronic nautical chart with track (photo)

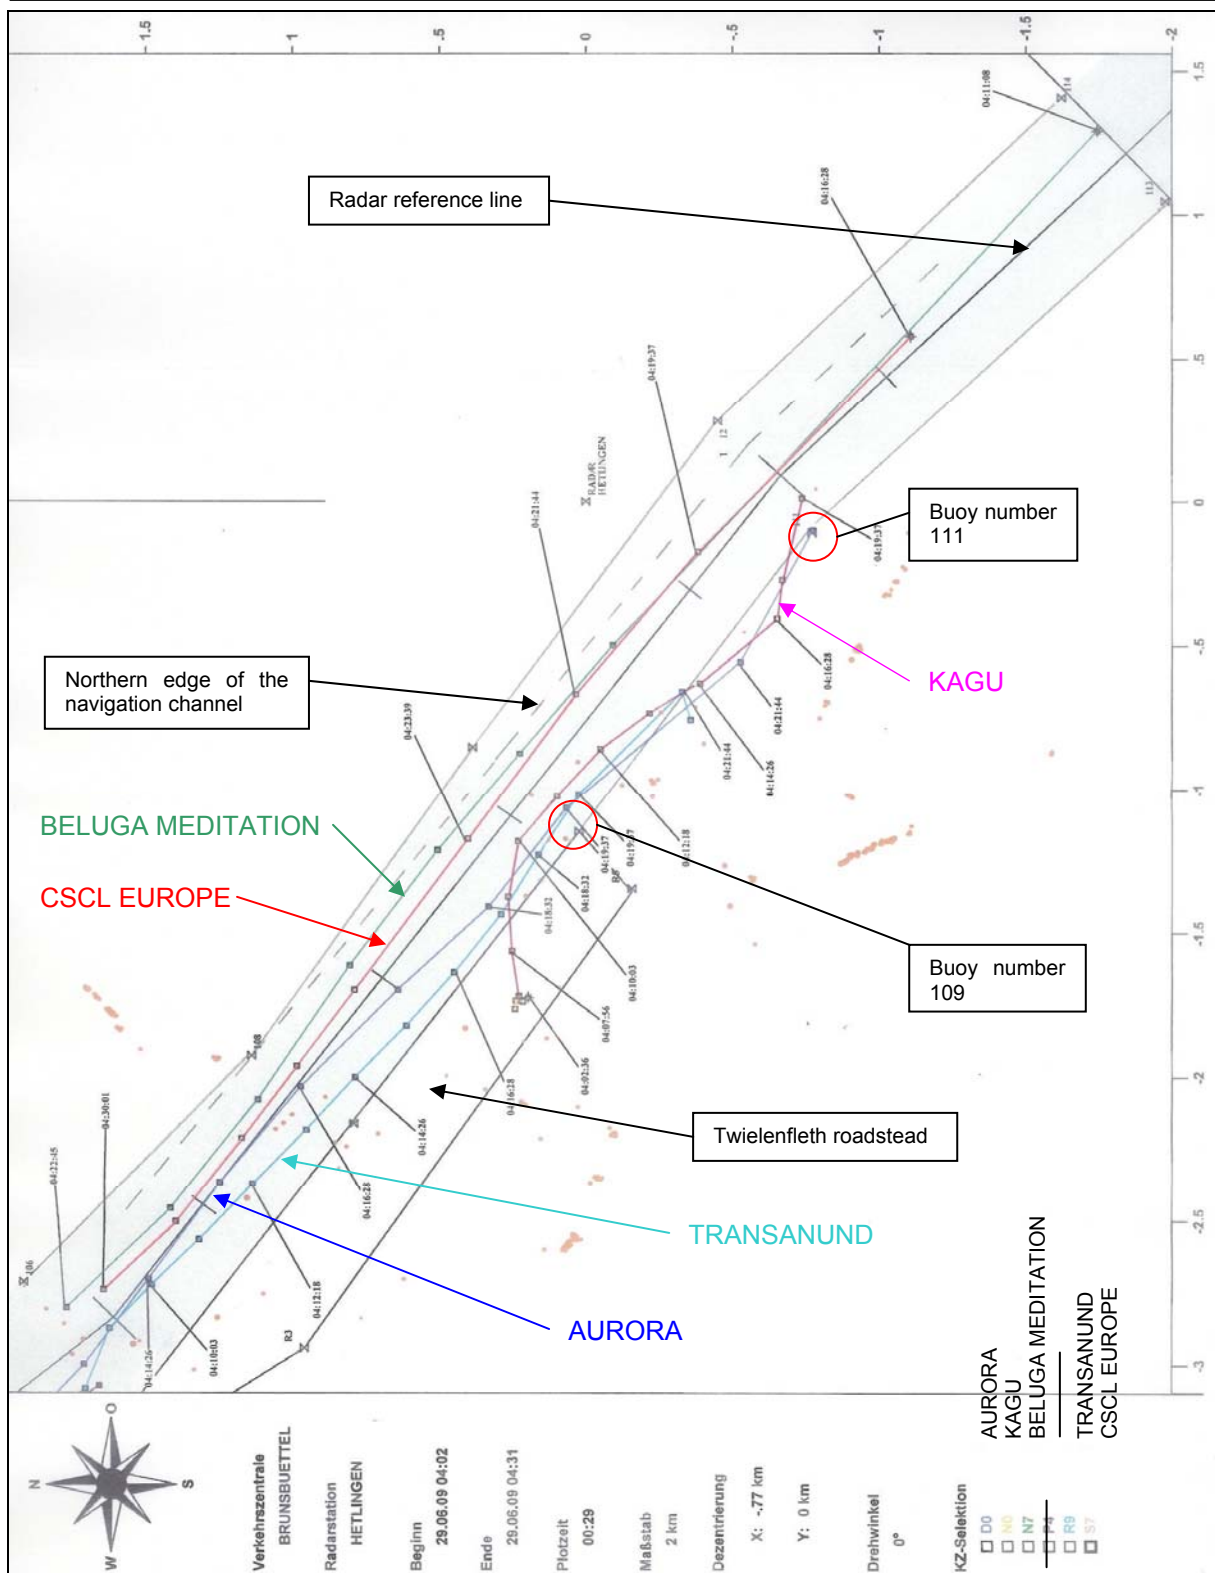
The radar plot of VTS Brunsbüttel (Figure 27) provides another perspective of the sequence of events. The northern edge of the navigation channel has been marked to provide better insight on the traffic area available to the CSCL EUROPE. The width of the navigation channel at buoy pair 109/110 is approximately 300 m. On the CSCL EUROPE's heading, the channel then widens moderately to about 340 m off buoy pair 107/108. The fairway itself is approx. 440 m wide off buoy pair 109/110. Since the CSCL EUROPE was reliant on the fairway, 350 m of water was available as traffic area to all three vessels off buoy number 109.

The radar plot also provides insight on the course of the KAGU and the resulting increased requirement for advice from the radar pilot. The vessel was at risk of running aground or colliding with buoy number 111 and crossing the stem of the CSCL EUROPE.

Figure 27: Radar plot of Hetlingen Radar from VTS Brunsbüttel over the period 29 June 2009, 0402 to 0431
