Bundesstelle für Seeunfalluntersuchung
Federal Bureau of Maritime Casualty Investigation
Federal Higher Authority subordinated to the Ministry of Transport,
Building and Urban Development

Investigation Report 161/09

Capsizing of the MB QUINTETT

on 21 May 2009

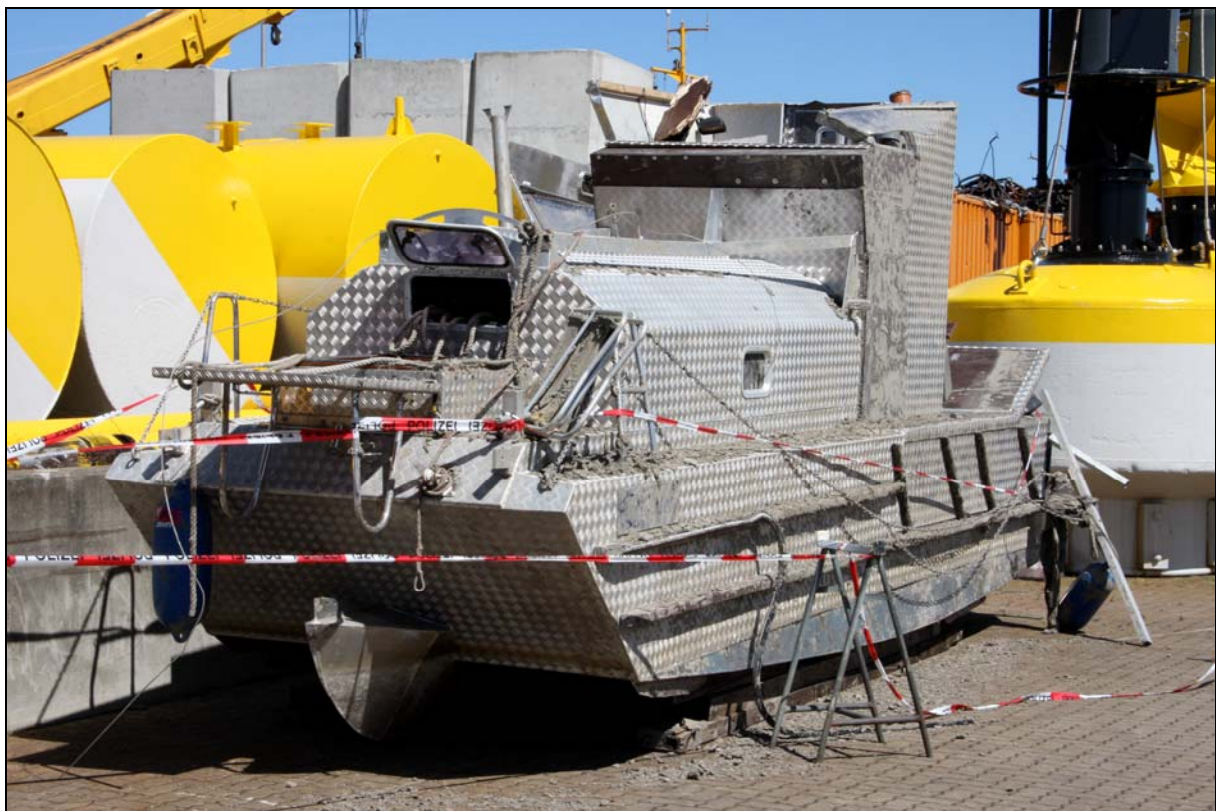
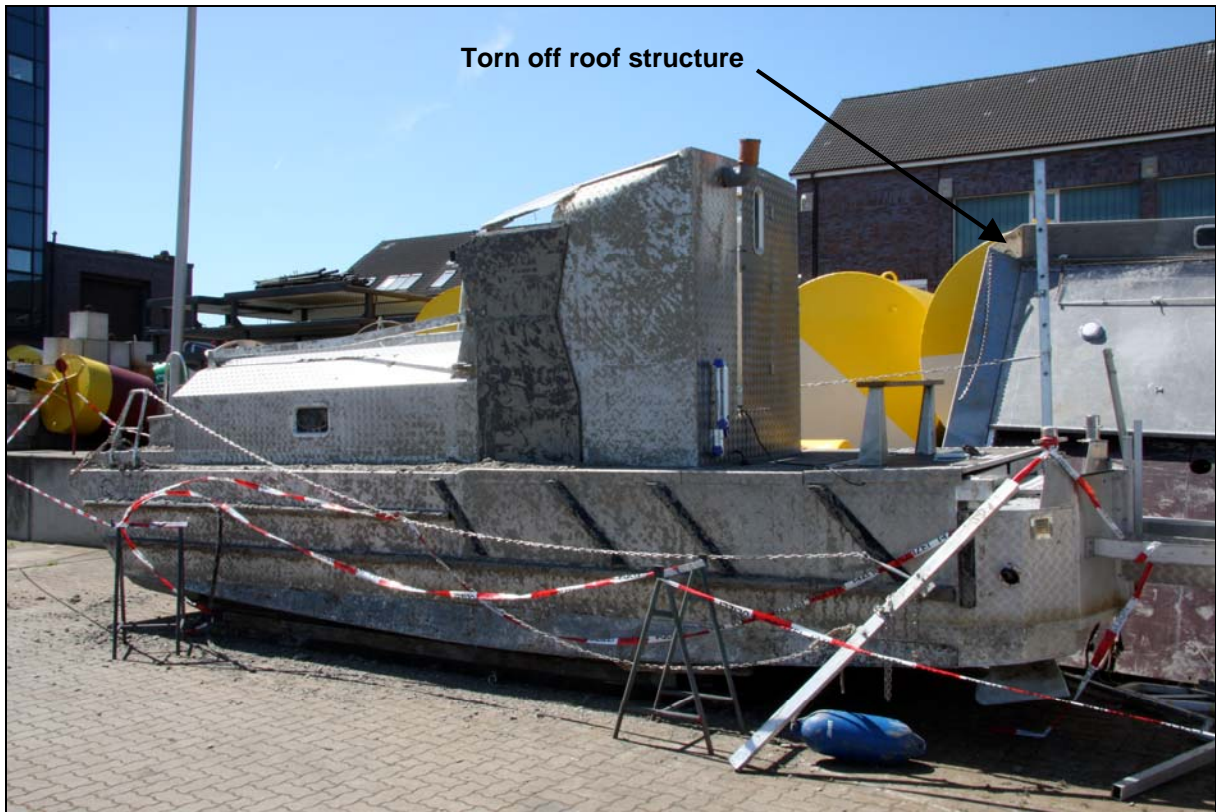
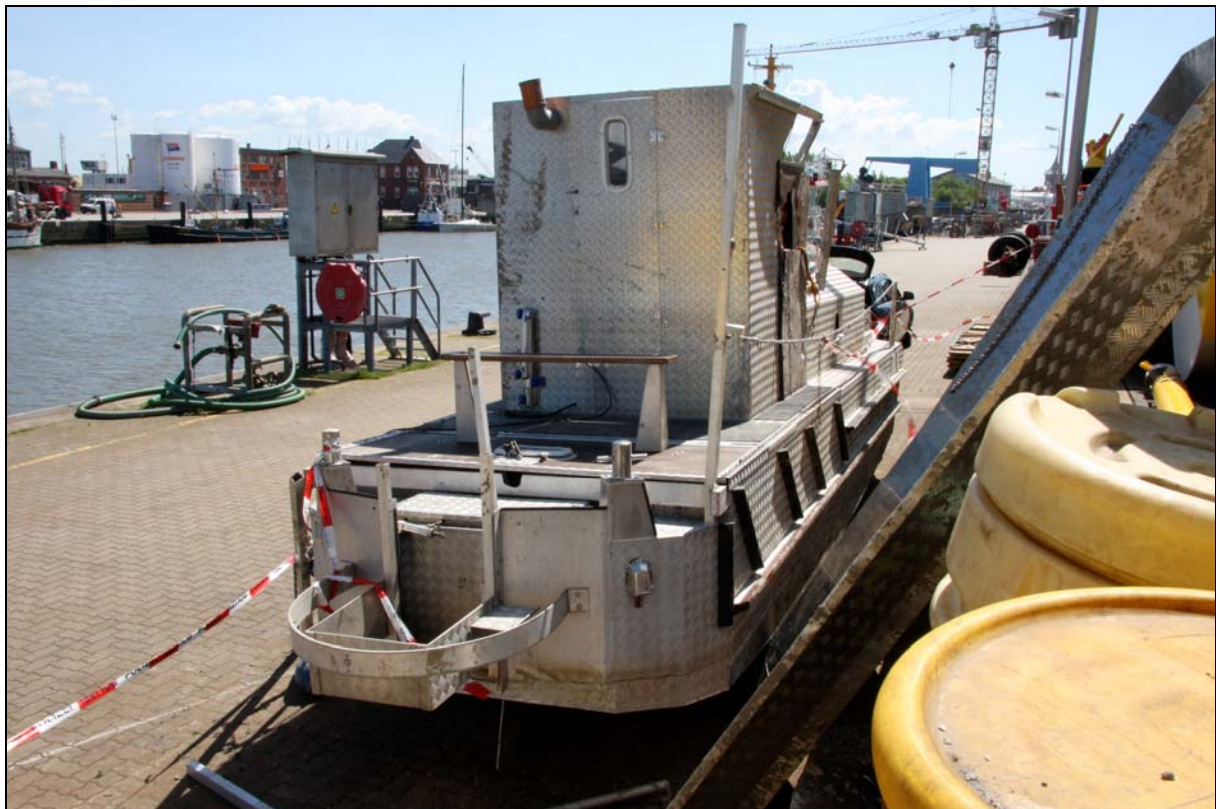
Officials from the Federal Bureau of Maritime Casualty Investigation (BSU) surveyed the wreck of the QUINTETT in Cuxhaven on 29 May 2009 (see Figs. 5 to 7).

The roof structure of the wheelhouse, including the window pane, was torn off while the wreck was being salvaged.

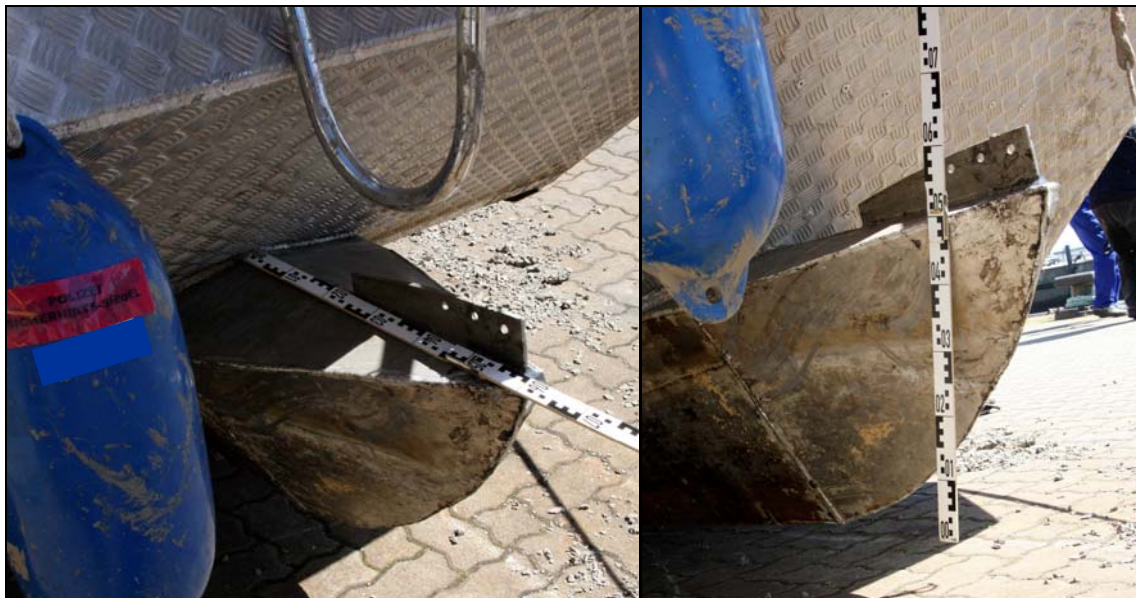
Figure 8: Keel design of the QUINTETT, view from fore

The QUINTETT did not have a conventional keel design for stabilising the hull; rather, a bulb-bow-style keel design was chosen, which did not span the entire length of the boat. Each side of the otherwise pontoon-style hull was fitted with two short bilge keels (see Figs. 8 to 11).

The QUINTETT was self-designed and built in disregard of basic stability requirements. In the prevailing flow conditions at the time of the accident, she was hardly in a position to enter the Lower Elbe without complications. The short bilge keels and bulb-bow-style keel design, which possibly had a moderate ballast function, could provide the strong tidal surge with only little resistance.

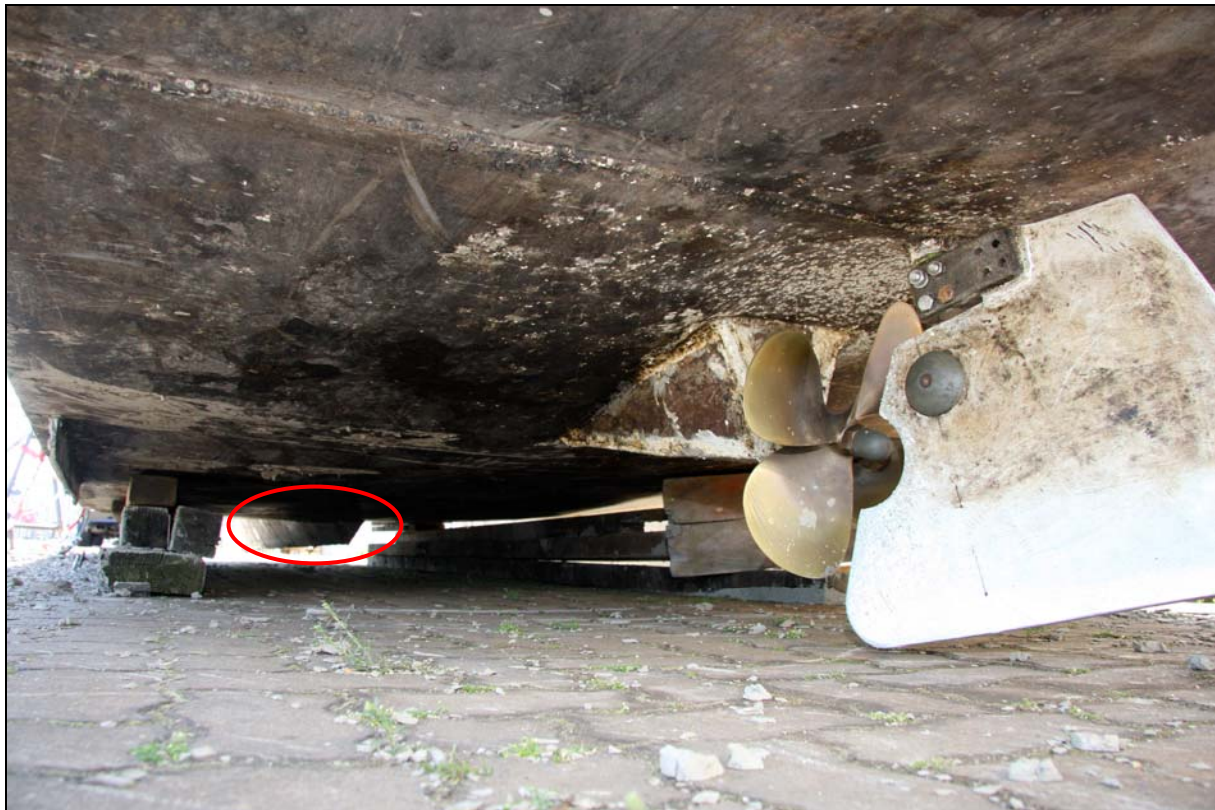
Figure 12: Underwater hull of the QUINTETT, view from aft

During the survey, the BSU officials were unable to detect an opening in the keel design through which water could penetrate. However, it cannot be ruled out that the hole mentioned during the interview by the vessel's owner is located in the underwater hull. The keel runs amidships up to the transverse axis (see Fig. 12), which means that the aft area of the keel was difficult to access.

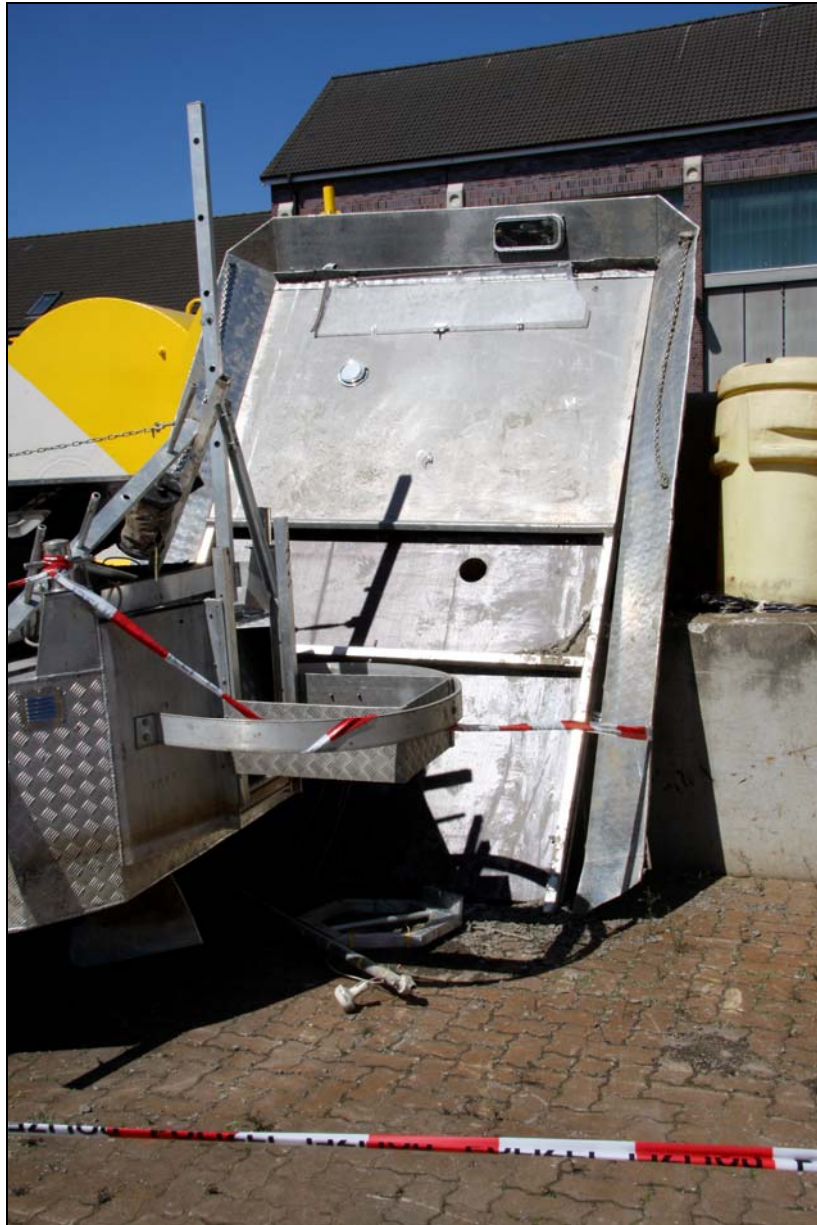
Figure 13: Torn off roof of the QUINTETT

The total weight of the QUINTETT was approx. 2.5 t without water, mud and the roof structure. The roof, which was assembled using aluminium and wood panels (see Fig. 13), weighed approx. 800 kg when the vessel was salvaged. The roof is 4 m long and 2.25 m wide.

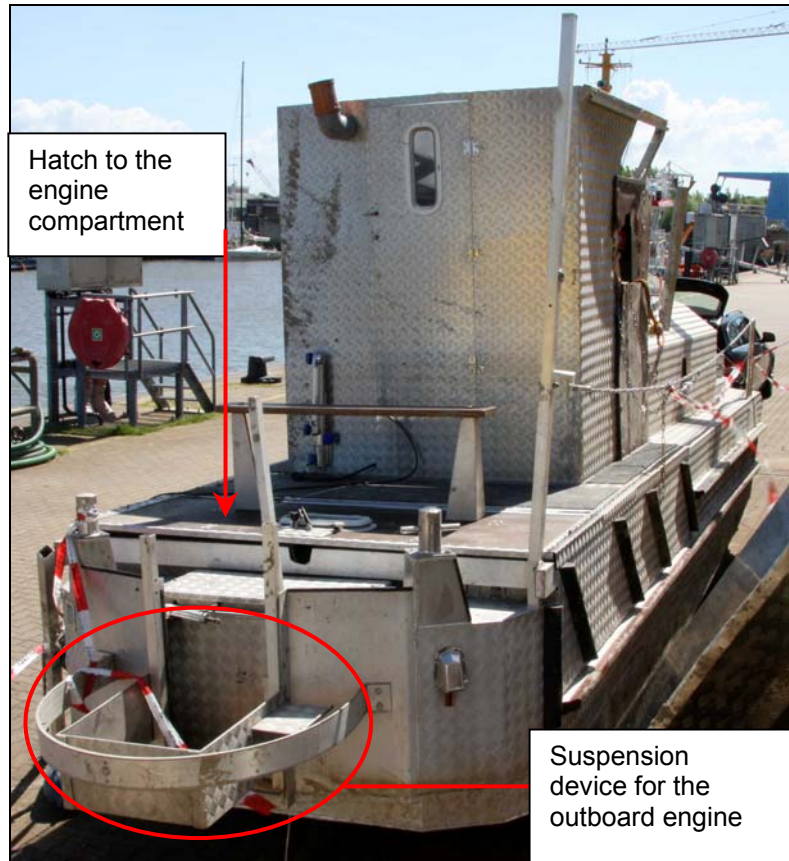
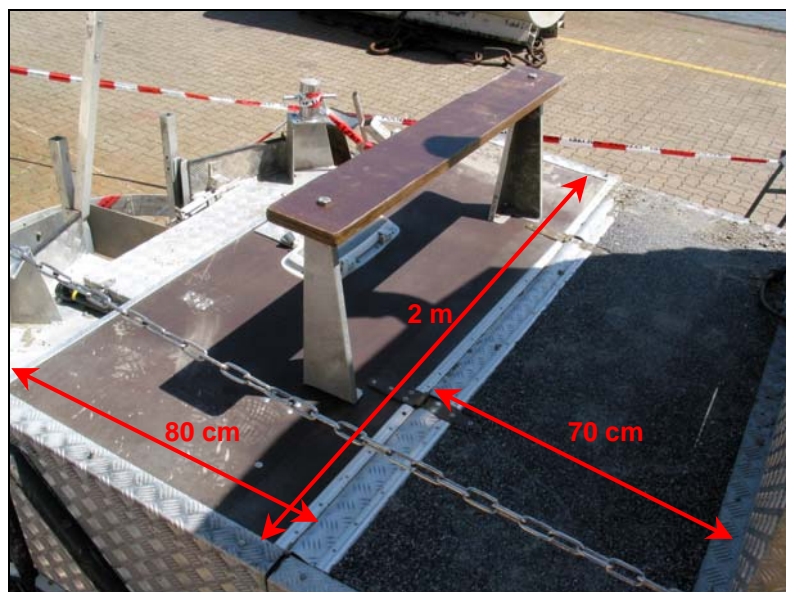
The engine compartment is accessible through a hatch in the aft section, on which a seat is attached (see Figs. 14 and 15). It was not possible to make the selected hatch design watertight.

Since it is not possible to fix the hatch of the engine compartment in a closed position with a latch or hinges, it opens without any intervention once the vessel is keel up.

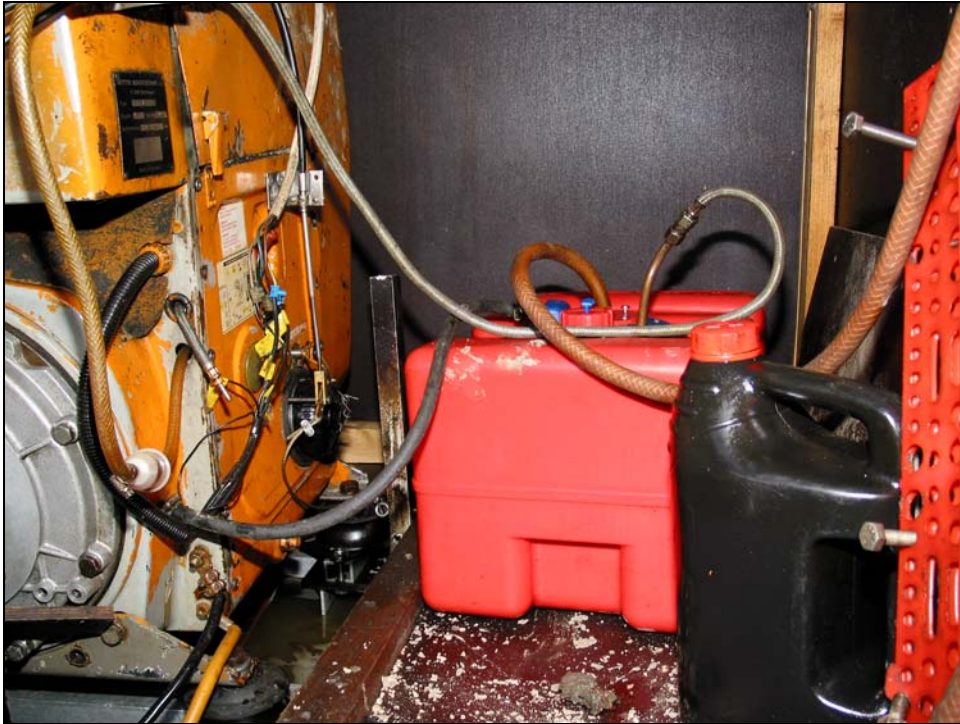
Figure 16: The engine installed on the QUINTETT

The drive rating of the 2 cylinder diesel engine is 18 kW. The fuel is supplied via a plastic tube, the end of which is attached to a copper pipe section, which is inserted into a hole in the lid of a plastic canister (approx. 25 l) without being fixed in place (see Fig. 16). The feed line was filled with fuel. The canister is also connected with the engine via a fuel-leakage line.

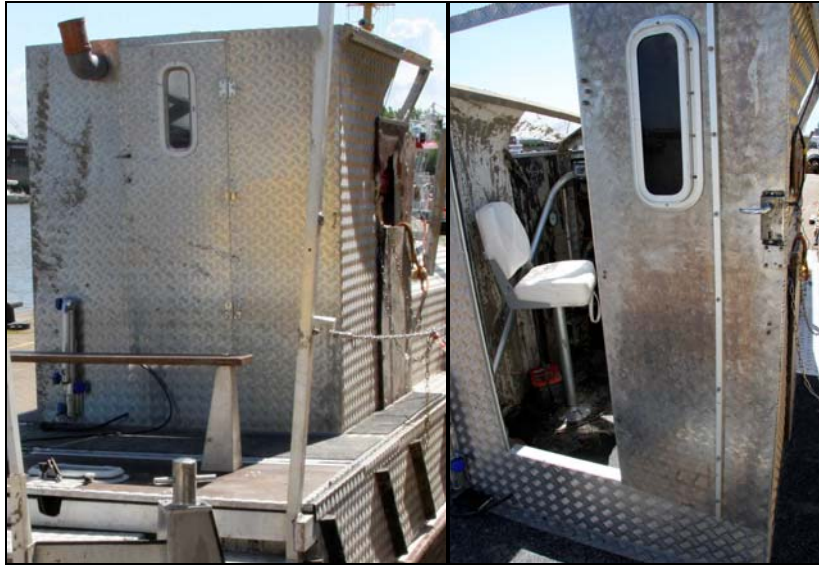
Figure 17: Access door to the wheelhouse

The superstructure is accessed via a door opening (about 1.50 m high and 50 cm wide) on the back of the wheelhouse (see Fig. 17).

During the survey by officials from the BSU, the door was buckled and increased effort was required to open and close it. When the door to the wheelhouse is closed and the hatch to the engine compartment is open, the door is obstructed by the seat. It is then impossible to open the door from inside the wheelhouse (see Fig. 18).

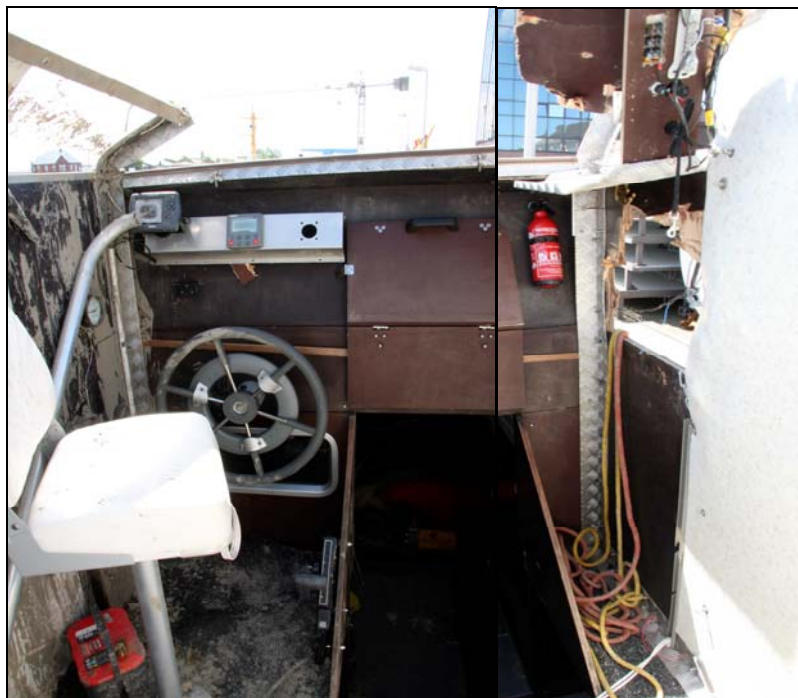
Figure 18: The wheelhouse of the QUINTETT

The BSU assumes that the wife of the vessel's owner, who was situated in the superstructure – presumably in the wheelhouse – at the time of the accident, had no way of opening the door while the hatch to the engine compartment was open.

At the moment that the vessel was keel upwards, the female skipper stood little chance of getting out of the superstructure through the only exit door because of the obstruction caused by the design. The vessel's owner drifted as a result of the current and was found dead later in spite of wearing a life-jacket and immediate search measures.

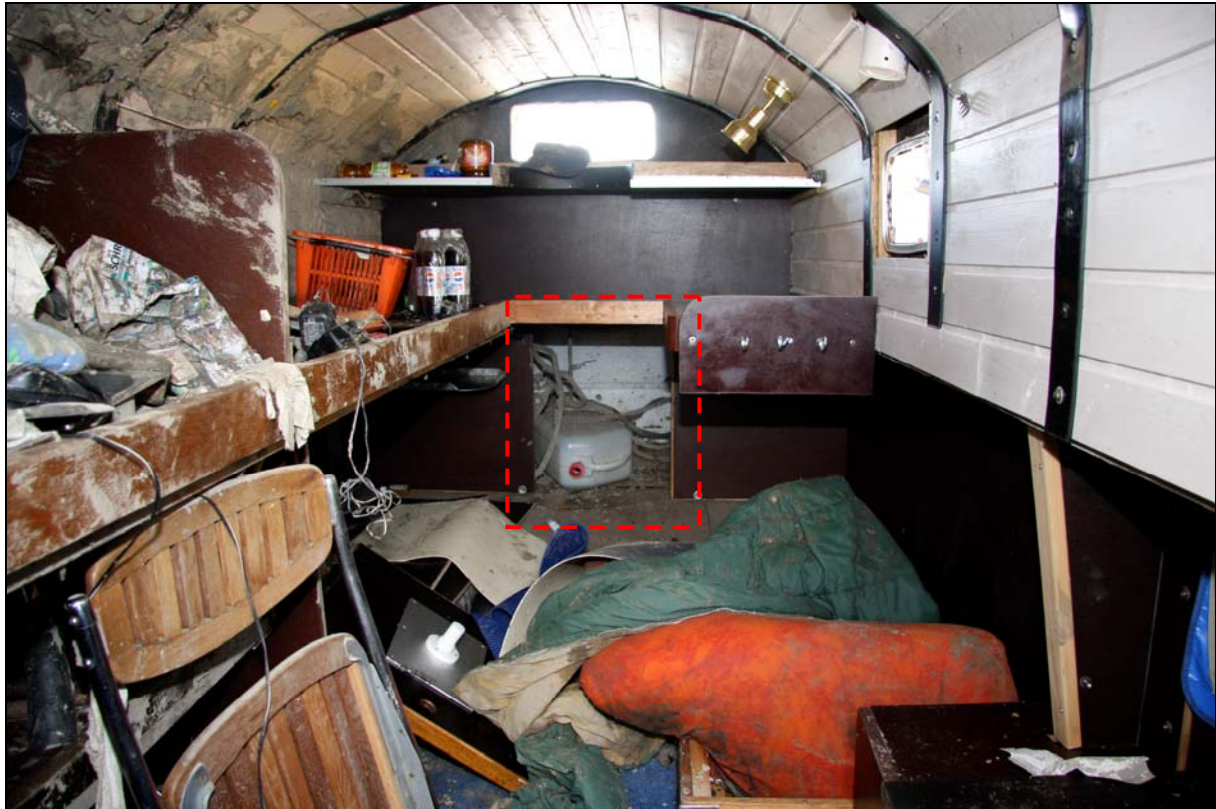
Figure 19: Cabin of the QUINTETT

There was another exit from the cabin, albeit very cramped. A stowage compartment exists in the forward area, which can be accessed through a 60 cm high and 48 cm wide opening (see Fig. 19).

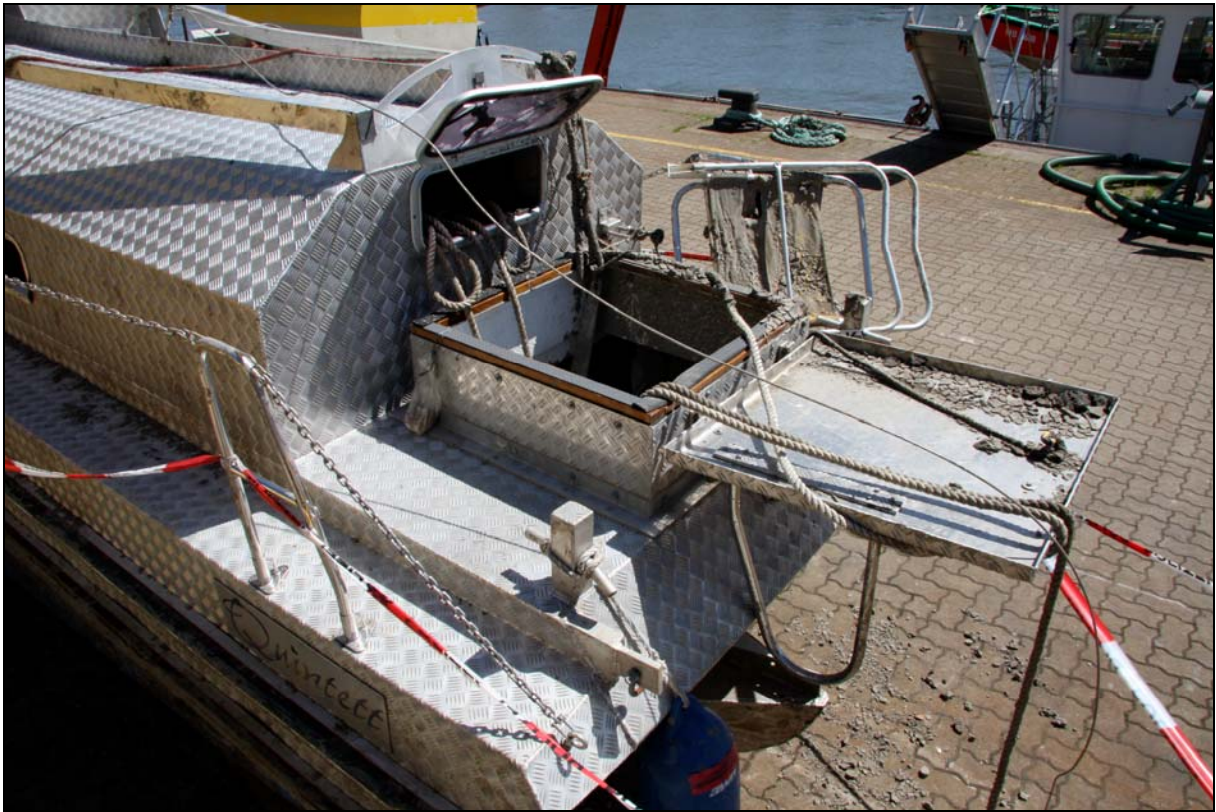
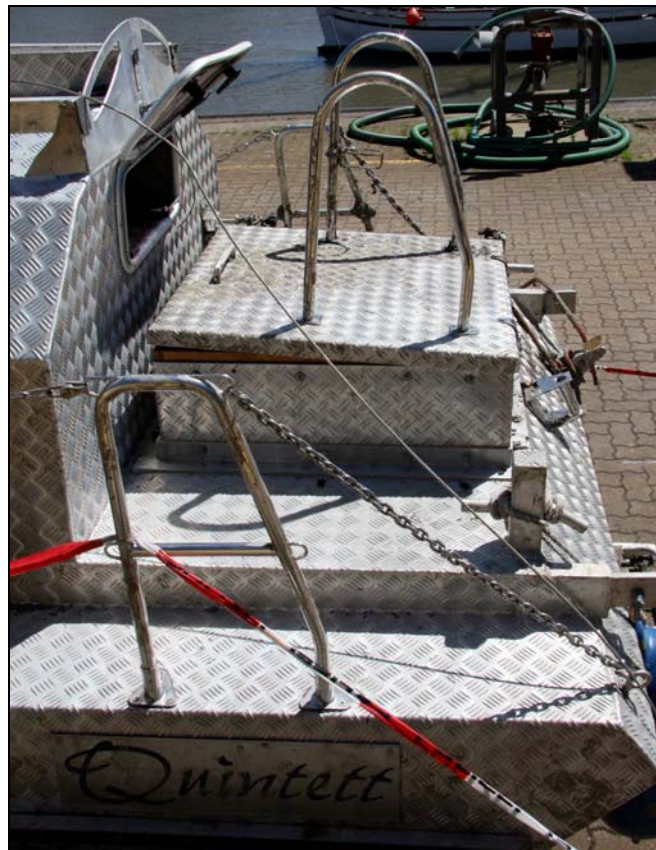
A hatch (70 x 70 cm) which leads to the foredeck can be reached via this stowage compartment (see Figs. 20 and 21). As is the case with the engine compartment hatch, this hatch cannot be locked from the outside. A 1 m long rope with a snap hook link is attached to the inside of the hatch cover, with which the cover can be fixed to a loop in the stowage compartment.

95 cm from the floor of the stowage compartment to the upper edge of the hatch coaming has to be negotiated in order to exit the cabin and go on deck.

The BSU assumes that after she capsized the cabin of the QUINTETT quickly filled with water because there was a general lack of watertight integrity. In particular, water could enter through the hatch unimpeded. The woman would have had to proceed from the wheelhouse to the forward stowage compartment under those circumstances in order to then go outside through the hatch. That only appears possible under conditions whereby the capsizing of the vessel did not lead to panic, severe injury or loss of consciousness. In retrospect, that can only be speculated on.

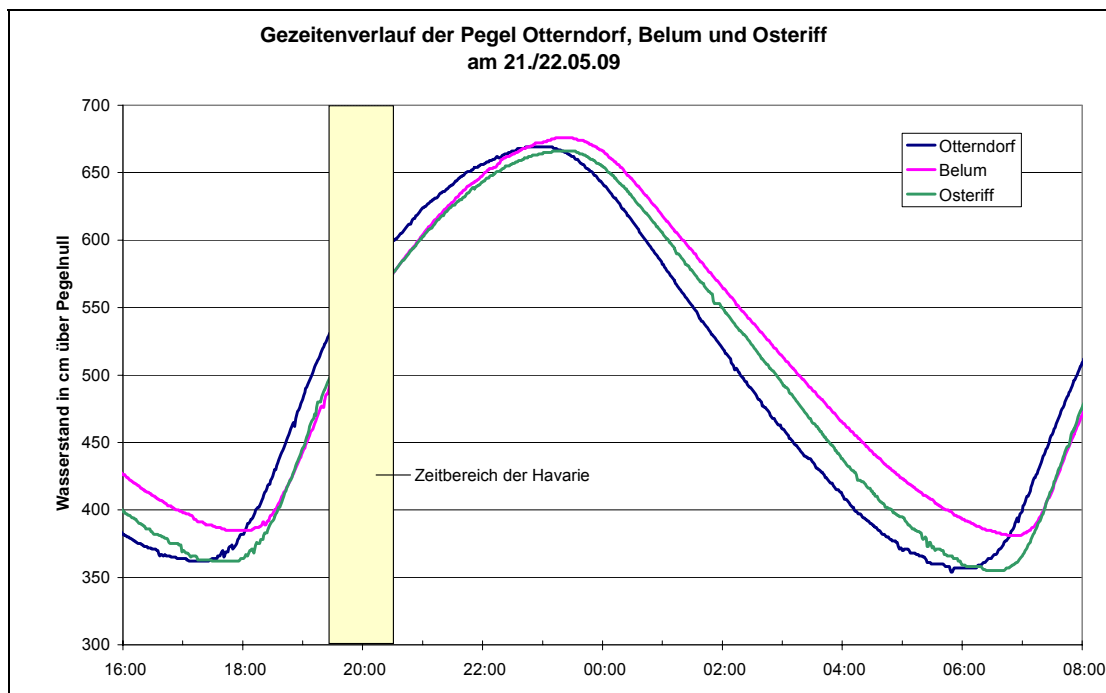
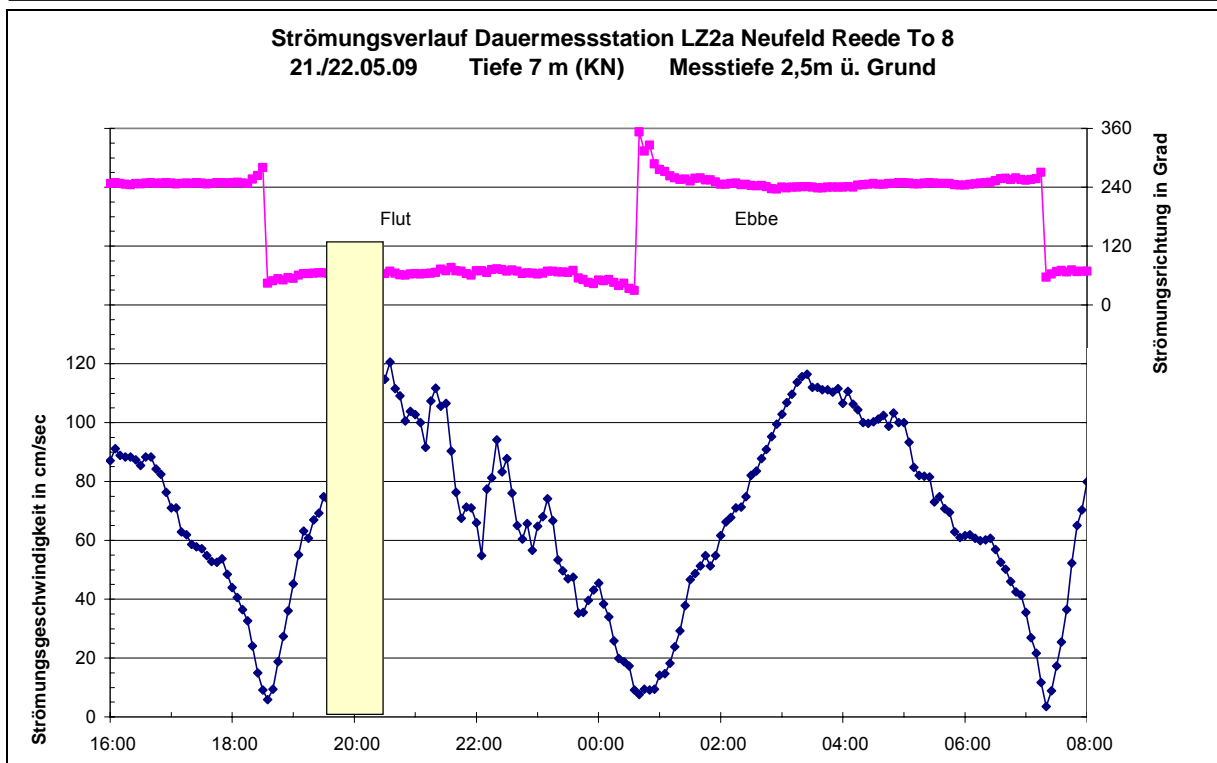
The graphical analysis of the findings of the WSA's expertise illustrates that the QUINTETT entered the Elbe fairway during the flood stream (see Figs 23 and 24).

The strong tide not only facilitated the capsizing of the QUINTETT, but also the way in which the vessel's owner drifted after she capsized.
