Bundesstelle für Seeunfalluntersuchung
Federal Bureau of Maritime Casualty Investigation
Federal Higher Authority subordinated to the Ministry of Transport,
Building and Urban Development

Summary
Investigation Report 218/09

Very serious marine casualty

**Fatal accident while hauling in the gangway on
the MV YOHJIN
on 17 June 2009
in Bremerhaven**

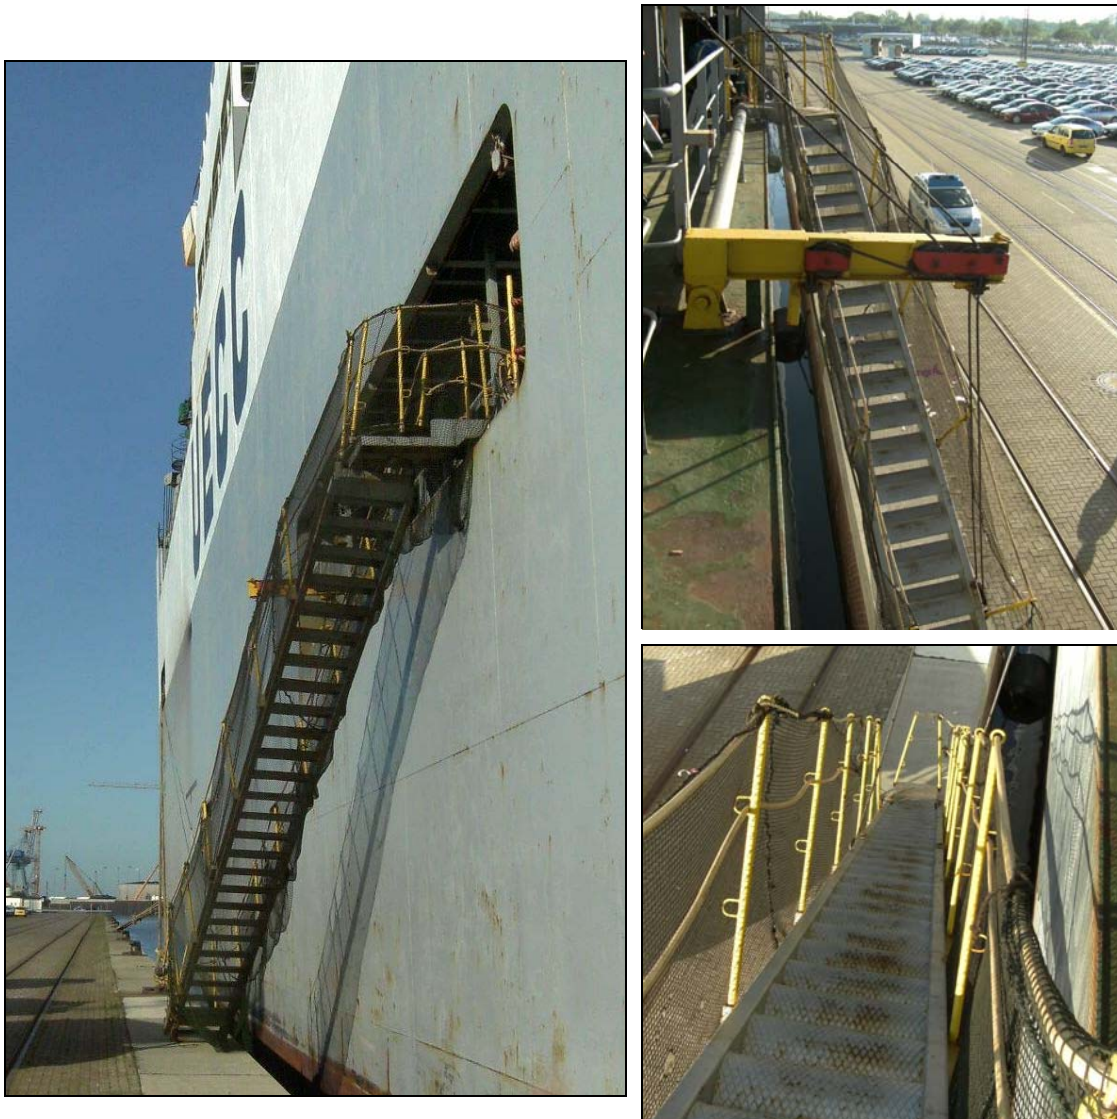
Figure 3: The gangway from different perspectives

It is clear that the fatally injured bosun was working alone and unsecured on the gangway. He had already removed the hand and safety ropes and loosened the safety net shore-side⁵. The gangway stanchions in the area of the steps of the companionway were still extended both shore-side and on board. The hand and safety ropes had still not been dismantled on board either. The gangway stanchions situated on the upper platform are of a plug-in design (see **Fig. 5** below). Due to their design, these are pulled out of their retention devices with a more or less inevitable jolting motion.

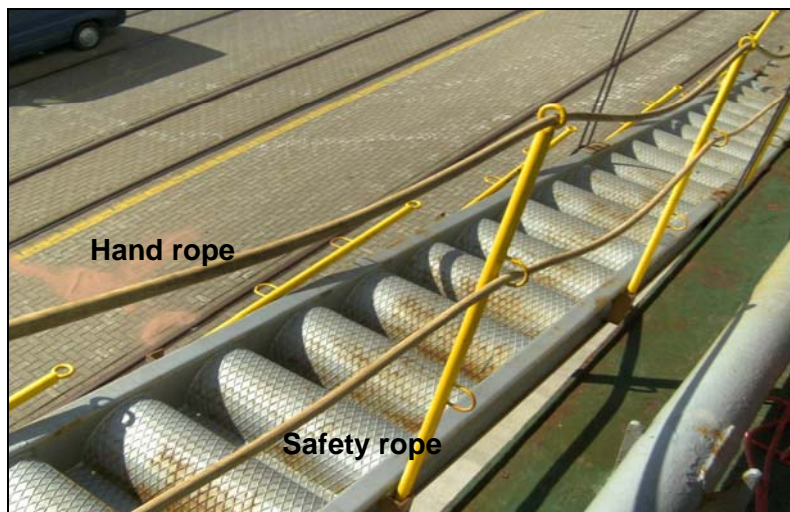
Figure 4: Folded outer gangway stanchions

Three of these plug-in platform stanchions were no longer in their retention devices after the accident. Two of them were in the immediate proximity of the casualty's position of impact on the pier. One of the two eyewitnesses onshore observed the bosun on the gangway platform working on the (outer) plug-in stanchions there immediately before he fell. It is assumed that in the process the seaman – possibly while jolting two stanchions, one with each hand, to release them – lost his balance and in the absence of a remaining handhold or of being secured fell (see reconstruction in **Fig. 6** with respect to the insufficient handholds).

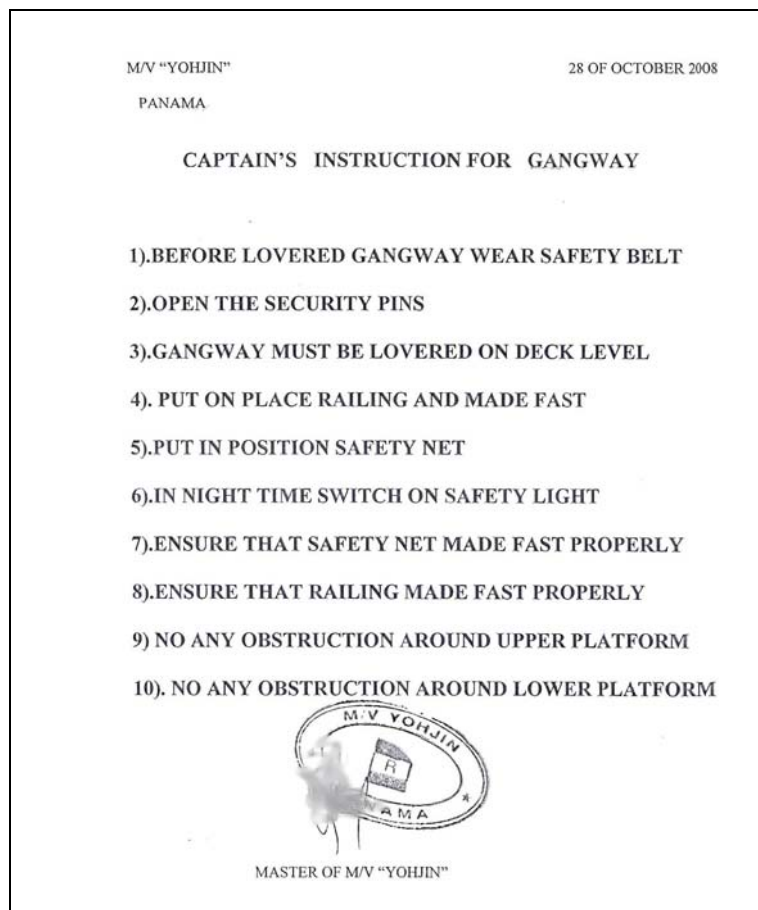
Figure 7: Master's order for clearing the gangway

A Master's order dated 28 October 2008 for handling the gangway exists on board the vessel (see **Fig. 7**). The instructions are very superficial and describe only a few aspects of safety in relation to deploying the gangway. Instructions were neither provided for hauling in and securing the gangway, nor was it specified how many crew members should carry out this task. However, it is probably no coincidence that the first instruction stipulates that a safety belt should be donned before the gangway is lowered. A literal interpretation of the instruction in question may lead one to limit its significance to the lowering procedure; however, the meaning and purpose of the instruction must surely be that personal protection is to be ensured for every task associated with handling the gangway, which involves a risk of falling.

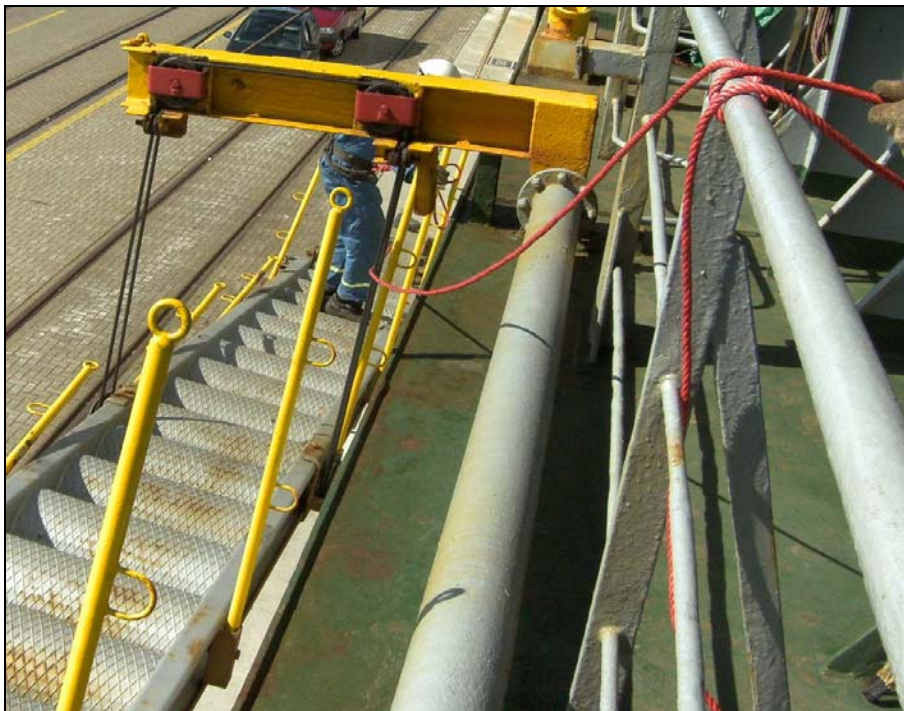
Figure 8: Work on the gangway with personnel protective equipment

It is evident that the red safety line would be only suitable for preventing the fall of the seaman who was working on the gangway to a very limited extent. The boom-construction for hoisting/lowering the gangway is a problem in terms of creating an obstacle when it comes to guaranteeing continuous and not too complicated personal protection. In addition, the illustrated safety methods urgently require the presence of an attendant who focuses on safety.

The same structural deficit affecting personal safety existed on the gangway system of the 'HEINRICH S'. In response to the accident, the shipping company installed a safety wire below the boom, which ran parallel to the folding-in position of the

gangway. Crew members could connect to this using a snap hook link before carrying out work on the gangway.

In safety recommendation 7.1 of the aforementioned investigation report, the BSU recommended that operators of sea-going vessels implement structural measures to facilitate uncomplicated use of fall prevention equipment in the area of the gangway. The enduring relevance of the other safety recommendations in the aforementioned report is also sadly demonstrated by the accident on board the YOHJIN. Therefore, at this point it should be stressed once again just how important an actively embodied culture of occupational safety on board is.¹⁰ Moreover, the recommendation that an unambiguous operating procedure is provided for handling the gangway, which also includes any safety aspects to be observed, is explicitly referred to at this point. In order to give a sound basis to the formulation of such an operating procedure as well as to be able to respond adequately to technical problems experienced on board with the gangway, it should also be ensured that the technical documentation of the manufacturer of the gangway system is also kept on board.
