Bundesstelle für Seeunfalluntersuchung
Federal Bureau of Maritime Casualty Investigation
Federal Higher Authority subordinated to the Ministry of Transport,
Building and Urban Development

Investigation Report 255/08

Serious marine casualty

Collision
CMV MARFEEDER
with
CMV APL TURQUOISE
on the Outer Weser
on 1 June 2008

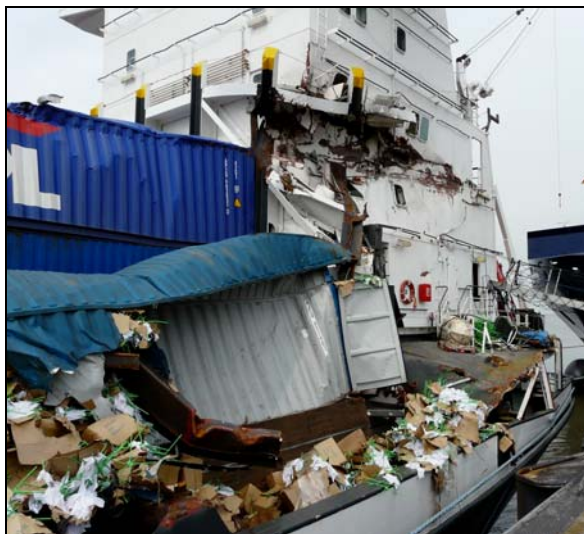
Figure 4: Damage MARFEEDER

The shell plating, the area of the bulwark and small sections of the deck were dented on the port side of the MARFEEDER's forecastle. Some of the hatch cover mountings were damaged. The bulwark in front of the superstructure was dented and the cell guide of the container slots deformed. Containers were torn open. The boat deck was destroyed along a length of 10 m, as was the davit and the rescue boat. The chambers on deck 2 and 3 were destroyed on the port side. The rescue boat was salvaged at buoy 33 by the police boat Visura and taken to Geestevorhafen. A life raft, which also went overboard, was salvaged by the rescue cruiser HERMANN RUDOLF MEYER.

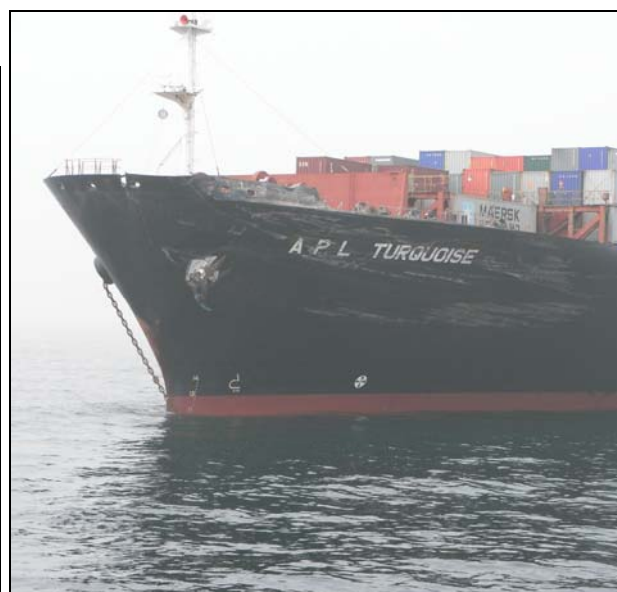
Figure 5: Damage APL TURQUOISE

The APL TURQUOISE had a crack below the panama fairlead on the port side of the forecastle and the bulwark was dented. Parts of a container were stuck to the anchor. A 1.2 m long and 20-30 cm high crack was located about 5 m above the water line. Paint abrasions existed at various places.

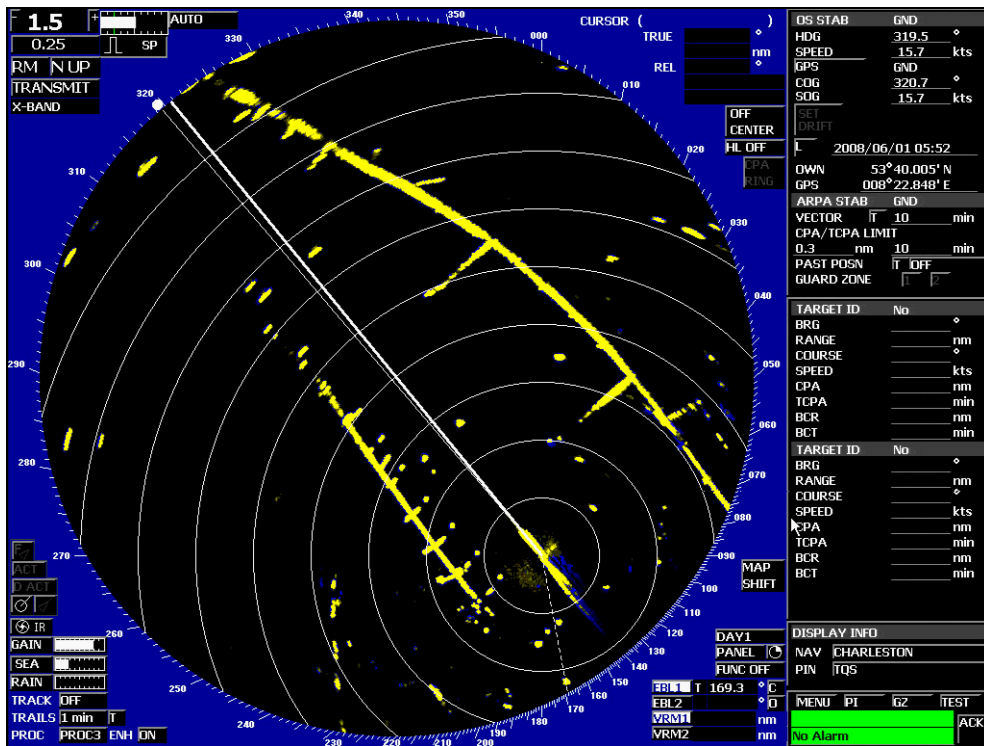
Figure 8: Radar image, TURQUOISE 055245

Preset range is 1.5 nm; the trail time (trail, plot-trail) is set at 1 min. The trails are displayed in true motion. This makes it impossible or difficult to establish visually that the risk of a collision exists. However, it is possible to distinguish between static and dynamic targets, since dynamic targets emit a trail where static targets do not.

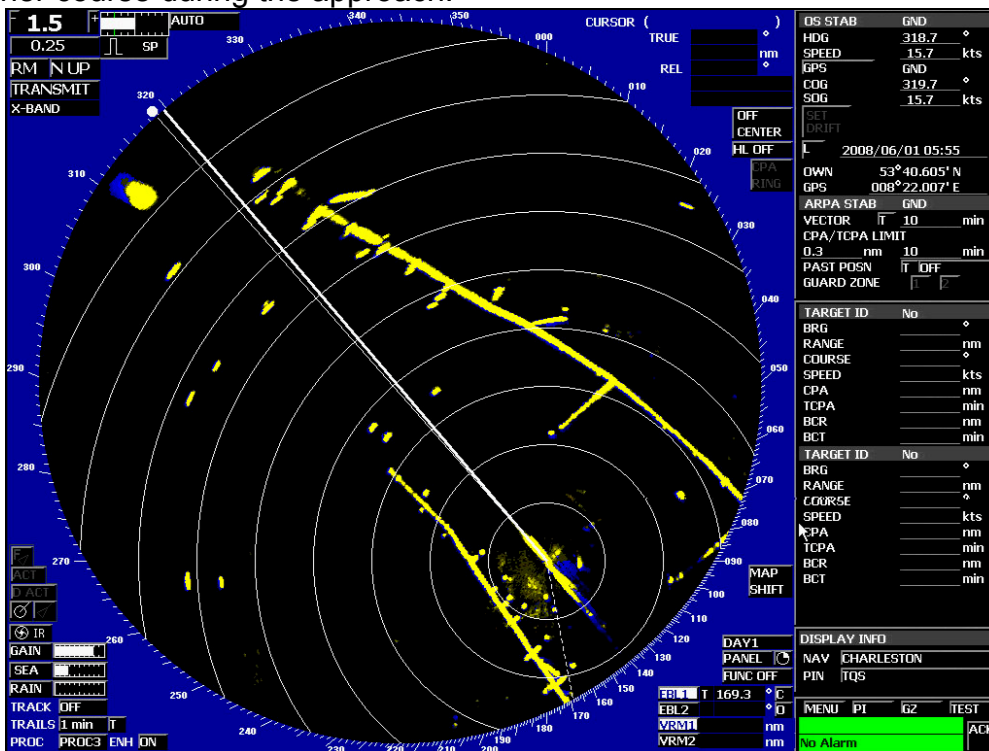
Figure 9: Radar image, TURQUOISE 055545

The other vessel involved in the collision enters the PPI (plan position indicator, radar screen/all-round view). At that point, it is the only upcoming vessel for the TURQUOISE. Based on the trails, we see that the upcoming vessel does not alter her course during the approach.

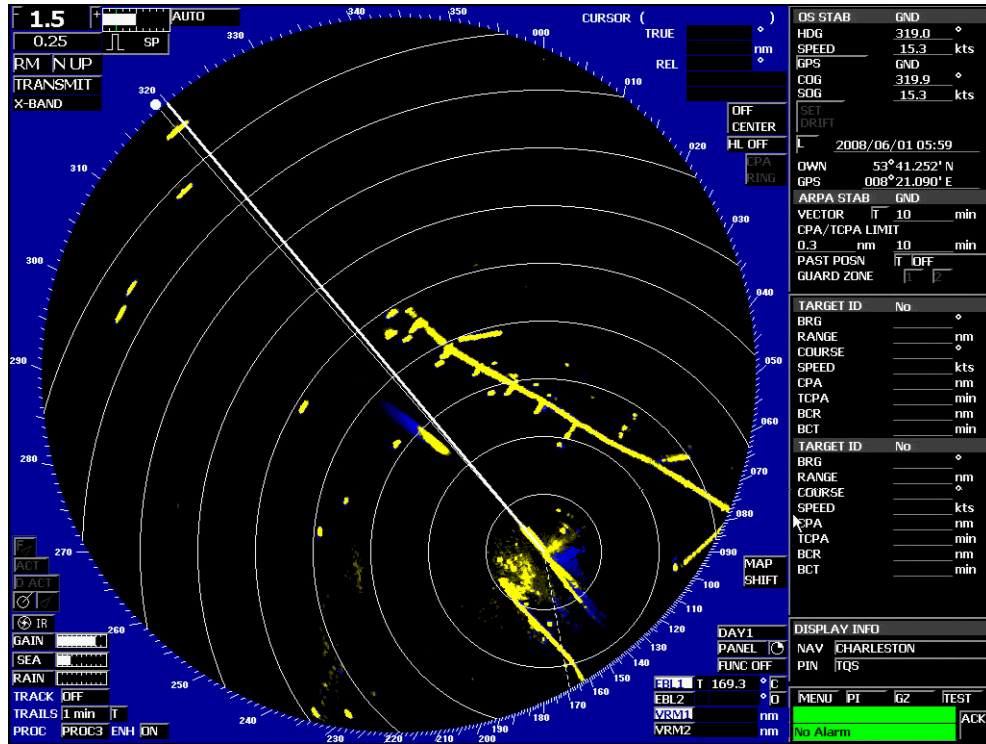
Figure 10: Radar image, TURQUOISE 055900

055900 (see Fig. 10)
 MARFEEDER on a collision course

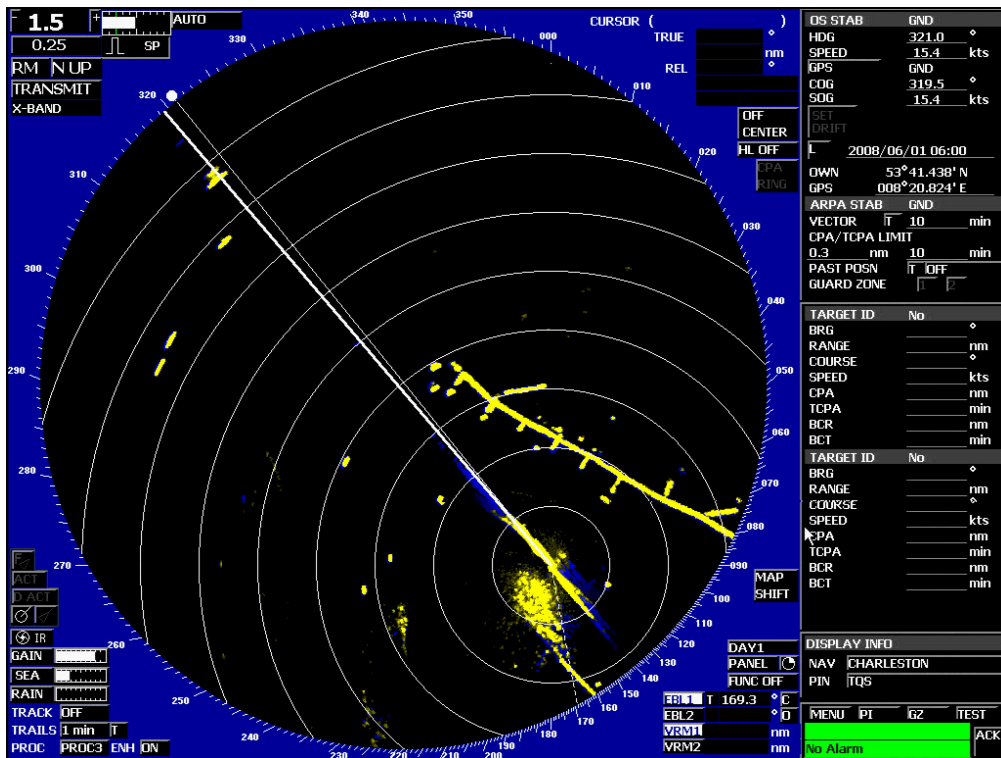
Figure 11: Radar image, TURQUOISE 060000

060000 (see Fig. 11)
 The collision occurs.

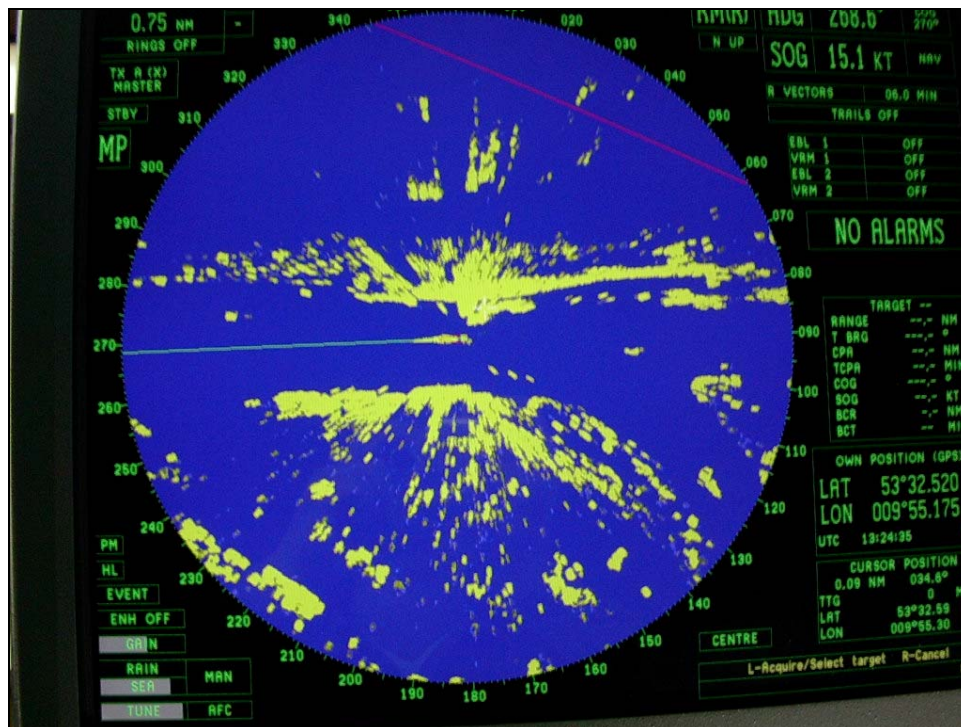
Figure 12: Photo of radar image taken on 10 July 2008

Targets in close proximity are shown up to approx. 1.5 nm, point targets up to approx. 3 nm, such as buoys, can be seen only faintly. Groynes and jetties are not displayed on the screen. No clutter can be seen on the radar screen. The display indicates inadequate performance in terms of what the receiver

provides the detector for analysing. To the extent that the automatic frequency control was used, the fault outlined in the service reports in relation to it being reportedly defective would explain this.

The service reports of Sperry Marine ServiceNet dated 31 May 2008 and 1 June 2008 noted that the automatic frequency control was reportedly defective, but that the manual tuning was operable.

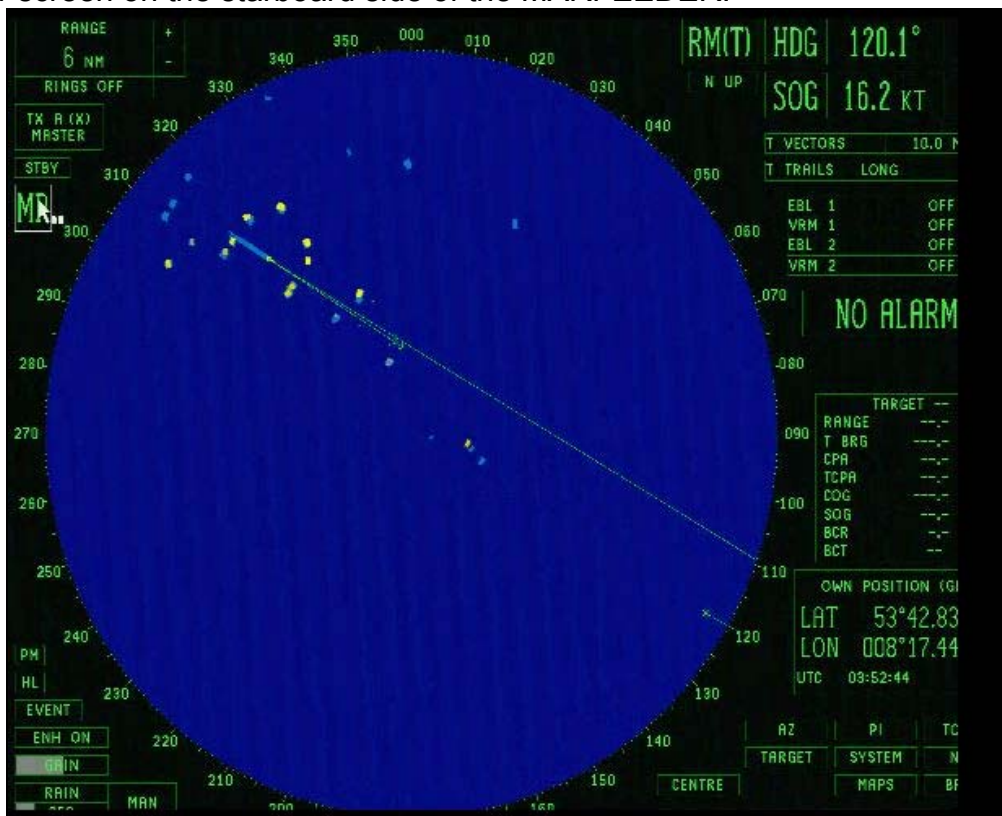
Figure 13: Radar image, MARFEEDER 055244

The other vessel involved in the collision is shown at approx. 6 nm at 120°. She is the only object shown at that distance. Since an image is recorded only every 15 seconds, it is not possible to determine the stability of the target.

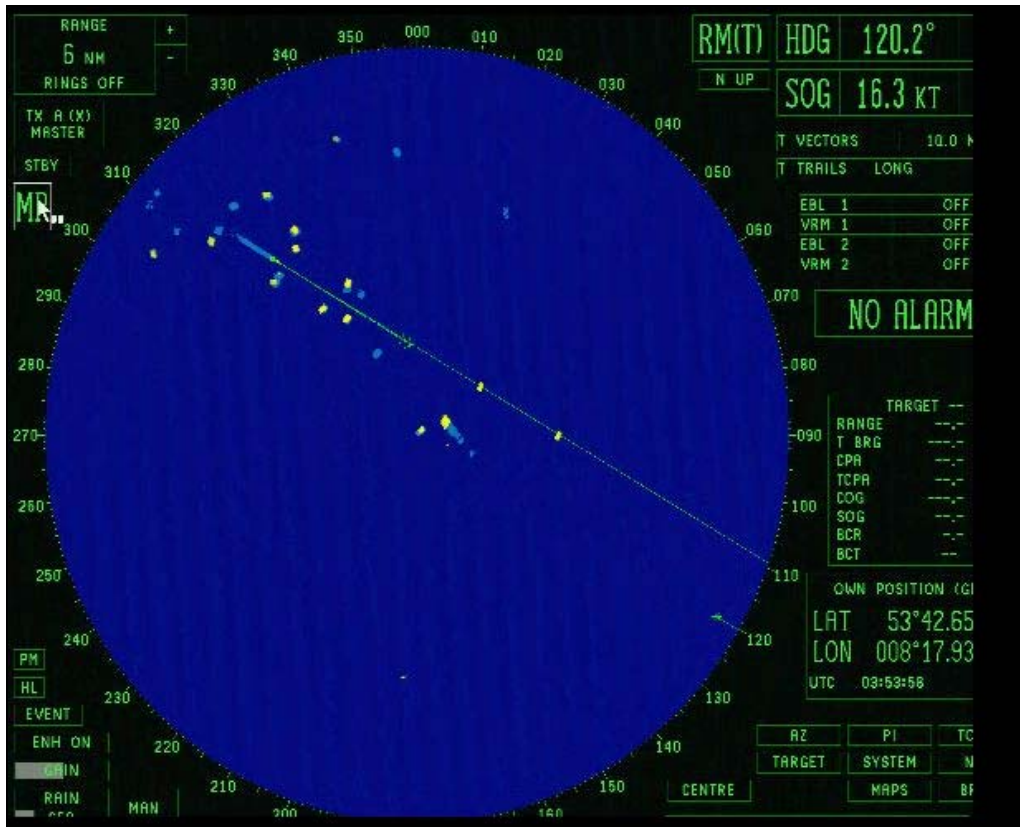
Figure 14: Radar image, MARFEEDER 055858

The target is permanently displayed on the radar image after the above recording.

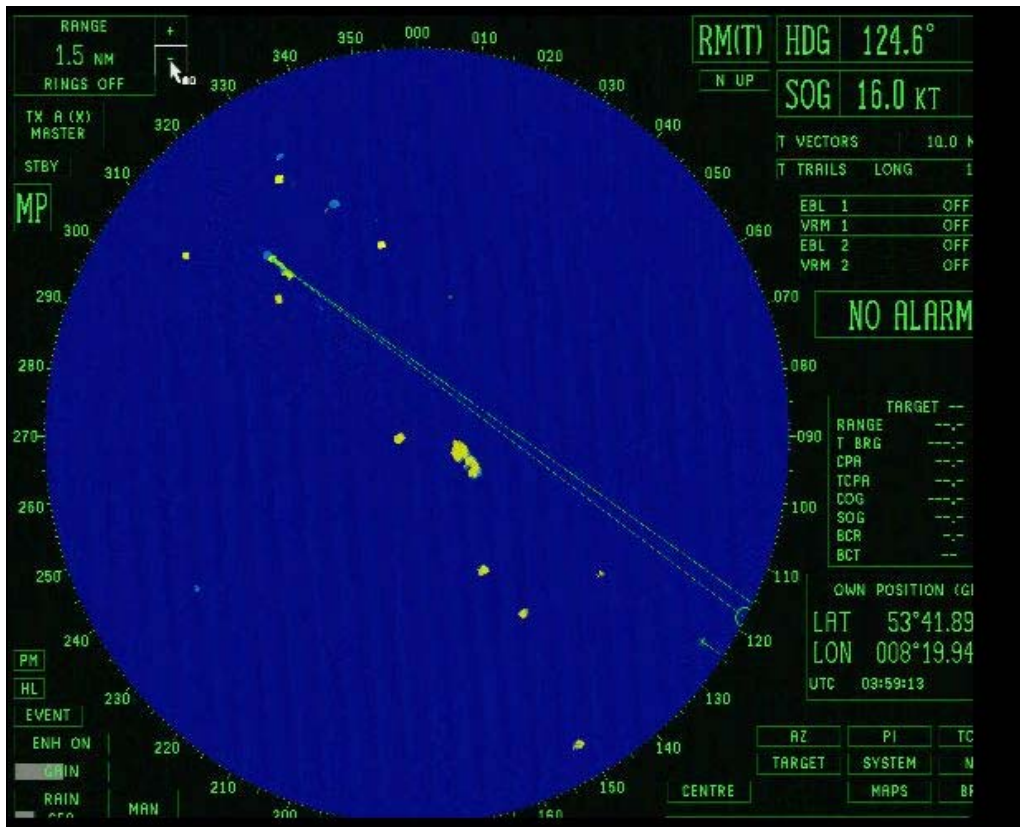
Figure 15: Radar image, MARFEEDER 055913

The radar is adjusted to a range of 1.5 nm. In addition to the other vessel subsequently involved in the collision, the fairway buoys are also shown on the radar screen on the starboard side of the MARFEEDER.

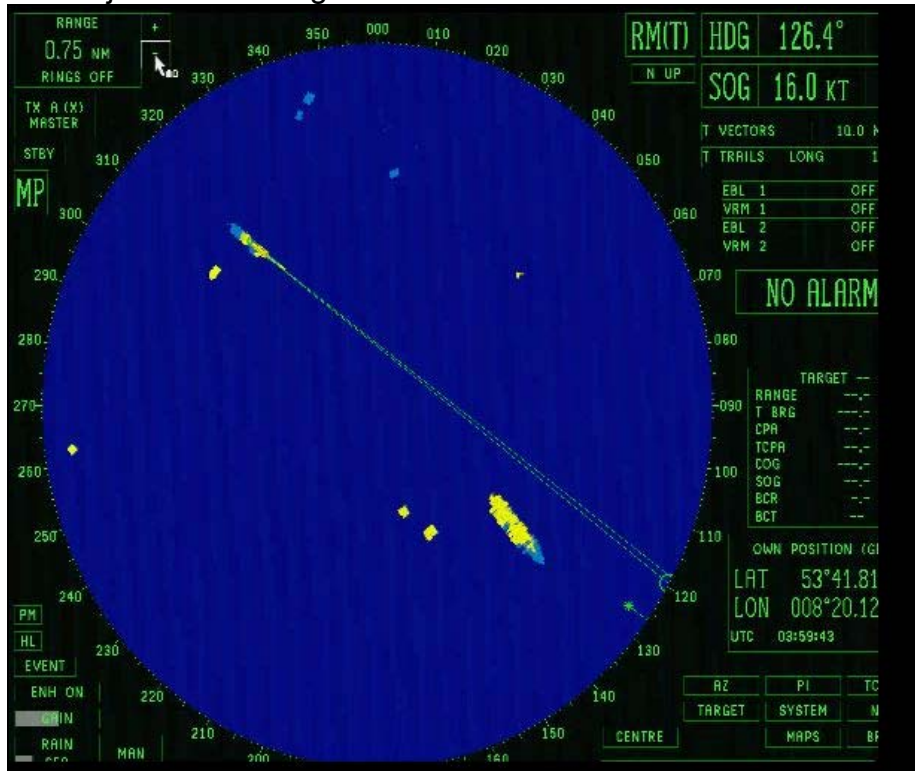
Figure 16: Radar image, MARFEEDER 055943

055943 (see Fig. 16)
 The radar is adjusted to a range of 0.75 nm.

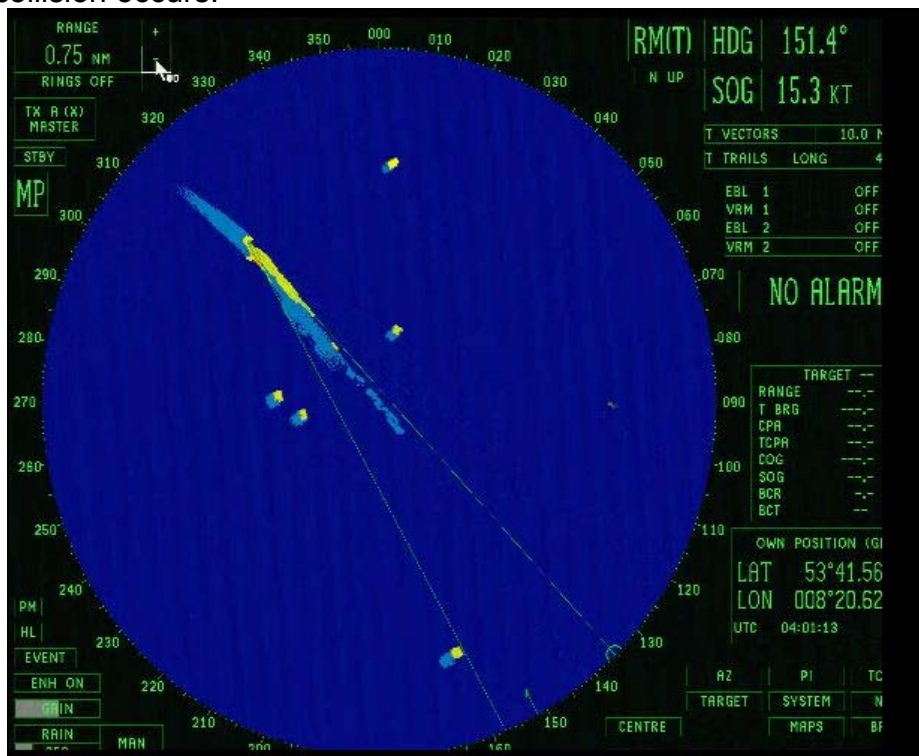
Figure 17: Radar image, MARFEEDER 060113

060113 (see Fig. 17)
 This collision occurs.

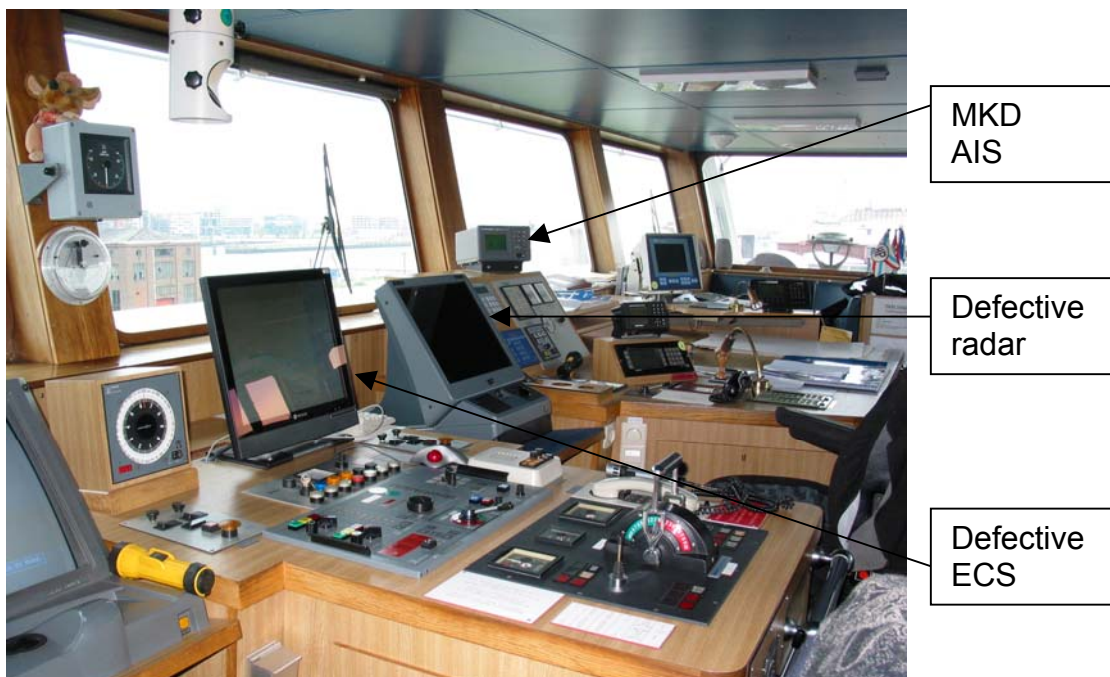
Figure 24: Bridge of the MARFEEDER

Overall, many aspects, which suddenly culminated, facilitated and led to the accident. Both vessels entered fog banks unexpectedly. The amount of time the Officers on Watch had to respond was limited. Although both vessels were manned by pilots and advised by VTS Bremerhaven, the vessels were unable to pass as planned at a sufficient distance. The MARFEEDER missed a course alteration in due time at the 'Robbennordsteert Light' and collided in the middle of the fairway with the upcoming right-of-way vessel APL TURQUOISE. This occurred at an inopportune moment during the change of watch on the MARFEEDER. Furthermore, in contrast with the safety management system (SMS), due to being insufficiently manned, organisation on the bridge was lacking and adversely affected by partially inoperable navigational equipment, such as a radar equipment and the defective electronic chart system (ECS). Hence, at about 0600 in the morning, the officers were distracted and could not concentrate on the situation fully. Fog signals may have increased the attention on the bridge of the MARFEEDER. The advising pilot on the MARFEEDER was unable to implement his required radar settings. With minimum key display (MKD), the AIS could not be evaluated for collision prevention in real time and was situated out of the pilot's sight on the starboard side of the conning position (see Fig. 24).

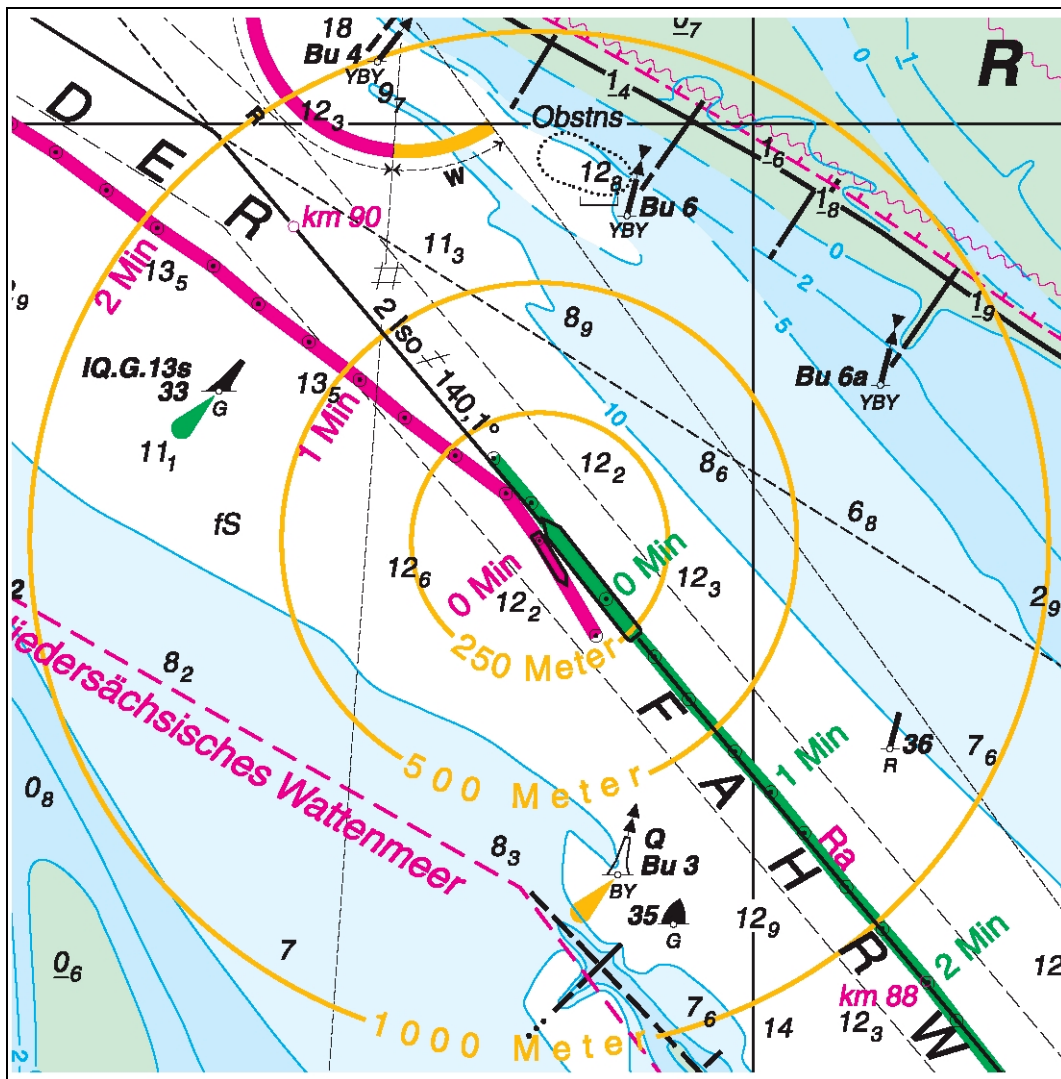
Figure 25: Scene of the accident with spacing rings

As the MARFEEDER requested radar pilot assistance at 0600 and she was informed that buoy 33 was reportedly astern and that the distance to the APL TURQUOISE was 500 m, she made an energetic course alteration to starboard; on the APL TURQUOISE it was realised that MARFEEDER was still heading for her. For the APL TURQUOISE, it was too late to take effective action to create more room between the vessels. The pilot of the MARFEEDER initially carried out the course alteration with the autopilot. That delayed the turn. It would have been possible to switch immediately to follow-up steering or even better to non-follow-up and steer a turning circle with a diameter of about 2 cbl with 'full astern'. That would probably have prevented the collision. This manoeuvre should have been initiated by the Officer on Watch. We are unable to understand the concerns of the pilot that the vessel would lose her steerability with this manoeuvre. Furthermore, in light of the knowledge that the navigational equipment was not fully functional, on recognising the deteriorating visibility it remains unclear why the speed was not promptly significantly reduced to gain more time to evaluate the situation.
