Bundesstelle für Seeunfalluntersuchung
Federal Bureau of Maritime Casualty Investigation
Federal Higher Authority subordinated to the Ministry of Transport,
Building and Urban Development

Summary
Investigation Report 350/09

Serious Marine Casualty

**Collision between MF SCHLESWIG-HOLSTEIN
and SY MAHDI on 24 August 2009
3 nm north-east of the Puttgarden ferry port**

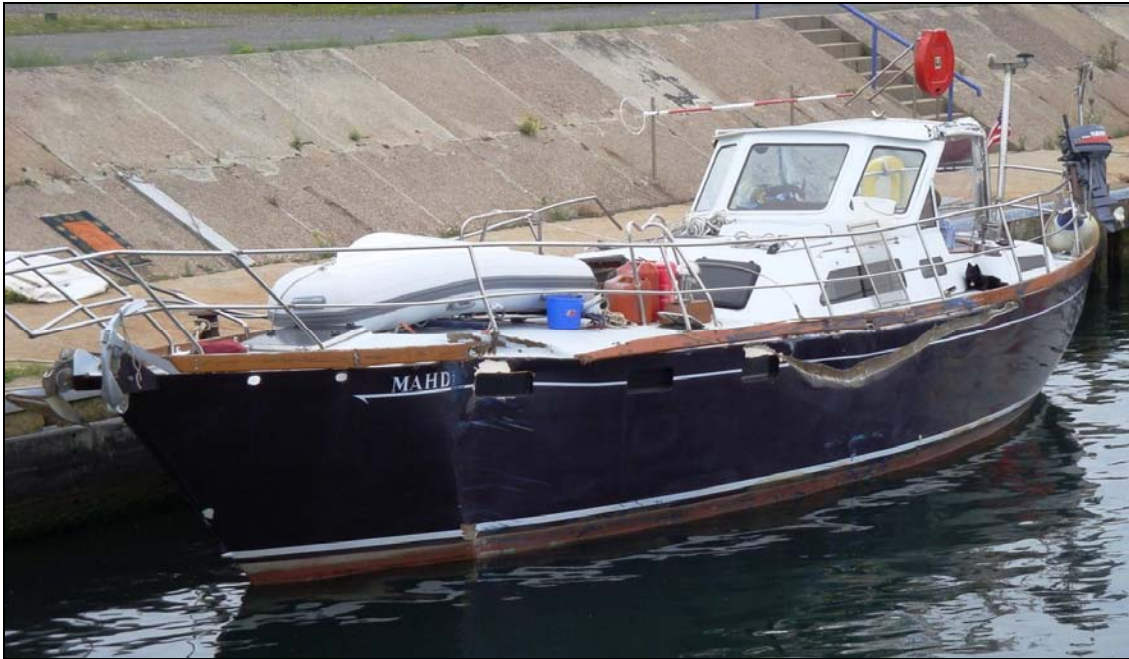
Figure 2: Photo of the SY MAHDI³

³ The photo shows the yacht after the accident and therefore without the broken mast.

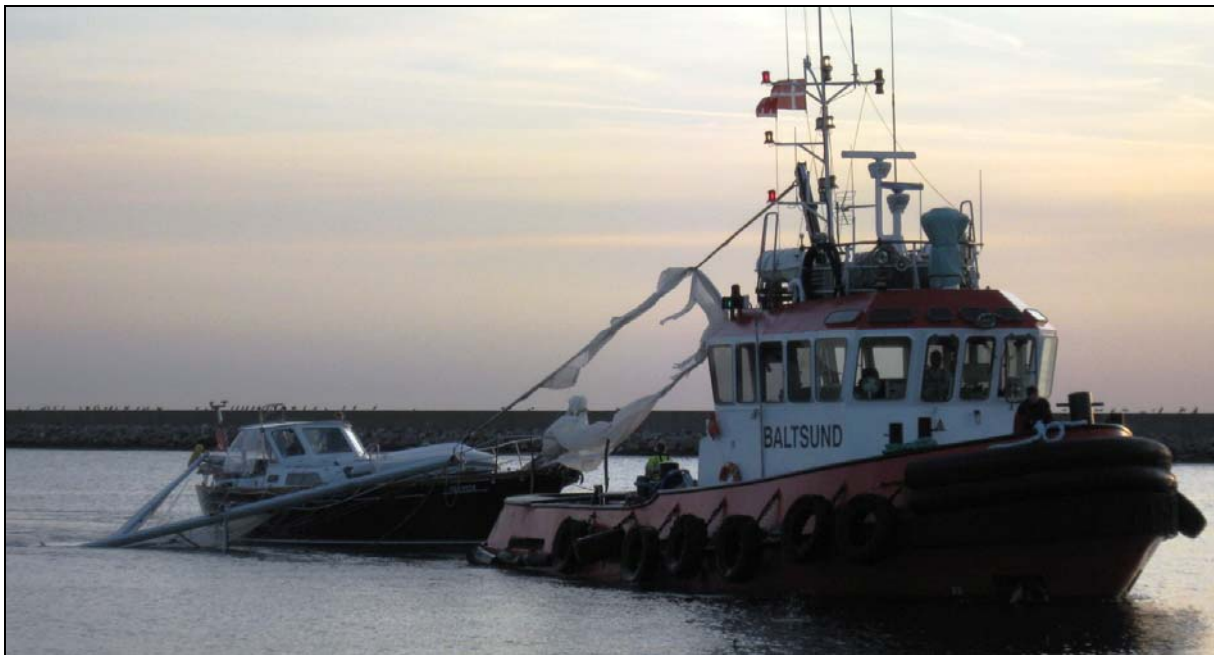
Figure 5: The tug BALTSUND towing the SY MAHDI⁹

⁹ The photo on which the broken mast and rigging can be seen protruding to starboard was taken at 0643 on the day of the accident.

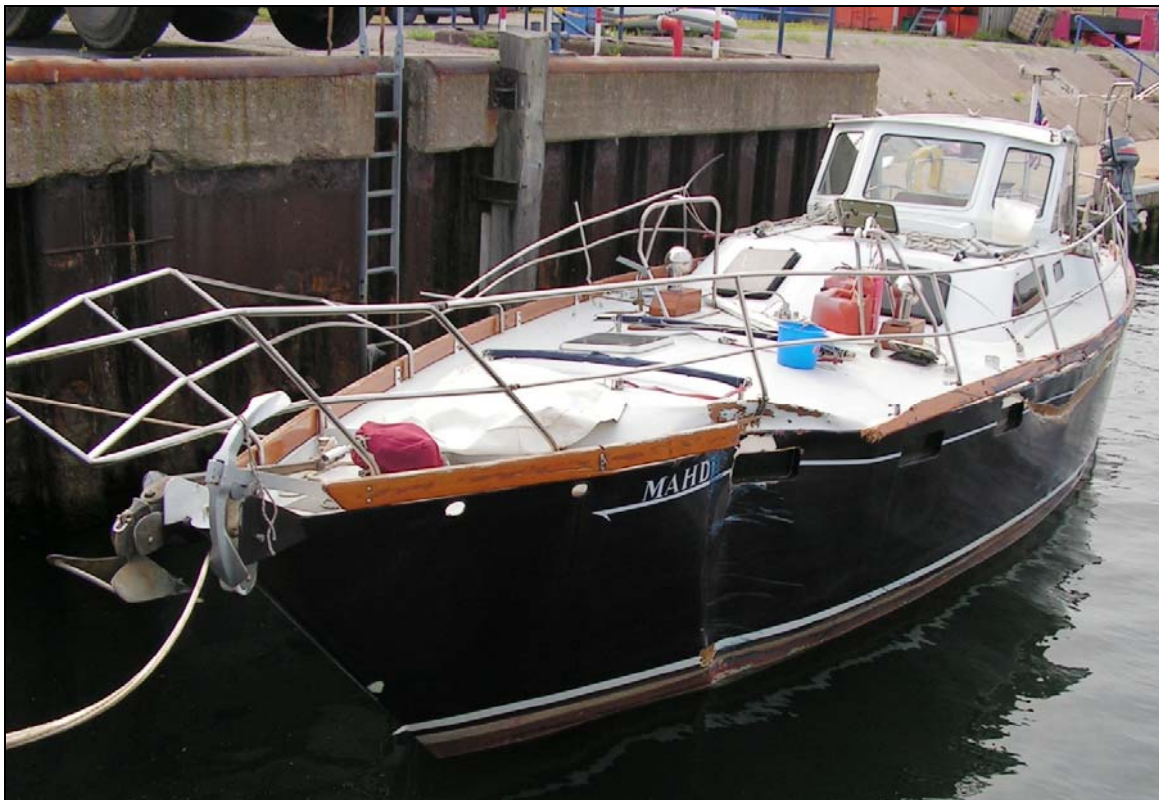
- Water ingress via the superstructure following the yacht's considerable heeling motion, causing damaging to the interior fittings and navigational equipment
- Severe buckling above the waterline on the port side of the fore section of the hull
- Large indentation amidships on the port side with a hole in the outer skin
- Damage to the cockpit
- Aft damage to the mounting of the outboard engine and the engine
- Dents on the hull underbody at the bow and on the forward starboard side
- Starboard railing damaged or torn off along the entire length of the yacht
- Mast broken and rigging destroyed

Figure 6: Damage to the SY MAHDI (long shot)

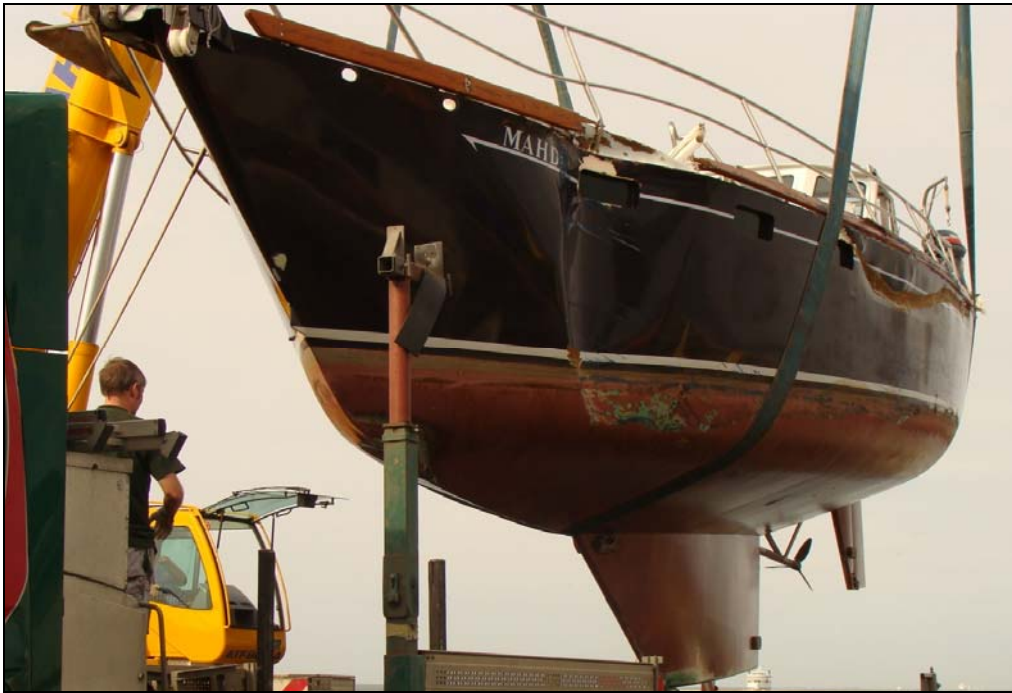
Figure 7: Damage to the SY MAHDI (port side)

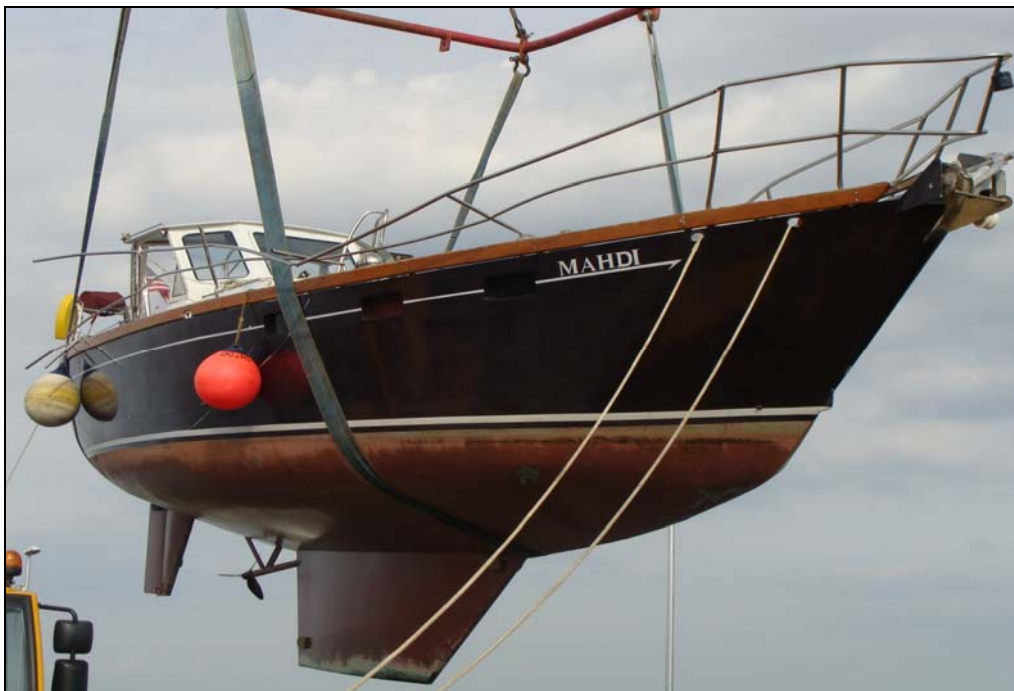
Figure 8: Damage to the starboard railing of the SY MAHDI¹⁰

¹⁰ The photo shows that the starboard side of the yacht's hull was largely unaffected by the collision.

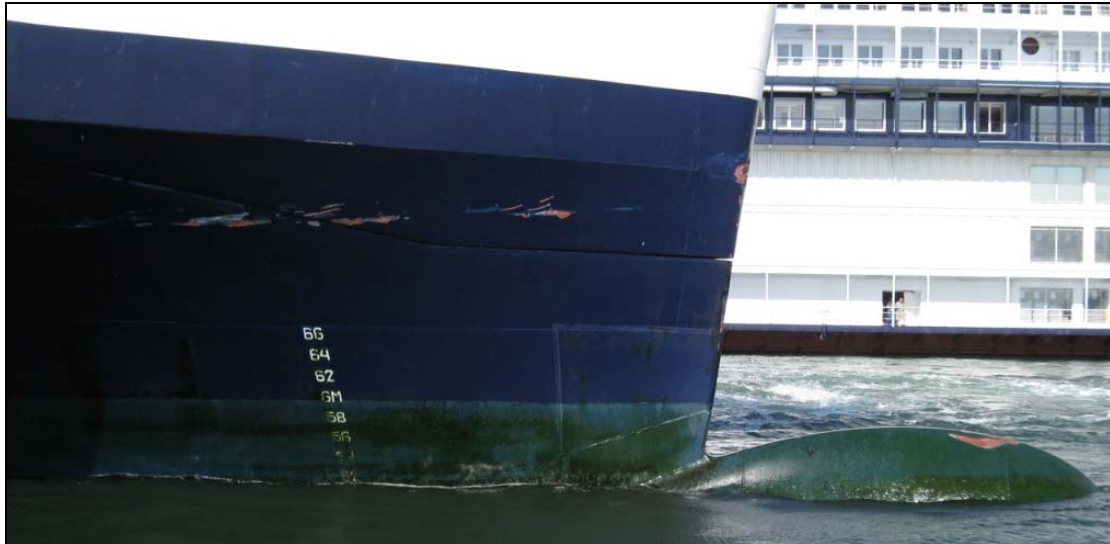
Contact with the MAHDI led to the ferry sustaining only very slight damage in the form of paint abrasions on the bow section (front and starboard side) and on the bulbous bow.

Figure 9: Paint abrasions on the MF SCHLESWIG-HOLSTEIN (1)

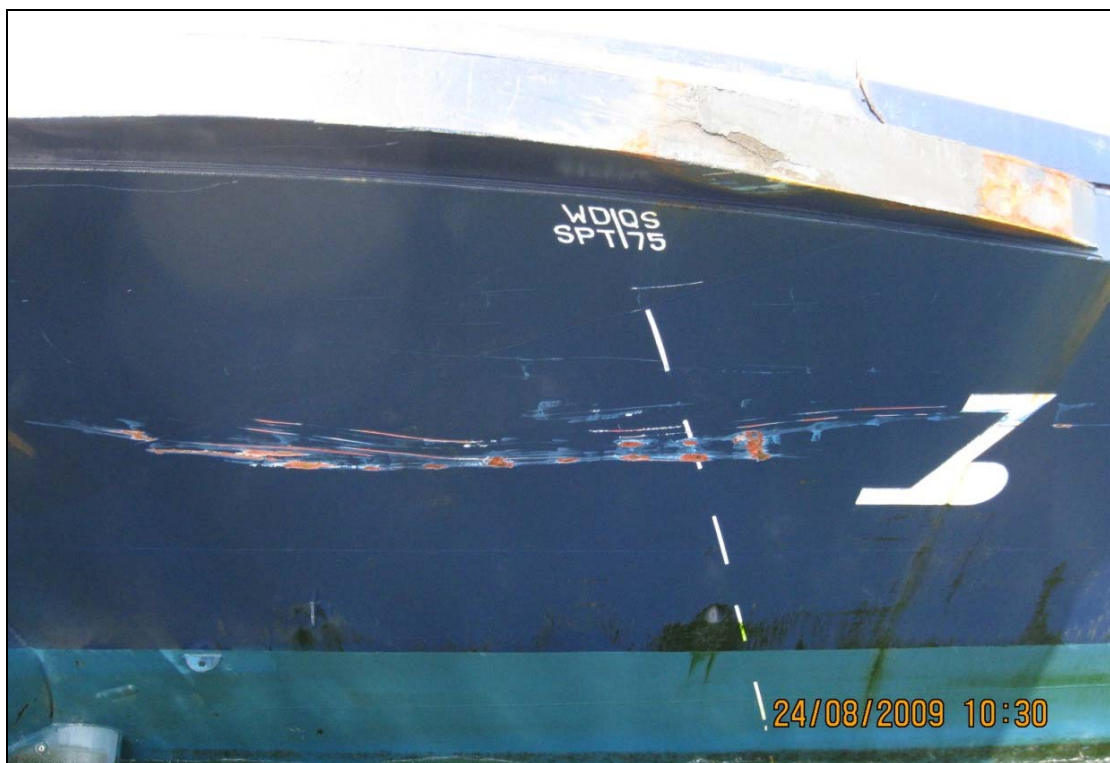
Figure 10: Paint abrasions on the MF SCHLESWIG-HOLSTEIN (2)

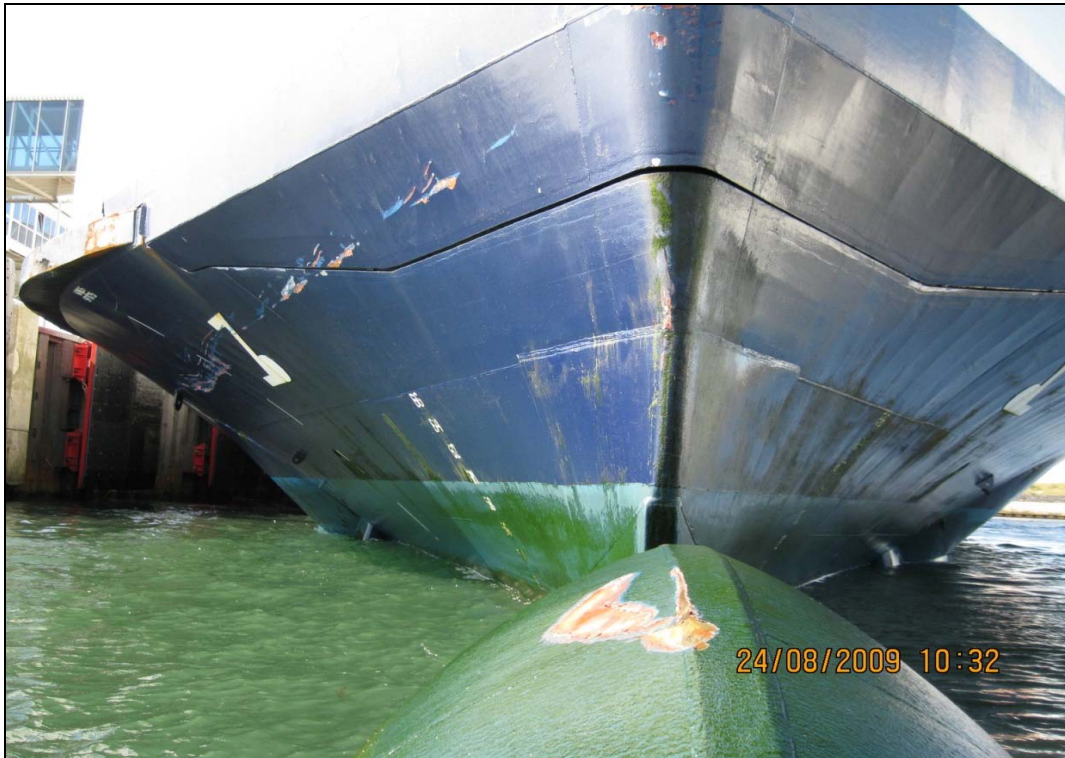
Figure 11: Paint abrasions on the MF SCHLESWIG-HOLSTEIN (3)
