**Bundesstelle für Seeunfalluntersuchung**  
**Federal Bureau of Maritime Casualty Investigation**  
Federal Higher Authority subordinated to the Ministry of Transport,  
Building and Urban Development

## **Investigation Report 496/09**

**Very Serious Marine Casualty**

**Grounding with water ingress  
on 21 November 2009  
to the south of São Miguel/Azores and  
constructive total loss of the  
MV S.GABRIEL**

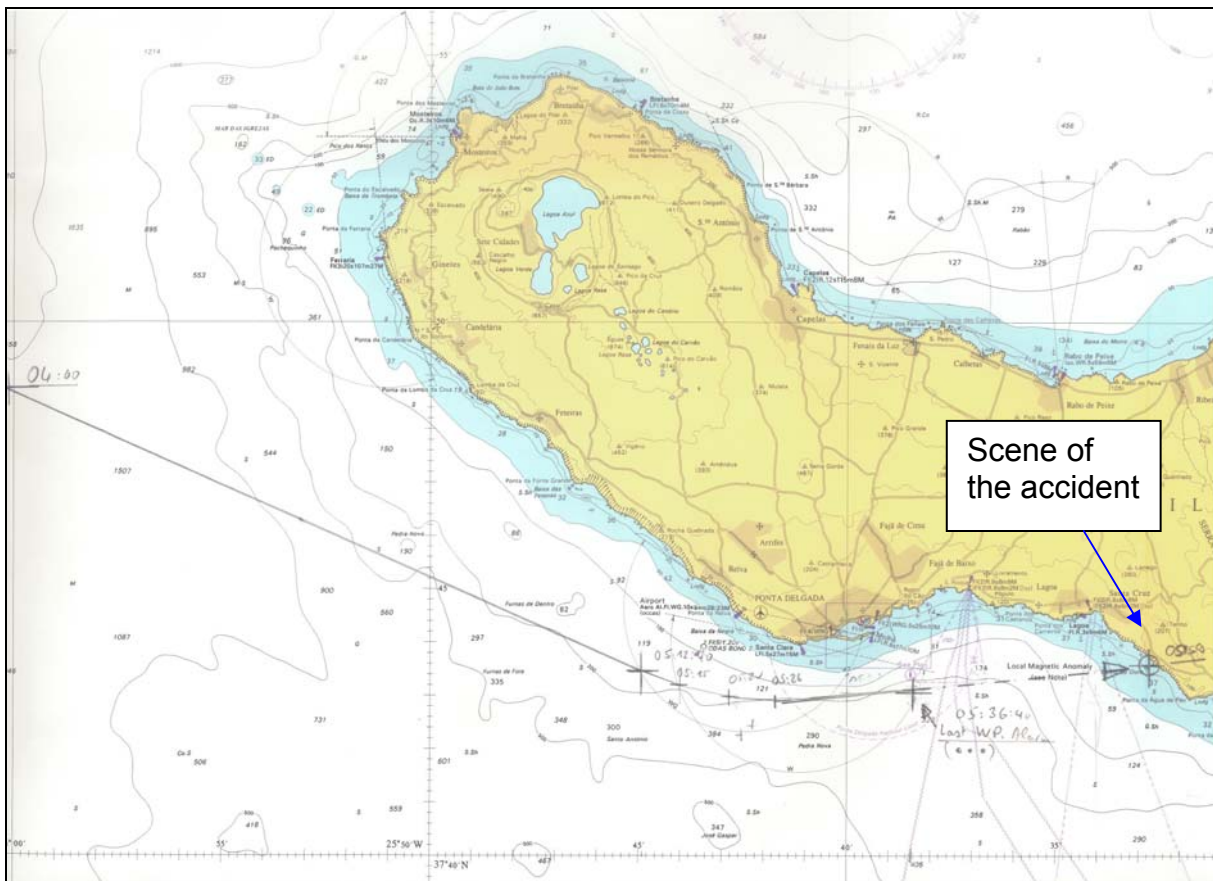
Figure 3: Scene of the grounding

The last recorded change of course was at 0526 to the south of Ponta Delgada Airport. The vessel ran aground at the plotted position (see Figure 3) at 0559 while at a steady speed of 12.3 kts.

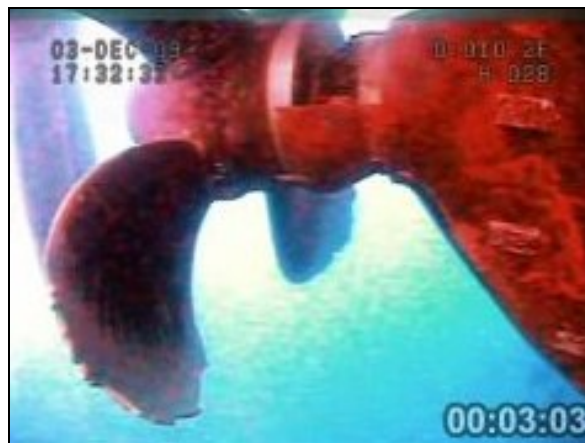
Figure 4: Damage to the propeller

After the vessel was salvaged, a damage report was prepared by Germanischer Lloyd on 6 December 2009. This was based on an underwater survey by divers. This report indicated that the bottom plating was damaged between frame 10 and frame 140 in the area of the bilge keel from port to starboard by dents, holes and cracks. The largest crack (1,500 mm in length) was discovered at frame 85 on the starboard side.

No damage to the hull was discovered in the area of the engine room. According to the audio recordings of the VDR, it was reported that the engine room was flooded about 1 hour and 48 minutes after the vessel ran aground. Since dry docking had not taken place up to the time at which this investigation report was prepared, it was not possible to properly clarify how the engine room flooded. Underwater photos taken at the port of Ponta Delgada were the only means available for assessing the damage.

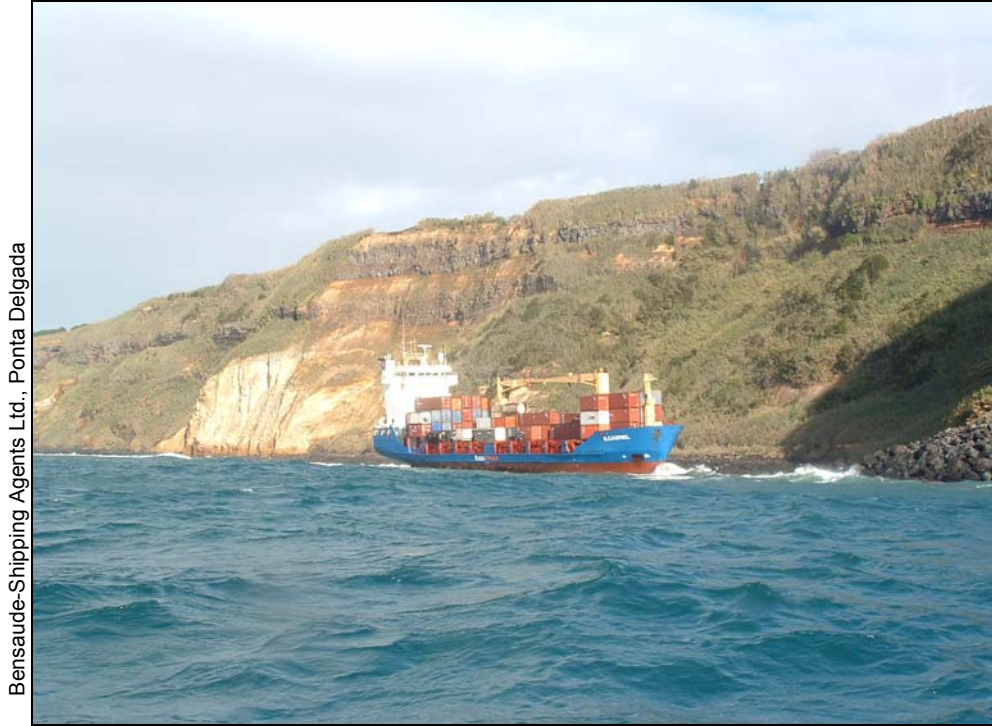
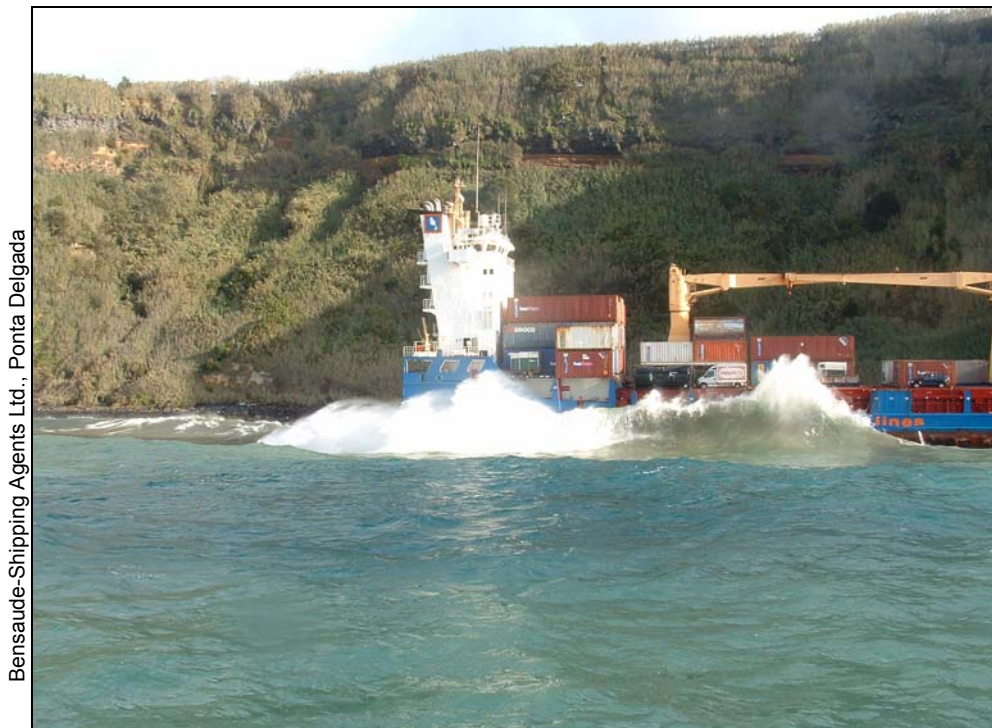
Figure 11: First photo of the grounded vessel

Figure 12: Second photo of the grounded vessel

The high elevations of the island can be seen in the background of each photo. The vessel is grounded in an extremely high position on rocks very close to the shore far behind the surf zone.

It is apparent that this was not carried out to a sufficient extent. If it had been, then the large rock formations of São Miguel (see Figures 11 and 12), which were on the course of the S. GABRIEL, would have been identified at an early enough stage both visually and by radar (Figure 14):

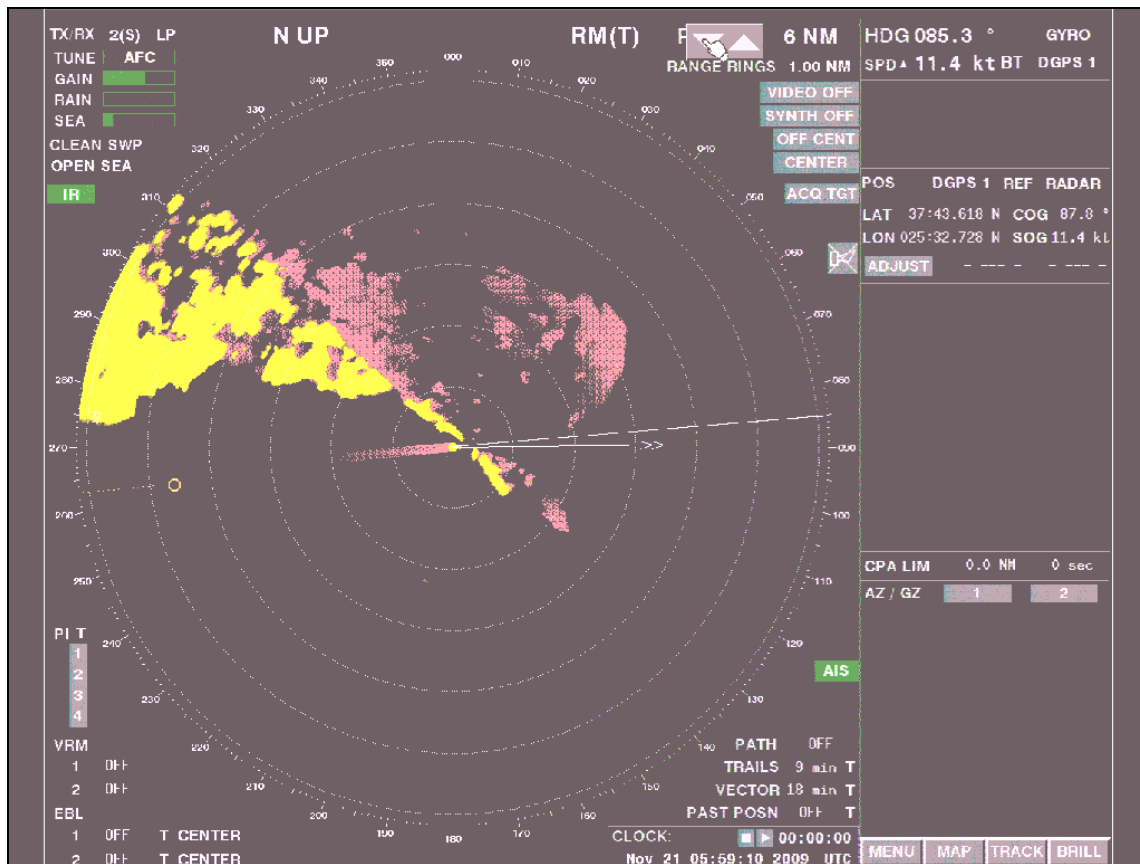
Figure 14: Radar image of the grounding

As basic principles and a minimum standard for safe, diligent navigation, the above regulations should be rigorously applied. These basic principles of seamanship were not observed. The officer of the watch was alone on the bridge from the time at which he took over (2350) to when the vessel ran aground. A proper lookout was neither maintained nor was position fixing carried out to a sufficient extent.

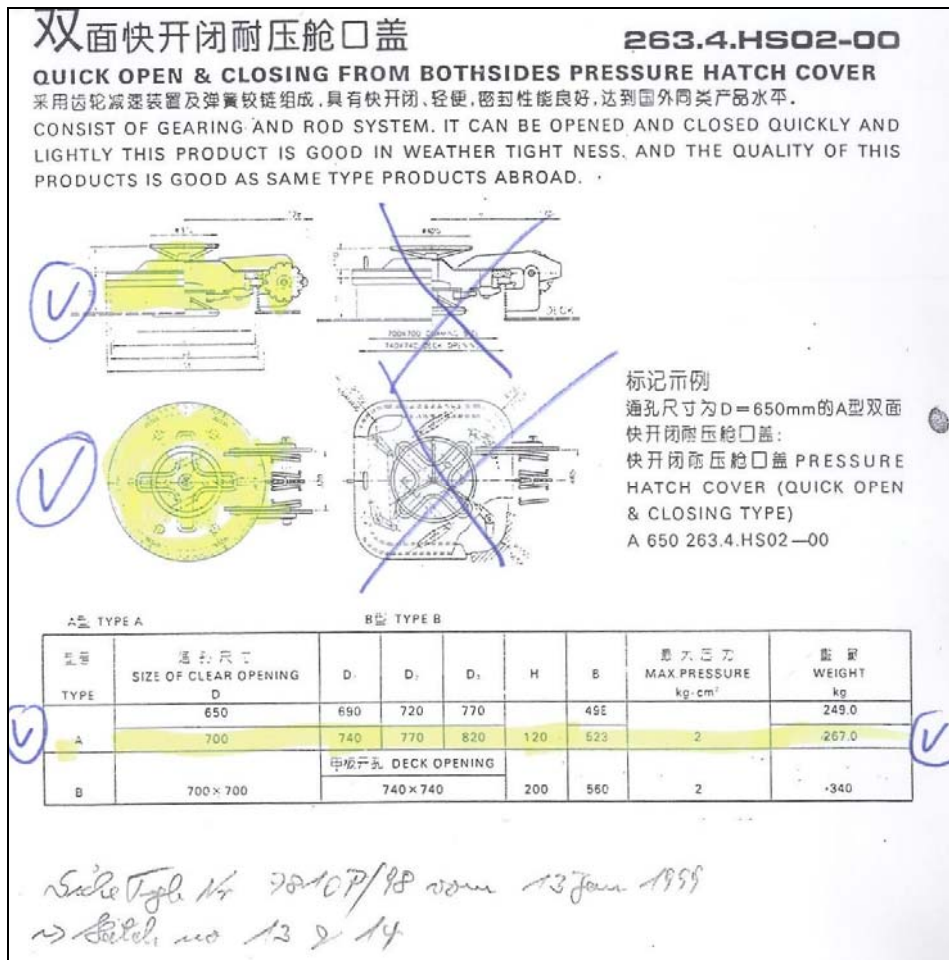
Figure 15: Approval drawing for the pipe tunnel cover

No visible damage to the shell plating visible from the engine room is evident in the engine room itself and the recordings did not indicate water ingress through the gland or sea-chest. However, the engine room flooded relatively quickly after the vessel ran aground and it is assumed that water entered through a larger opening, notably the entrance to the pipe tunnel at the forward bulkhead in the engine room. The entrance from the engine room is fitted with a round manhole cover 700 mm in diameter with a central locking system.

According to a letter dated 2 November 1999 from Germanischer Lloyd (GL) to the shipyard, this cover should be equipped with a remote indicator on the bridge, which displays whether it is open or closed and have a notice plate attached stating that it is to be kept closed at all times. *"The hatches shall be equipped with an indication showing on the bridge whether the hatch is open or closed. Additionally a notice is to be affixed to each such hatch to the effect that it is not to be left open."*

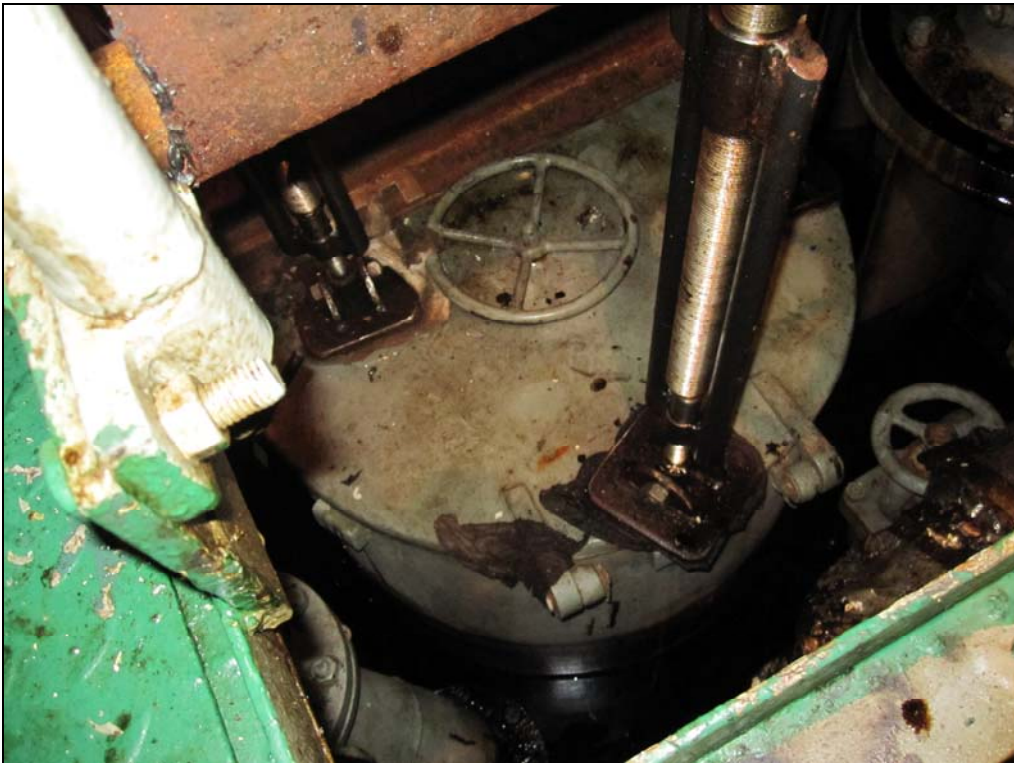
Figure 16: Hinges and hand wheel on the cover

Particular attention was given to inspecting the engine room during the survey by the BSU on 15 July 2010. The access cover for the pipe tunnel is slightly different to the above drawing. The hinges are of a simpler design and the top of the cover is level; the centre of the cover is not reinforced/raised at the hand wheel.

The Federal Bureau of Maritime Casualty Investigation recommends that the **owner and operator** of the MV S. GABRIEL, together with the **marine engineers responsible**, ensure that lockable openings in watertight bulkheads and access points to tanks, voids, cofferdams, pump rooms and pipe tunnels are kept closed at all times while the vessel is in normal operation.

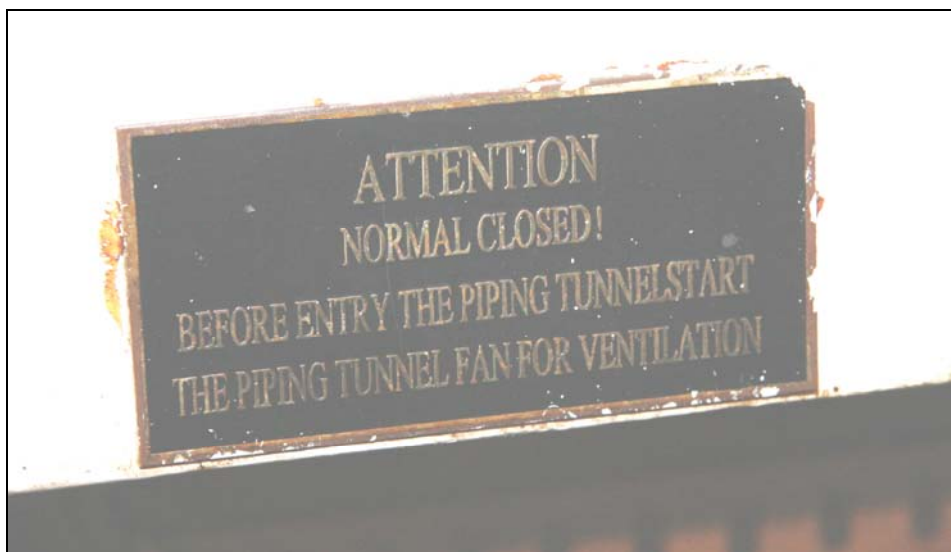
Figure 17: Notice plate above the pipe tunnel cover

A sender for the remote indicator, which displays whether the cover is open or closed, is mounted on the side towards the engine room bulkhead and corresponding indicator lights for the position of the cover are located in the engine control room on the monitoring panel. It was not possible to test the electrical operability of the remote indicator during the survey. The notice plate mentioned in the letter from GL is fitted above the entrance and states the following:

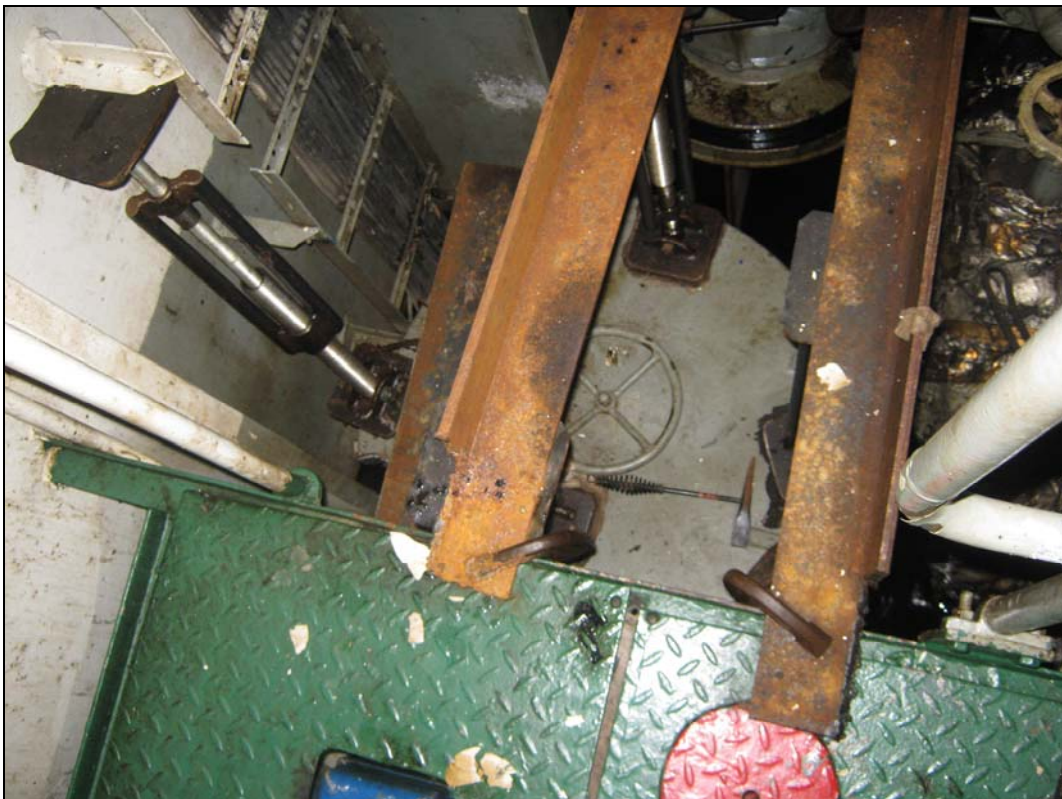
Figure 18: Pipe tunnel cover locked in place

In contrast with the BSU's findings relating to the pipe tunnel cover being open, the vessel operator believes that the oil leakage pipes were the cause of the water

ingress in the engine room. Several oil tanks in the area of the engine room were damaged when the vessel ran aground. This led to the oil/water mixtures being forced through the various oil leakage pipes into the engine room. The incoming mixture of oil and water prompted the chief to switch off the pump in order to prevent oil from spilling into the sea. These lines were sealed temporarily during the subsequent salvage operation to prevent the engine room from flooding again. The entrance to the pipe tunnel was closed when the vessel ran aground. The cover was locked in place with four clamping screws in addition as a safety precaution only for the period in which the vessel was being towed.

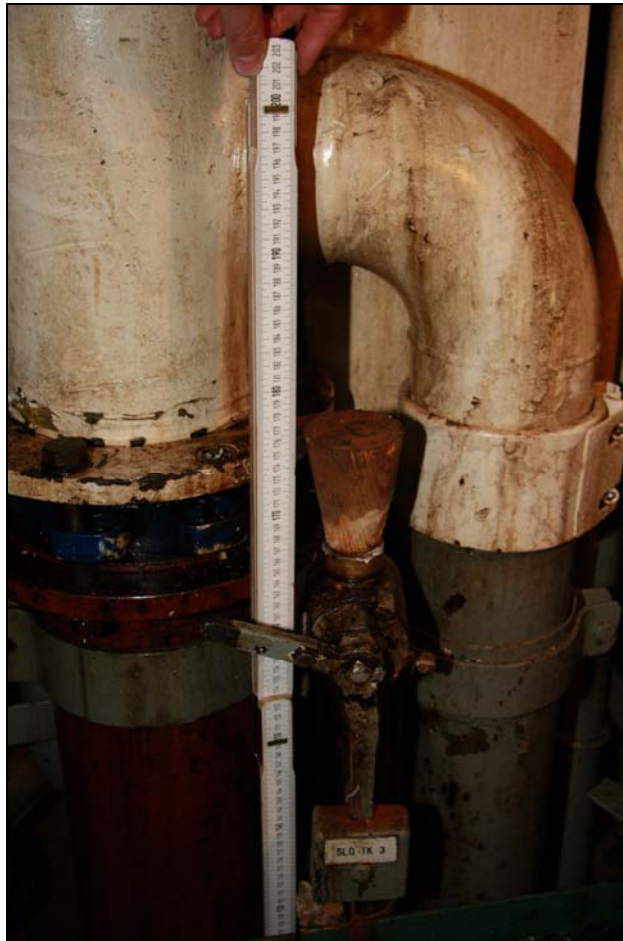
Figure 19: Closed sounding pipe valves

Another possible cause of the ingress of water could be the sounding pipes of these tanks, which run into the engine room. However, according to the drawing as well as provisions, the sounding pipes are fitted with self-closing sounding valves. Theoretically, a release of water due to excess pressure in the tank is not possible

The information provided by the vessel operator was reviewed during the survey on 15 July 2010, leaks or repaired damage to the overflow oil line system were not discovered locally. Only two sounding pipe valves were additionally sealed with bungs because small amounts of water/oil mixture leaked in this area in spite of them being closed:

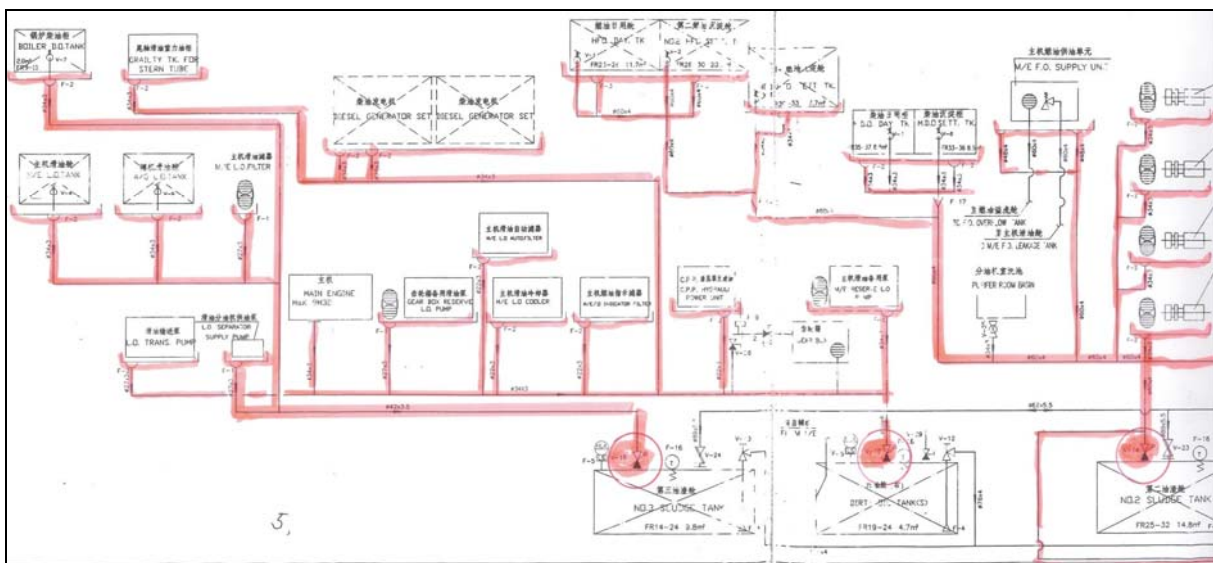
Figure 20: Leakage Oil Pipe Diagram

The BSU cannot agree with the vessel operator's opinion. See following drawing excerpt of the leakage oil pipe in the engine room.

All pipe tubes of the open oil save tanks run into 3 tanks (Nr. 3 Sludge Tank, Dirty Oil Tank and Nr. 2 Sludge Tank) through the retention valves (V-16, V-15, V-14), here marked with red circles. The vessel operator is of the opinion that the retention valve of the mentioned heavy fuel oil drainage pipe was temporarily gummed. Satisfying the calculation would have required the failure of another retention valve of the other pipes, since the biggest pipe tube, amounting to 60x4, is too small for the calculated flow. The vessel operator assumes a diameter of 5,28 cm and damage surface of 22 cm<sup>2</sup>. The pipe tubes inner diameter 60x4 is 5,2 cm and a surface of 21,24 cm<sup>2</sup>, respectively. The vessel operator's supposition as to whether the tested retention valves do not resist a water pressure of 6 m water column, is questionable.
