Bundesstelle für Seeunfalluntersuchung
Federal Bureau of Maritime Casualty Investigation
Federal Higher Authority subordinated to the Ministry of Transport,
Building and Urban Development

Summary Investigation Report 51/09

Collision between the fishing vessel GITTE and the Ferry SKANIA on 17 February 2009 13 nautical miles east of Rügen

1 April 2010

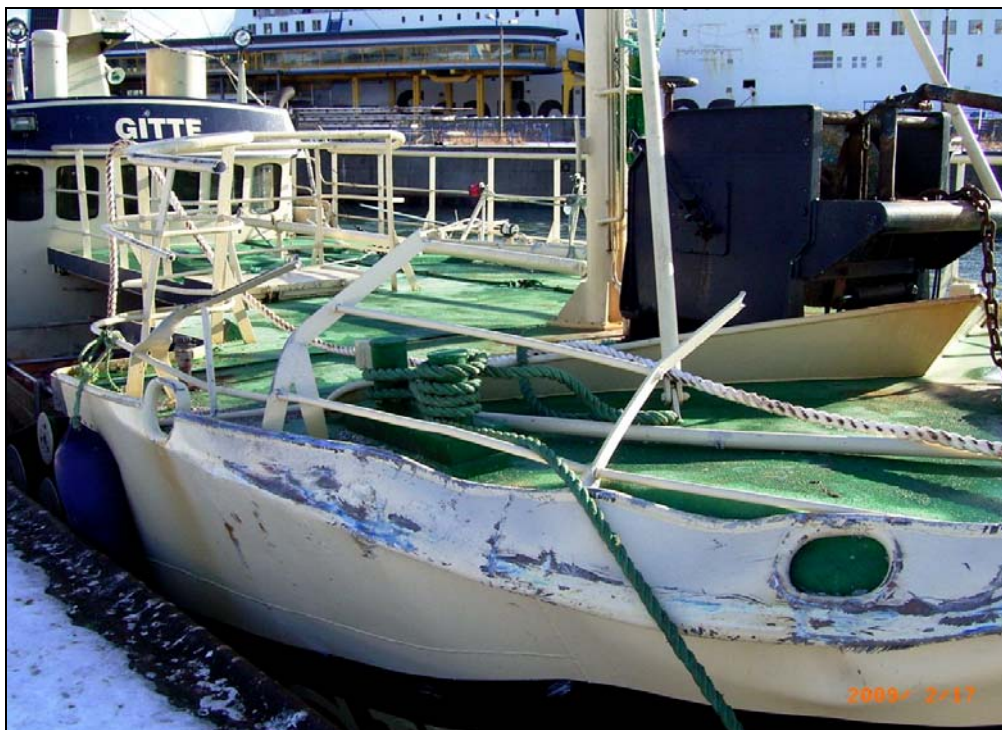
Due to the collision with the ferry, the damage above the fishing vessel's waterline was not insignificant; however, she remained seaworthy. A dent ran along the starboard side of the bulwark on the forecastle for a length of approx. 3 metres. Approx. 5 metres of handrail was destroyed in this area (see **Fig. 4**). Furthermore, inter alia the anchor windlass was damaged and the anchor equipment lost. There was other 'bodywork damage' in the area of the wheelhouse. The signal mast on the forecastle broke off.

Figure 4: Damage to the forecastle of the FV GITTE

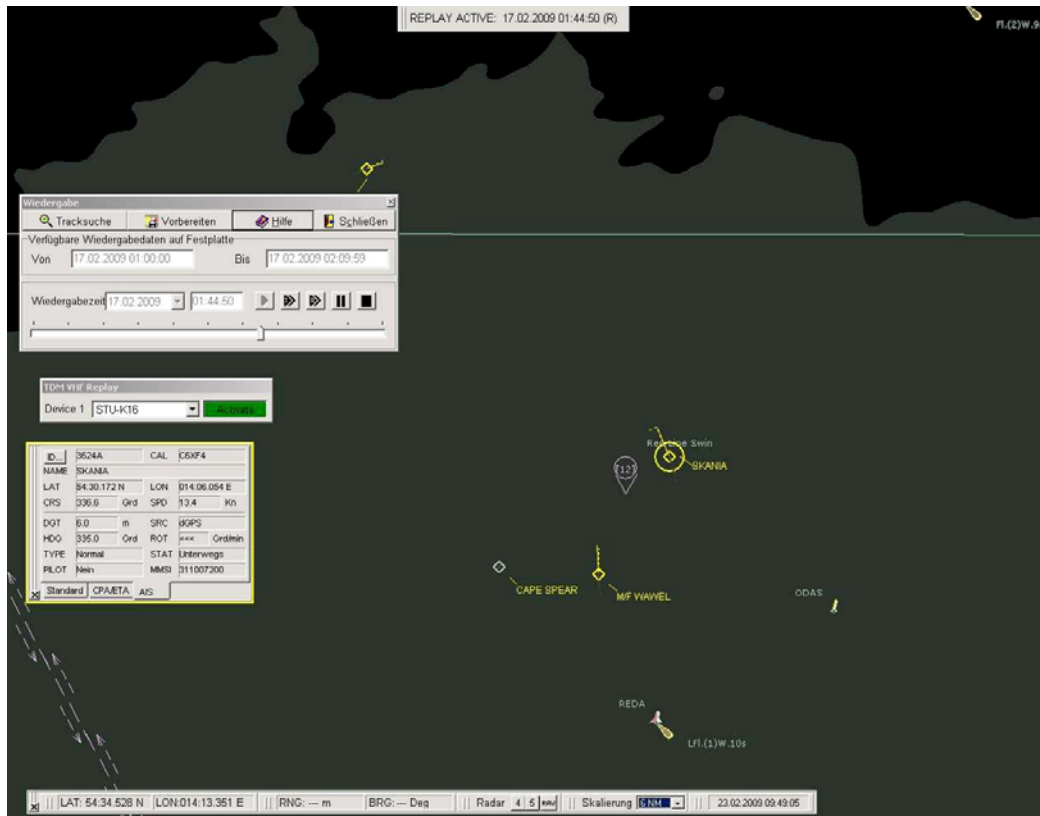
During the period from 014432 to 014450 (see **Figs. 11 and 12**), the ferry suddenly lost 1.2 kts in speed and the course over ground changed by almost 8 degrees from 344.3 degrees to 336.6 degrees. Even when allowing for system-related AIS inaccuracies, this change in course and speed within 18 seconds shows clearly that the course and speed of the vessel must have been vigorously acted upon on the ferry during this period in response to the collision.¹³

Figure 12: AIS signal of the MF SKANIA at 014450

¹³ The change in speed and in particular the significant change in course cannot be attributed solely to the collision (see further details in the comments in sub-para. 5.2.2. below).

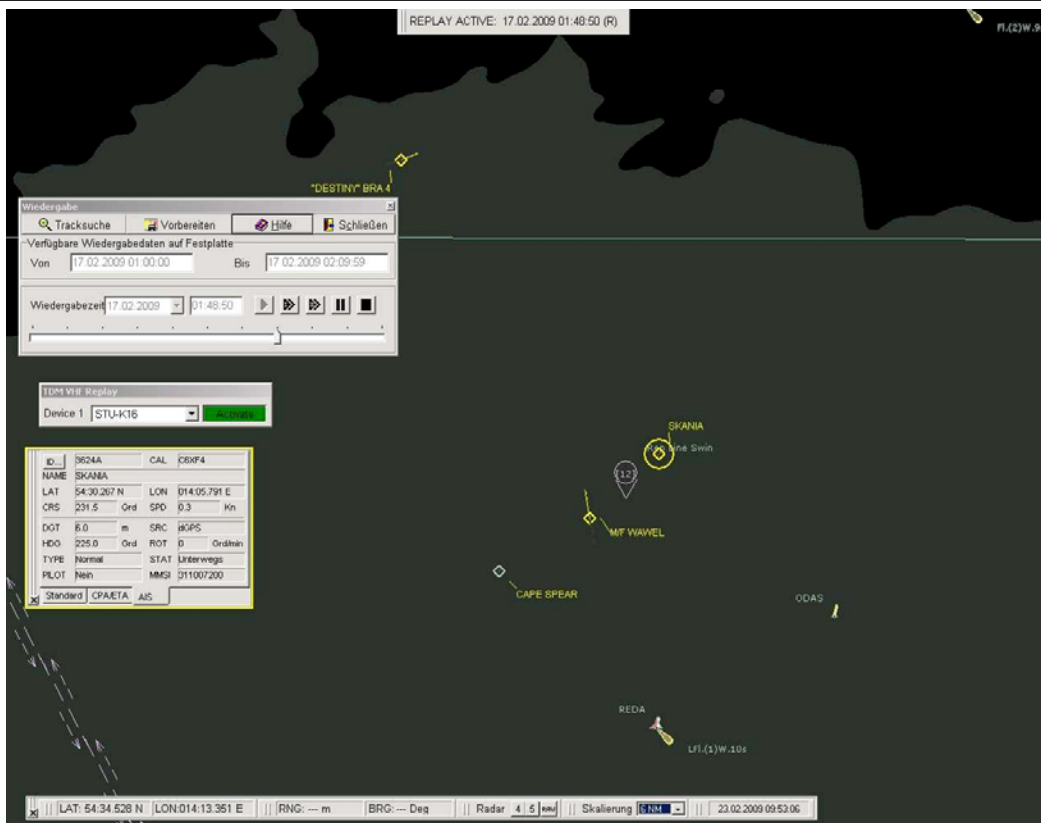
Between 014450 and 014850 it was possible to stop the ferry, which during this period turned to port to 231 degrees (see **Fig. 13**).

Figure 13: AIS signal of the MF SKANIA at 014850

From overrunning the position at which the fishing vessel anchored (= 0141¹⁵), it took until 0145, or about 4 minutes, for the SKANIA to change her course and speed in order to then come to a halt very quickly within a further 4 minutes (see **Fig. 13** above). The significant difference between the ferry and fishing vessel in dimension and mass explains why the course of the ferry was initially not appreciably impaired due to colliding or coming into contact with the side of and then dragging the fishing vessel by her anchor line. That the anchor of the GITTE as such had no particular obstructive affect is, in particular, understandable because in all likelihood the SKANIA only came into contact with the unwound part of the approx. 175 m long and 45 mm thick synthetic rope, which acts as a 'guy' and connects the approx. 40 m long fully extended chain with the fishing vessel's anchor windlass.

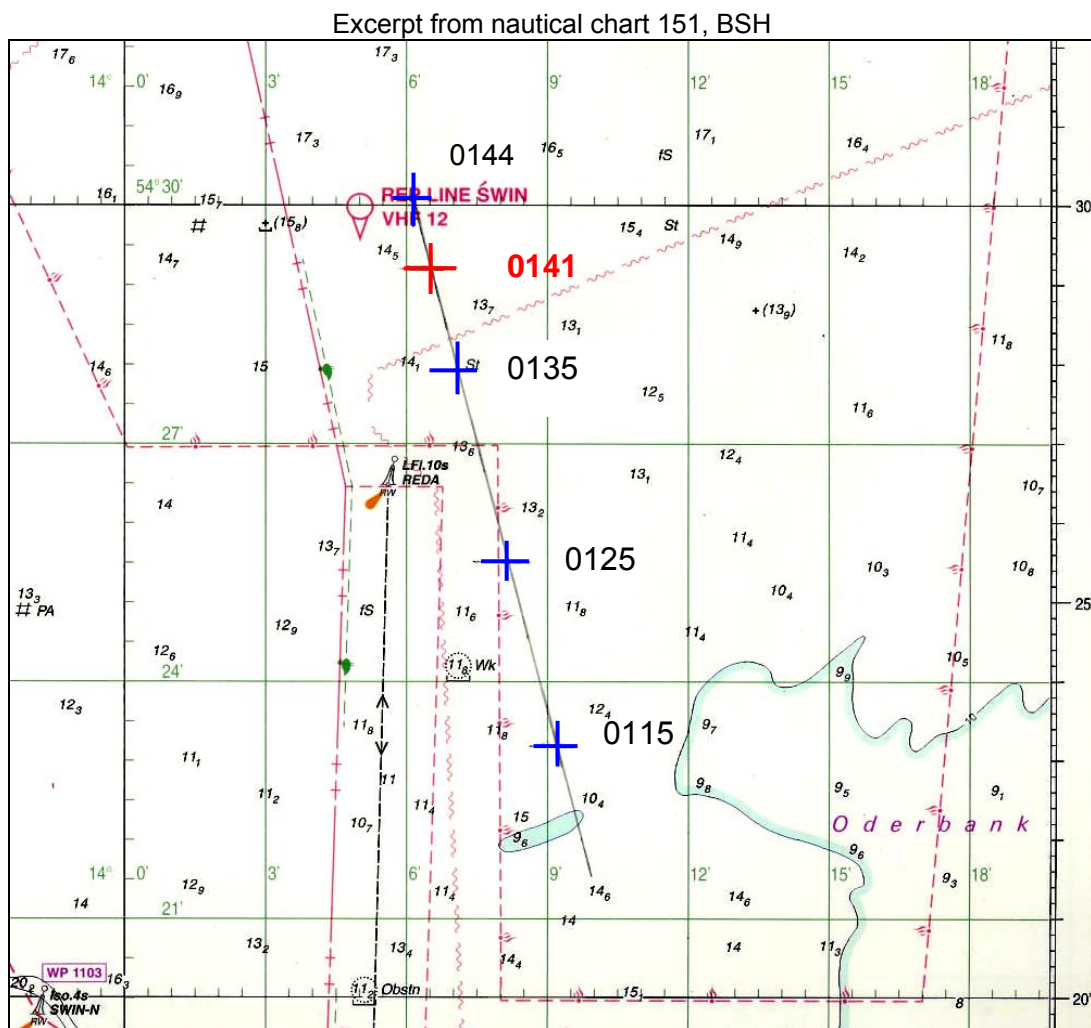
On the basis of the AIS positions of the SKANIA (blue) and GITTE's position at anchor (red, according to the satellite positioning of the Fisheries Inspectorate), it is easy to trace the collision of the two vessels on the nautical chart (see **Fig. 15**).

Figure 15: Development of the collision

It is clear that the statement that the Master of the fishing vessel reportedly identified an object at a distance of 3 nm with a CPA of 0.5 nm on his radar prior to leaving the bridge cannot have been in connection with the SKANIA. During the aforementioned thirty minutes up to the accident (and also before), the ferry sailed "as if on rails" directly for the anchored fishing vessel with absolutely steady course and speed values. However, the information that the collision was not initially perceived as such on the bridge of the SKANIA was confirmed.
