**Bundesstelle für Seeunfalluntersuchung**  
**Federal Bureau of Maritime Casualty Investigation**  
Federal Higher Authority subordinated to the Ministry of Transport,  
Building and Urban Development

**Investigation Report 557/08**

**Very Serious Marine Casualty**

**Fatal accident caused by a mooring line of the  
TMV COVADONGA breaking on 28 October  
2008 in Brunsbüttel Lock**

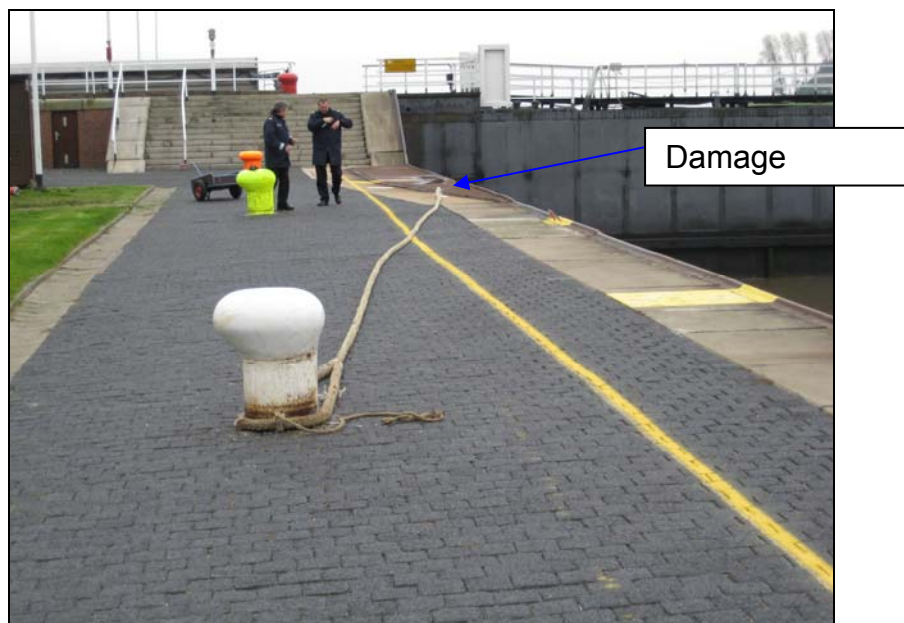
Figure 4: Broken mooring line laid out

The remaining 22.7 m of line was secured by the waterway police on the day of the accident. Its eye was placed over the bollard and the other end broken. The broken end of line found on shore and the broken end on board had relatively straight edges. Information given by the crew indicates that this line had only been in use for two years.

Two days later, on 30 October 2008, the apparently serviceable mooring line was laid out at the scene of the accident by the WSP.

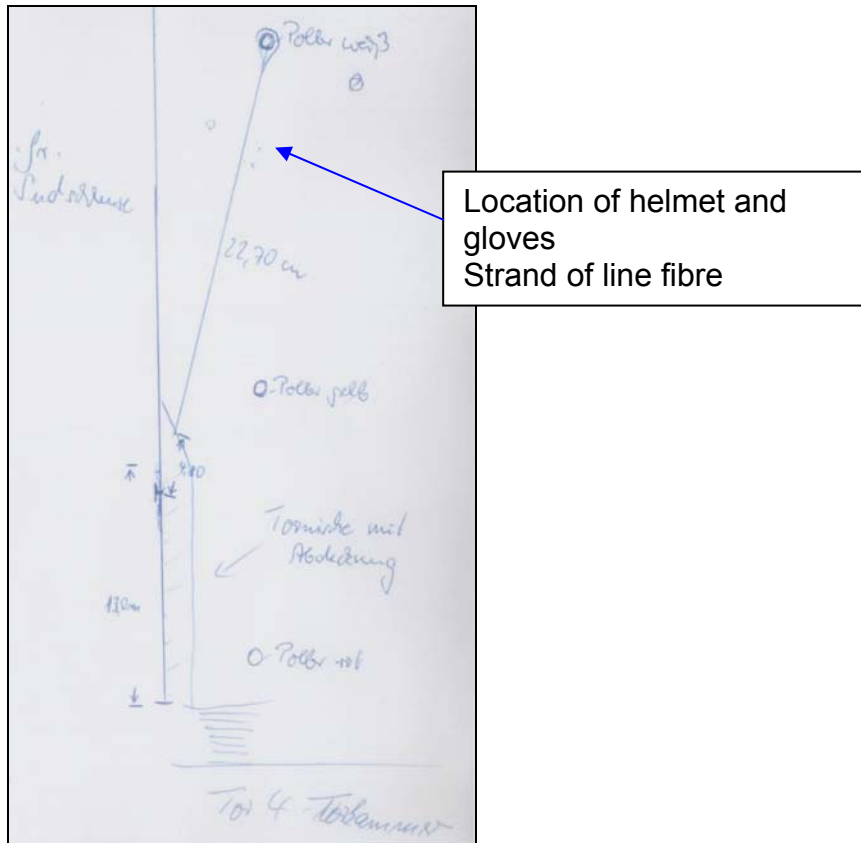
Figure 5: Drawing of the damage by the WSP

Significant deformation in the steel structure of the safety recess cover and sharp edge damages on steel elements, which were the result of earlier accident damage, were discovered during this inspection.

The distance from the broken end of the 22.7 m long laid out line to the sharp edge on the steel structure was measured at 4.8 m by the WSP. Accordingly, the total distance from bollard to damage was 27.5 m. This damage was approximately 13.0 m away from the lowest step of the outer gate (see following drawing). A strand of line fibre was secured; this was on the sharp, rusted edge of the upper profile, which is located just below the upper edge of the lock wall.

The length of the line from bollard to the breaking point was 22.70 m, the distance from bollard to the damage on the safety recess cover was 27.50 m according to the measurements of the WSP. To reach the existing damage, the line end would have needed to elongate by 21%. According to the line document of the manufacturer, the minimum elongation is 15% and higher elongation values are not excluded. Ultimate load tests carried out by the BSU revealed elongation of 11.5% in the first test and 15% in the second test. During both tests, the mooring lines broken just behind resp. in the area affected by the new eye splices made especially for the test. It was not possible to determine the actual ultimate load and maximum elongation in the part of the line not affected by the splices. Furthermore, after shipment the mooring lines were pre-elongated by months of use on board and yet elongation of 15% as stated in the manufacturer's certificate was still achieved. The force/distance ratio (elongation) resulting from the ultimate load tests (see Figs. 11 and 12) runs linearly up to the break in the right area of increase. If the ratio of the force/elongation determined in the tests to the required elongation of the discovered fore spring of 21% up to the damage on the lock wall is applied, the following values are returned:

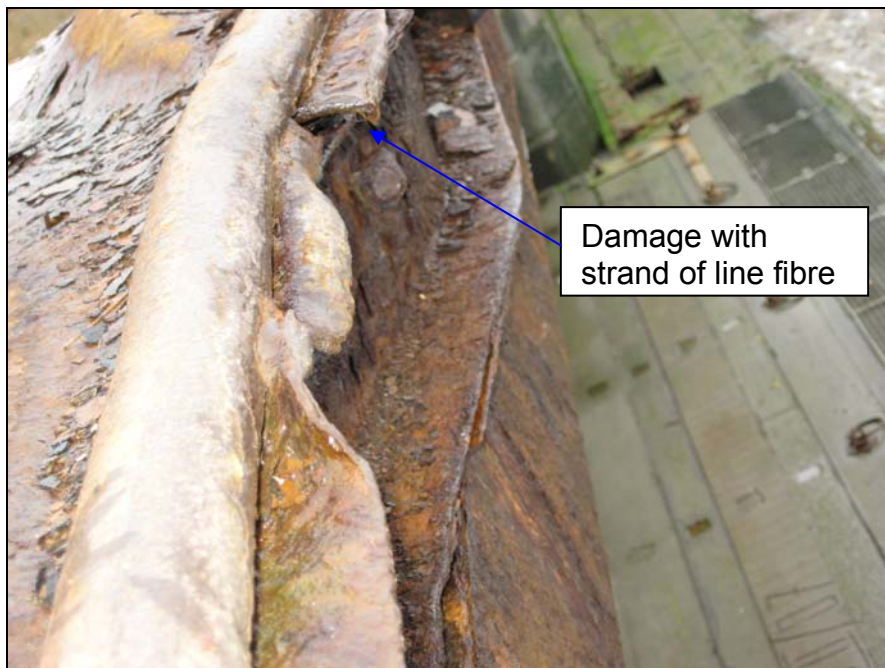
Figure 6: Edge with strand of fibre

The strand of fibre found on the damaged safety recess cover has the same composition as the discovered fore spring; the only difference is that rust deposits were adhered to the strand of fibre.

It was noted that coarse rust was firmly adhered to the entire area of the safety recess cover, which would not easily transfer to a fibre strand resting loosely on its surface. However, any mechanical action would cause this rust to rub off and quickly transfer to the fibre strand due to humidity.

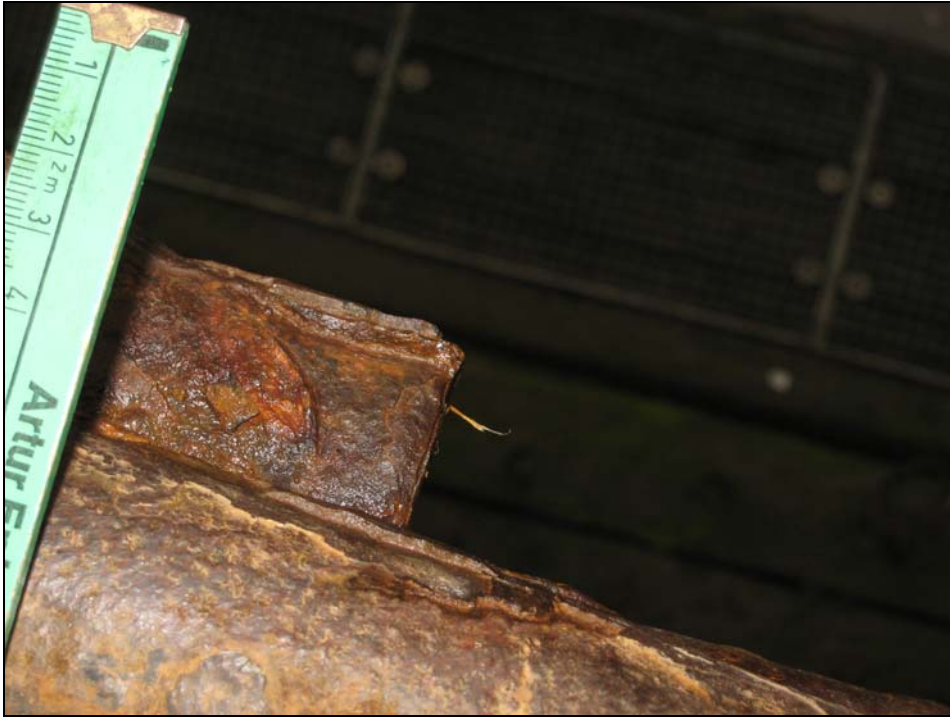
Figure 7: Strand of fibre on damaged element

The comparative forensic examination revealed that the strand of line fibre and the mooring line are composed of apparently colourless (white) polypropylene fibres and polyester fibres. The only difference is the deposits of rust on the strand of line fibre, which was found two days later on the rusted, damaged element. While preparing the expertise, it was not possible to clarify whether the deposits of rust had adhered to the strand of line fibre during the two days or were caused by the mooring line first chafing on the rusted area and then breaking. It was also not possible to clarify whether the strand of line fibre originates from the broken mooring line because the material examined is widely used and showed no differentiable colour.

Based on the given conditions, it is likely that the fore spring of the COVADONGA chafed on the damaged part of the safety recess cover and was cut through as if by a blade.

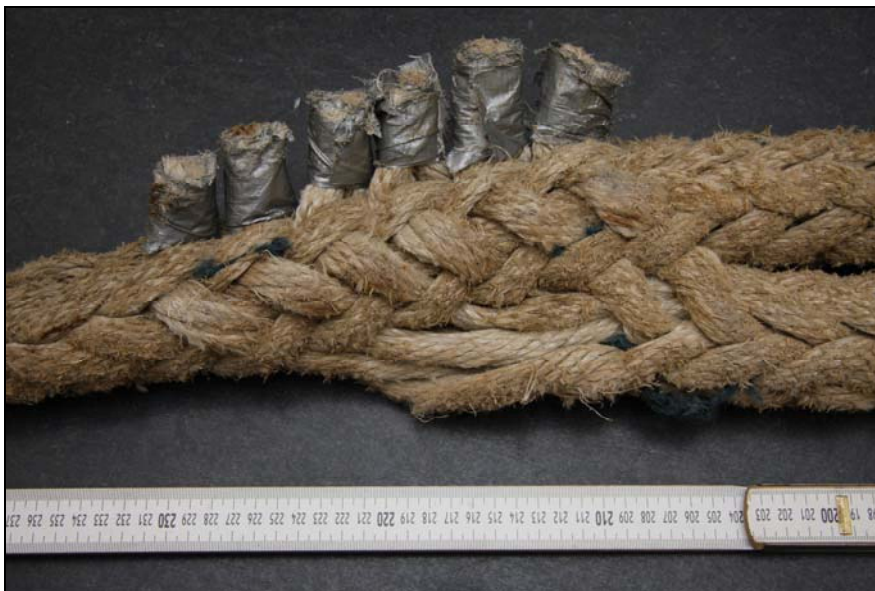
Figure 9: Eye splice

During the first visual inspection of the secured mooring line on shore, an eye splice was observed, which was neither spliced according to recognised standards nor manufactured in this manner by tackle companies.

This eye splice on the fore spring had been placed over the white bollard on shore and withstood the load while the line broken some 22.7 m away from the splice. The secured mooring line was divided into two equal lengths of 7 m for a load test and according to the manufacturer furnished with proper eye splices. Two ultimate load tests were carried out on both lengths of the line using the DYNA-MESS testing machine of Messrs Seil Hering on 9 March 2010.

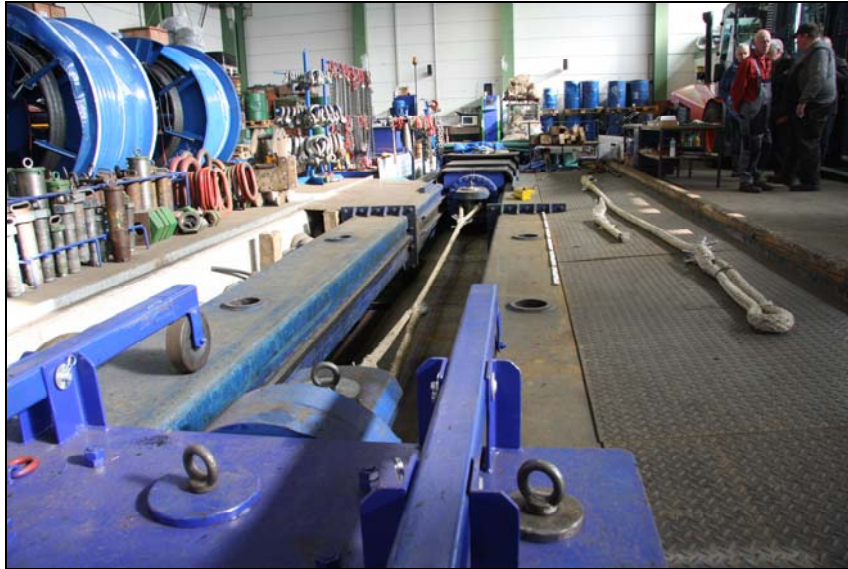
Figure 10: Ultimate load test

During the first test, the mooring line was clamped on one side with the existing eye splice that was made on board and on the other side with the new eye splice. During this test, the line broken just behind the new splice at a load of 16.78 t. The eye splice made on board, which did not look as robust externally, withstood the load test.

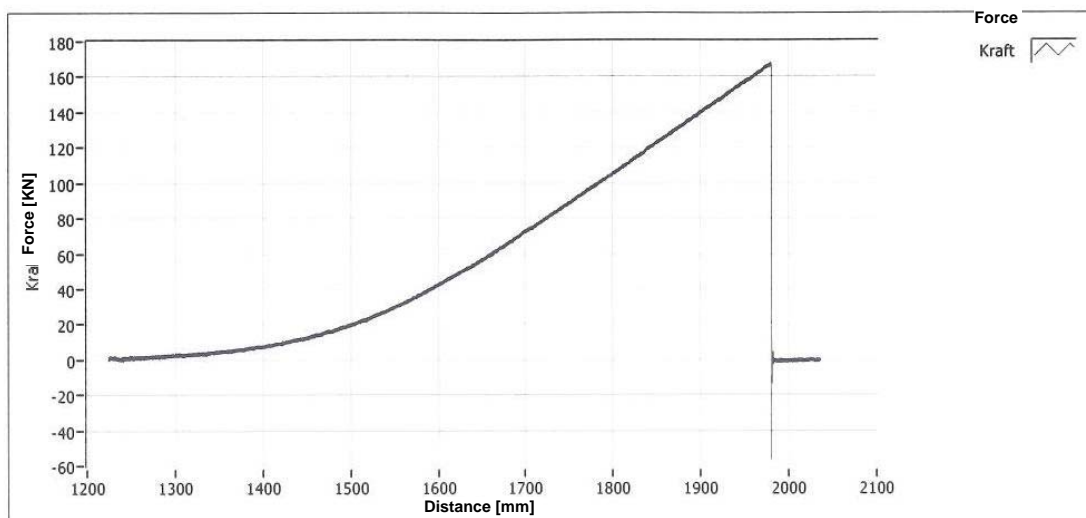
Figure 11: Force/distance diagram, first test

The pulling distance during this test was 1,224.24 mm – 2,035.91 mm = 811.67 mm, which equates to elongation of 11.6%.

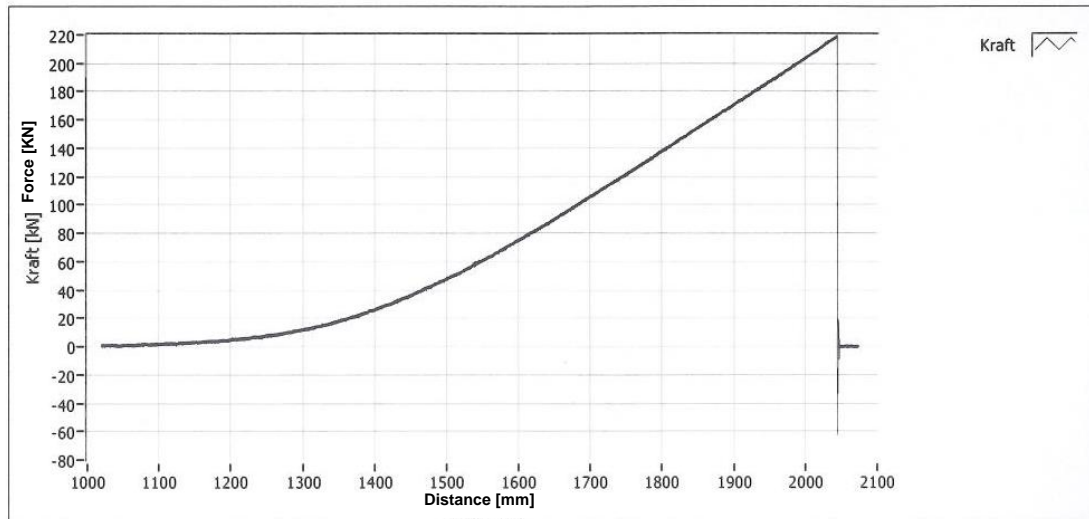
Figure 12: Force/distance diagram, second test

During the second test, the line end also broke, as expected just behind the eye splice, at a load of 21.975 t.

The pulling distance was 1,019.50 mm – 2,074.41 mm = 1,054.91 mm, which equates to elongation of 15%.

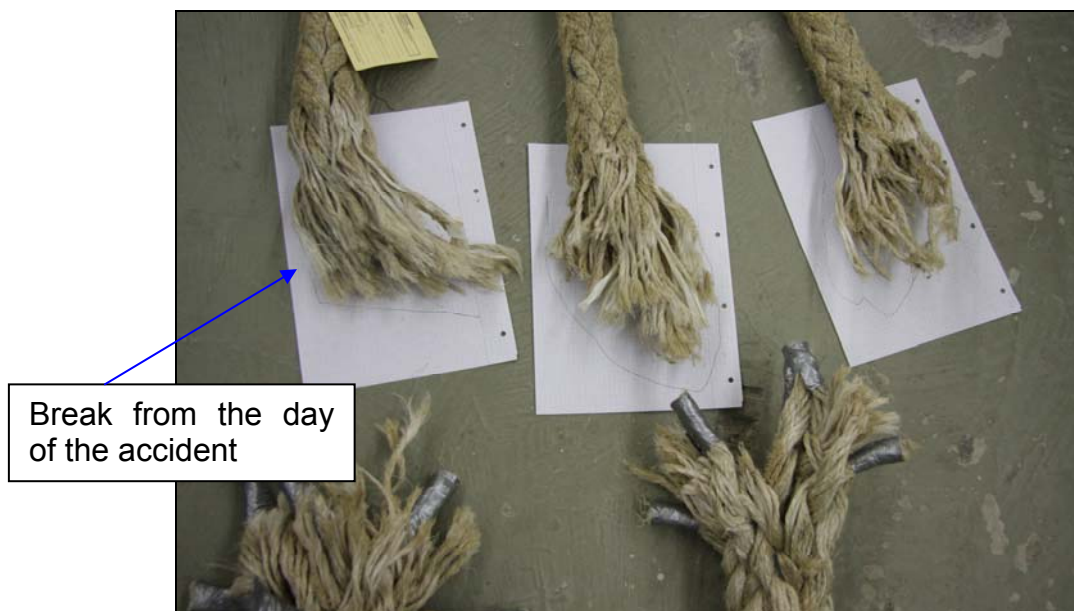
Figure 13: Break patterns

During the tests, the mooring lines broke just behind the newly made splices. The break pattern of each test exhibited the same break structures, but is not identical to the appearance of the break pattern created on the day of the accident.

It was not possible to arrive at further conclusions as to the condition of the line as well as the loads and elongations encountered on the day of the accident during this ultimate load test. The splice made on board withstood the load test and it was not possible to determine the actual elongation and ultimate load by testing with the technical resources available because the remaining line with the eye splice made on board was not long enough for further tests.

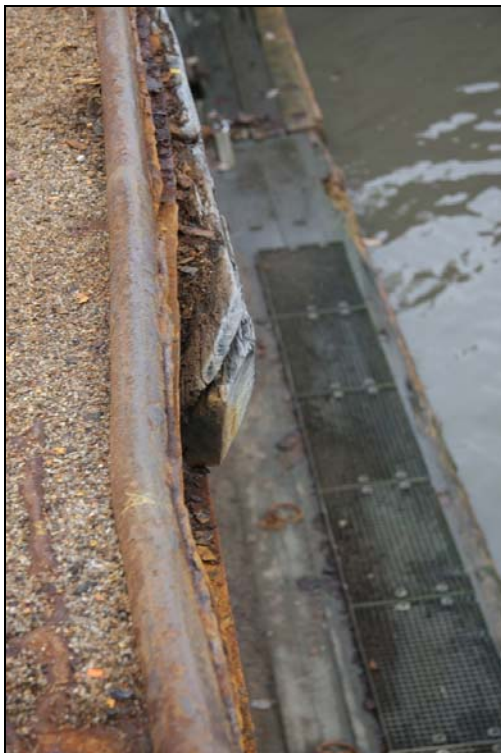
Figure 19: Damage in March 2010

The witnesses and WSP investigators were interviewed about the accident during a local inspection on 30 March 2010. Particular attention was given to the discovery of the person in the water. Only a lifejacket was seen floating about 1-1.5 m away in the water. It was only evident that the lifejacket was supporting a person, whose head lay sideways below the water, when this lifejacket was pulled to the pier. The lifejacket was not fitted with a recovery strap or crotch strap and was closed at the chest but had obviously ridden up. For the most part, the damage to the lock wall had already been repaired or removed by the time of this local inspection. It was no longer possible for the BSU to accurately measure the distance from the bollard to the damage in question on the edge of the lock.

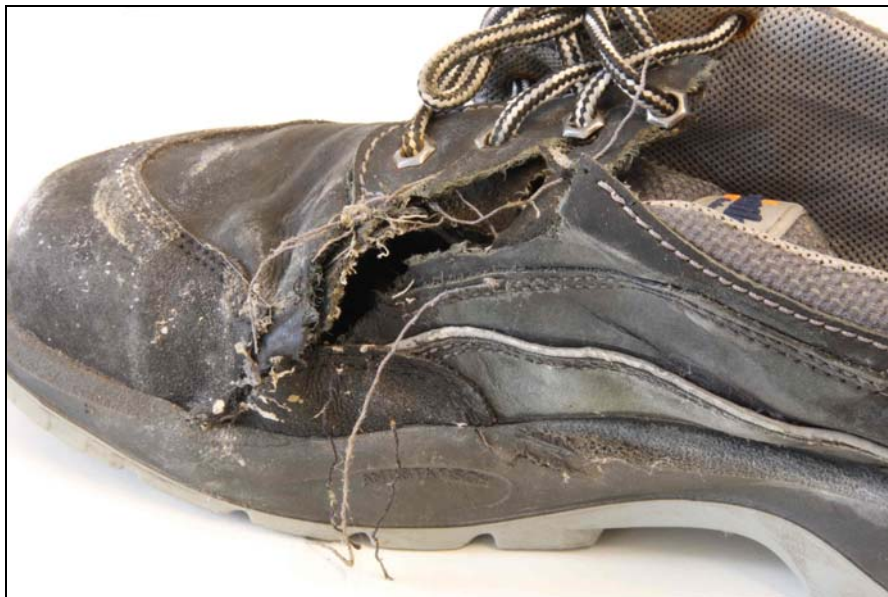
Figure 21: Shoe of the deceased

The right work shoe (Class S 3) of the deceased, which was torn diagonally across the instep to the sole, was found in the water.

He was still wearing the left shoe, which was undamaged. Based on this and the photos with identifiable injuries that the BSU have on hand, which show an open fracture on the right lower leg with detached skin to the foot, it can be assumed that the deceased was struck by the broken mooring line on the right leg and foot.

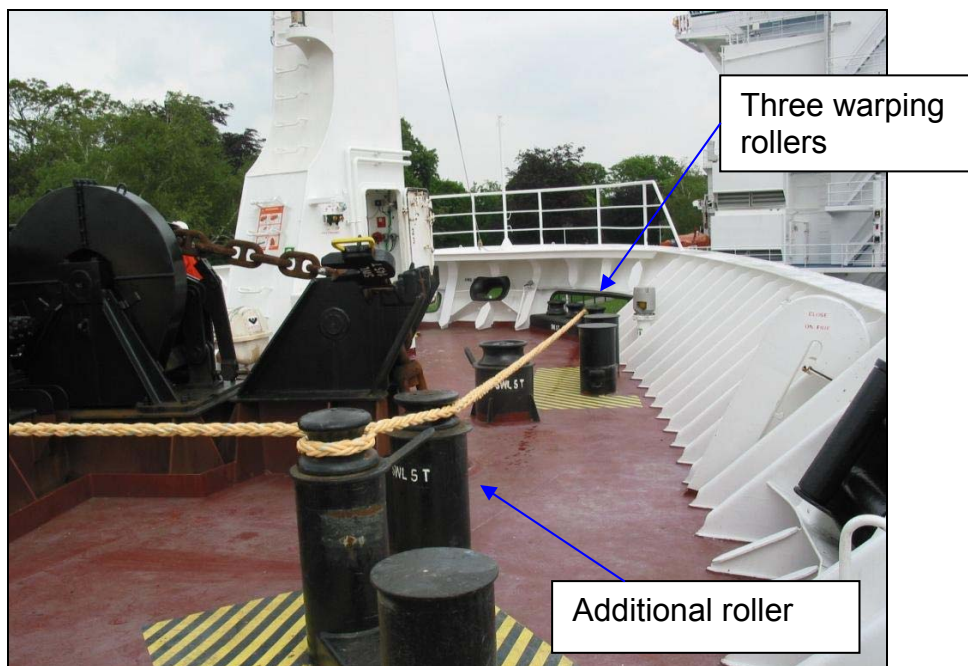
Figure 30: Line guidance of the head line on 11 June 2010

During the survey by the BSU, it was found that the Mooring Arrangement Plan approved by LR is not consistent with the actual circumstances. Another warping roller on a base has been additionally installed on board on the port and starboard side.

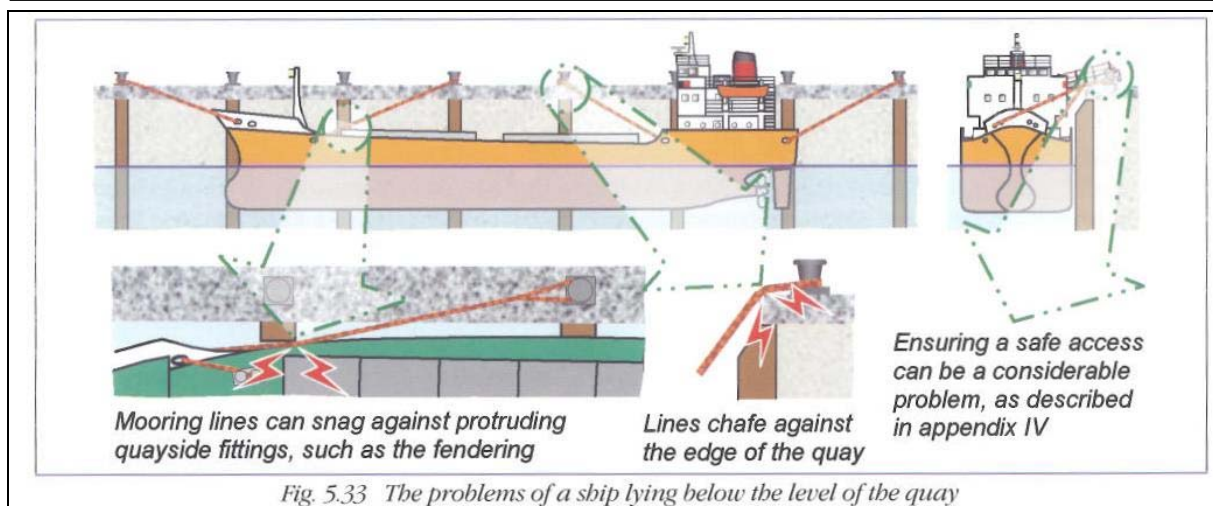
Figure 37: Danger of lines breaking with low lying vessels

According to the above drawing, there is a risk that the lines of a vessel can snag on vertical piles or fenders. This potential risk is low in the lock as vessels moor at a sufficient distance due to the floating wooden boom, which is at least 1.40 m wide. Only if the stern of the COVADONGA swayed substantially outward there would have been a possibility that the line would be trapped between the bulwark and upper edge of the lock. There are no statements regarding this premise.

The second possible risk occurs when the line runs downward over a sharp upper edge of the quay. To prevent this, half-round profiles are welded to the lock edges. On the day of the accident, the COVADONGA was lower and the welded profile was damaged in the relevant area. Hence, there is a possibility that the line broke on the damaged lock edge.

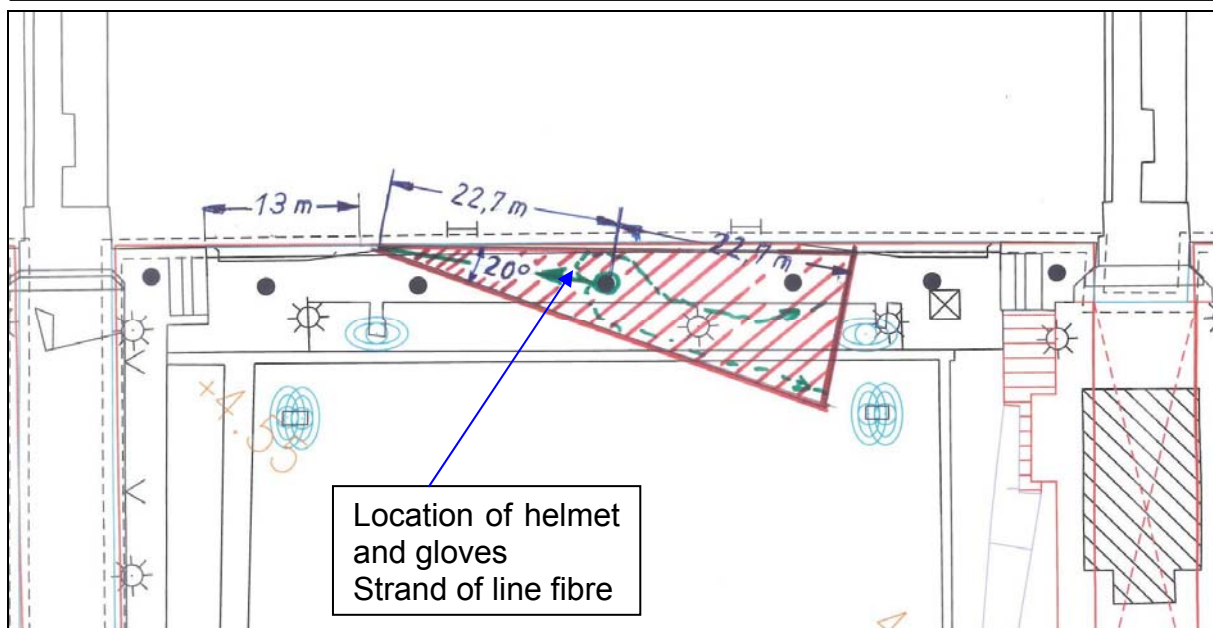
The section marked red around the bollard shows the danger area of a line snapping back after it breaks.

Besides the typical wounds of a leg injury caused by a line, it is certain that the deceased linesman was working in this area, to the left of the bollard, when one considers that his helmet and gloves were found in the danger area to the left of the bollard (see Fig. 5).
