Summary
Investigation Reports 642/08 and 114/09

Accident with subsequent loss of life
on board CMV SANTA ALINA
on 15 December 2008
in the port of Lomé, Togo

Accident with subsequent loss of life on board
CMV MOL UTILITY on 30 March 2009
in the port of Tanga, United Republic of
Tanzania

15 January 2010

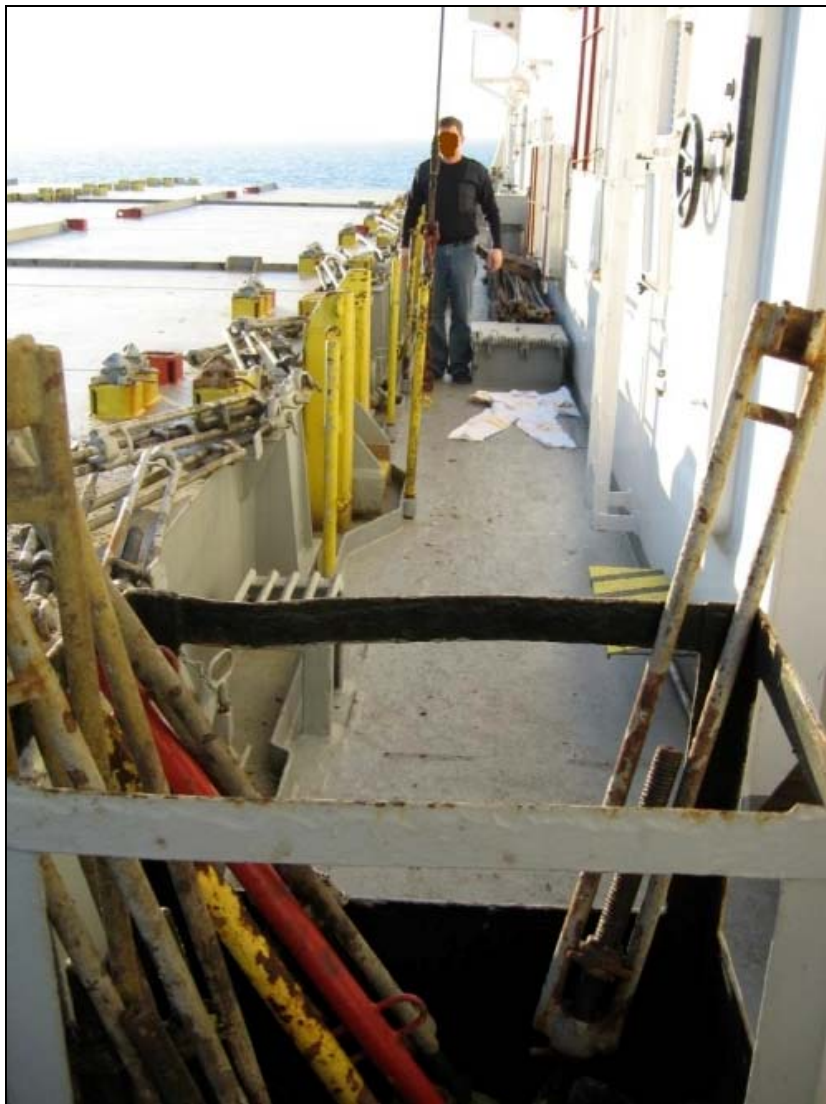
Figure 3: Accident scene, aft edge of Bay 39

The container vessel SANTA ALINA arrived at Lomé, Togo, on 12 December 2008 and shifted to her berth to begin loading operations on 15 December at 0300. At 1010, a fitter was fatally injured while a 40 foot container was being unloaded with the shipboard crane on the port side of the superstructure, aft edge of Bay 39 (see Fig. 3). Together with an able bodied seaman, he wanted to install a handrail on the working passage that runs athwartships to Bay 39. The rail consists of approximately 10-12 supports, has a twin-layered construction and is 105 cm high. It takes about 10 minutes to erect. The working passage has a width of 1.40 m. With exception to a 10 cm high edge, it is level with the coaming when the hatch is open. After the hatch cover is removed on the port side, the rail should be fitted to protect against falling. To that end, the fitter was situated at the port side and the seaman on the starboard side of the working passage.

It was not possible to establish why the container began to swing. The seaman did not observe a topping up or slackening of the crane jib. The container's centre of gravity was unknown. The vessel reportedly was on an even keel and the weather conditions were good. It was dry and windless with a temperature of 30 °C. The shore-based spreaders in West Africa are operated mechanically by means of a lever system used on the container. During the unloading operation, stevedores were situated in the hatch. As the 40 foot container was hoisted by the shipboard crane from the container frame, it began to swing. This was probably due to the crane cable being non-perpendicular to the bridle of the spreader or the container having an unfavourable centre of gravity. A guide for positioning the boom was reportedly not seen.

It remains unclear why the experienced seamen tried to install a handrail designed to protect against falling into a hatch during an unloading operation and in the process exposed themselves to danger. The seamen should have requested the Officer on Watch to arrange for crane operations at the open hatch to be discontinued so that the work at the 1.40 m wide working passage and 10 cm high coaming could be carried out without interruption. Basically, the unloading operations should not have commenced before the handrail was installed. This situation was possibly due to the lack of communication between the shipboard and shore-based operations in Lomé.

Two days after the fatal accident, the vessel operator issued a directive to the fleet to the effect that no crew member was to be situated in the area of loading and unloading operations while such operations were taking place.

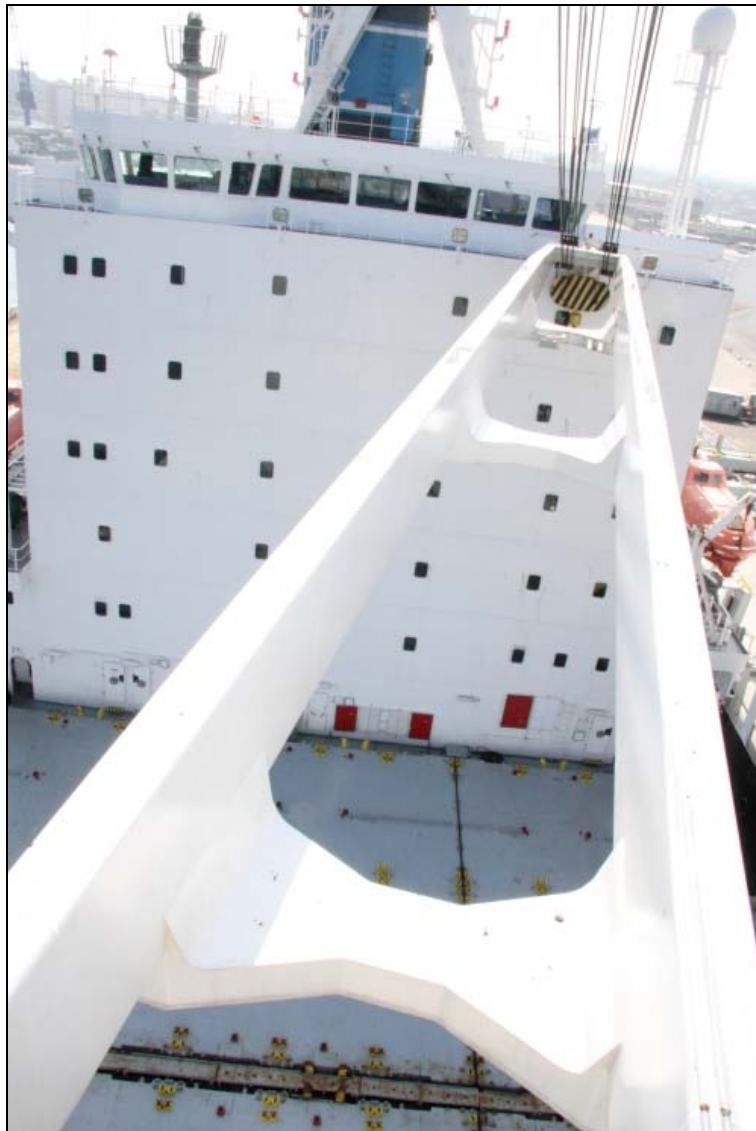
Figure 4: Crane operator's view

During the work in the working passage, containers were being unloaded from the open hatch. The crane was occupied by a shore-based crane operator. It was possible to see Bay 39 and the working passage from the crane operator's position (see Fig. 4). A spreader was mounted on the boom with which the containers could be locked. During the unloading of the third container, the fitter was reportedly hit by the swinging container and crushed. Following that, the seaman reportedly attempted to contact the crane operator in order to stop the unloading operation. He then ran to the casualty, who was still responsive, and informed the Officer on Watch. Immediately afterwards, the Master and another officer arrived at the scene of the accident. The casualty was then laid on the stretcher, which had been brought from the ship hospital, and was taken ashore at 1031. At 1040, the casualty and an accompanying officer were driven in a vehicle belonging to the terminal operator to the Clinique Barruet hospital in Lomé, where he succumbed to his internal injuries at 1210.

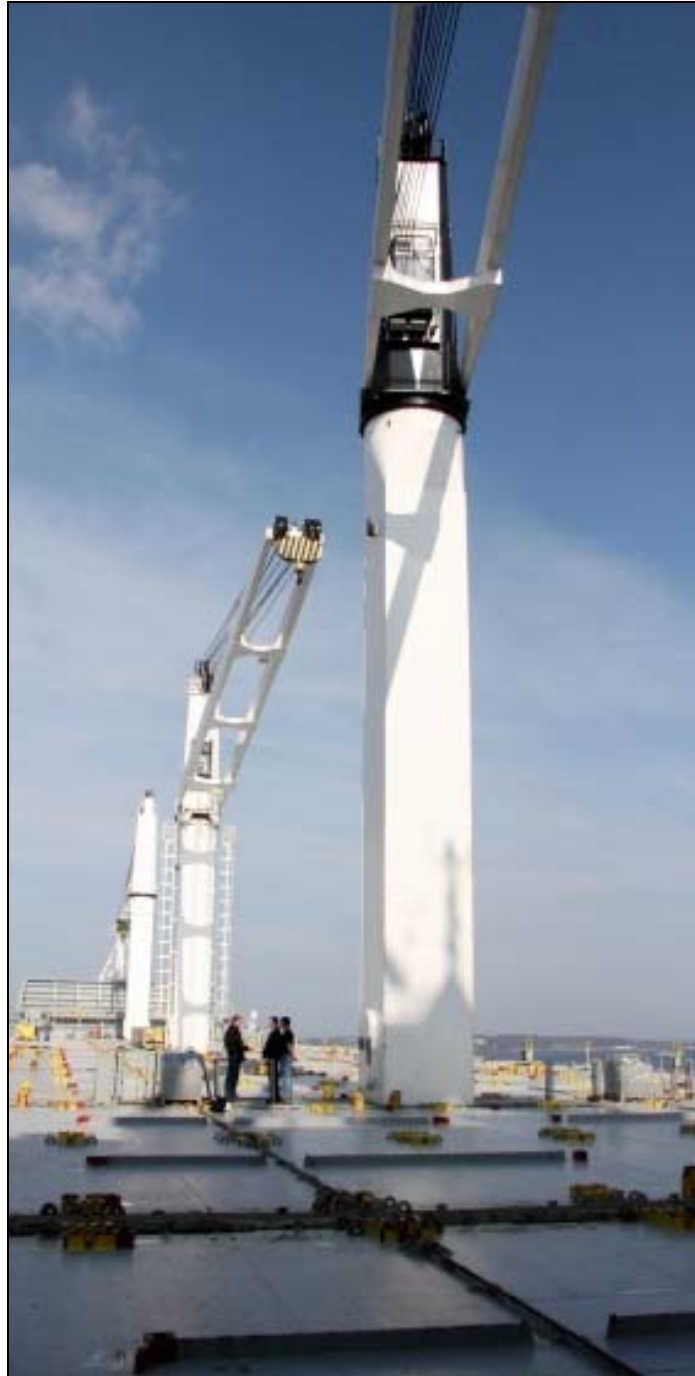
Figure 5: Main deck

Deck work in the area of loading operations involves an accident risk. It is not known why the experienced fitter and the seaman continued their work on the working passage in spite of that. Matters were complicated by the fact that there was no permanent communication link, such as via handheld transceivers, between the terminal and the vessel and the operating schedule had to be left solely to the terminal operator.

Improved protection against falling at open hatches, e.g. in the form of firmly installed folding handrails, has yet to be widely adopted in container shipping. This may be due to the equipment's vulnerability in terms of resisting destruction during loading and unloading operations. During the survey by the BSU, numerous handrail supports on the main deck were bent.

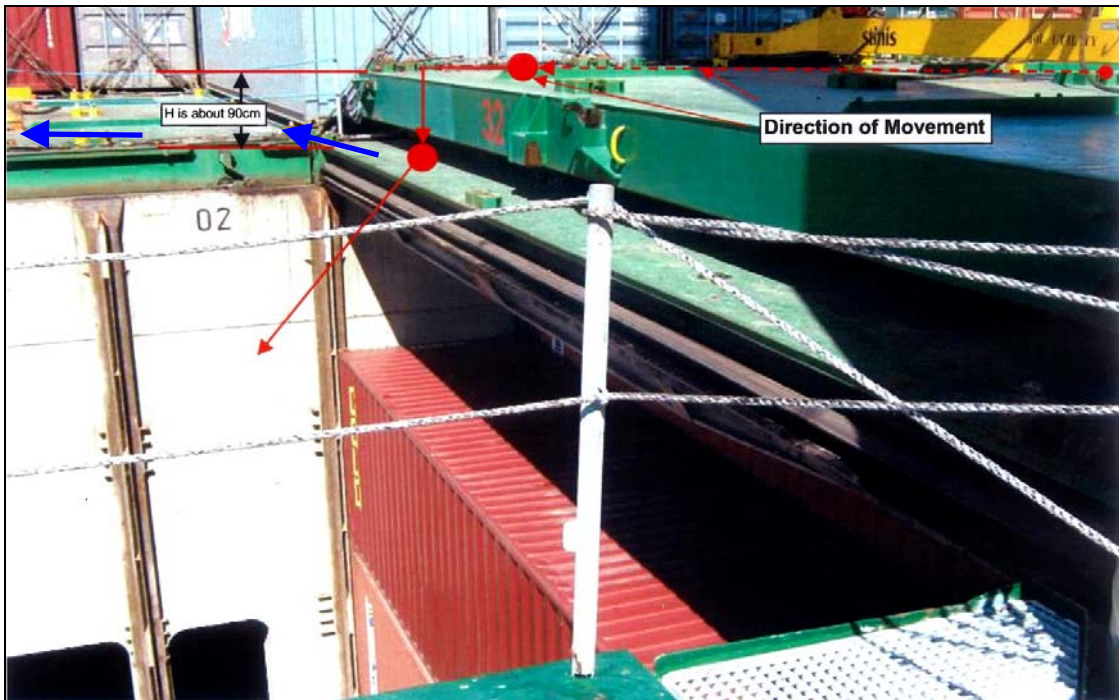
Neither the sailor nor the trainee (cadet) saw the accident. Shortly before the accident, the trainee reportedly received watch keeping instructions from the Third NO, then lost sight of the officer when he (the officer) departed via the hatch cover and shortly afterwards only heard the fall. The only actual eyewitness of the accident was a Tanzanian dock worker, who reportedly saw how the Third NO reportedly walked on the port hatch cover of cargo hold 3, which was placed on the starboard hatch of cargo hold 3/Bay 32, in the direction of the forward edge amidships. The Third NO then reportedly tumbled while descending from the deposited hatch cover onto the remaining approx. 0.6 m wide uncovered part of the starboard hatch cover and fell into the hatch.

Figure 3: Accident scene (red and blue arrows show the actual/possibly planned (?) direction of movement of the Third NO)

The question as to why the Third NO approached the area of the fall remains open. It is presumed that he wanted to look into the hatch from the edge of the hatch cover to check the progress of the unloading operations. However, because of the diagonal direction of his path towards the forward edge of the hatch cover in particular, it also seems possible that the officer had the intention of climbing across to the aft edge of the closed preceding hatch from the end of the forward edge of the starboard hatch cover amidships to get to the port side of the vessel from there (see blue arrows above in **Fig. 3**).

It is also only possible to speculate on the cause of the fall. However, it is arguable that the officer underestimated the height of the misalignment (approx. 0.9 m) and also the width of the available walking surface on the starboard hatch cover (approx. 0.6 m). When jumping down or climbing from the upper cover, he could then stumble and the area for catching the fall with his hands would be too small.

Finally, it should be noted that irrespective of the absence of a specific occupational safety regulation that addresses the accident in question, the fundamental principles of occupational safety include not overcoming differences in height by jumping and, if possible, avoiding areas in which there is a danger of falling or ensuring adequate personal protection if entering such areas is crucial.

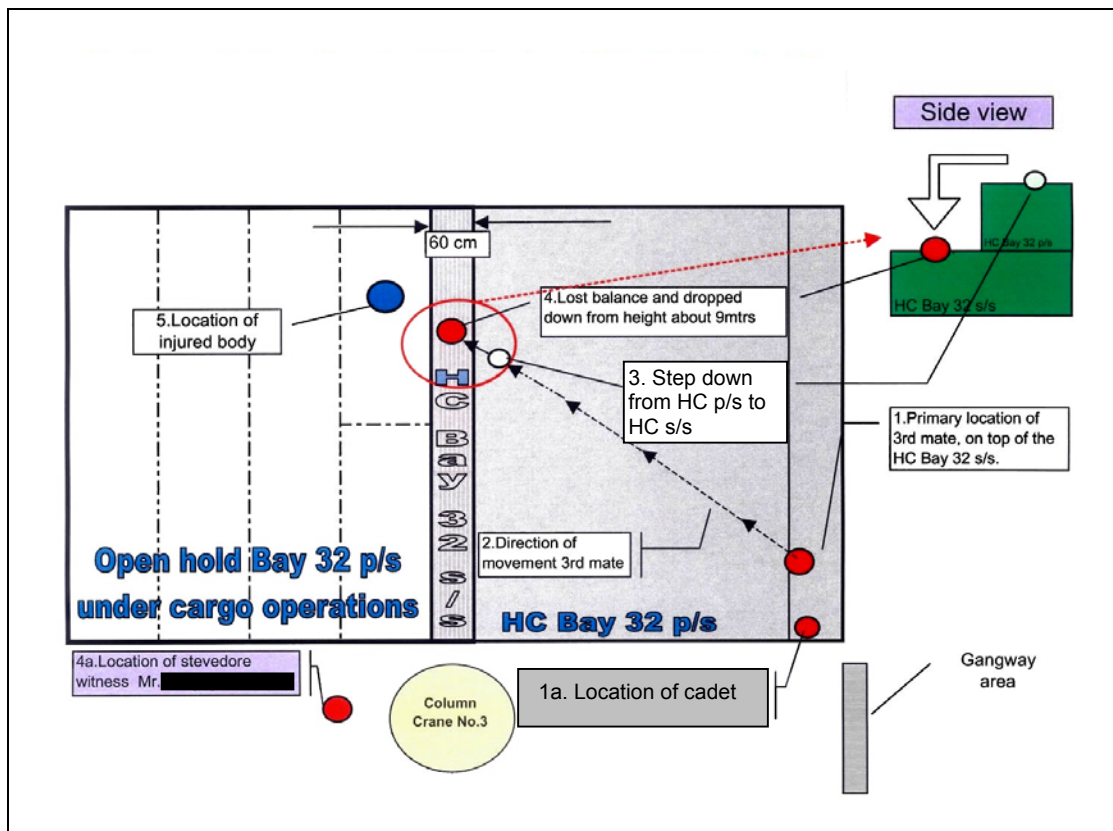
Figure 4: Diagram of the course of the accident⁵

At the time of the accident the Officer on Watch, the Third Nautical Officer (NO), walked diagonally on the port hatch cover from aft starboard towards the open hatch on the forward edge of the aforementioned misalignment. While descending from the cover placed on the starboard hatch cover, the officer tripped, lost his footing and fell approx. 9 m onto a container stowed at the second position in the hatch.
