**Bundesstelle für Seeunfalluntersuchung**  
**Federal Bureau of Maritime Casualty Investigation**  
Federal Higher Authority subordinated to the Ministry of Transport,  
Building and Urban Development

Investigation Report 168/09

**Serious Marine Casualty**

**Collision between the HÖEGH LONDON and  
three vessels moored on the Weser  
on 26 May 2009**

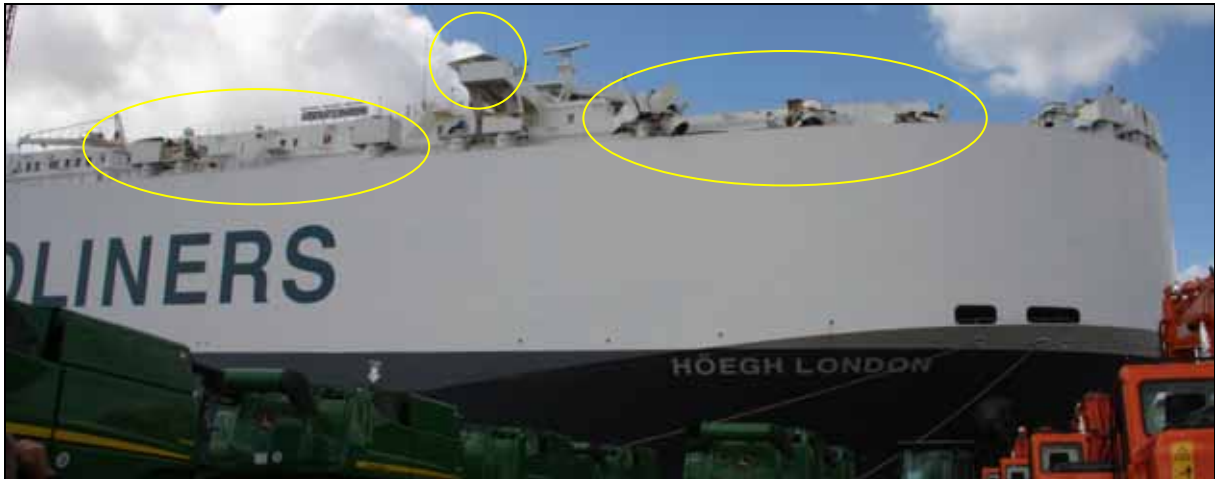
The collision with the three other vessels caused damages to the starboard side of the HÖEGH LONDON's superstructure. In the process, fan cowls were torn off or destroyed, the fixed awning in the wing damaged and the hull dented. The shell plating on the stern was torn open (see Figures 3 to 5).

Figure 3: Destroyed fan cowls and damaged awning on the wing

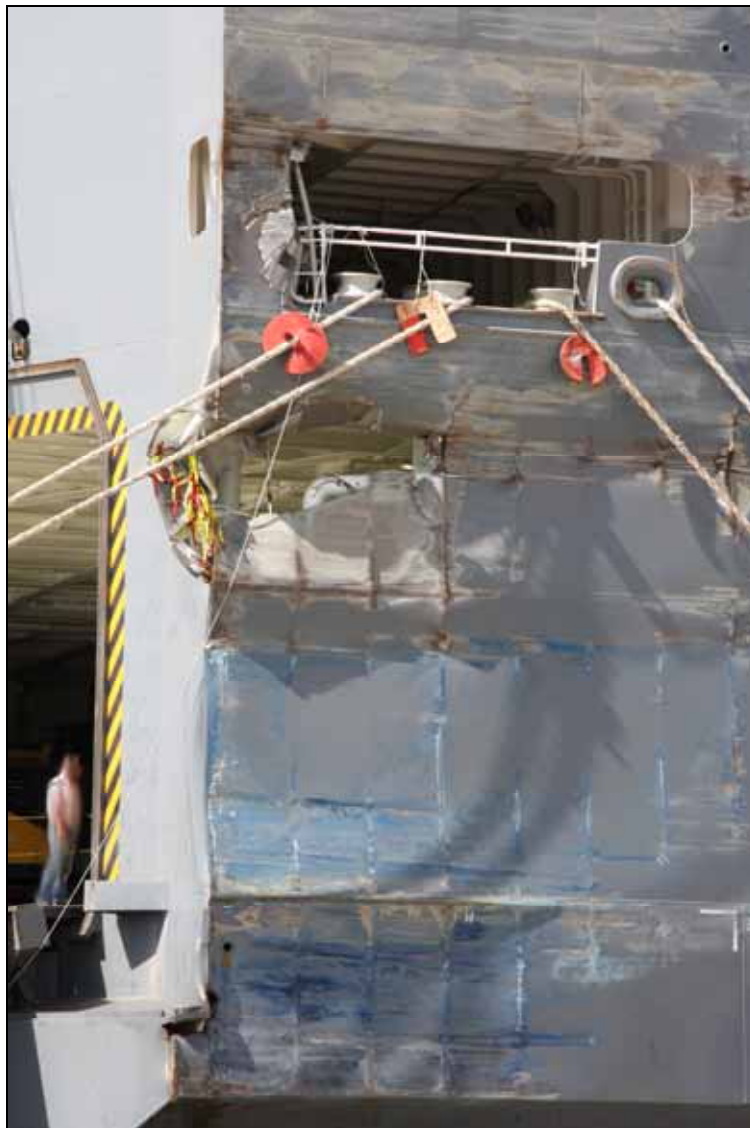
Figure 4: Stern of the HÖEGH LONDON

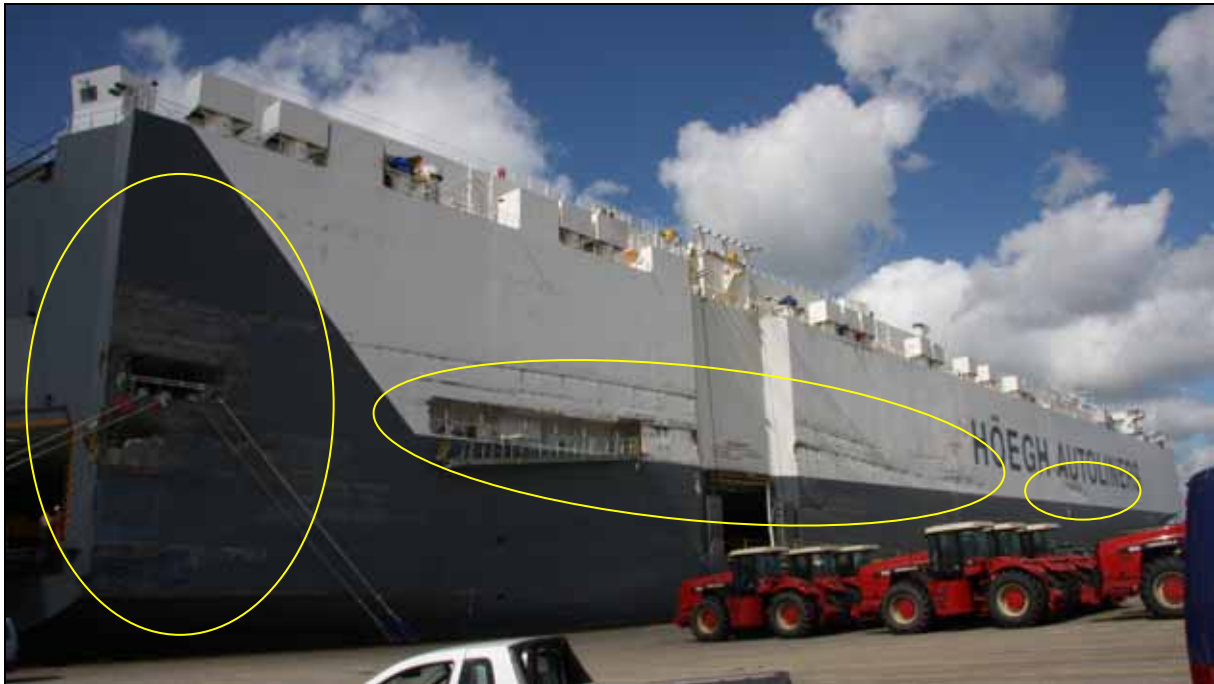
Figure 5: Side view of the HÖEGH LONDON with dents

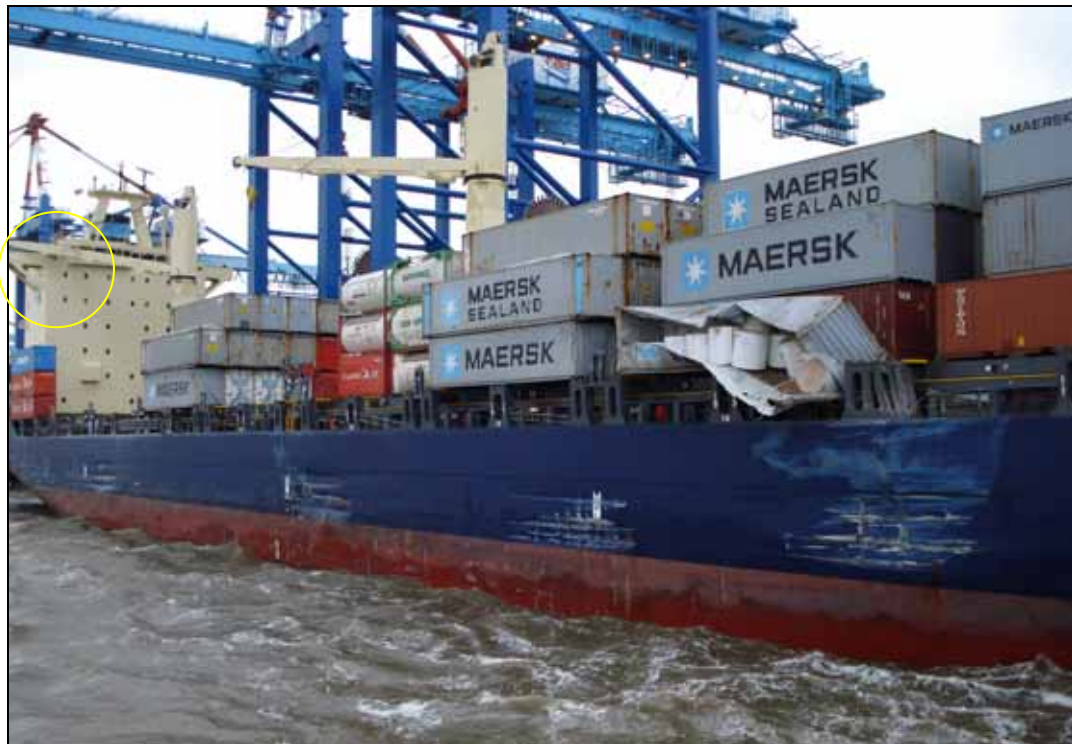
The MAERSK NEWARK sustained damages to the hull and the superstructure on the starboard side. Since the deck cranes obstructed loading by container gantry cranes, they were turned seawards. During the passage of the HÖEGH LONDON the crane jibs were caught and turned to the side. All three deck cranes were damaged or destroyed. Eleven of the deck cargo containers were damaged or fell into the water (Figures 6 and 7).

Figure 6: MAERSK NEWARK, damaged hull, twisted and damaged cranes

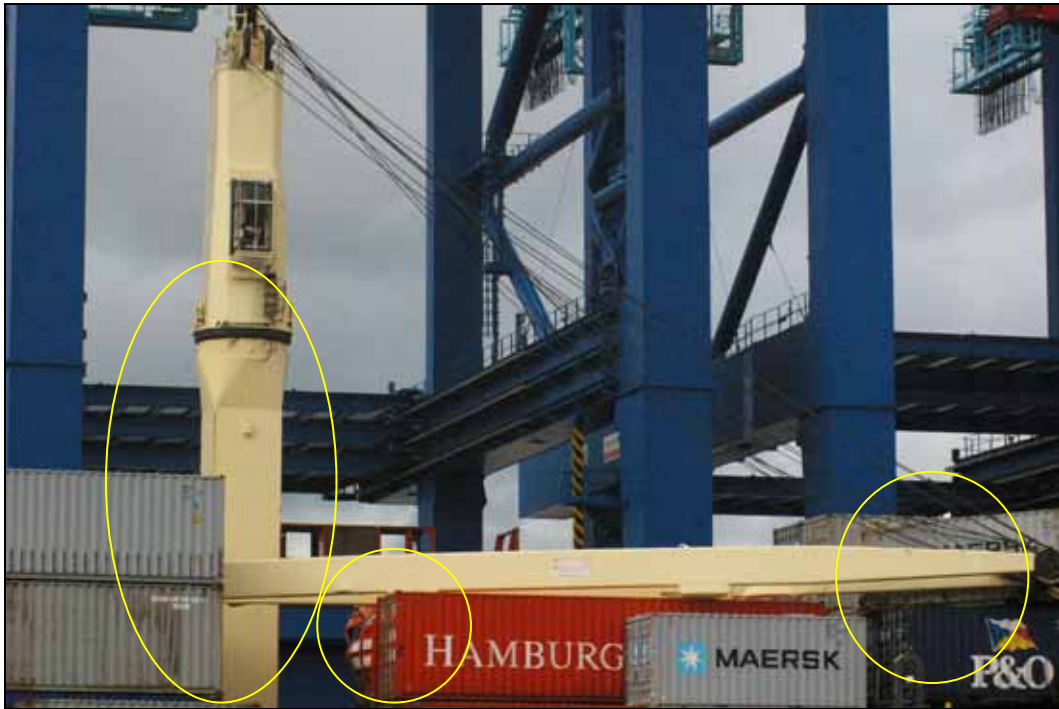
Figure 7: MAERSK NEWARK, crane jib of crane number 1 torn off and damaged container

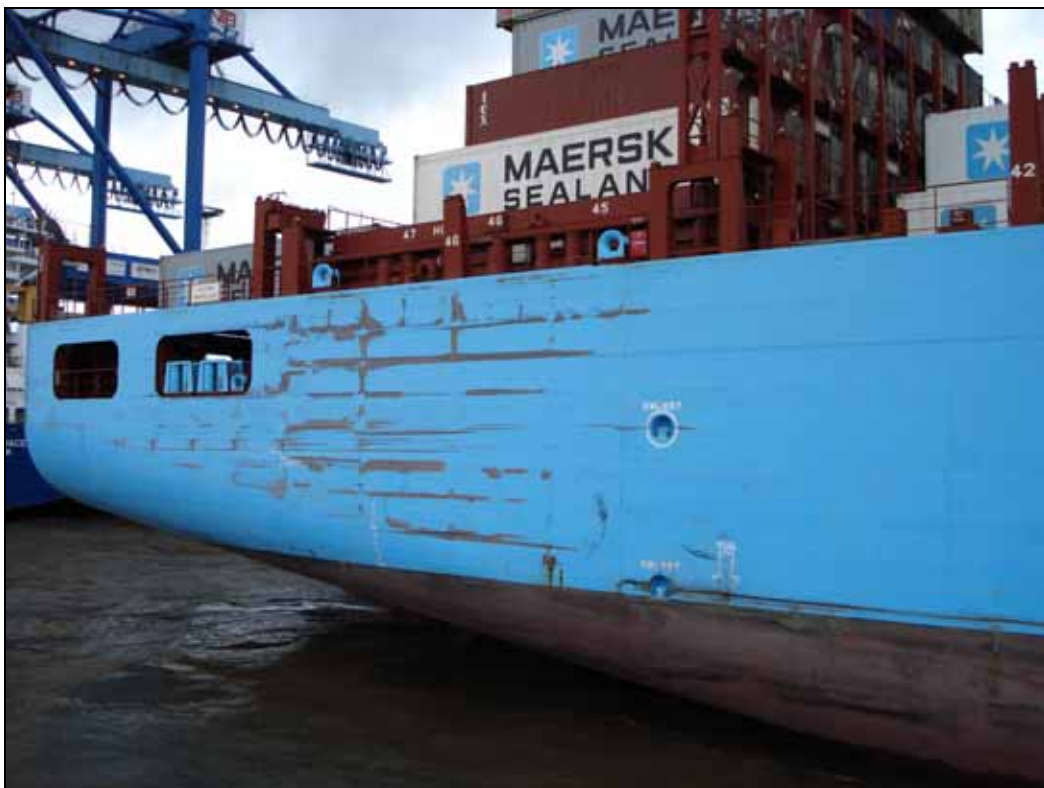
The MAERSK BINTAN sustained damage to the hull and superstructure (Figure 8). The extended gangway was torn off.

Figure 8: MAERSK BINTAN

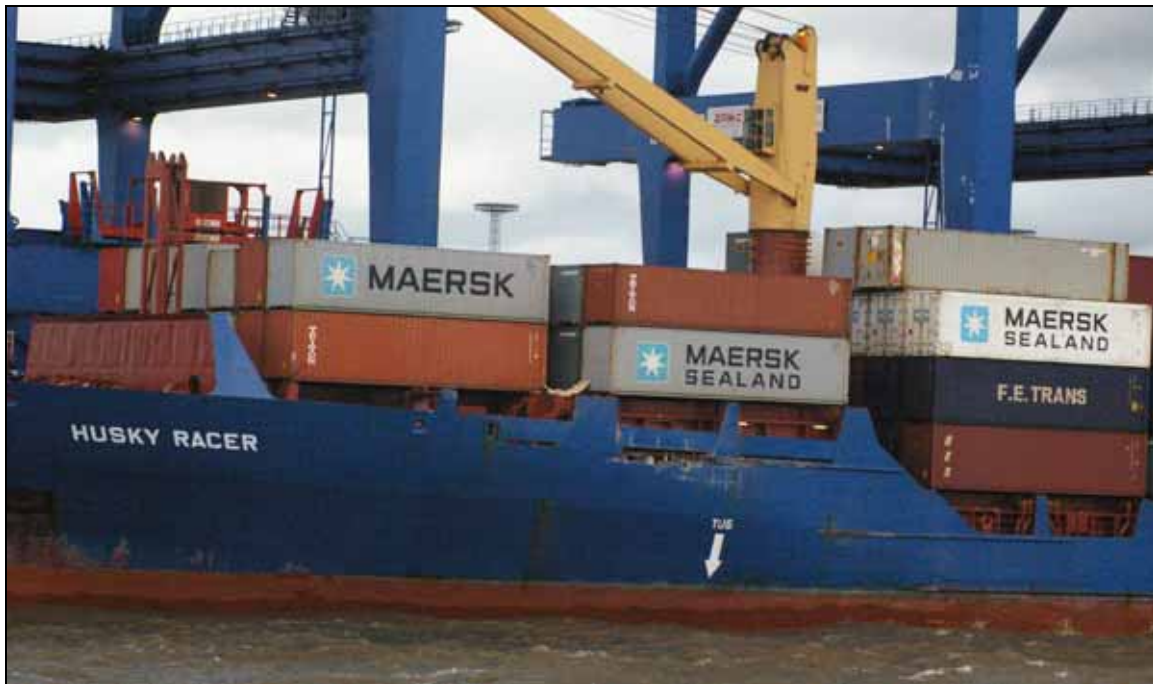
The hull of the HUSKY RACER was torn open on the port side. Both deck cranes were damaged as they too had been turned seawards (Figure 9).

Figure 9: HUSKY RACER, damaged hull, twisted crane

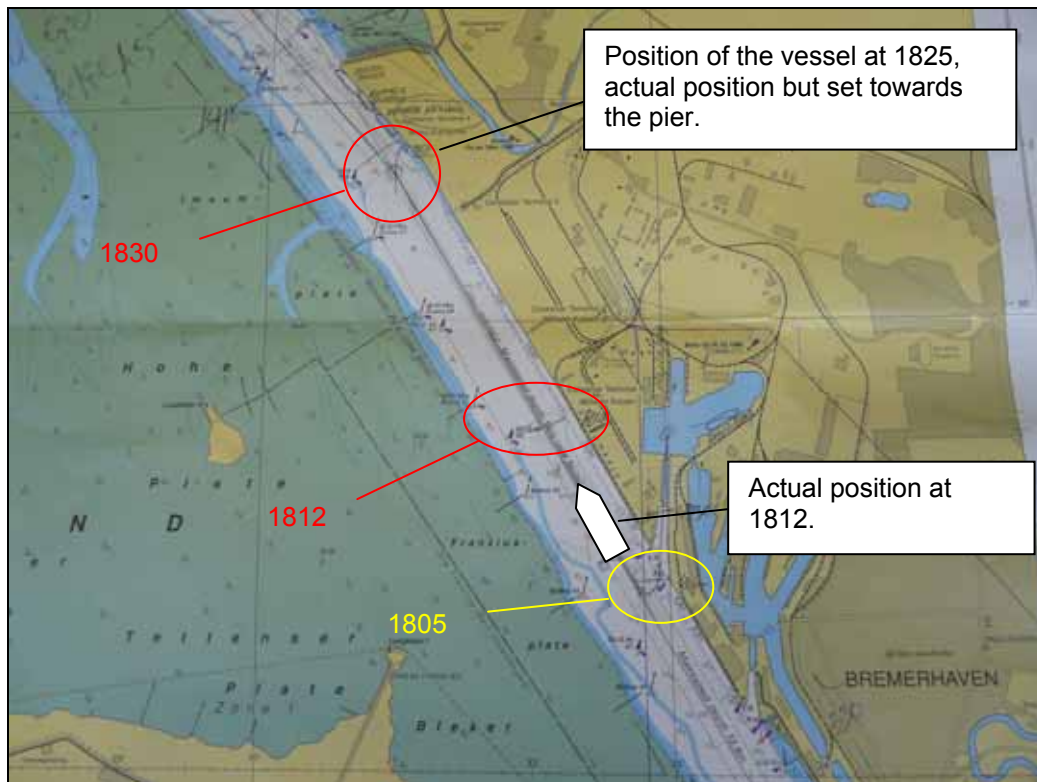
Figure 36: Photo of the HÖEGH LONDON's nautical chart with two incorrect positions (red) and one correct position (yellow)
