Investigation Report 174/10

Serious Marine Casualty

Grounding of the
MV BELUGA REVOLUTION
off ENUS (Tench) Island
in the South Seas
on 30 April 2010

1 August 2011

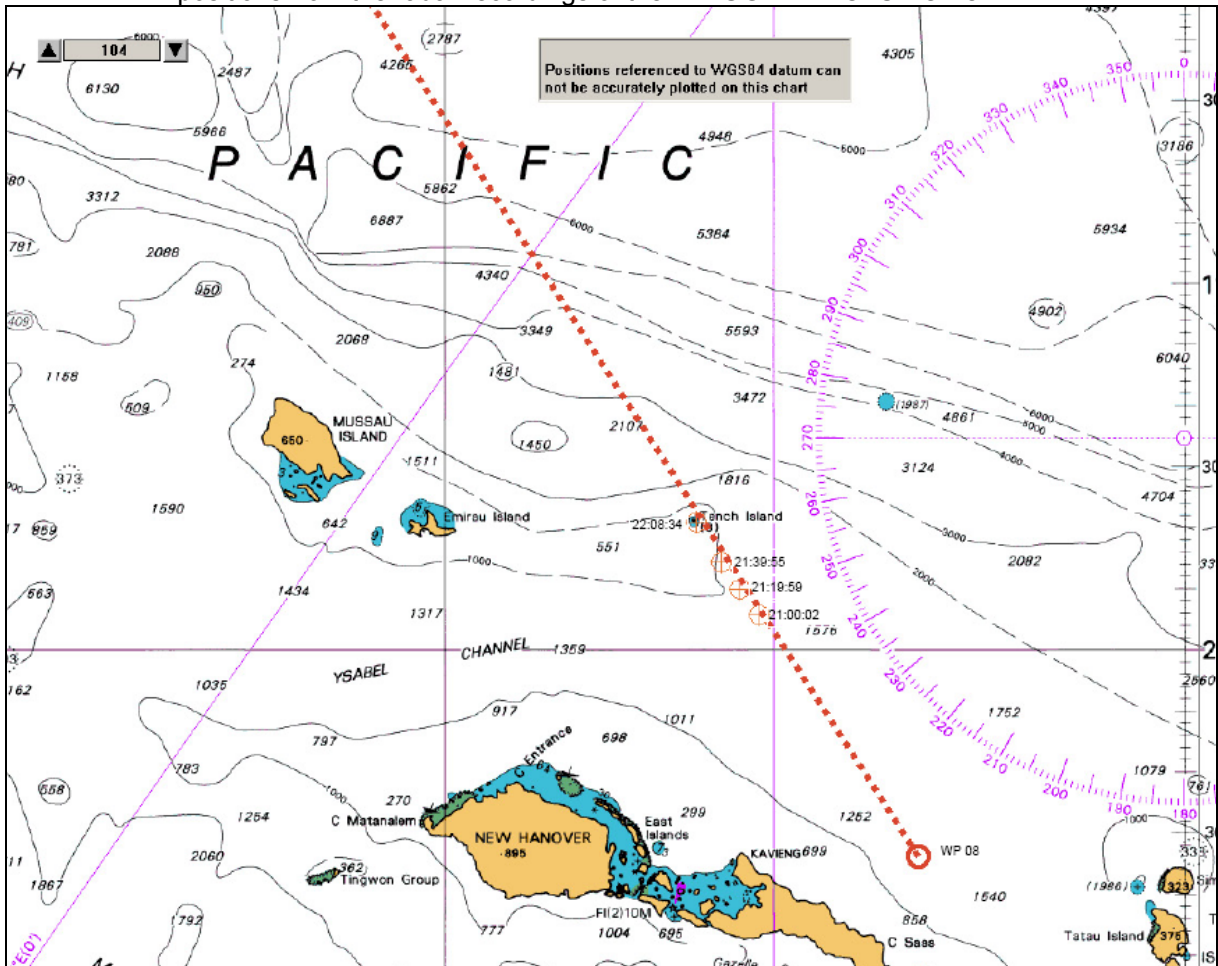
Figure 2: Nautical chart BA 4622 ARCS. Source: BSH

Sailing directions, charts, and the route from Noumea to Pohang, including waypoints, courses and distances, are recorded in the BELUGA REVOLUTION's voyage planning. Routing charts used and sailing directions about ocean tracks were not recorded. The valid routing chart in each case had always been below a transparent sheet covering the chart table. Consequently it was reportedly visible at all times. From waypoint 8 (02°33.8' S, 151° 16.8' E), a rhumb line of 327.4° and 2,301.8 nm was calculated for the track to waypoint 9 (29 ° 44.5 'N, 129 ° 48.1' E). At about 22 nm SE of Tench Island, the chart should have been changed to AUS 462, which was also performed by the ECS. When changing charts with ARCS data, the alarm 'NO OFFICIAL DATA' is triggered on the TRANSAS 2400 ECS. It is no longer possible to establish whether the vessel's position was switched back to after that. At 2100, Chart AUS 462 was already in use (see Fig. 2, vertical magenta line indicates the chart boundary).

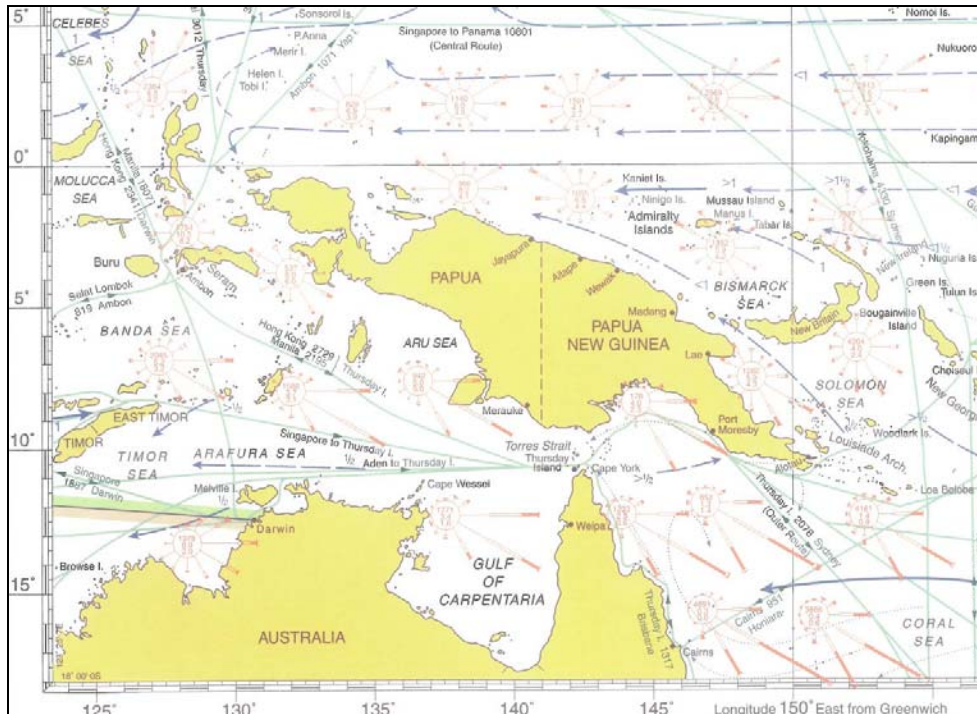
Figure 4: Excerpt of Routing Chart BA 5127 April

On the voyage planning data sheet for Noumea to Pohang, routing charts BA 5127 and BA 5128 for the months April and May, which take into account the wind and current conditions, Sailing Directions NP 60 for the South Pacific and NP 136 (Ocean Passages for the World) as well as Chart AUS 462 or similar publications for voyage planning are absent. In NP 60 and the above routing charts, the westward setting South Equatorial Current is indicated to be 1-1.5 kts at Tench Island. In April, the swell can reach up to 4 m, mainly from directions between the SE and NW. In the sailing directions, Tench Island is described as being 2-3 nm SW of the charted position in Chart AUS 462 (reported 1987). The island is forested and with the exception of the SW side surrounded by reefs, which reach about 1.5 cbl into the ocean. Possible routes across the ocean are recommended in NP 136. According to that, the St. Matthias group of islands would be passed either to the east of Tench Island, New Hanover and the Tabar Islands or west through the Bismarck Sea. In Routing Chart BA 5127, only the northern variant is recommended at some distance. The German Handbook of Ocean Passages, BSH 2057, also recommends passing to the east or west of New Hanover, but not necessarily to the east of the Tabar Islands. A tropical climate prevails there. Heavy showers and thunderstorms occur several times a day at air and water temperatures of around 28° C as well as light winds in the intertropical convergence zone (doldrums) and cloudiness. Tropical typhoons do not occur in parallels up to 4° from the equator or in the sea area NE of New Guinea.

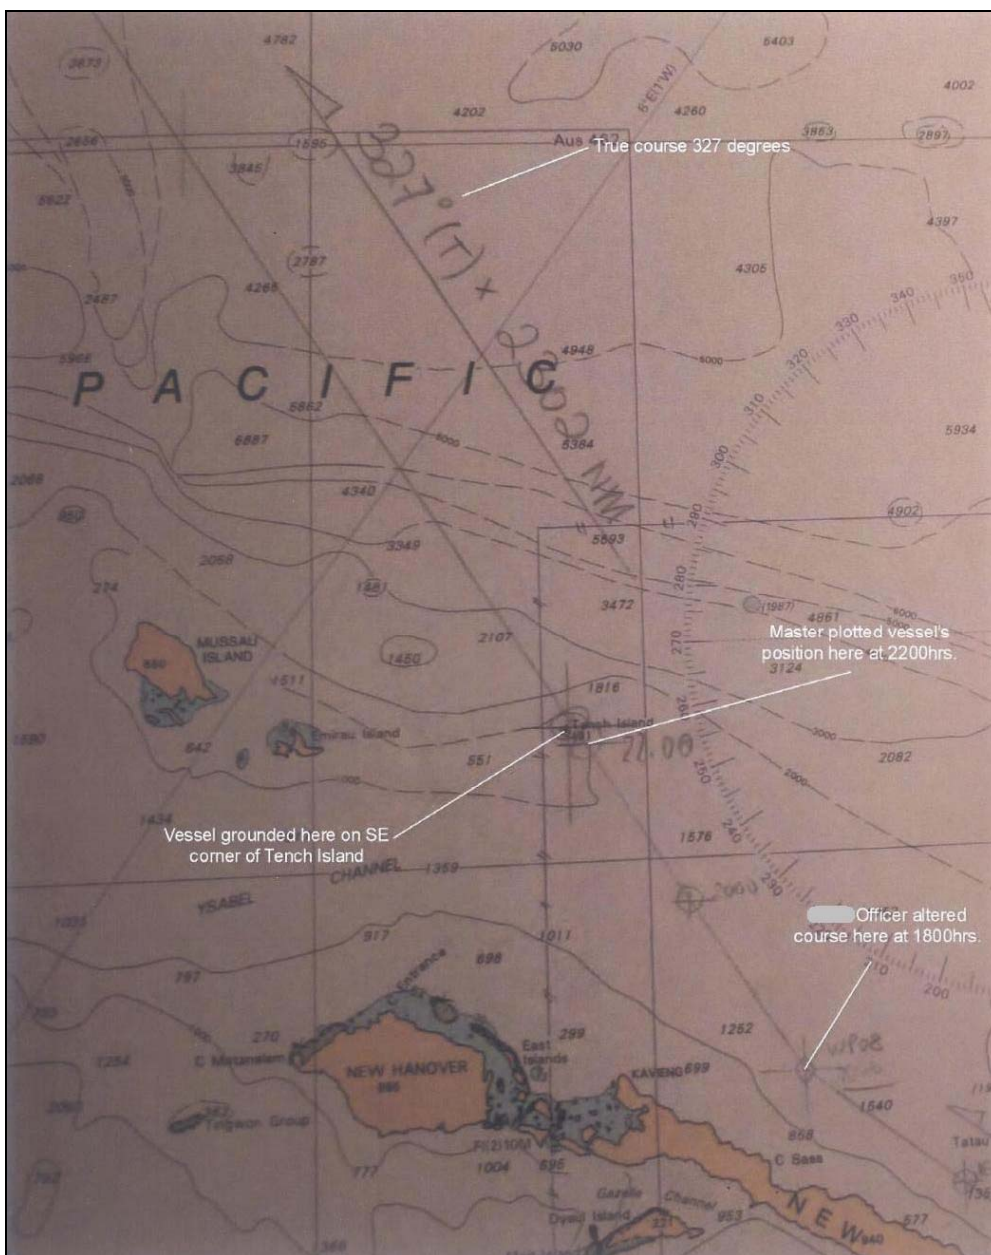
Figure 6: Nautical chart BA 4622. Source: Photo Australian Marine Inspections

At 2200, 10 minutes before the grounding, the paper chart in use, BA 4622, contained a recorded position which is exactly on the course line about 2 nm SE of Tench Island. Prior to that, the positions were entered at 2-hourly intervals in accordance with procedural instructions. According to the photo taken by the expert, these were all on the course line. The last course change occurred at 1800 from true 307° to 327°. If the course of 307° was maintained to the 2° S parallel and about 2130, the track would have run between the islands Emirau, Mussau and Tench at a distance of about 20 nm. It is apparent that none of the officers on watch questioned the courses recorded in the charts. According to the logbook, the vessel was steered between 2° and 3° E after the course change at 1800 to maintain the course line and in response to the westward setting South Equatorial Current. Here, 1 mm corresponds to about 1 nautical mile on the parallel of 2°.

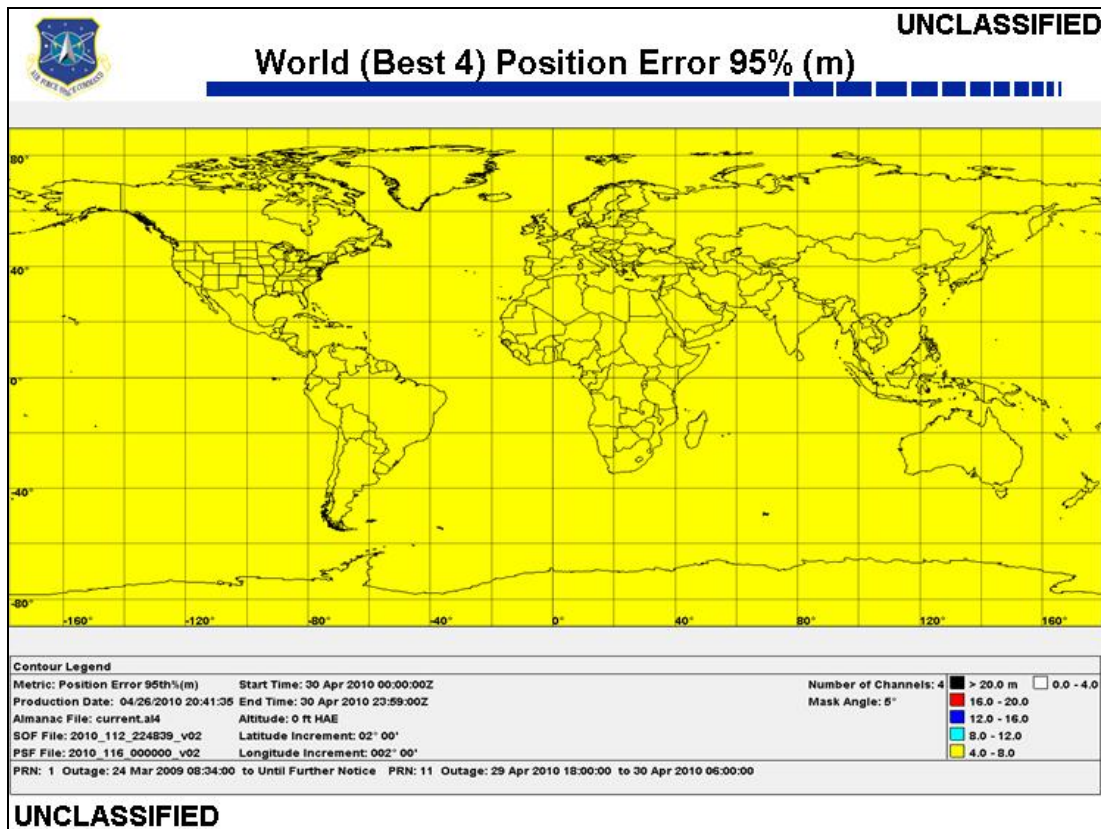
Figure 8: Source: GPS Operations Centre

From a technical perspective, the navigation equipment worked. With a probability of 95%, the GPS error stood at 4-8 m (Fig. 8) and, as demonstrated by a position comparison with another vessel, there was no interference (Fig. 9). It is unclear what led to the position data (see Fig. 7) of the logbook and VDR recordings being inconsistent after the grounding. This was probably due to transcription errors or different sources (GPS receiver). The objective in the SMS of maintaining a track deviation of 0.1 nm can be critical for fully automated track control near the coastline. However, in the case of a conventional heading control with autopilot such as this, it tends to be disturbing because limits can be reached too often and lead to alarms. The X-Band radar system was set according to the manufacturer's recommendations and provided an image with showers and other targets, which was to be expected. It is possible that due to the 10 cm wavelength, the radar image of the S-Band system would not have been affected by the false echoes from rain showers. However, it remains questionable whether the relatively flat island would have been shown as clearly as on the X-Band system with 3 cm wavelength.

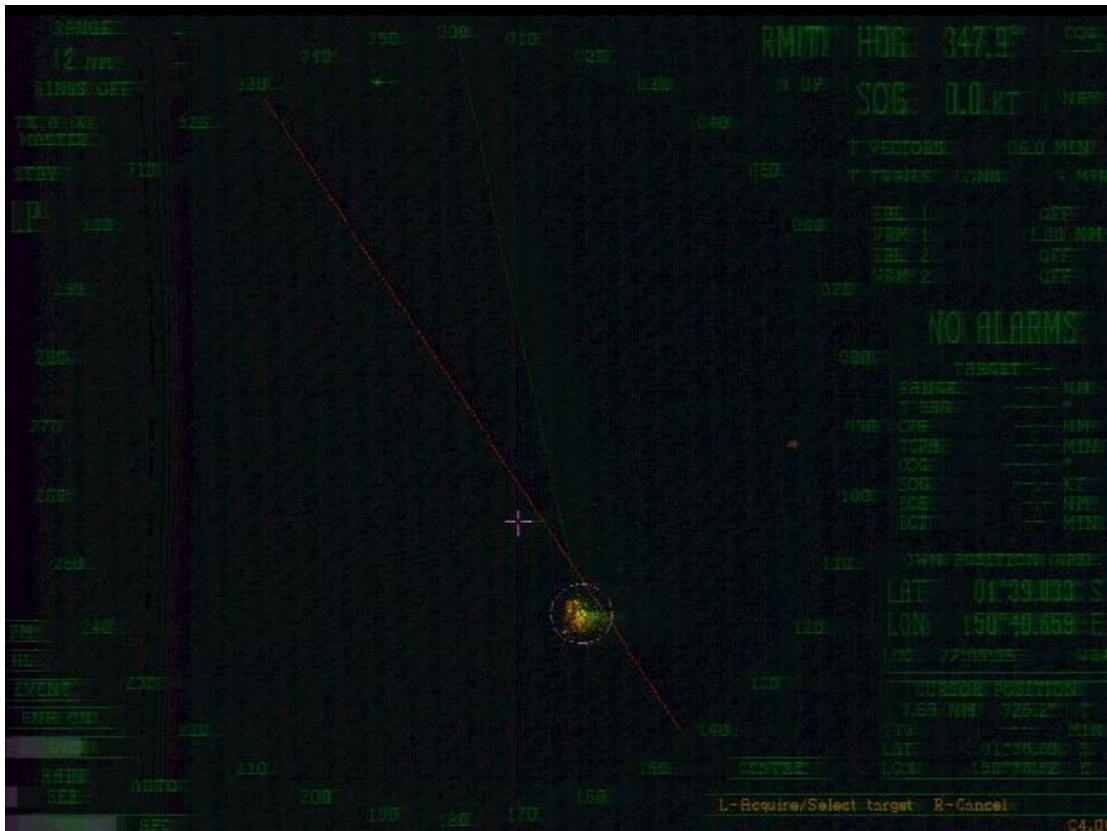
Figure 15: Radar time 220935, HDG 347.9°, COG ---°, SOG 0.0 kts

The VDR recorded the X-Band radar images at 15 s intervals. The settings correspond to the manufacturer's recommendations, i.e. automatic tuning, long pulse length and expanded target display for areas larger than 3 nm as well as automatic anti-clutter for rain and sea. In addition, the system was set to relative motion north up with true vectors (6 min) and true long trails (6 min), the range at 12 nm off-centre and the variable range rings at 1 nm. The red line is the displayed course line between waypoints 8 and 9. The target highlighted with a red circle by the author in Fig. 10 is Tench Island. All other targets are rain showers or, within the variable range ring, sea clutter. At 2204, the echo of Tench Island enters the 1 nm area of the range ring.

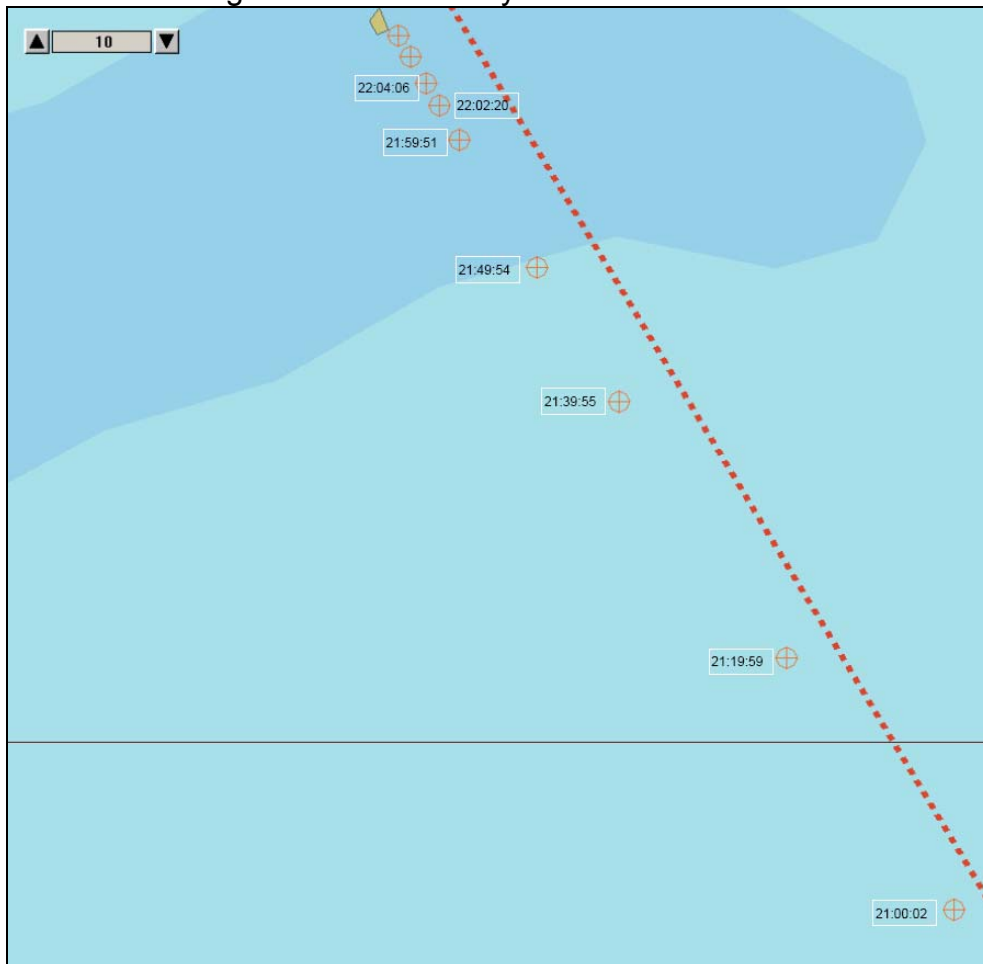
Figure 16: Source: BSH, course line and track

The examination of the vessel's track revealed a significant drift toward the island (Fig. 16) in the hour before she grounded. The ECS displayed a drift of 254° and 1.4 kts (see Fig. 5) shortly before the grounding. At the time of the grounding, the vessel steered a course of 332° (GYHDG), with a track of 322° entered in the logbook. The calculated track to the next waypoint was 327°. This is probably a transcription error in the 2000 position. This error could have influenced determination of the correction angle for compensating for the drift. Since the position at midday, the GPS positions on Chart BA 4622 were entered in the logbook every 2 hours. Chart AUS 462 was not used and it is unclear whether this was on board.
