**Bundesstelle für Seeunfalluntersuchung**  
**Federal Bureau of Maritime Casualty Investigation**  
Federal Higher Authority subordinated to the Ministry of Transport,  
Building and Urban Development

Investigation Report 215/10

**Less Serious Marine Casualty**

**Accident involving the shipboard crane on  
board the  
wind turbine installation vessel  
WIND LIFT 1  
on 23 May 2010 at the  
'BARD Offshore 1' wind farm  
about 50 nm north-west of Borkum**

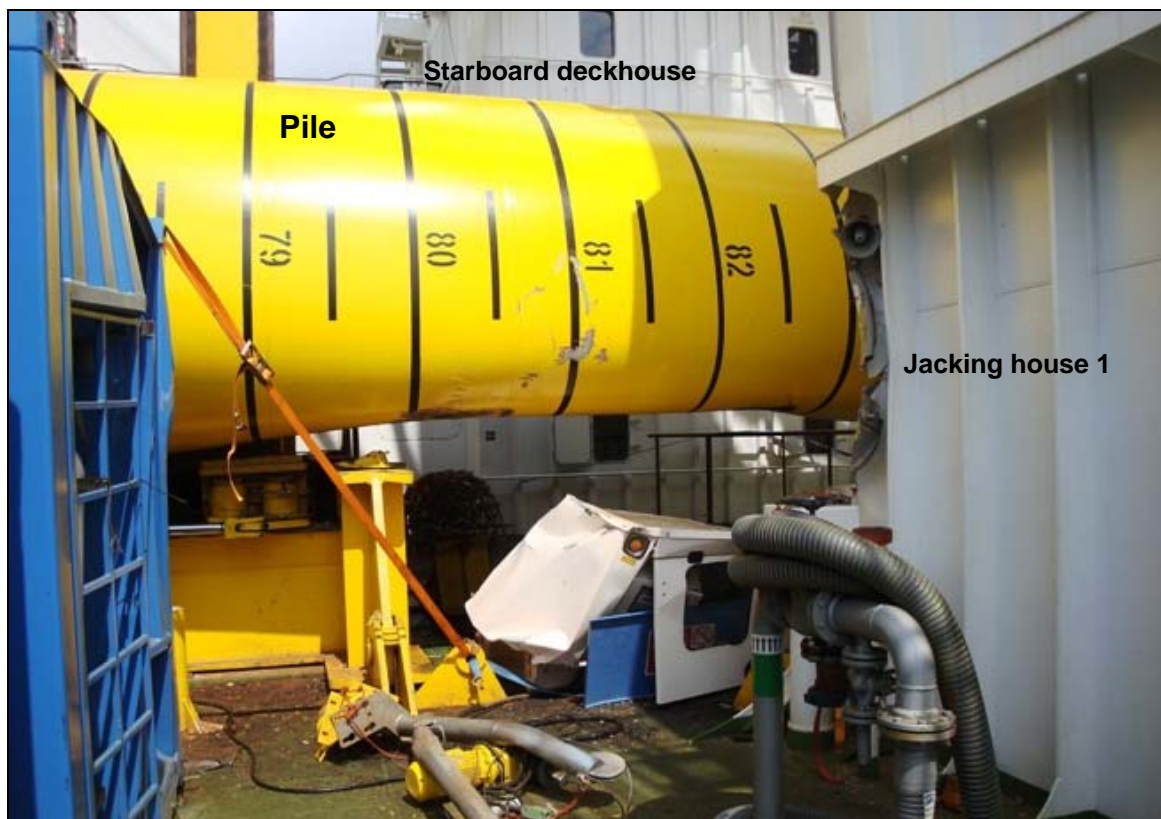
In the area of the upper deck, it was mainly jacking house 1<sup>7</sup> that was damaged due to a glancing blow by the pile as it fell. There was also superficial damage to various loose and fixed items of equipment and components in the area of impact. In addition, the violent shaking of the platform caused damage to various navigation lights and other minor technical problems. Contrary to initial concerns, there was no structural damage.

Figure 5: Damage on the upper deck<sup>8</sup>

<sup>8</sup> Shot from the starboard side of the vessel in the direction of the pile. The damaged fairlead (see Fig. 6 below) is located behind the position of the photographer.

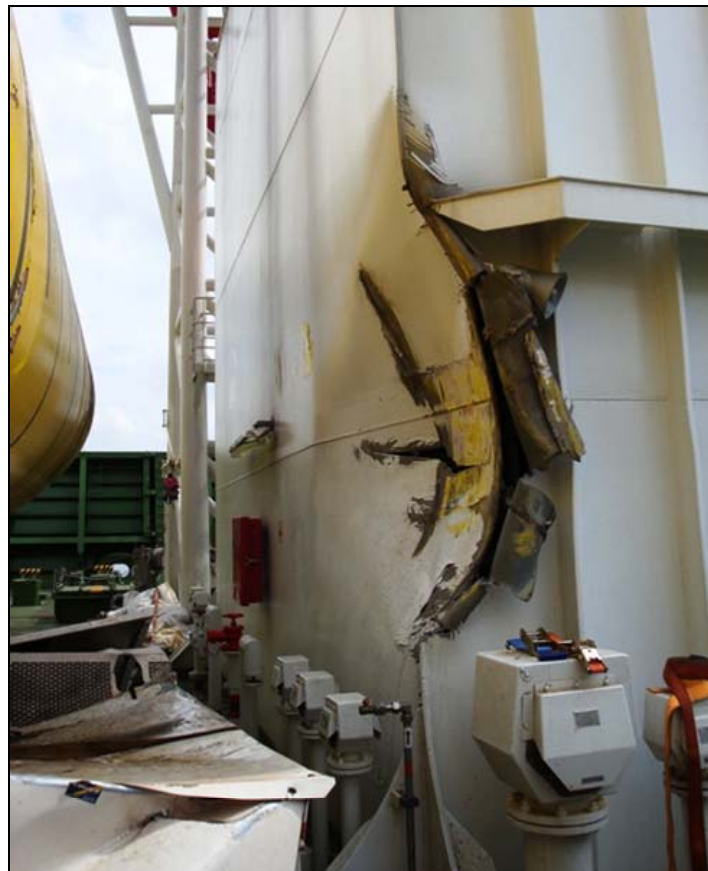
Figure 7: Damage to jacking house 1<sup>9</sup>

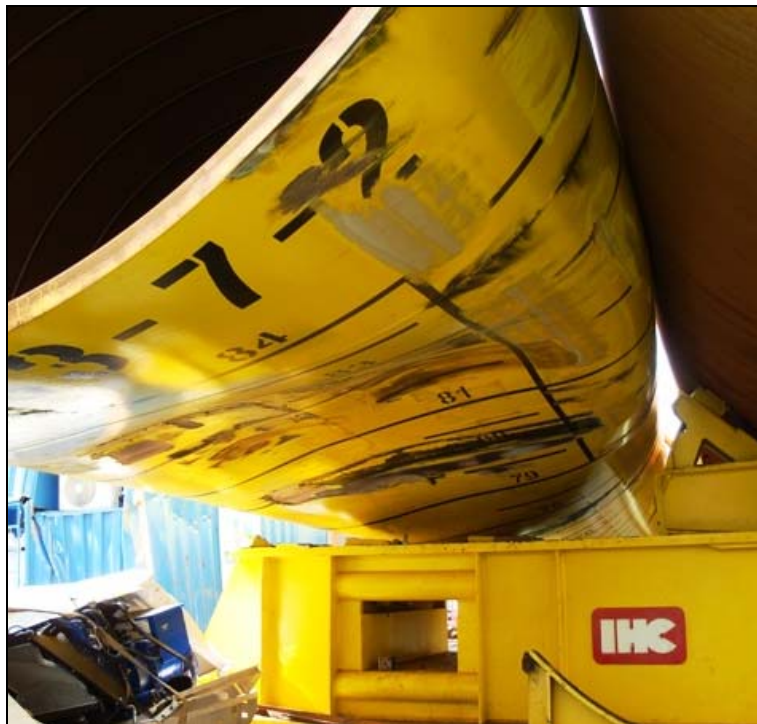
The pile itself was significantly deformed due to slamming heavily onto the deck (Figs. 8 and 9).

Figure 9: Deformed pile (from below)

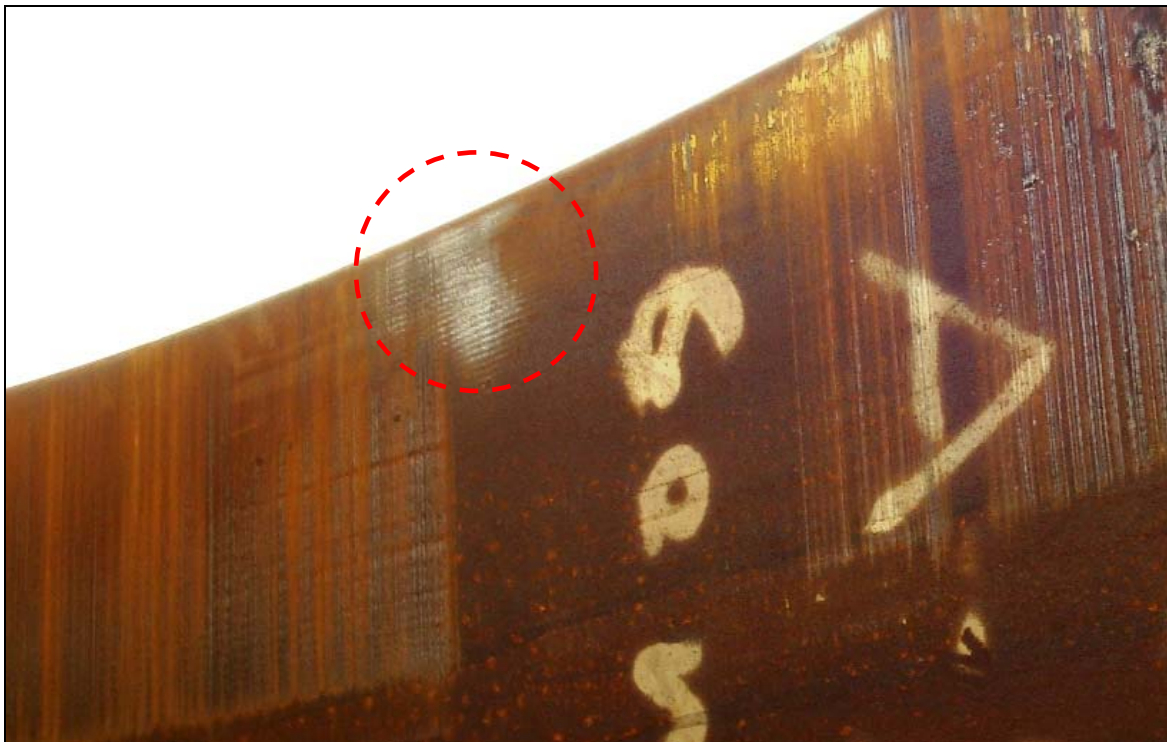
An assessment of the supposed pressure marks on the surface of the pile after the accident revealed that in contrast to the inner pressure position (**Fig. 19**), the clamping jaws left no indentations on the outer pressure position painted yellow (**Fig. 20**).

Figure 19: Clamping jaw pressure mark (inner surface of the pile)

Therefore, it must be assumed that the pile was not held properly by the clamping jaws. The ridges found on the inner surface of the pile (see area highlighted in red on **Fig. 19**) in spite of that were probably caused by pressure from the 'lower' clamping jaw on the inner surface of the pile, which inevitably built-up while the pile was being raised.

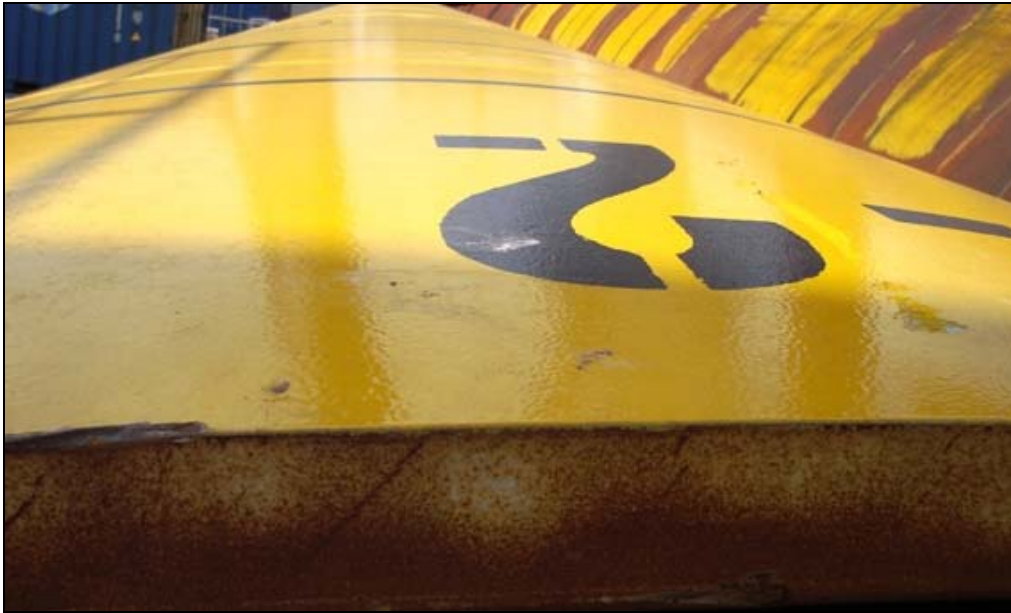
Figure 20: Outer surface of the pile (no pressure marks)

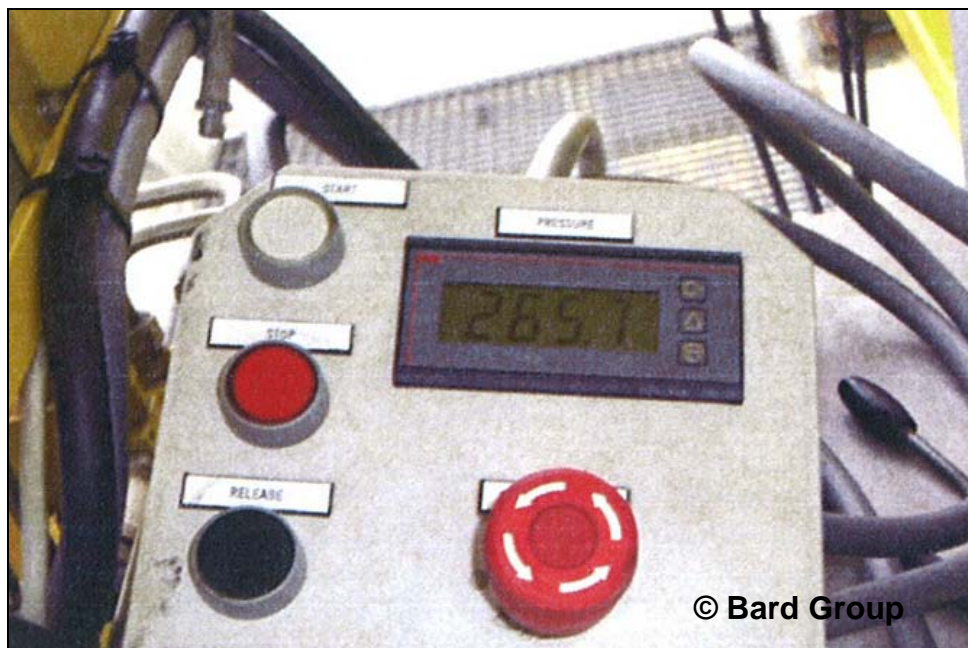
The operator provided the BSU with photos, which were reportedly taken immediately after the accident. Shown are the digital pressure gauge on the fox's wired RCU and the analogue pressure gauge on the housing of the power pack (see **Figs. 21** and **22**) with values of 265.7 and about 273 bar.

Figure 21: Fox's wired RCU – digital pressure gauge

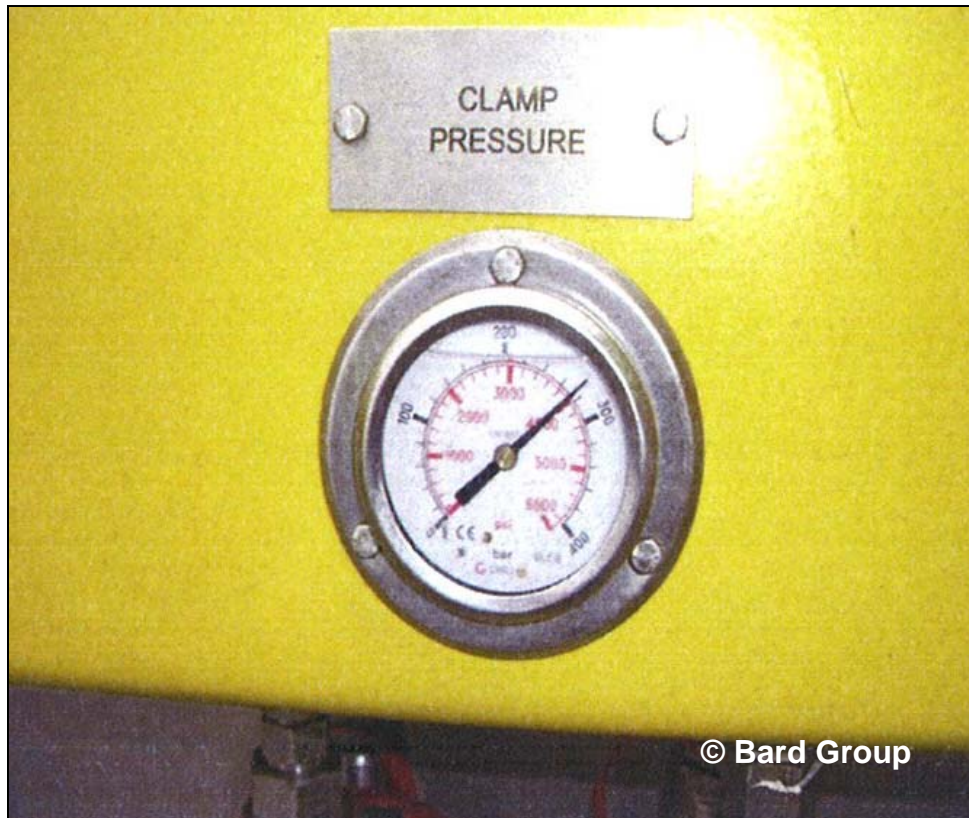
Figure 22: Analogue pressure gauge on power pack<sup>36</sup>
