Bundesstelle für Seeunfalluntersuchung
Federal Bureau of Maritime Casualty Investigation
Federal Higher Authority subordinated to the Ministry of Transport,
Building and Urban Development

Investigation Report 264/10

Serious Marine Casualty

**Collision of the tug STEINBOCK
with the MV MINERVA
off Bremerhaven on 29 June 2010**

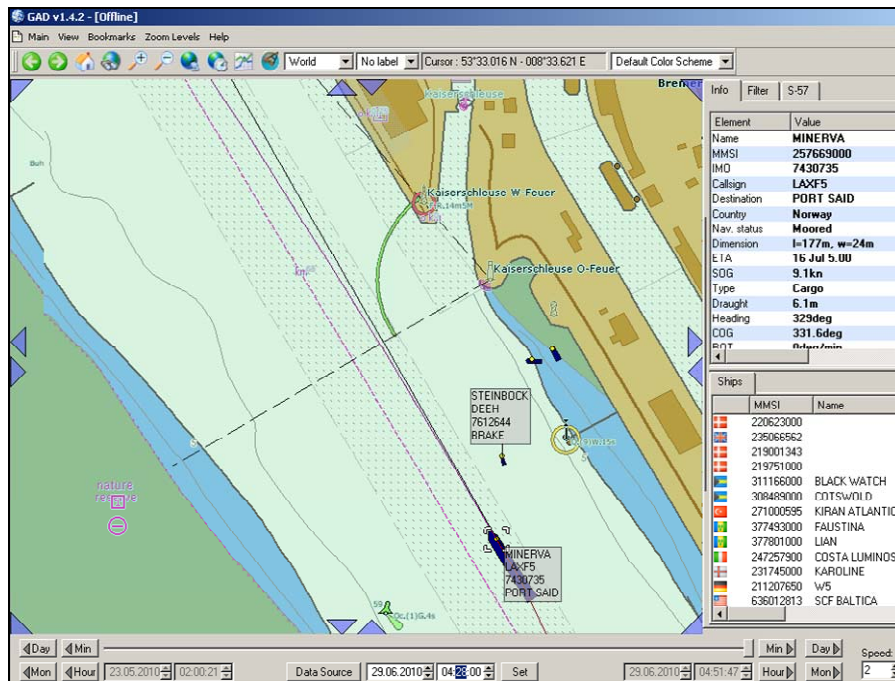
Figure 4: Waterway Police Bremerhaven 015147

The AIS recordings with recorded electronic nautical chart, provided to the BSU by the Waterway Police in Bremerhaven, only provide a snapshot of the approximate situation of the vessels at the time in question. It must be taken into consideration that the transmission frequency of the vessels' positions etc. is dependent on the respective speeds of the vessels and that position messages of vessels are not necessarily synchronous with each other. As a result, time shifts in the images for position data for the vessels with respect to each other can occur, including likely passing distances (see Fig. 5), but also collision locations can be shown in individual images that possibly did not occur in that way. A reliable analysis is only possible with AIS plot time series of both vessels with additional interpolation of intermediate positions.

To assess the process, possible active manoeuvres of the respective ship's command that are unknown must also be taken into account. It currently seems plausible that according to the following figures, a water-level depression induced suction effect could have been the cause of the tug approaching the RoRo vessel, but the possibility that the approach of the tug was caused actively by her rudder angle cannot be ruled out.

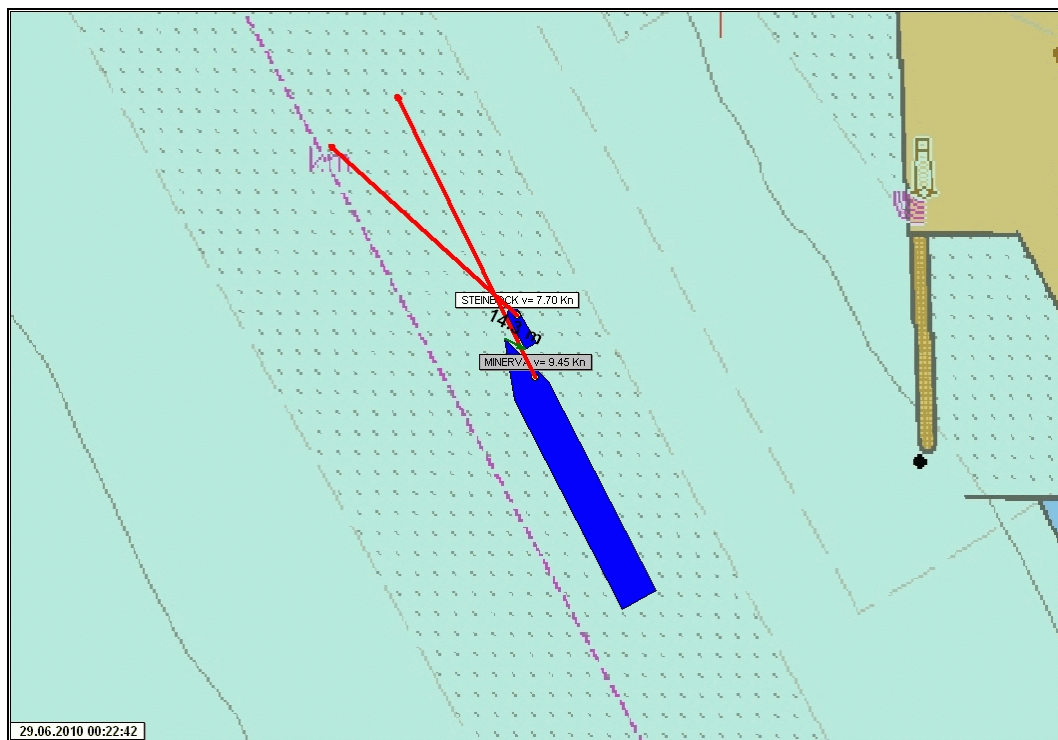
Figure 13: BAW Hamburg 022242 collision

From the BAW technical paper it can be seen that the actual sequence of the collision can be traced to the manoeuvring of the tug and not to the suction effect of the overtaking vessel, because the tug was continuously abeam ahead of the bow of the overtaking vessel. The red vectors refer to the antenna positions of the AIS

signals received, and show the course over ground (COG). The speed over ground was 9.4 kts for the MINERVA and for the tug STEINBOCK 6-8 kts. The track in the approx. 200 m wide dredged channel is 330° (leading light Hofe 330.8°). The currents in the area of the dredged channel run parallel (see Fig. 14).
