Summary
Investigation Report 304/10

Very Serious Marine Casualty

Collision about 25 nm east of Tianjin
between the CMV JULIA S
and the MV ZENITH WINNER on 24 July 2010

15 October 2011

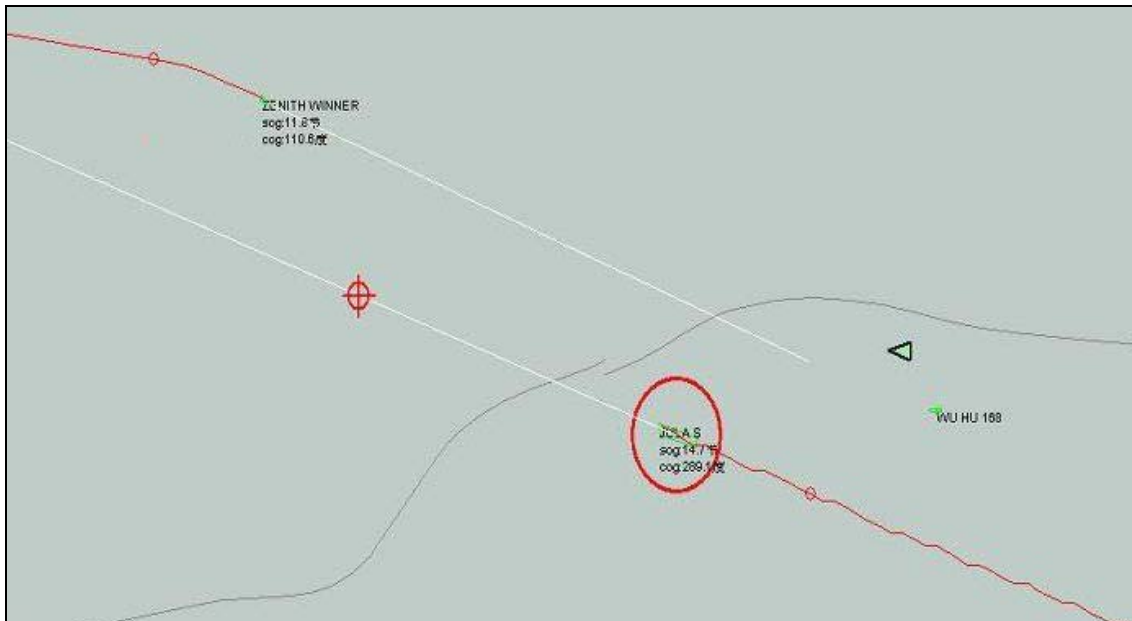
At about **055030** at a distance of some 1 nm to the JULA S, the ZENITH WINNER suddenly began to alter her course to starboard without warning.

Figure 5: Traffic situation at 0551 (screenshot of the AIS recording of VTS Tianjin)

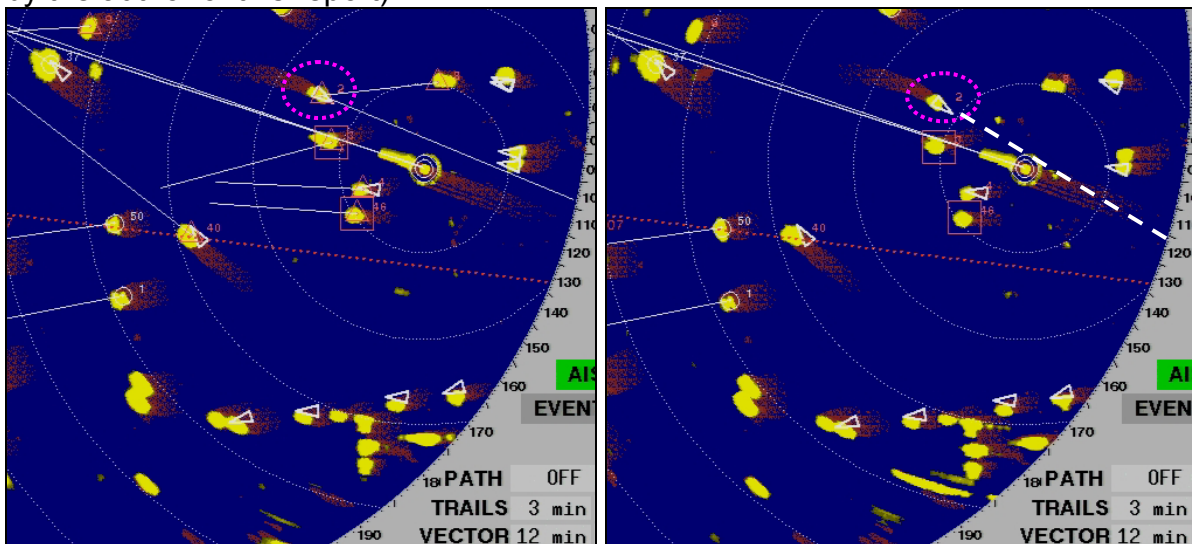
This course change becomes increasingly apparent on the radar of the JULA S between **055214** and **055229** (see Fig. 6; MV ZENITH WINNER highlighted in pink by the author of this report).¹²

Figure 6: Screenshot of the radar recording of JULA S at 055214 and 055229¹³

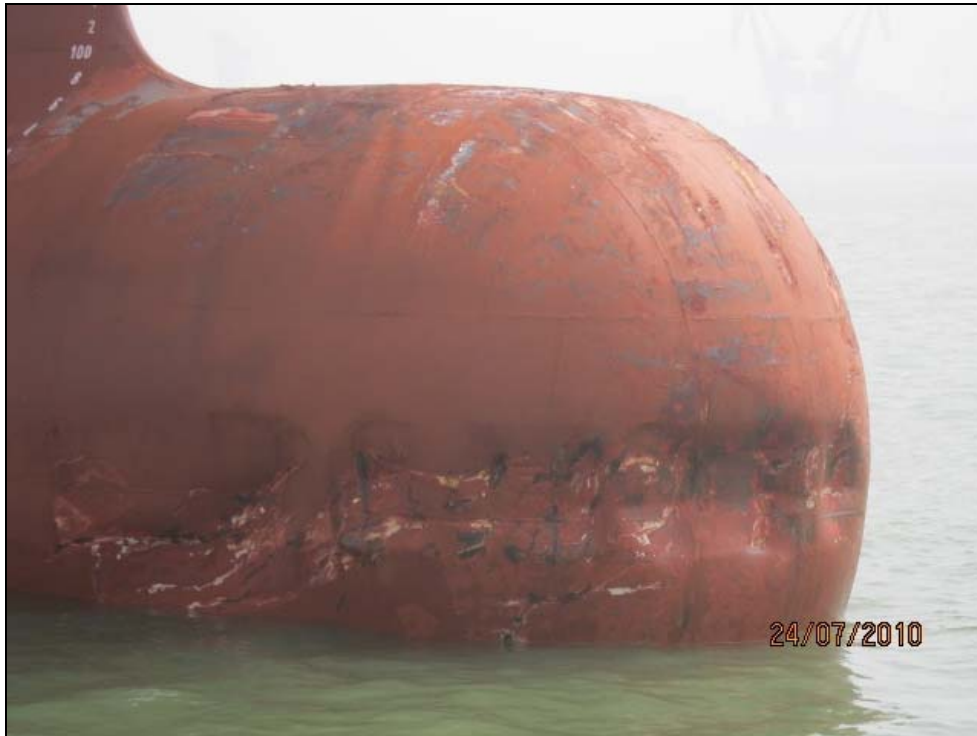
The side of the JULA S in the area of the forepeak and her bulbous bow were slightly damaged, respectively, deformed (see **Fig. 7 f.** below) due to the collision. No water ingress or damage to the tanks was found. There were no injuries on board the container vessel.

Figure 7: Damage to the bulbous bow of the JULA S¹⁵

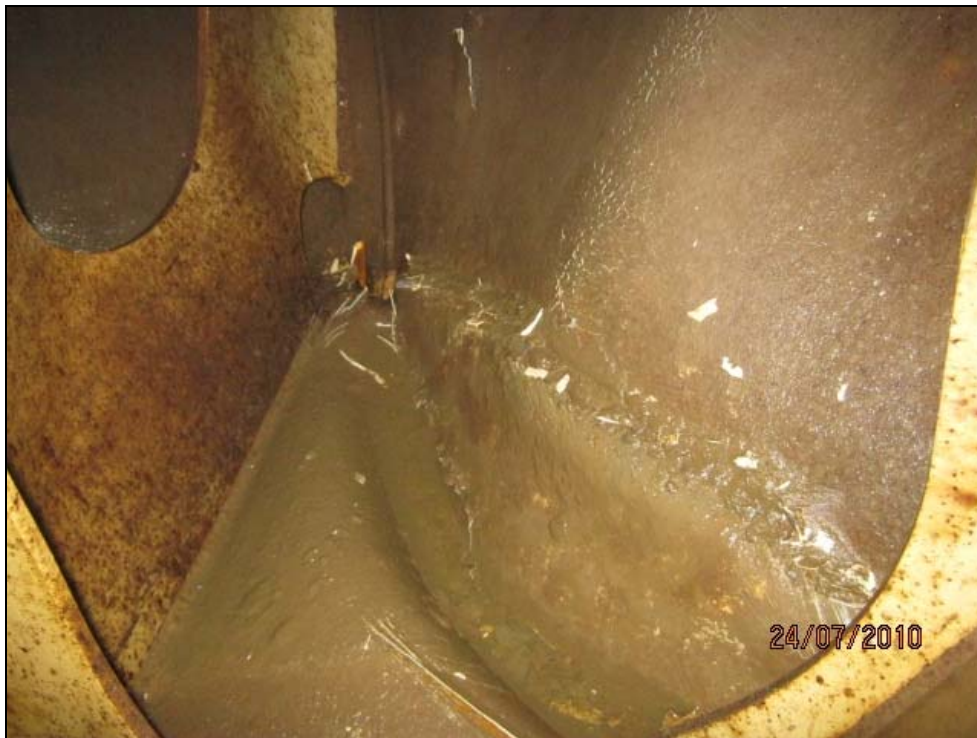
Figure 8: Damage to the forepeak of the JULA S¹⁶

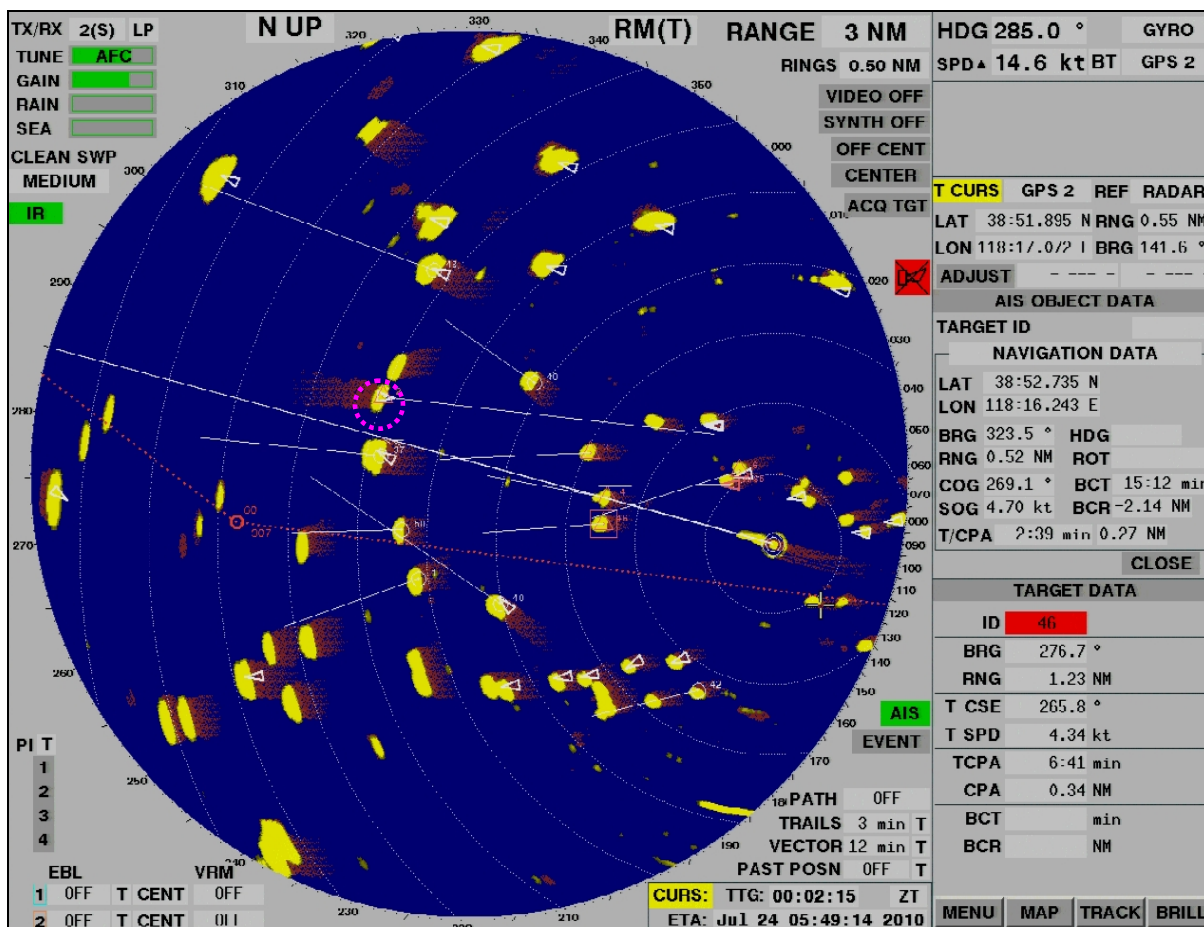
An example of the traffic situation at **054659** (see **Fig. 9** below; oncoming ZENITH WINNER highlighted in pink here and below¹⁹) illustrates the high volume of traffic in the area of the scene of the subsequent accident. Most of the echoes can be attributed to fishing vessels; these are often found in large formations in the coastal regions of Southeast Asia, in particular. Passing through such formations calls for heightened awareness on the part of the ship's command, but also a degree of serenity. To that extent, the implementation of traditional evasion manoeuvres is hardly possible. Rather, in line with local practise, fishing vessels operate in the immediate vicinity of large merchant vessels, but regularly take timely action on their own initiative to ensure an unimpeded passage.

Figure 9: Radar image of the JULA S at 054659

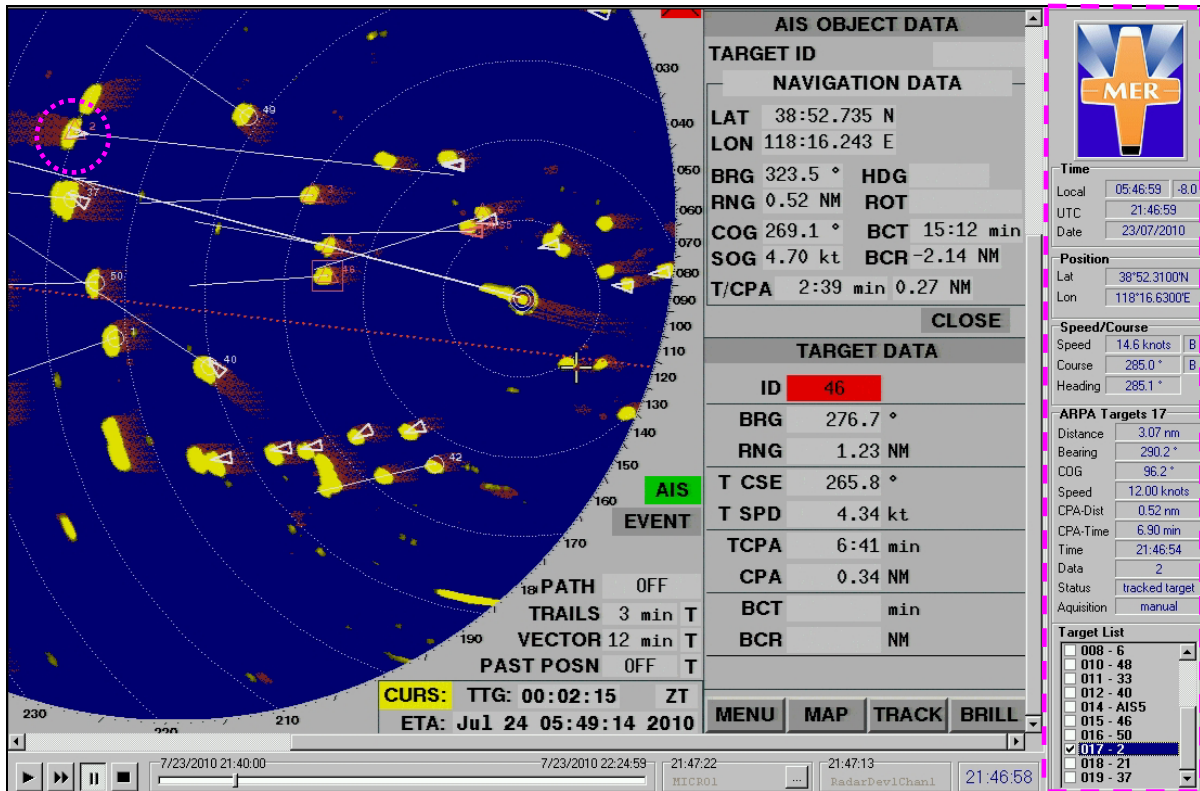
In addition to a screenshot of the above radar image, **Figure 10** (see below) shows the ARPA²⁰ data of the ZENITH WINNER (= target 2; see pink highlighted area on the right side of the figure).²¹ Both the graphical representation of the vector ahead of the ZENITH WINNER and the numeric ARPA data (the CPA²² and the TCPA²³, in particular) show that the track of the other vessel involved in the subsequent collision did not indicate any potential danger about 7 minutes before the collision. The ZENITH WINNER, which was 3.1 nm away, was acquired²⁴ as an ARPA target and identified as dangerous by the radar because of the forthcoming close-quarters situation (see red triangle on the echo of the ZENITH WINNER).

Figure 10: Screenshot of the radar image at 054659 plus VDR replay information window

With a CPA value of 0.52 nm and a TCPA value of 6.9 minutes, the ARPA data subsequently reproduced by the VDR's replay software in the course of the investigation confirm the harmless nature of the approach of the two vessels at the time in question.

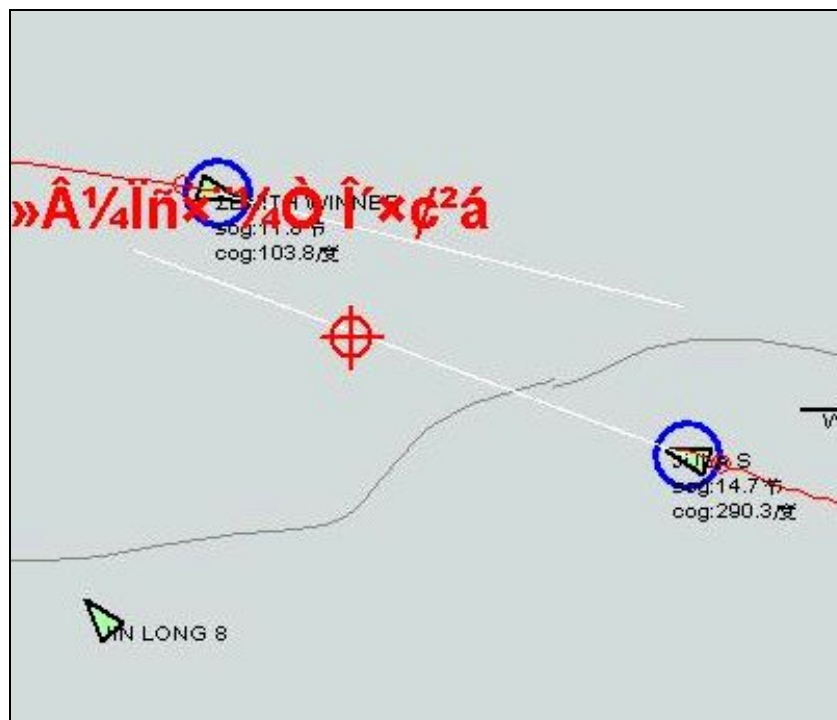
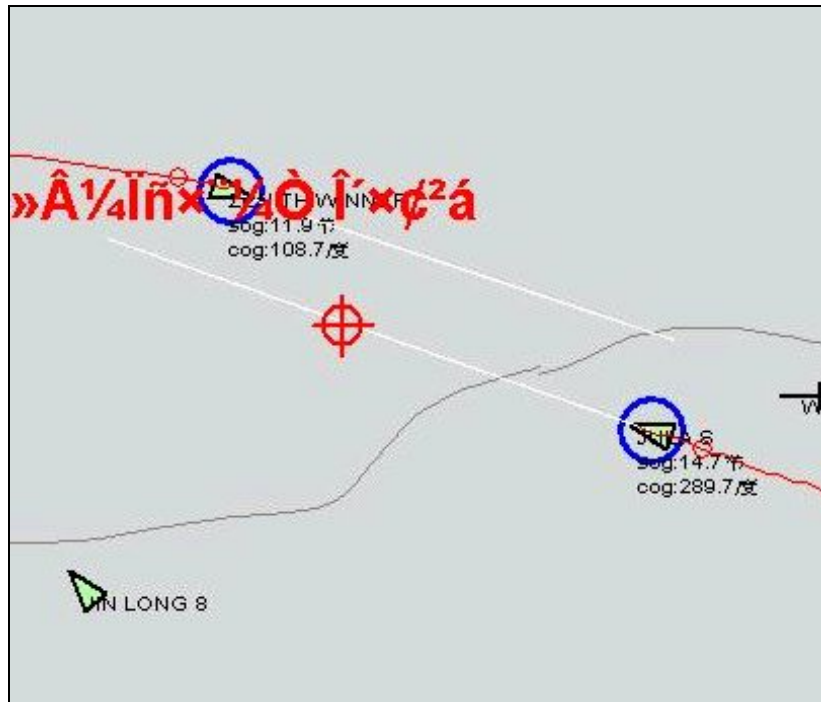
Figures 24 and 25 show that up until about 3.5 minutes before the accident, it was not possible to predict that the courses would cross.

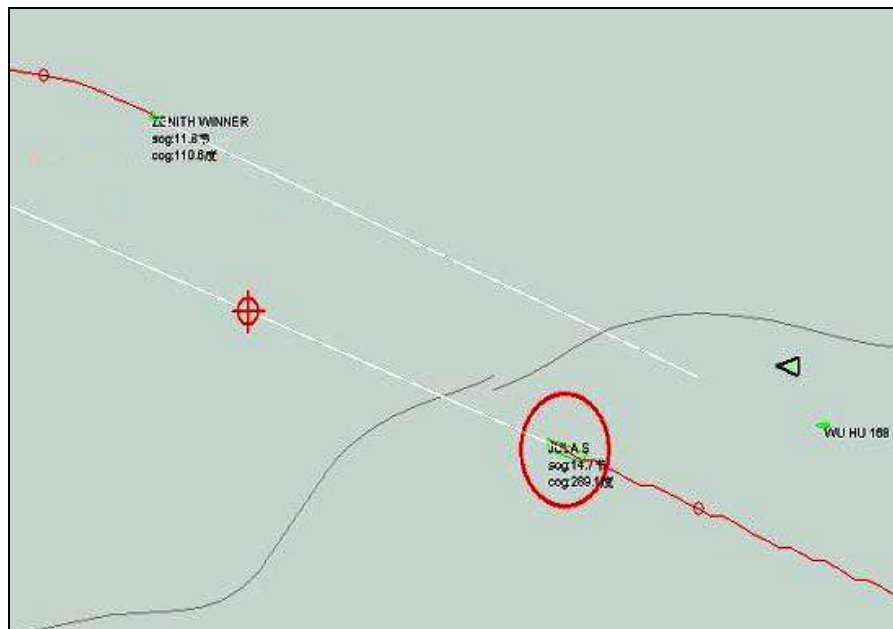
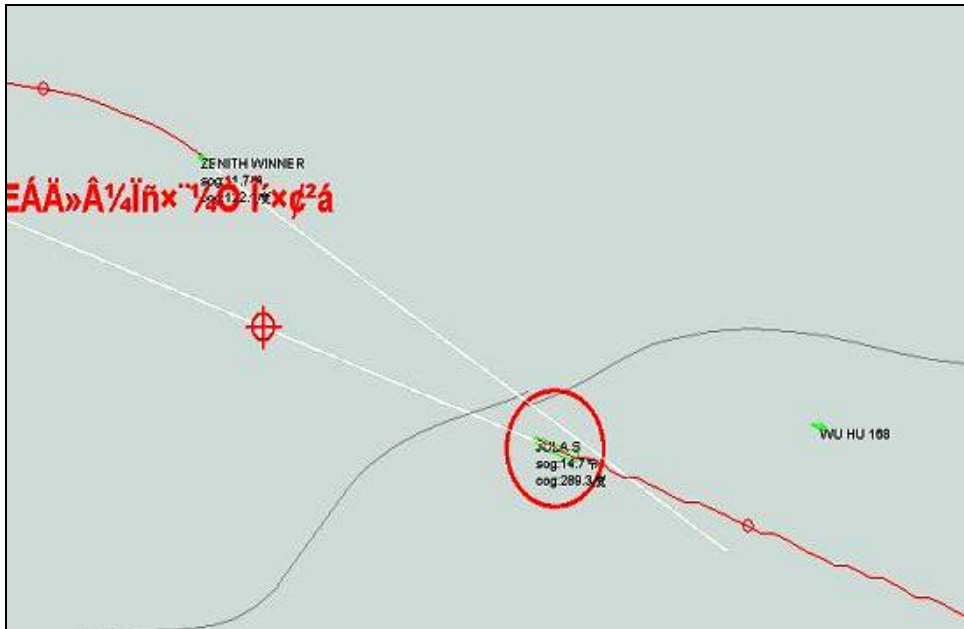
Based on the AIS data, **Figures 26 and 27** show that the ZENITH WINNER switched to a course that crossed that of the JULA S at about **0551**.

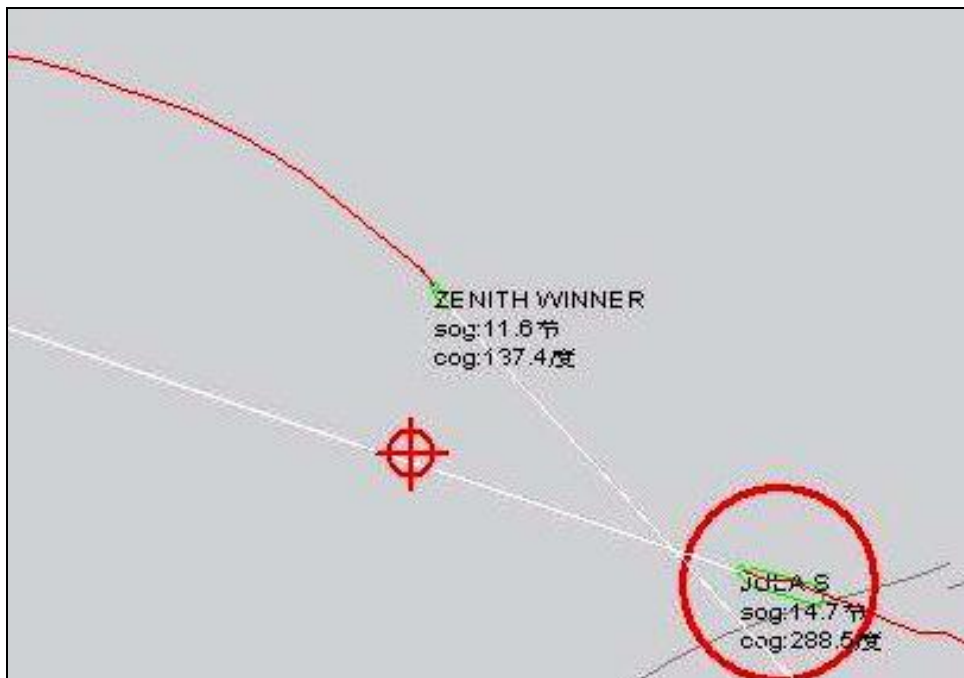
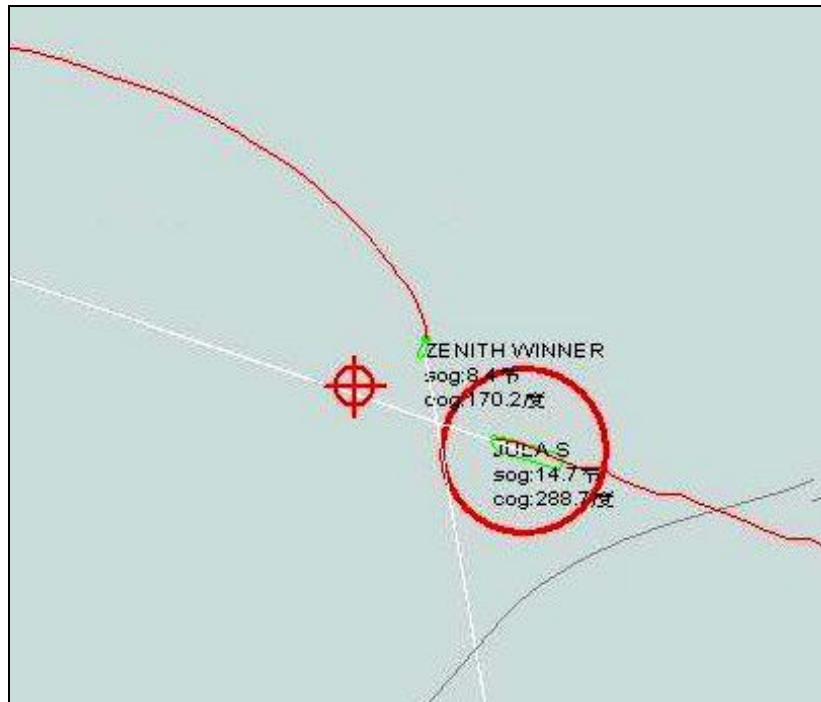
Figures 28 and 29 show that in the period between **055152** and **055247**, the ZENITH WINNER steadily changed her course to starboard and at the same time the point of intersection with the course line of the JULA S veered from astern to ahead.

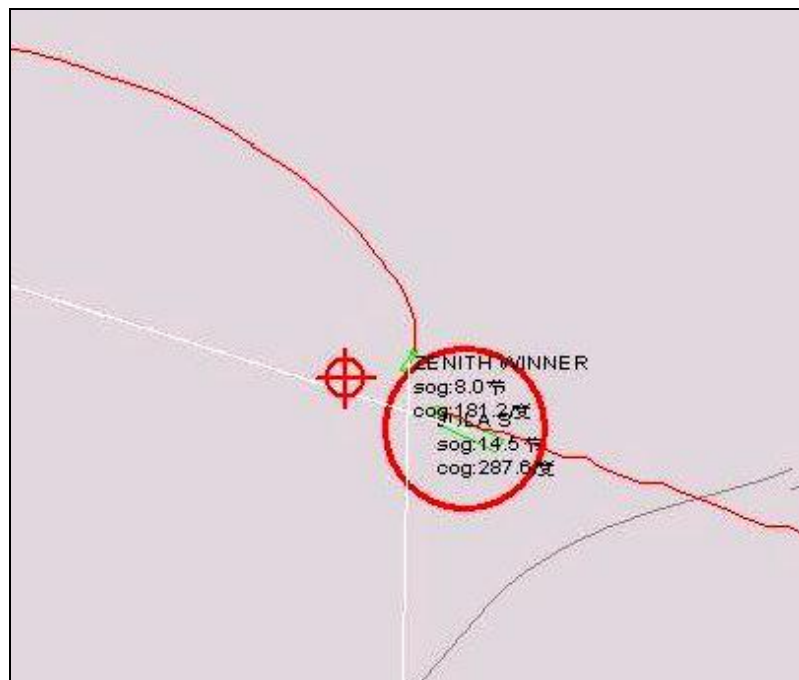
Figure 31: AIS recording at 055343

Based on the AIS data, the collision between the two vessels was imminent at **055343**.

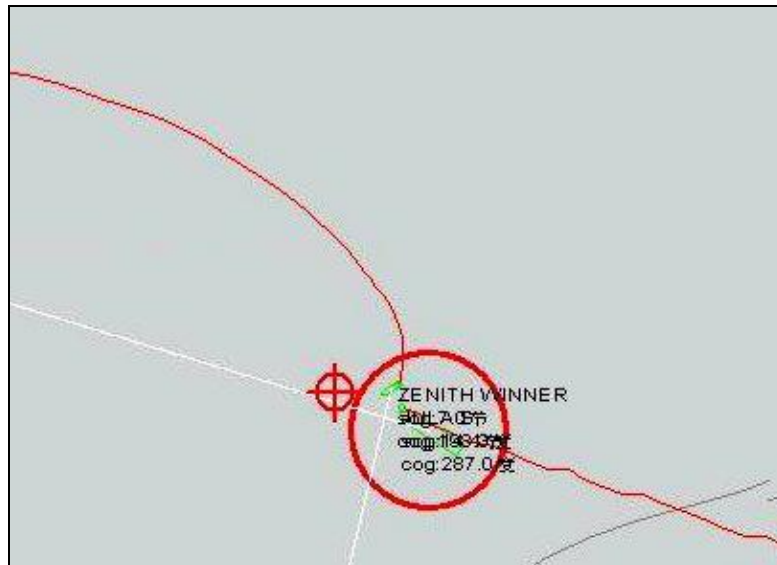
Figure 32: AIS recording at 055351

At about **0554** (see **Fig. 32** below), the AIS symbols of the two vessels merge and thus confirm the time of the accident.
