Summary
Investigation Report 551/10

Serious Marine Casualty

Collision west of Skagen
between the MV FRISIA ROTTERDAM
and the MV CLEANTEC
on 13 December 2010 at 0518

15 November 2011

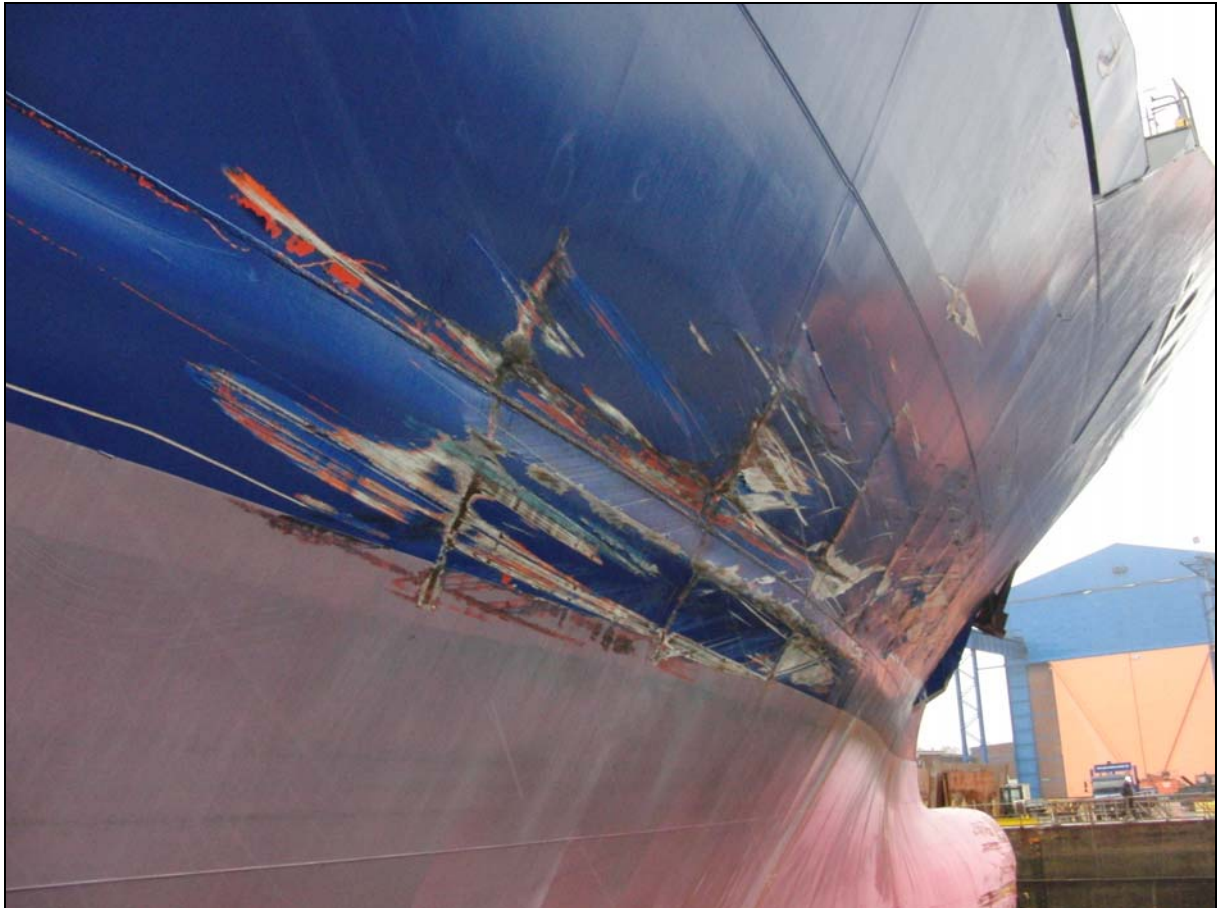
Figure 5: Damage photo 1 – FRISIA ROTTERDAM

Figure 5 shows scarring on the forecastle of the FRISIA ROTTERDAM and Figure 6 the vessel's heavily damaged bulbous bow.

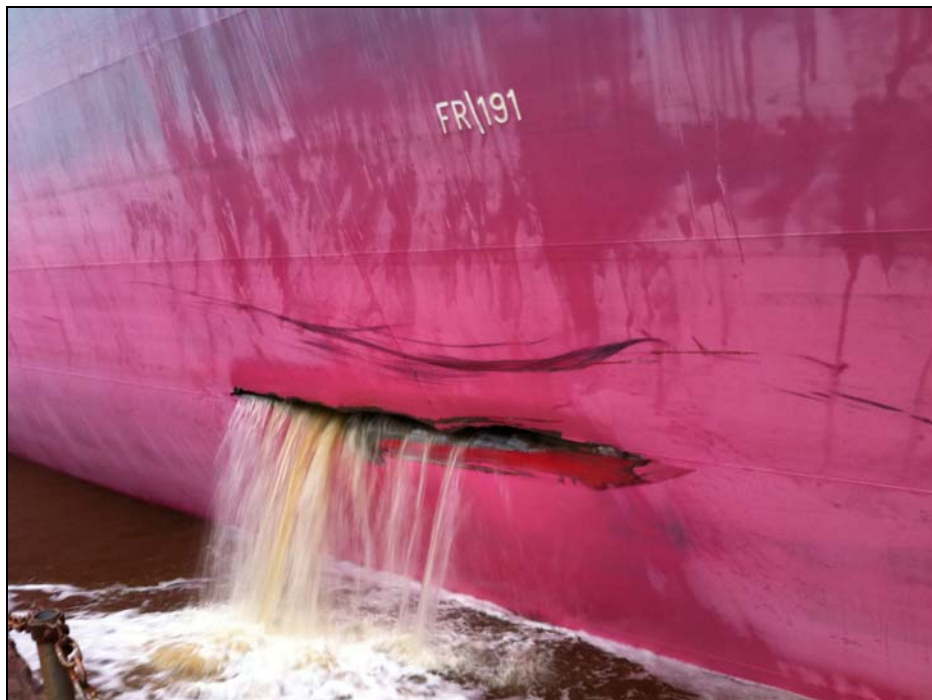
Figure 7: Damage photo 3 – FRISIA ROTTERDAM

It appeared that the crack in Figure 7 was only on the shell plating. The crew did not detect water ingress inside the vessel.

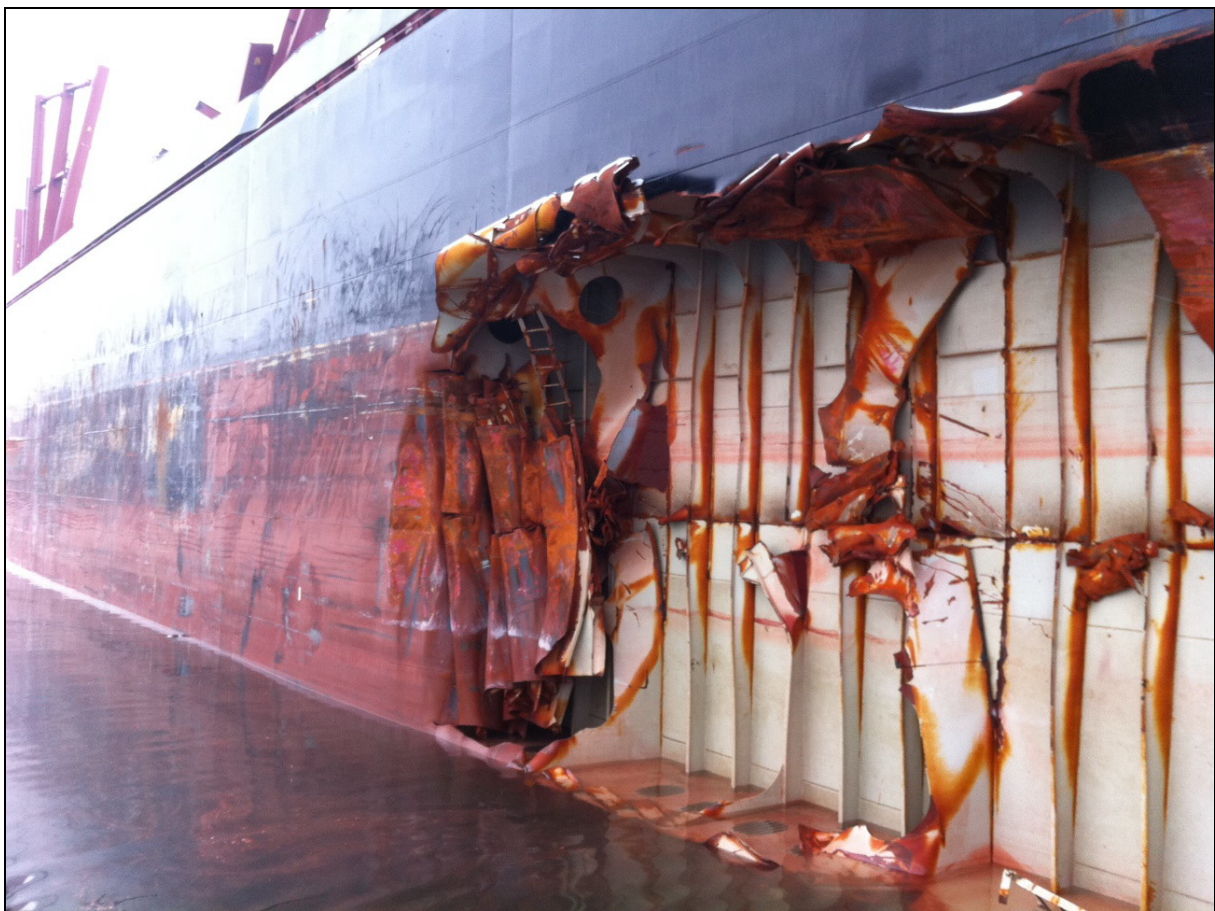
Figure 8: Damage photo 4 – CLEANTEC

Taken after the vessel was unloaded, Figure 8 shows the point of impact below the waterline.

In its report, the ship's command subsequently described the damage in the following manner: the port side was very heavily damaged between frames 120 and 135; quite a few stanchions broke on deck. On the port side, the deck superstructure was damaged up to the boat deck. Cargo hold 3 filled with water. The vessel heeled 3° to port and the bow dropped by one metre.

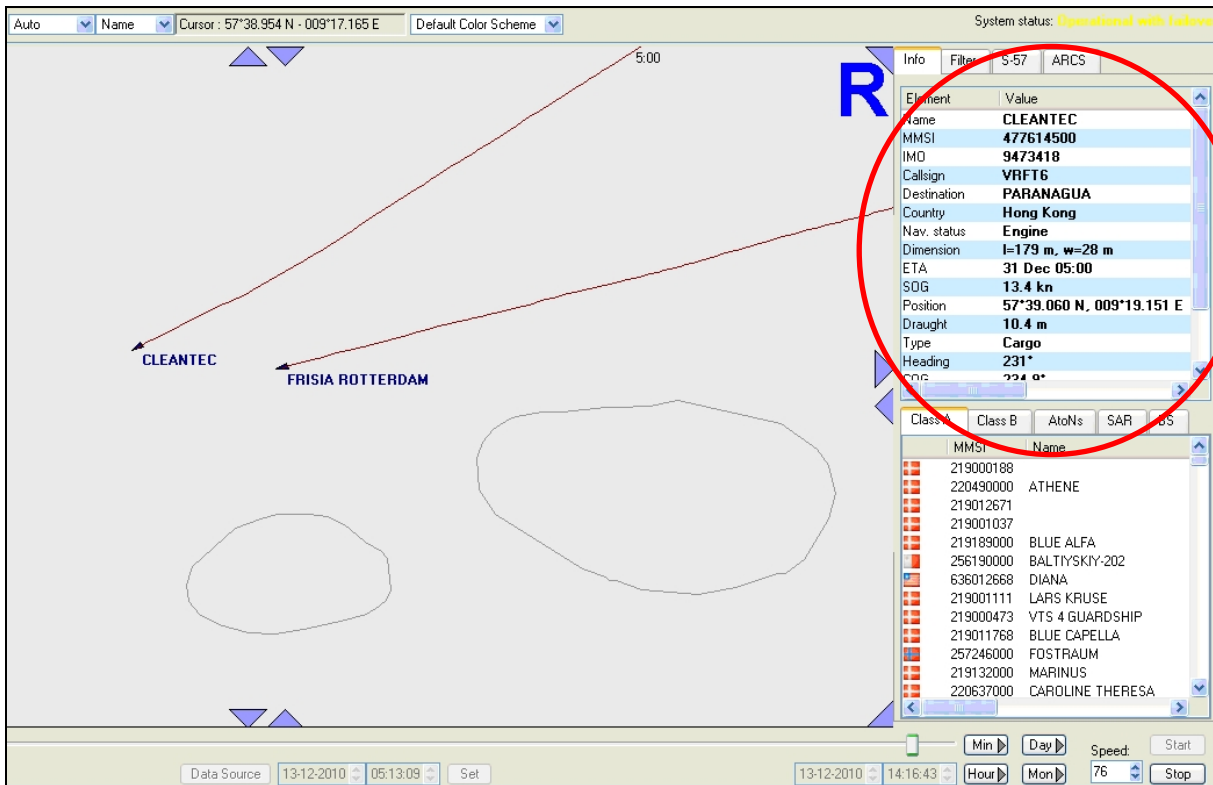
Figure 12: AIS recording of 051309

The following figures illustrate the sequence of events surrounding this collision. Figure 12 shows how the course lines of the two vessels continuously converge at 0513. A change of course and speed by either vessel is not recorded up until the collision at 0518.
