Bundesstelle für Seeunfalluntersuchung
Federal Bureau of Maritime Casualty Investigation
Federal Higher Authority subordinated to the Ministry of Transport,
Building and Urban Development

Investigation Report 286/10

**Collision between the CMV NAVI BALTIC and the
sailing vessel J.R. TOLKIEN on the
Kiel Canal at
Kilometre 90.5 on 12 July 2010**

1 March 2011

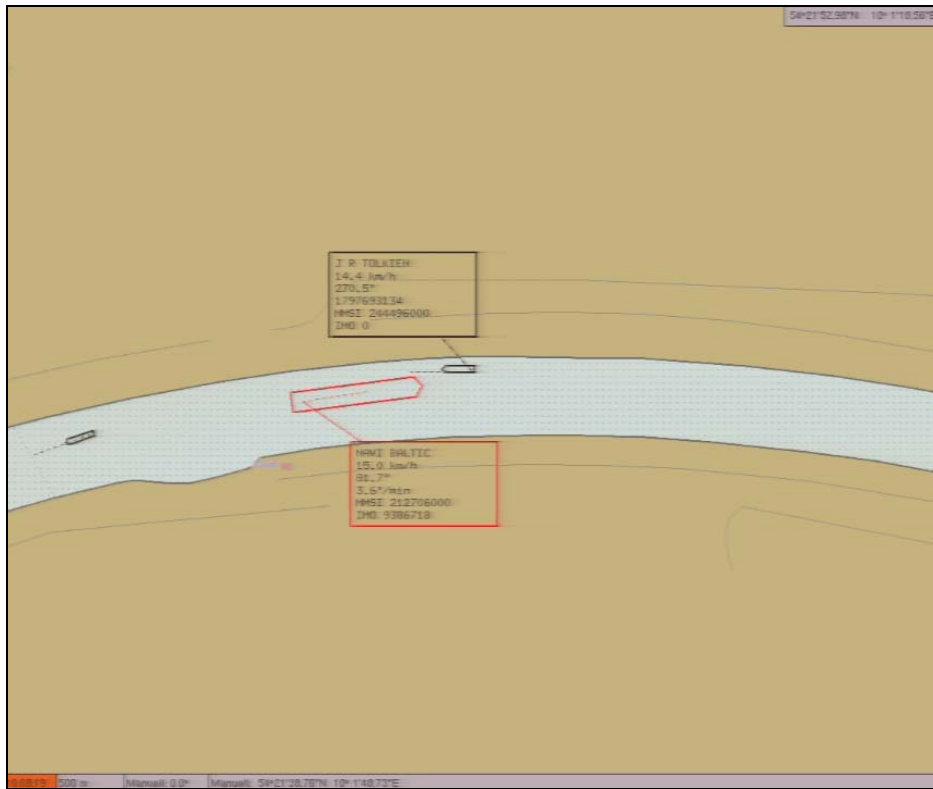
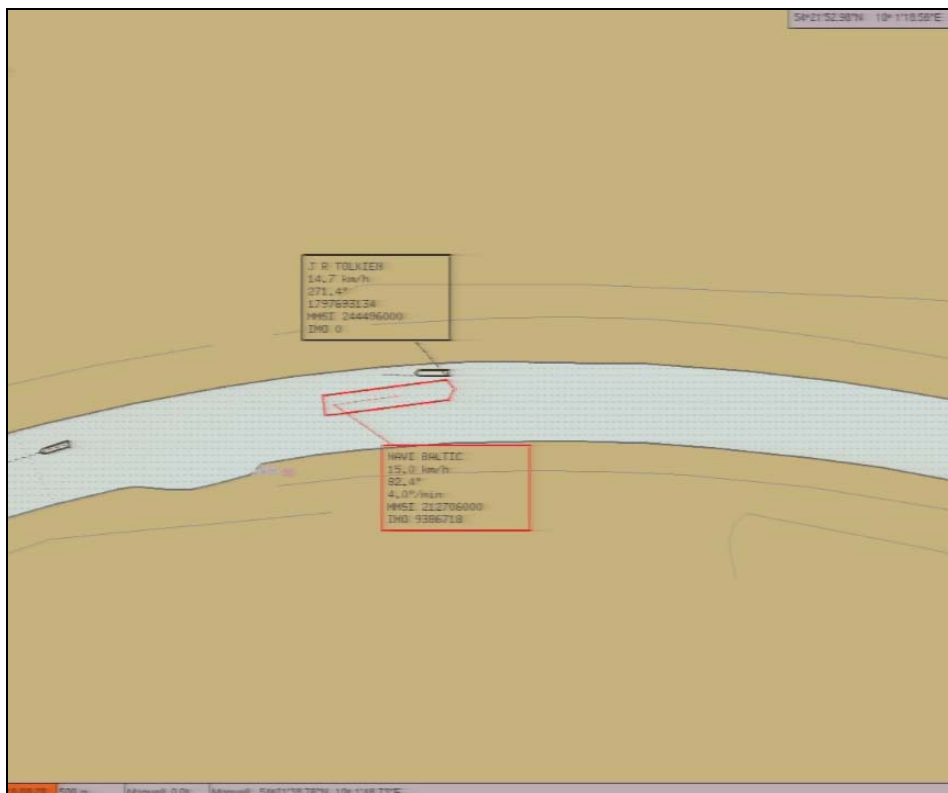
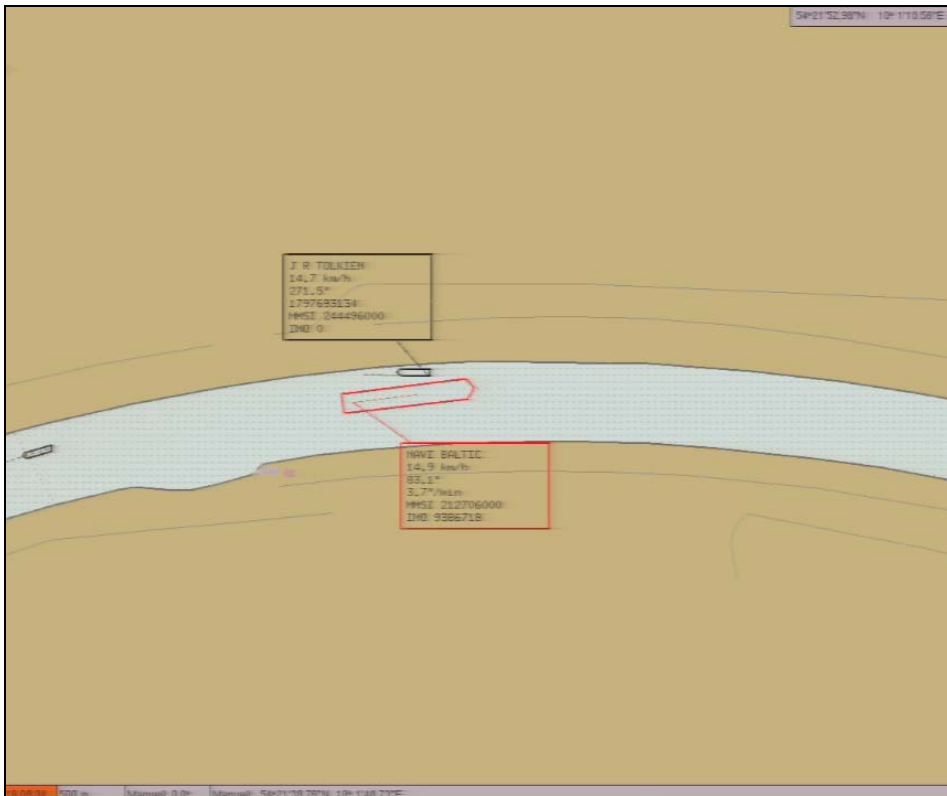
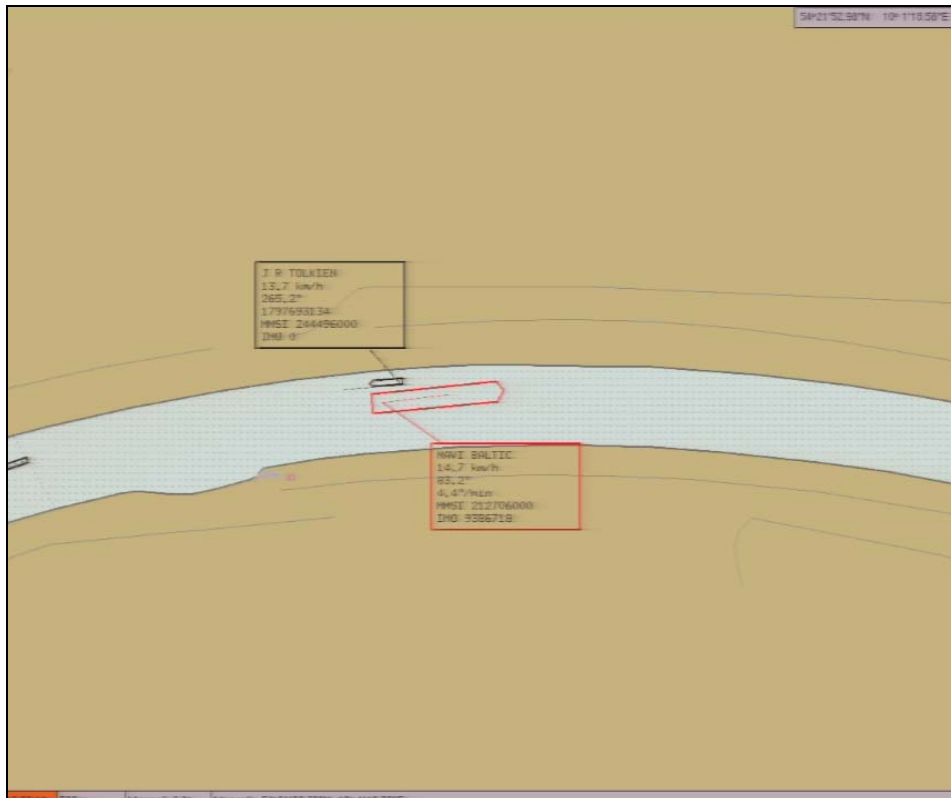
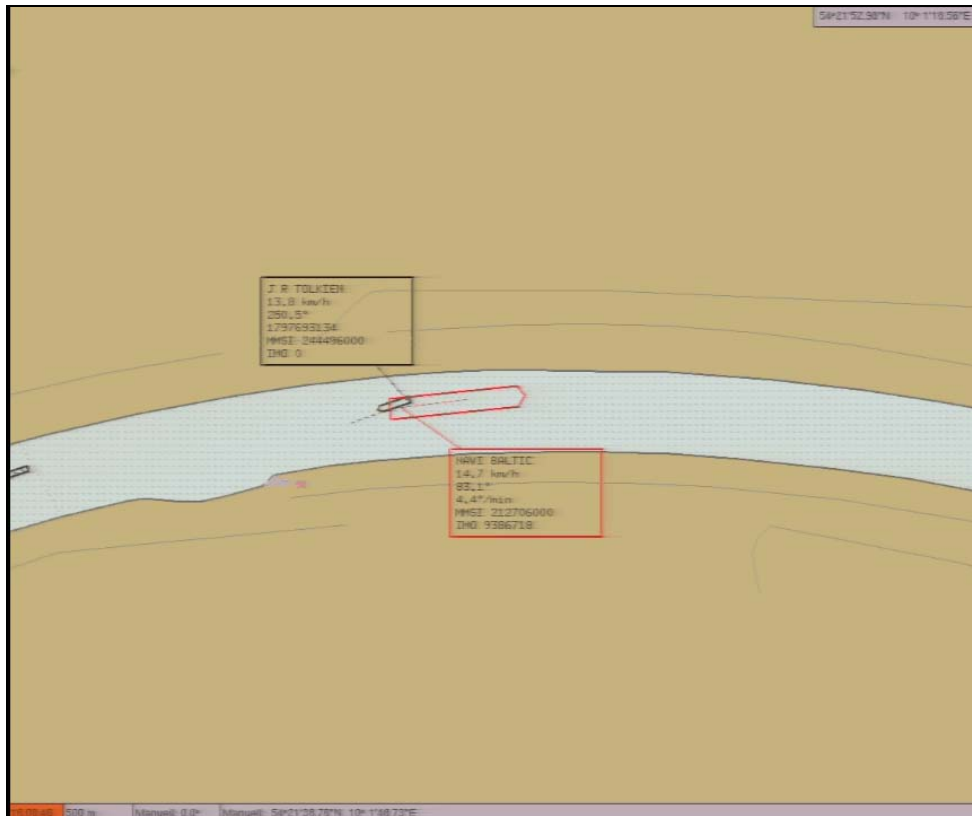
Figure 4: AIS data recording

According to the recorded AIS data, a collision did not take place or occurred only at the aft section of the CMV NAVI BALTIC (see last image). Therefore, as has been the case in other marine casualties on the Kiel Canal investigated by the BSU, the AIS recordings are only evaluable to a certain degree.

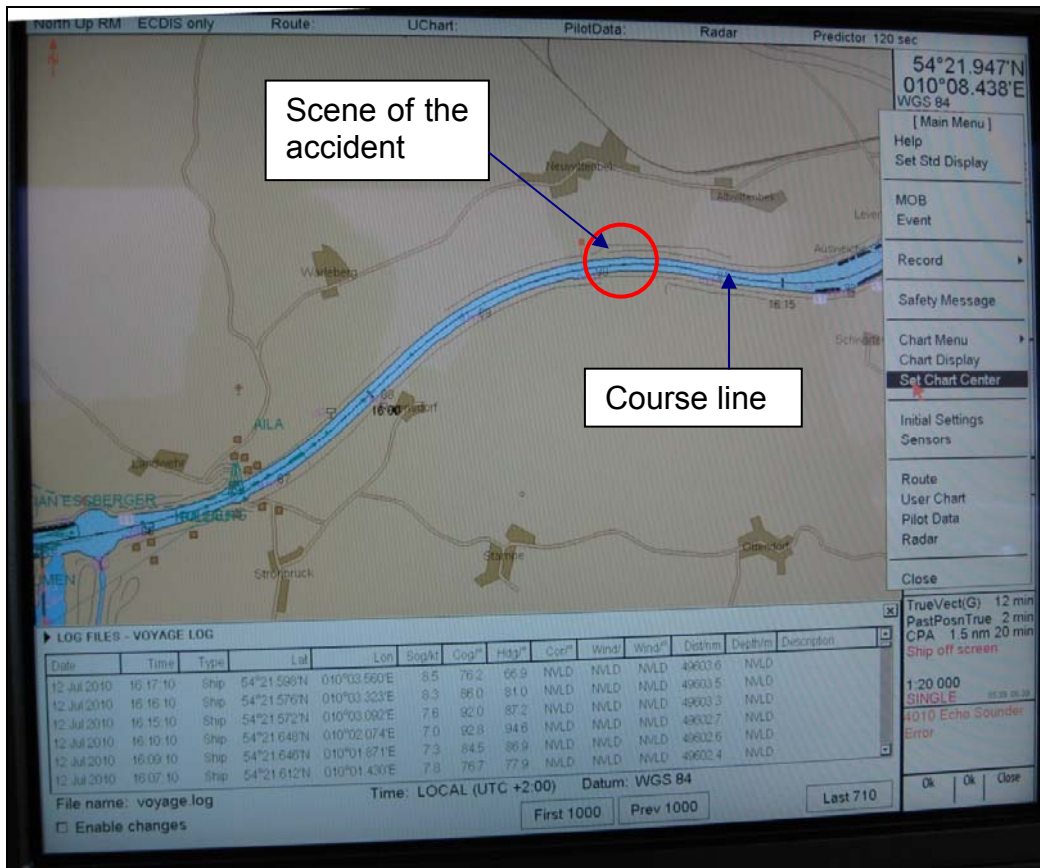
Figure 5: Electronic chart of the CMV NAVI BALTIC

According to the recorded course line above, the CMV NAVI BALTIC proceeded along the middle of the canal trough. Recordings of the electronic chart on board the J.R. TOLKIEN are not on hand.

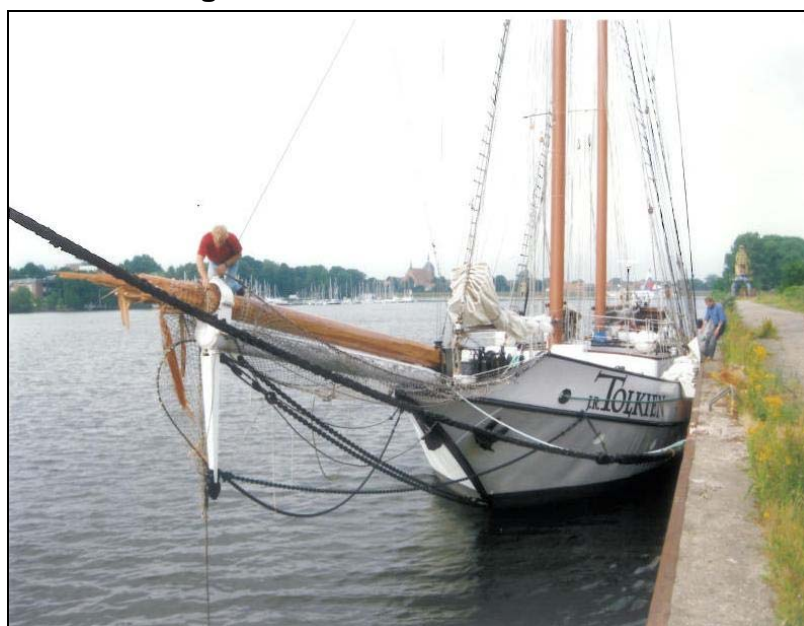
Figure 6: Damage to the J.R. TOLKIEN

The J.R. TOLKIEN was surveyed by the WSP (waterway police) and the Ship Safety Division in the Upper Eider port and the damage recorded. The survey revealed that the wooden jib boom was completely broken off, the bowsprit was bent and the bulwark and frames were buckled at several points on the port side and heavily compressed.

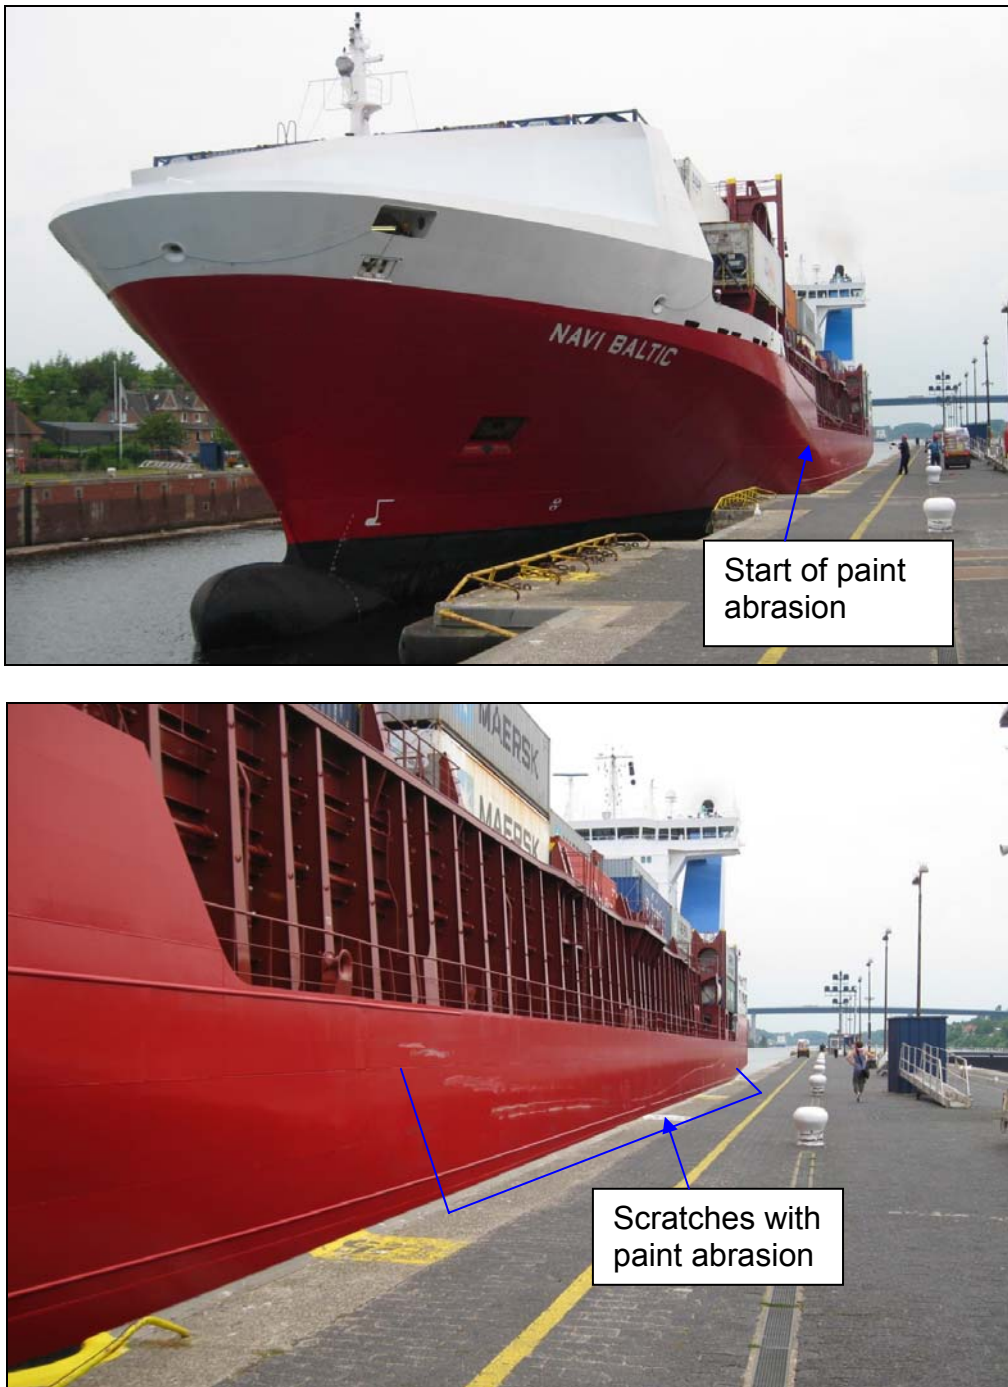
Figure 7: Damage to the CMV NAVI BALTIC

The CMV NAVI BALTIC was surveyed in the locks at Kiel. On the port side there was only paint abrasion stretching for about 120 m on the hull; this started about 40 m from the stem and ran to aft to the beginning of the superstructure.

Based on the damage configuration, this statement does not seem plausible. The first paint abrasion on the shell plating of the CMV NAVI BALTIC occurred on the forward section of the vessel, ahead of the parallel midship; therefore, hydrodynamic suction is not solely responsible for this accident. When the J.R. TOLKIEN changed course to port she must have still been influenced by the bow wave in a position where attracting forces were not yet evident. It is more likely that the J.R. TOLKIEN, which was proceeding at her maximum speed of 8 kts, came too close to the northern bank, moved away from there and as a result of too hard or the incorrect rudder manoeuvres moved across to the middle of the canal towards the approaching vessel. As such, the serious marine casualty was presumably caused by a steering error on the J.R. TOLKIEN.

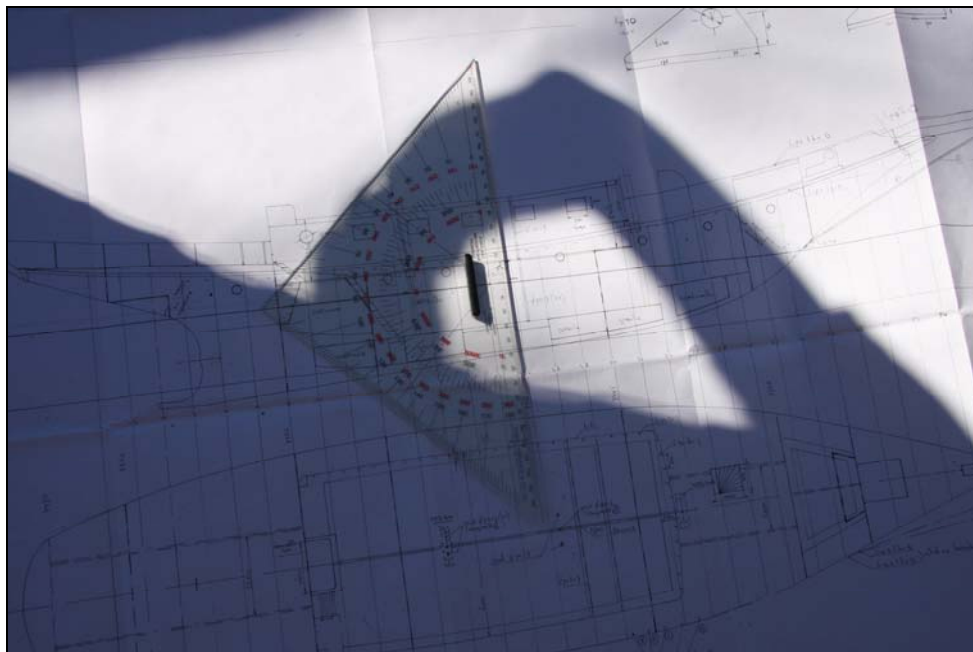
Figure 9: Construction sketch from aboard

The vessel was no longer fully equipped at the time since all the head gear from the forward section, e.g. bowsprit and jib boom, was taken ashore for repairs. By measuring the freeboard at the shipyard, the BSU established a draught of 3.30 m at the stern, of 2.70 m at the freeboard mark, and of 2.45 m at the bow. The BSU concludes that if all weights were brought back on board, then the vessel would, at any event, have had a maximum draught at the rudder heel of more than 3.10 m on the day of the accident.

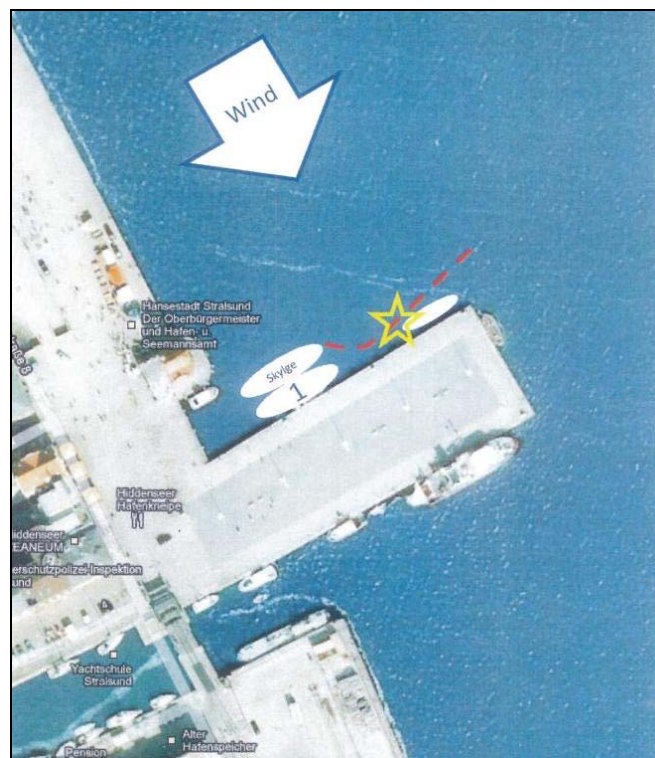
Figure 14: Sketch of the accident by the owner of the MY SPUTNIK 2¹²

According to the above sketch and statements by the crew members of the MY SPUTNIK 2, it is apparent that the master of the SKYLGE underestimated the onshore wind or did not manoeuvre sufficiently clear of the other vessels. Statements by the crew members of the SKYLGE were not available, meaning it was not possible to determine whether any technical problems, gaps in experience/qualification, or simply navigational miscalculation of the overall situation caused the marine casualty.

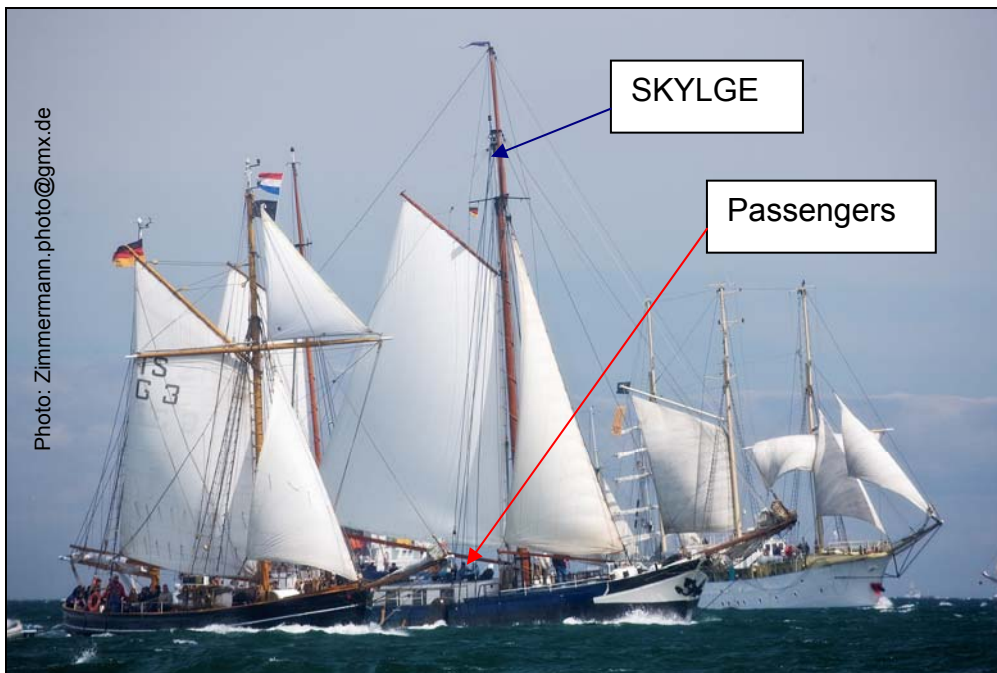
Figure 15: Kiel Week Parade 2009

There was no information with respect to safety management, if present on board the SKYLGE at such events. Regardless of that, when looking at the above photo one must critically question whether positioning passengers on the roof of the superstructure is consistent with conventional seamanship. The above photo is not an isolated case. Photos of other Dutch vessels exist where in parades passengers are also positioned in such a vulnerable, unprotected area.

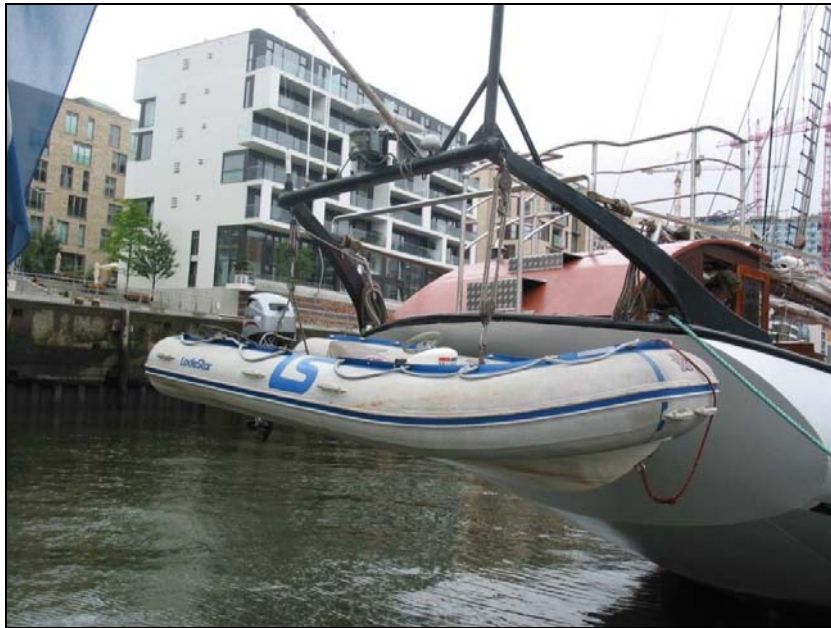
Figure 16: Inflatable boat of the J.R. TOLKIEN

On Figure 16 above, the J.R. TOLKIEN had an inflatable boat for lowering hanging outboard at the stern during the survey by the BSU. This launching device and also the inflatable boat are not approved as a fast rescue boat according to SOLAS, IMO Res. 81(70) and LSA Code, Chapter V, Section 5.1 and Chapter VI.

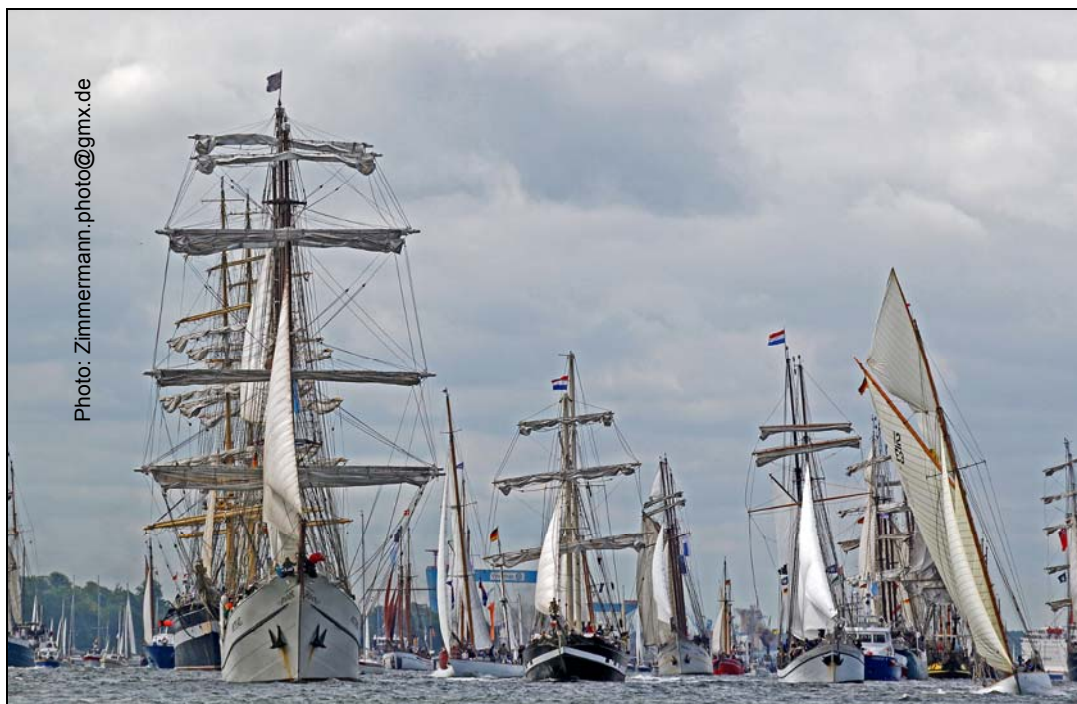
Figure 17: Departure Parade, Kiel 2010

At major maritime events, a departure parade such as that shown above for example, the crew has enough to do with handling the sails, navigating and observing the rules for avoiding collisions. If these vessels are then sailed with only two experienced crew members with, for example, 90 passengers, problems and critical situations are inevitable. Whether used as a passenger ship or as a special purpose ship, the right ratio must prevail between the number of qualified crew members and the number of passengers or the special purpose of the ship. A reduction of experienced crew

members and replacement by passengers, without the definition of criteria for qualification and experience, reduces safety standards significantly.
