Investigation Report 523/10

Serious Marine Casualty

Collision in the Kiel-Holtenau siding

on 28 November 2010

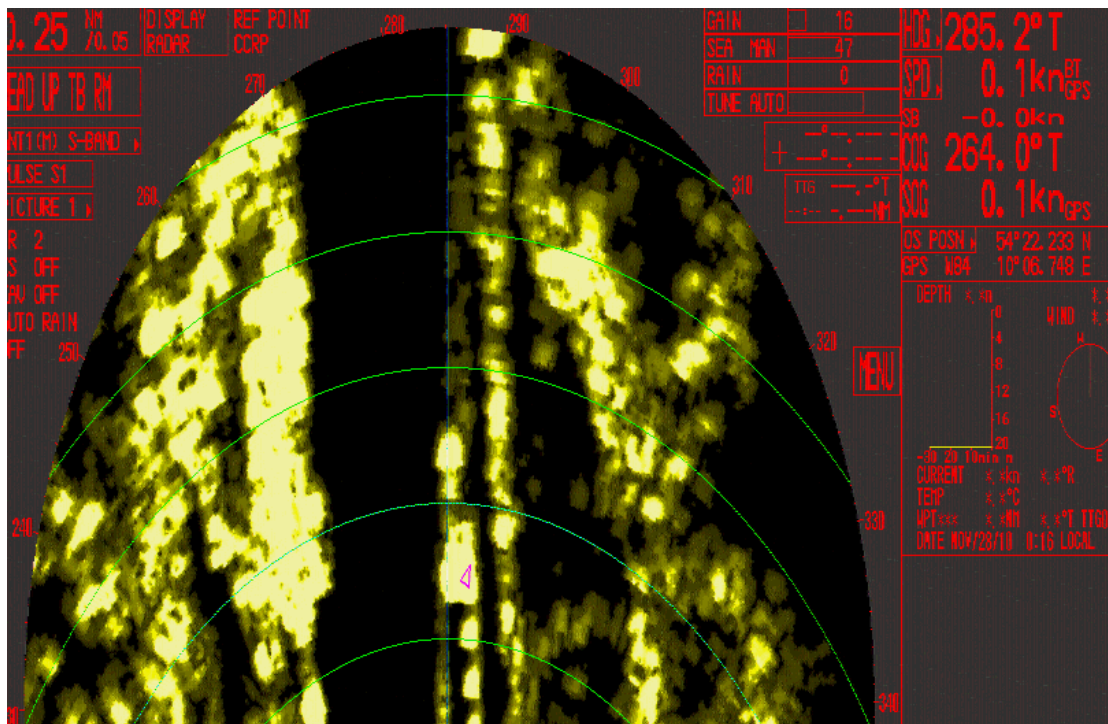
Figure 12: SANDY RICKMERS at 0016, GAS CRYSTAL ahead⁴

Use of the recordings was only limited due to the VDR being improperly installed. The radar images of the port radar system were not fully recorded and are distorted. The area around the radar antenna is absent. For the most part, the audio recordings are incomprehensible. Helm commands cannot be heard. The rate of turn (ROT) was neither recorded in the VDR data nor in the AIS data. The following images show how the SANDY RICKMERS enters the siding at about 3.5 kts and then at first, at a speed of 0.1 kt, first of all stops 1 cbl behind the GAS CRYSTAL and then veers with a drift of 0.5 kt (s. radar fig. 14 "SB"). GPS was chosen for the speed sensor. It can be deduced from the audio recordings that the planned overtaking manoeuvre of the MALAGA is abandoned at 0012 and it becomes apparent that the CRYSTAL GAS is remaining at the forward row of dolphins. At 0014, the searchlight on the starboard wing is made ready. At 0017, the pilot inquires as to the functioning of the bow thruster, which reportedly did not respond when operated at the conning position. At 0018, the controls of the bow thruster are changed from the starboard wing, where the controls were switched before the lock manoeuvre, to the conning position. During this procedure, the SANDY RICKMERS veers to port and the pilot decides to pass the GAS CRYSTAL (Fig. 13). At 0026, he obtains information from the Vessel Traffic Service (VTS) about the oncoming vessels that could be expected. Following that, the SANDY RICKMERS steers towards the signal mast. The speed at 0031 is 0.1 kt. The BALTICBORG is called and informed that the SANDY RICKMERS was getting under way and converging.

⁴ The distortion and missing areas on the radar image are caused by the faulty installation of the VDR on the SANDY RICKMERS.

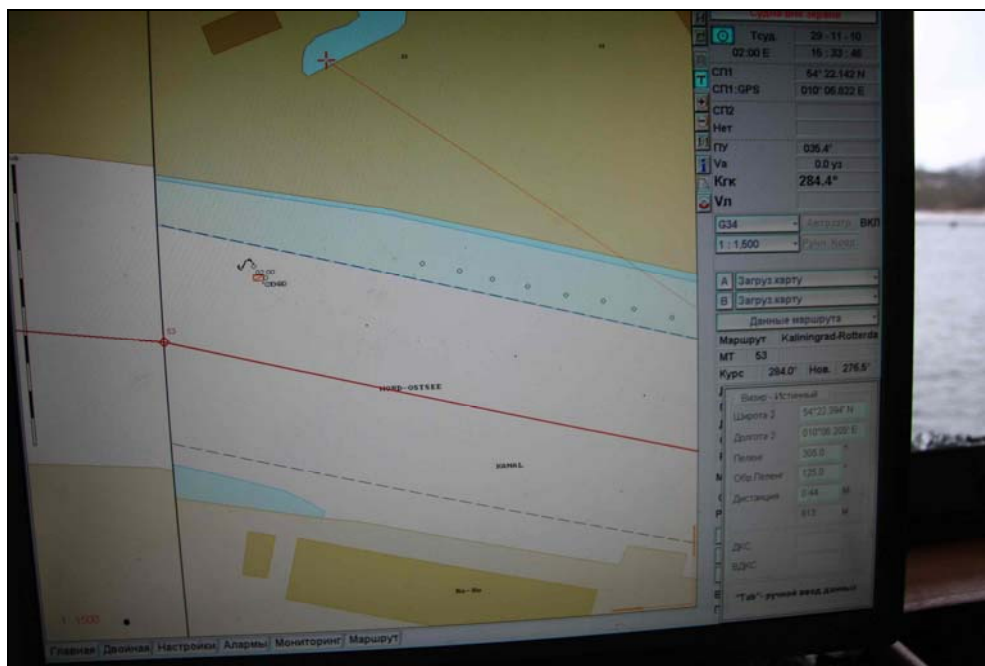
Figure 19: ECS on the MALAGA, collision

in addition to the starboard radar system on a minimum keyboard display (MKD). The GPS position is centred on the ECS, but displayed about 20 m too far forward (Fig. 19). The antenna is entered correctly in the AIS configuration with a location of A = 70m, B = 12m, C = 10m and D = 2m.

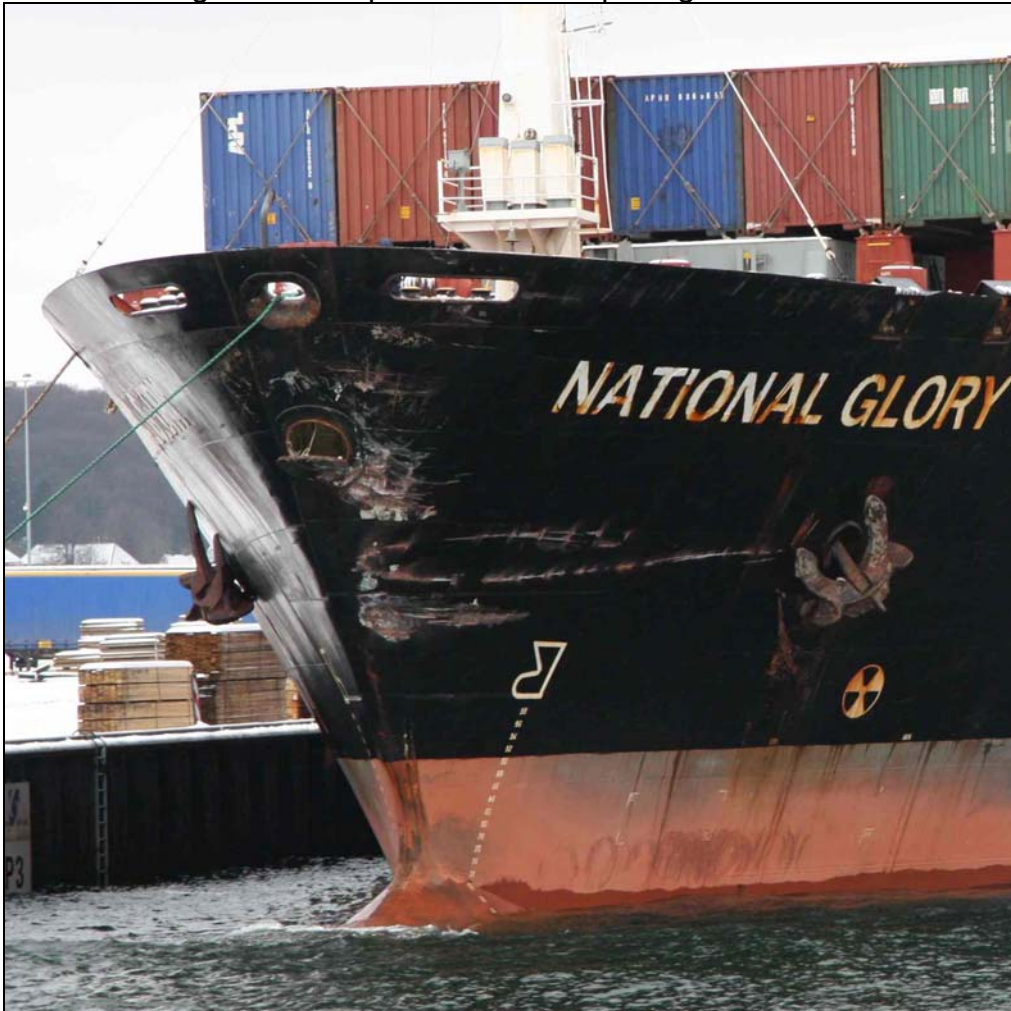
Figure 26: Bow of the NATIONAL GLORY

November 2010. In zone C, 2,450 mm was measured on the suction side and 3,500 mm on the pressure side. It is reported that the damage had been repaired provisionally until the next inspection in dry dock by divers of the Tuukritoode Ou diving company during cleaning work in agreement with ABS. This led to an improvement of 20 mm on the suction side. The bow had damage to the cover of the Suez Canal searchlight and scrapes on the shell plating due to the collision.

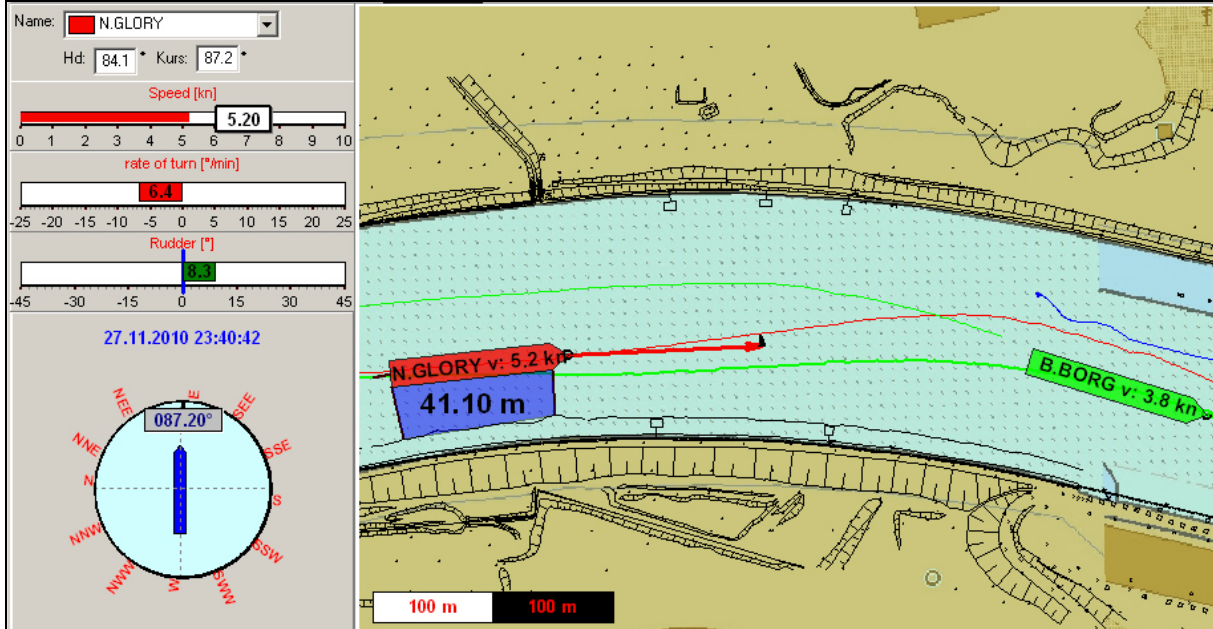
Figure 29: Situation at 004042

After the encounter, from approximately 004042, the distance of the underwater hull to the 4 m contour line is only about 41 m, which, in contrast to the BALTICBORG sailing ahead (about 4 kts), may have led to the NATIONAL GLORY (speed about > 5 kts) being influenced significantly by the bank effect with her stern being sucked in (ROT to port up to about 6.4°/min). From a hydrodynamic perspective, after the

encounter it seems more likely that the bank effect caused the NATIONAL GLORY to change course to port rather than the vessel/vessel interaction with the SANDY RICKMERS.

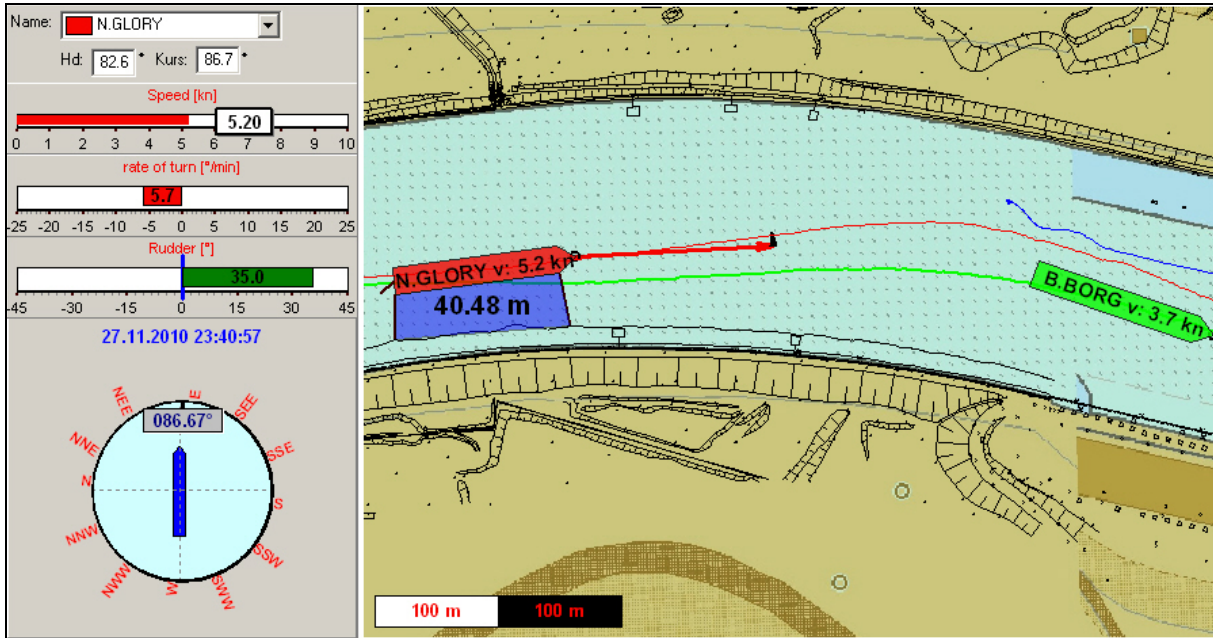
Figure 30: Situation at 004057

At 004057, the NATIONAL GLORY attempts to counteract the bank effect with a full rudder angle. Here, the rate of turn is indicated at 5.7°/min to port.

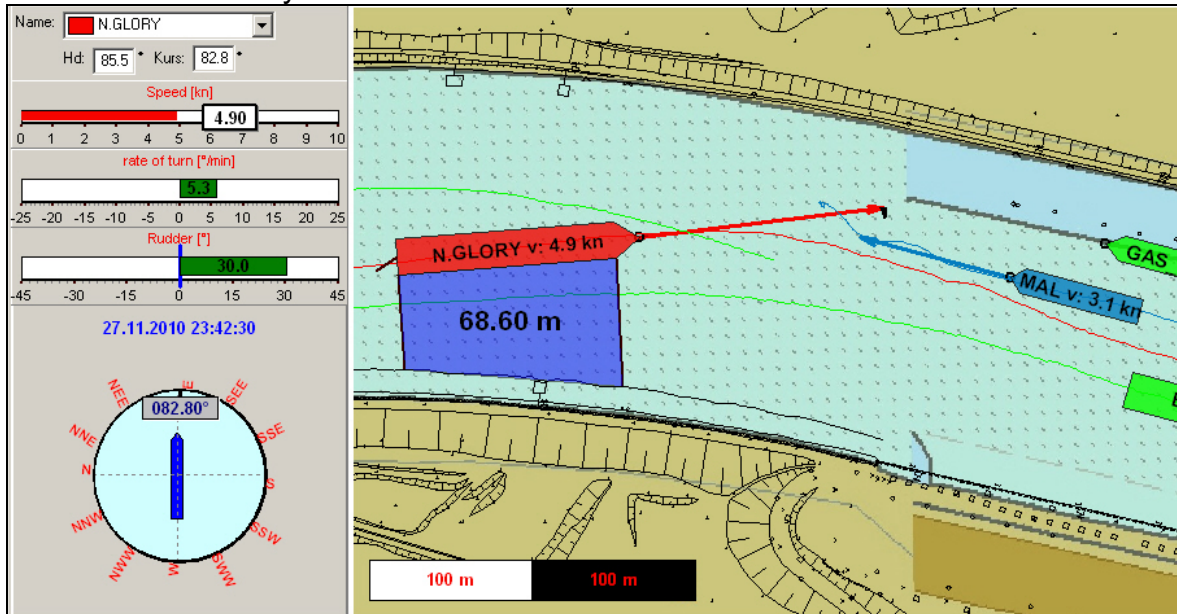
Figure 32: Situation at 004230

Although it was only acted with starboard rudder angles in the final 2 minutes up to 004230 and then up to the collision at 004330, no sufficient rate of turn was developed to pass through the canal bend at Projensdorf without entering the northern side of the fairway. This would, depending on track and selected radius, require a rate of turn of about 10°/min.

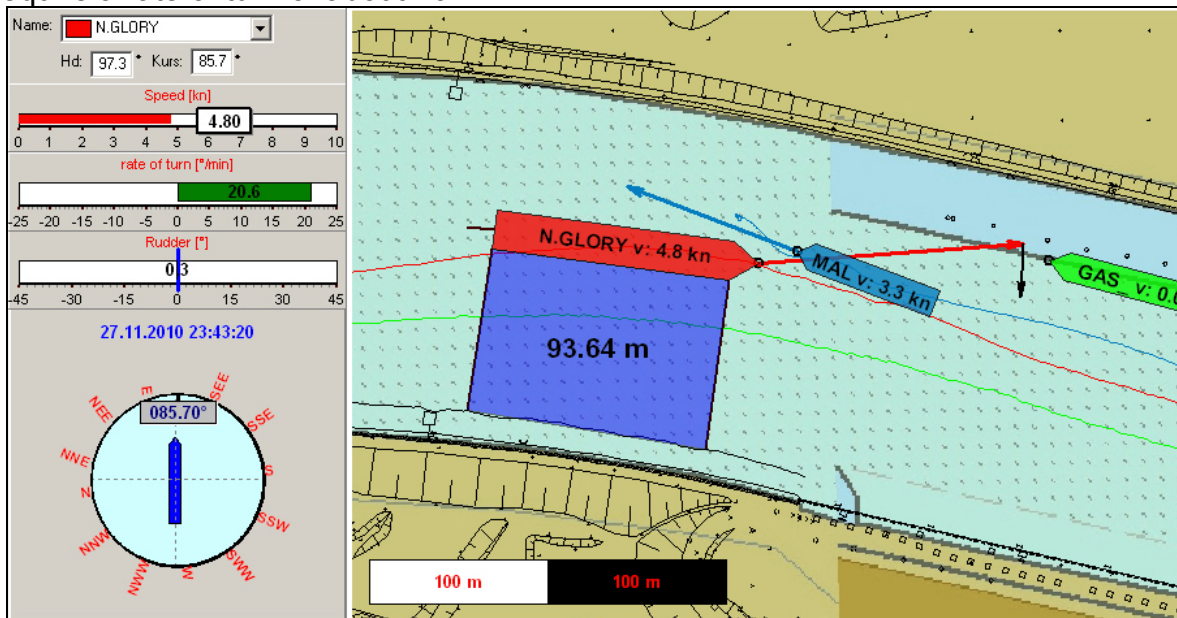
Figure 33: Situation at 004320

At 004320, 10 seconds before the collision with the MALAGA, the NATIONAL GLORY has developed a rate of turn of 20.6°/min and rising. This rate of turn would have probably been enough to just pass the GAS CRYSTAL had the MALAGA not been there.
