Investigation Report 102/11

Serious Marine Casualty

**Collision between the TMV ZAPADNYY and a
floating dock moored on the bank of the River
Weser belonging to the
Fr. Lürssen shipyard after an overtaking
manoeuvre involving the
TMV RHONESTERN and the TMV ZAPADNYY
on 5 April 2011**

15 August 2012

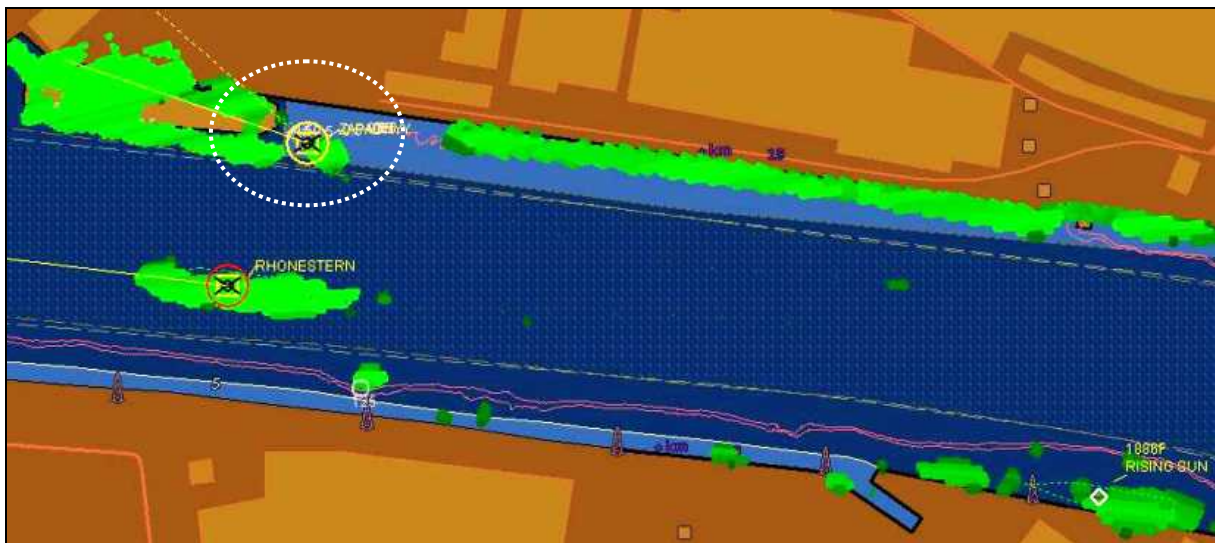
Finally, the engine was reportedly set to 'full astern' to at least soften the collision with the floating dock, which was no longer avoidable. At about 080425, the forecastle of the ZAPADNY collided with the front end of the floating dock, which was moored on the bank of the River Weser and belonged to the Fr. Lürssen shipyard (see **Fig. 10**).

Figure 10: AIS/Radar of VTS Bremen at 080425⁸

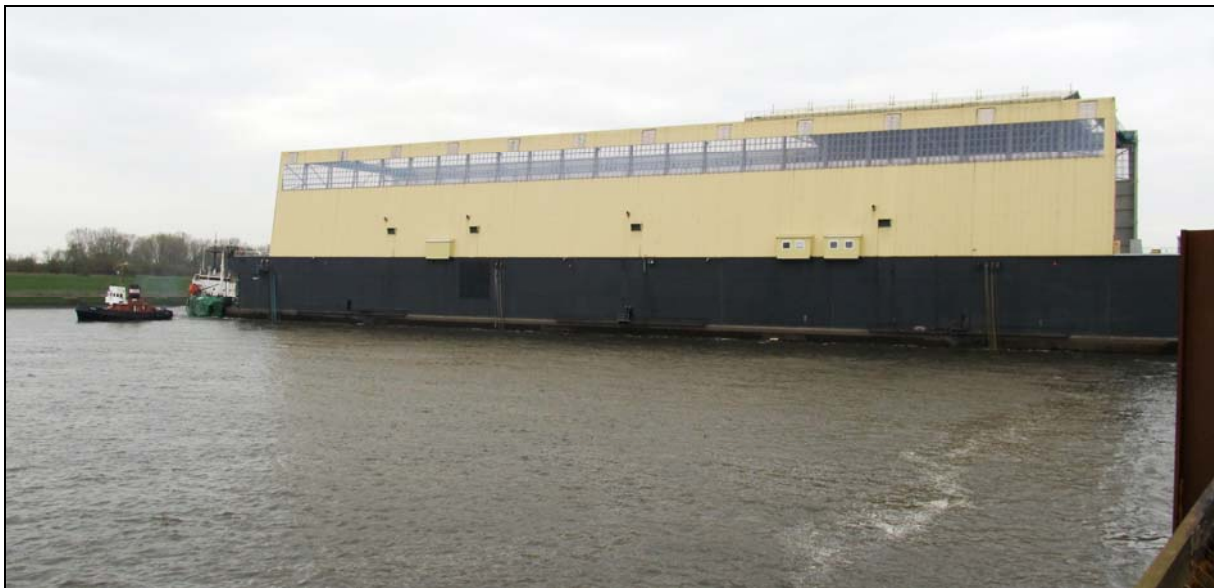
Figure 12: Floating dock lying crossways to the river⁹

⁹ The ZAPADNY is visible to the left at the front end of the dock (see also the following close-up).

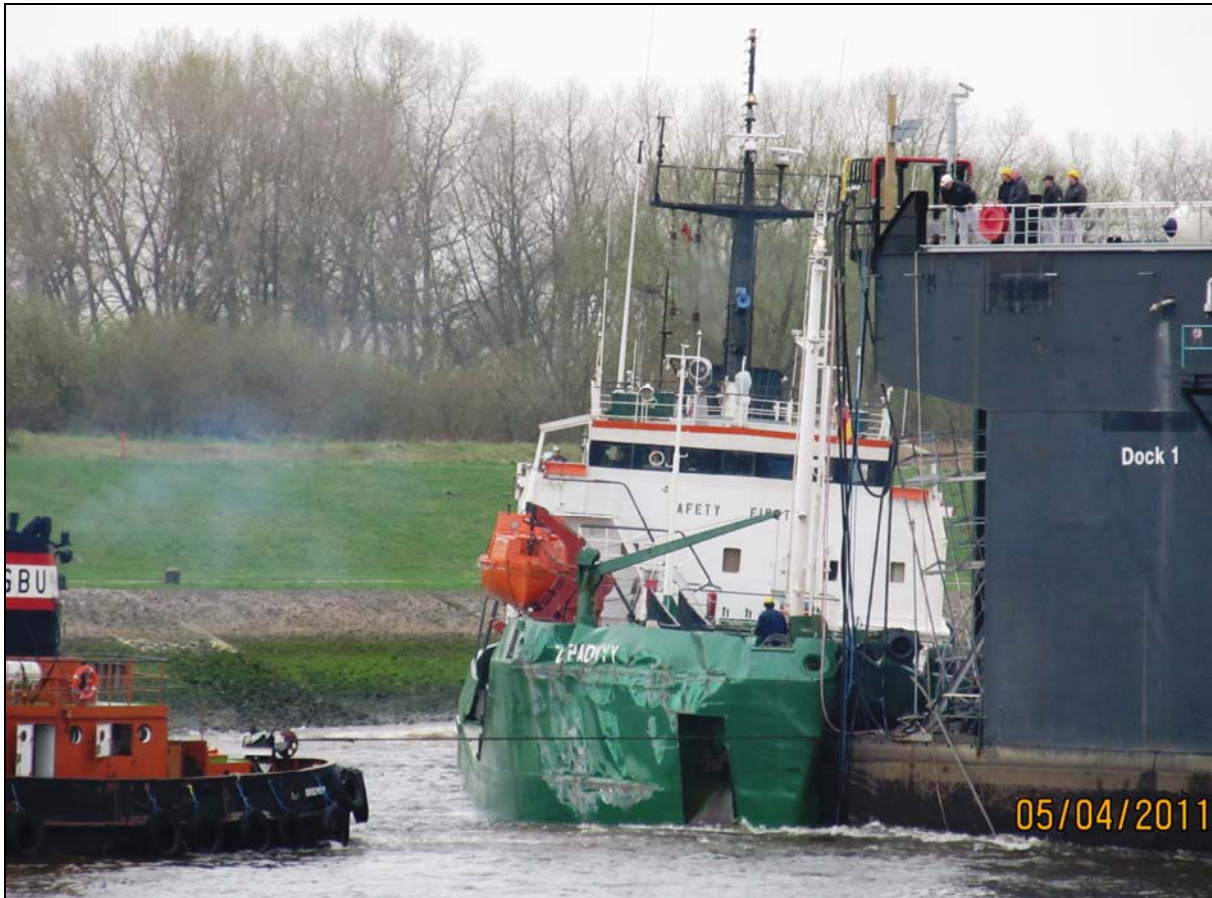
Figure 13: Front end of floating dock wedged into forecastle of the ZAPADNY (1)

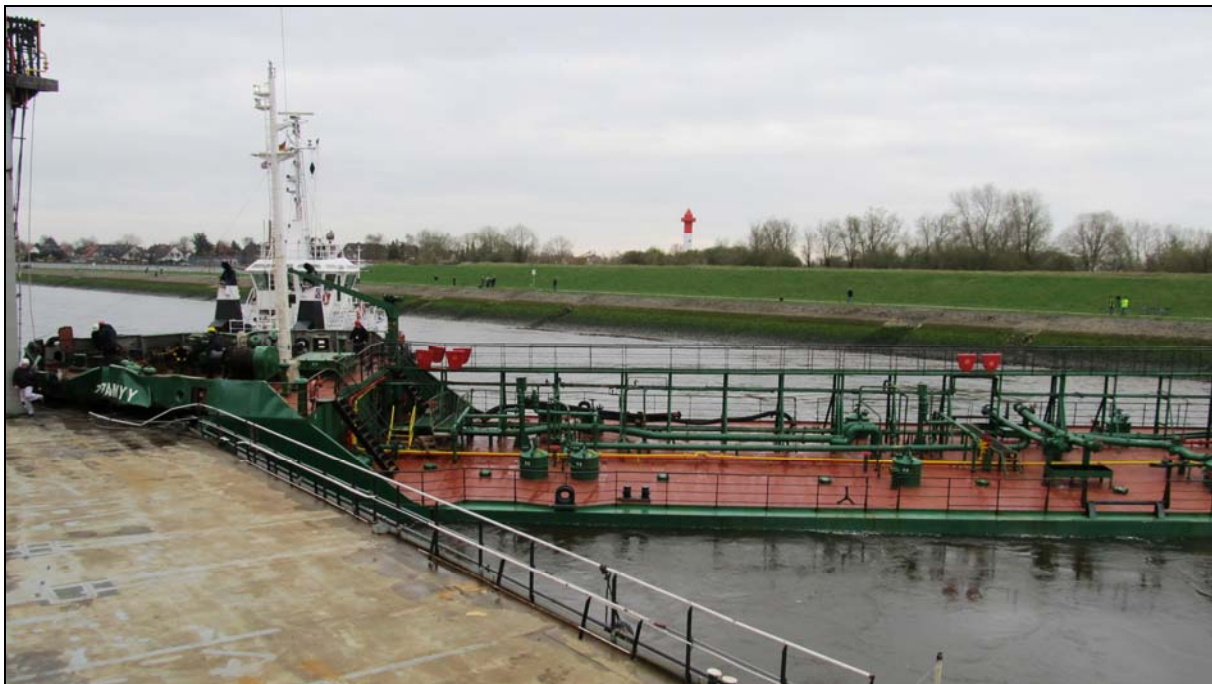
Figure 14: Front end of floating dock wedged into forecastle of the ZAPADNY (2)

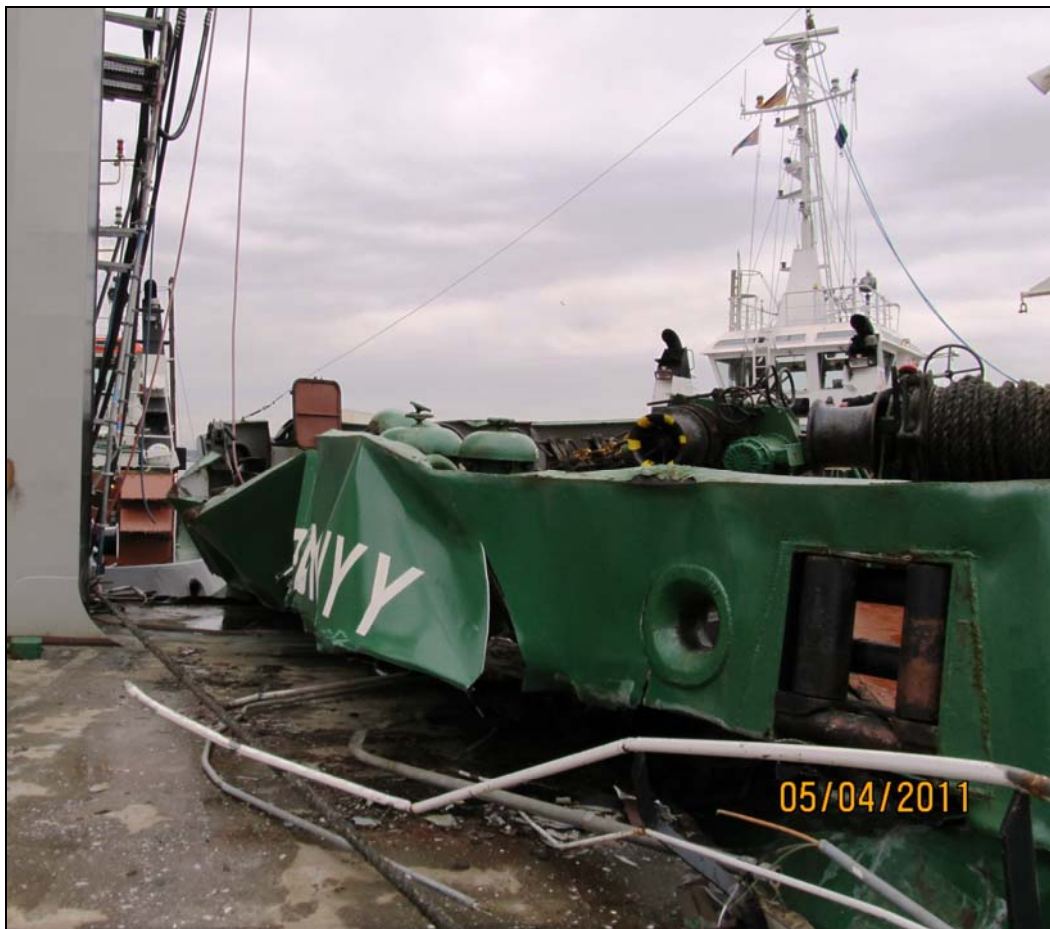
The forecastle of the ZAPADNY was severely damaged above and below the waterline due to the collision with the dock (see **Fig. 15 f**). The vessel took on water. However, the buoyancy of the vessel was not significantly impaired.

Figure 15: Damage to the forecastle of the TMV ZAPADNY (1)

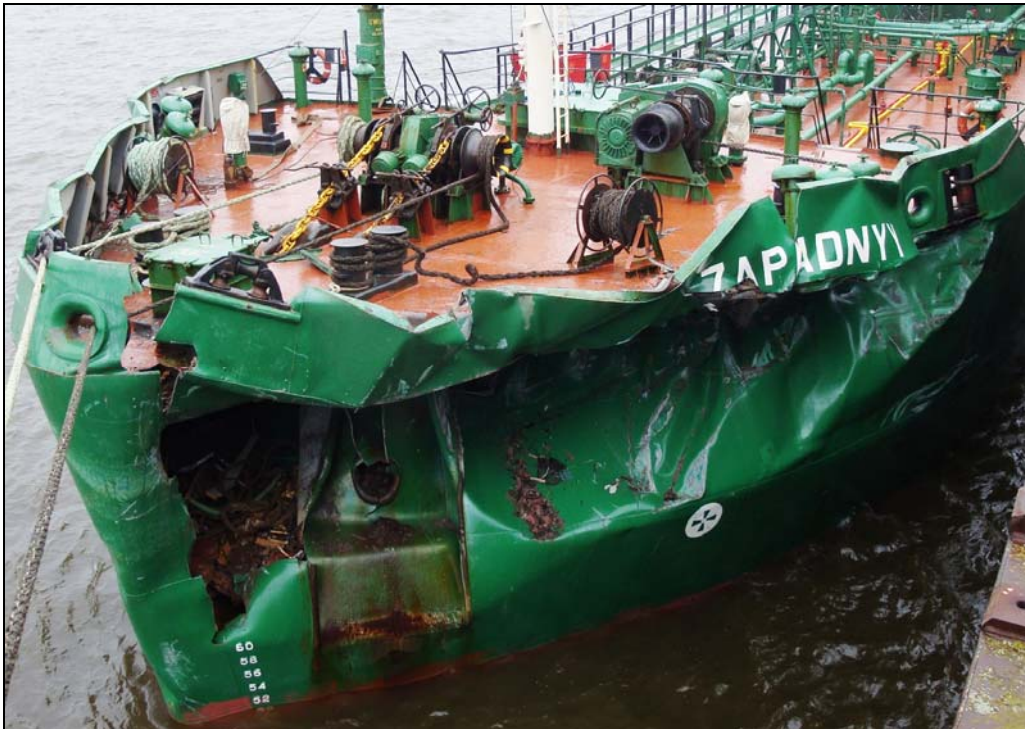
Figure 16: Damage to the forecastle of the TMV ZAPADNYI (2)

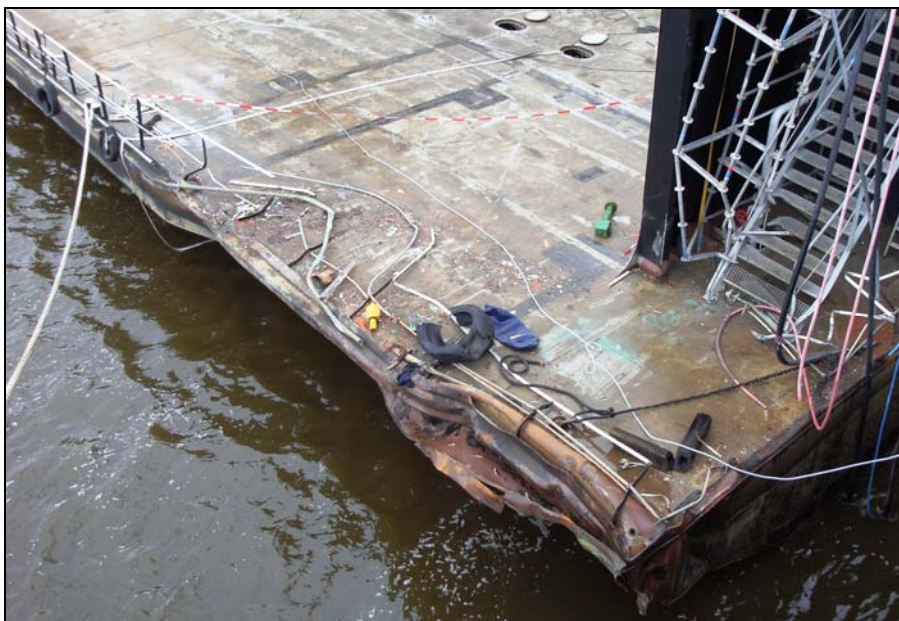
Since there was not vessel in the dock at the time of the accident, the material damage was limited to the empty floating dock. The damage to the dock's floating body was relatively low (see **Fig. 17 f**). The damage in the course of the various shore connection points being torn off (see **Fig. 19 ff**) was significant (to the operational readiness of the dock), however. Furthermore, several access points to the dock, inclusively a crossing bridge and its foundation, were affected.

Figure 17: Damage to the floating dock (1)

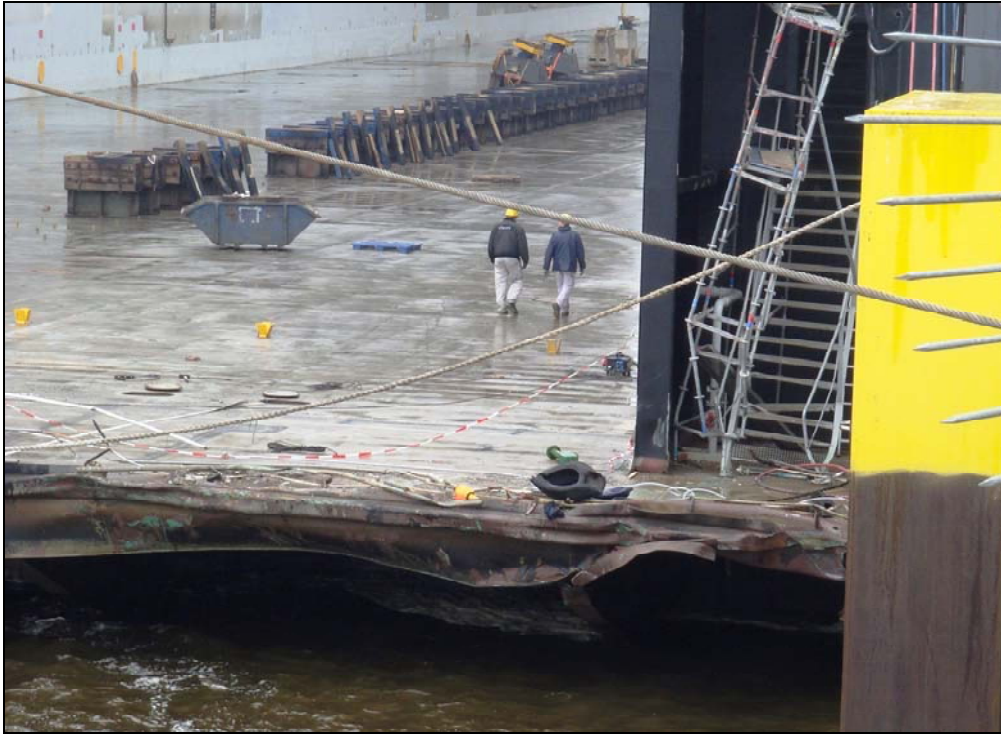
Figure 18: Damage to the floating dock (2)

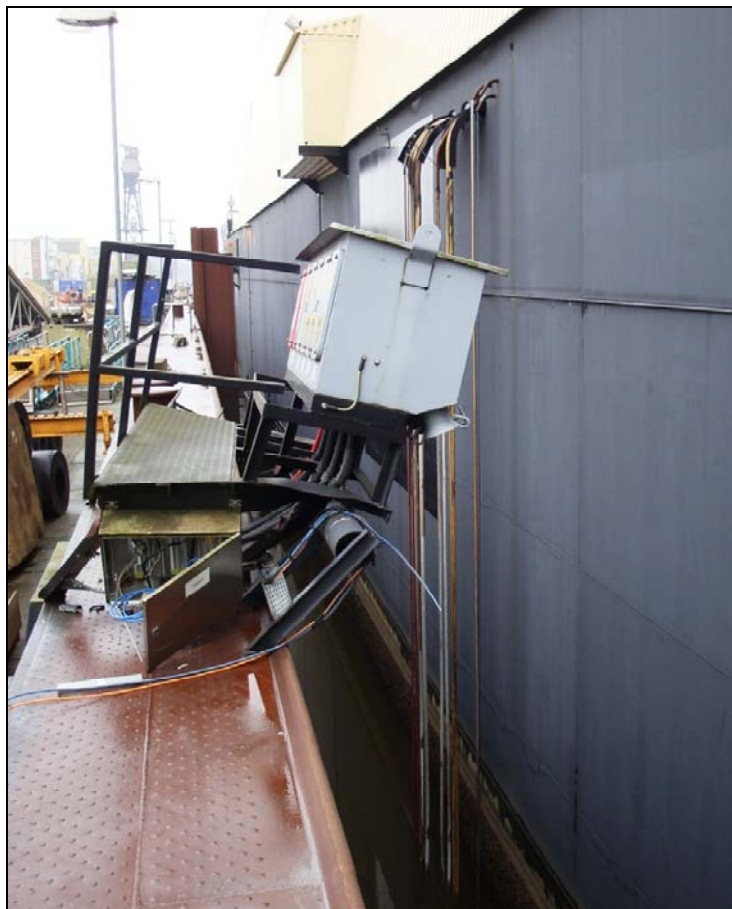
Figure 19: Damage to the shore connection points (1)

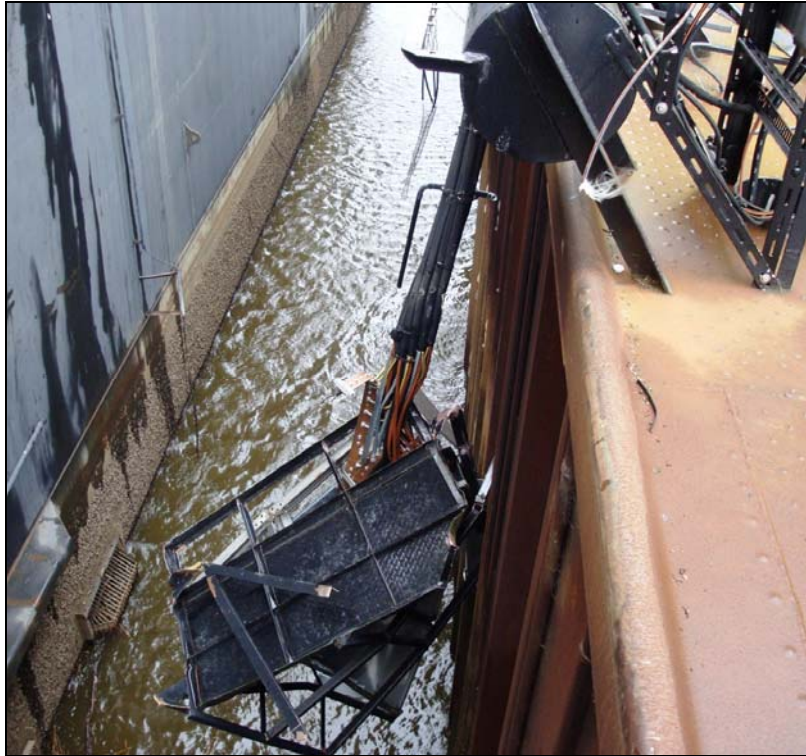
Figure 20: Damage to the shore connection points (2)

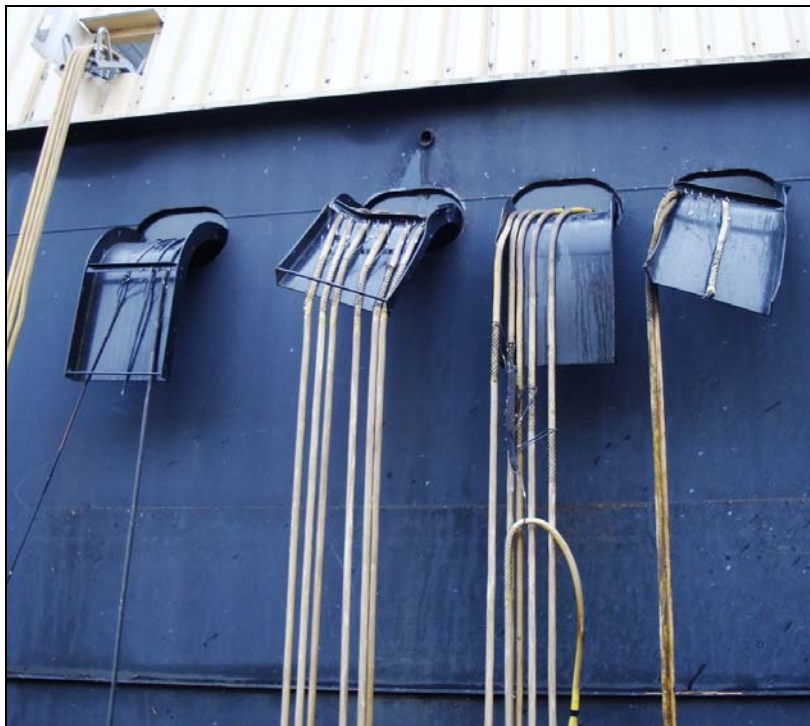
Figure 21: Damage to the shore connection points (3)

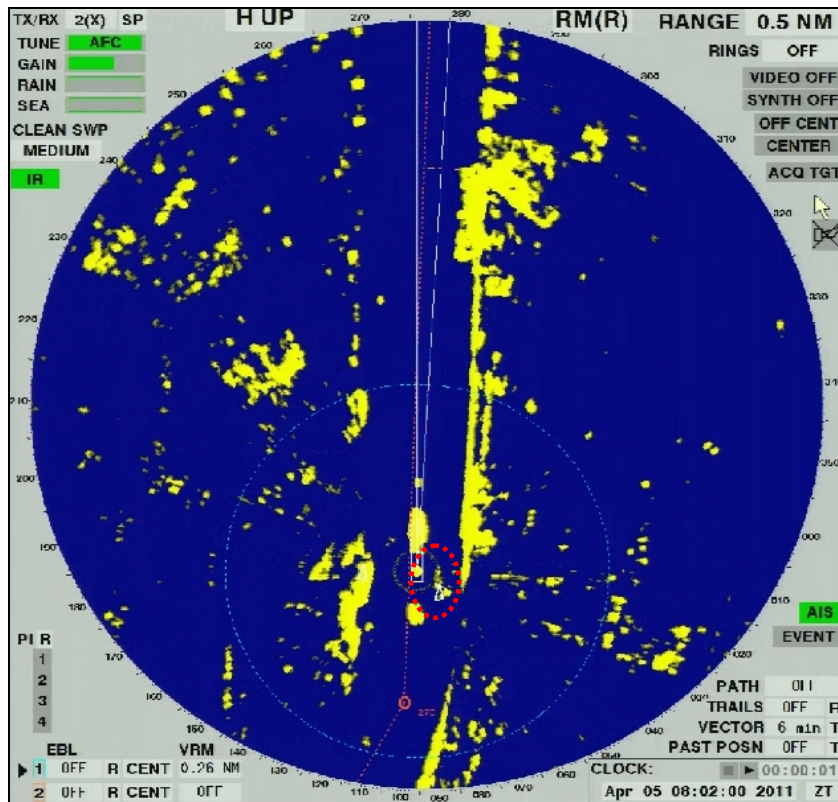
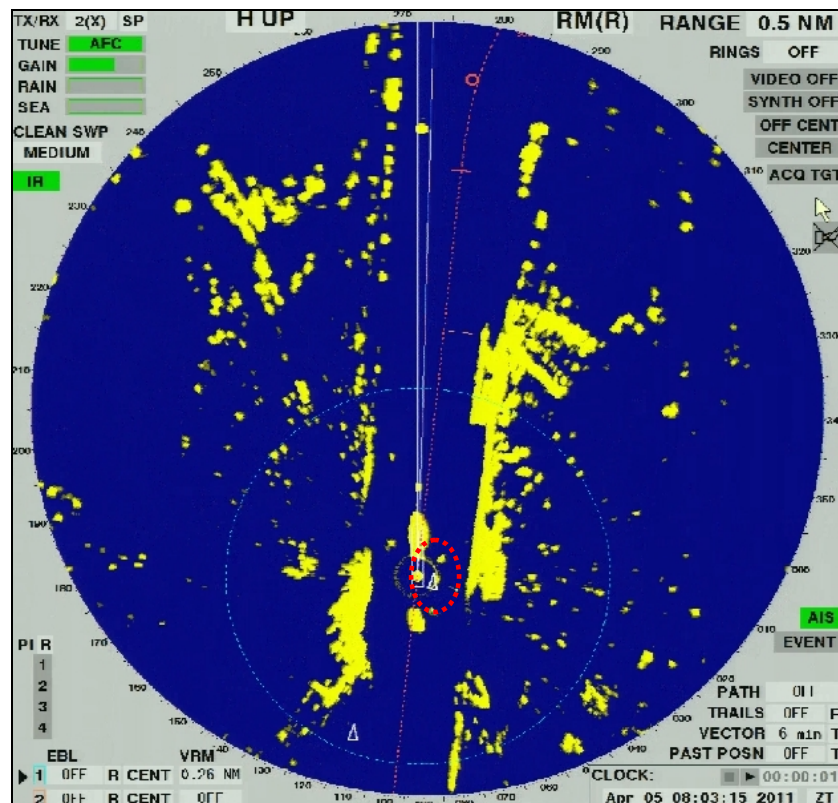
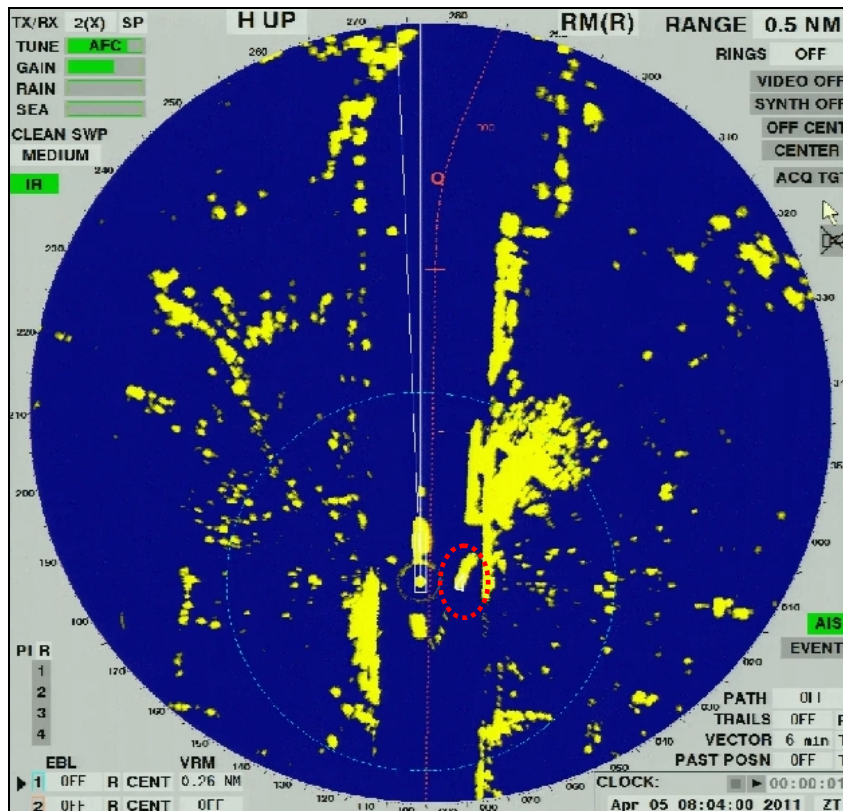
The selected radar images show how the RHONESTERN converges with ZAPADNY. The representation of the radar echoes of the two vessels in **Figs. 27, 28 and 29** implies that the overtaking manoeuvre must actually have been almost completed when the ZAPADNY was suddenly accelerated to port in the direction of the RHONESTERN, before she veered off, apparently out of control, to starboard towards the bank of the river shortly after. Moreover, when looking at the course of the fairway visible on the radar, it also becomes, in particular, very clear that the overtaking manoeuvre was initiated in the area at which the bend at Vegesack starts, that it was executed throughout the radius of the bend, and that the ultimate development of the subsequent accident began at the exit of the bend.
