Investigation Report 140/10

Marine Casualty

**Contact with the embankment by
the MV SONORO and
collision between the MV SONORO
and MT SÜLLBERG
on the Kiel Canal (NOK)
on 18 April 2010**

16. January 2012

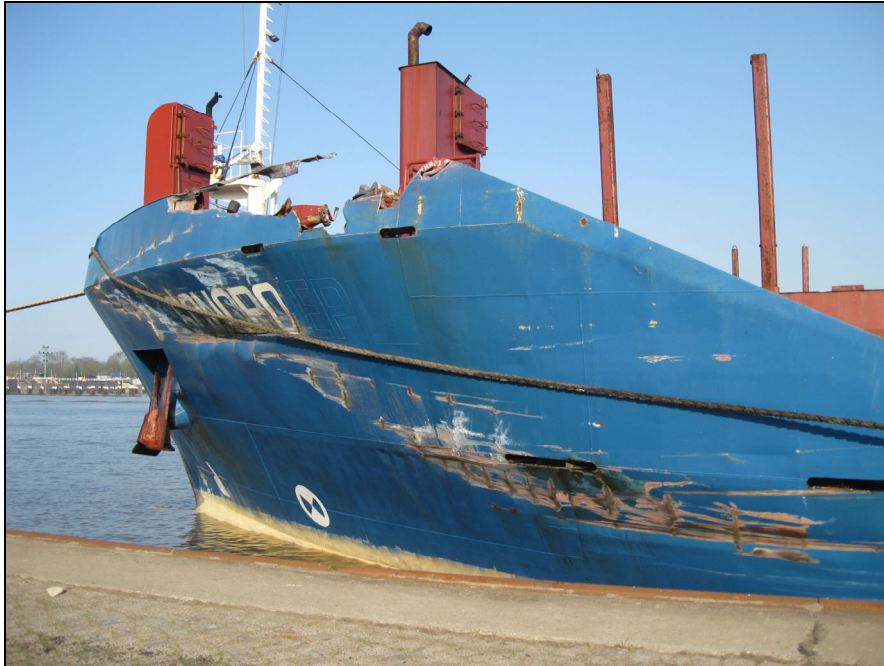
The SONORO sustained damage on the port side of her forecastle due to the collision.

Figure 4: Damage to the bow of the SONORO

The Federal Bureau of Maritime Casualty Investigation recommends that the ship's command of the SONORO and the operator of the vessel review the accident as part of their safety management. Here, the principles to be observed in keeping a navigational watch, conduct in restricted visibility and heavily used, narrow waters as well as navigating with pilot advice should be addressed, in particular.

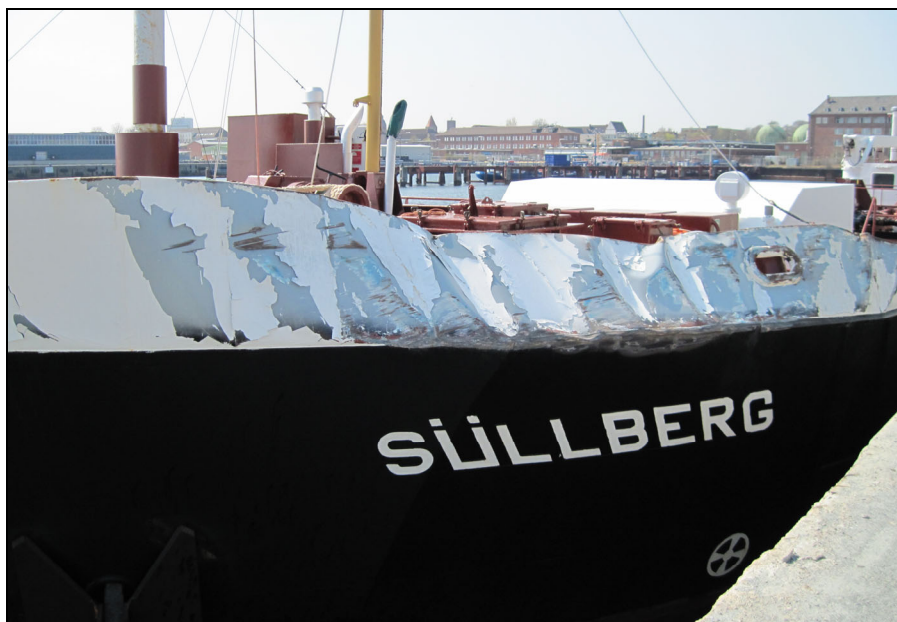
The SÜLLBERG was damaged on the port side of her bow, on her hull in the area of the bulwark and on her superstructure.

Figure 5: Forecastle of the SÜLLBERG

The Federal Bureau of Maritime Casualty Investigation recommends that the ship's command of the SÜLLBERG and the operator of the vessel review the accident as part of their safety management. Here, the principles to be observed in keeping a navigational watch and navigating with pilot advice should be addressed, in particular.

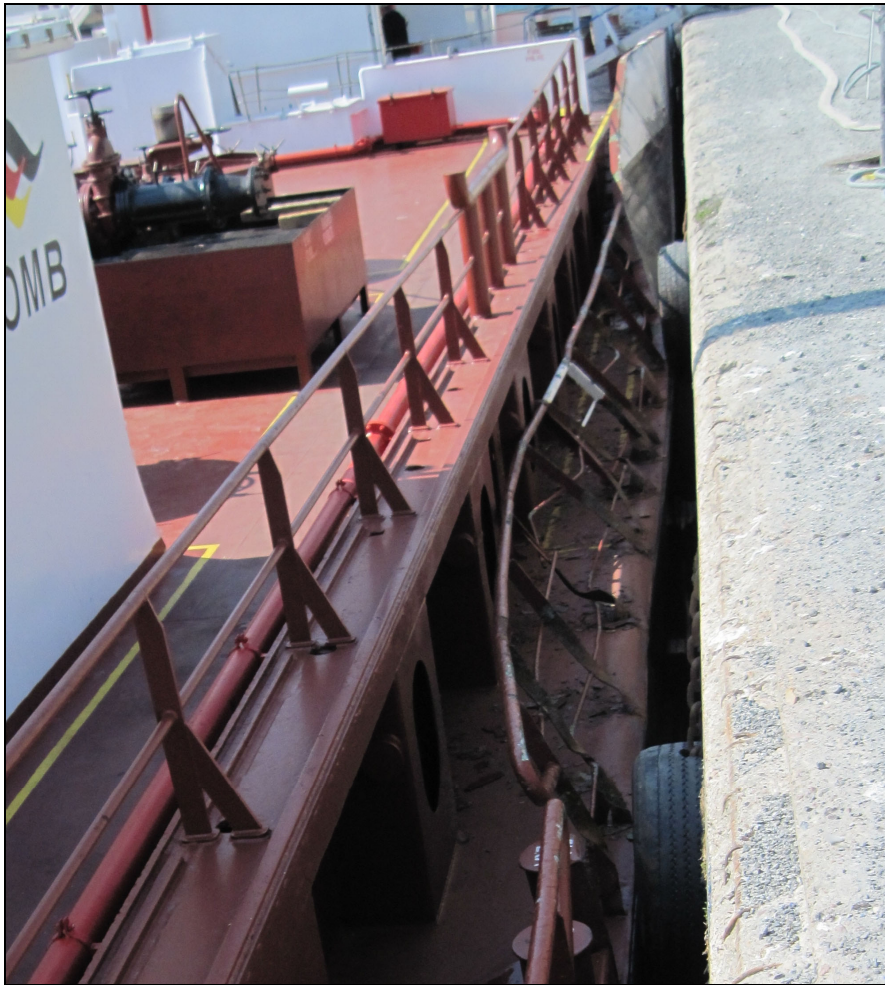
Figure 6: Port walkway of the SÜLLBERG

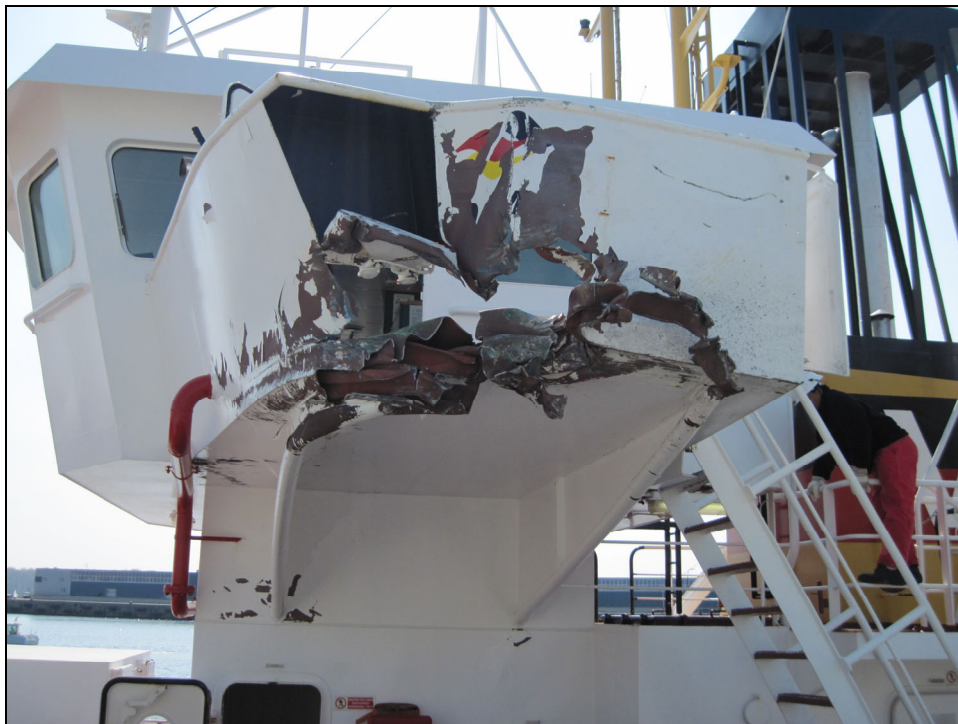
Figure 7: Port wing of the SÜLLBERG

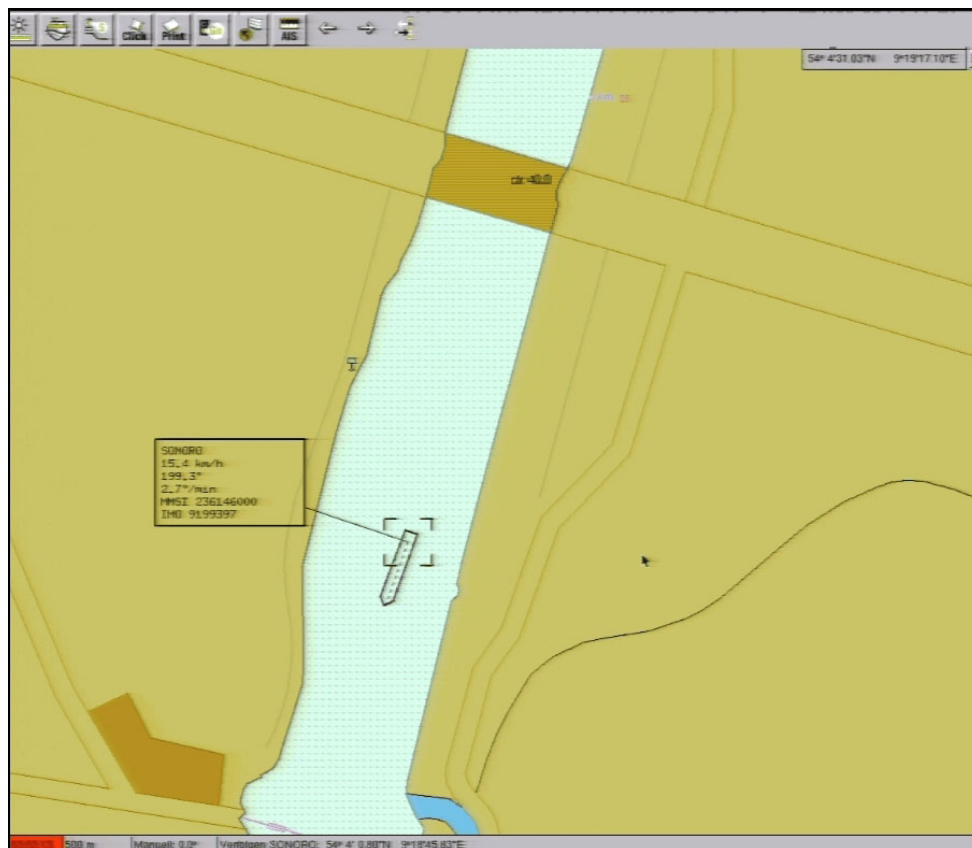
Figure 8: Time: 030313, the SONORO has passed the Hohenhörn Bridge

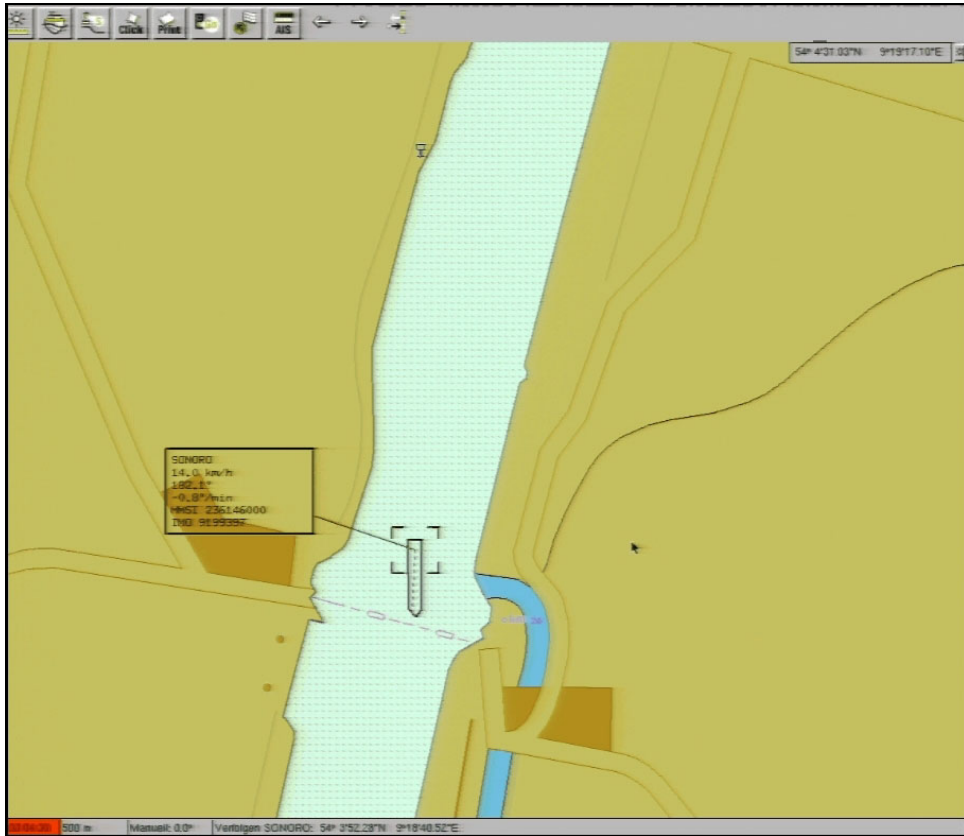
During the sudden change of course to port (figure 9) and the approach with the MARIDA PATEA, there was no communication between the bridge crew except for the request of the pilot to turn on the bow thruster at 030730. Hence, neither helm commands nor recommendations regarding controlling the engine were given. Only at 0310, immediately after contact with the embankment, did the pilot request that the master be informed.

Figure 9: Time: 030430, the SONORO is level with the Hohenhörn ferry

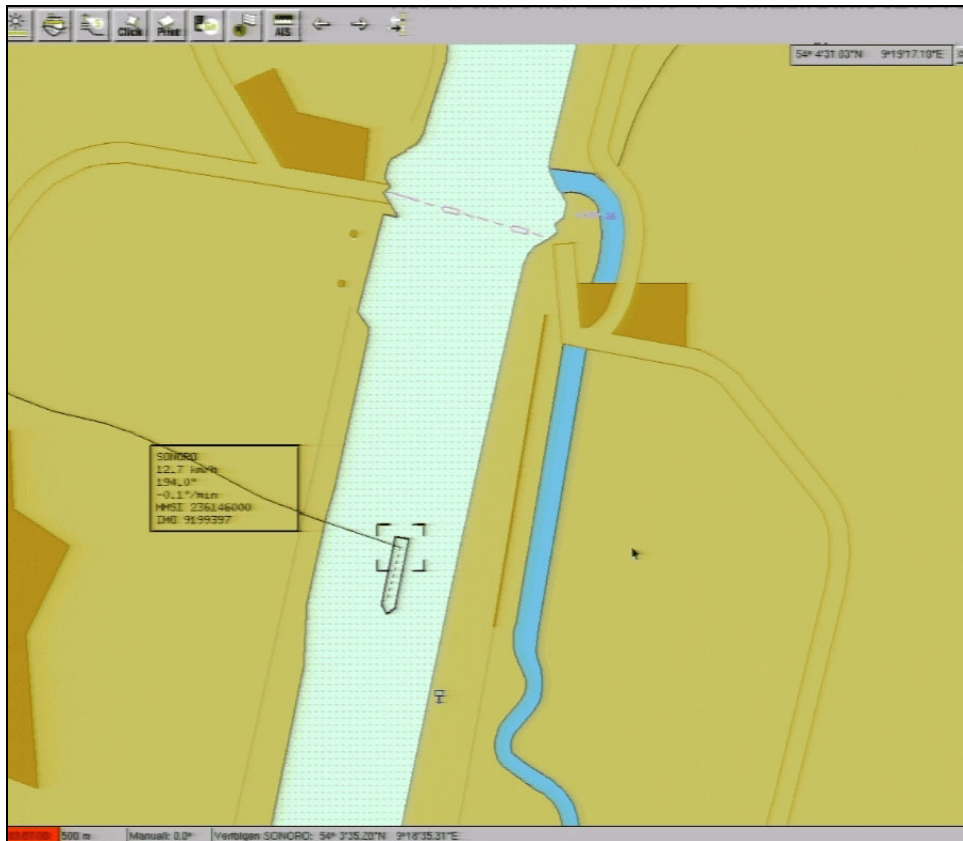
Figure 11: Time: 030700, the SONORO is in the middle of the canal

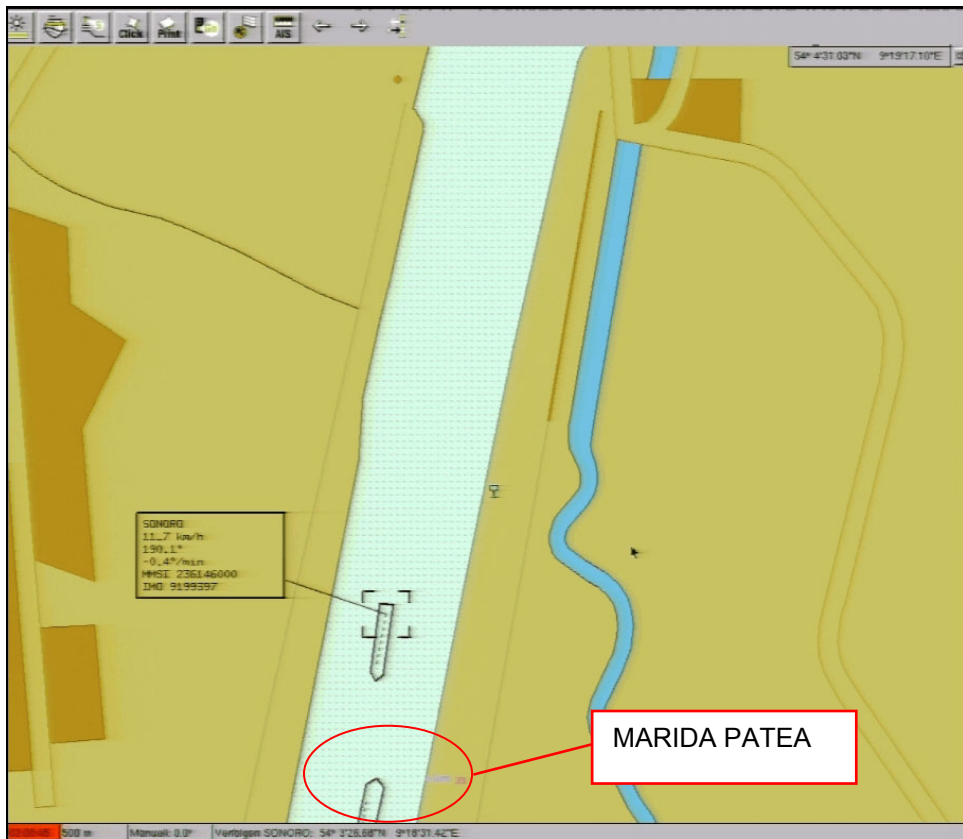
Figure 12: Time: 030845, the SONORO and the MARIDA PATEA converge

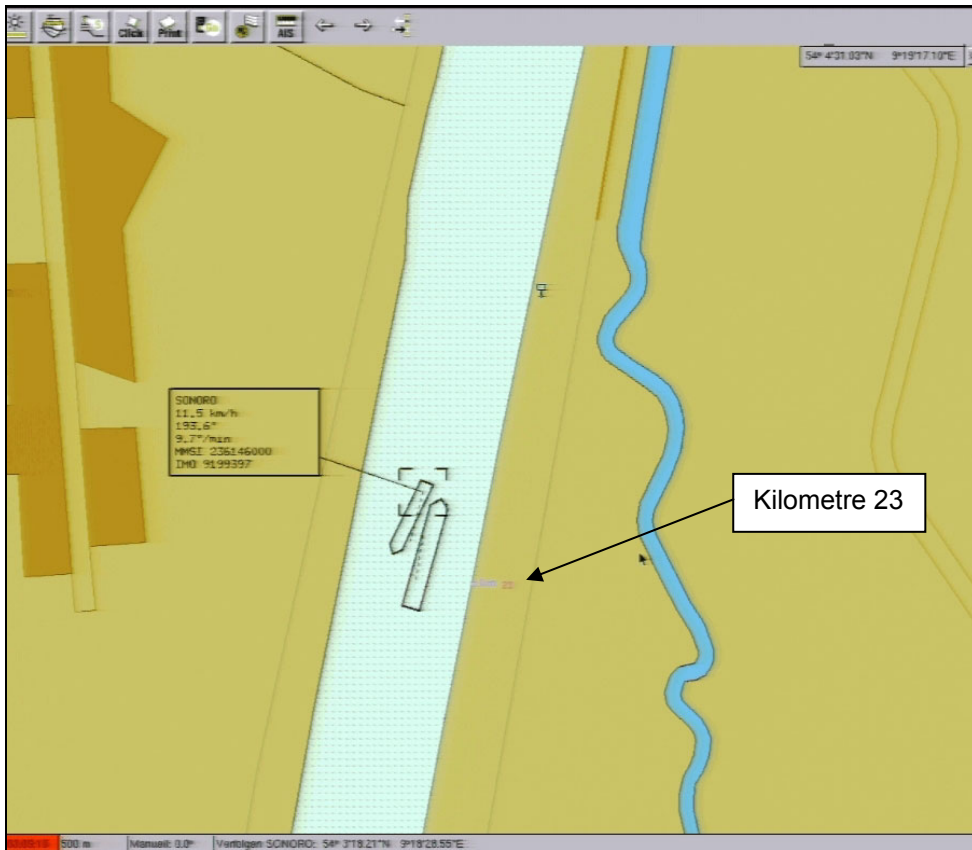
Figure 14: Time: 030915, the SONORO begins to turn to starboard

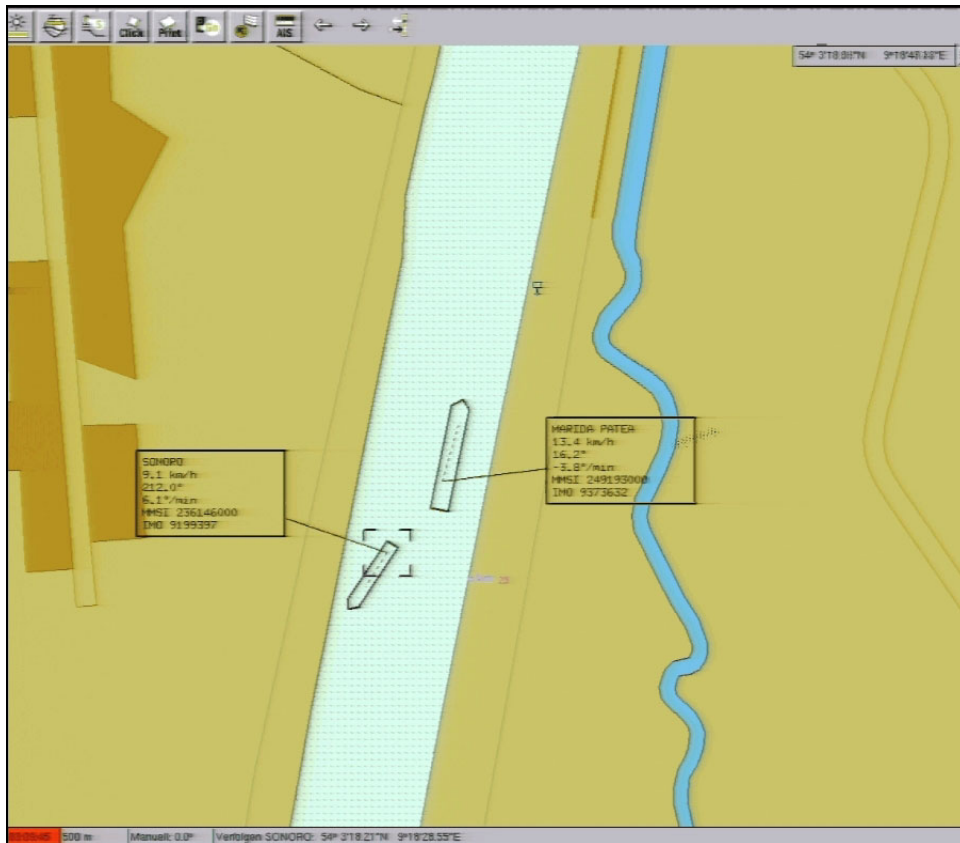
Figure 16: Time: 030945, the SONORO runs into the embankment

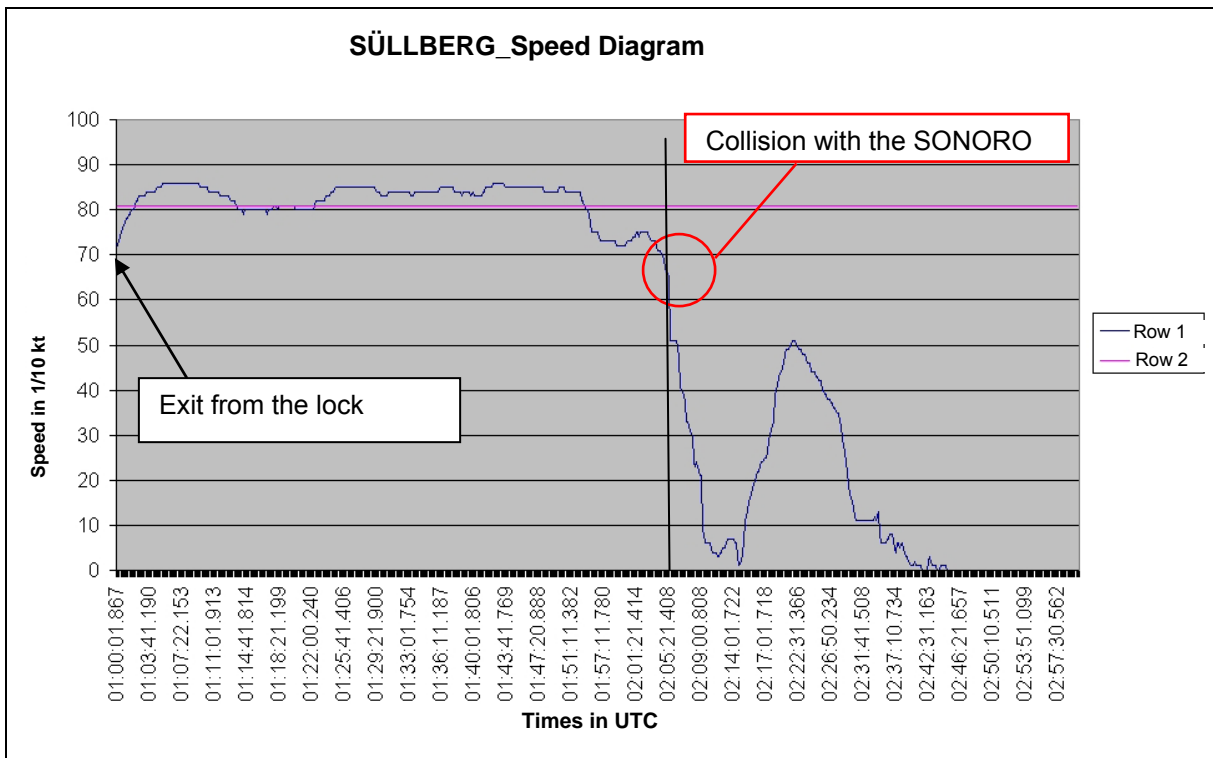
Table 2: Speed of the SÜLLBERG from 030001 to 045730, row 1 = speed of the vessel, row 2 = maximum permitted speed

Therewith the SÜLLBERG exceeded the maximum permitted speed by 65 % of the duration of the journey from the log to the collision.
