Bundesstelle für Seeunfalluntersuchung
Federal Bureau of Maritime Casualty Investigation
Federal Higher Authority subordinated to the Ministry of Transport,
Building and Urban Development

Investigation Report 143/11

Very Serious Marine Casualty

**Death of a crew member
of the sailing yacht SPECIAL ONE
on 30 April 2011 off Fehmarn**

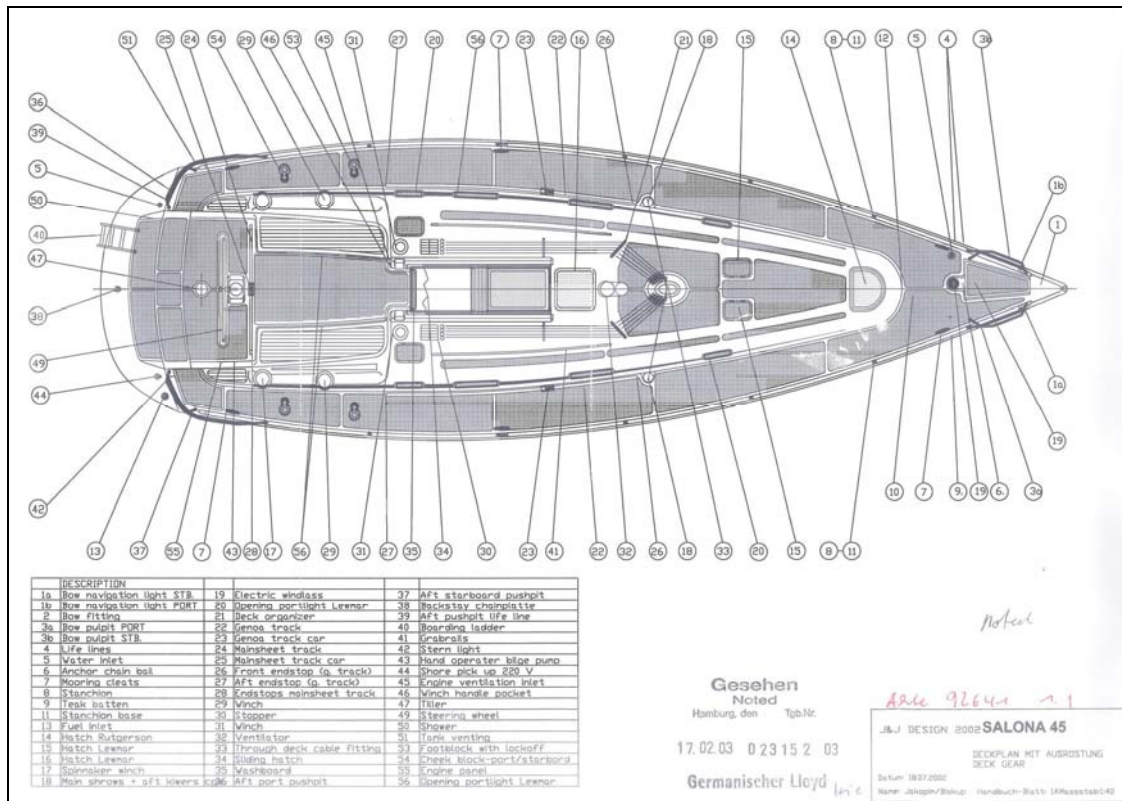
Figure 3: SALONA 45 deck plan

Item 40 of the above deck plan is referred to as 'Boarding ladder'. It is not clear that this concerns a portable bathing ladder or where the stowage position for the bathing ladder should be, nor is the stowage position of the liferaft, which is required on charter yachts, clear.

The Federal Bureau of Maritime Casualty Investigation recommends that the building yard of the SY SPECIAL ONE, type Salona 45, refrain from mounting portable bathing ladders and describe the reboarding devices in the manuals for the skipper precisely.

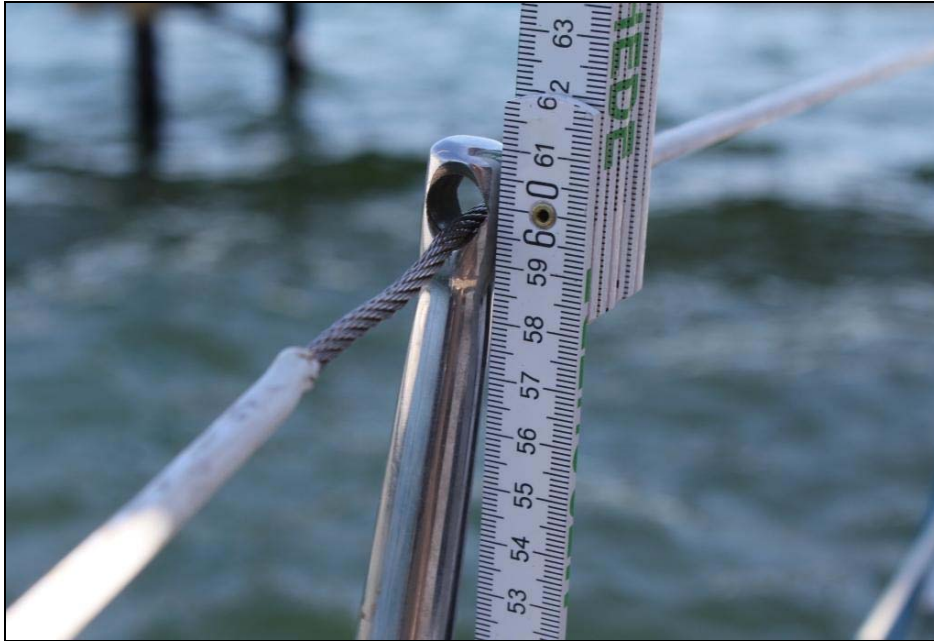
Figure 6: Guardrail on the port side

The measured freeboard on the port side level with the mast was 1.15 m. The height of the guardrail on the port side was measured at 60 cm and the first deflecting force was 30 cm above the deck. Anomalies or damage that triggered or were caused by the accident were not discovered. The guardrail sheathing in the area of a stanchion was no longer present. Typically, the wire is completely encased, or not all. The wire on racing yachts may not be encased so that hidden damage and corrosion are easier to detect.

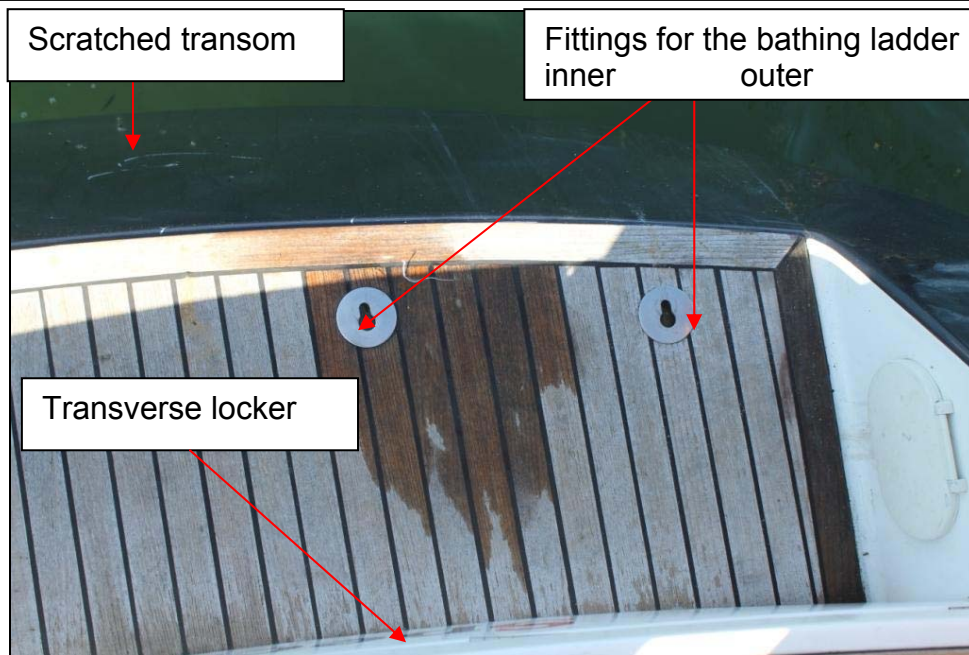
Figure 7: Bathing platform from above

The area marked bathing platform (shower) at the stern is actually the continuous cockpit deck, which is interrupted by a locker transversely mounted behind the steering wheel. The passable area on the bathing platform is approximately 2.55 x 0.44 m and the height from the water surface was measured at 0.80 m. Two fittings with hole and slot are mounted on the port side of this area. These are used for attaching the bathing ladder, which is suspended from above and should be secured against slipping out by two knurled thumb wheels.

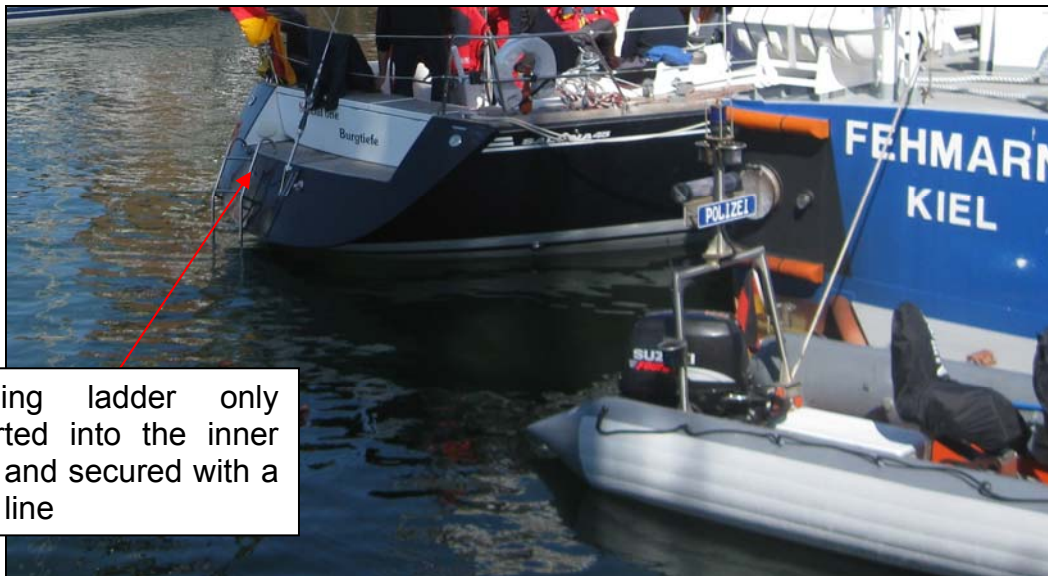
Figure 8: Photo of the vessel taken by the WSP on the day of the accident

However, in contrast with the latter statement, at the time of the inquiries by the WSP in Burgstaaken, the ladder was inserted only with the inner pin into its intended fitting on the bathing platform and tied to the backstay with a thin blue line (see next photo).

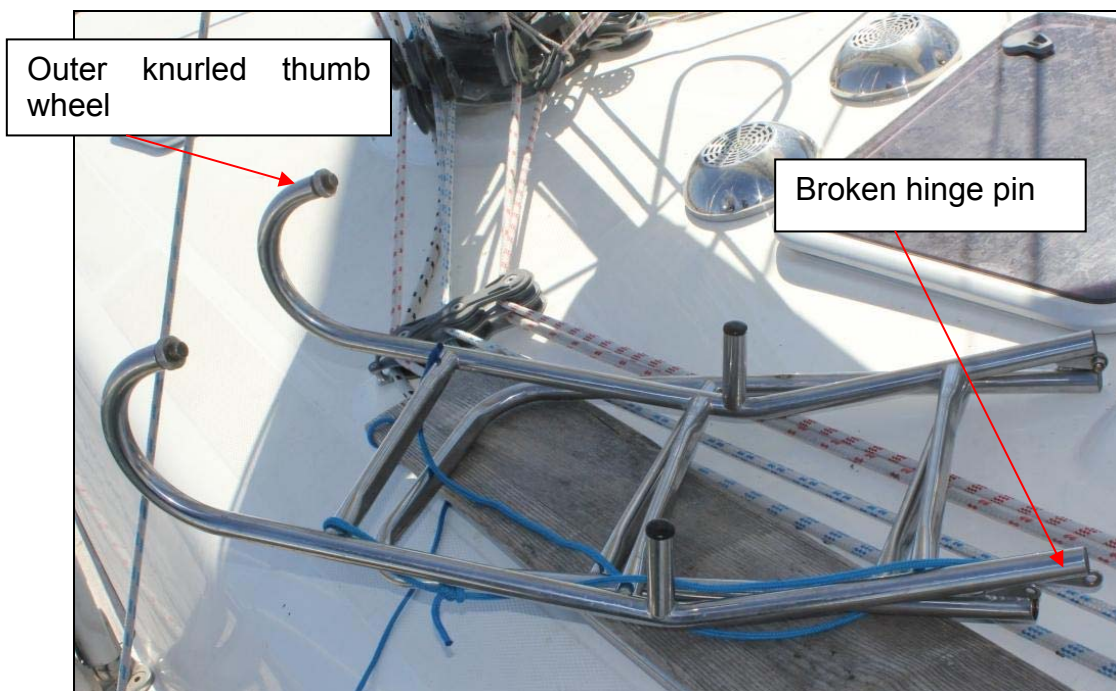
Figure 9: Photo of the bathing ladder taken by the BSU on the day of the accident

During the survey by the BSU in Burgtiefe one day after the accident, the bathing ladder was lying on the port side of the deck. The joint located on the inner side of the ladder was no longer intact as the pin was missing. The two knurled thumb wheels on the ladder could be moved by hand, but were a little stiff.

The charter company arranged for the bathing ladder to be checked and repaired immediately. It points to the fact that all the screws are checked for functional efficiency, greased and maintained as part of the winter work schedule.

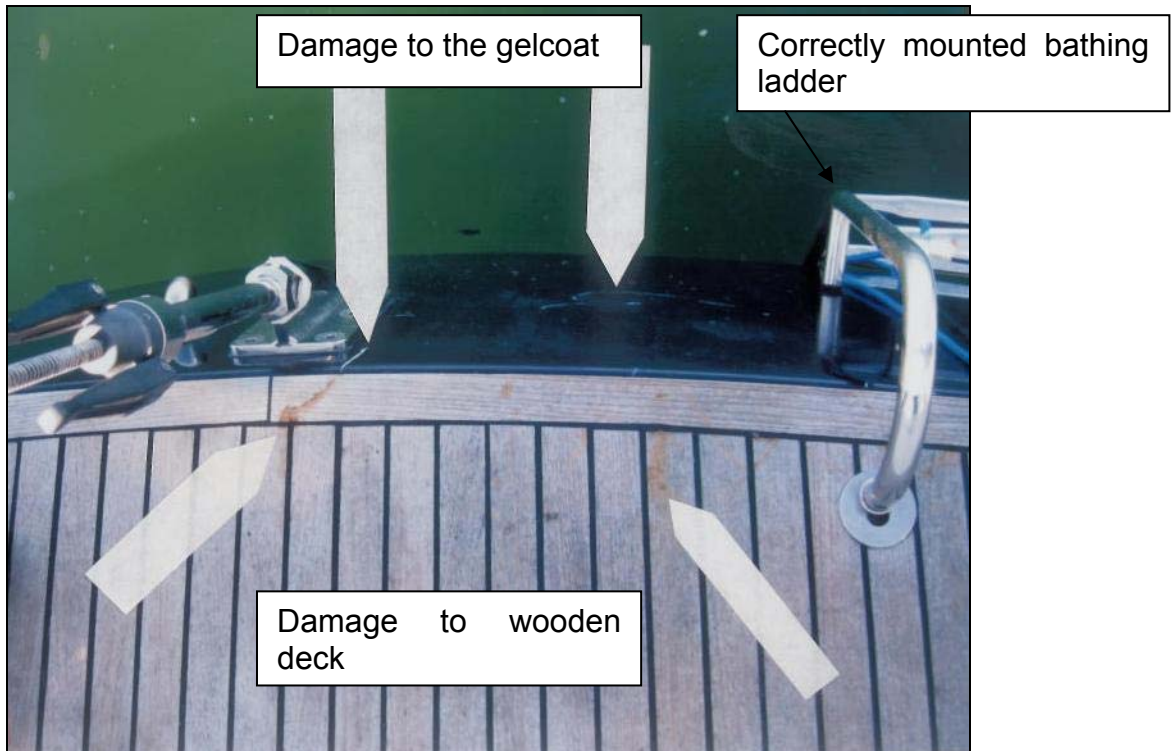
Figure 10: Damage to wood and gelcoat

Fresh scores were detected in the teak on the bathing platform and also in the gelcoat on the transom, which were apparently caused by the bathing ladder slipping. The evidence suggests that at the time of slipping, the ladder was not secured in the fittings on the bathing platform by either of the two pins.

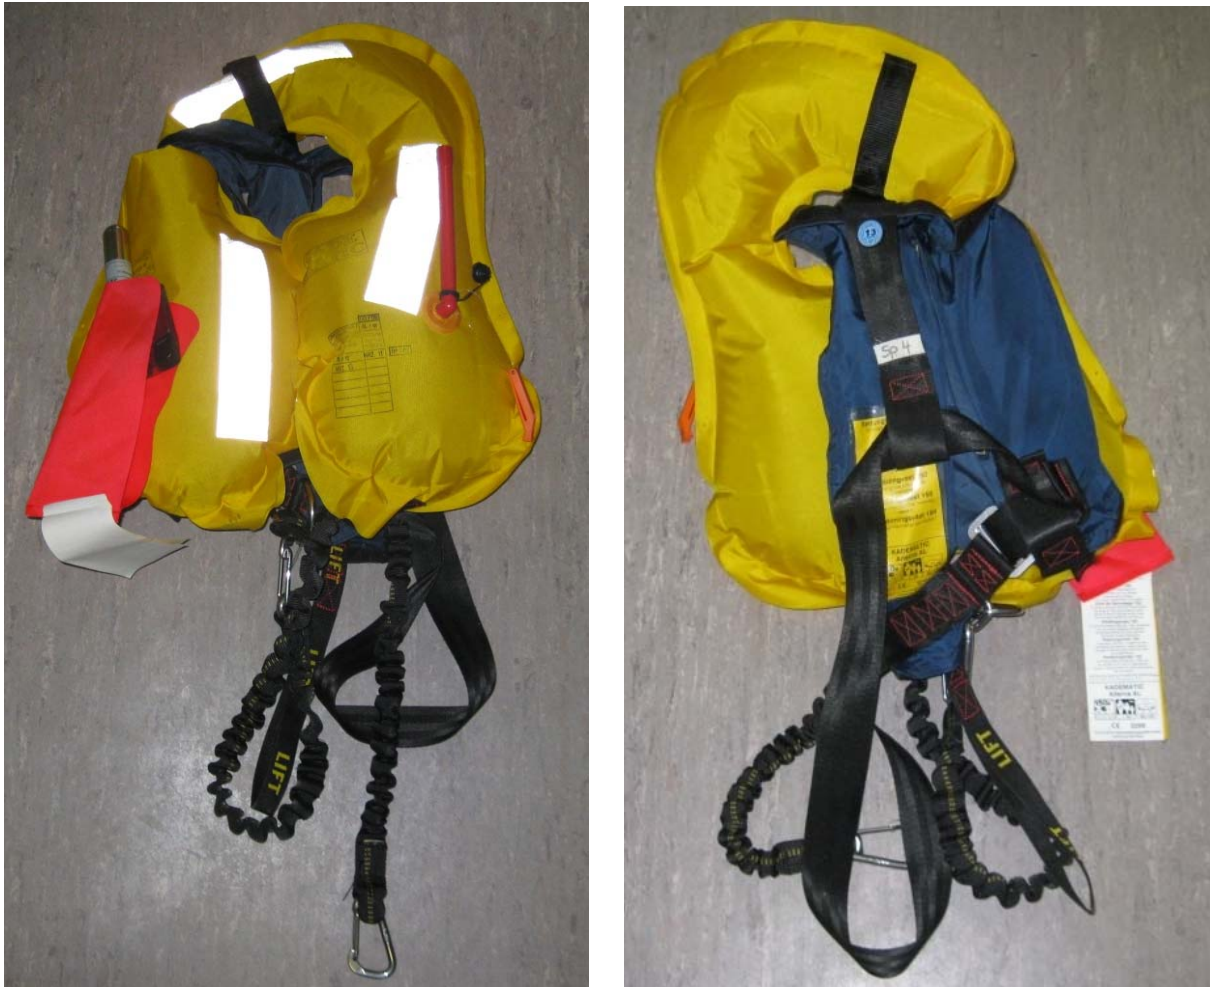
Figure 14: Lifejacket worn by the casualty with safety line

A safety line was attached to the lifejacket by means of a snap hook in the jacket's D-ring. This safety line was passed through the belt marked 'LIFT' sewn onto the inside of the buoyancy device.

Damage was found on neither the lifejacket nor the safety line.

When interviewing the crew of the SY SPECIAL ONE, nobody was able to explain the meaning of the designation 'LIFT' adequately.

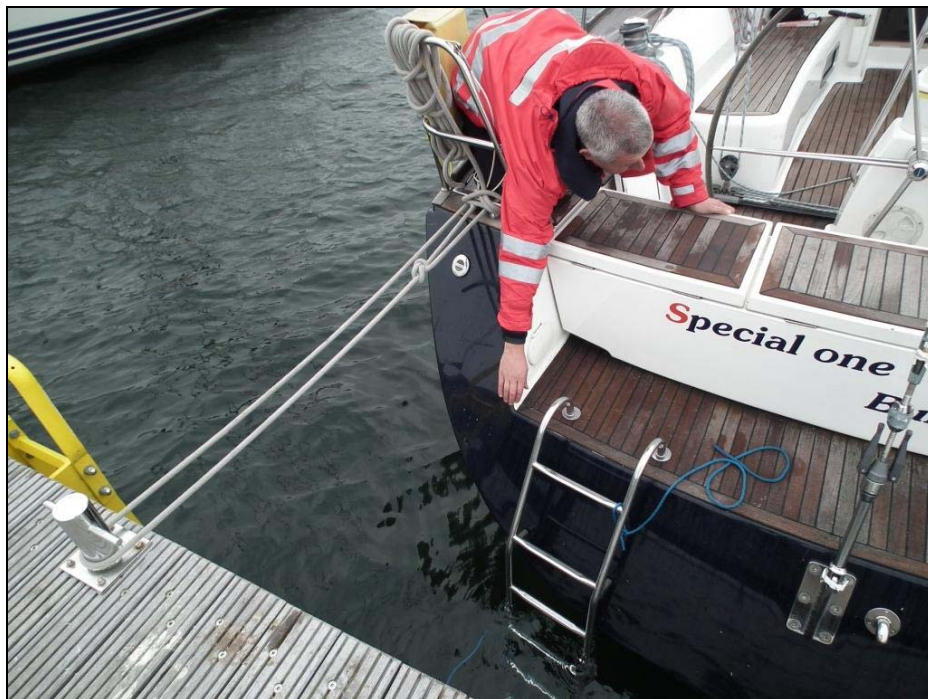
Figure 15: Providing assistance from the stern

A 'bathing platform', which is designed as an extension of the cockpit, corresponds to the present day standard. The bathing platform's dimensions and characteristics are typical for a yacht with this type of stern. The bathing platform on such yachts is only marginally or not at all suitable for using as a position from which a rescue operation can be carried out or for assisting in one. First, the size of the standing area does not permit working when knelt down; second, the distance to the water surface is still very large (see following figure).

However, since such ladders are usually fixed permanently to the hull, a bathing ladder not permanently fixed to the hull does not conform to the present day standard on yachts of this size. With that being said, the bathing ladders fixed permanently to the hull serve their purpose as a so-called 'reboarding device' only to a limited extent. For people who are weak or slightly overweight, climbing such ladders, the steps of

which only reach a little way below the surface, is difficult to virtually impossible. As demonstrated by the accident, inflated lifejackets complicate saving oneself or providing assistance in a recovery operation further. Added to this is the fact that in even poorer sea conditions, the stern of such a yacht represents a significant potential risk due to pitching.

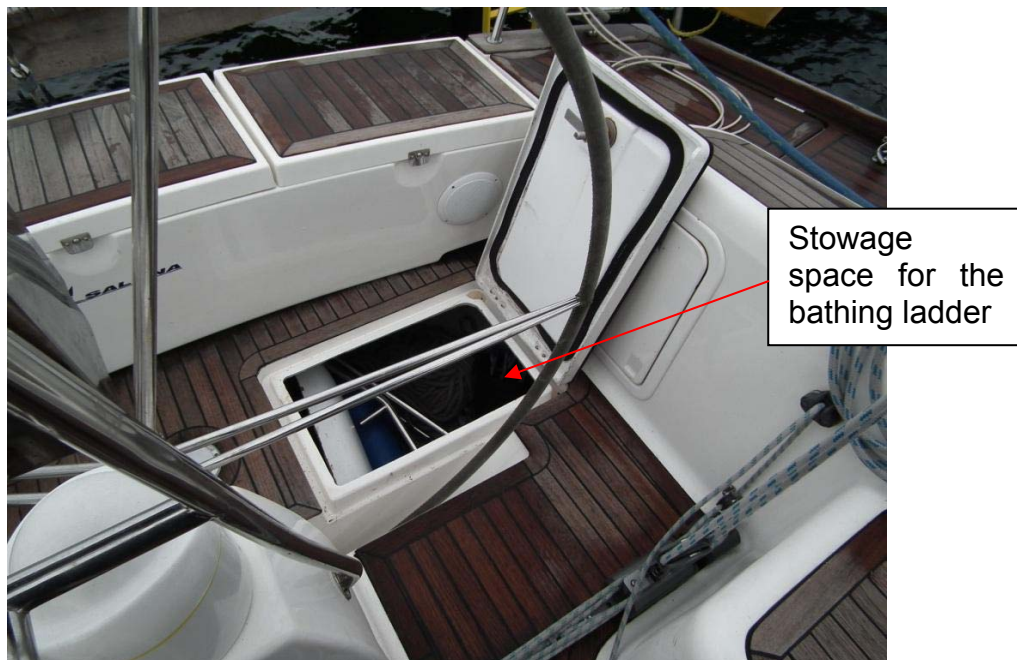
Figure 16: Stowage space for the bathing ladder

The detachable, not permanently mounted bathing ladder that was present on board, which, inconveniently, first had to be obtained from a locker and led to considerable difficulties when being mounted in a confined space, does not meet the requirements of DIN EN ISO 15085. At a wind force of 8 Bft and significant wave heights of 4 m – in accordance with the yacht's certification – it would probably be almost impossible to mount this bathing ladder.

Assuming the time specified for mounting the bathing ladder would be the same as the specification for the operational readiness of liferafts (15 seconds), then it must be concluded that it is impossible to adhere to the specified time even with functioning knurled thumb wheels.

As a measure to enhance safety, the charter company recommends that customers install the bathing ladder and secure it accordingly when at sea.

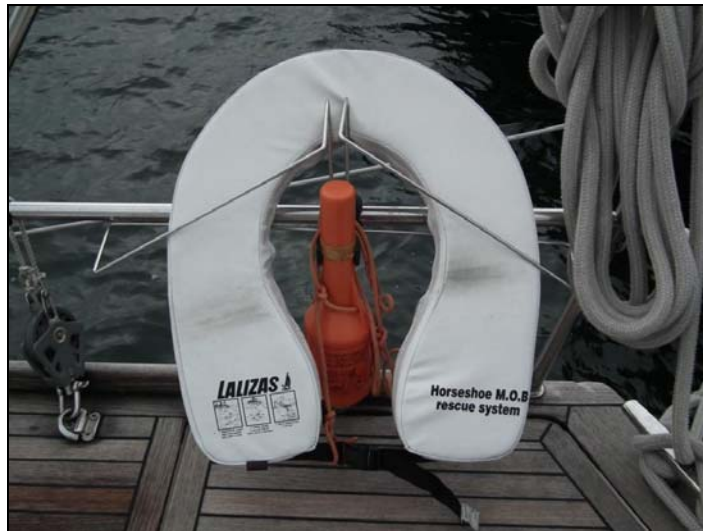
Figure 17: Life preserver on the starboard side

A horseshoe-shaped life preserver, type LALIZAS Horseshoe M.O.B. Rescue System, which could have assisted the casualty as a buoyancy aid when he was no longer wearing a lifejacket, was located on the starboard side. The disadvantage of this life preserver would have been that a line was not attached to it, meaning there would no longer be a connection with the vessel.

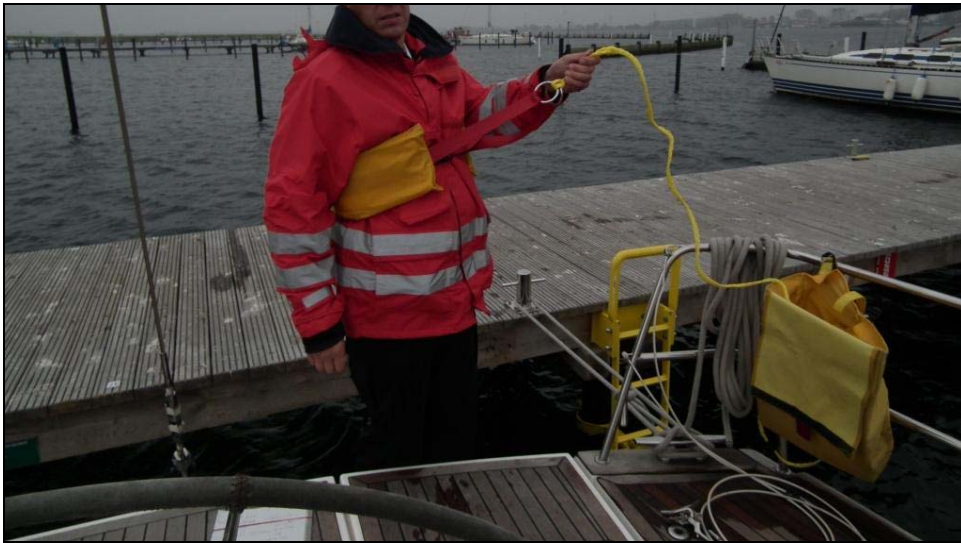
Figure 18: Rescue system on the port side

An ideal rescue system with a line of approximately 40 m was located aft on the port side in the form of the TALAMAX Rescue System; however, this was not used to get the person out of the water.

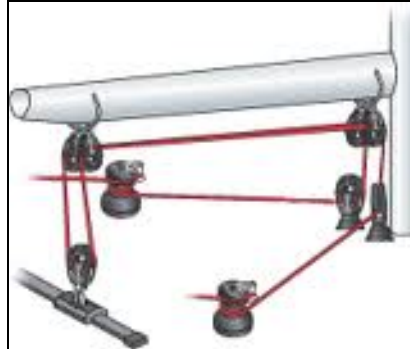
Figure 19: Mainsheet routing

The mainsheet routing on board the SPECIAL ONE is a so-called 'German Mainsheet System' (or 'German Sheet System'). In the case of this sheet routing, which at one time was often used on gaff yachts as well as on Swedish skerry cruisers, for example, the sheet consists of two loose ends.

The sheet on board the SPECIAL ONE was routed from a winch via guide rollers to the mast and boom head and then via a guide roller on the traveller track back to a winch on the other side of the vessel, as shown in the above drawing. The advantage of sheet routing of this nature is that the mainsheet can be operated on both sides by two winches, depending on which is more favourable or easier to reach. However, the disadvantage is that two ends of the sheet must be secured and that if one side is continuously eased and the other permanently close hauled, at some point the entire sheet will be on one side of the vessel, upon which it will not be possible to ease the other side.

The Federal Bureau of Maritime Casualty Investigation recommends that the charter company of the SPECIAL ONE continue to draw attention to particularities, e.g., unusual sheet routing, which differ from normal yachts, during the handover of the vessel.
