MARINE SAFETY INVESTIGATION REPORT

Joint investigation into the collision between the
Maltese registered general cargo

MARTI PRINCESS

Marine Safety Investigation Report No. 03/2012

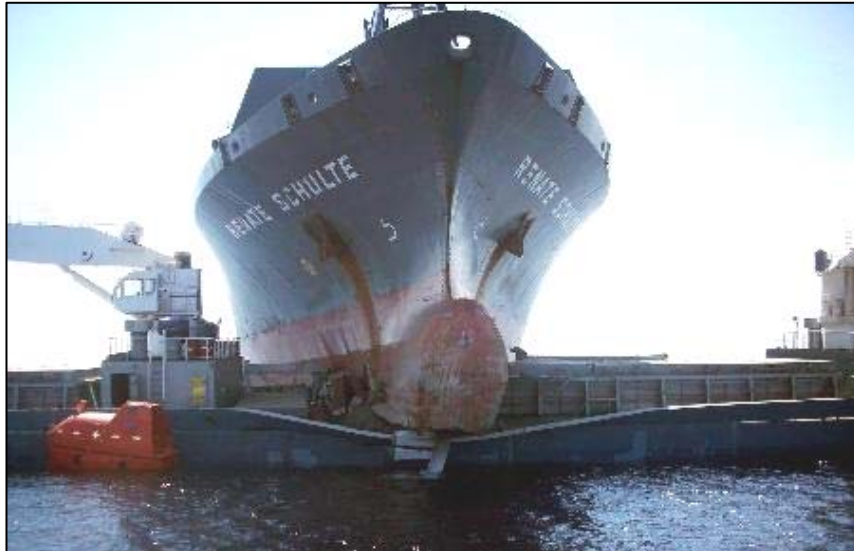
Figure 1.3i: *Marti Princess* and *Renate Schulte* on the morning following the collision

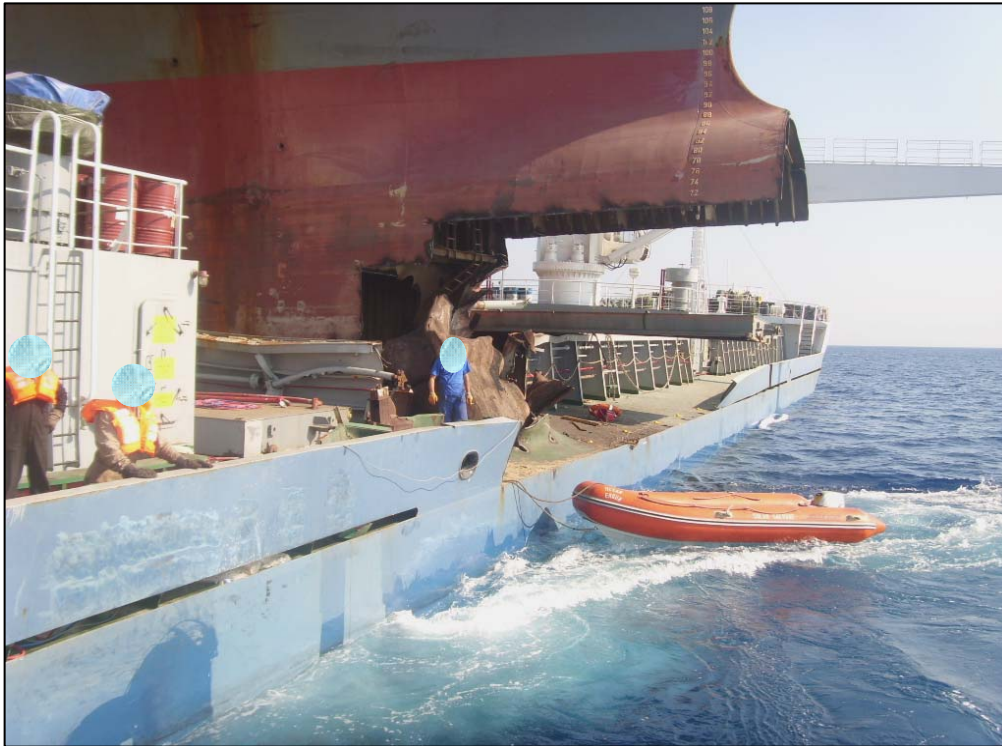
Since *Renate Schulte* was in ballast condition (and *Marti Princess* fully loaded), most of the sustained damage as a result of the impact was in way of her bulbous bow.

A damage survey on *Renate Schulte* revealed the following heavy damages as a direct result of the impact:

- No. 1 cargo hold side shell and attached frame;
- Starboard side and port side shell from frame 193 to bow and from bottom plate to 1 m above from the 2nd stringer deck and bottom plate ballast tank 1;
- Fore peak tank (inclusive bulbous bow and internal structures) lower parts heavily damaged and holed;
- Bow thruster heavily damaged, side shell and attached frame holed from starboard side, stringer deck heavily damaged and buckled; and
- Bow thruster electric motor damaged.

Figure 1.6i: The bow of *Renate Schulte* after it was cut by salvors

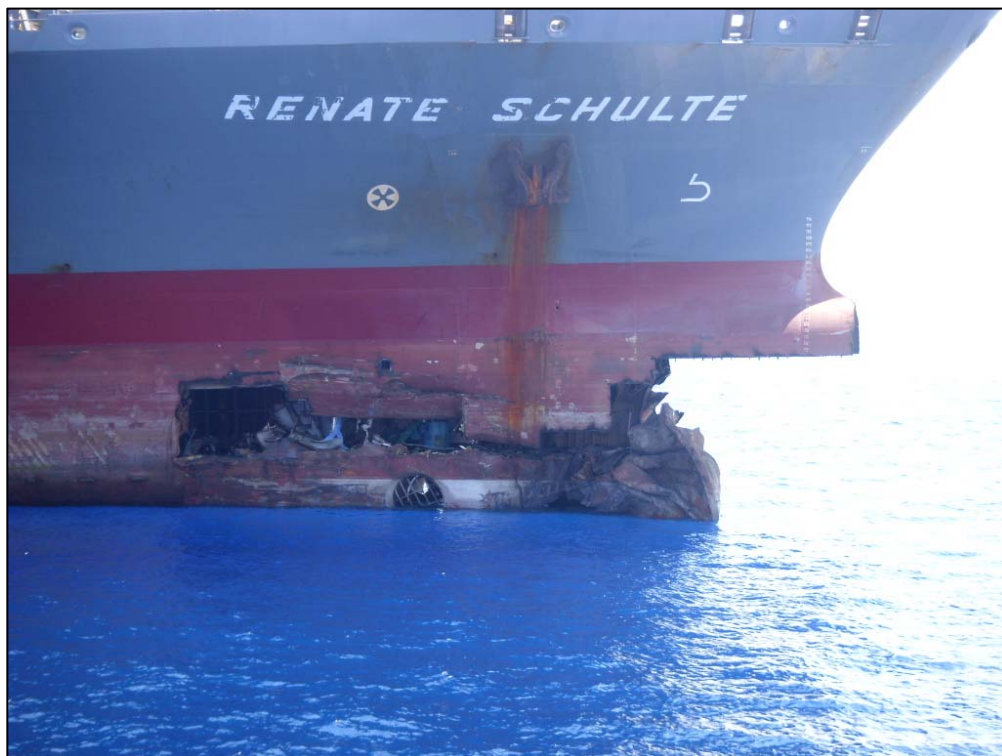
Both vessels sustained considerable damage as a result of the collision, and in the subsequent salvage operation to separate the two vessels. *Renate Schulte*, however, was the vessel that sustained more damage during the salvage operation, whereas *Marti Princess* sustained most of the damage as a result of the collision.

Figure 1.6ii: *Renate Schulte* following the salvage operation

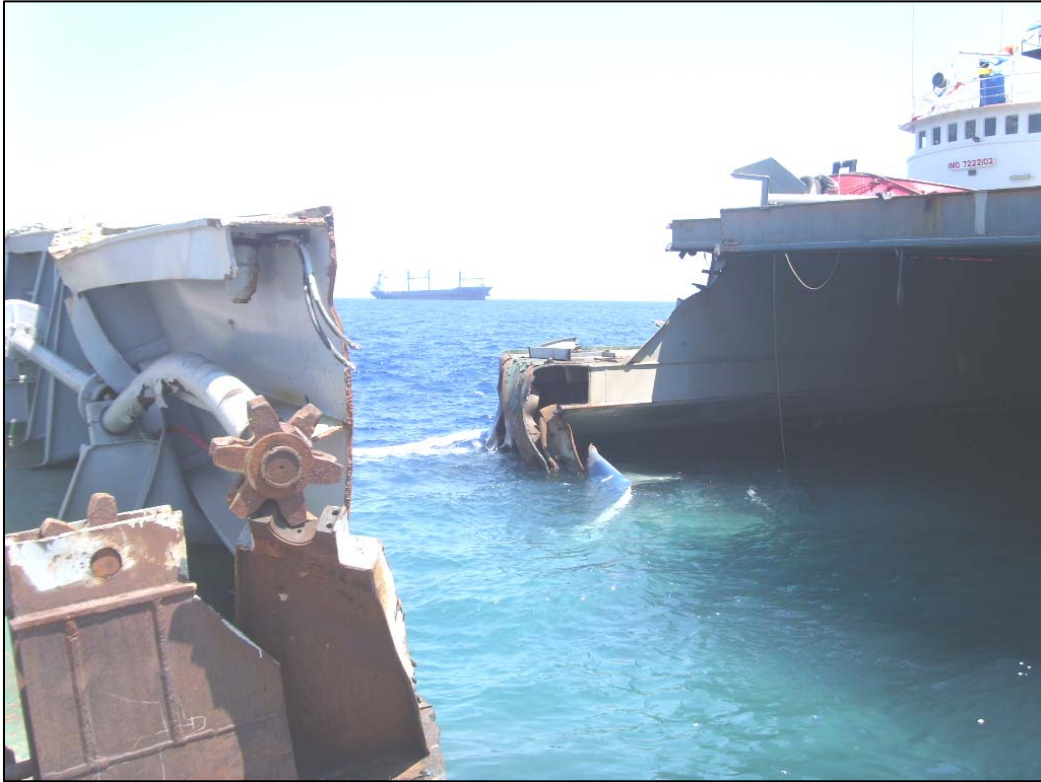
On 02 July 2009, a class surveyor boarded *Marti Princess* to carry out an occasional survey as a result of the collision with *Renate Schulte*. The reported damage included:

- Shell plating i.w.o. frames 79-94 torn from 1.5 m above the BL to the upper deck;
- Port side deck plating and longitudinal girder and sloping plate of. no. 2 port top side tank completely broken i.w.o. frames 82-96;
- Cargo hold coaming i.w.o. frames 82-96 broken and torn;
- Starboard deck plating and under deck longitudinals i.w.o. frames 83 to 92;
- Starboard longitudinal girder i.w.o. frames 82-92 broken;
- Starboard shell plating indent i.w.o. frames 83-92 from upper deck downwards for a distance of 900 mm;
- Deformed deck plating i.w.o. port side forward cargo hold # 2 hatch cover;
- Aft hatch coaming of cargo hold no. 2 broken and deformed;
- Missing pontoons and opening/closing gear; and
- Damaged fire main, cable piping, and bulwark i.w.o. cargo hold no. 2.

Figure 1.6iii: *Marti Princess* with her cargo hold no. 2 completely open to sea

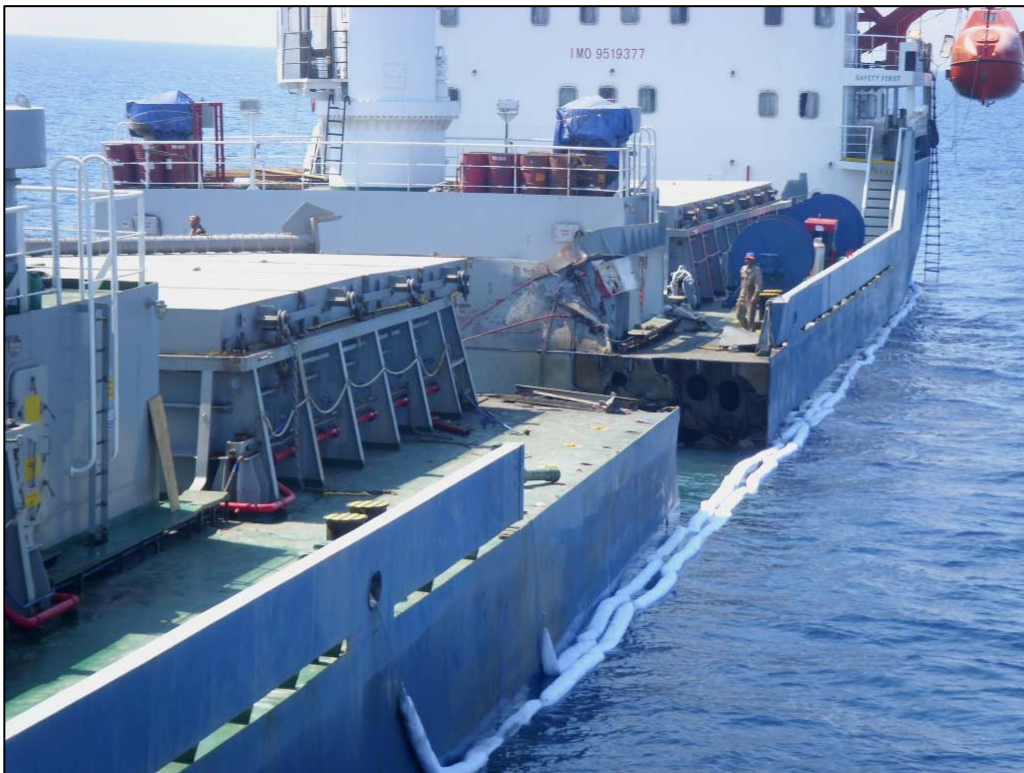
Figure 1.6iv: *Marti Princess* sustained most of her damage i.w.o. cargo hold no. 2 and down to 1500 mm above the BL
