Bundesstelle für Seeunfalluntersuchung
Federal Bureau of Maritime Casualty Investigation
Federal Higher Authority subordinated to the Ministry of Transport,
Building and Urban Development

Investigation Report 301/09

**Occupational accident on board the
TMV ECE NUR K
on the Lower Elbe
on 1 August 2009**

1 March 2012

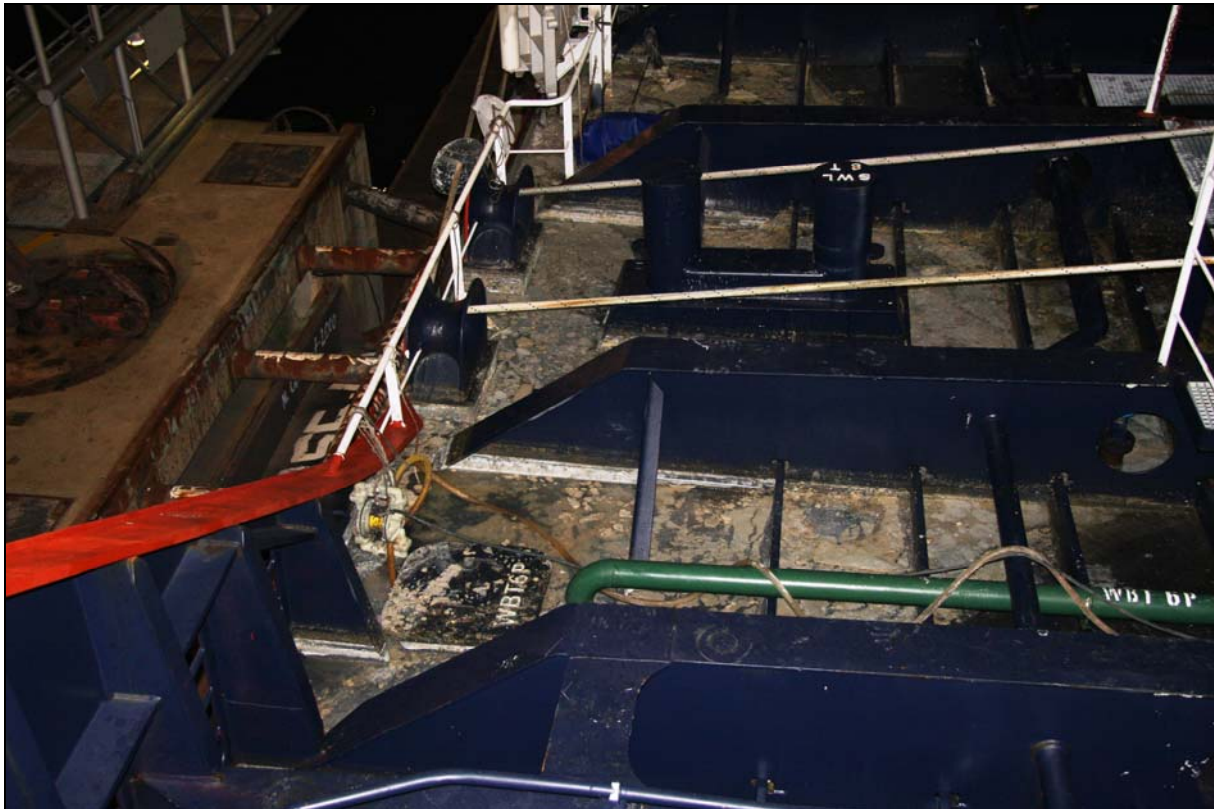
The unusually high level of contamination on the deck area (see Fig. 3) was apparent on boarding the ECE NUR K. A mobile pump was installed amidships on the starboard side, obviously to pick up some of the contamination. However, the film extended, on both sides of the deck, from the forecastle to the superstructure. Seemingly, it was palm oil residue.

Figure 3: Contaminated deck (port side)

- Work spaces and accident prevention:
Due to a lot of cargo residues access to the decks is unsafe.
- ISM related deficiencies:
Due to the current situation it seems that the crew was not very familiar with handling the cargo (palm oil) or has not enough experience with chemical tanker operations. Internal audit is required.
- MARPOL annex I:
Found wrong or missing entries in Oil Record Book. Dirty oil tank not in item 3.1 IOPP¹². Heavy Fuel Oil drain tank and incinerator sludge tank were not recorded.
- Ship's certificates and documents:
Prevention of pollution by oil (IOPP) - Missing.
Dirty oil tank not in the item 3.1 IOPP. Has to be proved by class society.

The deck area should be kept in a condition which permits work to be carried out safely.

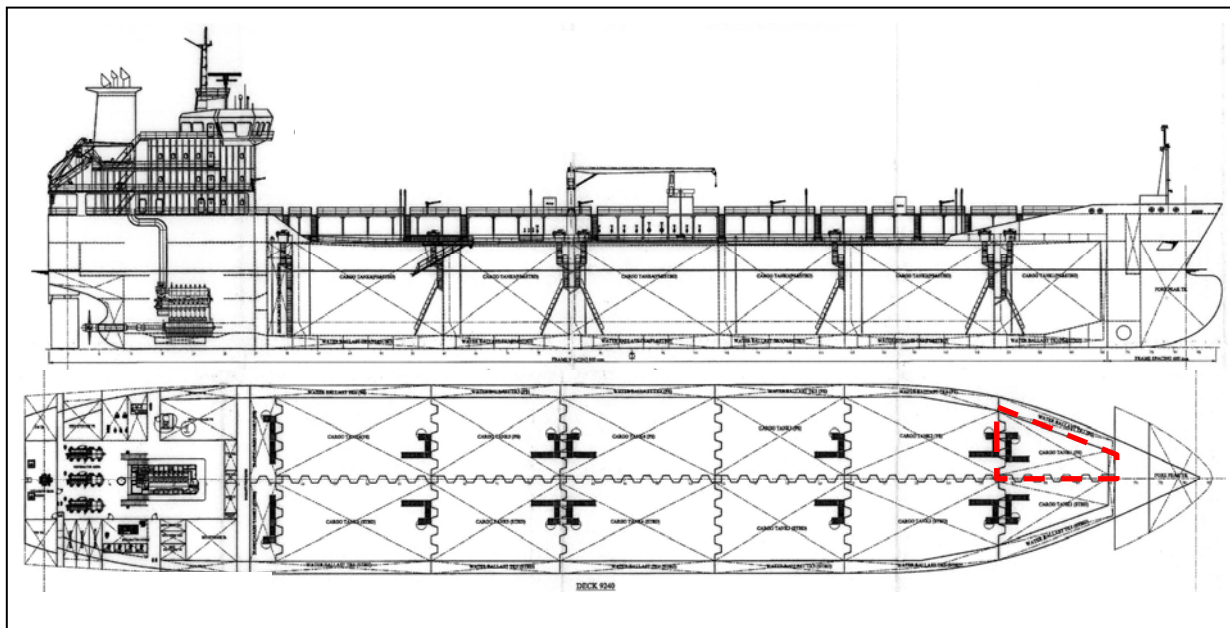
Figure 4: Excerpt from the general arrangement plan

The accident occurred in the first tank (no. 1 p/s) on the port side (see Fig. 4, red marking). This tank has a capacity of nearly 800 m³ when full laden. The tank had

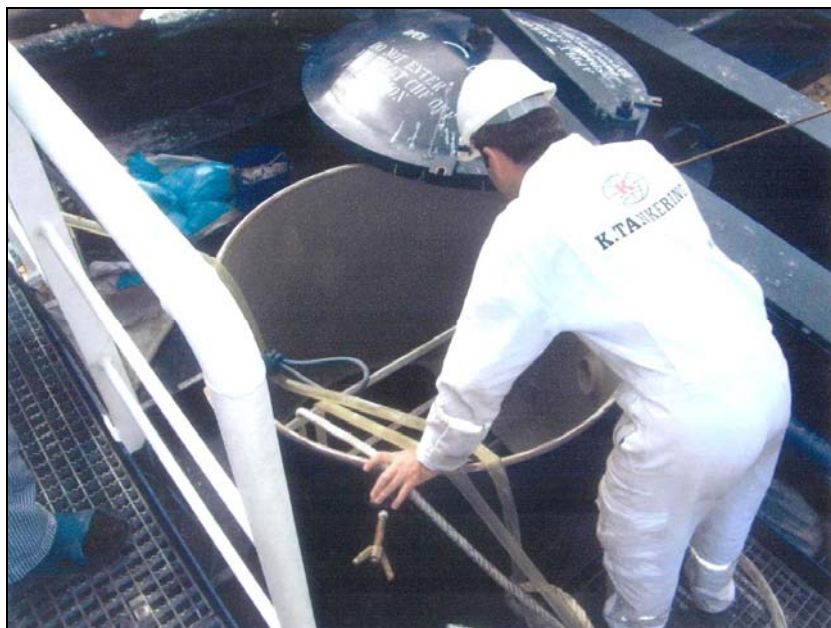
Figure 5: Tank no. 1 p/s hatch coaming

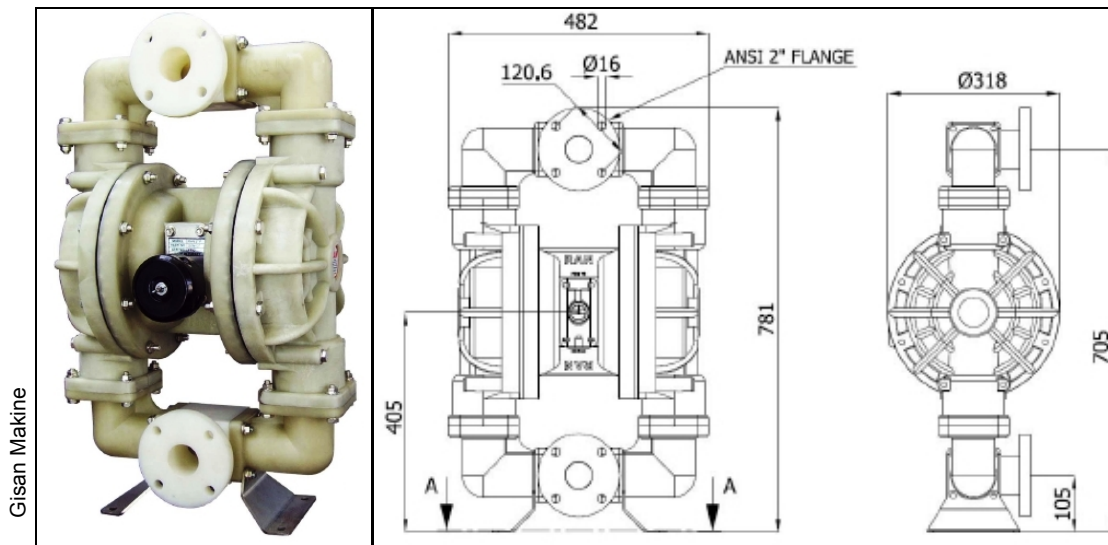
Figure 6: 2-inch membrane pump, type RAN

The mobile pump used on the day of the accident is a 2-inch membrane pump powered by compressed air, type RAN, manufactured by Gisan Makine (see Fig. 6). Made of polypropylene, the pump has a pumping capacity of 520 l/min at a maximum working pressure of 8 bar.

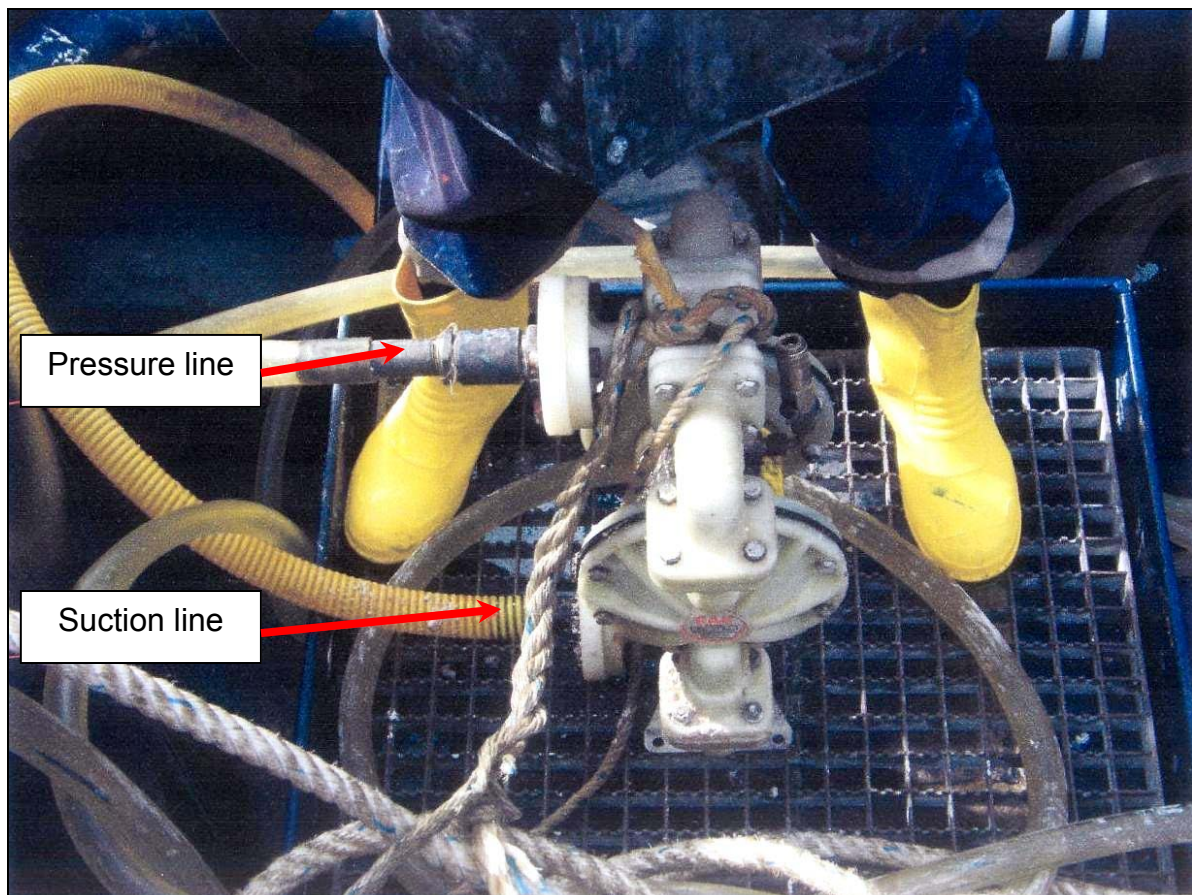
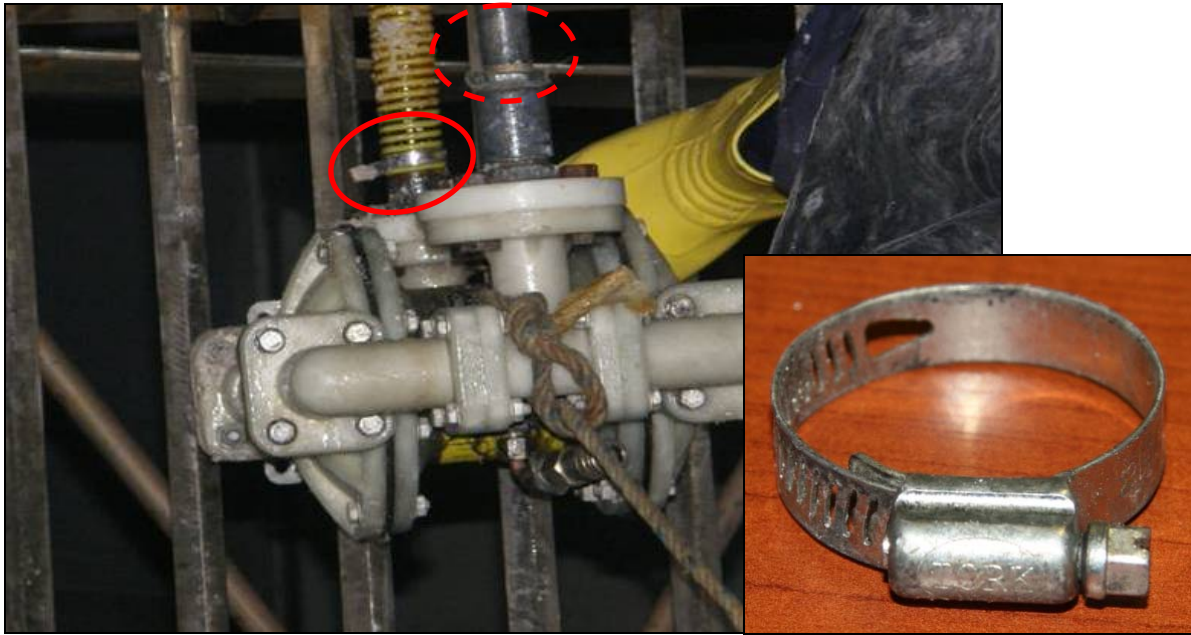
The hoses for the pressure and the suction line were each attached to the pump used on the day of accident with hose clamps (see Figs. 7 and 8). According to statements of the crew, it had not been possible to find the clamp that had parted from the pressure line.

Figure 7: Pump used on the day of the accident

Figure 8: Remaining hose clamp on the suction line and sample clamp

In retrospect, it was not possible to establish the actual cause of the hose clamp parting from the mobile pump as the clamp could not be found. In this respect, it remains open whether a case of material fatigue existed.

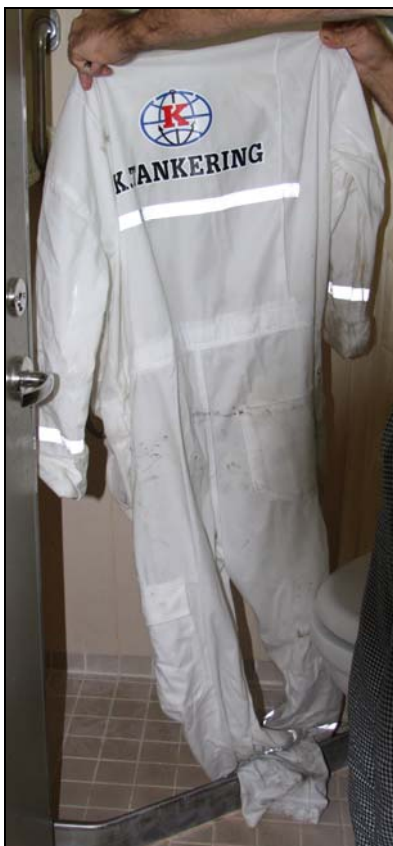
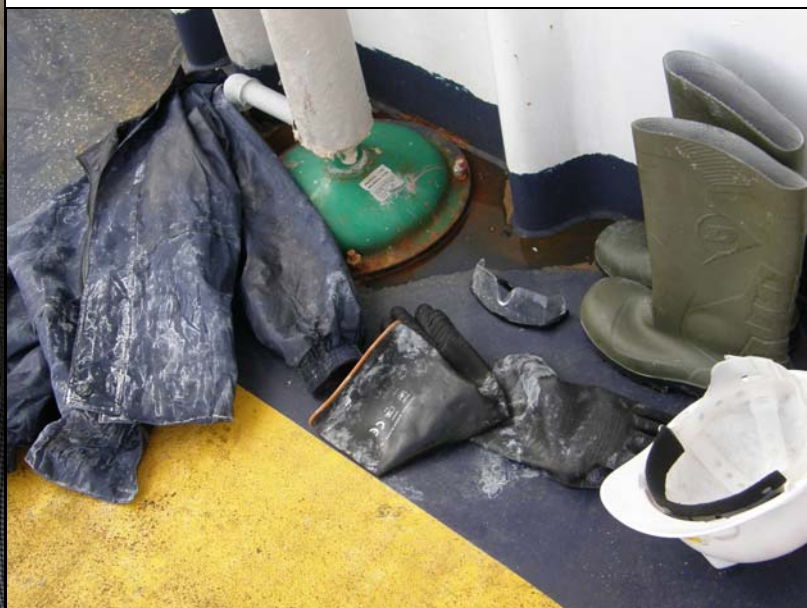
While cleaning the tank on the day of the accident, the third officer was wearing his personal protective equipment. This consisted of a cotton overall, a rubberised jacket, safety boots, protective gloves, eye goggles and a safety helmet (see Figs 9 and 10).

Figure 9: Work overall

Figure 10: Personal protective equipment used by the injured

In the opinion of the BSU the protective equipment used by the injured on the day of the accident was inadequate for the planned tank cleaning. Chapter 14 subparagraph 14.1.1 of the IBC Code states, inter alia, that protective clothing made of chemical-resistant material as well as tightly fitting eye goggles and/or face shields must be used. The cotton overall and the eye goggles, which were open at the sides, used by the third officer did not meet these requirements, whereby not only his eyes but also his skin was exposed to the caustic soda with virtually no protection.

The serious injury to the third officer is largely due to inadequate safety equipment. The eye goggles worn were open at the sides, allowing the caustic soda to enter the eyes of the injured more or less freely. Neither the eye goggles nor the cotton overall complied to European safety regulations or the information on the safety data sheet for the hazardous substance caustic soda, respectively.

The Federal Bureau of Maritime Casualty Investigation recommends that the ship's command and the operator of the ECE NUR K provide all crew members who are exposed to hazardous substances in the course of daily shipboard operations with appropriate protective clothing, which conforms to international, European and national standards.

The donning of appropriate protective clothing before engaging in dangerous activities, such as tank cleaning, should be logged in the prescribed tank cleaning plan and verified by a responsible member of the crew. The crew members should be extensively informed about the hazards associated with the substances with which they come in contact during tank cleaning as well as about appropriate first aid measures.

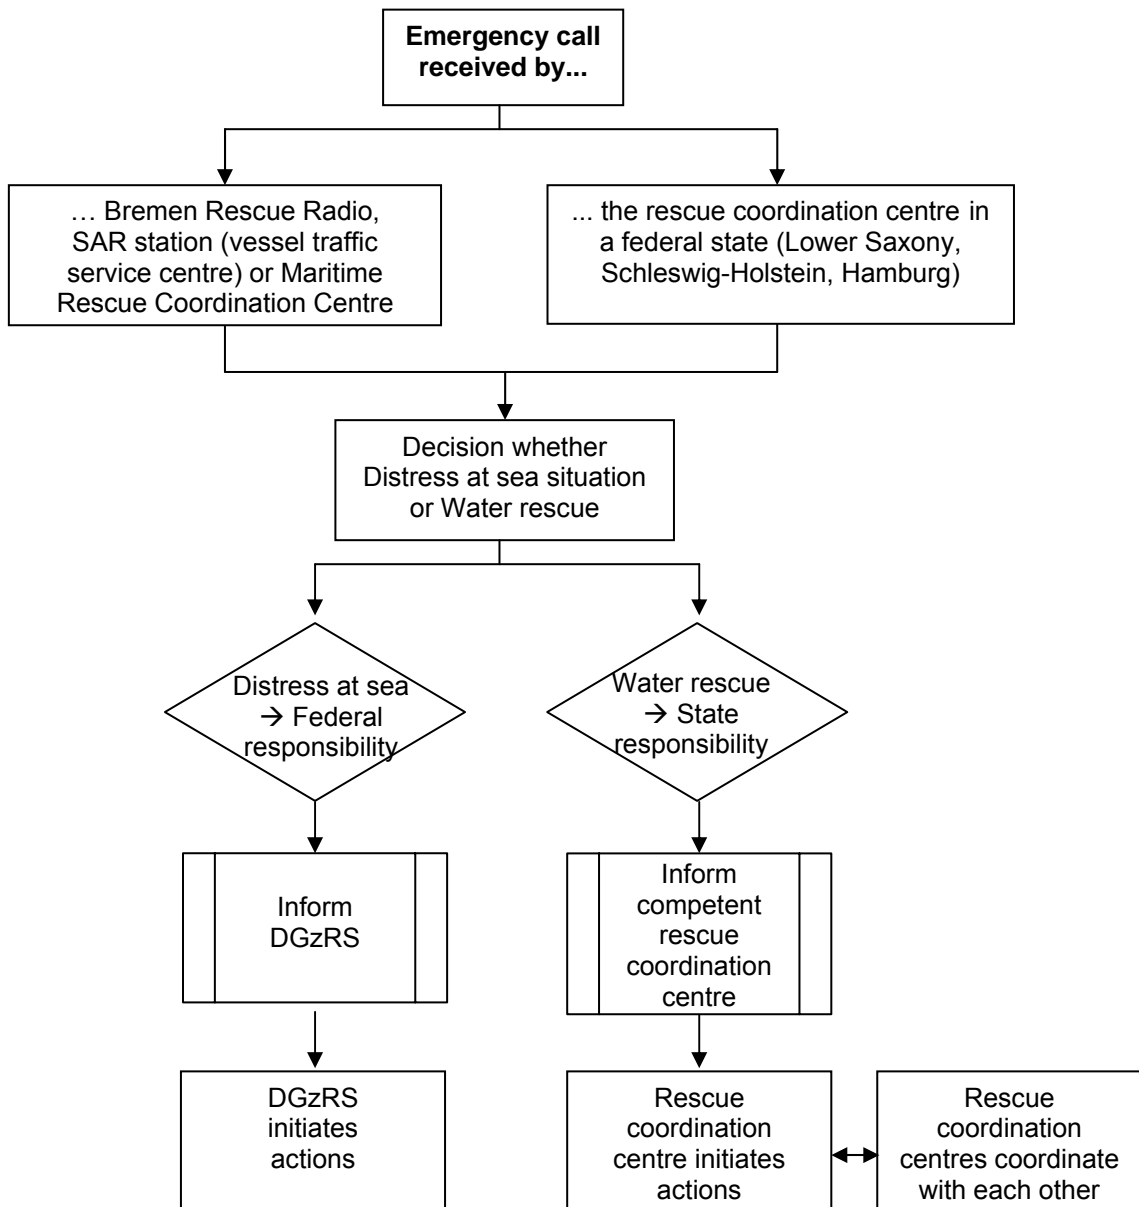
Figure 13: Proposed notification scheme

This proposal contains the following difficulties as regards practical implementation:

- Due to the lack of capacity, the DGzRS is unable to cope with distress at sea situations upstream of Brunsbüttel on its own. Furthermore, due to the different communication systems of the various land and sea rescue services, coordination by MRCC is only to a very limited extent possible. If a distress at sea situation occurred just before the Hamburg port boundary, then the DGzRS would need several hours to reach the scene from Brunsbüttel.
- Theoretically, the emergency call "Person in the water off buoy xy" would give rise to a number of requests in order to be able to decide on how the call should be handled: Does the person look like a swimmer, water sports enthusiast or the crew member of a sea-going vessel? Is she/he swimming inside or outside the fairway, and if outside, then in whose jurisdiction?

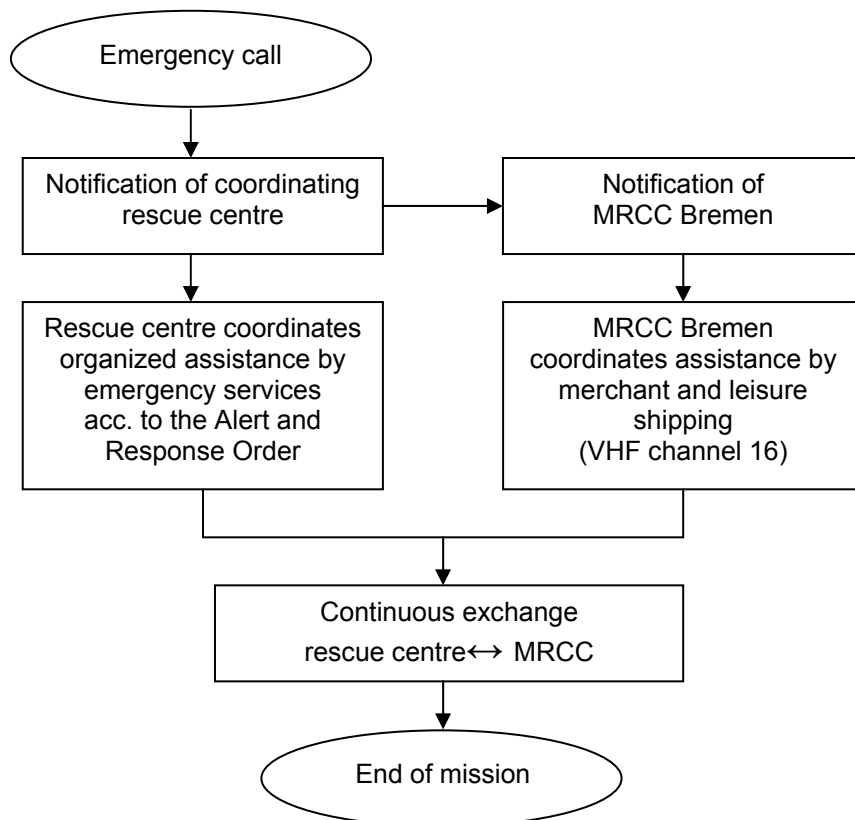
Figure 14: Further proposed notification scheme

This scheme as well does not cover the equipment and training aspects of voluntary rescue personnel, both of which are limited when it comes to a distress at sea situation. Additionally, it is not in the best interest of the DGzRS that MRCC Bremen be informed about every single case of water rescues (e.g. technical assistance). After all, the DGzRS does not provide for own survival crafts upstream of
