Bundesstelle für Seeunfalluntersuchung
Federal Bureau of Maritime Casualty Investigation
Federal Higher Authority subordinated to the Ministry of Transport,
Building and Urban Development

Investigation Report 325/11

Serious Marine Casualty

**Grounding of the
Traditional sailing vessel AMPHITRITE
in the Little Belt
on 29 June 2011 at 2335**

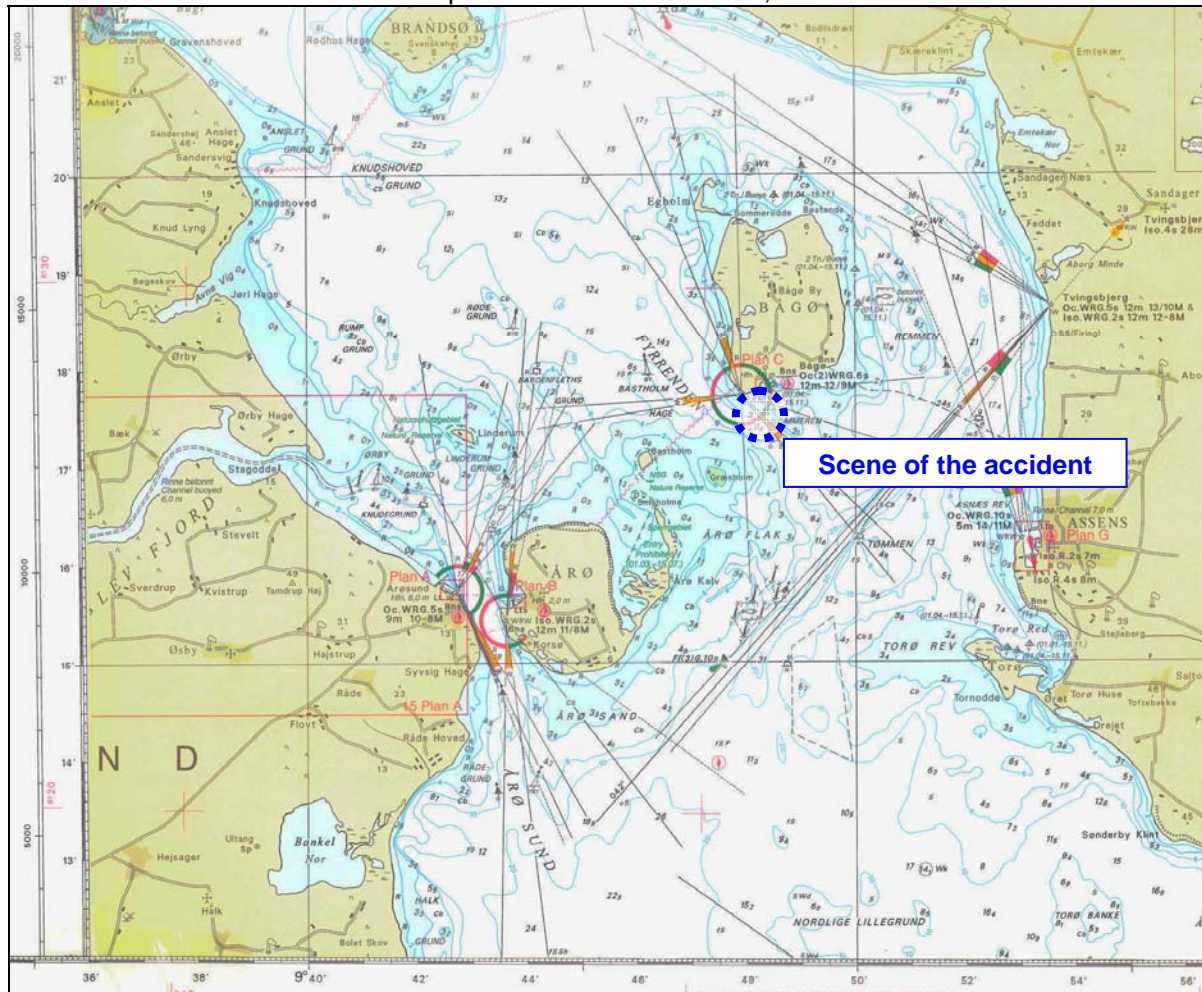
Figure 2: Nautical chart showing the scene of the accident

Type of event:	Serious marine casualty/grounding
Date, time:	29 June 2011, 2335 CEST
Location:	Little Belt
Latitude/Longitude:	ϕ 55°17.46'N λ 009°48.67'E

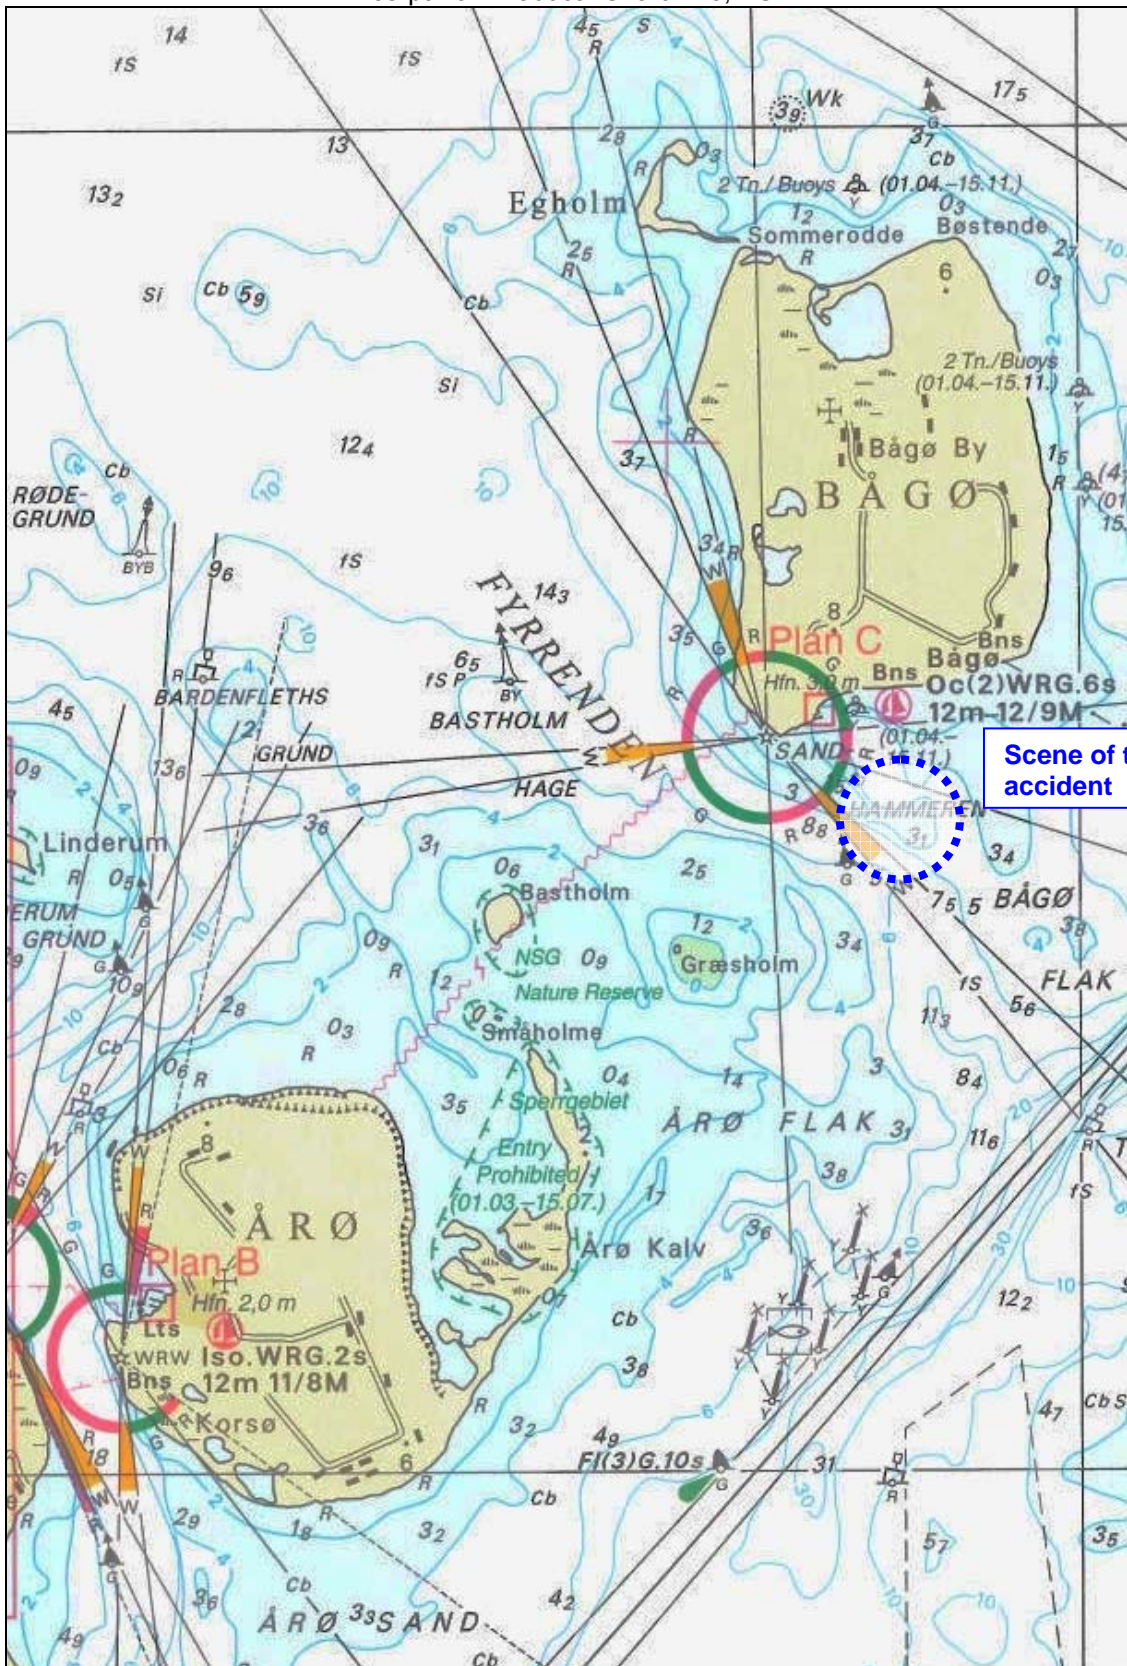
Figure 3: Scene of the accident in detail

The vessel was sailing on a port tack. Shortly before the green buoy, the wind suddenly switched to north and the sails beat aback, causing the vessel to luff hard. The vessel started to turn to port and move towards the shallows. The master immediately gave orders for the helm to be set to hard to starboard, the engine to full ahead and the sails to be slackened. In spite of this avoiding action, the AMPHITRITE traversed further to the northeast and grounded at 2335; her position was $\phi 55^{\circ}17.46'N \lambda 009^{\circ}48.67'E$.
