Investigation Report 413/10

**Marine Casualty**

**Personal accident on the aft manoeuvring  
station of the hopper dredger  
WATERWAY while making fast in the port of  
Emden on 21 September 2010**

1 March 2012

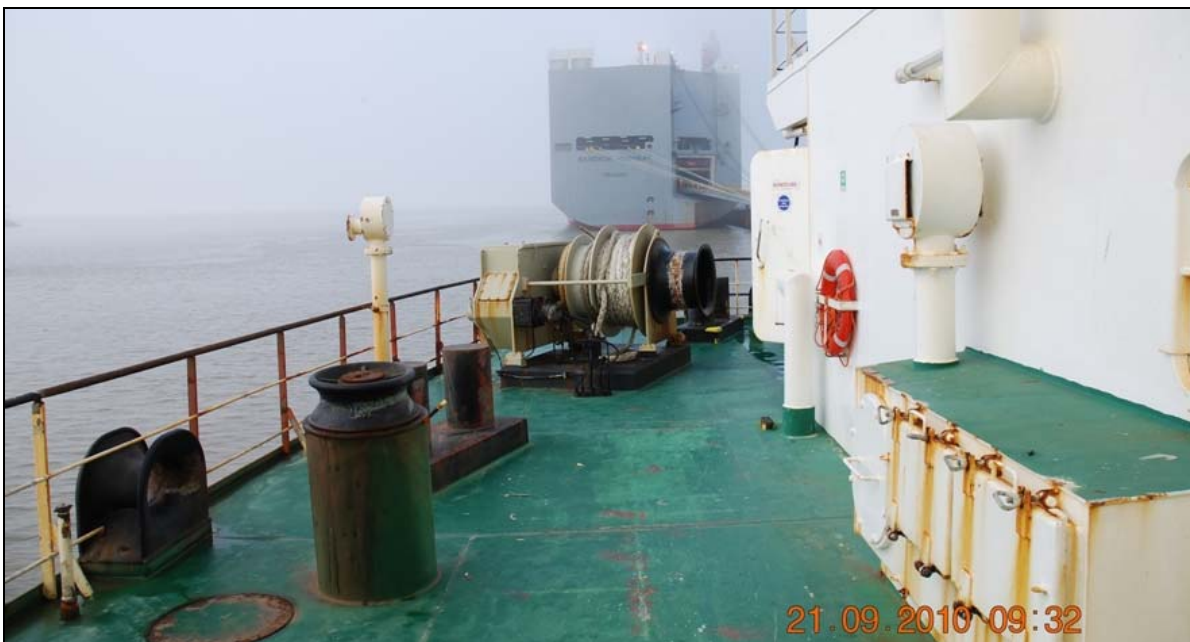
Figure 3: Aft manoeuvring station, starboard side (1)<sup>6</sup>

The aft manoeuvring station of the dredger WATERWAY consists of two identical work areas on the port and starboard side of the main deck (see **Figs. 3 ff**), each with a hydraulic winch, two twin bollards and a guide pulley. Only a narrow passage (bounded by the aft railing) is situated behind the superstructure in the aft section of the vessel via which the two work areas of the manoeuvring station are connected. Visual contact between the operating positions of each winch does not exist due to the superstructure between them.

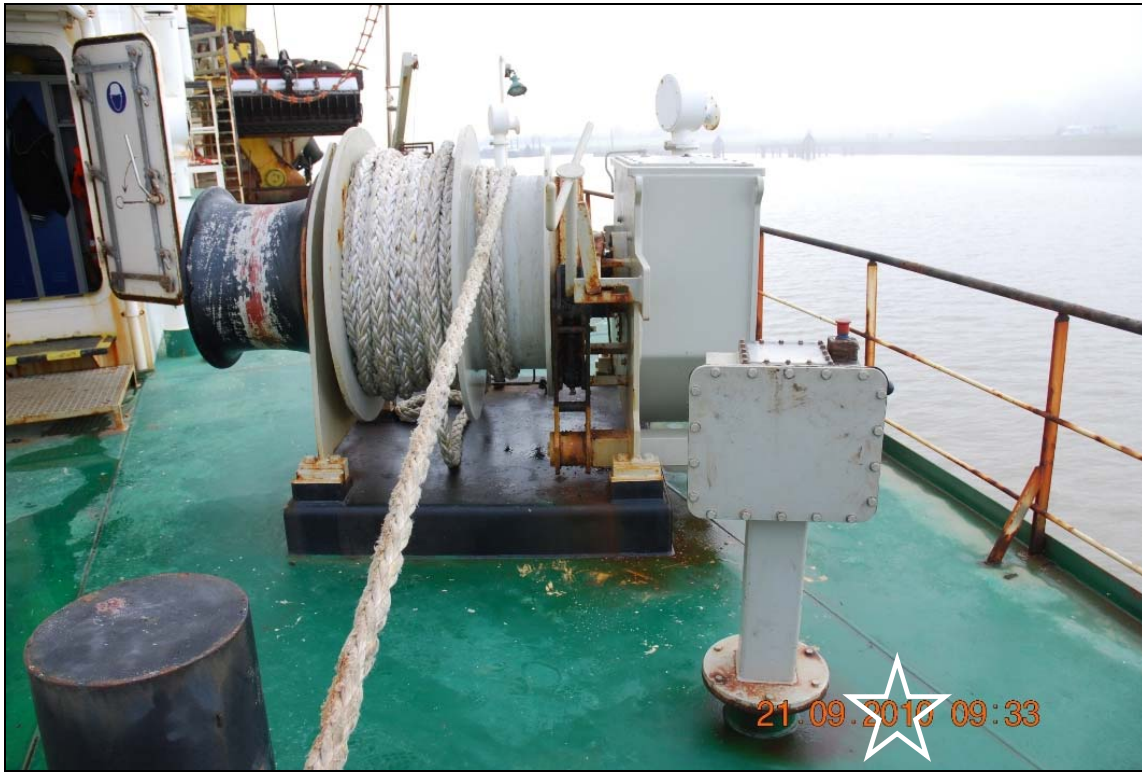
**Figure 4: Aft manoeuvring station, starboard side (2)<sup>7</sup>**

**Figs. 4 ff** below illustrate the position of the chief officer at the operating lever of the winch at the time of the accident (see white marking).

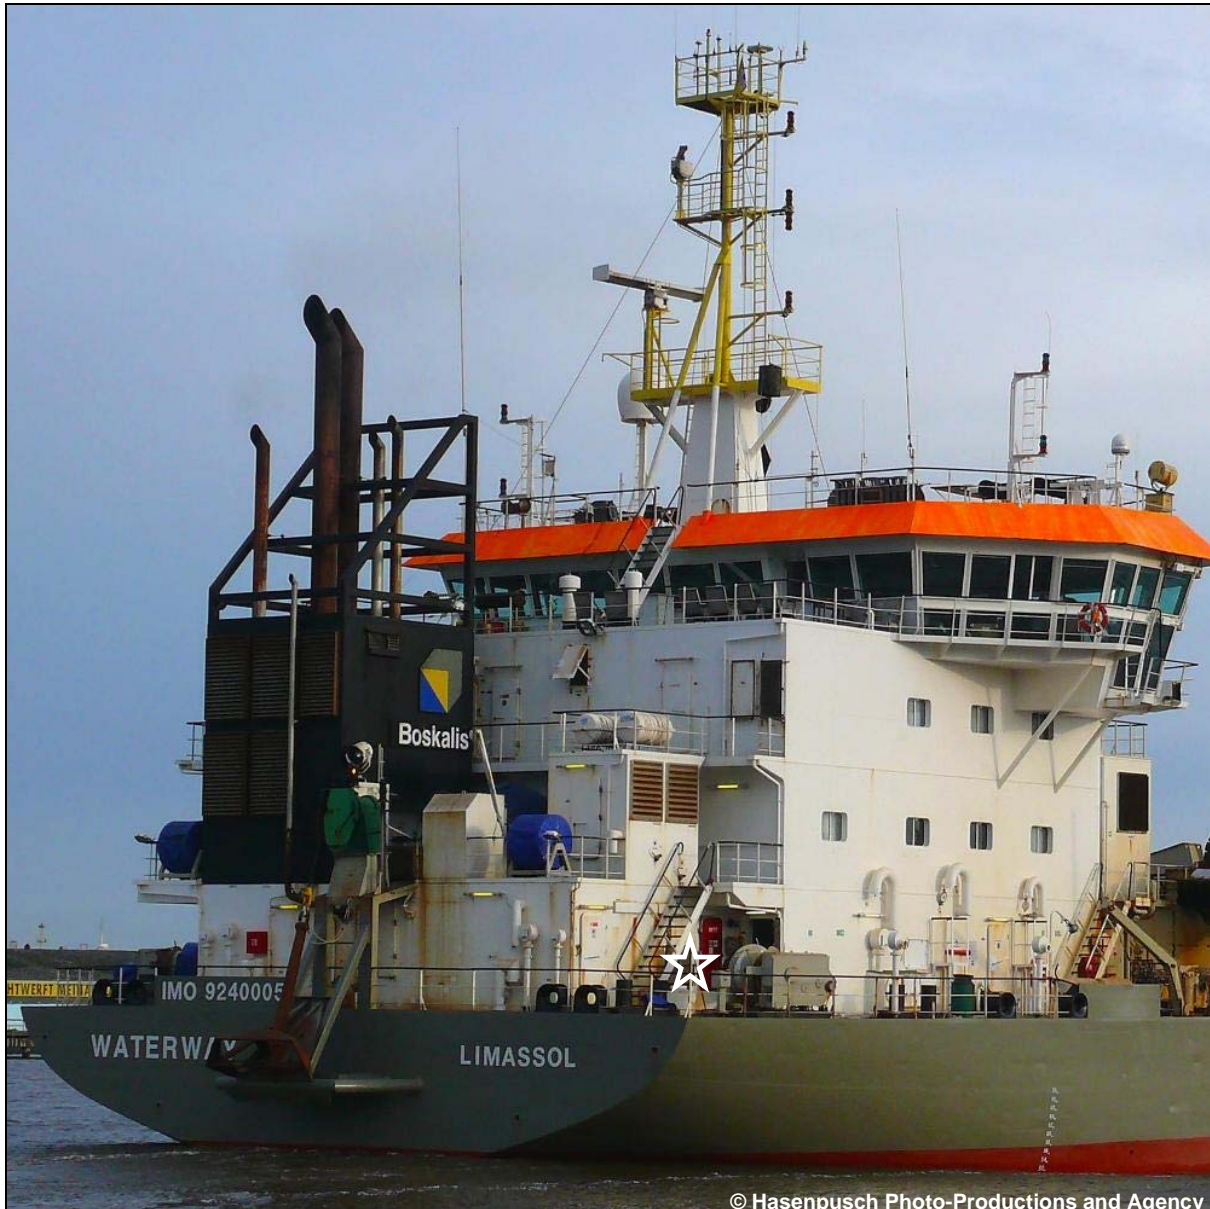
Figure 7: Long shot of the aft section of the WATERWAY

**Fig. 7** (see below) illustrates the structural features of the aft section of the WATERWAY, especially the arrangement of the aft manoeuvring stations in two separated work areas, which are relatively far apart on the port and starboard side of the dredger. The visibility on the aft section and the affect of operating noises offer a reasonable explanation as to why the cries of the chief officer and his helpless state were not noticed by the crew members working in the port work area, while this was possible for the master from the outer area of the bridge deck.

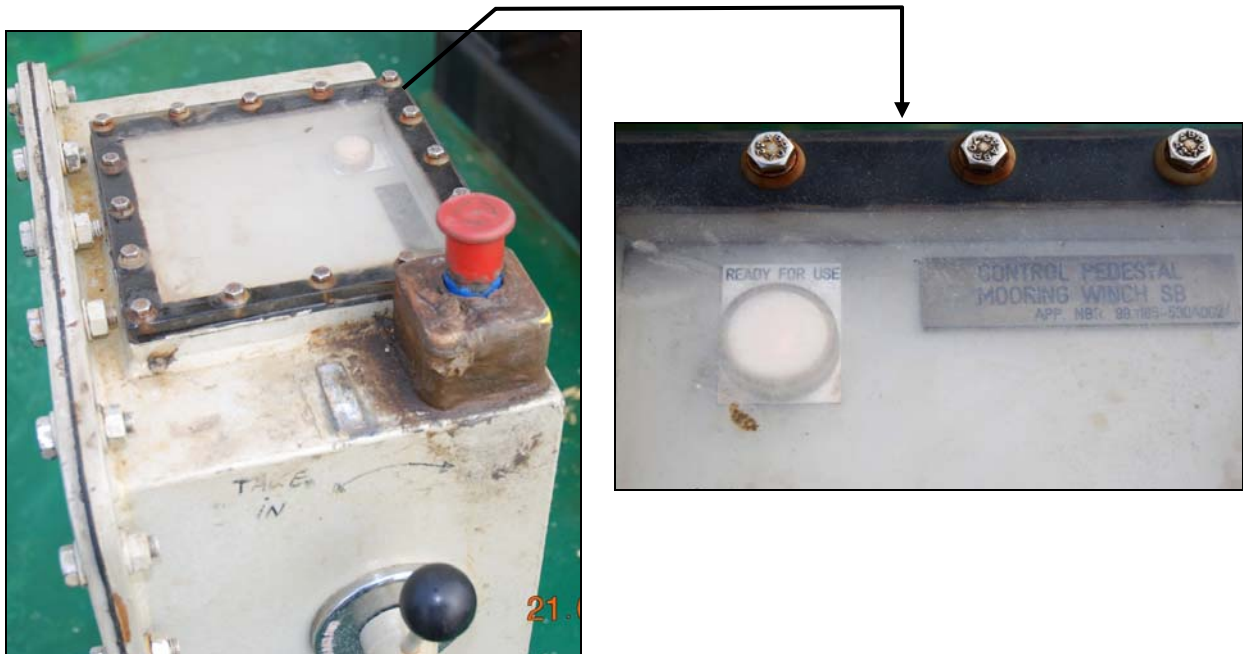
**Figure 9: Control station (close-up)**

The winch is controlled by means of a control station. A horizontally adjustable, spring-loaded operating lever is mounted on the side of this control station, which – based on its vertical starting position – can be moved about 60 degrees back and forth in the fore and aft direction. A red emergency stop button and a window with a power-on lamp are positioned on the top of the control panel (see **Fig. 9** below)

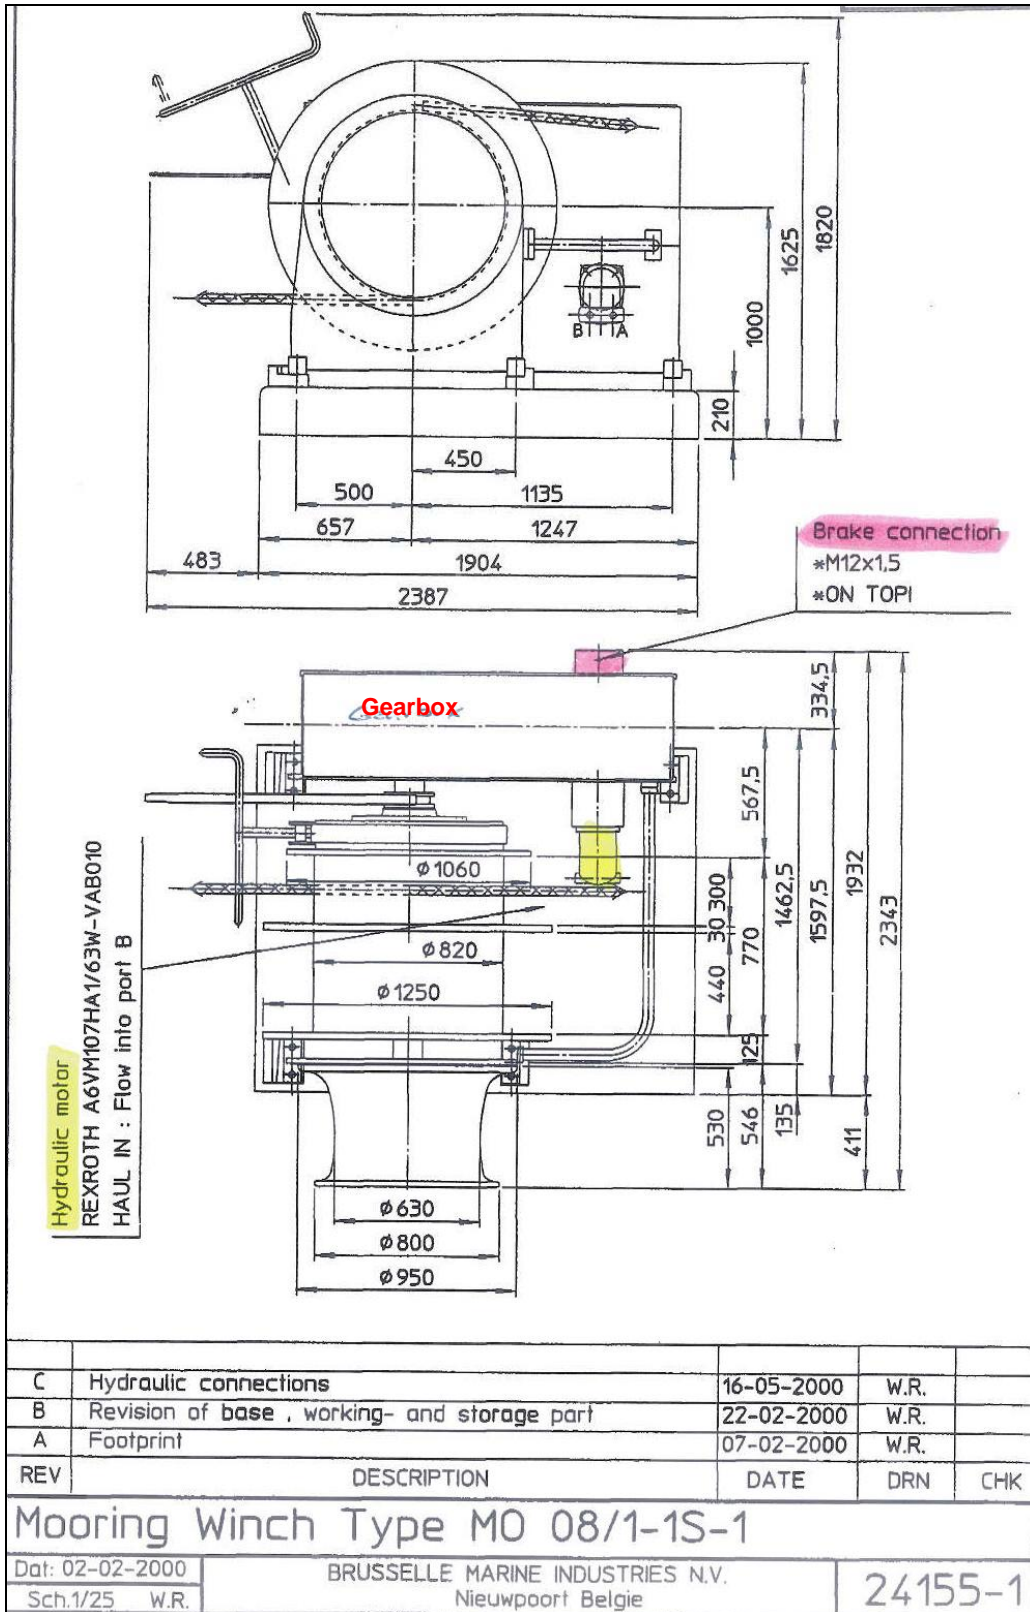
Figure 10: Technical drawing – hydraulic winch<sup>10</sup>

When the operating lever is released, a spring returns it to the neutral position. The oil flow in the system is 'short circuited' and after a built-in delay, the brake on the reduction gear is activated by a spring due to the lack of oil pressure.

The engineering company concludes that the delay (stopping time) of the system on board the dredger WATERWAY can be explained by an electronic setting (probably on the PCB of the control electronics). It was not possible to establish why this was set at a value of 3.5 seconds. A modification to the delay value to about 2 seconds should be possible for the winch manufacturer or an authorised service operation without excessively complex technical implications.

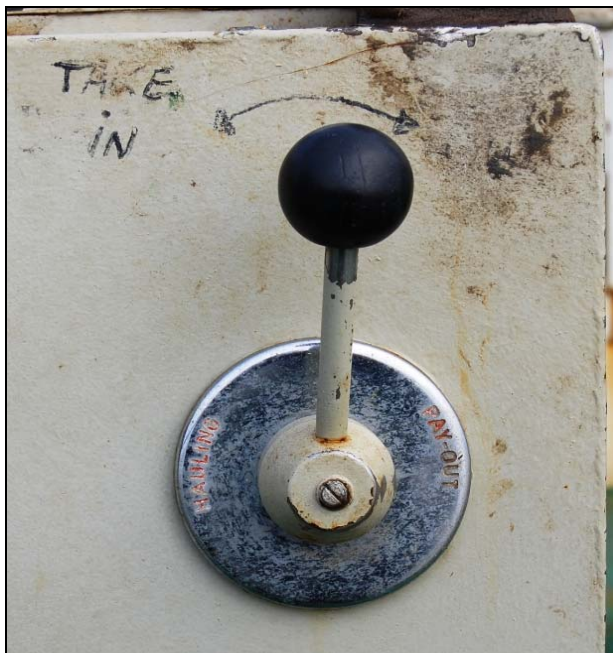
**Figure 11: Operating lever 'label'**

The handwritten and only partially readable 'label' on the winch's control station shows that uncertainty with respect to the direction of rotation of the winch in relation to the respective lever position apparently also existed before the accident (see **Fig. 11**).

'TAKE IN' aims to indicate that setting the lever in the corresponding direction causes the stern line to be hauled in. The red labels 'HAULING' and 'PAY-OUT' stamped on by the manufacturer also refer only to handling a stern line, but do not account for the fact that the necessary direction of rotation of the winch and thus the direction of the operating lever reverse when hauling in/paying out a spring (i.e. a line that runs in the direction of the fore section) using the capstan head.

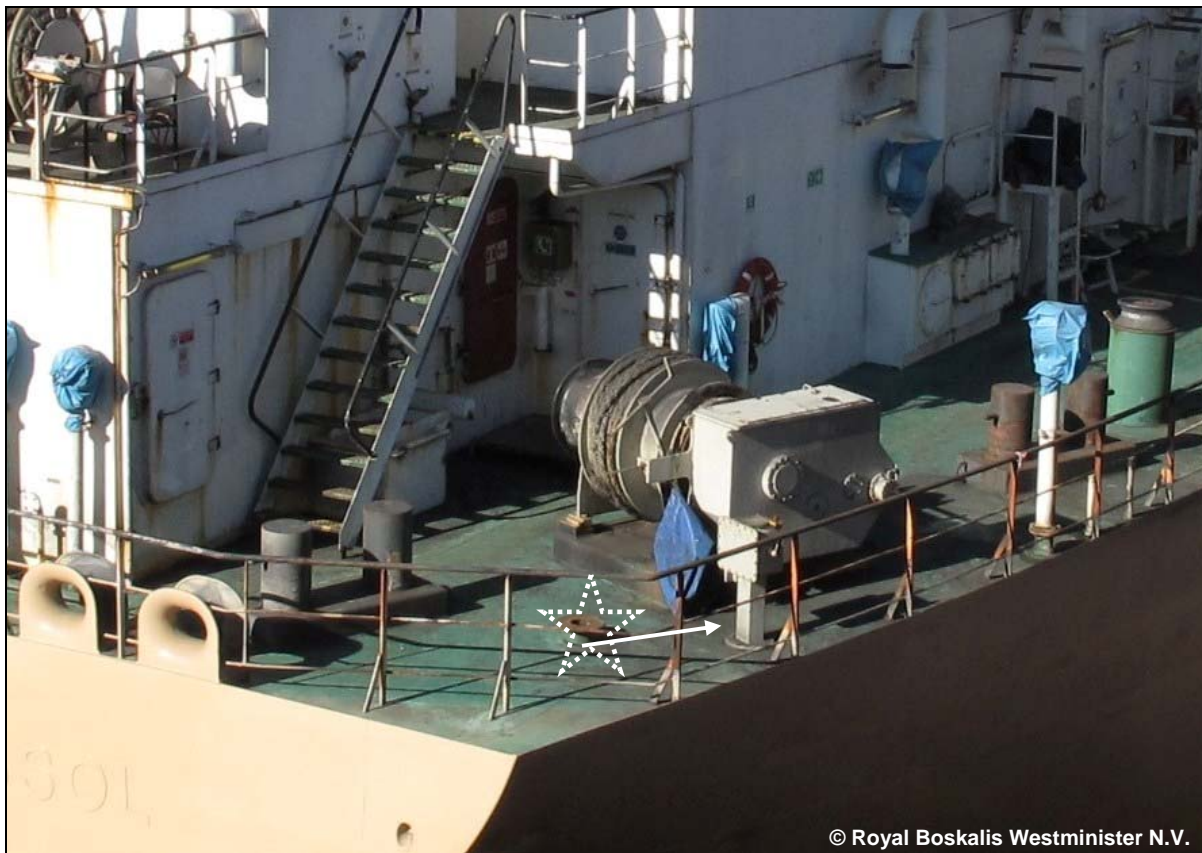
Figure 12: Old and new position of the control unit of the winch<sup>17</sup>

<sup>17</sup> Movement of the position of the control unit: See white marking from the author of the report!

3. *The control units of the winches on the stern of the WATERWAY and her sister ship COASTWAY have been moved to a different position and each equipped with a safety cage for the winch driver (s. **Figs. 12 ff**).*
4. *Meanwhile, the mooring/unmooring activities are an inherent part in the standard risk assessment on board of all company vessels.*
5. *Responsibilities for the mooring operations are displayed on board.*
6. *Boskalis is in contact with the manufacturer of the winch to reduce the stopping time of cable drum after stop function.*

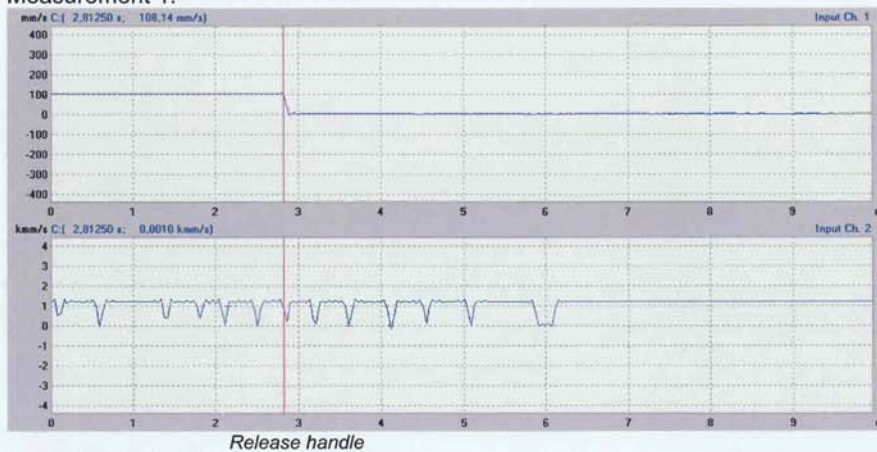
Measurement 1:

Approximate duration: 3.5 seconds.  
Approximate distance: 1.5 meters

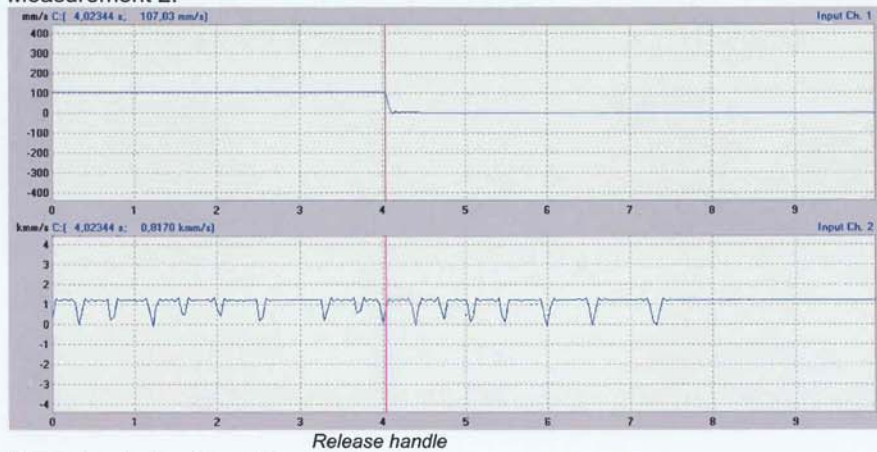
Measurement 2:

Approximate duration: 3.5 seconds  
Approximate distance: 1.5 meters

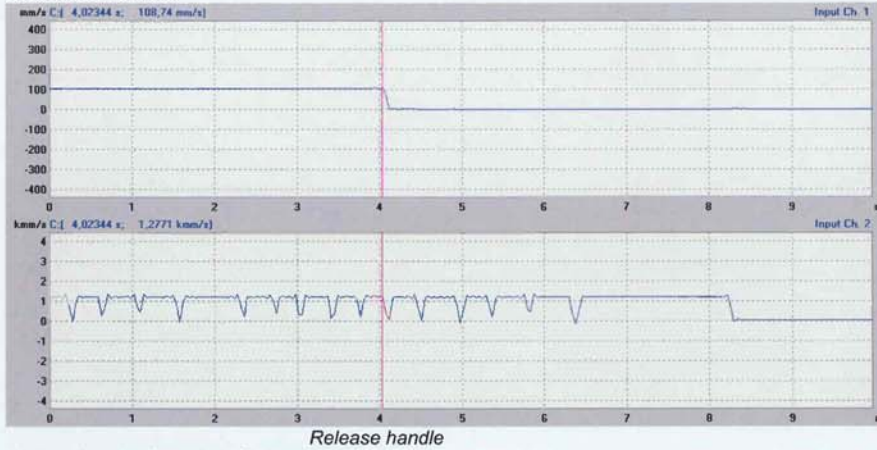
**Measurement 3:**

Approximate duration: 3.5 seconds  
 Approximate distance: 1.5 meters

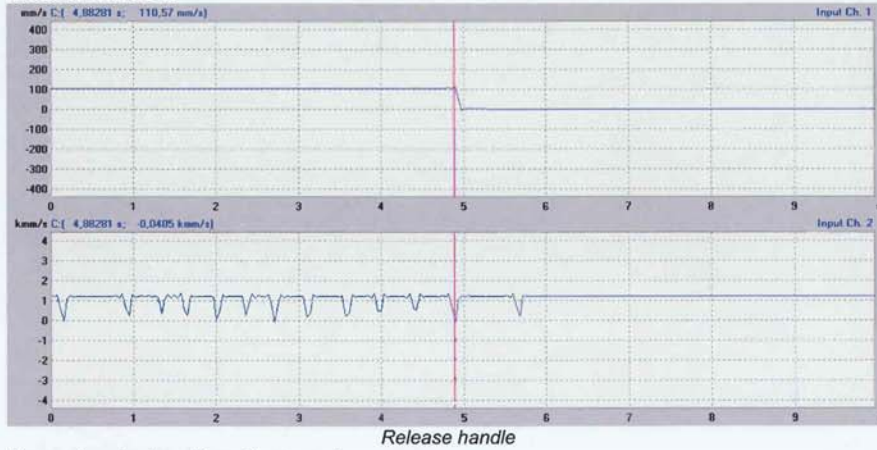
**Measurement 1:**

Approximate duration: 1 second  
 Approximate distance: 0.5 meters

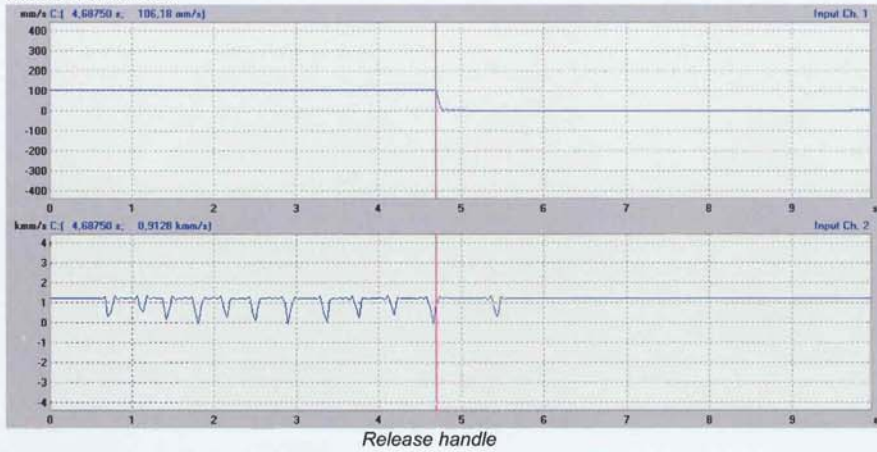
**Measurement 2:**

Approximate duration: 1 second  
 Approximate distance: 0.5 meters

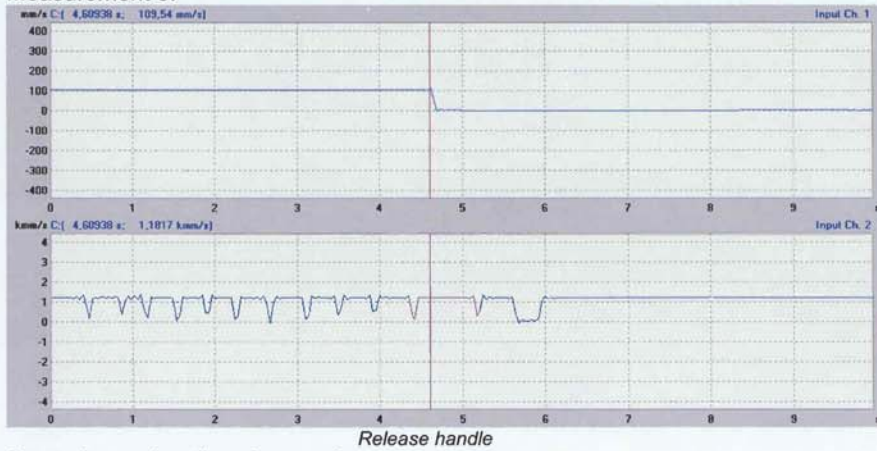
**Measurement 3:**

Approximate duration: 1 second  
 Approximate distance: 0.5 meters

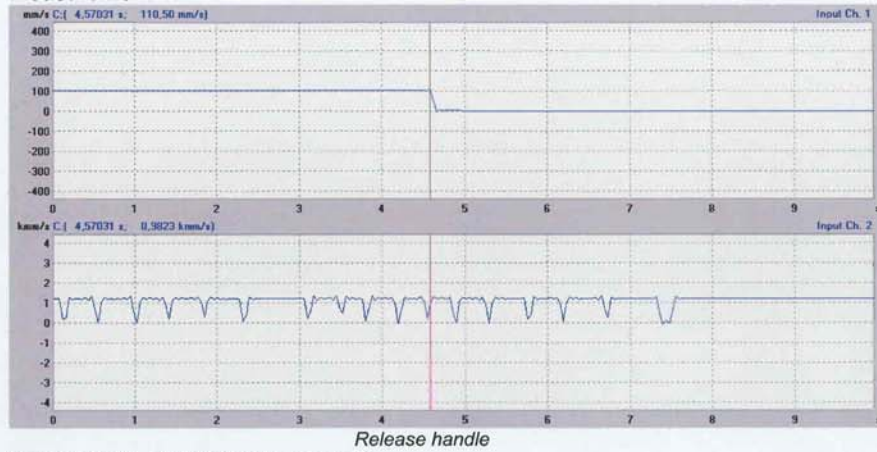
**Measurement 1:**

Approximate duration: 3.5 seconds  
 Approximate distance: 1.5 meters

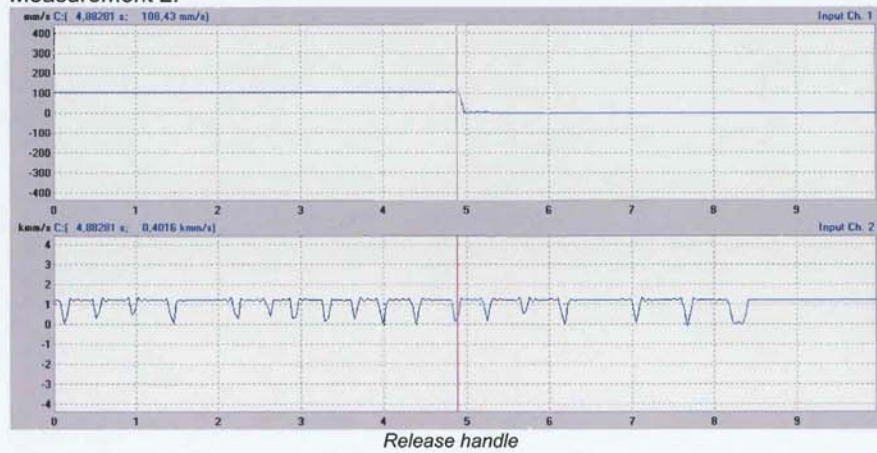
**Measurement 2:**

Approximate duration: 3.5 seconds  
 Approximate distance: 1.5 meters

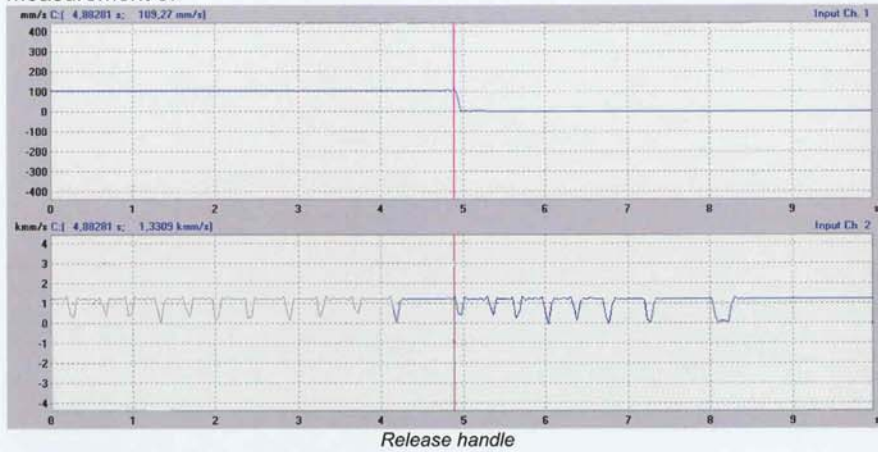
**Measurement 3:**

Approximate duration: 3.5 seconds  
 Approximate distance: 1.5 meters

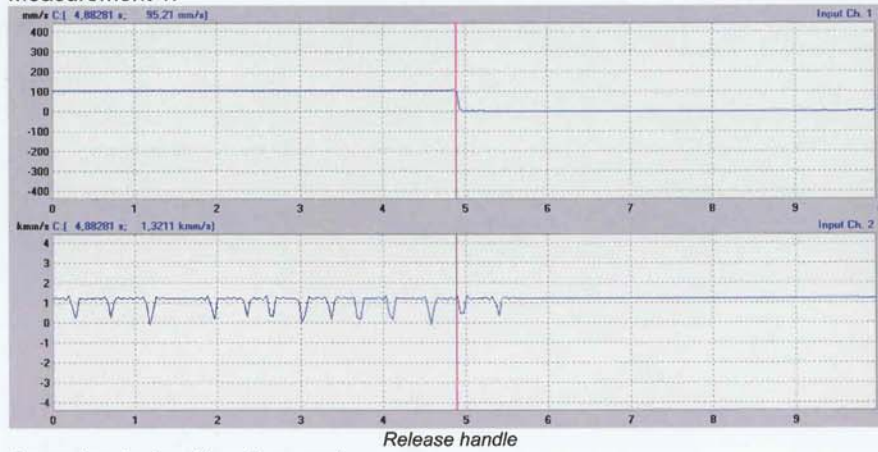
**Measurement 1:**

Approximate duration: 1 second  
 Approximate distance: 0.5 meters
