Investigation Report 415/10

**Very Serious Marine Casualty**

**Fatal accident  
on board the MV THULE  
in Naantali, Finland  
on 22 September 2010**

2 April 2012

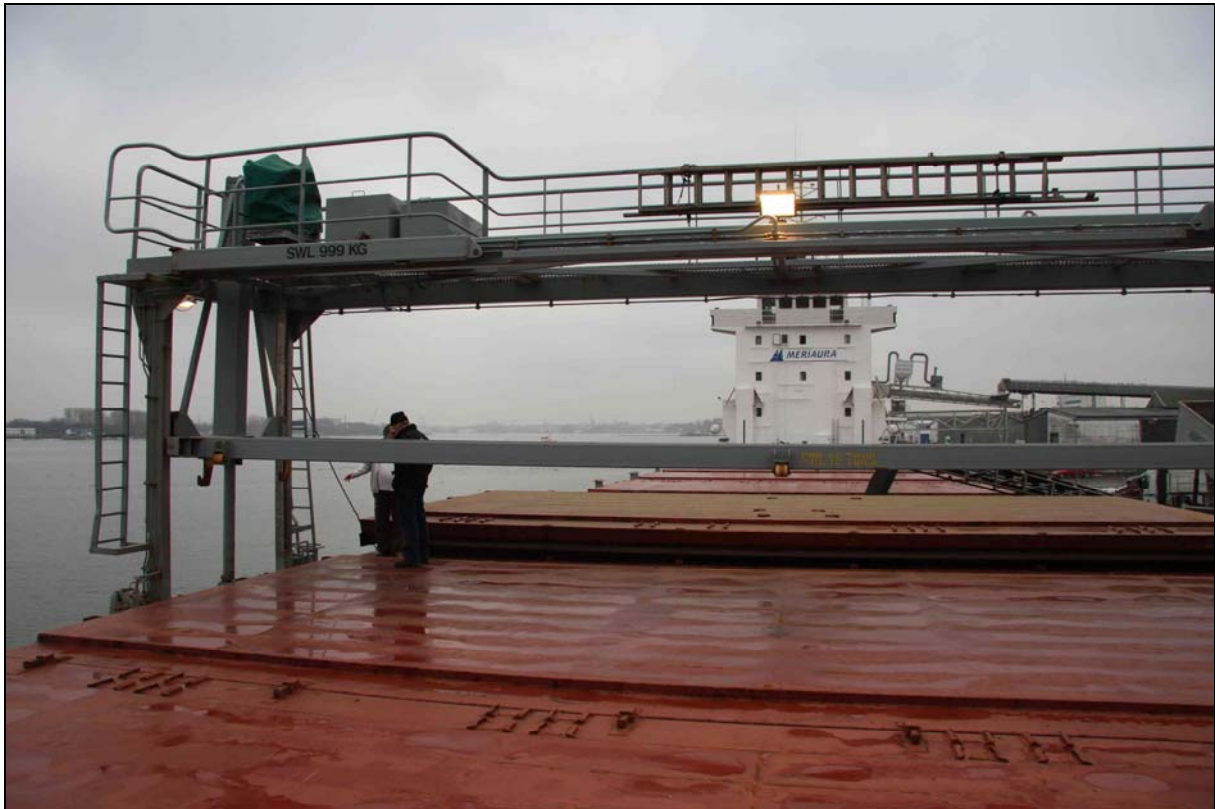
The hatch cover was to be moved while rape was being unloaded with a suction dredger. In the process, one ordinary seaman was reportedly on the platform of the gantry crane and the other on deck to give directions. There were no eyewitnesses. Direct visual contact did not exist between the crane's control position and the position on the catwalk in which the accident occurred. The height of the hatch coaming is 2.20 m. Both ordinary seamen were wearing overalls, helmets, safety shoes and protective gloves. Traces of blood were found on the 1.10 m high guard rail.

Figure 4: Gantry crane, platform and control position

It is recommended that the shipyard Bodewes Scheepwerf Volharding Foxhol B.V. include more ladders on the coaming in the design of the Coops & Nieborg hatch and crane system and with regard to positioning the gantry crane also consider monitoring by closed circuit TV so that the crane operator can see the side passageways.

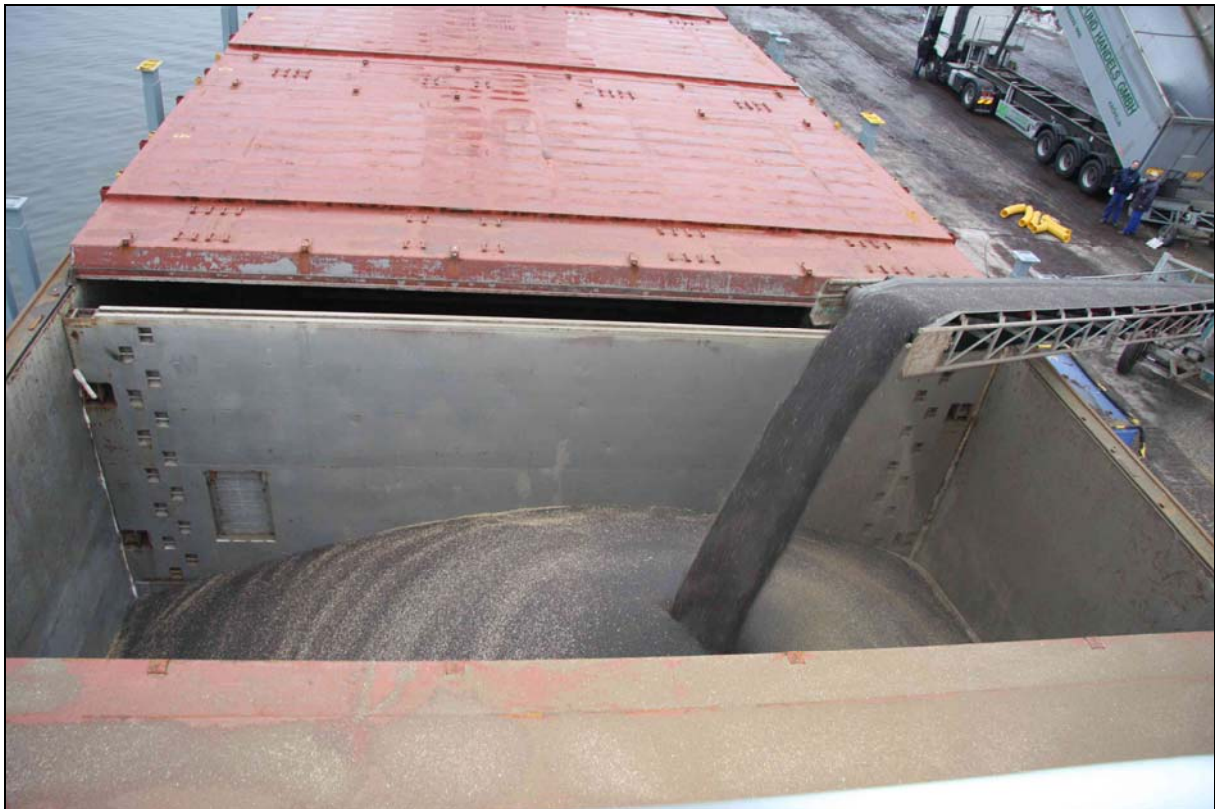
Figure 5: Cargo hold viewed from the crane platform

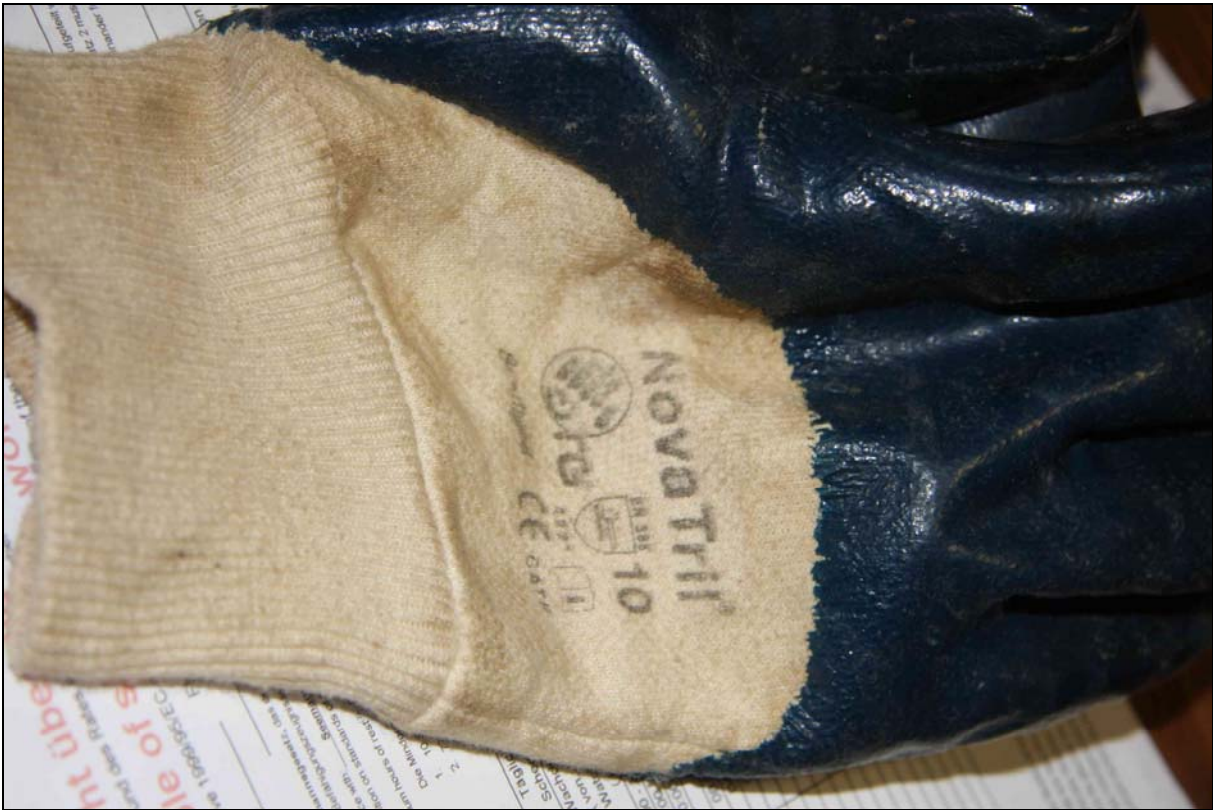
A pontoon cover was to be shifted. To that end, the second ordinary seaman climbed onto the hatch coaming and used the guard rail for support. Presumably, he lost his footing while grasping the coaming, fell backward onto the deck and struck the guard rail with his head. He was wearing NovaTril mixed fabric gloves made by 'atg'. The category 2, size 10 glove used is made using nitrile and lined with cotton. It is reportedly durable, resistant to grease and oil and is said to have good properties vis-à-vis grip in both dry and wet conditions. It is certified according to the CE EN388 standard and has been tested for compatibility, abrasion, cut, tear and puncture resistance. Typical applications are reportedly construction and rail, the sheet metal, plastics and metal industries, waste management, forestry, agriculture and fisheries.

Figure 7: Protective glove

The BSU recommends that the owner of the MV THULE describe in more detail the handling procedures for moving hatch covers with the gantry crane during loading/unloading operations in the SMS manuals, arrange for more ladders to be mounted permanently on the hatch coaming, equip the crew with portable transceivers, and keep a selection of protective gloves that are appropriate to the requirements of the place of duty available on board in different sizes.

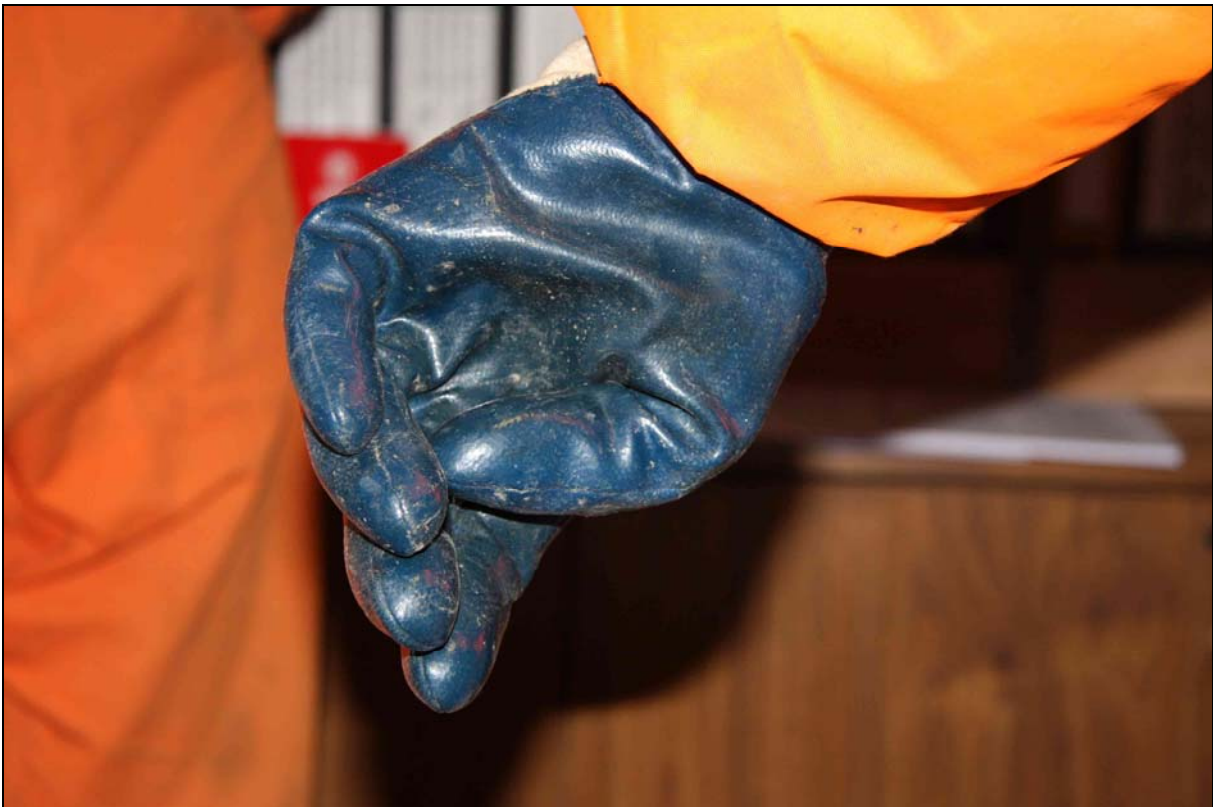
Figure 8: Grip surface of the protective glove

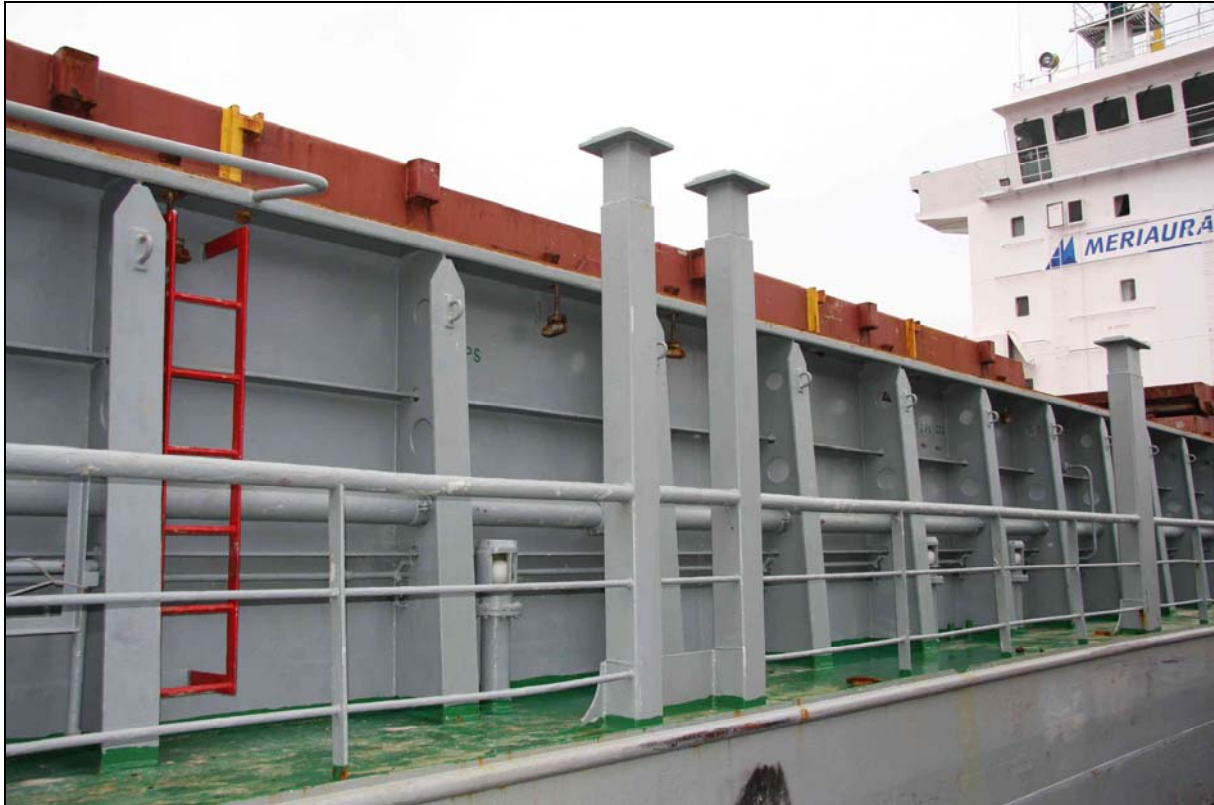
No ladder was located in the immediate vicinity of the accident and there were only three permanently installed along the whole of the hatch coaming. It would have been possible to operate safely on the hatch coaming with a ladder. An additional handhold and support possibility is offered by the rail above the ladder. The ordinary seaman would also have been protected from behind. There is no direct visual contact between the crane operator on the starboard side and the person on the port side service corridor giving directions. There was also no radio contact by means of handheld transceiver.

Figure 9: Ladder with rail

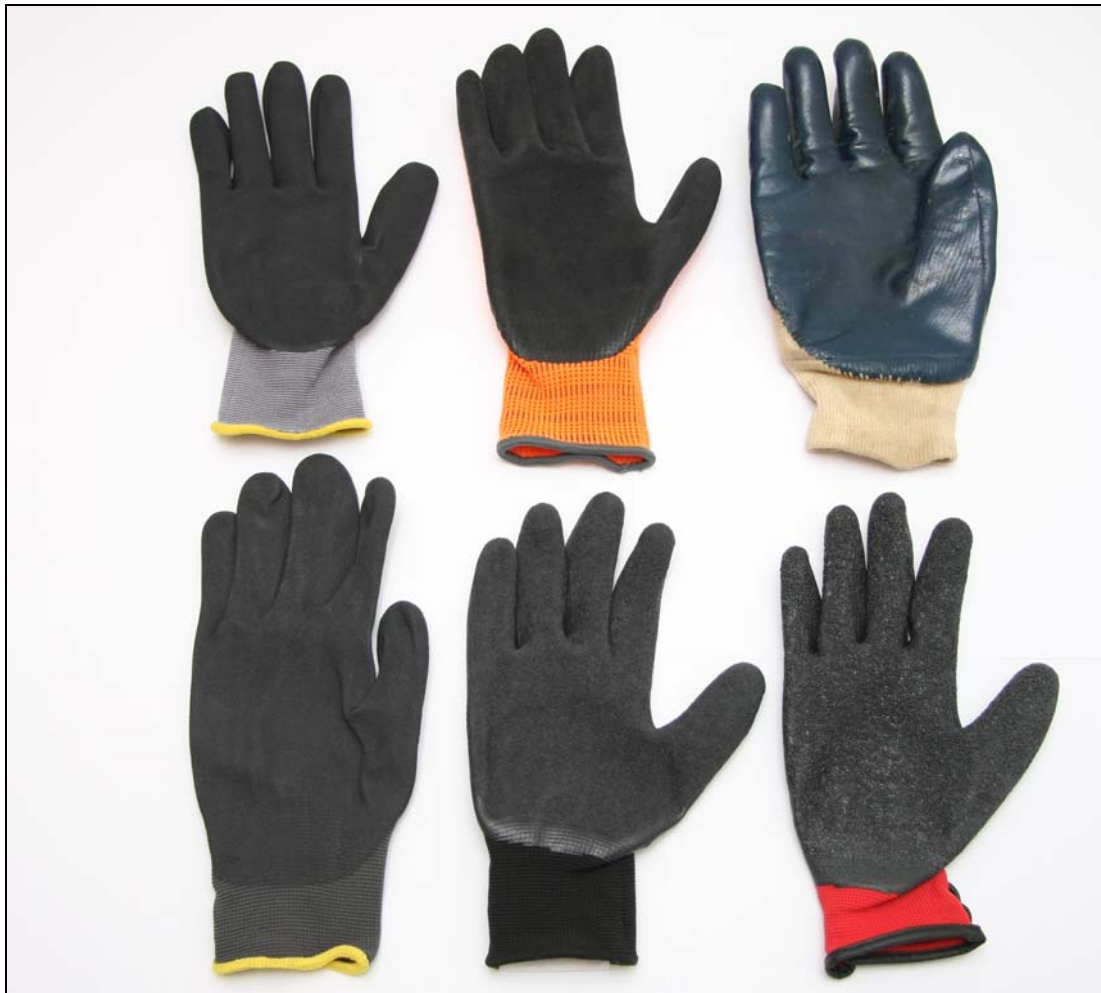
BIG Arbeitsschutz GmbH, a distributor of the nitrile gloves used on board, which are manufactured by ATG Lanka Private Ltd., was kind enough to provide the BSU with exemplary pairs of the protective gloves, all of which were classified according to the CE EN388 standard. In terms of fit and slip resistance, all the size 10 samples were better than the nitrile gloves without gripper dots. In this regard, it should be noted that all the gloves had gripper dots on the inner side and that nitrile gloves with gripper dots are also available on the market. In the case of the fatal accident on the MV THULE, it was noted that only the same type had been made available in size 10 for all the shipboard activities. This type (see Fig. 10, top right) is very large and did not fit any of the employees of the BSU. In the testing standards, there are no criteria for fit, size designation, application or non-slip properties. In the opinion of the distributor, it is likely that additional standards would complicate the distribution of protective gloves. Basically, every seaman should check that his gloves are fit for purpose and try them on.

Figure 10: A comparison of the gloves
