Investigation Report 445/10

Very Serious Marine Casualty

**Fire on the
ro-ro passenger vessel
LISCO GLORIA
on 8 October 2010
north-west of Fehmarn**

1 February 2012

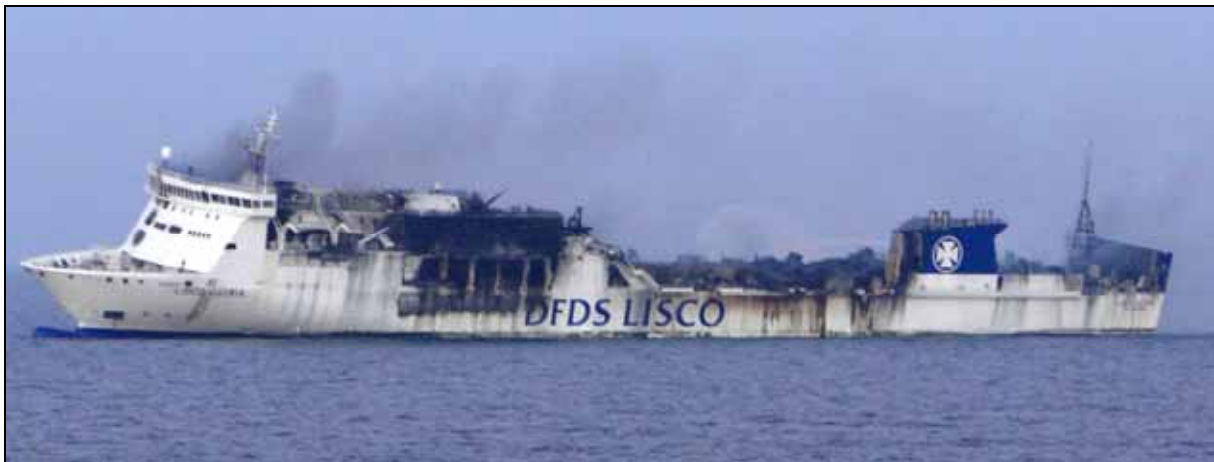
Figure 8: LISCO GLORIA after the fire

The LISCO GLORIA was damaged so heavily by the accident (see Fig. 8) that she was declared a constructive total loss. The superstructure as well as cargo decks 4 and 6 were completely gutted by the fire. Beyond that, amongst others, the engine room was damaged by water used for fighting the fire and by smoke.

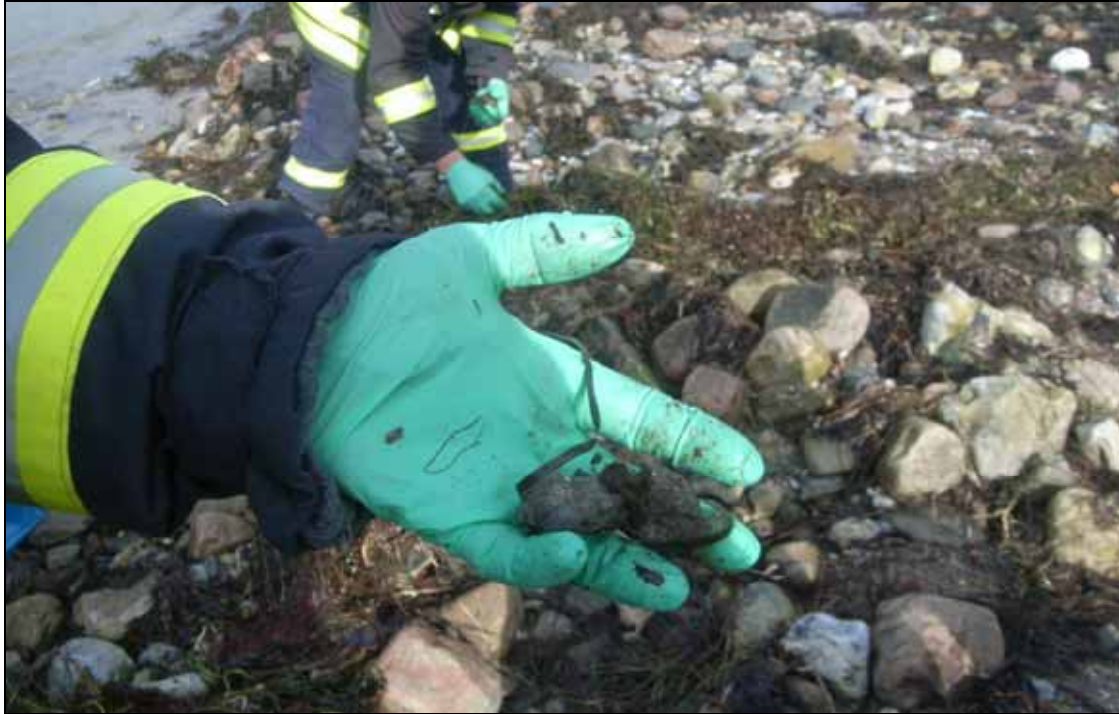
Figure 11: Contamination on the beach at Lindhöft

In the days following the fire aboard the LISCO GLORIA, there were isolated cases of sooty lumps of fat (see Fig. 11) being washed ashore on both the German and the Danish Baltic Sea coast.

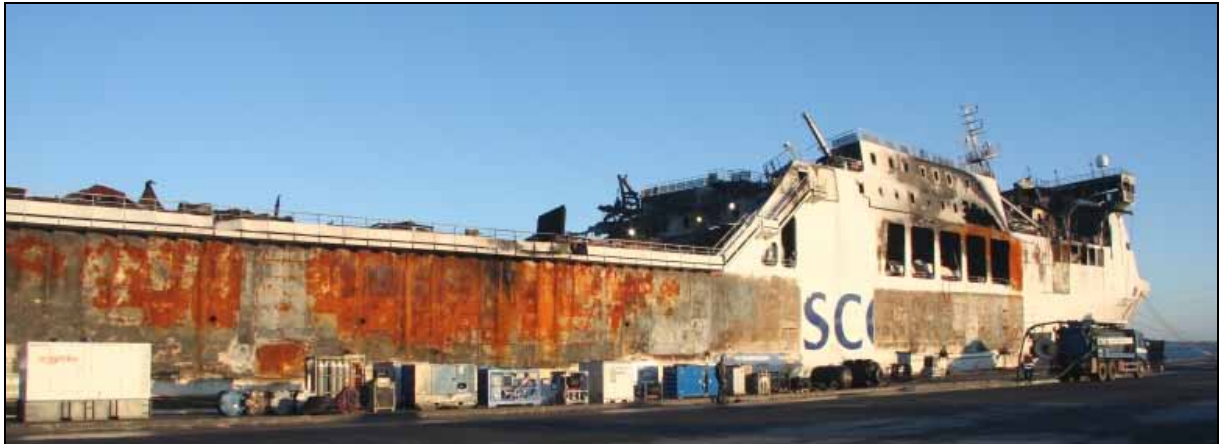
Figure 13: LISCO GLORIA alongside the pier in Munkebo after the fire

Large areas of shell plate coating were burned on the side (see Fig. 13).

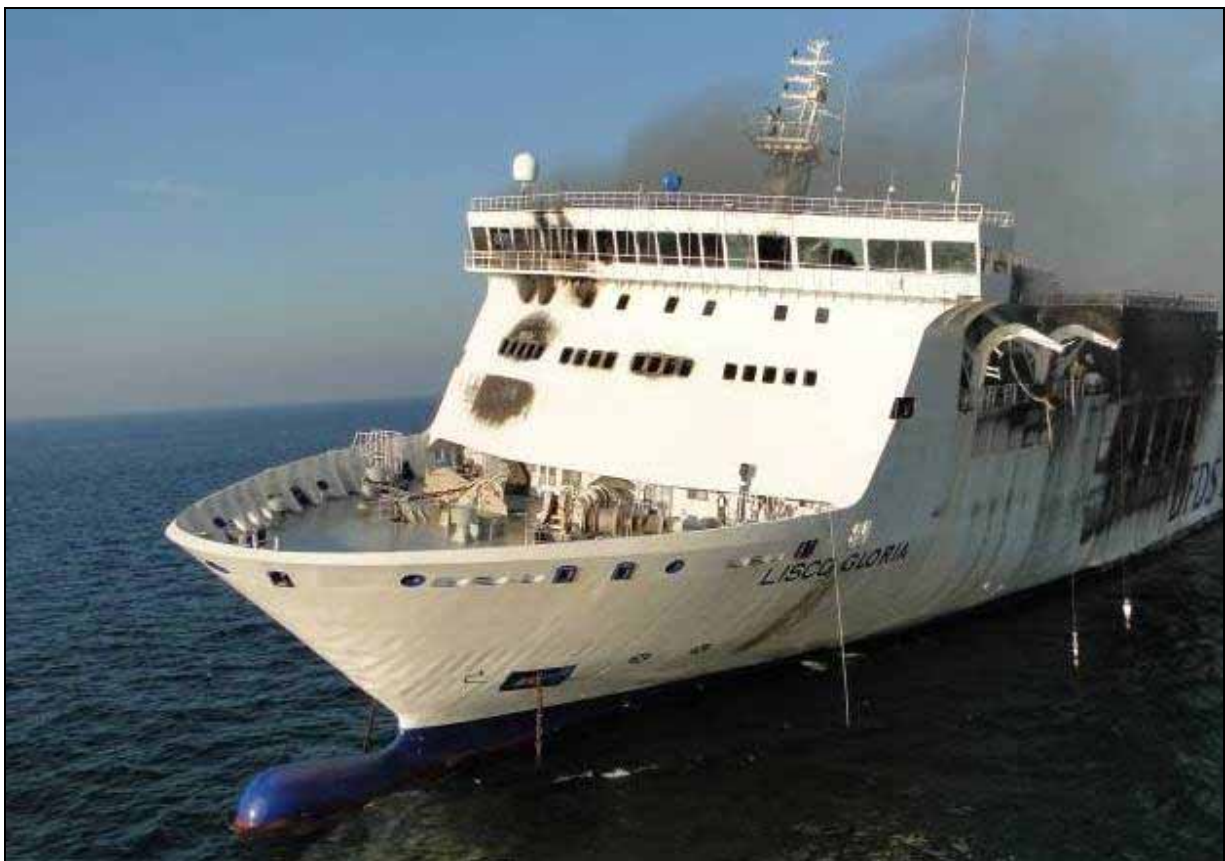
Figure 14: Hardly damaged forecastle of the LISCO GLORIA

In contrast, the bow's coating as well as the forecastle were hardly affected by the fire (see Fig. 14).

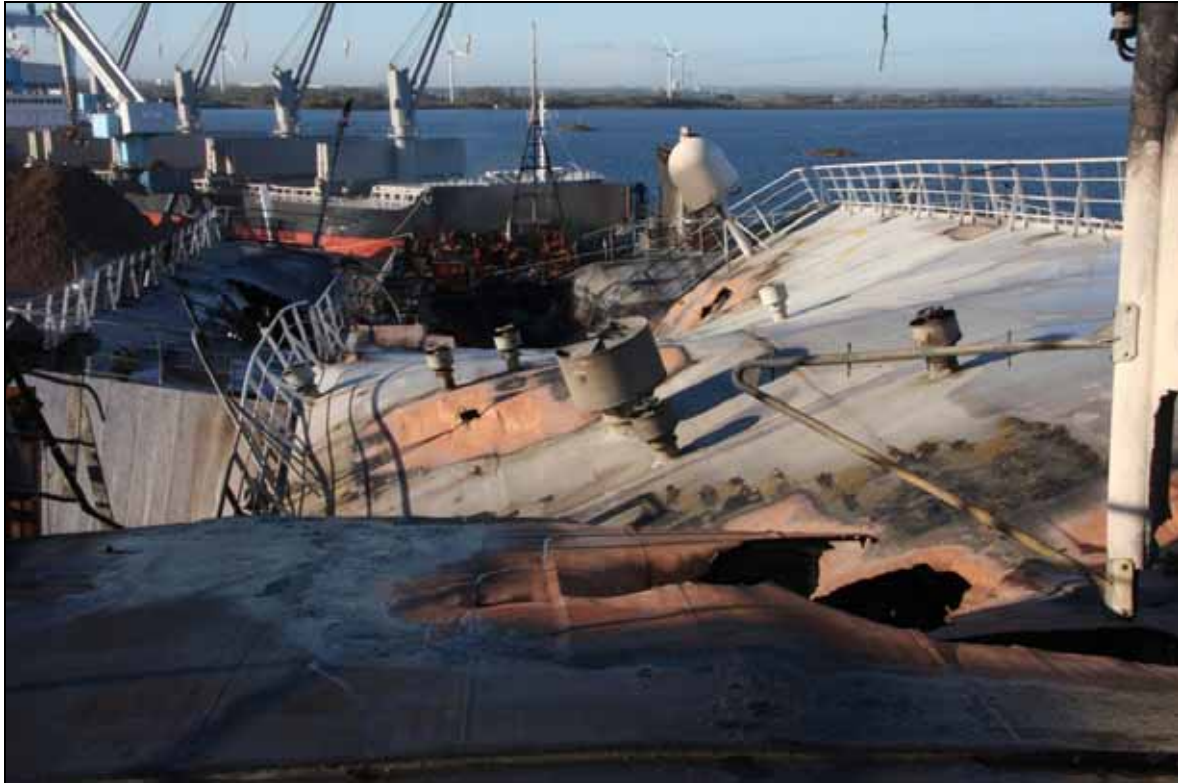
Figure 15: Structural damage in the superstructure, view from observation deck to the stern

For the most part, the superstructure had collapsed on the starboard side (see Fig. 15). The accommodation decks 7 and 8 were completely destroyed (see Fig. 16).

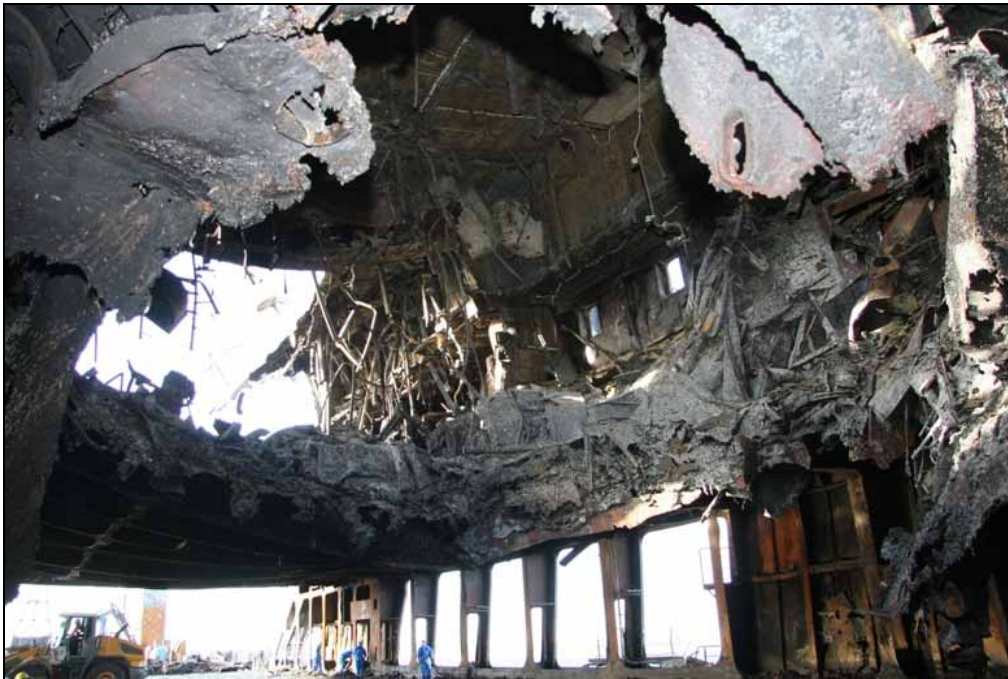
Figure 17: Fire funnel opening between deck 6 and the accommodation decks above

The steel ceiling between the upper deck and overlying accommodation decks showed signs of a very large fire funnel (see Fig. 17).

The starboard side had sustained far more severe structural damage than the port side. In relation to the longitudinal axis, the fire funnel (origin: frames 210 to 220) was offset slightly to starboard. On the other hand, the outside area on the port side on deck 9 showed only limited damage, was still passable and partially equipped with intact wooden table sets (see Fig. 18).

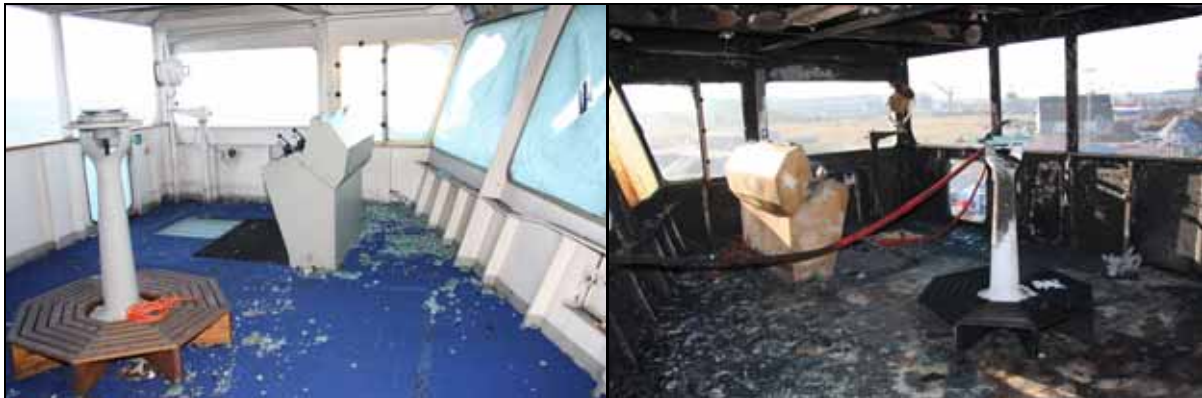
Figure 19: Port and starboard bridge wings

The investigation team had access to the bridge via deck 9 (port side). Unlike the rest of the bridge, there was no fire damage to the port wing (see Fig. 19).

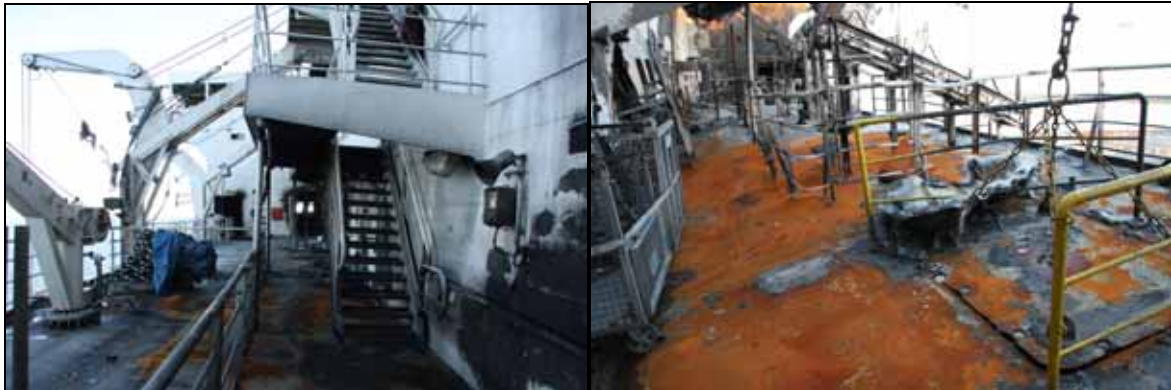
Figure 22: Lifeboat station to port and to starboard, view to the bow

The severity of fire damage suffered by the lifeboat station on deck 7 was considerably less to port than to starboard (see Figs. 22 and 23).

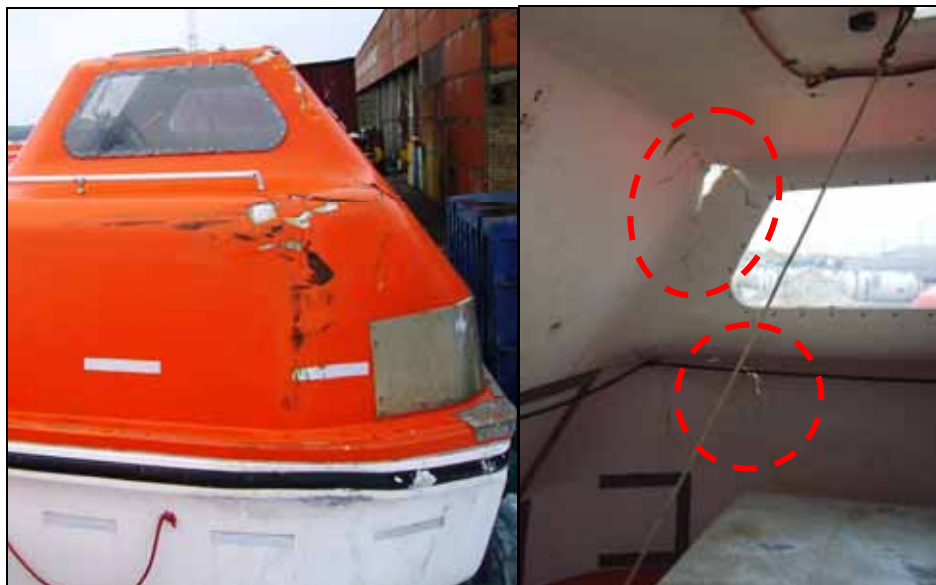
Figure 28: Damage to the stern of Lifeboat 1, view from outside and from inside

Each lifeboat was able to accommodate 150 people. Both boats on the LISCO GLORIA were taken to Klaipėda after the accident and examined there by the Lithuanian investigating authority (see Fig. 27). Here, damage was found on the stern of Boat 1 on the port side (see Fig. 28). A video, which was recorded on board the NEUSTRELITZ, indicates that the damage resulted from the lowering of the boat at LISCO GLORIA. Other damage or deficiencies were not found.

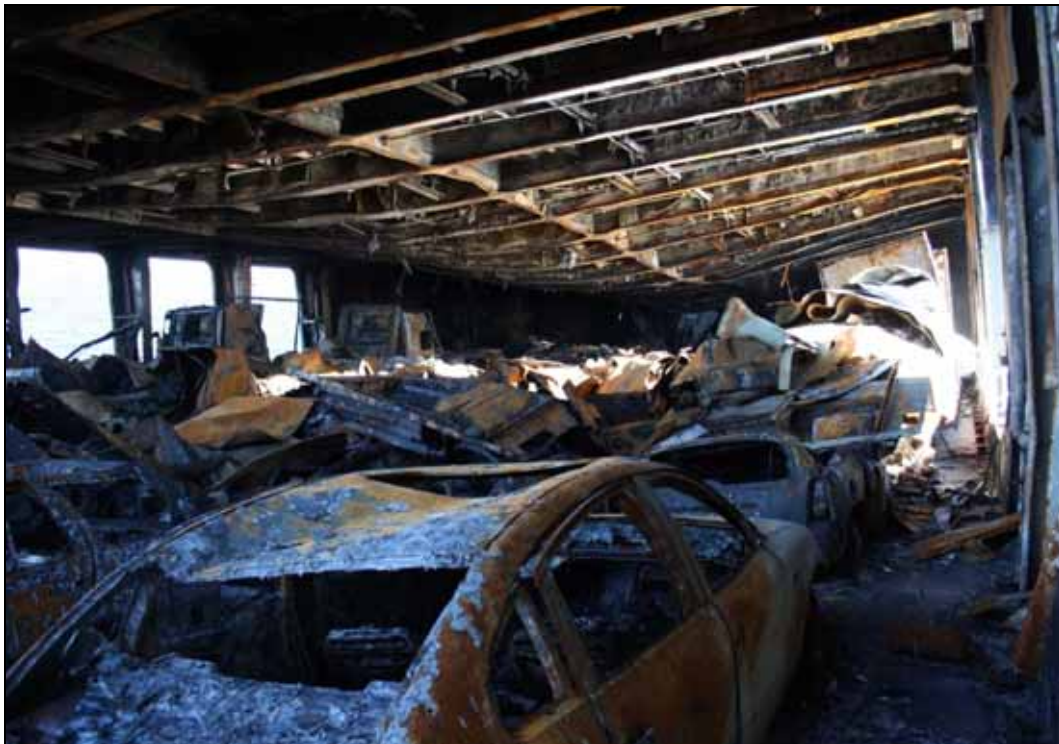
Figure 29: The remains of cargo in the garage area of the upper deck

A scene of destruction (see Figs. 9 and 29) prevailed throughout the upper deck (deck 6). The remains of the trucks, trailers and cars parked there formed a confusing mixture of debris. Only an extremely limited inspection was possible during the first survey.

Initially it was not possible to determine any clear pattern of fire damage.

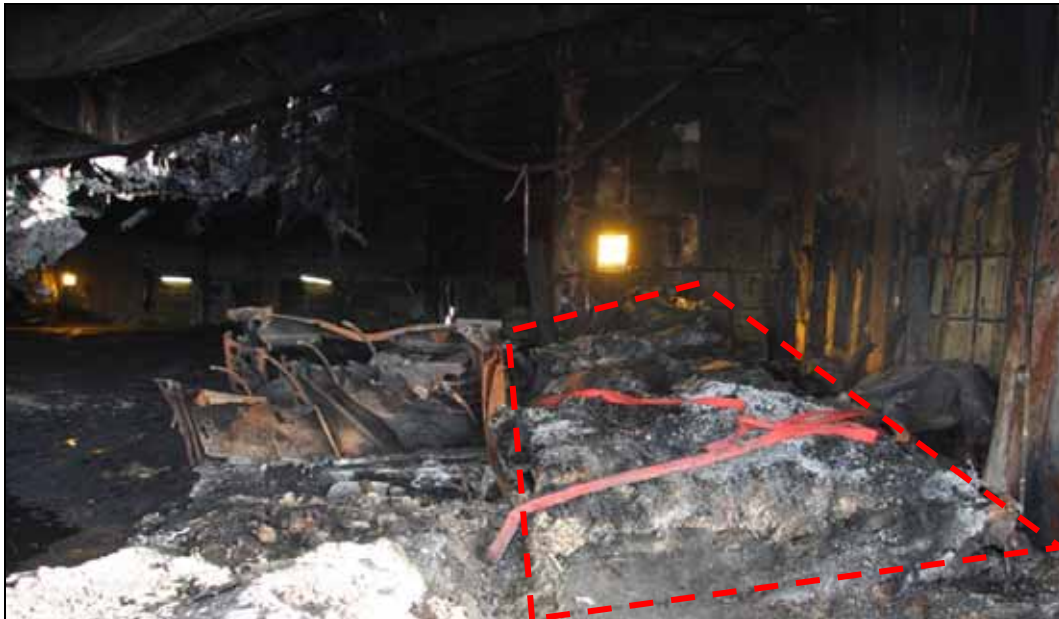
Figure 34: Remains of the truck and refrigerated trailer on lane 8

The heavily damaged remains of a truck with a refrigerated trailer were found in the first parking position on lane 8 (see Fig. 34).

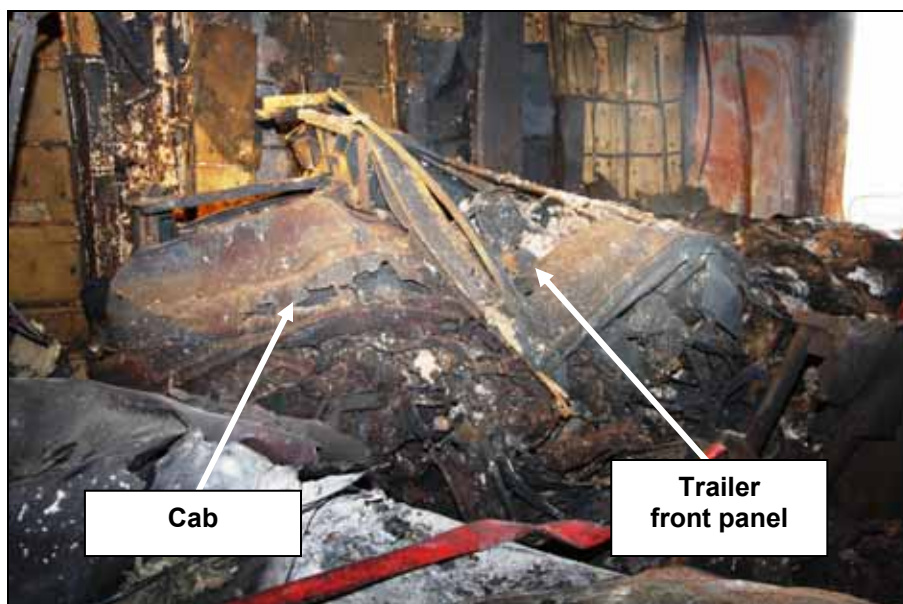
Figure 35: Collapsed truck on lane 8

The cargo consisted of offal (chicken necks). The registration number of the trailer was still legible and corresponded with the truck/trailer identified by the Kiel Criminal Investigation Department on 9 October 2010 on which the outbreak of fire was observed. As opposed to other towing vehicles, the cab of the truck had completely collapsed (see Fig. 35). Metal parts of the body had transformed into a condition which appeared brittle owing to the tremendous heat effect. They could be 'crumbled' simply by touch.

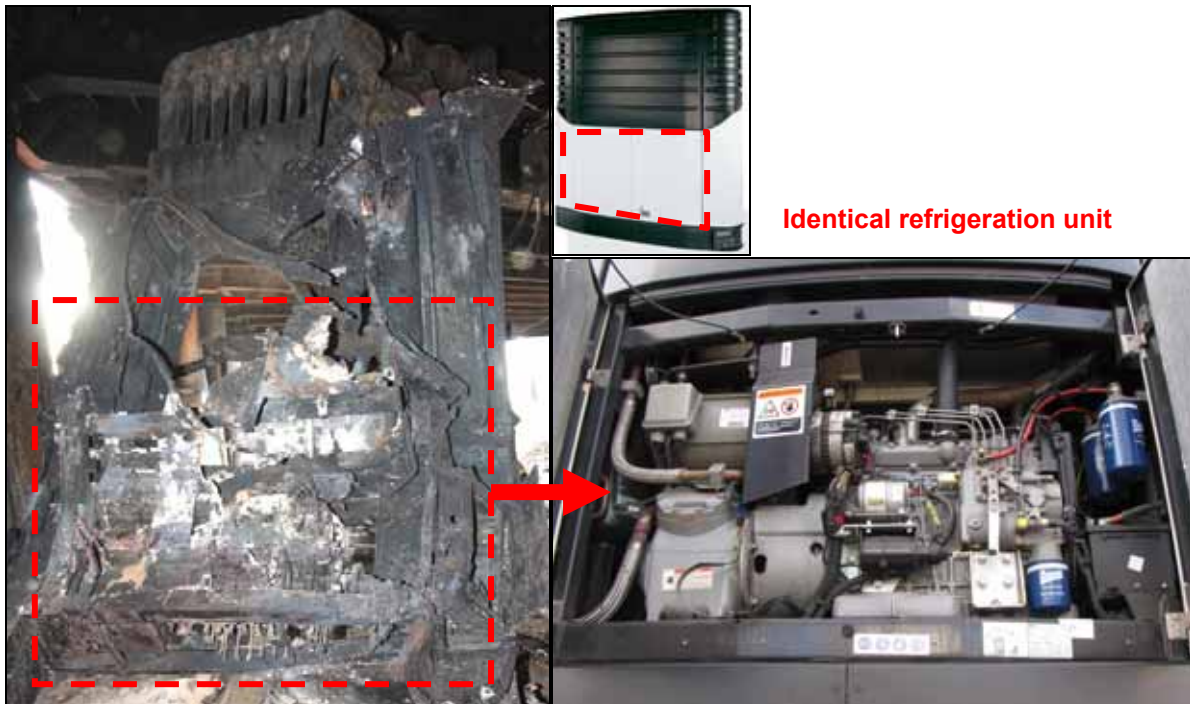
Figure 36: Remains of the refrigeration unit on the first refrigerated trailer on lane 8

The front panel of the trailer on which the remains of the refrigeration unit were still present was held upright using an excavator (see Fig. 36).

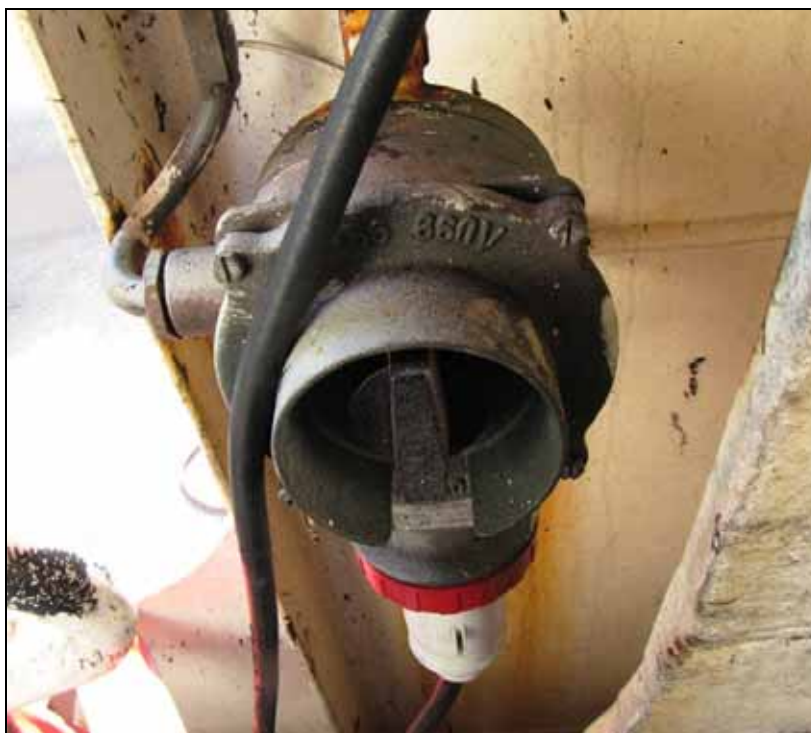
Figure 39: Slightly thermally stressed socket with an inserted plug (deck 6, lane 8)

To provide the trailers parked on the upper and the main deck with shipboard electrical power, switchable three-phase current power outlets with a rated current of 32A were mounted next to the frames. Using appropriate extension cables, a connection could be made between consumers and the vessel's electrical systems. On deck 6, several preserved switchable three-phase current power outlets were found in the area of frames 176 to 188 (starboard), which had only been slightly thermally stressed (see Fig. 39).

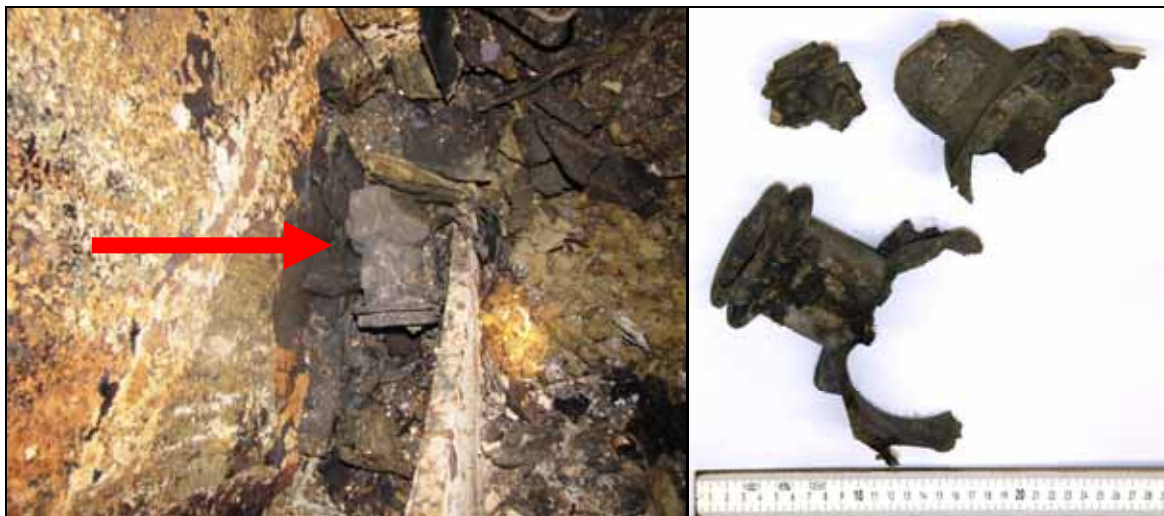
Figure 40: Remains of three-phase current power outlets at frame 200 (starboard)

According to the vessel's electrical plans, there were a total of eight three-phase current power outlets installed up to the end of lane 8 on the starboard side of deck 6 (frames 159 to 201). The two sockets that should be mounted at frame 201 were not present; therefore, these were searched for in the fire debris. It was possible to find fragmentary parts of two switchable three-phase current power outlets (see Fig. 40) in the area of frame 200.

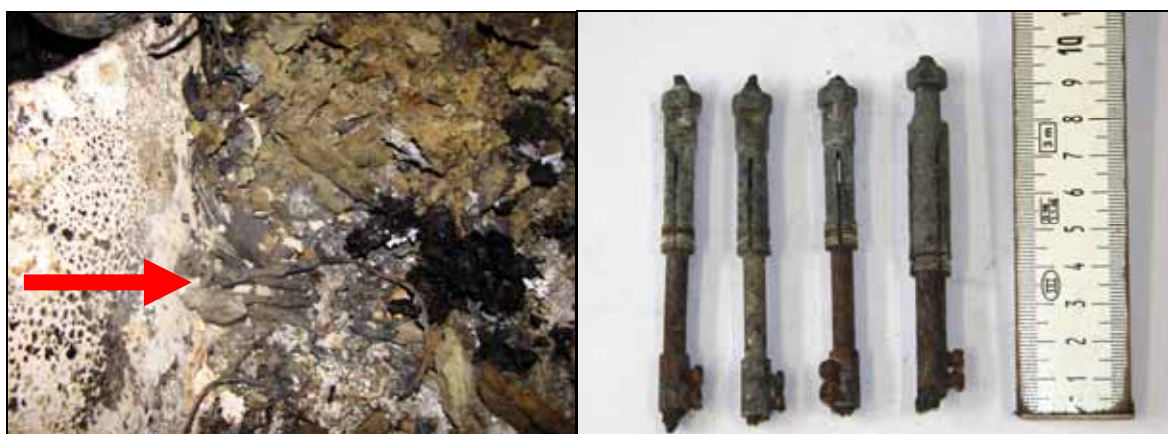
Figure 41: Remains of the male plugs and female contacts from the electrical socket at frame 200 (starboard)¹⁶

In addition, the electrical contact materials of two plugs and sockets were also found in this area (see Fig. 41).

¹⁶ They were found remaining coupled together showing that a plug was inserted into the socket before the fire.

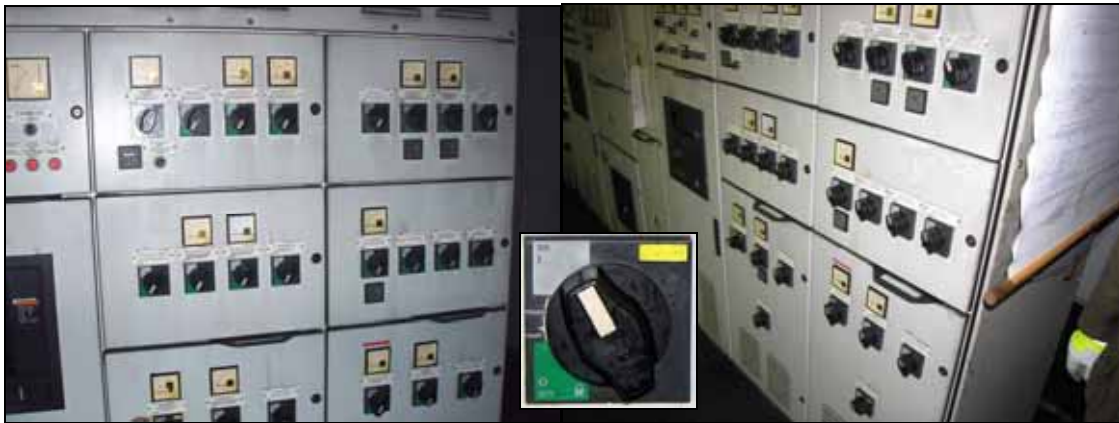
Figure 43: Part of the main switchboard on 11 October 2010 (left) and on 25 October 2010 (right)

It was found later that, meanwhile, the switch settings on the main switchboard had been changed. On 11 October 2010, when the fire was under control, the salvage company was able to take a member of the crew into the engine room to assist them. During this inspection the crew member took photographs of the main switchboard. All the switches are in the 'Off' position on these photos; however, during the first inspection by the German and Lithuanian investigation team on 25 October 2010, the switches were, almost without exception, set to 'On' (see the right of the main switchboard on Fig. 43, for example).

The switch settings found on the main switchboard were therefore no longer conclusive for the investigation. It was not possible to clarify who changed the positions or when this happened. Since it was neither possible to restore the shipboard power supply at sea nor at the pier in Munkebo, the investigators could not see any need to operate any switches on the main switchboard.

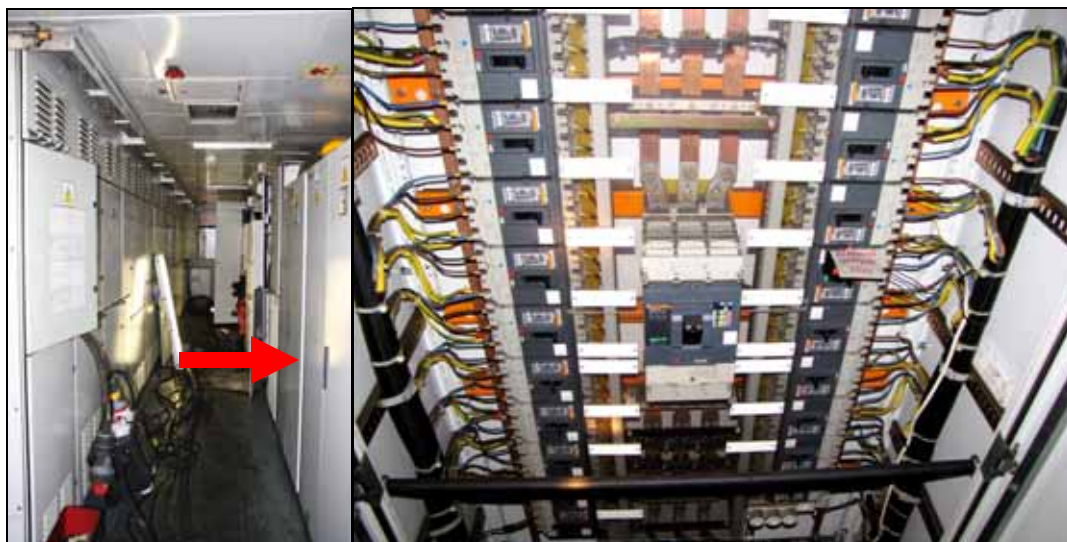
Figure 44: Switch cabinet with circuit breakers

In the engine control room behind the main switchboard is a second corridor in which several mostly locked switch cabinets are situated. Two of these contain circuit breakers serving the switchable three-phase current power outlets (see Fig. 44). The key for these cabinets was not readily available; therefore, the investigation team used its own tools. Due to the limited accessibility, it could be assumed that the switching or tripping condition corresponded to the original incident-related situation.

Based on the circuit diagrams, these circuit breakers were upstream of the three-phase current power outlets on deck 4 and deck 6. The switch settings found were documented in detail and evaluated by the expert for electrical engineering (see sub-para. 3.3.2.7).

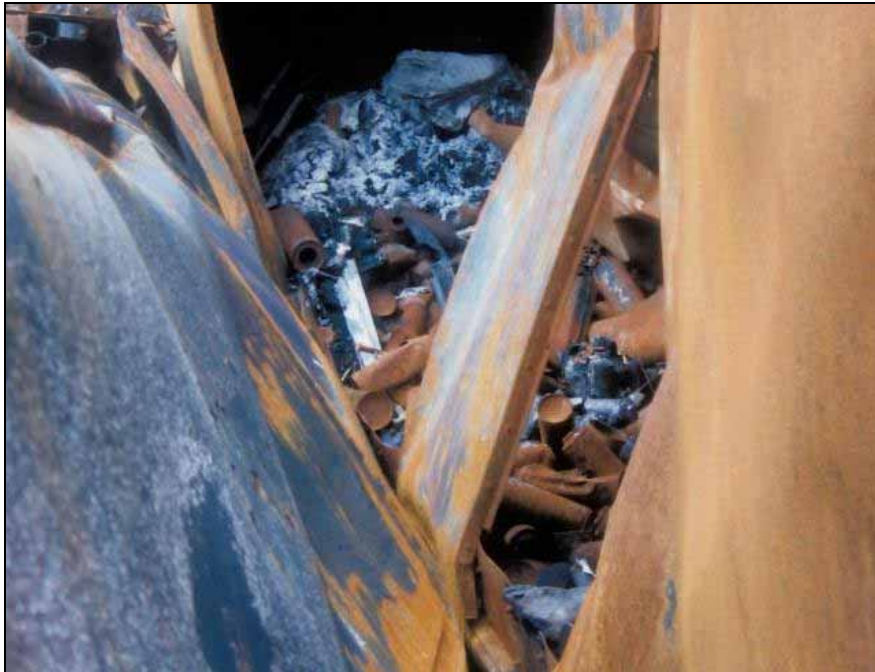
Figure 54: Cargo remains (spray cans) from a dangerous goods shipment

The stowage positions of the dangerous goods being transported were listed properly in the dangerous goods manifest. Based on the remains of the cargo (see Fig. 54), during the survey of the LISCO GLORIA it was possible to confirm that the actual stowage position complied with that specified in the manifest for four of the five dangerous goods shipments. The fifth cargo transport unit was too badly damaged to permit identification. Altogether, it became clear during the survey that to a large extent the dangerous goods had thermally reacted due to the fire.
