**Bundesstelle für Seeunfalluntersuchung**  
**Federal Bureau of Maritime Casualty Investigation**  
Federal Higher Authority subordinated to the Ministry of Transport,  
Building and Urban Development

Summary  
Investigation Report 450/11

**Serious Marine Casualty**

**Ground Contact  
by the Container Vessel FIDUCIA  
off Cebu, Philippines  
on 16 September 2011**

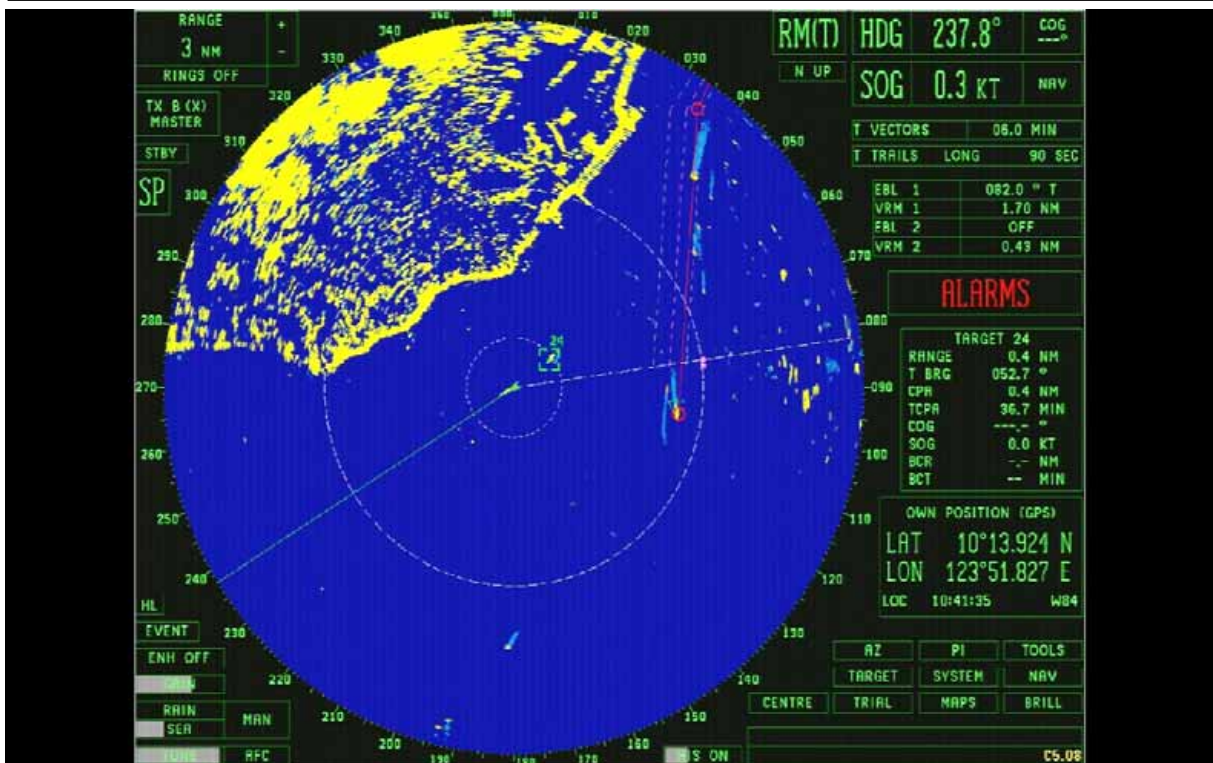
Figure 4: Initial situation

Figure 4 shows the initial situation. The vessel is lying at anchor with her bow pointing towards the southwest as the pilot station calls and gives notice of the pilot on VHF. The traffic separation scheme in which – approaching from the south – the vessel was to turn can be seen clearly on the eastern side of the radar image. With the exception of two lengths, the anchor is hoisted at 1114 and the pilot enters the bridge (Figure 5). In Figure 6, the anchor is on deck and the FIDUCIA slowly picks up speed in order to turn towards port and head for the TSS.

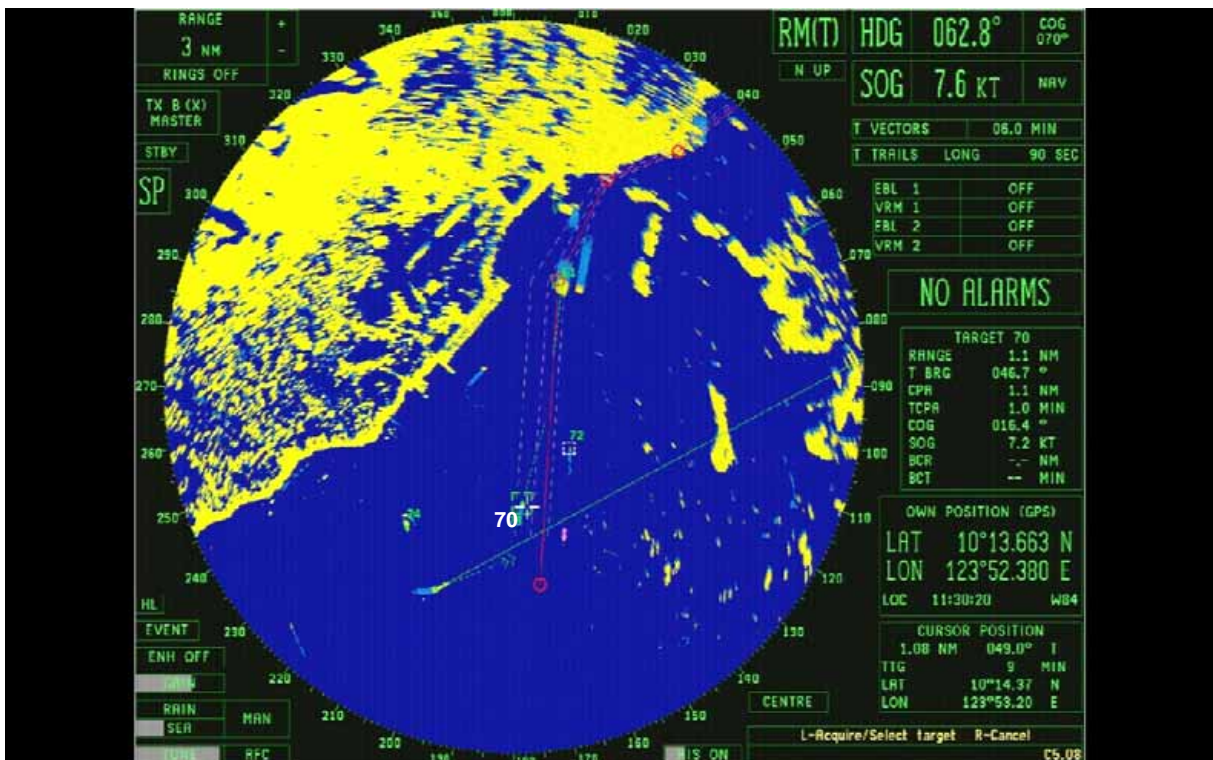
Figure 7: Fishing boats pass

The fishing boats that had just been allowed to pass can be seen next to number 70<sup>2</sup> in Figure 7. The speed of the FIDUCIA is now almost 8 kts.

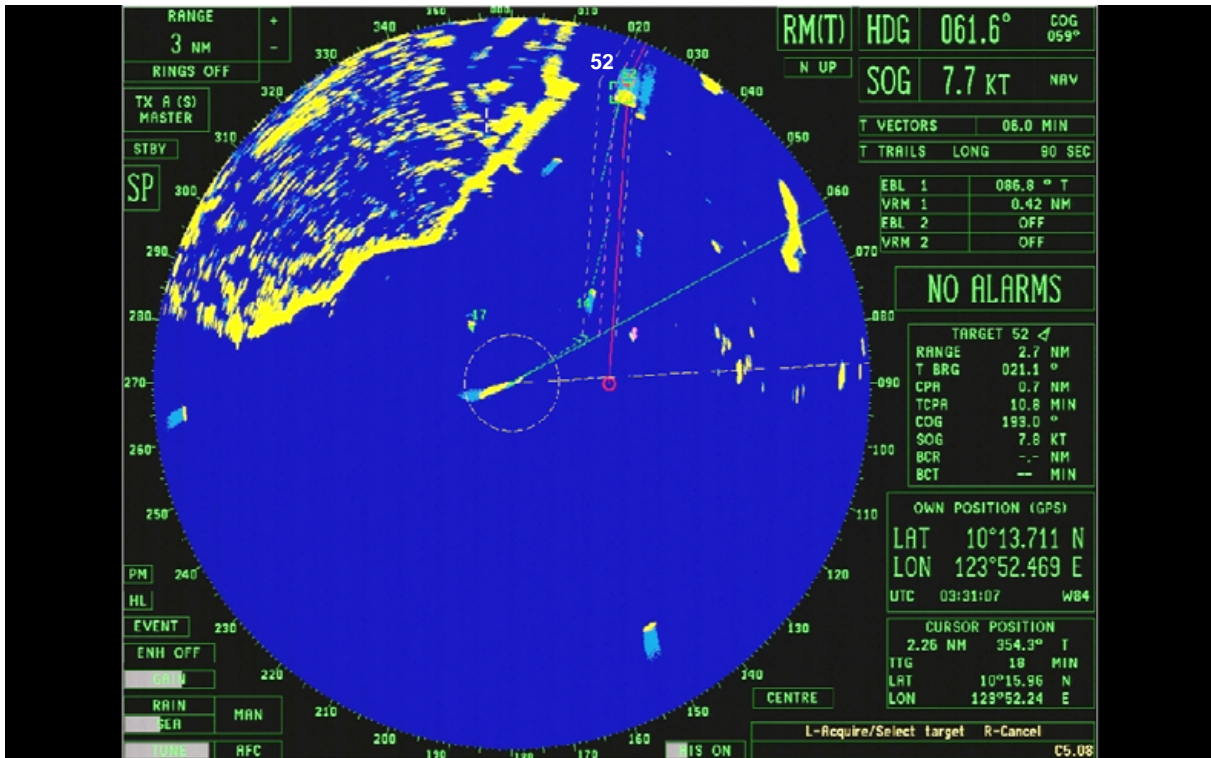
Figure 8: First contact with the CEBU TRADER

Figure 8 shows the first contact with the CEBU TRADER on radar 2 at 1131. This vessel's data are shown under target number 52.

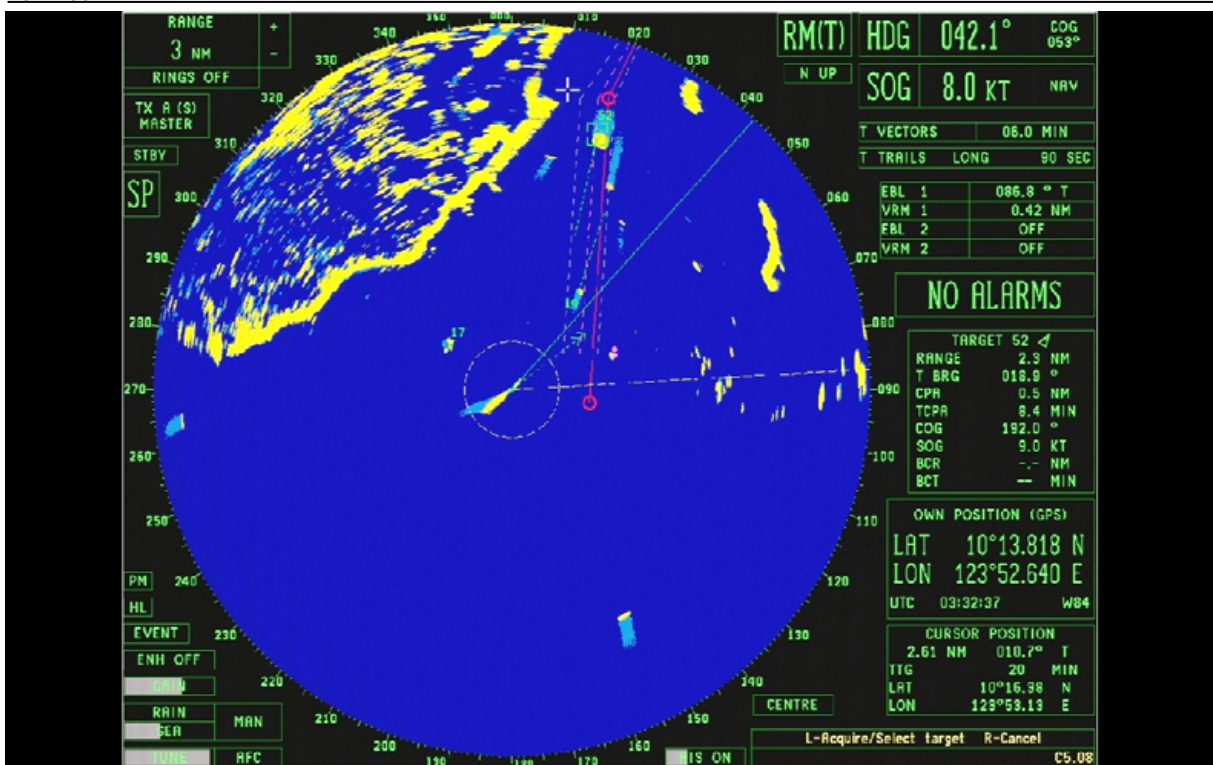
Figure 9: Consultation between master and pilot

Just one minute later, the FIDUCIA clearly turns to port (Figure 9). This is the result of the consultation between the pilot and ship's command. Prior to that, the pilot had agreed with his colleague on the CEBU TRADER that her draught was even greater and therefore she should remain more centrally on the fairway. The ship's command of the FIDUCIA established the current data using the AIS data of the CEBU TRADER (Figure 10).

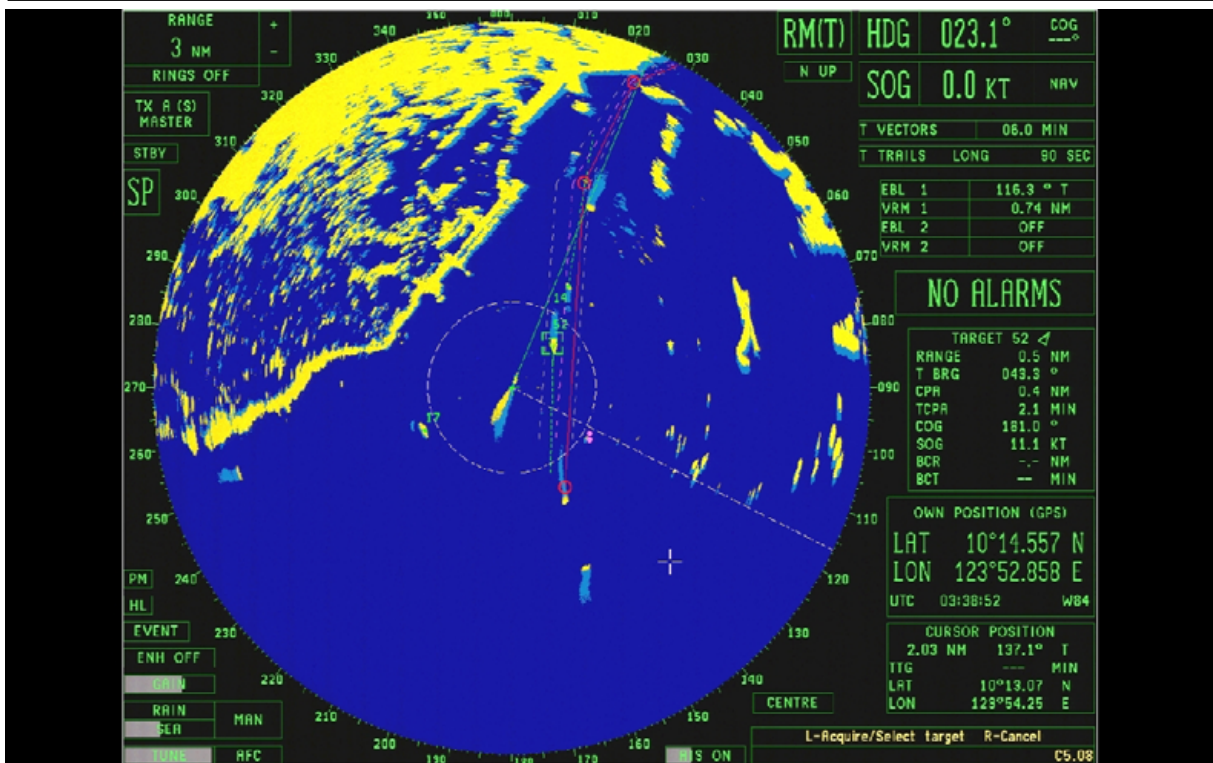
Figure 14: Radar screen when the vessel grounded

Figure 14 shows the radar image at the time of the grounding. FULL ASTERN has already been set by the ship's command, but this has no effect. The audio recording of the VDR indicates that the pilot does not realise that the FIDUCIA has run aground until 1141. Figure 15 illustrates very clearly that all the instruments are at ZERO. Figure 16 shows the radar screen at that moment. Figure 17 demonstrates the passing distance to the CEBU TRADER with a CPA of 0.34 nm.
