Bundesstelle für Seeunfalluntersuchung
Federal Bureau of Maritime Casualty Investigation
Federal Higher Authority subordinated to the Ministry of Transport,
Building and Urban Development

Summary
Investigation Report 515/10

**Fire on a semi-trailer on board
the ferry MECKLENBURG-VORPOMMERN
on the Warnow river
on 19 November 2010**

1 November 2012

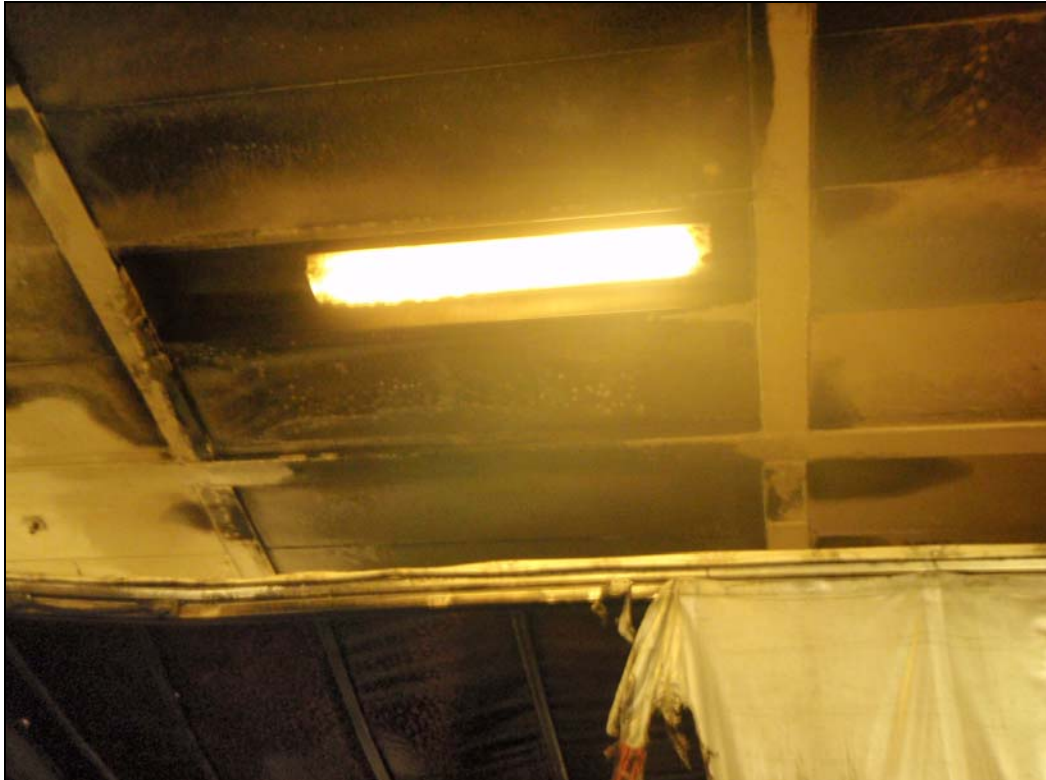
The MECKLENBURG-VORPOMMERN was slightly damaged by the fire. The ceiling above the slot position of HGV trailer was scorched.

The MECKLENBURG-VORPOMMERN sustained damage on the ceiling above the semi-trailer affected by the fire and due to soot and smoke (see Fig. 4 and Fig. 5).

Figure 4: Scorch marks on the ceiling above the scene of the fire

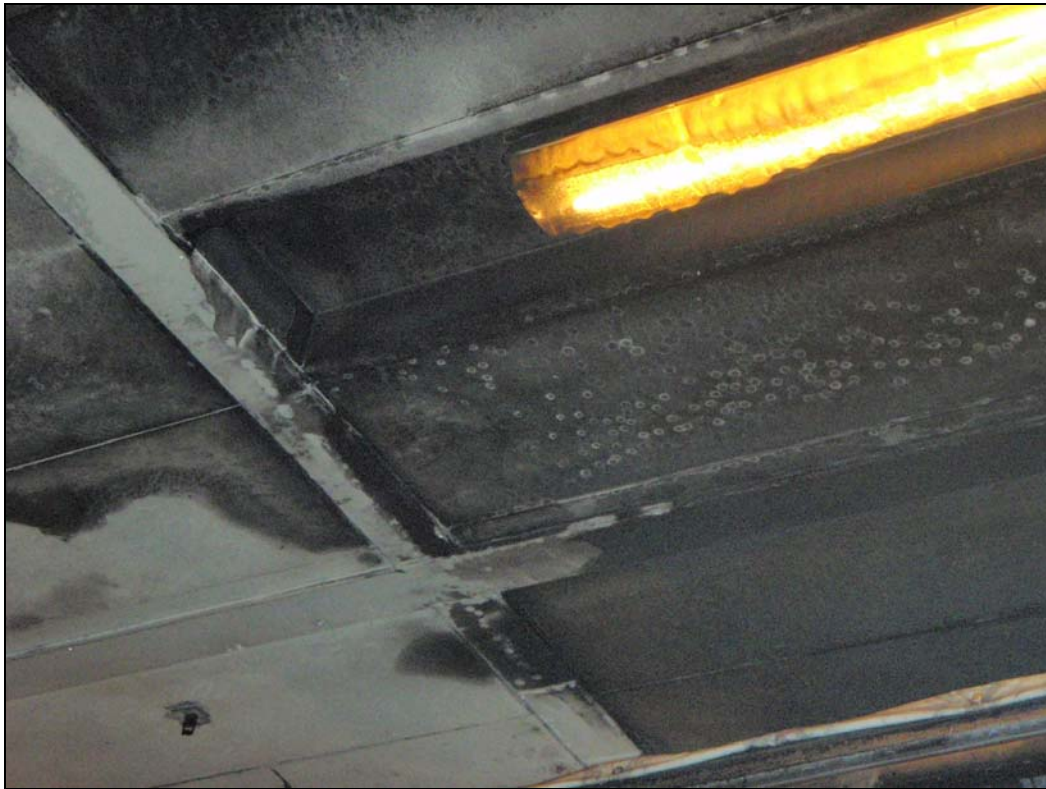
Figure 5: Close-up of the scorch marks on the ceiling

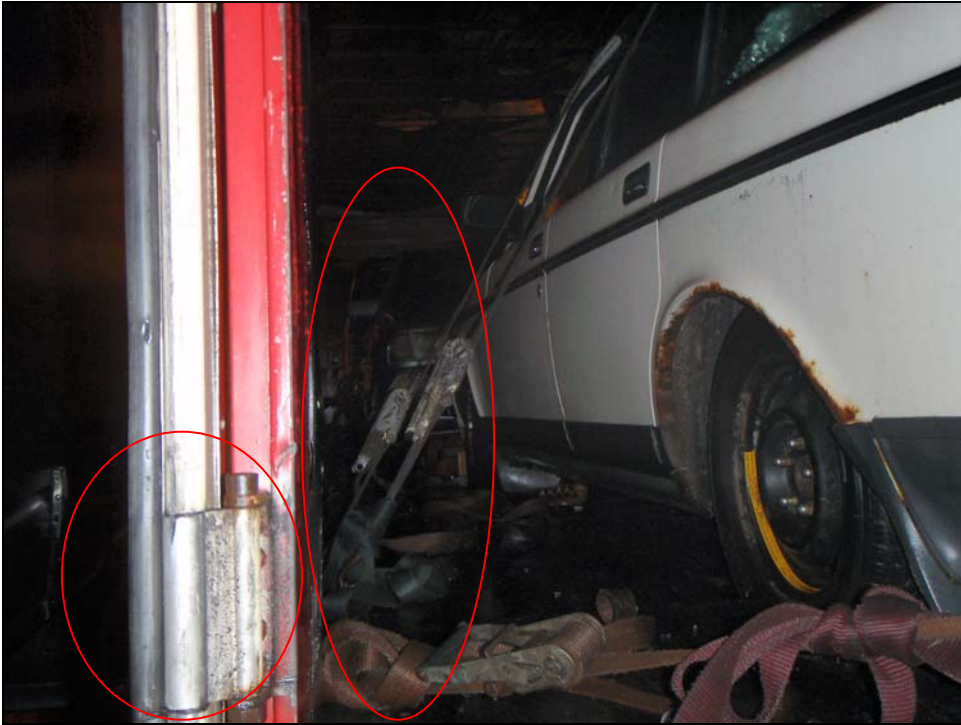
Figure 6: Load on the trailer and position of the doors

The front and the rear vehicle were fully loaded with used items, such as furniture, electrical appliances and clothing.

In addition, three used car engines were in the VW Transporter.

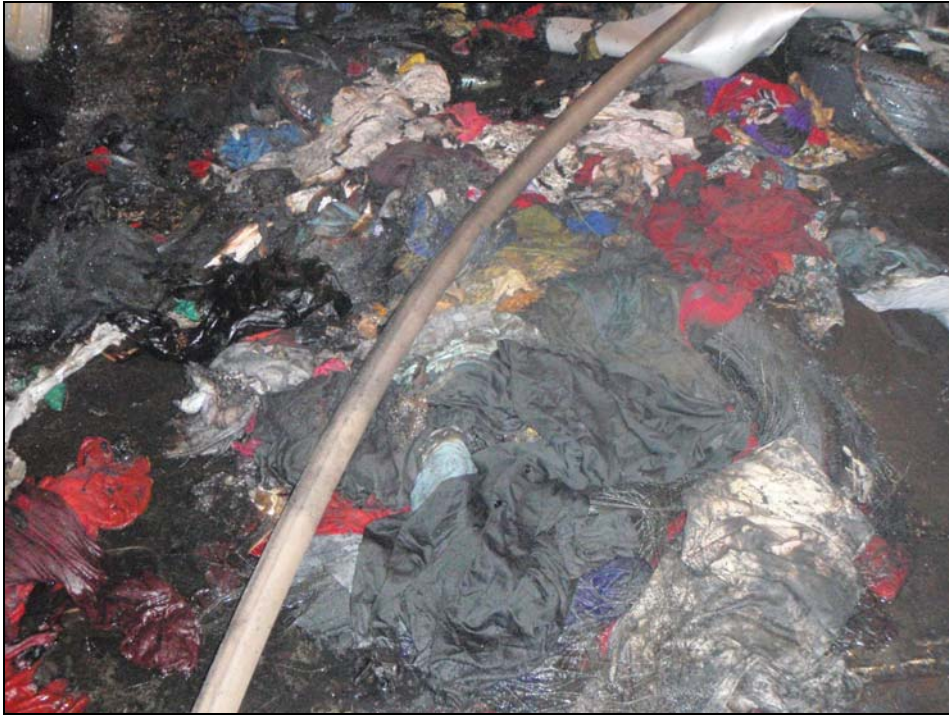
Figure 7: Remnants of the cargo after the firefighting operation

Figure 8: Remnants of the cargo after the firefighting operation

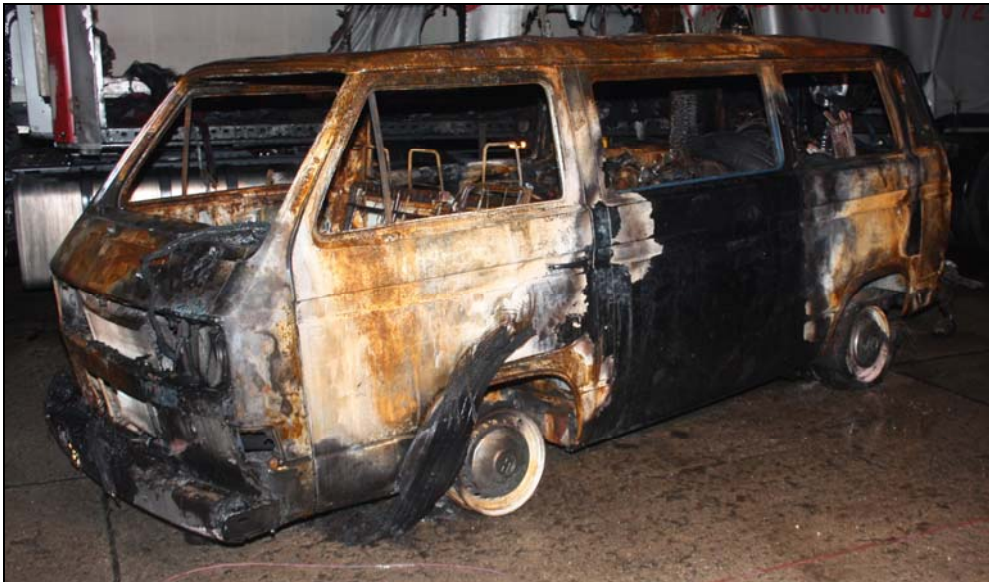
A vehicle on the semi-trailer was destroyed due to the fire (see Fig. 9). The semi-trailer and the two other vehicles were damaged (see Fig. 11).

The fire broke out in the VW Transporter, the upper part of which was burnt out almost completely. There was also immense fire damage in the area of the cab and to the engine located in the rear. All four wheels were burnt (see Fig. 9).

Figure 9: Driver's side of the VW Transporter

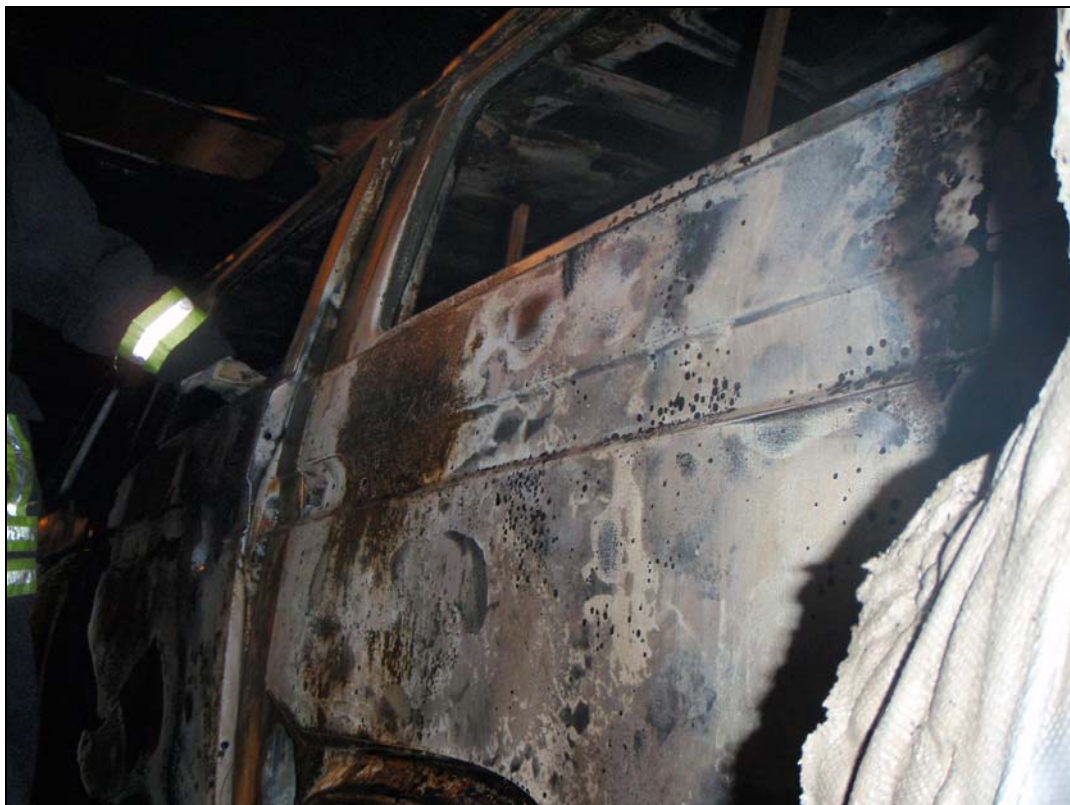
The expert assigned by the public prosecutor's office identified a battery located under the passenger seat as being the probable source of ignition.

In particular, the positive terminal clamp was conspicuous. Its defective condition was indicative of a build-up of heat due to the increased transition resistance.

Figure 10: Passenger side of the VW Transporter

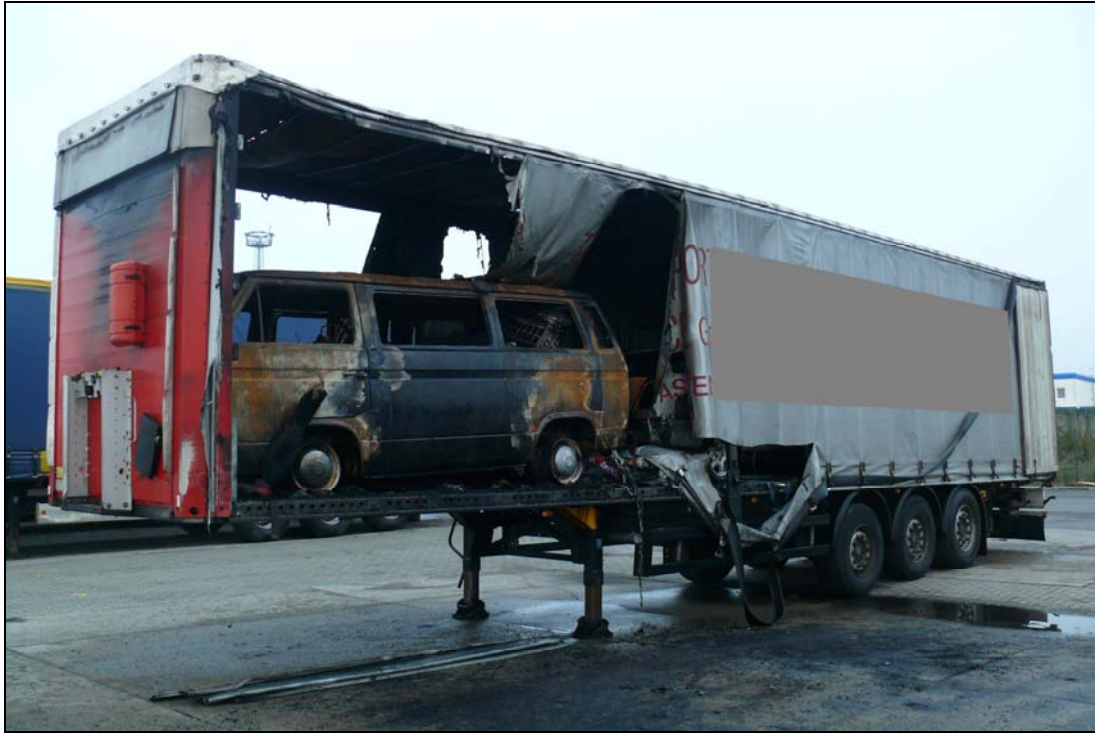
Damage to the side tarpaulins and roof was most severe in the area where the Transporter was parked. The semi-trailer's floor was burnt and its front wall sustained moderate fire damage (see Fig. 11 and Fig. 12). There was no fire damage on the tractor unit.

Figure 11: Fire-damaged semi-trailer with VW Transporter

Figure 12: Fire-damaged semi-trailer with VW Transporter

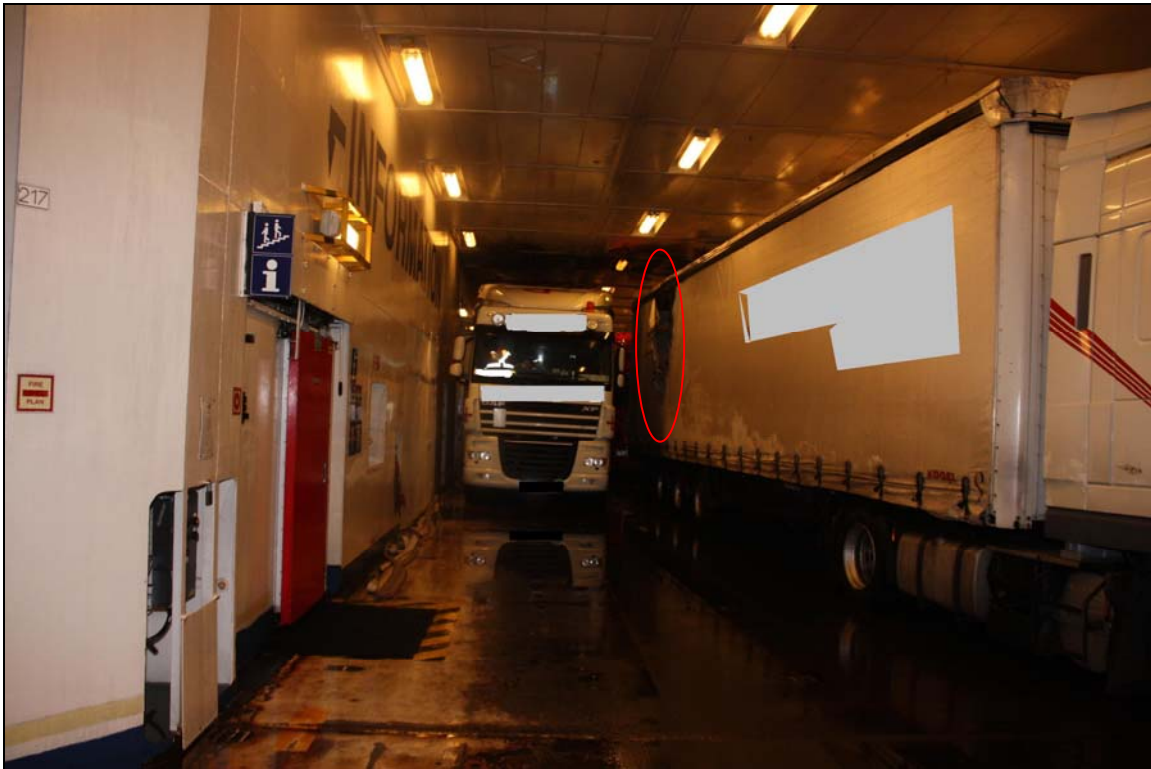
Another semi-trailer parked adjacently was also damaged (see Fig. 13).

Figure 13: Deck 4, articulated vehicle affected by the fire and adjacent semi-trailer damaged by the fire

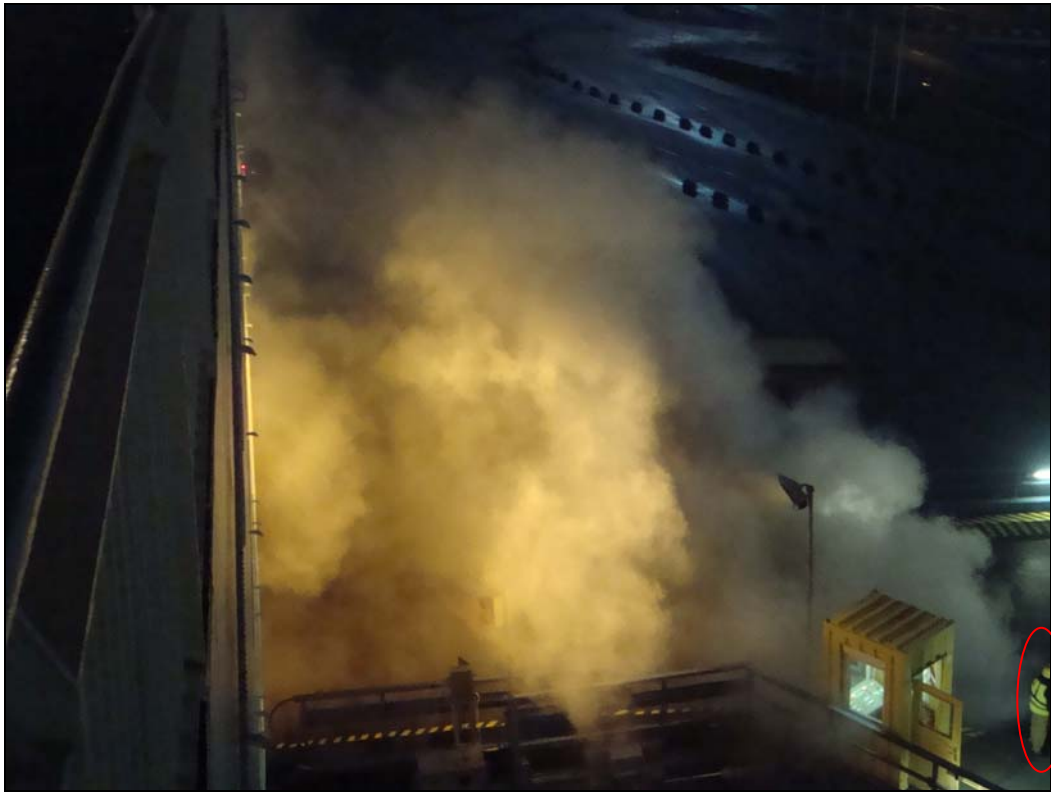
From the start of the extinguishing operation with respiratory protection, visibility on deck 4 was equal to zero due to the smoke caused by the fire (see Fig. 15).

Figure 15: Build-up of smoke outside the vessel after the bow side door on deck 4 was opened⁶

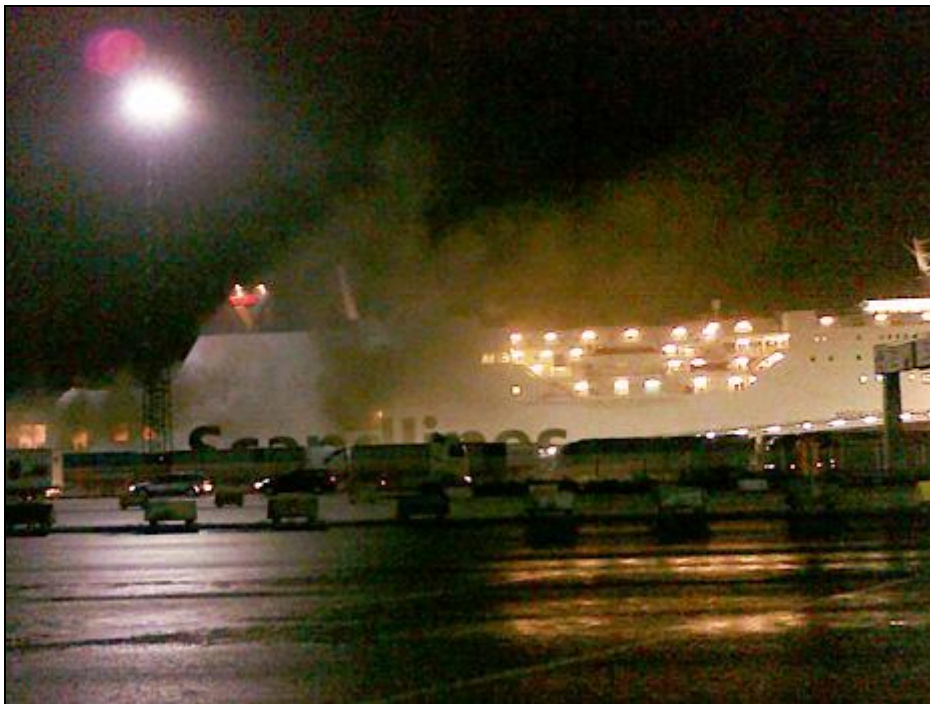
On arrival, the fire brigade found a heavy build-up of smoke (see Fig. 18).

Figure 18: Build-up of smoke caused by the fire

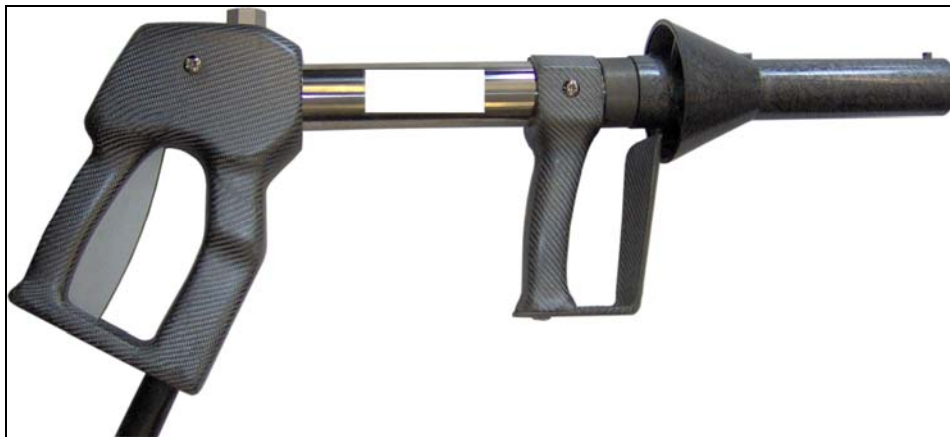
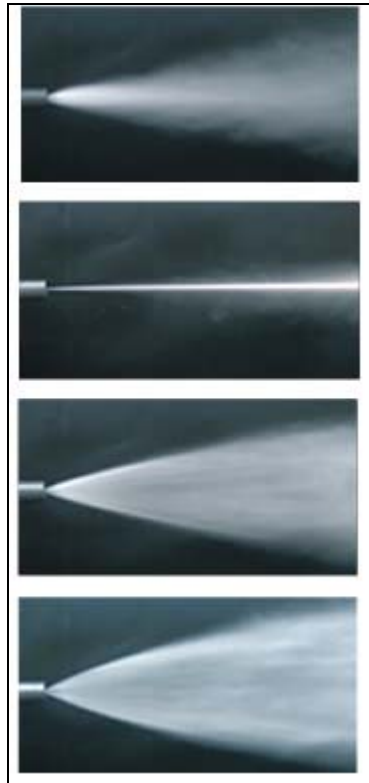
Figure 19: Use of a new type of extinguishing pistol due to the spatial restrictions

Figure 20: Choice of extinguishing jet and extinguishing agent

Figure 21: Extinguishing unit with extinguishing pistol and hose connection

Based on experience gained in relation to firefighting on board the LISCO GLORIA (DFDS Seaways) and the MECKLENBURG-VORPOMMERN, Scandlines has invested, inter alia, in the procurement of new firefighting technology (see Fig. 19 and Fig. 21).

This new technology enables firefighting units not only to select the type of extinguishing jet (see Fig. 20), but also to determine the type of extinguishing agent most effective (water, extinguishing foam, carbon dioxide foam, carbon dioxide) directly at the source of the fire.

The extinguishing unit has a 100 metre high pressure hose (see Fig. 21). This version is portable and mounted on wheels.

Compared to conventional extinguishing technology (pressure hoses, such as c-hose with c-tube), the length, width and flexibility of the hose, the option of selecting the extinguishing agent as well as the size, weight and shape of the extinguishing pistol enable more effective use in confined conditions.
