Summary
Investigation Report 570/10

Personal accident
on board the container vessel
MSC LA SPEZIA
in the port of Gioia Tauro, Italy
on 21 December 2010

15 May 2012

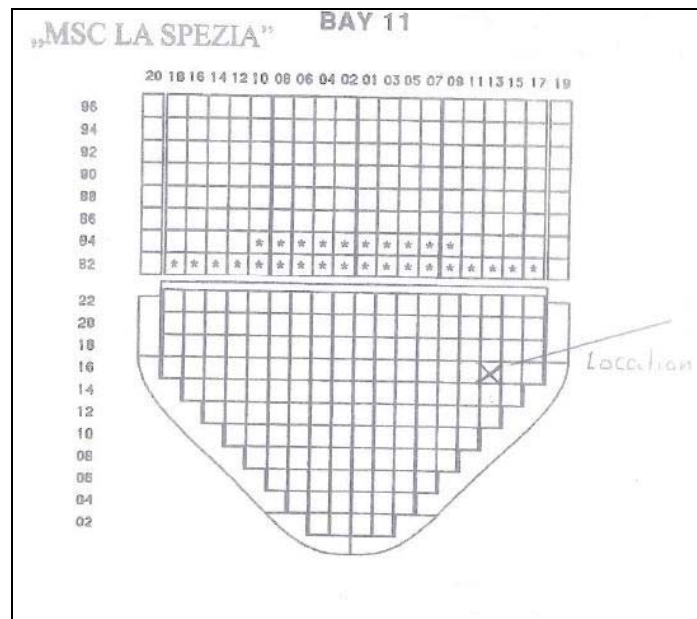
Figure 3: Scene of the accident, Hatch 2, Bay 11

The casualty was found at the stowage position at Bay 11, Row 13, Tier 14 (see Fig. 3). He was wearing overalls, a helmet and safety shoes. The stowage position is located about 2.50 m laterally offset from a gate in the railing, which is secured by a hinged bar (see Fig. 5).

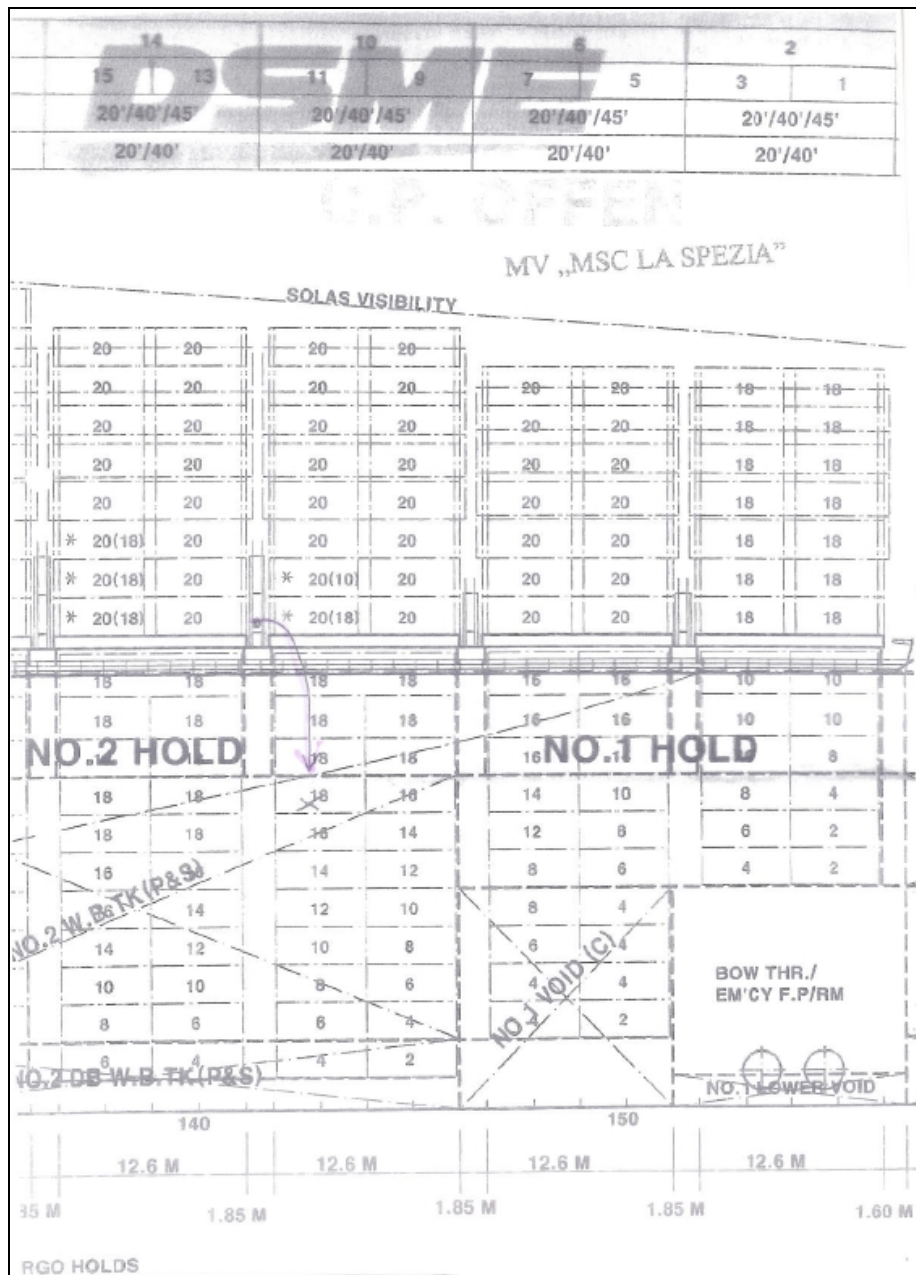
Figure 4: Height of fall = 10 m

The casualty was traumatised and therefore, unable to remember the accident in detail properly. The BSU regards it to be unlikely that a person could fall over the 1.20 m high railing. It was noisy because of the loading/unloading operation; furthermore, muffled noises and vibrations were caused by the seating and unseating of containers, which was an additional disruption. Moreover, the work height could have been unsettling.

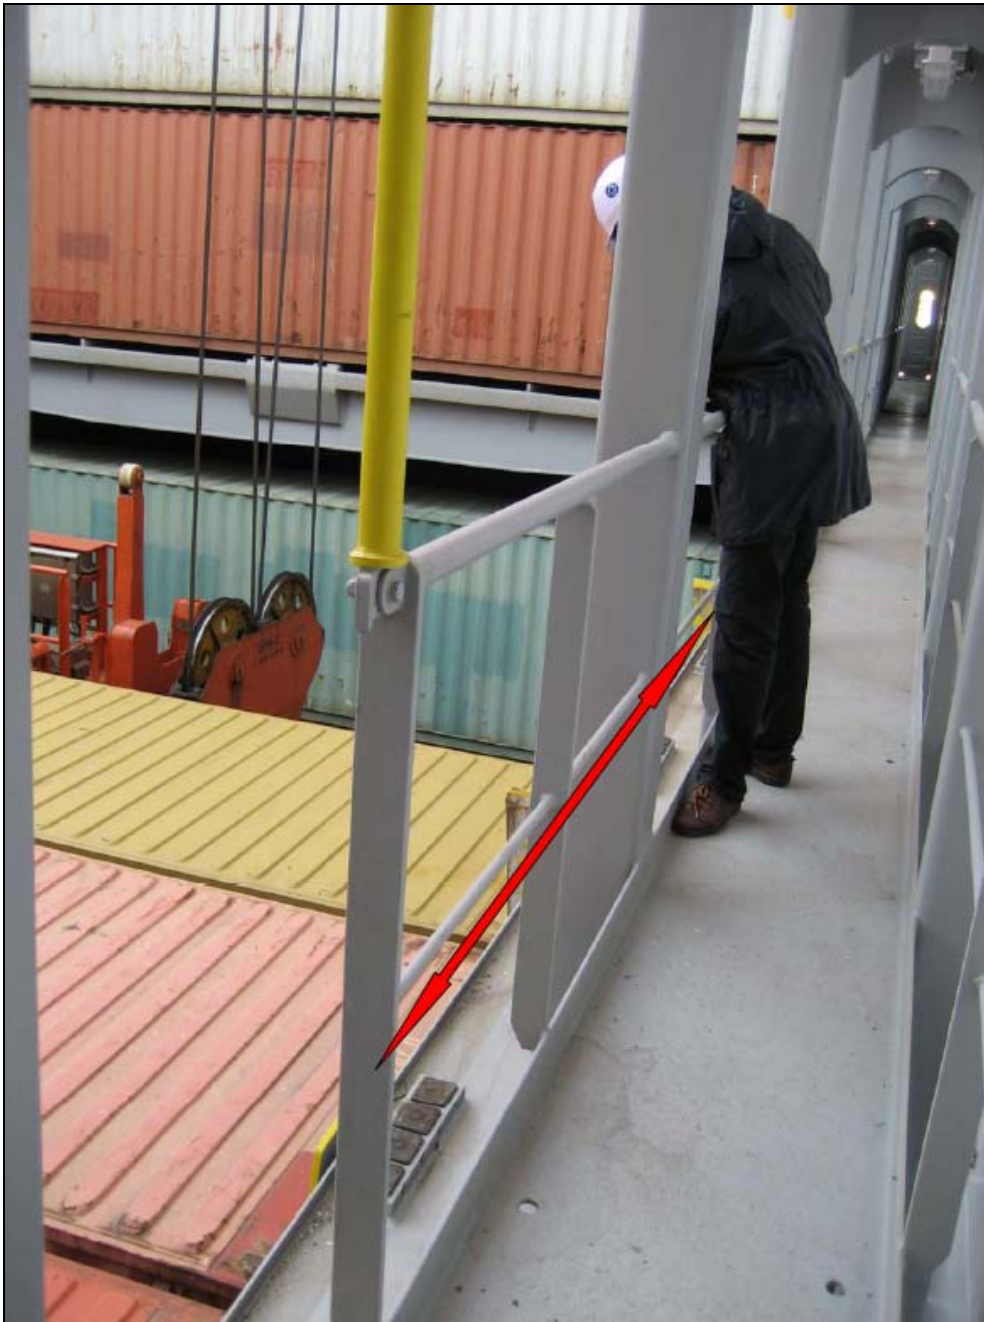
Figure 5: 2.50 m offset from the gate

The BSU believes that the casualty lost his balance and fell into the hatch while using the broom to sweep in front of the gate in the railing. It is likely that the barrier had been opened to make it easier to reach the coaming. The casualty's position was laterally offset about 2.50 m from the gate in the railing. Following the fall, the casualty must have moved.

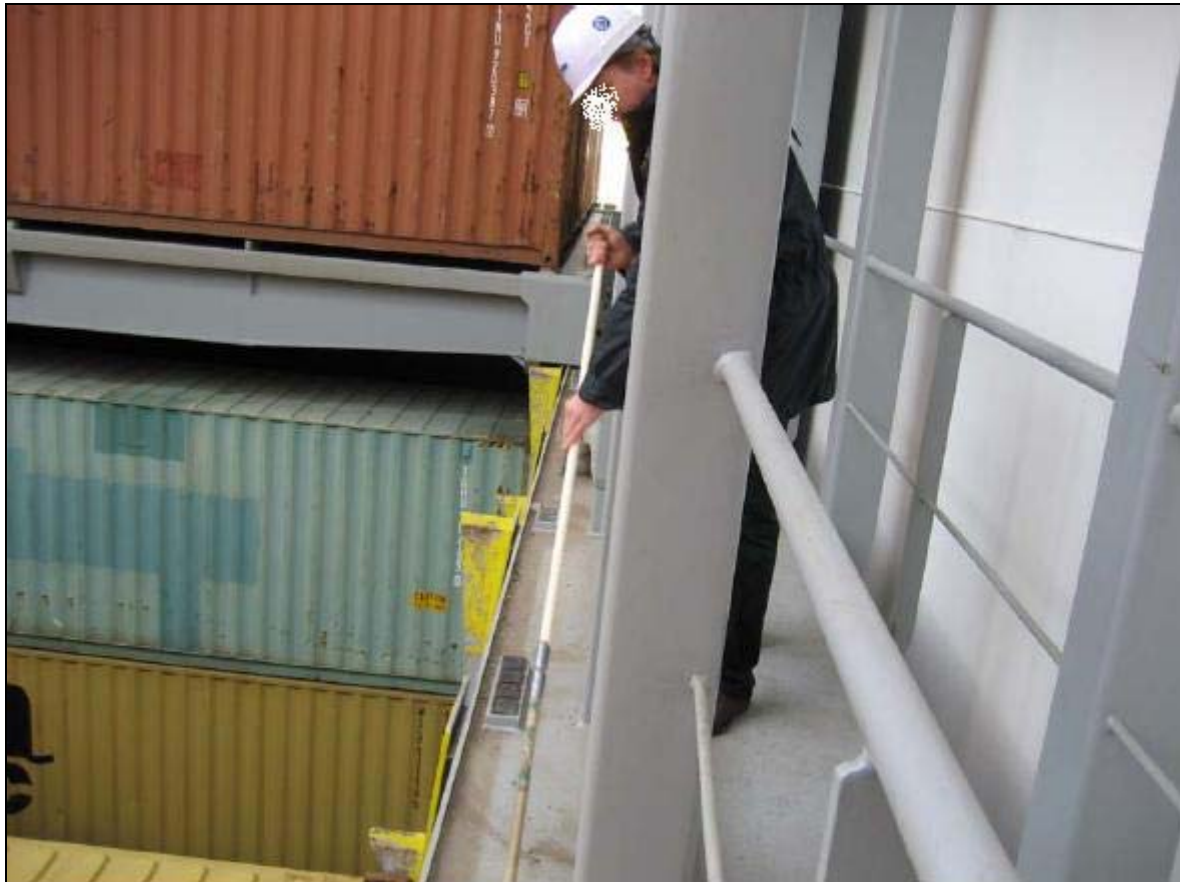
Figure 6: Sweeping with extended handle

While laid up in port, it is reportedly usual for members of the watch to sweep the coamings and carry out lubrication work as part of normal maintenance when the hatches are open. The broom handle has been extended to enable such work to be carried out safely from the transverse corridors (see Fig. 6).

The extended handle was more of a hindrance in front of the gate in the railing. It would have been necessary to hold it almost vertically. It may also have slid in his hands and protective gloves. The broom was not secured. Inasmuch, to clean the coaming and also make sure that the broom did not slide out, considerable care would have been needed when working. Cleaning was effected by simply sweeping the dirt over the narrow edge of the coaming, for provisions for removing it, for example, with a dustpan, had not been made.
