Summary Investigation Report 13/12

**Death of a member of the crew of CMV
E.R. STRALSUND on 19 January 2012
en route from Algeciras, Spain, to
Tema, Ghana**

Summary Investigation Report 179/12

**Injury to a member of the crew of MV
RED CAT on 1 May 2012 in the
port of Bremen**

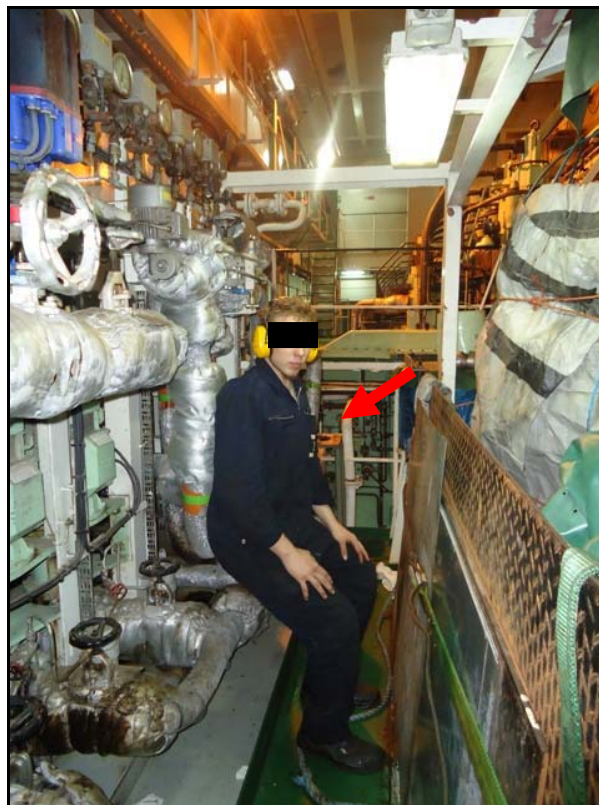
Figure 3: Location of the casualty

Laying at an angle on the casualty, the steel plates weighed about 700 kg and could only be pushed back to their original, upright position with the help of several crew members.

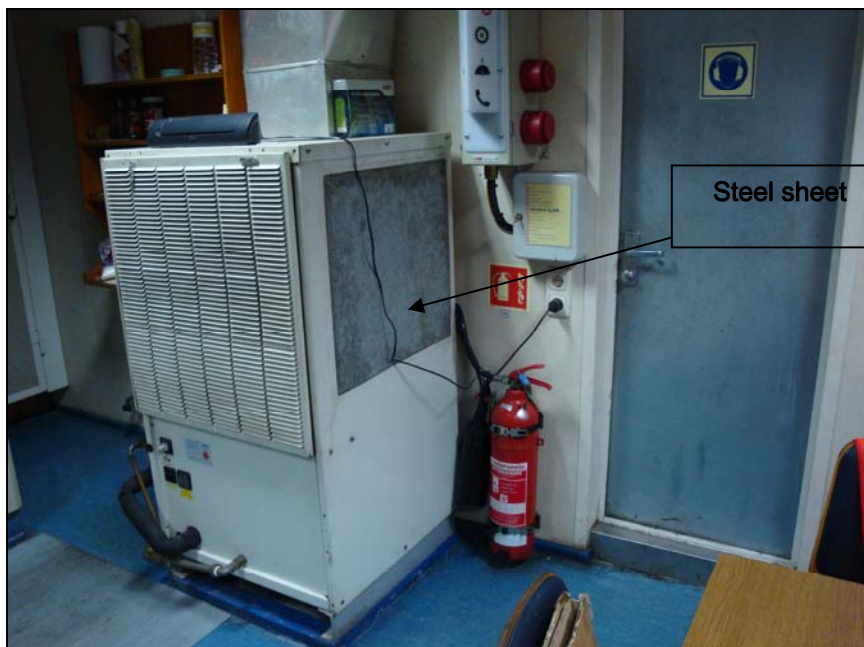
Figure 4: Ventilation fan with closed steel sheet

The air conditioning unit in the control room was closed with a thin galvanised steel sheet when the survey was carried out. These thin steel sheets were stored upright together with thick steel plates lashed to two steel supports opposite the piping for the main engine's fuel oil mode in the engine room.

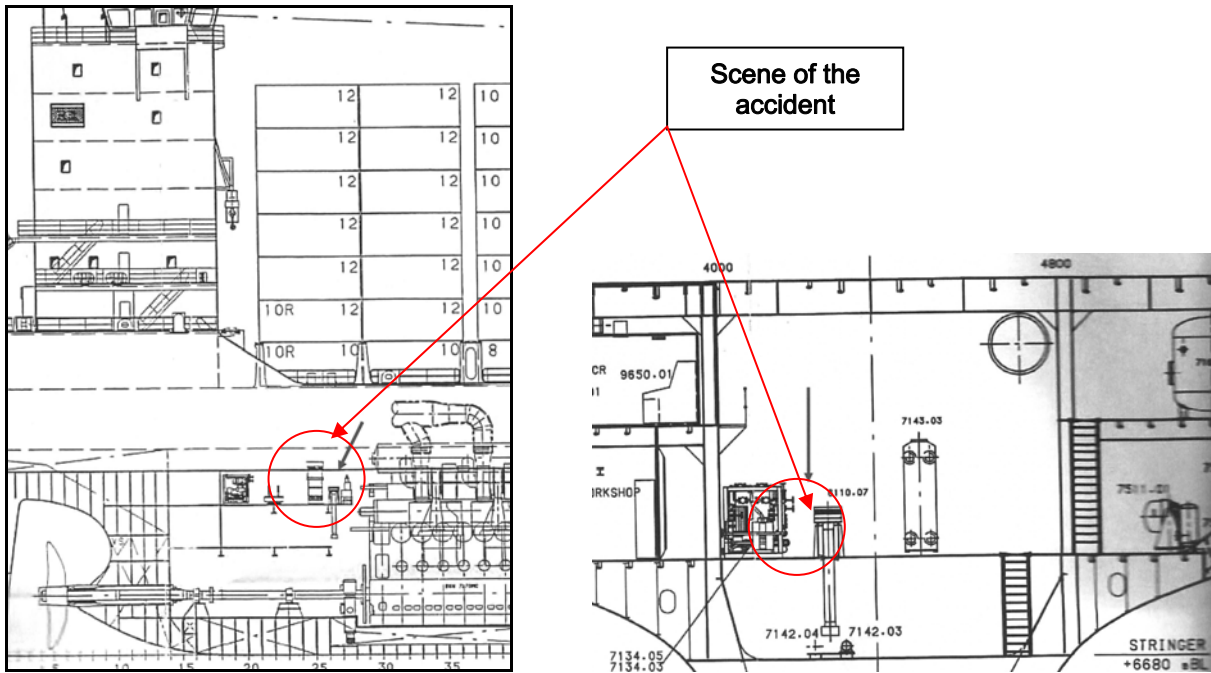
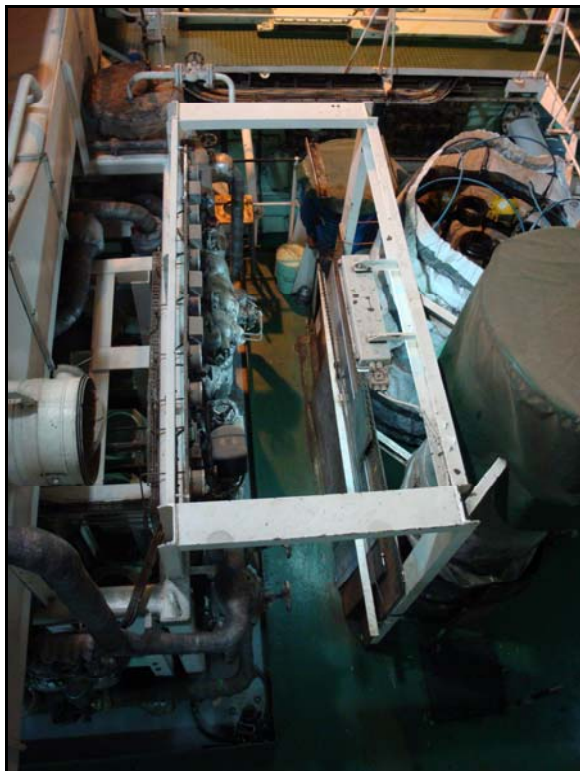
Figure 5: Storage, view from above

At the time of the survey, the plates were secured by an additional wire and chain block, as well as a bolted angle.

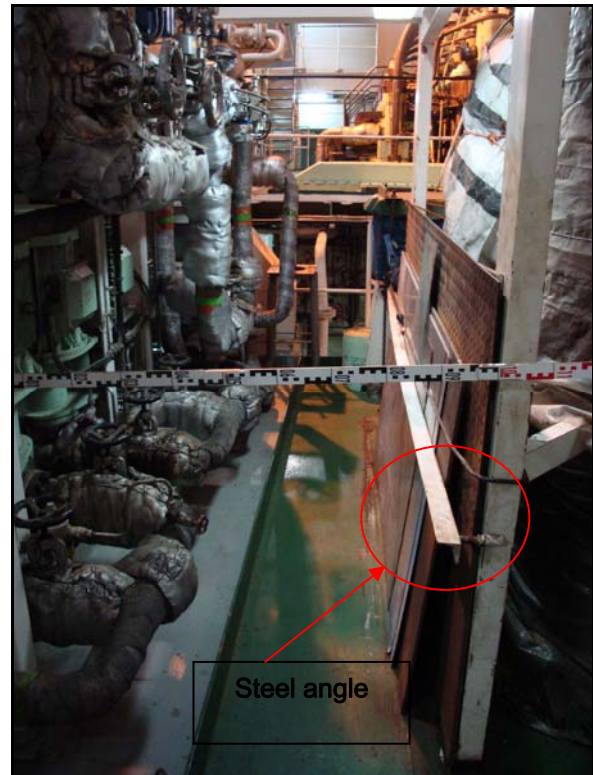
Figure 6: Storage, view towards the bow

The roughly 2.50-metre long bolted steel angle (securing angle), which was not there on the day of the accident, is visible in Figure 6. The steel plates were stored upright and secured only by a chain block and wire sling.

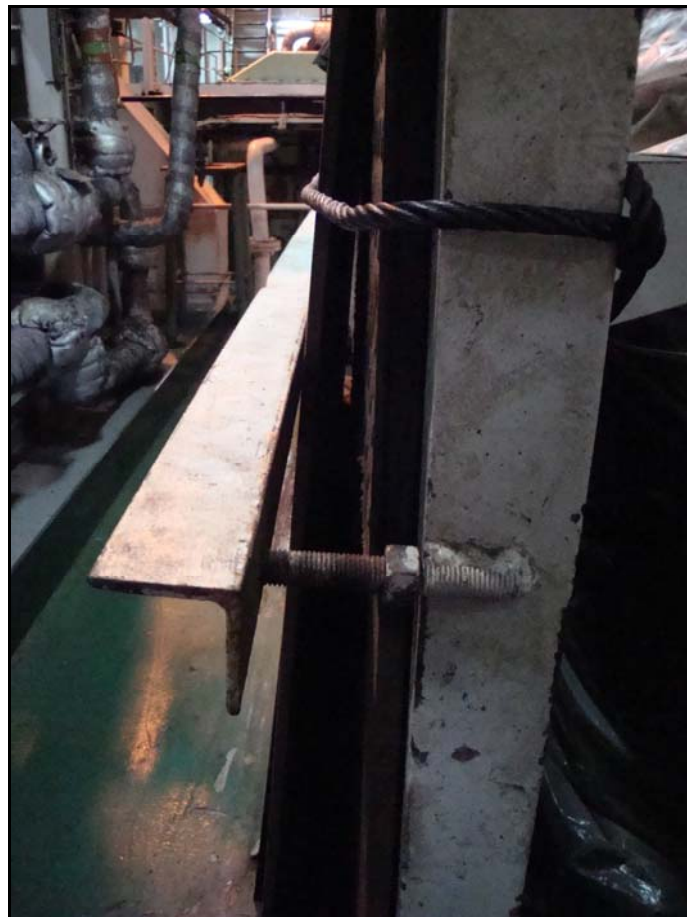
Figure 7: Securing device with bolted steel angle

It appears that the casualty wanted to obtain a thin steel sheet alone and without being instructed to close a ventilation fan. This steel sheet was stored upright in the engine room together with other thick steel plates and secured only by a chain block and steel wire. A steel angle intended as a means of securing by using bolts on the rack was not in position as a securing device. The casualty apparently released the chain block and wire sling and pulled the thin steel sheet out of the batch of steel. It is likely that the upright thick steel plates tilted due to the rolling motion of the ship and trapped the casualty against a pipe.

This means of storage was originally intended for only a limited, small number of steel plates. The length of the bolt used to secure the steel angle has already reached its limit, meaning no more plates can be stored.

One measure to prevent tipping would be the assembly of additional, permanently welded vertical supports or to store everything in a rack with at least two supports on each side. If the plates are additionally secured on the floor against slipping, e.g. using wooden underlays, then the risk of accidents due to vertically stored steel plates would be minimised significantly.

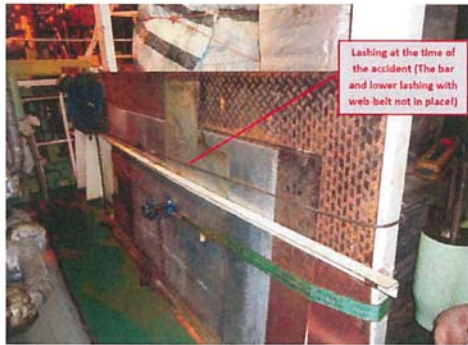
The steel sheets were not stored on an anti-skid surface (e.g. flat timber bars) to minimize their movements.

The Fitters' Superiors were occupied with other tasks and apparently delegated the planning and execution of the repair job to the Rating himself. A detailed plan of the work scope or work sequence had not been given as the job appeared to be a routine task and the hazard of the unlashed steel sheets, being stored in parallel to the ship's longitudinal axis, had been misjudged by the Fitter. The intended removal of the galvanized steel sheet was neither addressed to any crew member by the Fitter nor had any colleague been asked for help while an inappropriate method of securing the stack of steel sheets was in place for already a long time and had never been identified and considered as a danger by the Safety Wardens or any other crew member.

Storage places of steel sheets are to be reviewed and, if necessary, to be replaced by safe storage racks in order to ensure that a single steel sheet can be safely removed while the remaining stack of sheets remains secured.

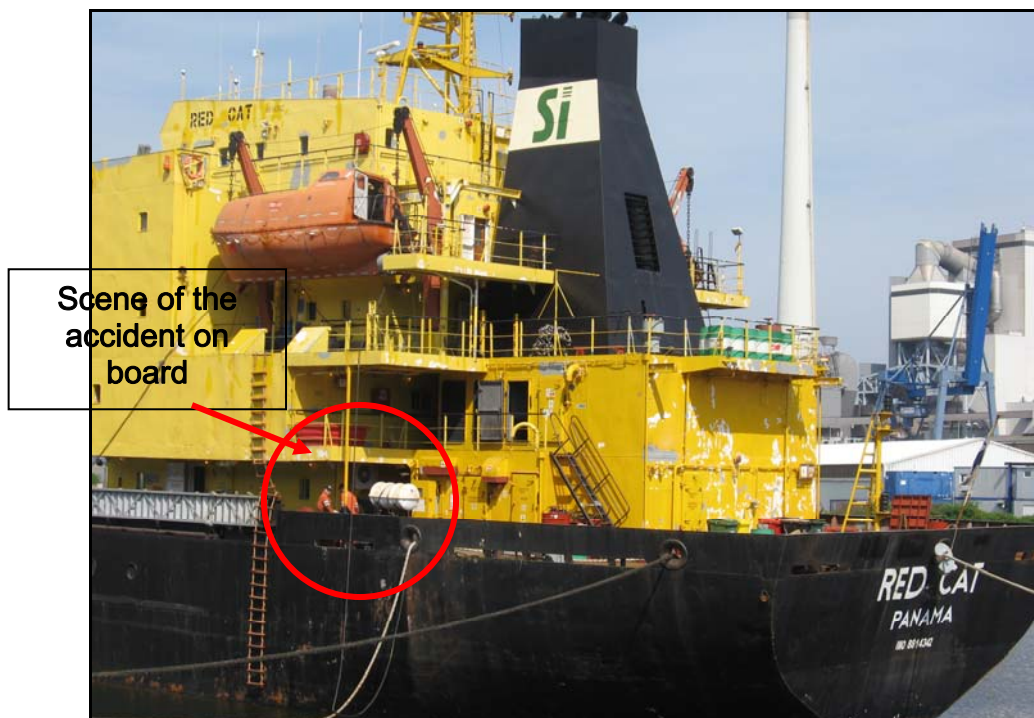
Figure 10: Aft section of the RED CAT

The scene of the accident was on the main deck at the rear edge of the superstructure where approximately 20 1.4 m x 1.2 m steel plates with a thickness of 5-10 mm were stored upright. These plates probably weighed some 1,000 kg. The plates were resting vertically on the superstructure of the ship and secured by only one lashing strap.

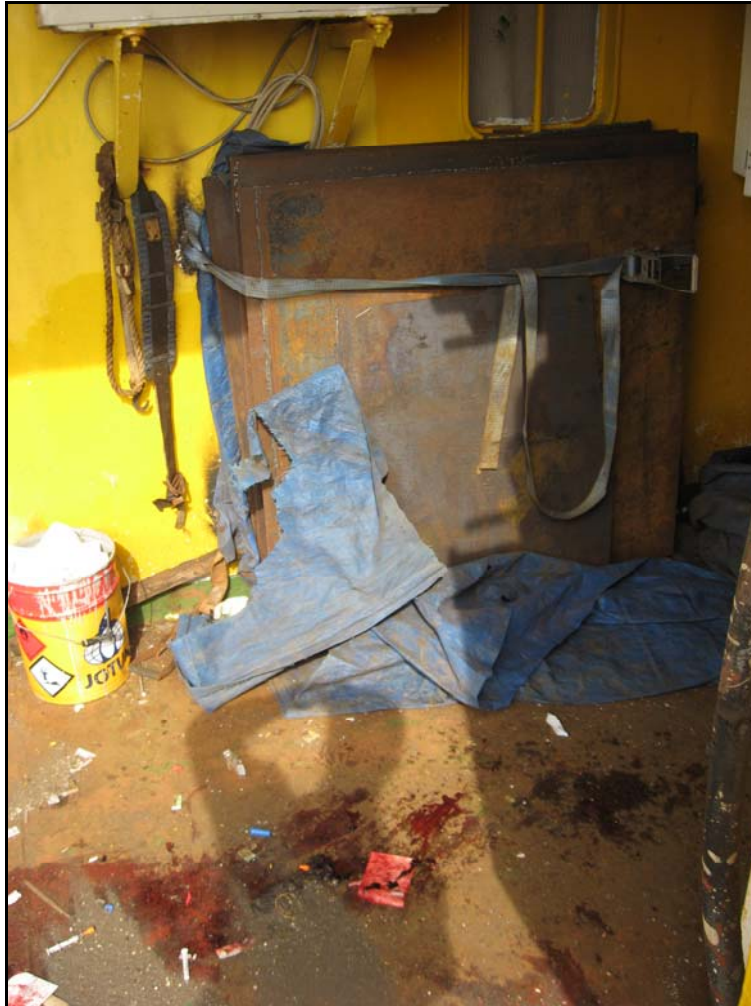
Figure 11: Steel plates on the superstructure

The casualty was employed as an able bodied seaman and was to replace the torn blue tarpaulin together with another crew member. After the single lashing strap used to secure them was released, a number of steel plates became unsteady, tipped forward one after the other, and partially buried the casualty. Only with the assistance of other crew members was it possible to remove the plates. First aid was administered until the arrival of the emergency physician. The casualty was taken to hospital to receive further treatment for the contusions suffered in the chest area and fractured leg.

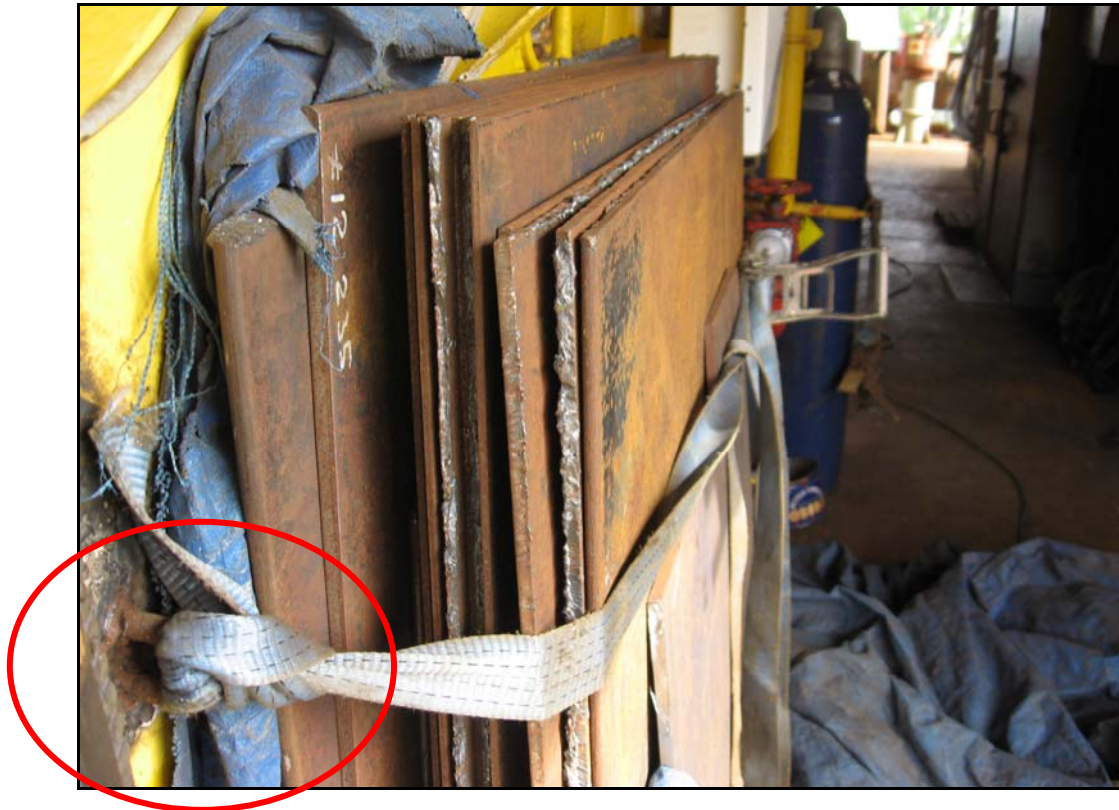
Figure 12: Ring for lashing strap

Inquiries as to why the steel plates were stored at the rear edge of the superstructure were not made during the investigation. However, it can be assumed that it concerned steel plates used for repairs on board. The special mounting rings welded to the superstructure indicate that storage of the steel plates is permanent rather than temporary:

The above photo shows that the plates are almost vertical. The rearward inclination of the plates becomes even more extreme when the ship is trimmed by the stern with a large aft draught. It can be anticipated that the plates will tilt again when they are released.

Securing with only one lashing strap also raises doubt as to whether the steel plates will remain in their upright position in heavy swell.
