Bundesstelle für Seeunfalluntersuchung
Federal Bureau of Maritime Casualty Investigation
Federal Higher Authority subordinated to the Ministry of Transport,
Building and Urban Development

Investigation Report 154/12

Serious Marine Casualty

**Collision between the ro-pax ferry
NILS HOLGERSSON
and the ro-pax ferry URD
in the port of Lübeck-Travemünde
on 3 May 2012**

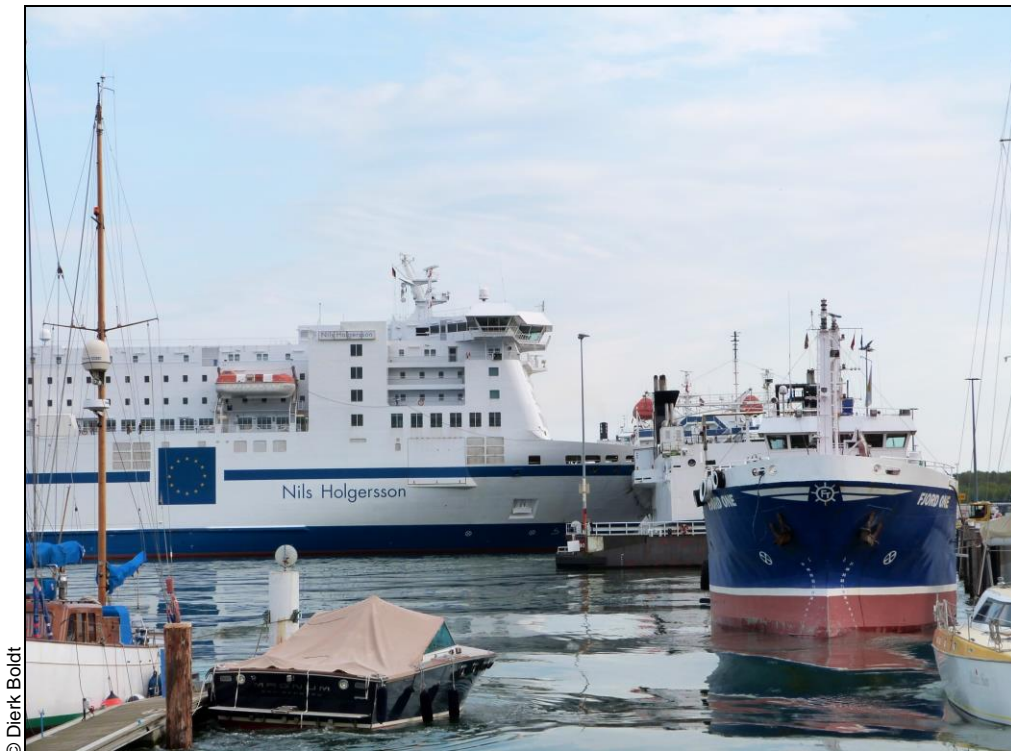
The shell plate of the URD (to port level with the weather deck and main deck) was pressed in by the bow of the NILS HOLGERSSON. The bulbous bow of the NILS HOLGERSSON ripped a hole in the URD level with the water line.

Figure 7: Photo taken shortly after the collision

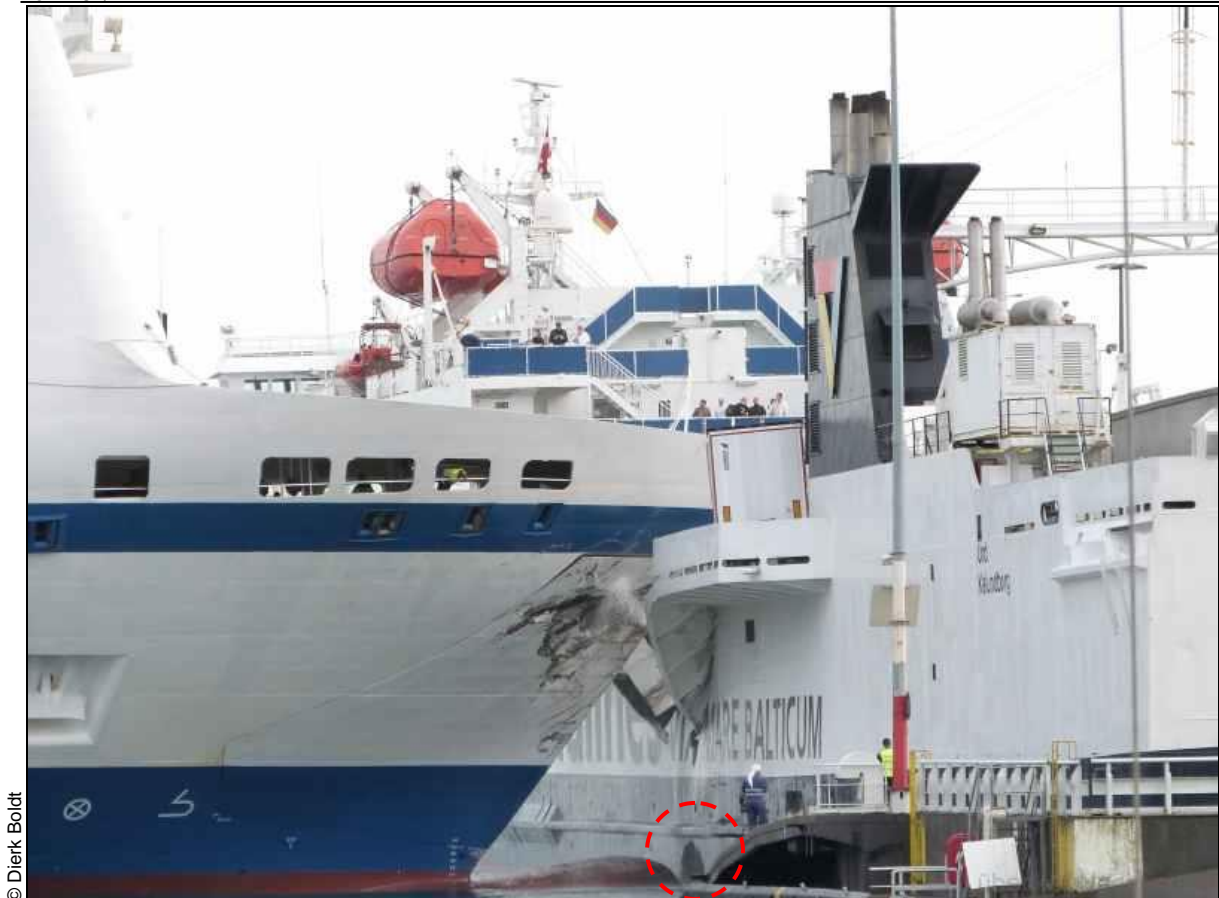
Figure 8: Photo taken shortly after the collision, close up

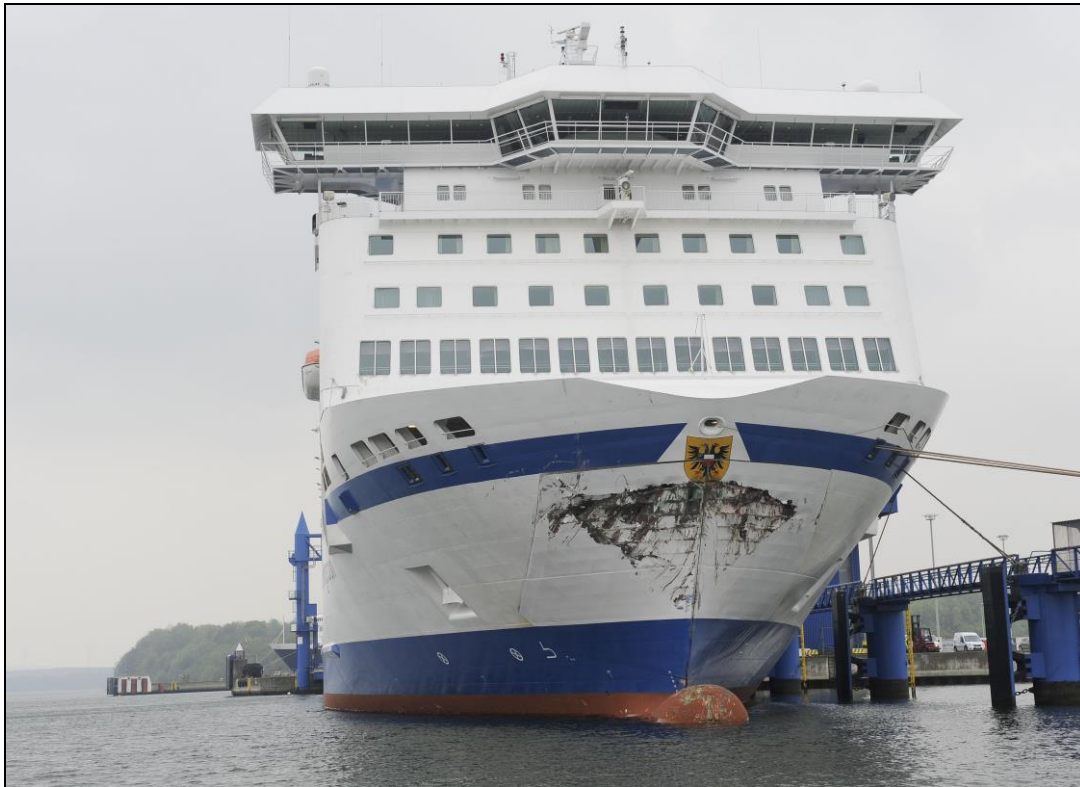
In retrospect and contrary to the preliminary assessment, the ensuing material damage on the bulbous bow, and on the bow visor in particular (see Figure 9), proved to be substantial.

Figure 9: Damage to the bow visor of the NILS HOLGERSSON

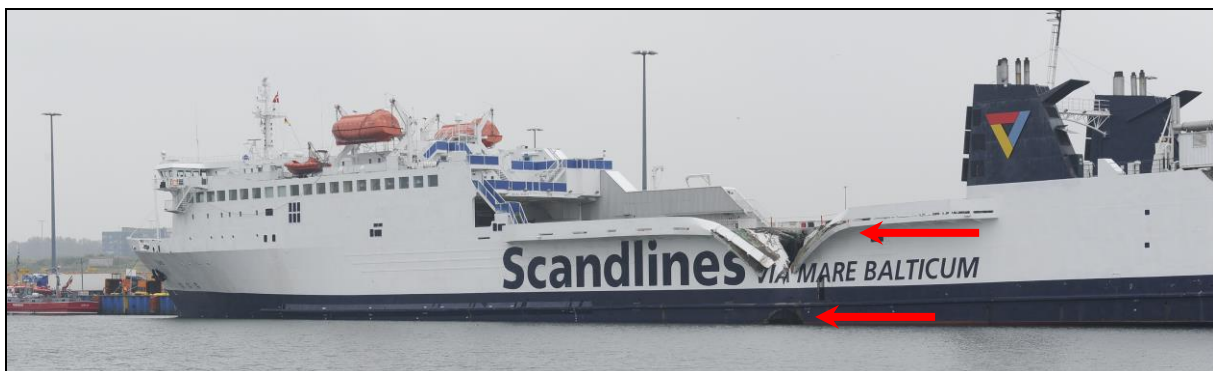
The master of the URD and the third nautical officer arrived on the bridge after the collision. After that, a public announcement was made in German by the master and he informed everyone about the collision. The public announcement was repeated by the third officer in Russian. A damage report by the chief officer was received on the bridge shortly after. The bow of the NILS HOLGERSSON had caused a v-shaped tear in the side of the URD (to port) about 8 m wide and about 4 to 5 m deep. The main deck and the weather deck were affected. In addition, the bulbous bow of the NILS HOLGERSSON had torn a hole of some 3 x 3 m in the side of the URD.

Figure 10: Damaged port side of the URD

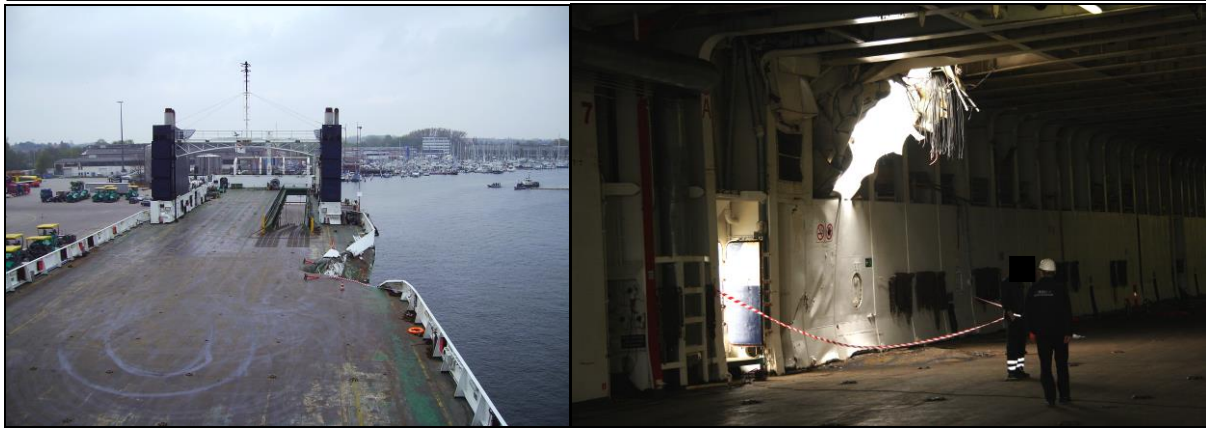
Figure 11: Photos of the v-shaped tear in the shell plate of the URD

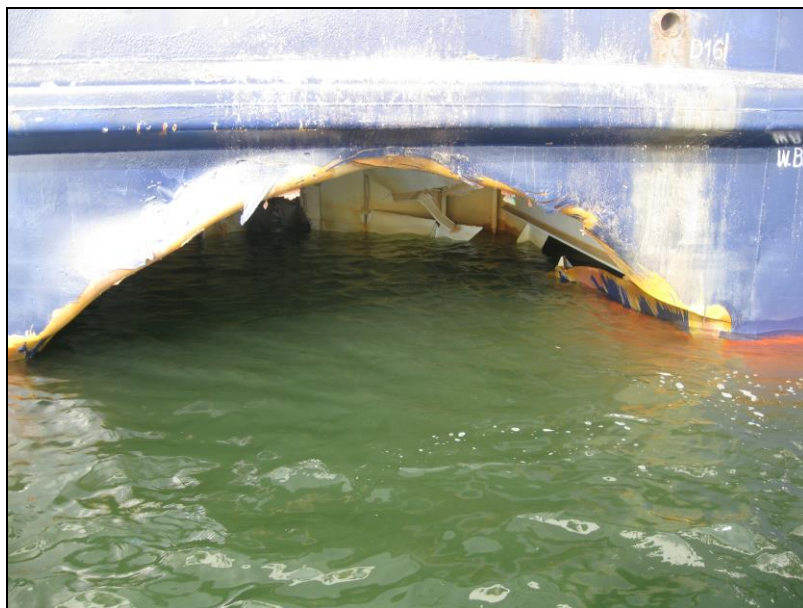
Figure 12: Hole level with the waterline in the shell plate of the URD

After the assessment of the underwater damage, the diving team submitted a proposal to seal the hole in the side of the vessel. A collision mat initially requested from ashore was not used in the end because the hole in the side of the URD was too big (about 3 x 3 m). Instead, the hole was to be closed temporarily using welded on plates, which had to be cut first.

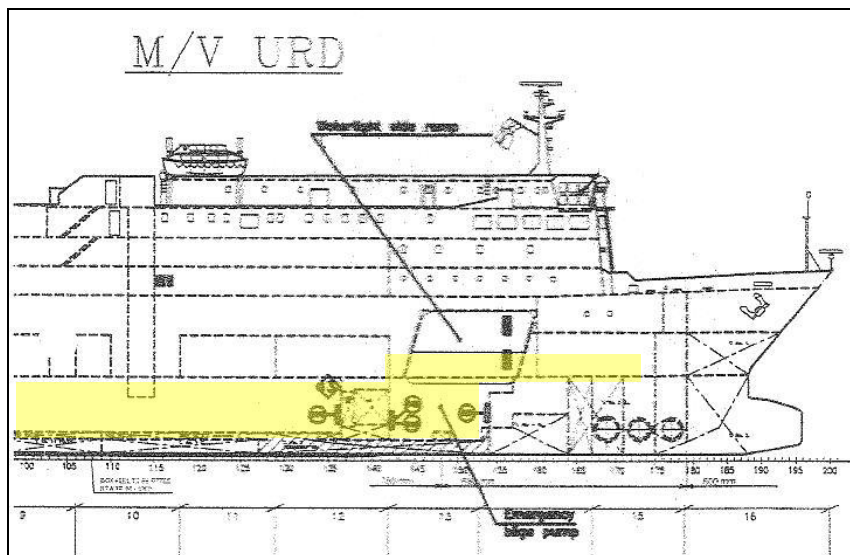
At 2220, the engine crew of the URD reported water ingress in the pump room and in the air conditioning system in front of the lower cargo hold (see Figure 14). The lower cargo deck stood at a height of 5 m below water; the deck height was about 6 m. After the report was received on the bridge, instructions were issued to close the valves. The shore-based operational units at the scene continued the pumping work with submersible pumps. There was evidence to show that the water that had been pumped out was not contaminated, meaning there had been no intermixing with fuels and lubricants. At this point, with the exception of an HGV and trailer that were heavily damaged during the collision, the weather deck was completely unloaded. The draught of the URD had dropped to 6.80 m at the bow and 5.20 m at the stern.

Figure 14: Excerpt from the damage card of the URD with the area of the reported water ingress marked

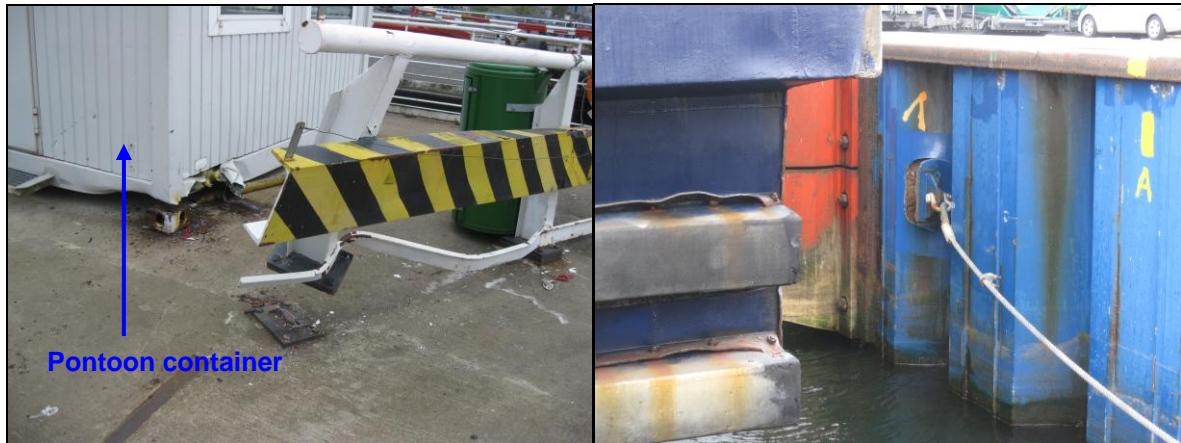
During the collision, the URD was pushed about 4 m sternward. This caused the stern door, which was resting on the floating ramp pontoon at pier 3, to strike a steel guard rail structure and the pontoon container that was there. Due to the displacement of the pontoon, a steel cable attachment was also torn out of the sheet piling (see Figure 16) and a steel cable was damaged.

Figure 16: Damaged guardrail and damaged sheet piling at the pier

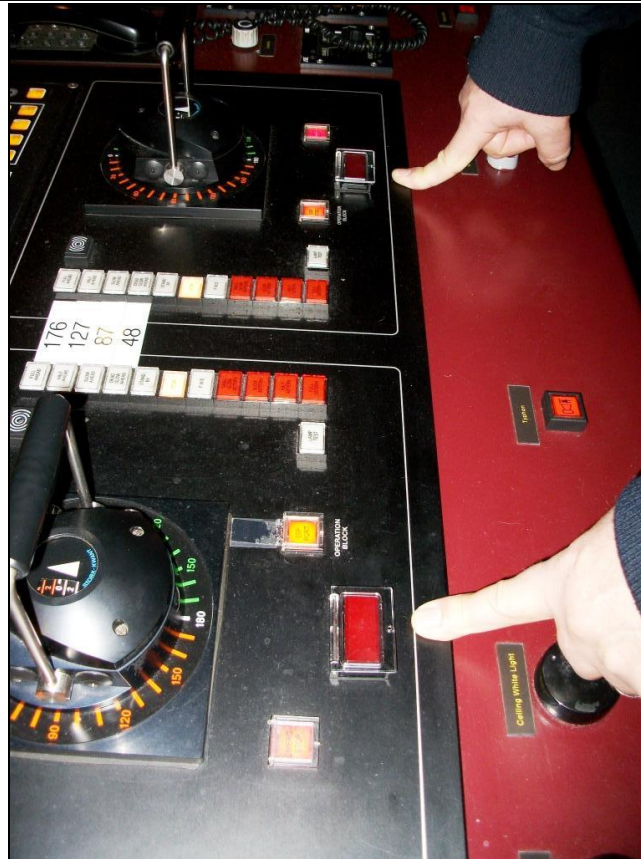
Figure 27: New position of the 'Crash stop' buttons below the control levers

The button for triggering the automated 'Crash stop' sequence has been made bigger on the ships NILS HOLGERSSON and PETER PAN and is no longer next to the other buttons on the panel, but positioned individually below the control levers (see Figure 27).
