**Bundesstelle für Seeunfalluntersuchung**  
**Federal Bureau of Maritime Casualty Investigation**  
Federal Higher Authority subordinated to the Ministry of Transport,  
Building and Urban Development

Investigation Report 301/11

**Accident with four casualties on board**

**SEUTE DEERN**

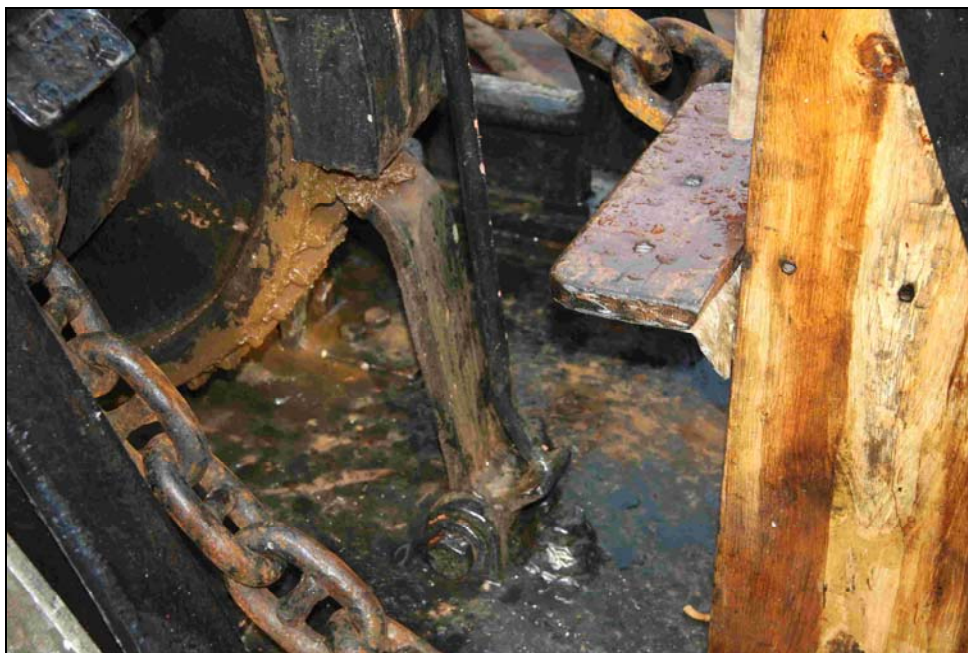
Figure 7: Pawl, gear

The winch is fitted with a cogwheel. In this design, the external gear teeth act as a locking device or brake. During a proper hoisting operation, a gravity-driven pawl drops against the tooth flanks of the cogwheel. Unless the crank is turned, respectively, hoisting force is applied to the crank handle, this pawl will prevent the anchor chain from running out.

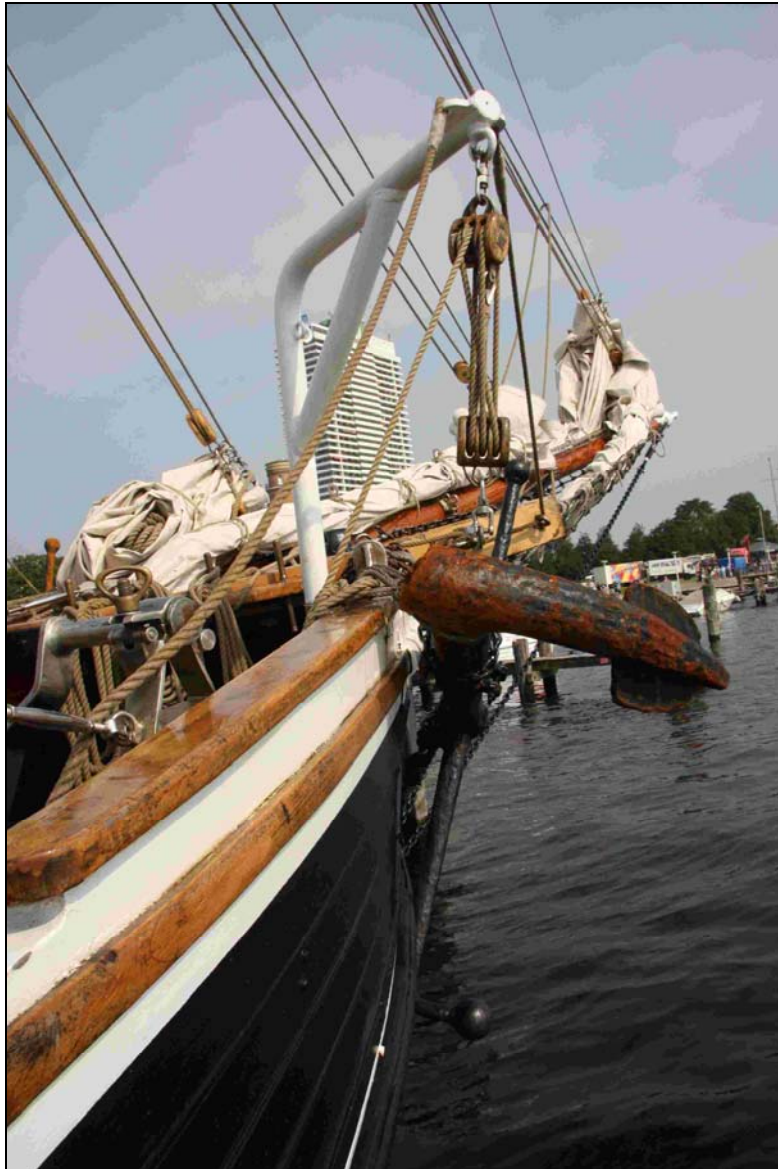
Figure 9: Stock anchor, missing fluke

Carrying on, it should be noted at this point that at the time of the accident an enormous force was acting on the capstan due to the anchor chain. The force was so great that during this manoeuvre one of the anchor's flukes broke. The anchorage ground is considered to be rocky. This suggests that the anchor may have snagged. According to the vessel report, the accident happened after one chain length of about 25 m had already been hoisted in, probably with the anchor still snagged. This exerted enormous force on the anchor chain, which was intensified by the pitching of the vessel and increasing wind. Due to the force acting on the anchor chain, it was no longer possible to apply sufficient force to the two crank handles in order to hoist the anchor further. This could easily be explained by the anchor chain reaching the maximum hoisting position just at the point that the pawl was on the tip of the cogwheel. Due to the pitching and jerking movements of the vessel, the pawl may have dropped forward into an unsafe position and stayed there.

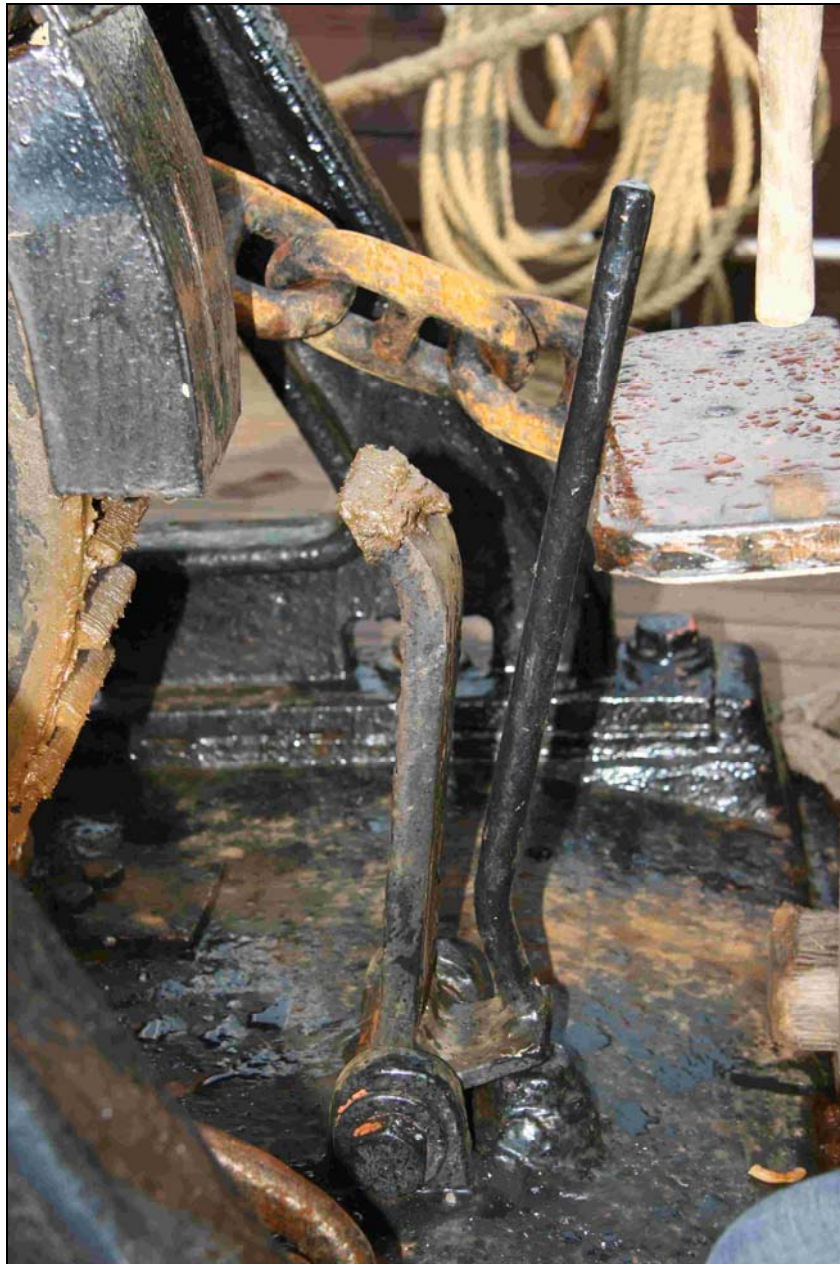
Figure 11: Pawl in tilt position

During the survey of the vessel on 3 September 2011, it was found that the pawl could be in a position from which it may not automatically drop back into the cogwheel by means of gravity. Thus, it did not fulfil its function as a locking device during the hoisting procedure. In normal hoisting mode, the operation of the pawl is recognised by a clicking sound as it moves from one tooth to the next. This clicking must have been absent immediately before the accident.

At the front bottom edge, the pawl can be set by means of an adjusting screw so that there is a maximum distance of about 15 mm between the pawl and cogwheel tip. At such a setting, the pawl would always drop into the cogwheel automatically and reliable operation would be ensured. On board, the adjusting screw was found to be fully tightened. The adjusting screw was immovable and covered with a thick coat of paint, which permits one to conclude that the pawl was operated in this unsafe condition for a very long time.

The fully tightened, non-serviceable adjusting screw was the reason for the operating position of pawl being unsafe.

- the existing adjusting screw should be used to set the pawl such that it always drops back to the operating position by means of gravity. A maximum distance of 15 mm between pawl and cogwheel should not be exceeded;
- a seawater-resistant tension spring could be used as an additional safety element to enhance the safety of the system.

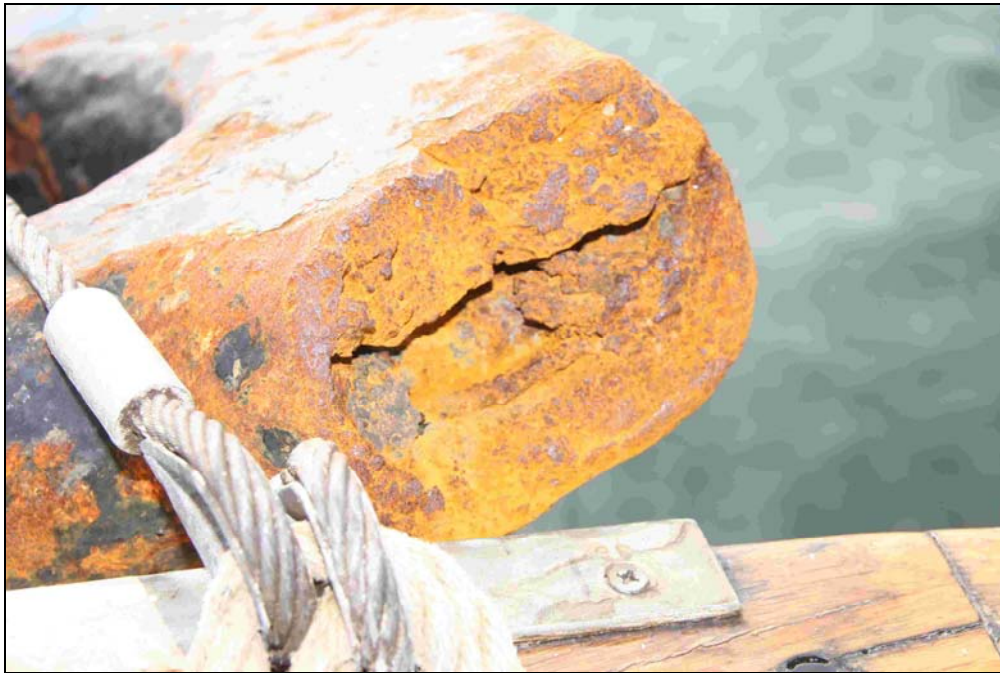
Figure 12: Breaking point

The vessel report indicates that this was the point at which the anchor's fluke broke and the anchor was released, causing the vessel to start drifting. The fact that the anchor's fluke broke is also indicative of the very heavy load acting on the anchor chain. That the release of the anchor from the anchorage ground produced a jolt, which caused the people to be thrown from their optimum position in terms of rotating the crank handles and, with open pawl, not be able to apply the necessary retention or rotational force, is not excluded. According to the vessel report, eight people operated the crank handles in the positions intended for this.

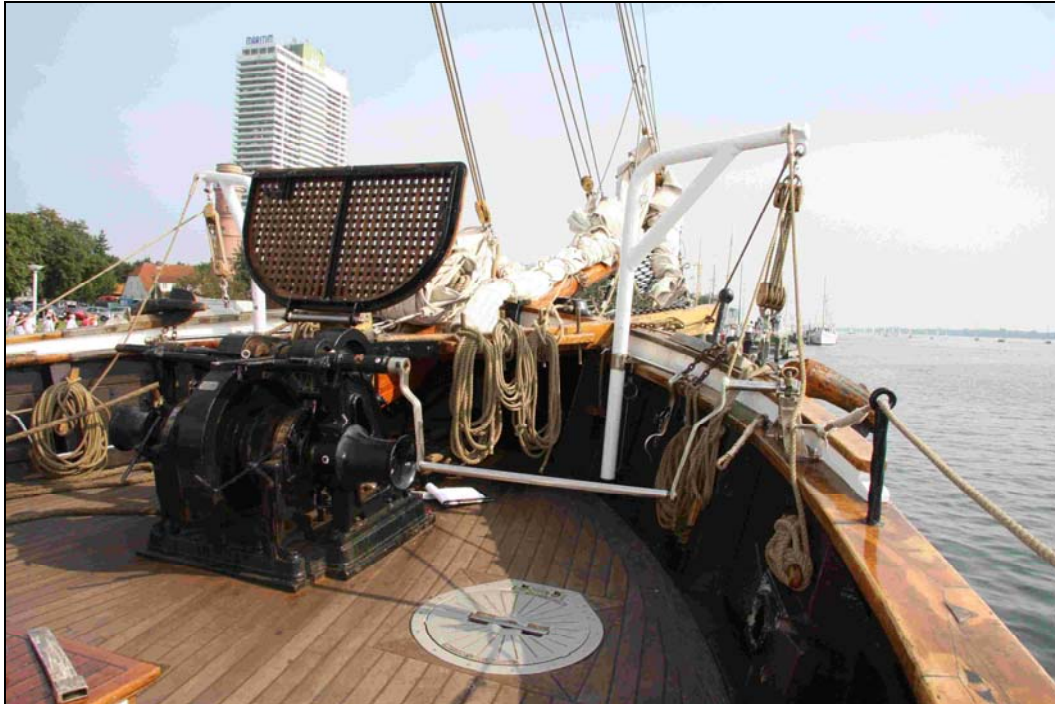
Figure 16: Crank handle

The extent to which such a labour-intensive manual capstan in the design portrayed is practicable for anchor manoeuvres was not assessable in this investigation. Although extending the cranks to the bulwark facilitates the work, during hoisting two crew members stand directly in front of each crank and due to the confined space would have only limited options for evading a crank rotating violently in the opposite direction should the need arise.
