Investigation Report 422/11

Serious Marine Casualty

Accident involving a person on board

TAUCHER O. WULF 5

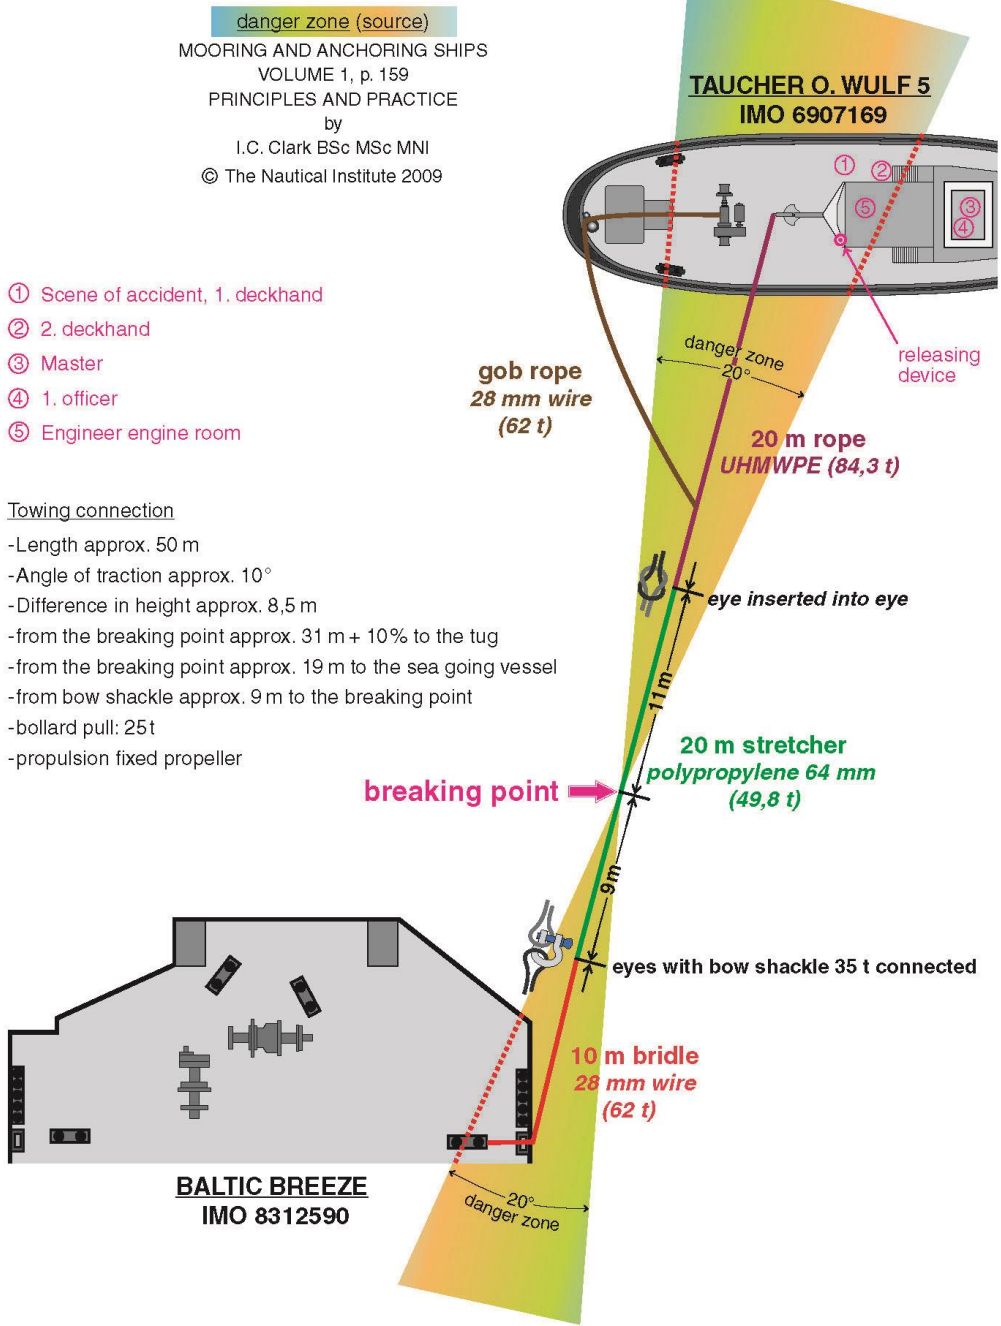
Figure 5: Towing connection, drawn in accordance with statements and certificates
 (Figures reproduced with kind permission from Tug Use in Port, published
 by the Nautical Institute, written by Henk Hensen FNI)

As can be seen in Fig. 5 (towing connection), the deckhands were within the snap back zone. While one of the deckhands managed to jump on to the port side companionway, the other was struck by the towline as it snapped back. The casualty was experienced and has worked on the tug since March 2000. His safety area by the companionways has reportedly already been tried and tested. The only other possible safety area on the deck of an aft tug would be the forward edge of the bridge (see Fig. 9). However, the towing connection cannot be controlled from there, e.g. to trigger the slip device (see Fig. 8) with a lever. A second set of towing gear is available for the event of the towing connection breaking. A parted towline is unpredictable in that when it snaps back it moves faster than the speed of sound. In the present case, this means that the accident had already happened before the bang was heard on the aft deck and the deckhands could not move to safety if they were still within the danger area. The best protection is located in the superstructure. At the same time, it should be noted that there is room for only two people on the bridge while towing because the entire stern is only controllable by continuously moving backward and forward and more people would interfere with each other. The funnel obstructs the view astern due to a large blind spot. In this situation, the skipper usually steers the tug and the chief officer monitors the towing connection. The procedures of the owner's quality management system do not define safety areas for the crew. During the task, the doors must be closed and crew members wear protective clothing.

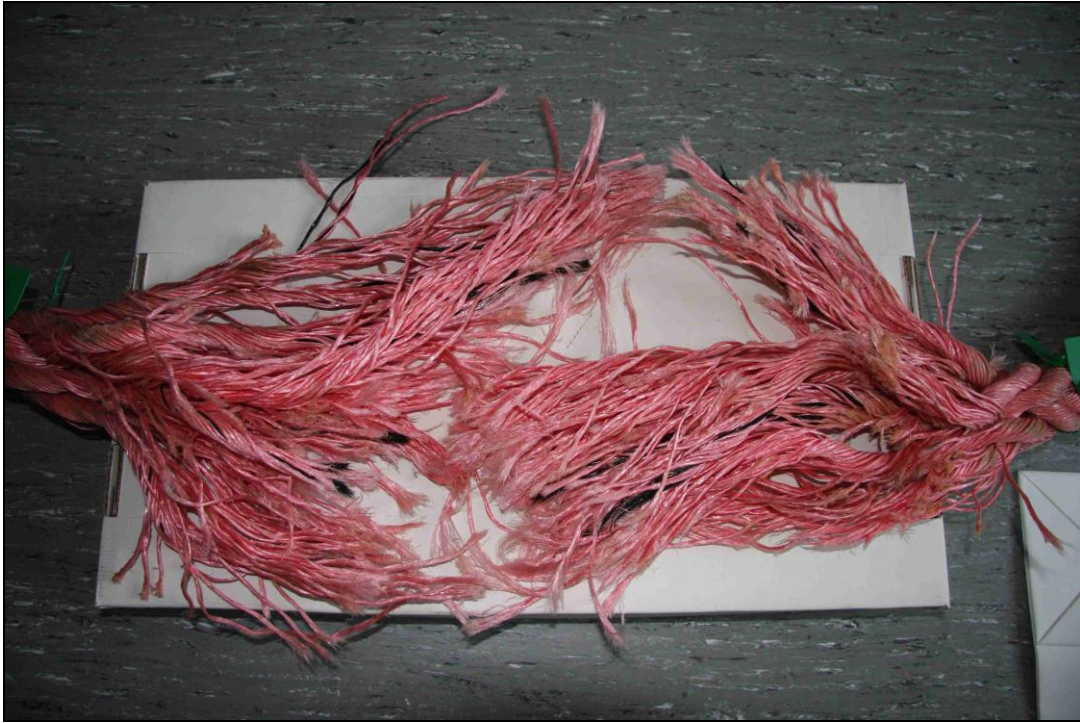
Figure 13: Point of failure on the stretcher

The stretcher was seized by WSP Cuxhaven. It was reported that the point of failure was roughly in the middle. The operator submitted a certificate for the line from the supplier Canel & Sohn, which indicated a breaking load of 49.8 t at a diameter of 64 mm. The stated material is polypropylene.

The parted stretcher evidently represents non-certified material from an unknown manufacturer that cannot be correlated.

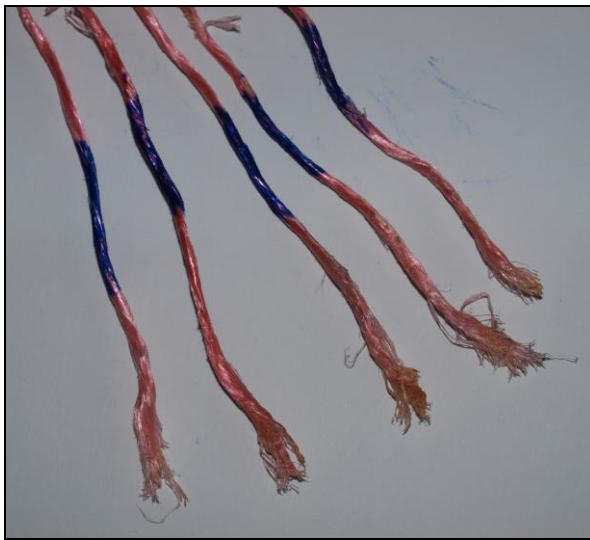
Figure 14: Damage before the break

An analysis of the point of failure on the rope revealed that regardless of the tractive forces exerted, the rope failed due to being severely damaged at the point of failure (see characteristic representations of the point of failure in Figs. 14 and 15).

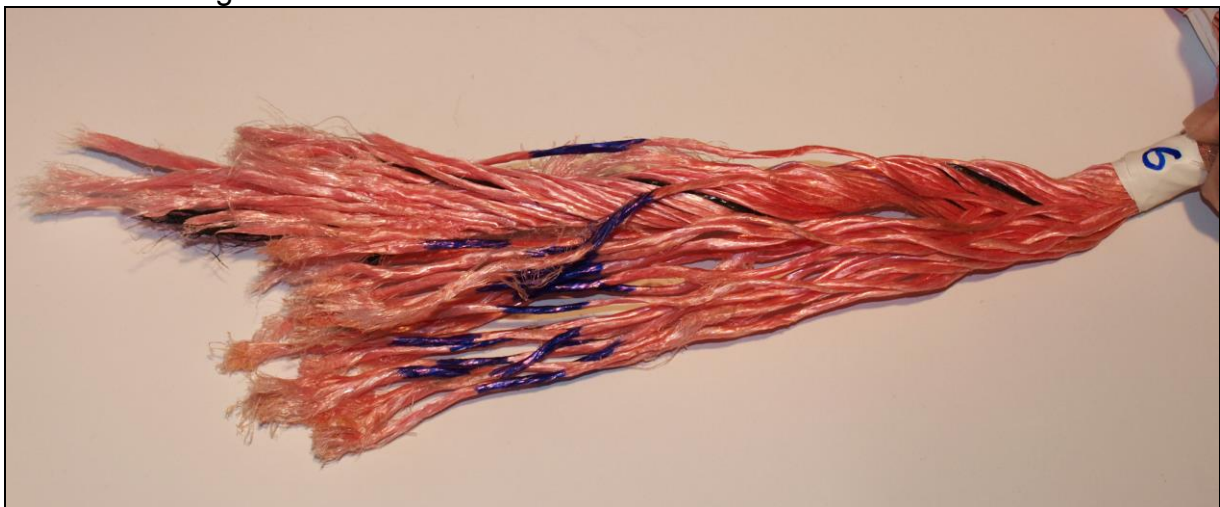
Figure 16: Most damage to a strand

The examination of each individual strand and the respective strand fibres at the point of failure on the rope revealed that at least 73 fibres of the total of 456 fibres in the eight-strand square plait were completely or partially frayed. That corresponds to damage to 16% of the total number of fibres. Here, at a total of 20 damaged fibres the most damage to a strand stood at 36%.

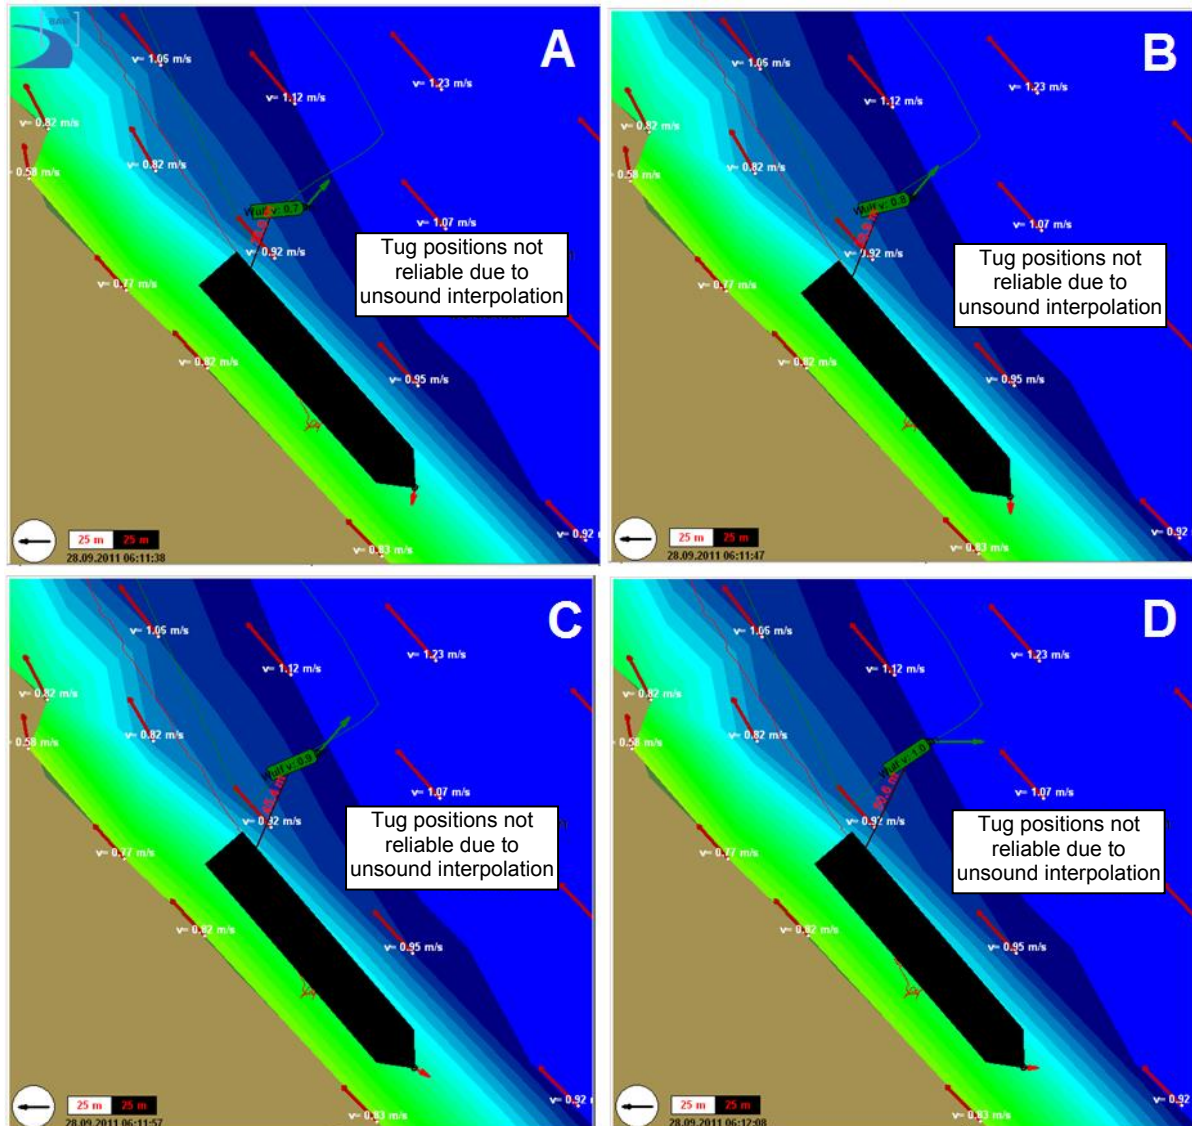
Figure 18: Analysis, interpolated towing connection distance

Based on the substantiated positions of the BALTIC BREEZE and her direction of movement at the bow, as well as the distance calculations between the BALTIC BREEZE and interpolated positions of the TAUCHER WULF 5, the following sequence of events may be assumed on the basis of Fig. 18:

- the distance between the vessels at 061157 is presumably about 45.4 m (angle of pull about 11°) and it is likely that as before the tug is still turning to port (Image C). Since the bow of the BALTIC BREEZE is now also turning slightly to port (substantiated AIS data), it is assumed that tractive force from the tug is no longer acting on the BALTIC BREEZE;
- at this point, the tug is presumably at an angle of 80° to the tidal flow of about 0.9 m/s to 1.0 m/s, where this inclination may have caused a further force component in addition to the propeller thrust (dynamic stagnation pressure at oblique inflow; see notes below);

- the tug straightened herself after the line parted (presumably between Images B and C), which permits the conclusion that a roll and pitch moment acted previously due to tractive forces from the propeller thrust and oblique inflow;
- the turn to port of the BALTIC BREEZE after the presumed failure of the line connection becomes even more evident on the basis of the substantiated AIS data at 061208 (tow/tug distance about 50.6 m and angle of pull about 10°, Image D).

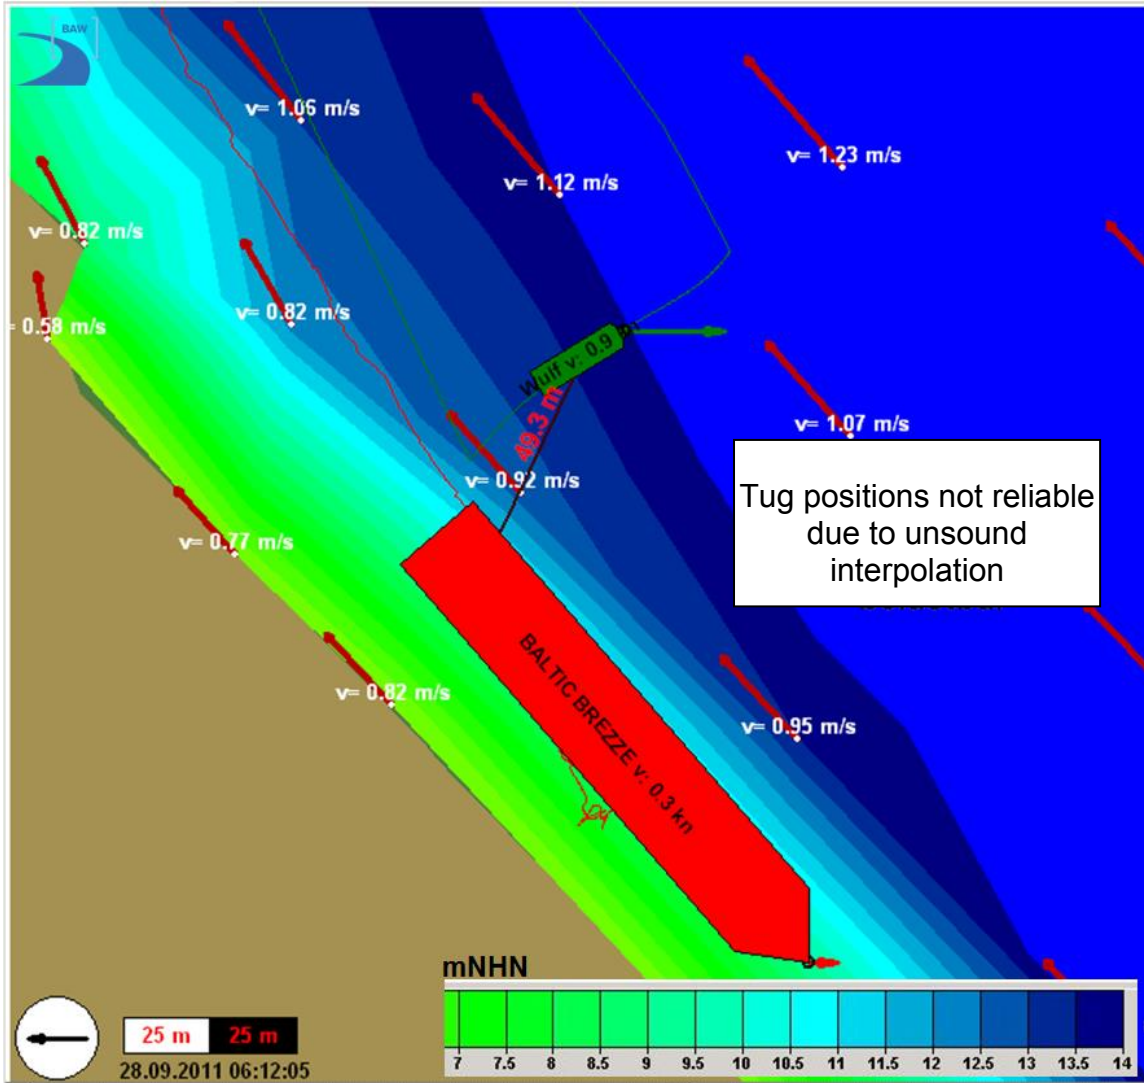
Figure 19: Accident situation

- the accident occurred at a water level of about msl 0.8 m in an almost fully developed ebb current estimated at roughly 0.9 m/s to 1.0 m/s in the area between the tug and tow. Considerable simplification (rectangular, lateral underwater profile of tug at $l \cdot t = 30 \text{ m} \cdot 3 \text{ m} = 90 \text{ m}^2$, slight oblique inflow 80°, water density $\rho = 1,000 \text{ kg/m}^3$, inflow velocity $v = 1 \text{ m/s}$) results in dynamic stagnation pressure according to BERNOULLI of about $p \approx 37 \text{ kN}$ ($p = 0.5 \cdot \rho \cdot v^2$), which would presumably have to be absorbed by the line proportionally in addition to the propeller-induced tensile load;

Fig. 19: calculated positions, flows and underwater bathymetry (2010) at the presumed time of the failure of the line connection between the TAUCHER WULF 5 and the BALTIC BREEZE (presumed distance about 49.3 m, 061205). In the table below, the information between the verified AIS data highlighted yellow is interpolated. The distances and angles relate to the space between the towline anchor points. The time of the accident is highlighted red. At this point, the towing connection specified at about 50 m in length was fully elongated and parted. The course of the accident can be obtained as an animation on the BSU website. Due to the low data density vis-à-vis AIS information, the tug positions are uncertain and the headings displayed should be rated only as an indication. VDR data were not available to the BSU.

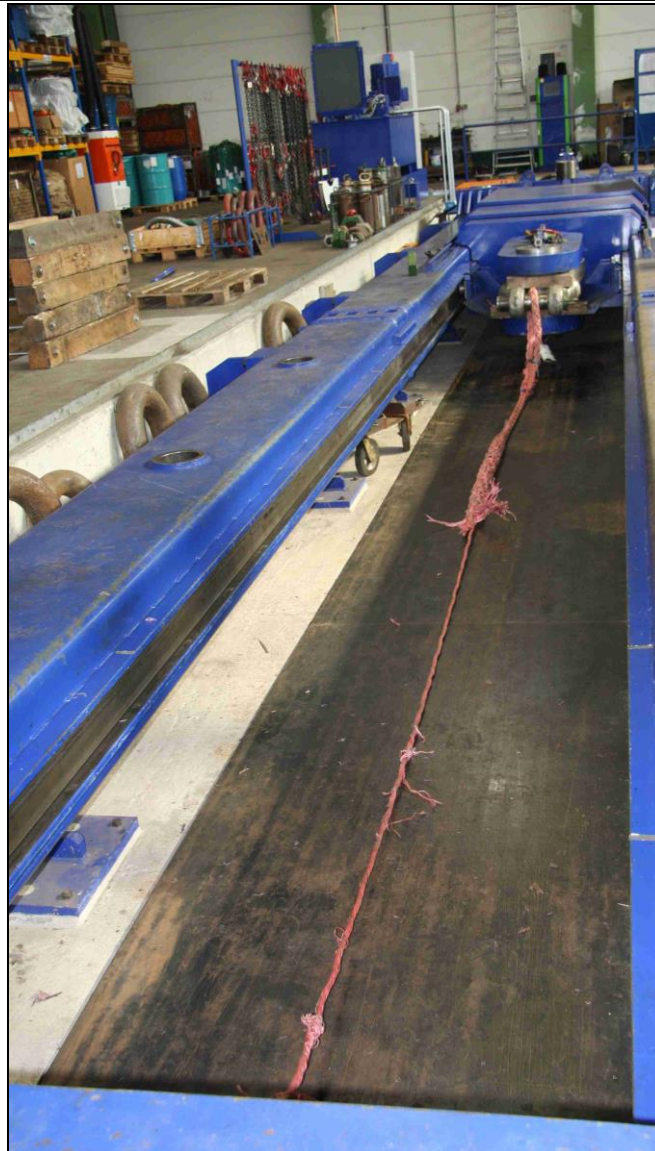
Figure 22: Breaking load test by Messrs Seil Hering

On 21 August 2012, the seized, failed stretcher, with a total length of 8 m and an additional eye spliced at the point of failure, was clamped into a tractive unit so as to measure the breaking load in Hamburg. A visual inspection indicated that the sample was a polypropylene line (PP) from an unknown manufacturer with a diameter of 56 mm and a four x two strand square plait. The theoretical breaking load would be 38.9 t. The expert emphasised that the sample does not meet the requirements of a stretcher and therefore, should not be so identified. The reported purpose of a stretcher is to absorb shock loads. Neither the original length of about 20 m nor the material and specified breaking load are reportedly fit for that. The submitted certificate for a polypropylene line of 64 mm in diameter and a breaking load of 49.8 t reportedly does not correspond to the sample.

The breaking load test revealed a tensile strength of 224.2 kN (22.9 t) and elongation of 1,041.8 mm, i.e. 13%. The elongation at break in the case of polypropylene is reportedly 12%⁶, depending on the frequency of use and wear on the line.
