Bundesstelle für Seeunfalluntersuchung
Federal Bureau of Maritime Casualty Investigation
Federal Higher Authority subordinated to the Ministry of Transport,
Building and Urban Development

Summary
Investigation Report 507/11

Serious Marine Casualty

Collision
between the MOL EFFICIENCY and the
SPLITTNES
on 22 November 2011 at 2013
on the Weser

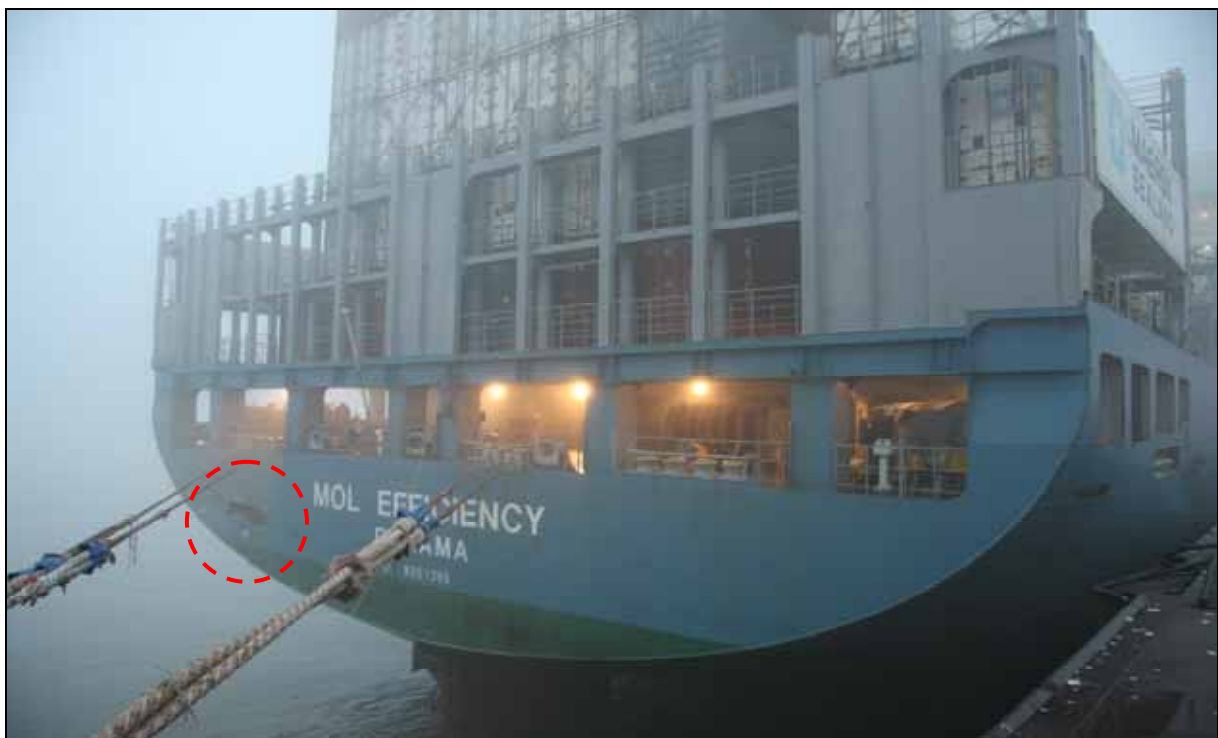
The MOL EFFICIENCY sustained damage on the aft port side, the helm and the transom because of the collision. Two holes were created, each about 2 m long and 0.5 m wide. The frames below were fractured. The rudder post was bent and the rudder blade damaged. The repairs continued for several months.

Figure 4: Hole in the transom of MOL EFFICIENCY

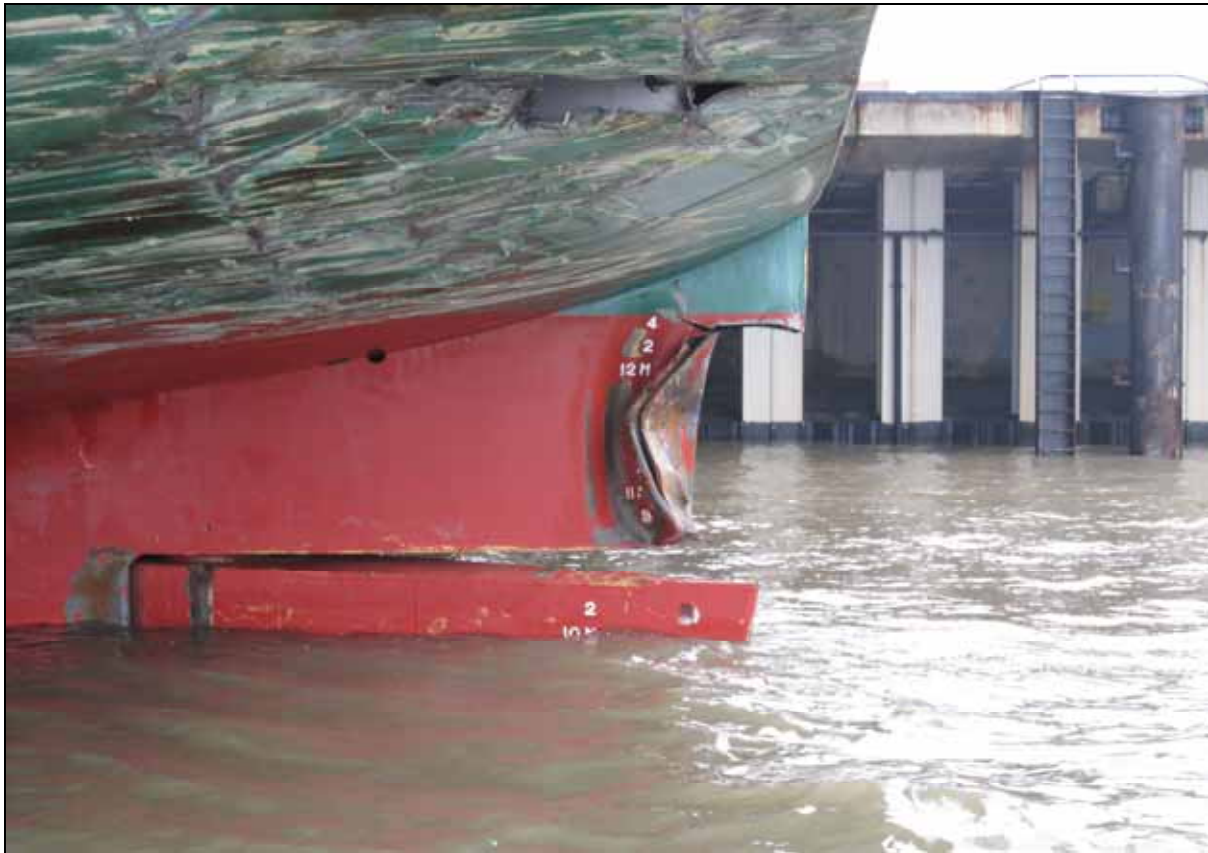
Figure 5: Damage to the rudder area of MOL EFFICIENCY

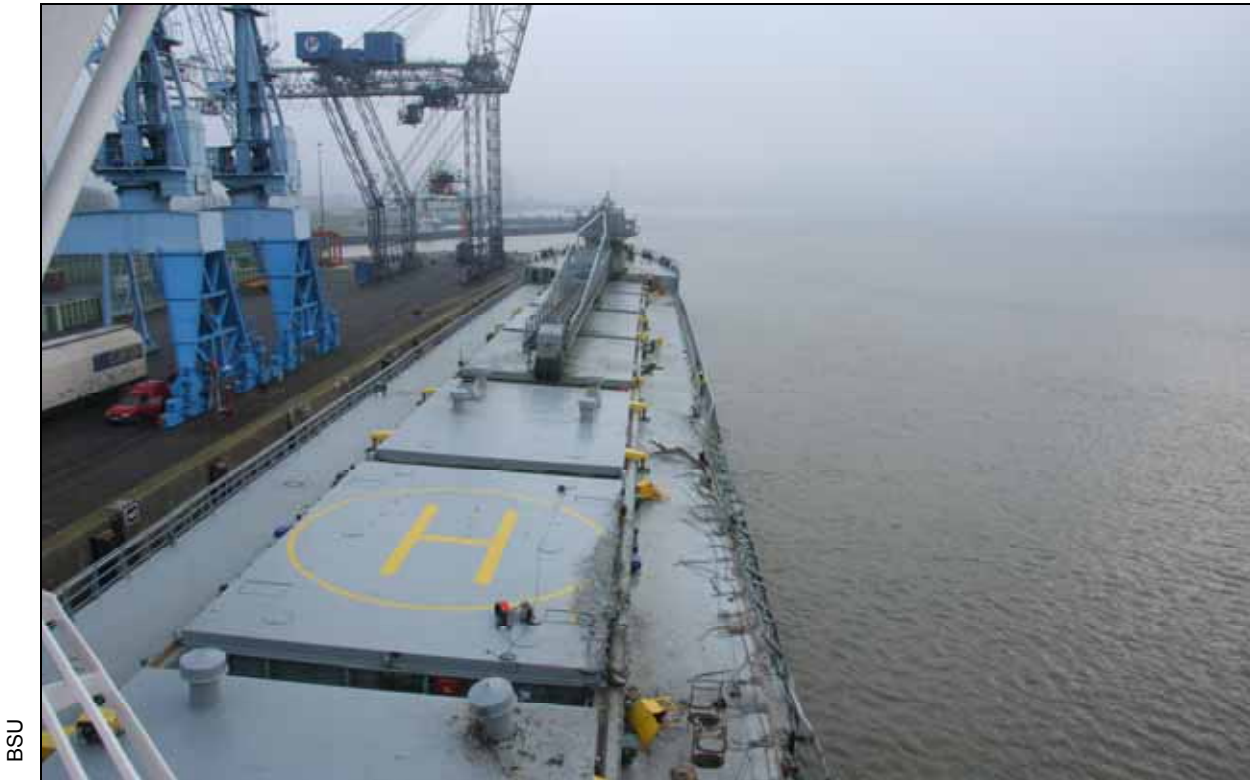
The starboard side of the SPLITTNES was heavily damaged by the collision. A 15 m long gash was sustained on the shell plating. This immediately led to a strong inrush of water, which, in turn, caused the vessel to list to about 20°. Above and beyond that, damage was sustained on the starboard side of the main deck from the forward edge of the superstructures to 40 metres in front. The guard rail was completely destroyed there.

Figure 6: Destroyed starboard guard rail on SPLITTNES

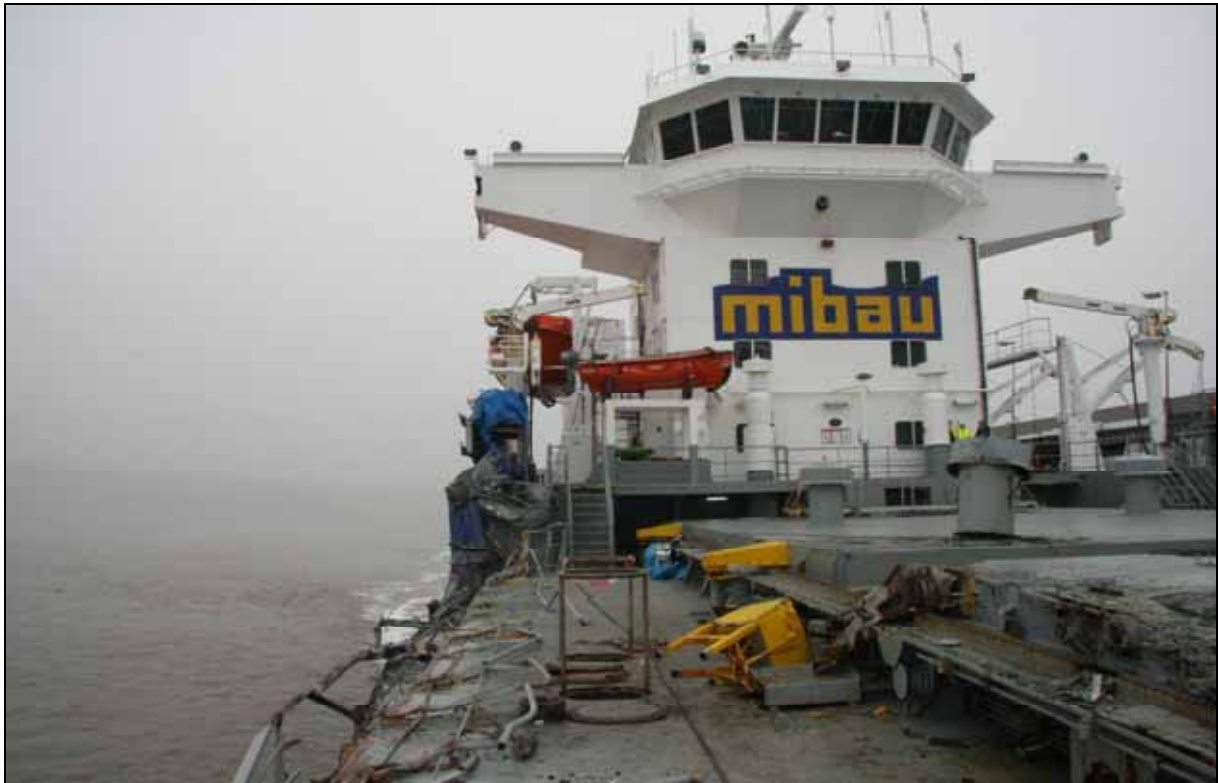
Furthermore, hatch covers 5 and 6 were damaged amongst other things. The damage sustained amounted to more than EUR 1 million.

Figure 7: Destroyed main deck on SPLITTNES

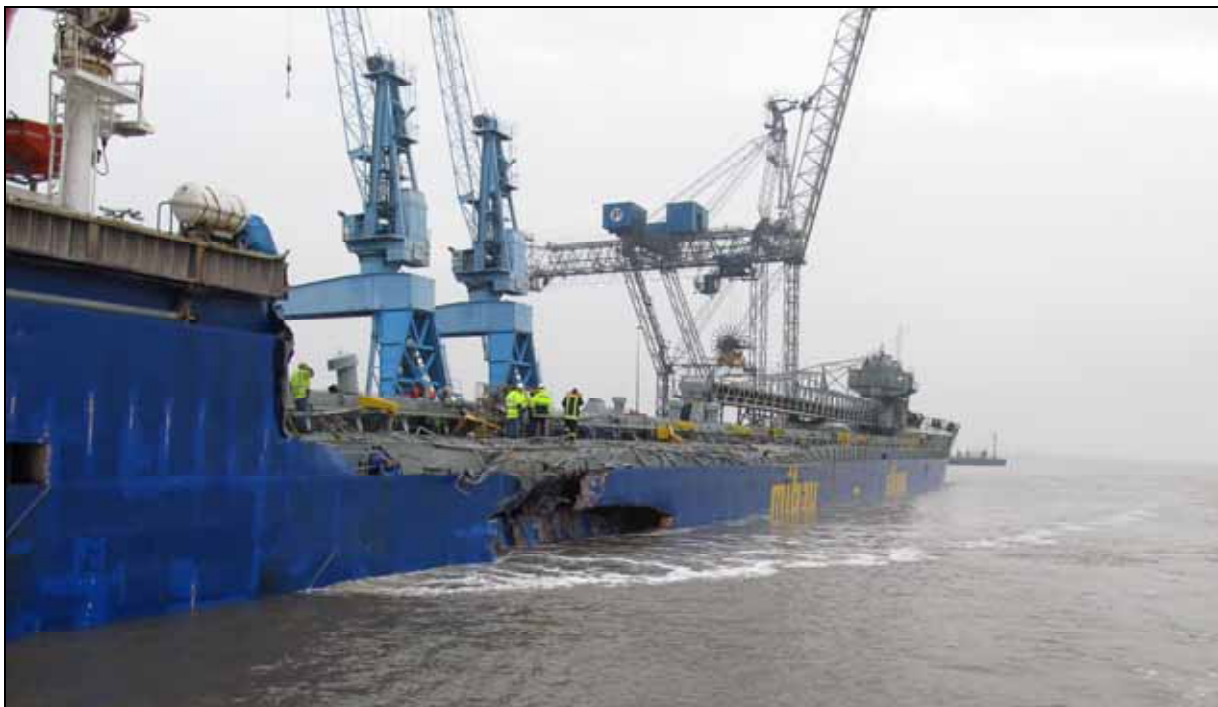
Figure 8: Water ingress on the starboard side of SPLITTNES

The final, seemingly unimportant constraints follow. The dimension difference between the two vessels is so unfavourable that the top edge of the MOL EFFICIENCY's rudder blade tore open the side of the SPLITTNES below water and thus caused a sudden inrush of water. Fortunately, only the shell plating was torn, meaning the SPLITTNES was able to stay afloat and no fuel tanks were holed. Favourable was the fact that the SPLITTNES was fully laden and that her ballast water tanks were empty because of this. They could be used to trim the vessel.

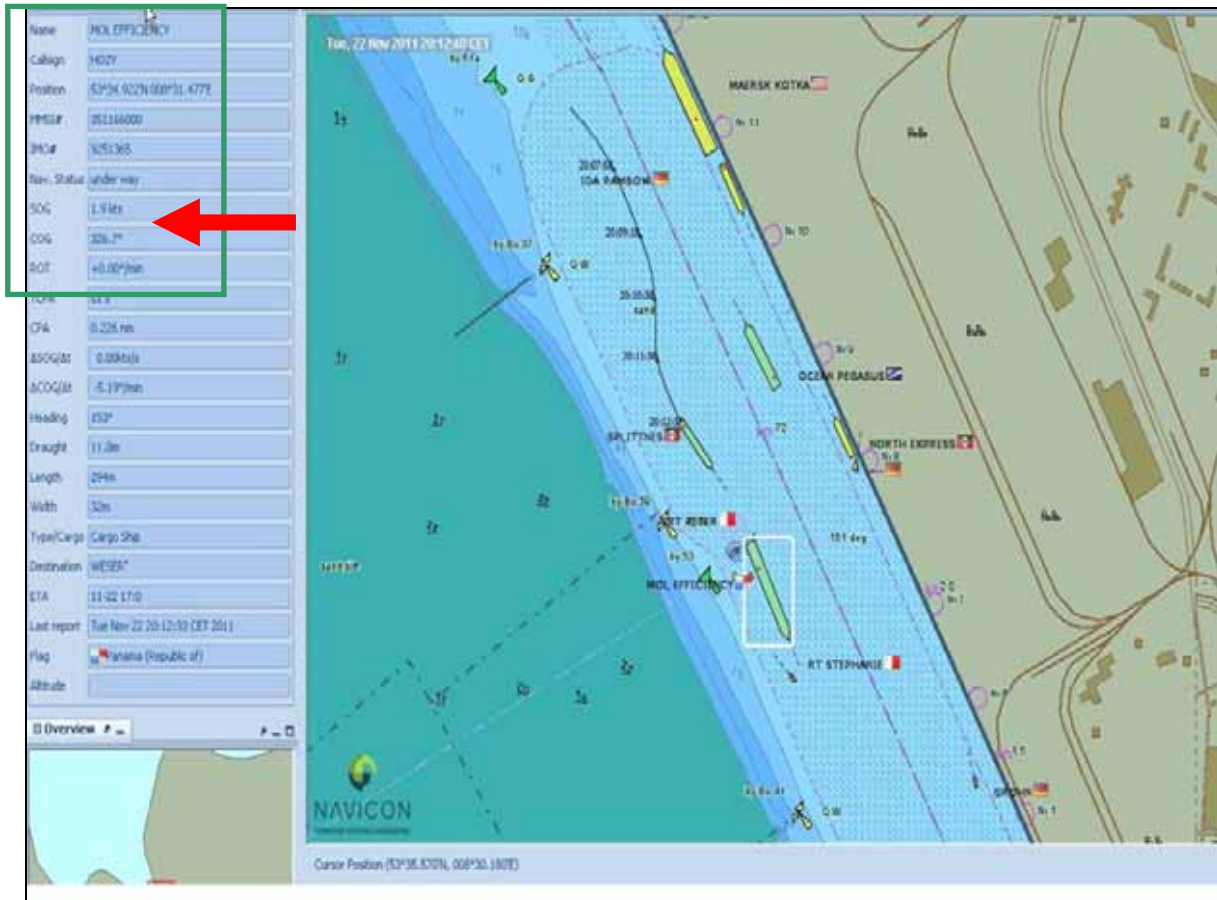
Figure 13: AIS display at 201240

Figure 13 shows the data of the MOL EFFICIENCY about one minute before the collision. Her speed over ground is about 2 kts in a northwesterly direction, i.e. astern. The ship's command and pilot of the MOL EFFICIENCY endeavour to keep the position of the large container vessel inside the turning circle.

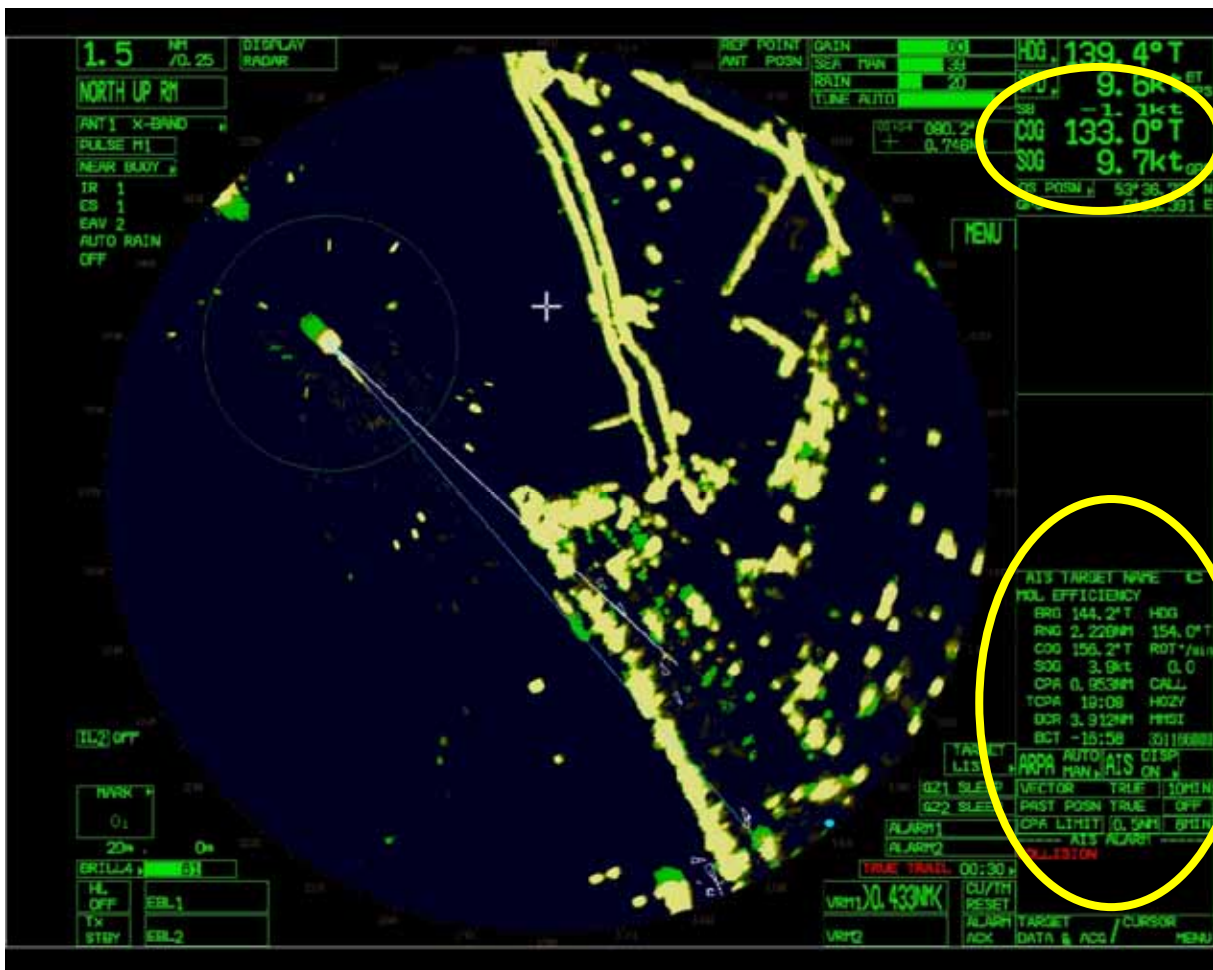
Figure 23: Radar image of the SPLITTNES during the planning at 2006

Figure 23 shows the radar image of the SPLITTNES as available to the pilot when the plan was made on VHF that he would stay behind the MOL EFFICIENCY until she had berthed. Following that, the speed (shown top right as speed over ground – SOG) of 9.7 kts is reduced considerably, as can be seen in Figure 24. During the second round of planning at 2009, the SPLITTNES moved forward at only 4.4 kts. The MOL EFFICIENCY's data are displayed at the bottom right and thus available to the pilot of the SPLITTNES at all times.

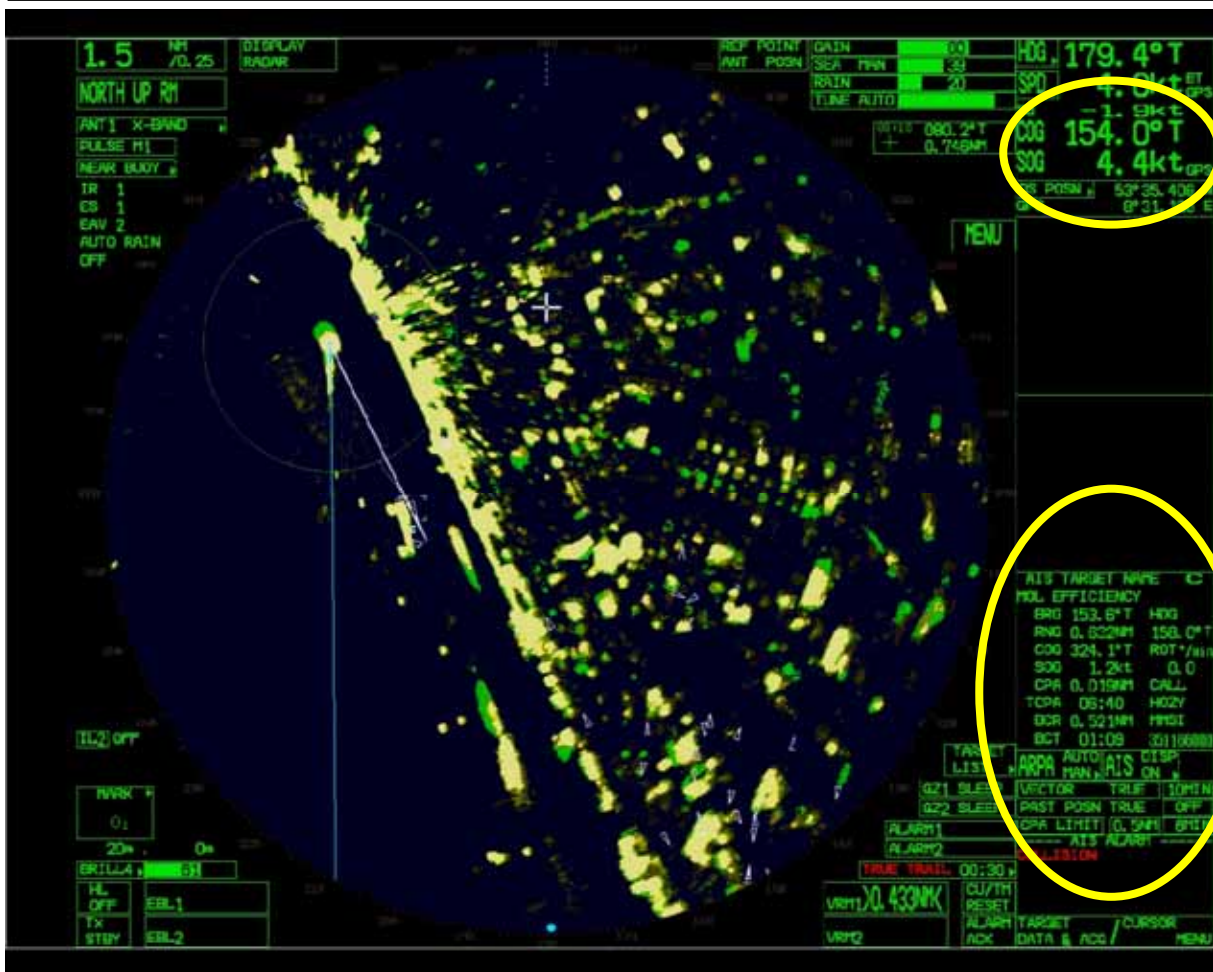
Figure 24: Radar image of the SPLITTNES during the second round of planning at 2009

After the pilot of the MOL EFFICIENCY suggested that the SPLITTNES could overtake after all, as the OCEAN PEGASUS had passed, the SPLITTNES accelerated again to overtake the MOL EFFICIENCY – now relatively close (RNG about 0.6 nm) ahead of her – on the eastern side. The audio recordings of the VDR indicate that at 'PORT 20' and 'HALF AHEAD', the pilot had made a firm decision to implement an evasion manoeuvre since she had turned to starboard due to stopping.

The AIS data of the MOL EFFICIENCY are still displayed at the bottom right. At this point, it can be seen that the MOL EFFICIENCY is proceeding with a speed over ground (SOG) of 1.2 kts and course over ground (COG) of 324.1°. This means that she is moving astern towards the SPLITTNES.

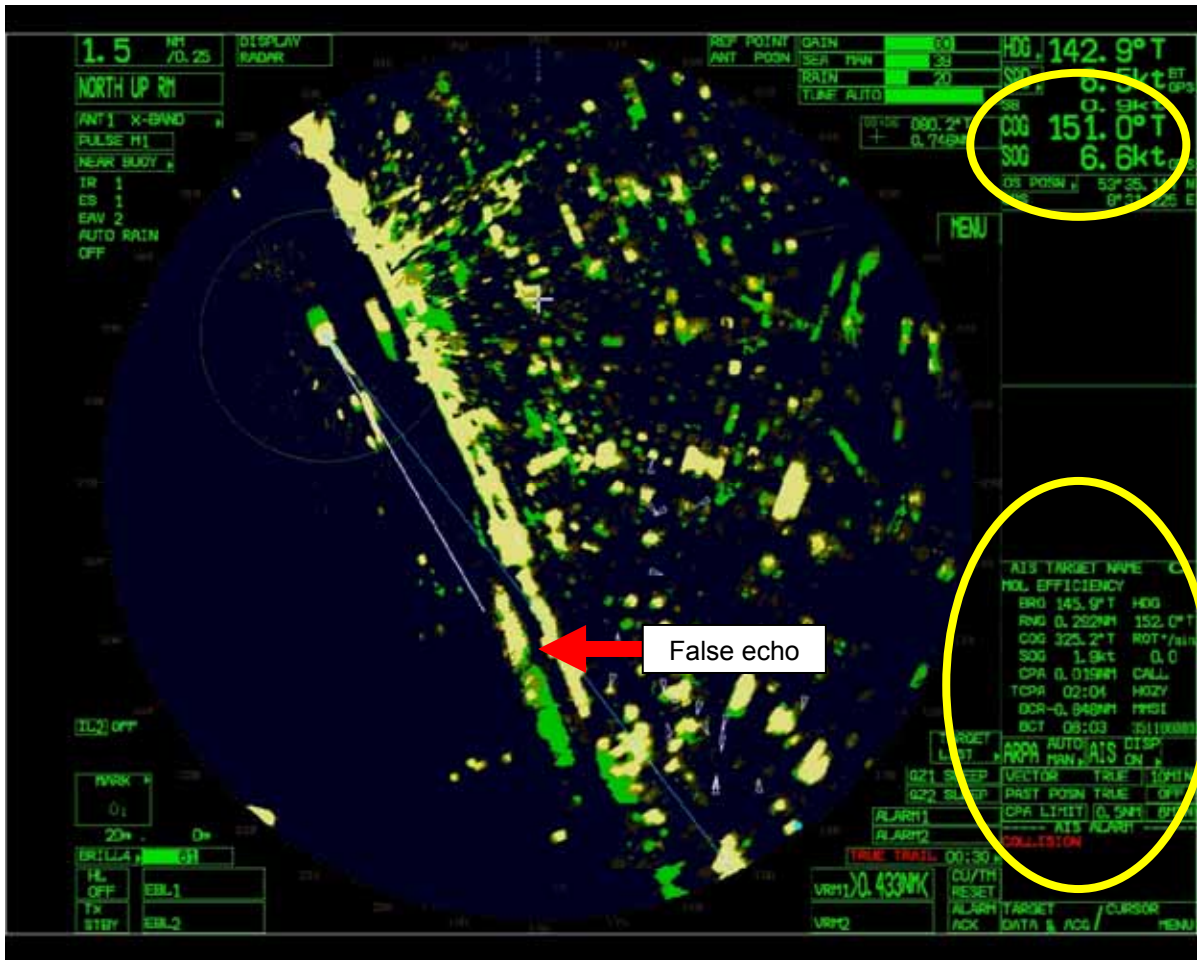
Figure 25 shows that the SPLITTNES is finding it difficult to turn to the east. Her speed is slowly increasing. The distance to the MOL EFFICIENCY is only a few metres (RNG: 0.29 nm = approx. 500 m).

Figures 25, 26 and 27 each reveal a false echo similar to an oncoming vessel. The BSU has marked the false echoes in the interest of clarity.

Figure 25: Radar image of the SPLITTNES at 2012

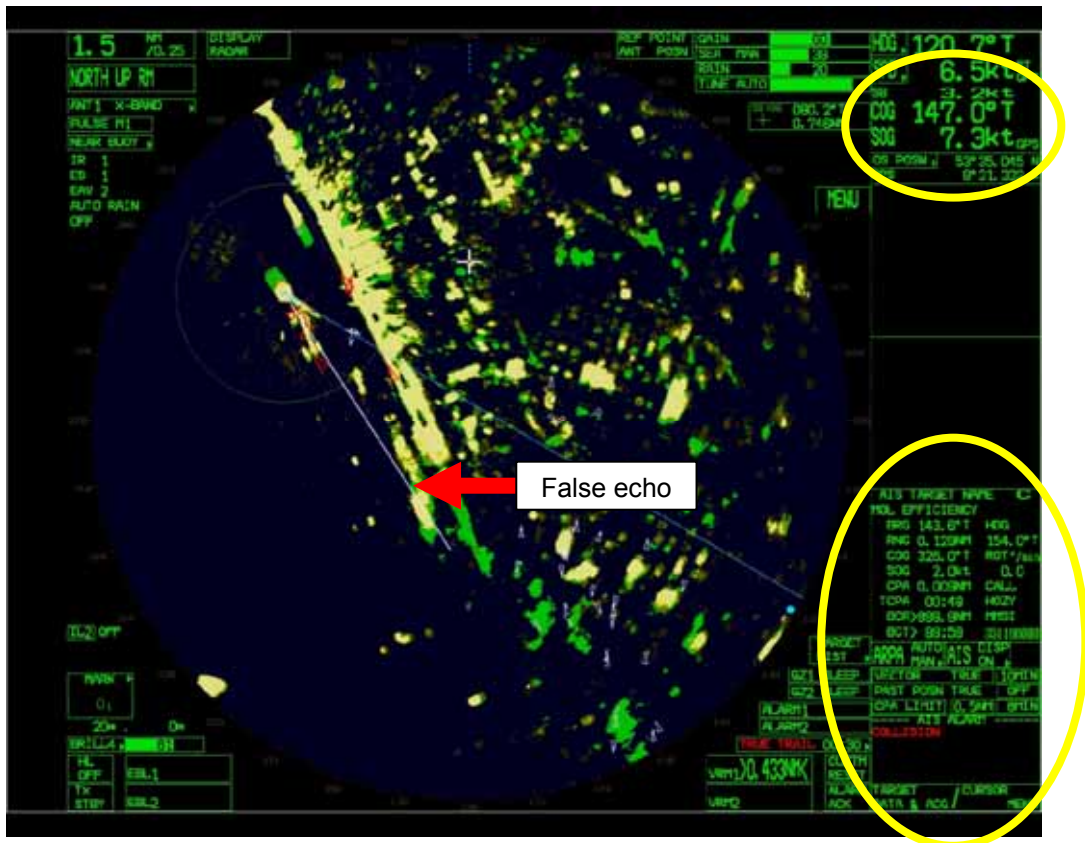
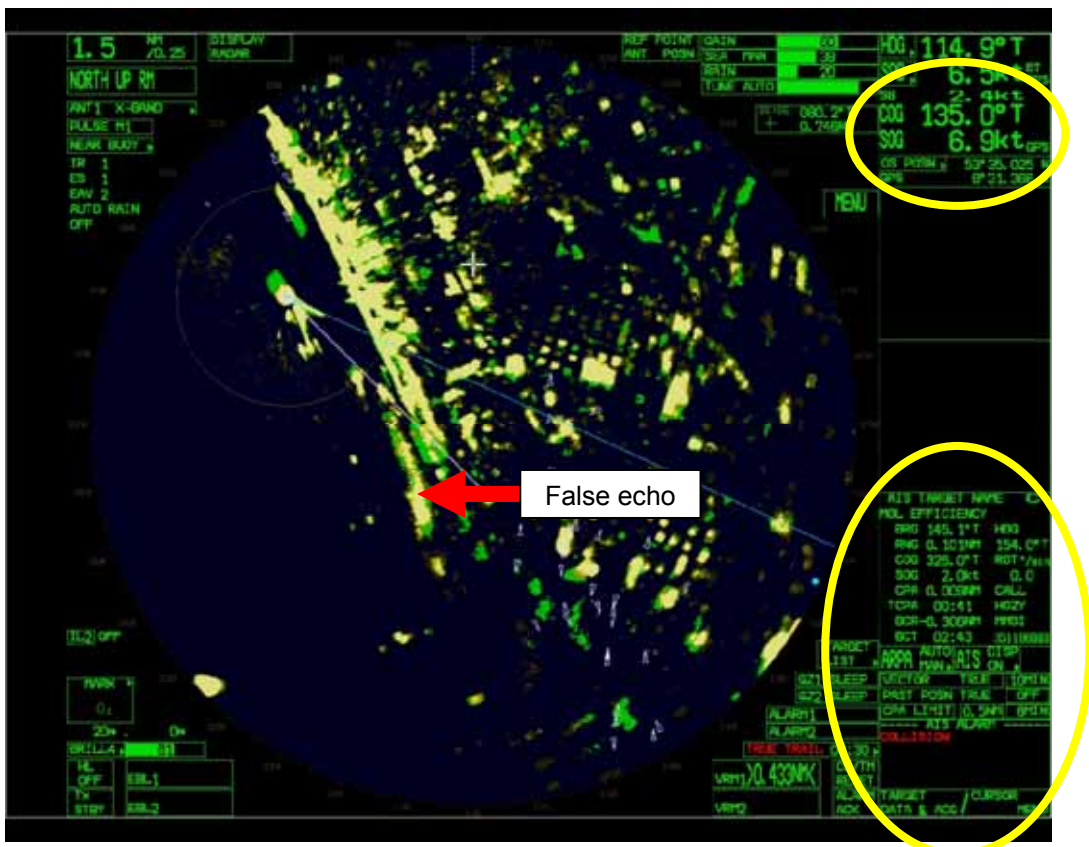
The two vessels collided at 201330 (Figure 26 and Figure 27).

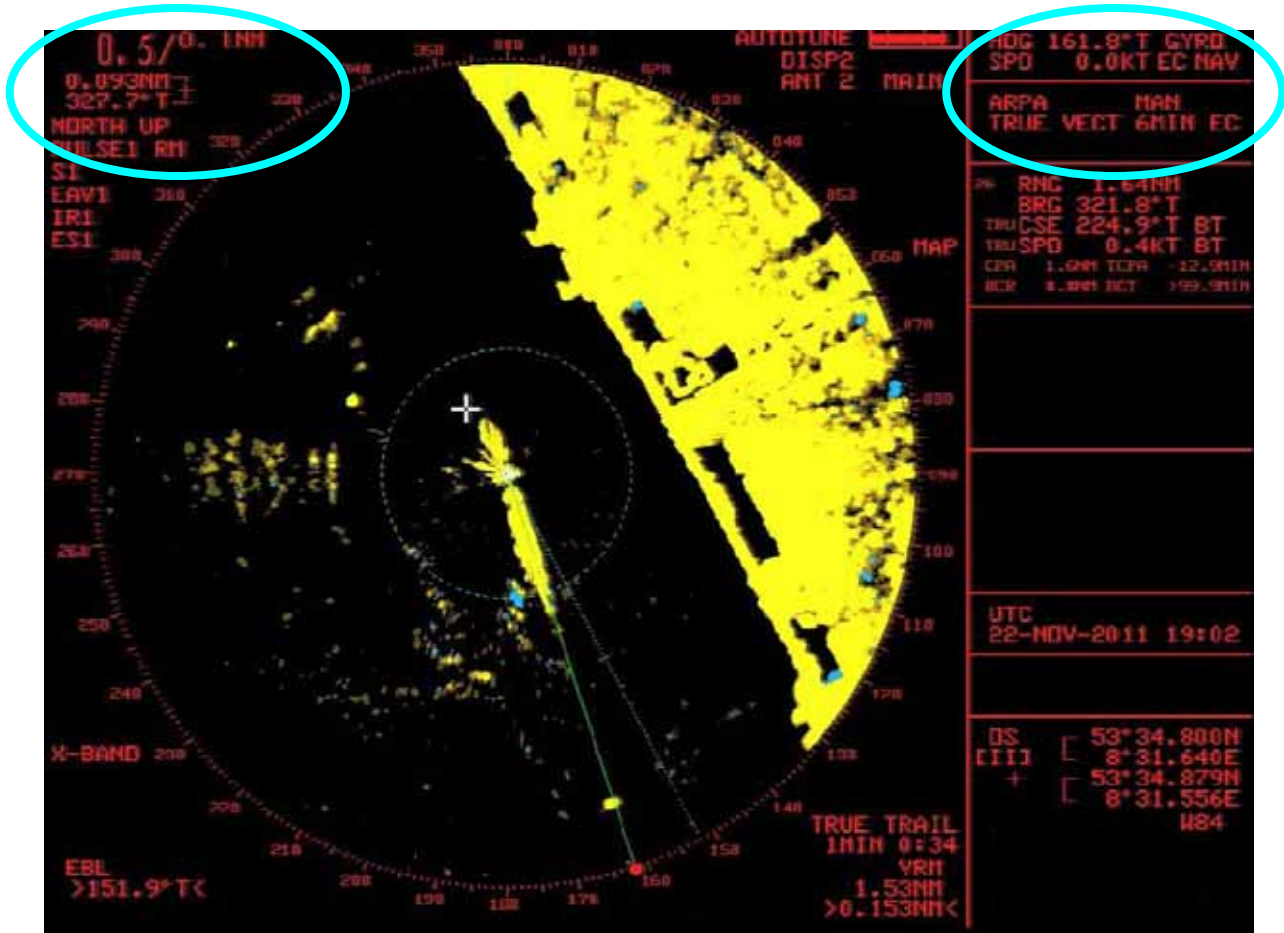
Figure 28: Radar image of the MOL EFFICIENCY at 2002 – first round of planning

Figure 28 shows the radar image at 2002. The speed over ground of the MOL EFFICIENCY is displayed at the top right as 'SPD 0.0KT'. The course over ground (COG) is shown in the top left corner as 327.7°.

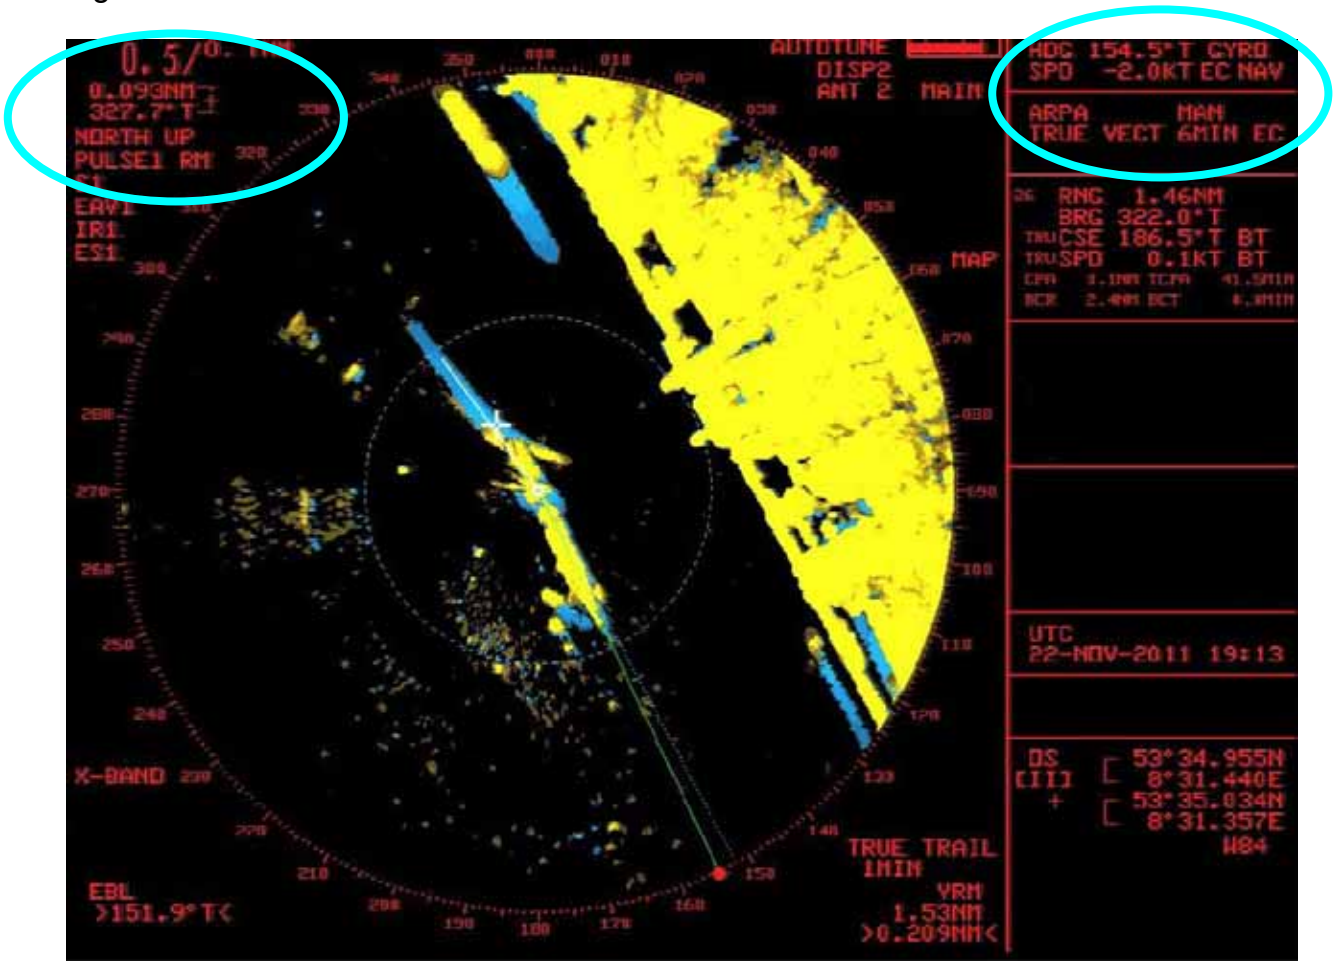
Figure 31: Radar image of the MOL EFFICIENCY at 2013 – collision

At the time of the collision, the radar image of the MOL EFFICIENCY shows a speed over ground of 2.0 kts; the course over ground stands at 327.7°.
