Bundesstelle für Seeunfalluntersuchung
Federal Bureau of Maritime Casualty Investigation
Federal Higher Authority subordinated to the Ministry of Transport
and Digital Infrastructure

Summary Investigation Report 10/11

**Accident involving a person on the FRISIA II
while casting off at Norddeich
on 7 January 2011**

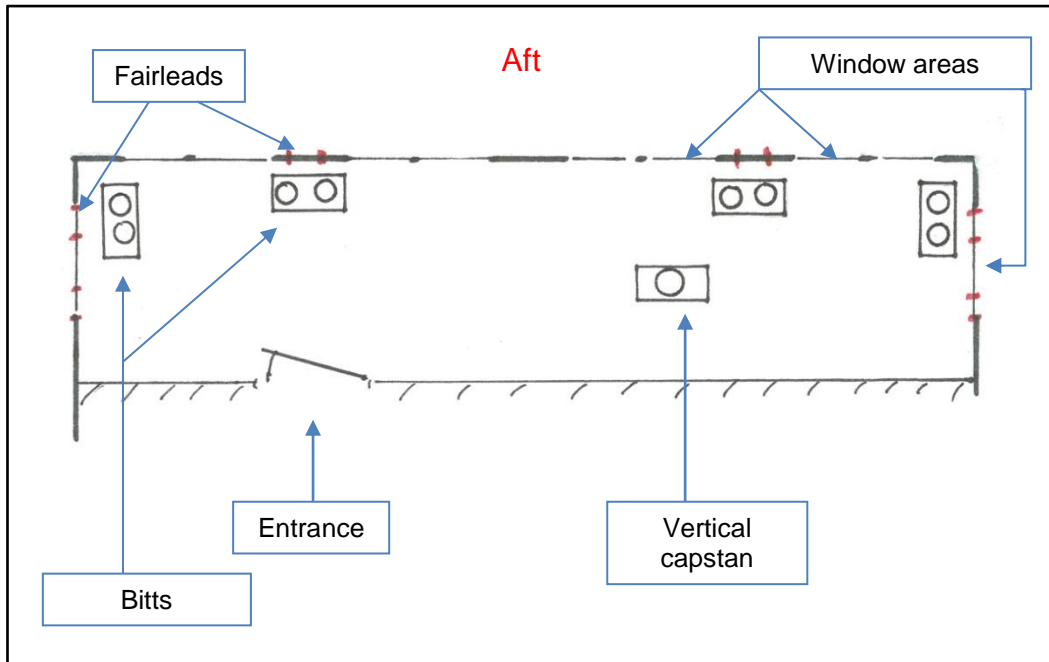
Figure 3: Drawing of the aft manoeuvring station

For mooring the ship, two bitts are installed on each side of the ship on the aft manoeuvring station. These are offset by 90°. In front of each bitt, one single fairlead is located to aft with two more single fairleads at the sides.

The outer side of each bitt is equipped with a nose, which is designed to prevent the mooring line from slipping up.

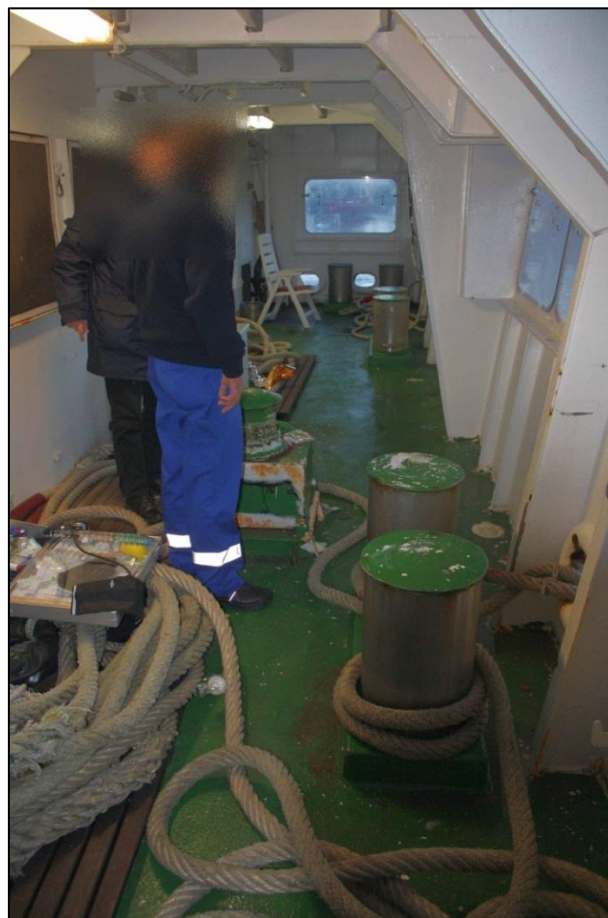
Figure 4: View of the aft manoeuvring station from port

The required lines are stored on gratings in the area of the manoeuvring station. This restricts the existing space further (see Figure 4).

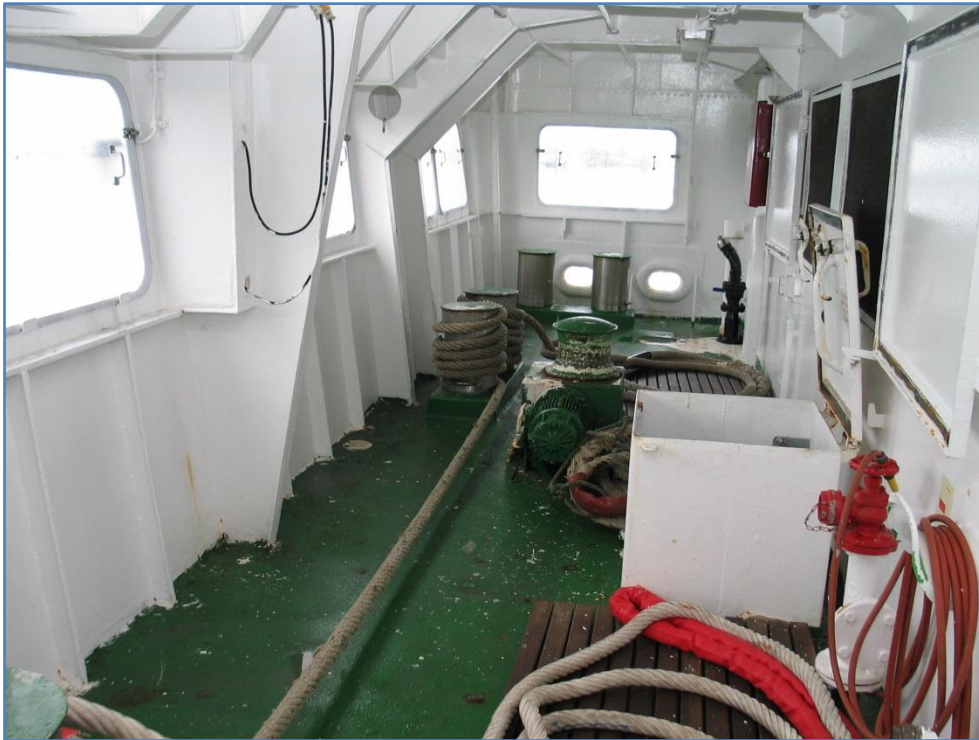
Figure 5: View of the port side of the aft manoeuvring station from starboard

The style of line guidance and spatial constraints due to the structural conditions meant it was necessary for the two crew members to move extremely close to the bitt on the port side. Safe movement was restricted further by the described course of the accident. It was thus possible for the later casualty to step into a bight and be surprised by the suddenly tightening mooring line.

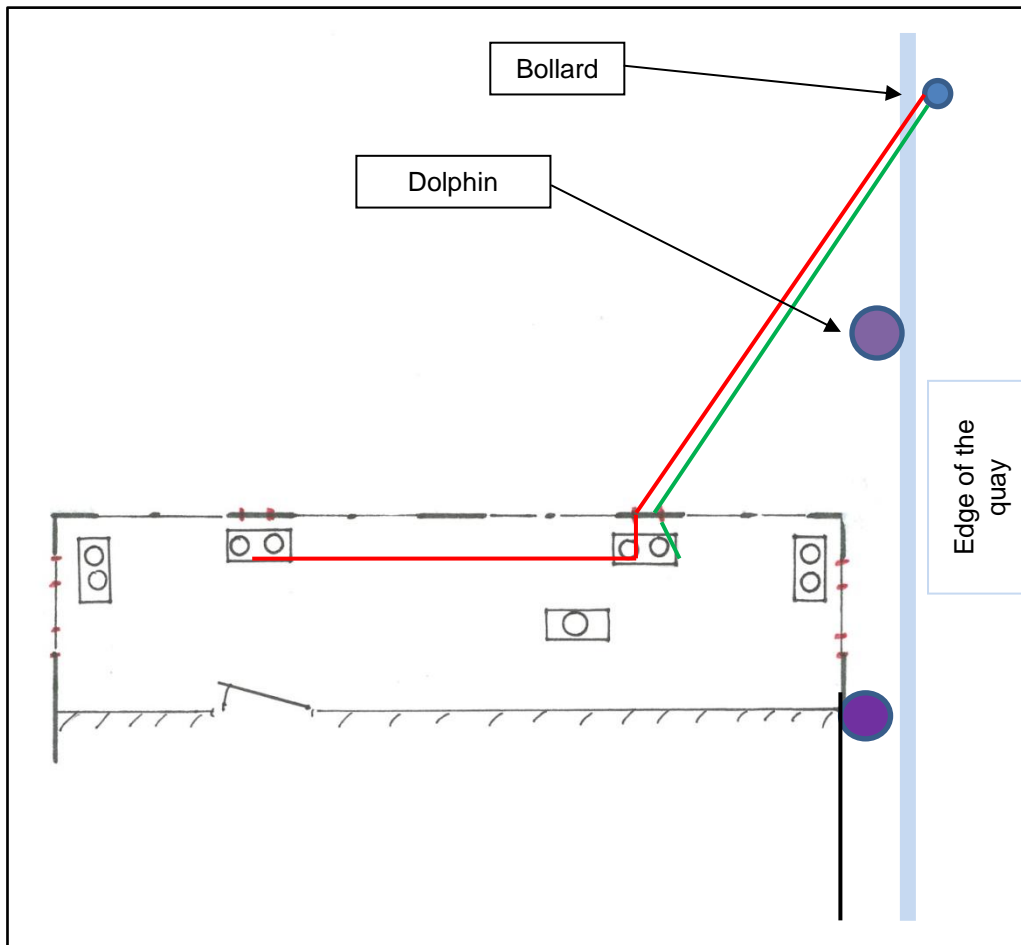
Figure 6: Drawing of the mooring setup at the stern of the FRISIA II

On the aft manoeuvring station, only two stern lines were deployed at the time of the accident. Both lines were directed outside through the aft fairlead on the port side. Moreover, the lowest line came from starboard and was directed to the fairlead via the bitt on the port side (see Figure 6). Each of the two lines was placed on one of the bitts, which were positioned transversely to the direction of the ship. The lines were belayed in bights in the usual manner.

The distance from the fairlead to the quayside bollard was about ten metres.

In its statement, the shipping company said that the style of mooring shown above is usual for the winter months. In justifying the procedure described, it said that the intention was to have the same direction of pull for both lines to ensure the load on the lines is evenly distributed. The shipping company believes that this also simplifies handling the line as compared to deploying them from the seaward fairlead, from which passing the line ashore involves some difficulty. Furthermore, the risk of the line falling into the water is reduced.

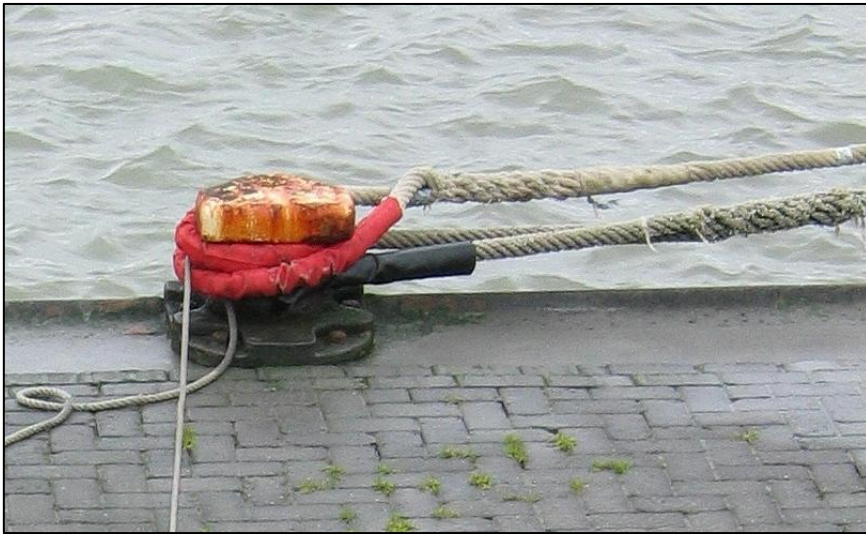
Figure 7: Bollard with two lines placed over it

The mooring lines were placed on the quayside bollard in the manner described in section 3.1 (see Figure 7). According to the shipping company, this is also the common and proven procedure for the winter months. It is done to prevent lines from possibly floating and loosening automatically when a bollard becomes immersed during higher water levels.

The quayside bollards are furnished with pronounced noses to prevent mooring lines from slipping unintentionally. The line-bearing surface is about 24 cm. This means that there was basically enough space available to accommodate the eye of the line placed over once and that of the other line placed over twice.

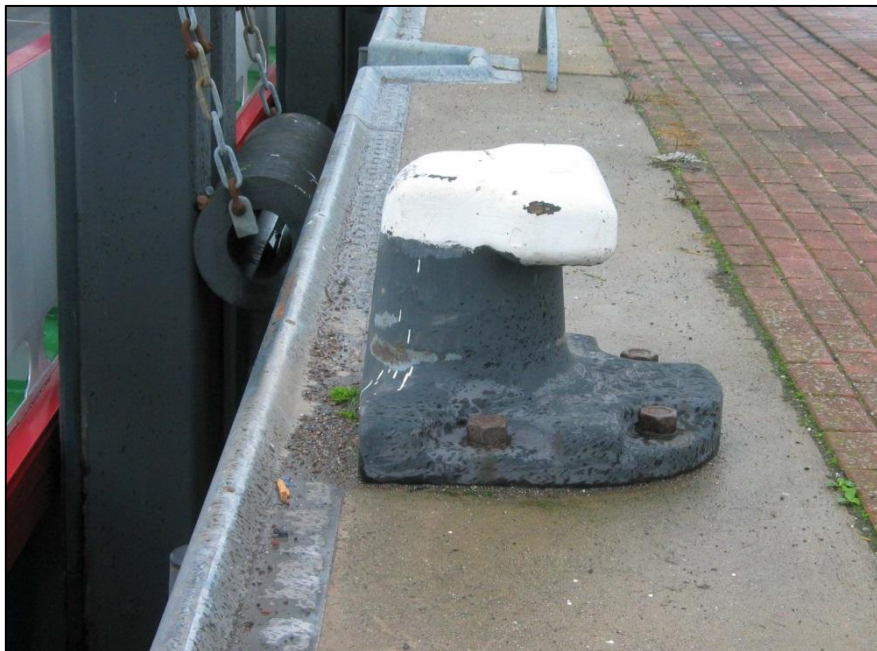
Figure 9: Edge of the quay with bollard, dolphin, and fender

Dolphins are driven into the area in front of the edge of the quay. They are designed to ensure ships can be moored safely and do not set up on the quay when water levels are high. To absorb hard impacts during a berthing manoeuvre, plastic fenders are installed between the dolphins and edge of the quay. The overall structure (dolphin and fender) creates a distance of about half a metre between ship and edge of the quay.

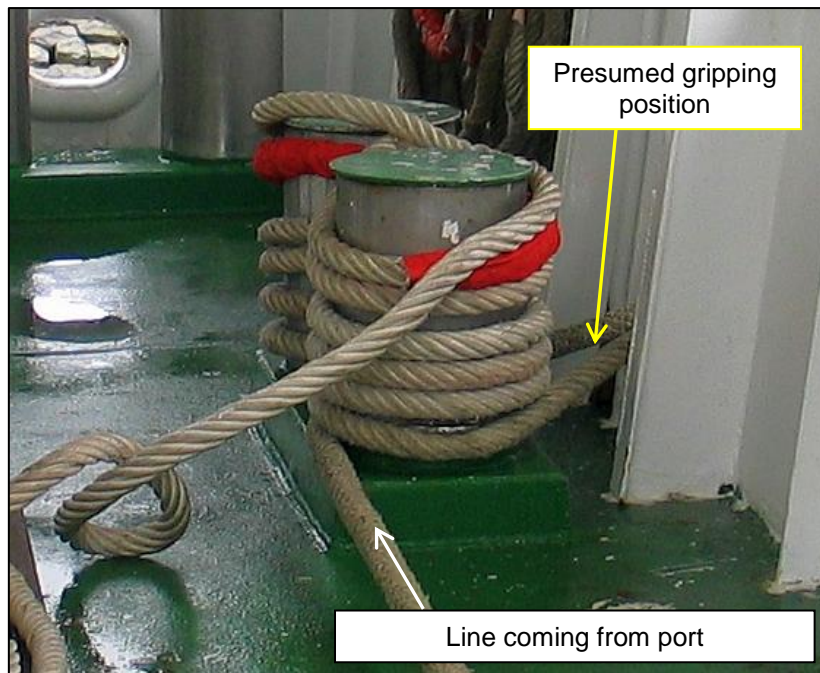
Figure 10: Typical setup on the starboard bitt

It follows that both stern lines had to be taken hold of in the area between the fairlead and bitt to haul them in (see Figure 10 – gripping position). The result of this is that both crew members worked in a very confined space and it was necessary to move extremely close to the bitt. When the later casualty took hold of the line for the second time, he moved the leg that was supporting him close to the bitt. His leg became trapped when the propeller caught and tightened this line at this very moment. The procedure was responsible for the lines that became caught by the propeller not simply slipping out but tightening in the manner described and subsequently parting, as they were still placed over their bitts.
