Investigation Report 15/13

Serious Marine Casualty

**Collision between the MV CORAL ACE
and the MV LISA SCHULTE
at the Neue Weser Nord-roadstead
on 31 January 2013**

2 October 2014

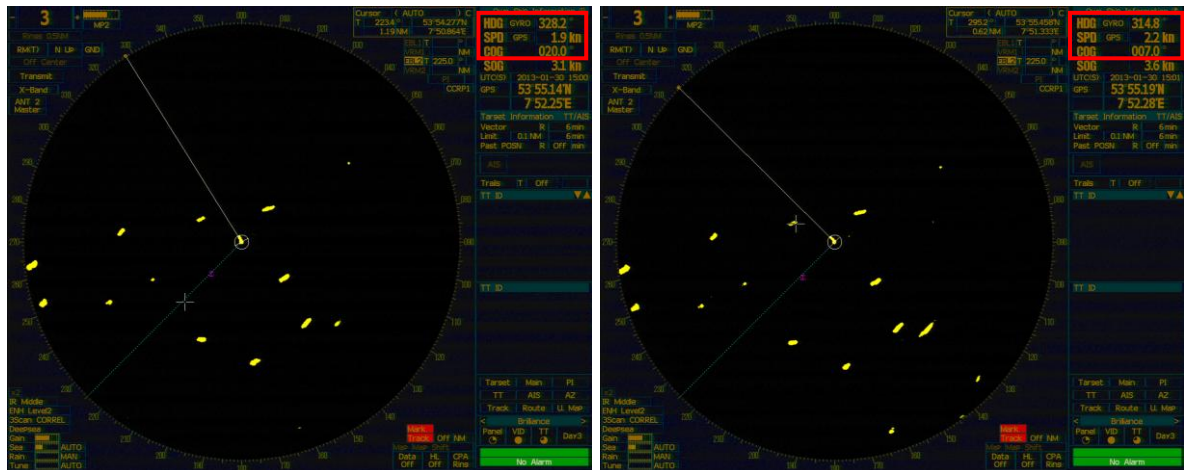
Figure 8: Radar images of the CORAL ACE at 154441 and 154526

As indicated by the radar track recordings, the CORAL ACE was heavily influenced by wind and swell during the turning manoeuvre (see Figure 8 with course deviations of more than 50° between heading and course over ground at times).

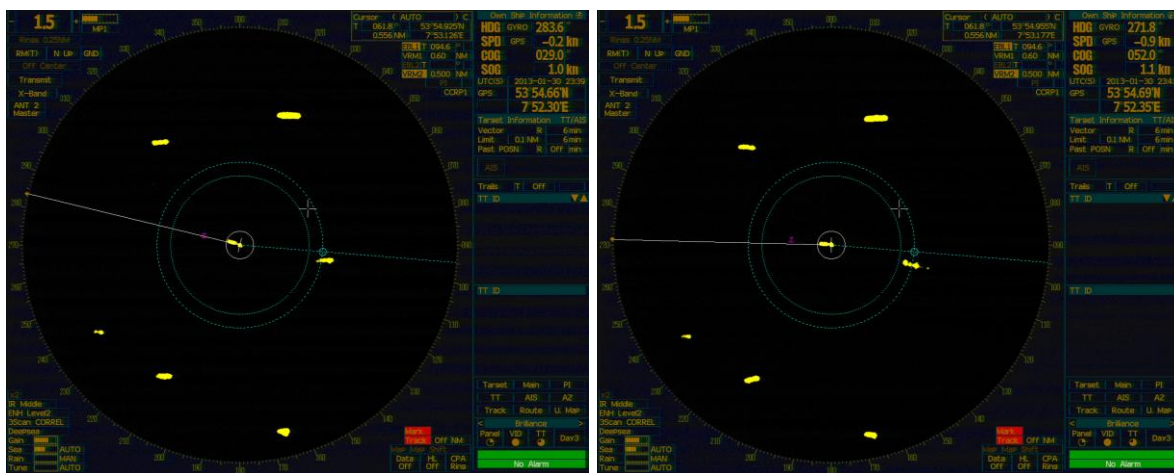
Figure 11: Radar images of the CORAL ACE at 002311 and 002511

On the night of 31 January 2013, gusts of between 41 and 54 kts, equivalent to 9 to 10 Bft, were registered in the area of the roadstead. Significant wave height stood at 4 to 5 m with single waves possibly reaching 7 m. The CORAL ACE rolled heavily. From 0023 onwards, the anchor lost its grip and the CORAL ACE dragged towards the LISA SCHULTE (see Figure 11).

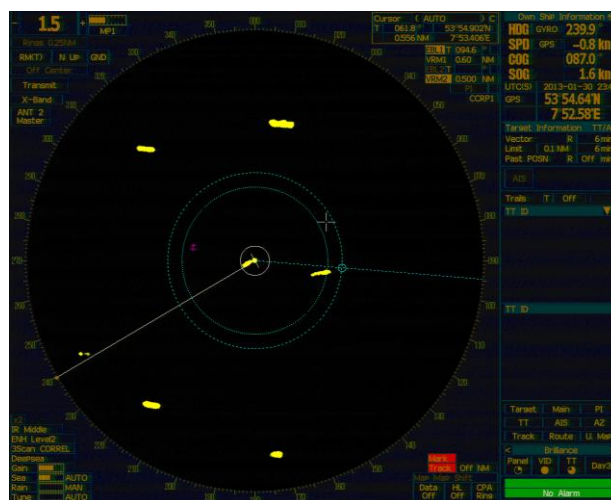
Figure 12: Radar image of the CORAL ACE at 002958

The OOW on the CORAL ACE noticed the dragging at 0030 when the radar shadow of the LISA SCHULTE had already moved to within the inner range marker (see Figure 12).

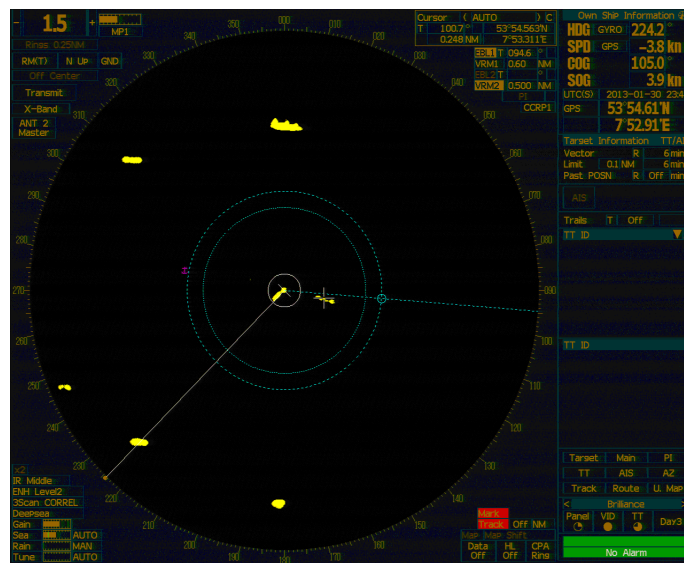
Figure 13: Radar image of the CORAL ACE at 003341

The CORAL ACE moved astern towards the LISA SCHULTE at a speed of almost 1 kt. At first, no countermeasures were taken on the bridge of the CORAL ACE. The OOW on the LISA SCHULTE also noticed that the CORAL ACE was not being held in position by her anchor and called his counterpart on VHF channels 2 and 8 at 003208. There was no response. At 003257, the LISA SCHULTE called the CORAL ACE again. After a pause, the OOW on the CORAL ACE replied to the call and promised to arrange for the engine to be started. On the LISA SCHULTE, the master was notified of the convergence and that VHF contact had been made. The distance between the two ships had already dropped to 3 cbl at this point (see Figure 13). The CORAL ACE was parallel to the sea, about 90° to the wind, and rolling heavily. She dragged towards the LISA SCHULTE at almost 4 kts.

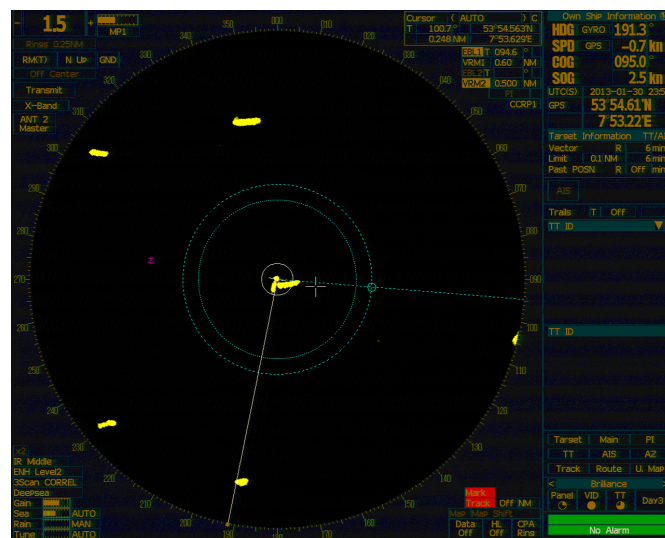
Figure 14: Radar image of the CORAL ACE at 003711 – time of the collision

At 003436, the OOW on the CORAL ACE ordered that the engine be set to standby. The first engineer and an oiler were on engine room watch. At 003625, the master was called to the bridge and arrived there half a minute later at 003706. The collision occurred at virtually the same time.

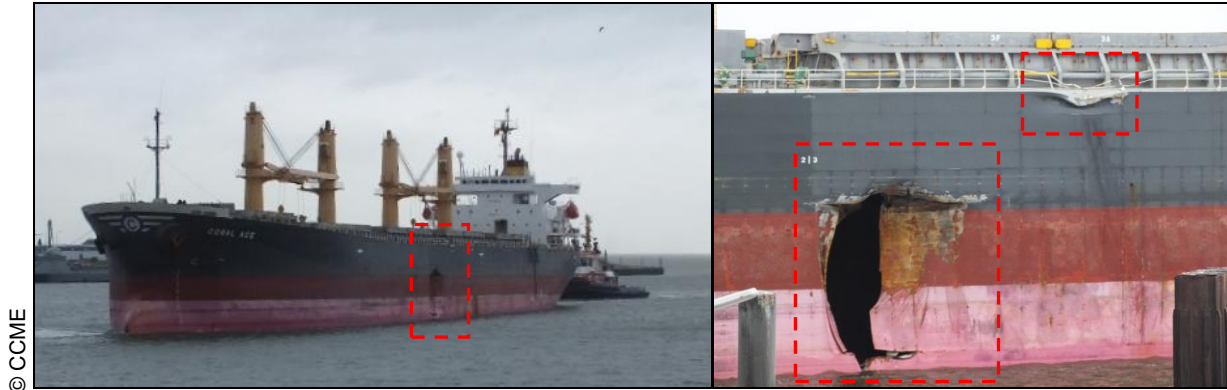
Figure 17: Damage on the port side of the CORAL ACE

The bulbous bow of the LISA SCHULTE tore a hole of 4 x 10 m in size in the CORAL ACE's shell plating on the port side level with cargo hold 3 (see Figures 17 and 18). The cargo hold filled with water to a height of 6 m.

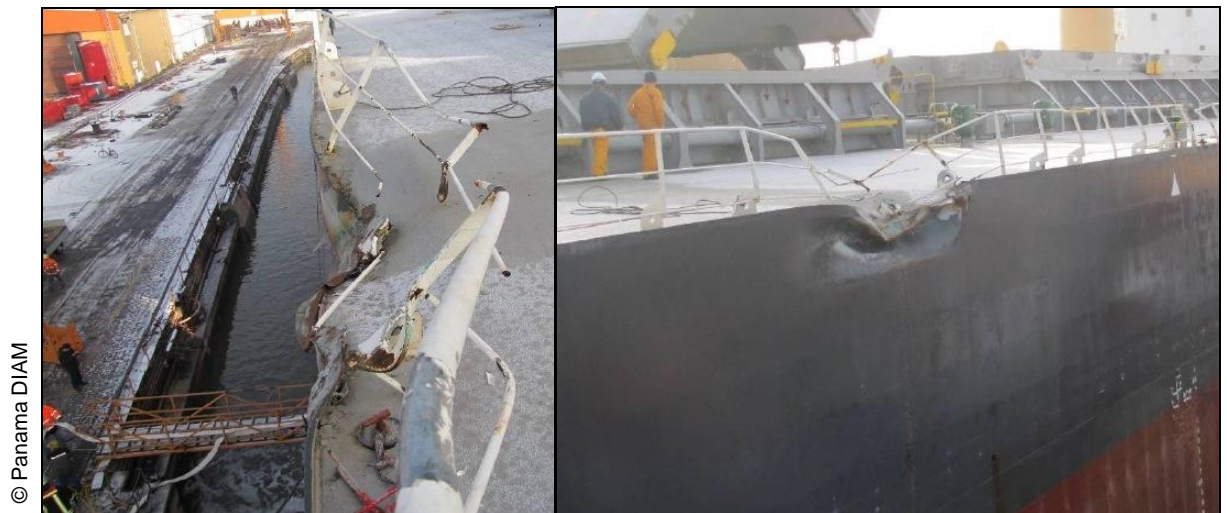
Figure 19: Pressed in railing

The railing was also pressed in (see Figure 19).

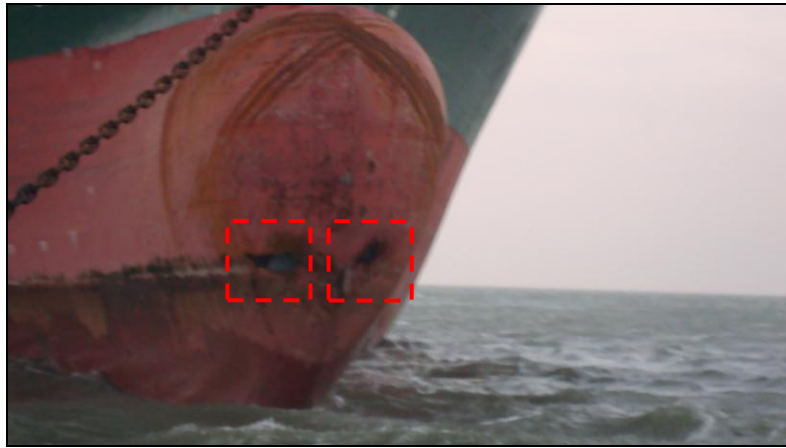
Figure 20: Damaged bulbous bow of the LISA SCHULTE

During the collision, the bulbous bow of the LISA SCHULTE was torn laterally in two places and also heavily deformed (see Figure 20). The shell plating was also deformed level with the main deck.

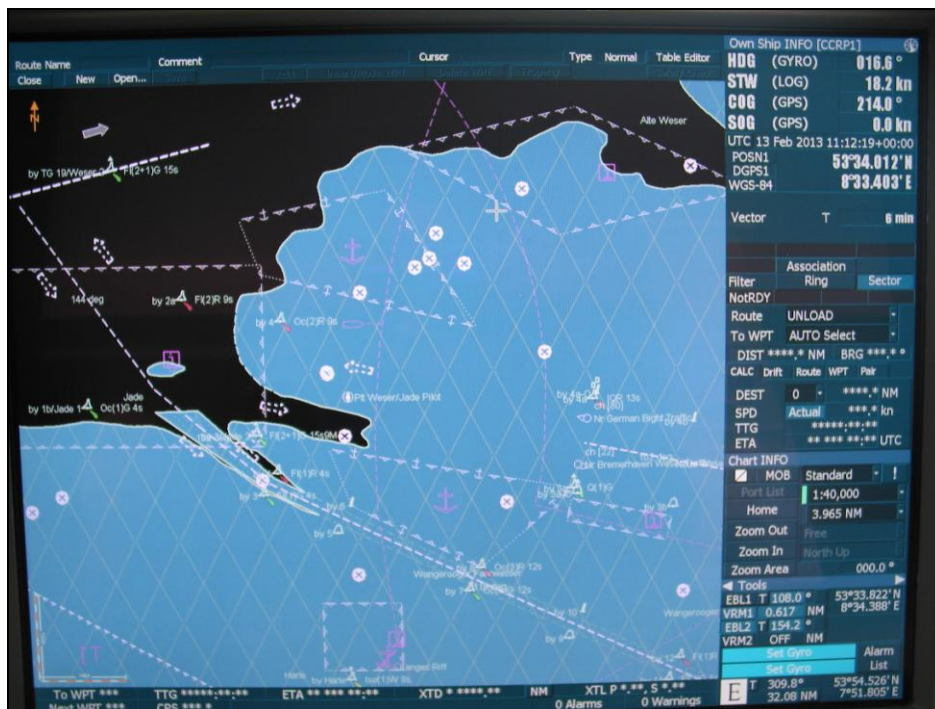
Figure 26: ECS view on the day of the survey (13 February 2013)

Although the ECS used for reference purposes was operable (see Figure 26), it was not possible to save data.

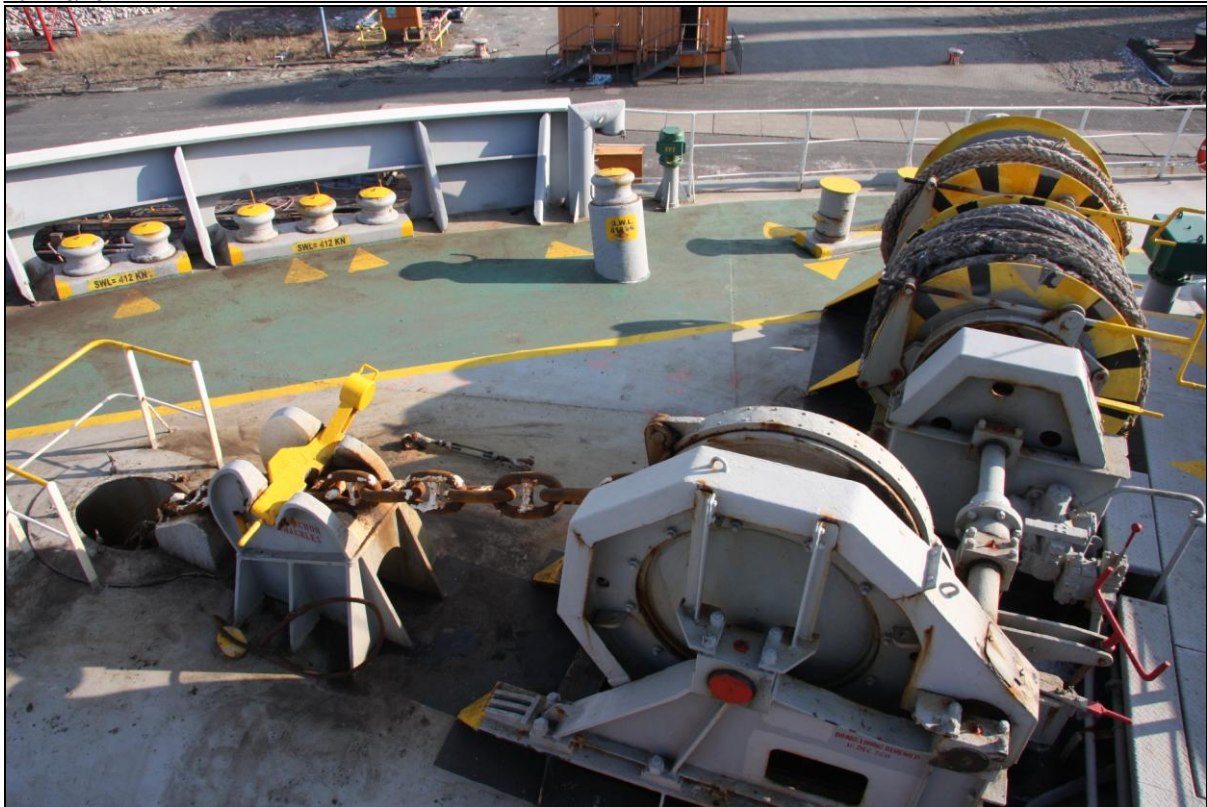
Figure 27: Starboard windlass and anchor chain on the fore section of the CORAL ACE

According to the information in the bridge log, eight starboard anchor shackles (see Figure 27) were lowered into the water on 30 January 2013.

The ship's command of the CORAL ACE ignored basic practices of seamanship. The choice of anchor position in conjunction with the decision to deploy only eight of the 10 lengths of anchor chain was subsequently shown to be the cause of the accident. In the predicted and prevailing 9 to 10 Bft and swell of 4 to 5 m, the eight lengths of chain in the water were unable to hold the CORAL ACE in position.

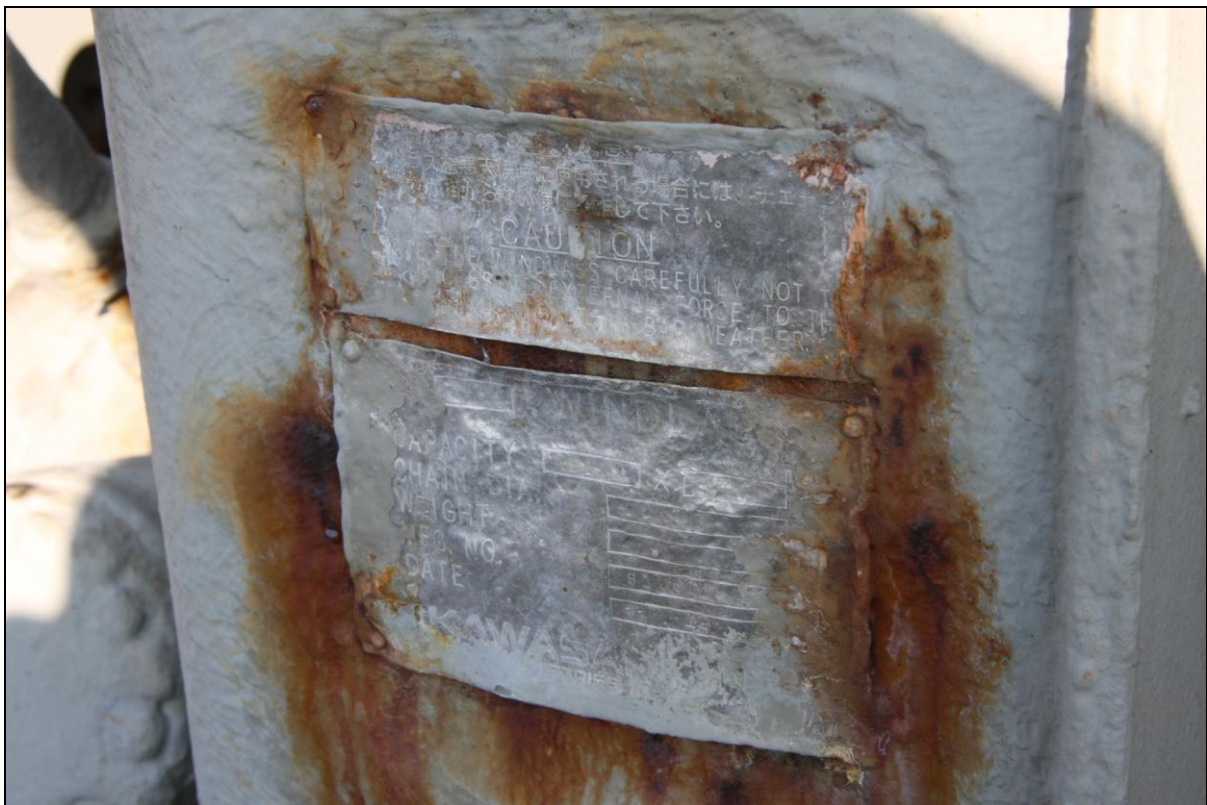
Figure 28: Plates on the starboard windlass

The plates containing warnings and characteristics on the starboard windlass and anchor chain were illegible (see Figure 28).

Warnings and operating instructions on plates at the two windlasses on the fore section of the CORAL ACE were no longer legible. For safe operation of the windlasses by the deck crew, it is essential to replace the plates with ones that are legible. This is especially true in view of the fact that the length of the anchor chain is different on the two anchors.

The investigating authorities recommend that the owner of the CORAL ACE replace the existing plates containing warnings and operating instructions at the windlasses with ones that are legible.
