Investigation Report 160/13

Serious Marine Casualty

**Water ingress on the traditional vessel
RAKEL
on 21 June 2013 in the
North Sea about 10 nm south of Heligoland**

25 February 2014

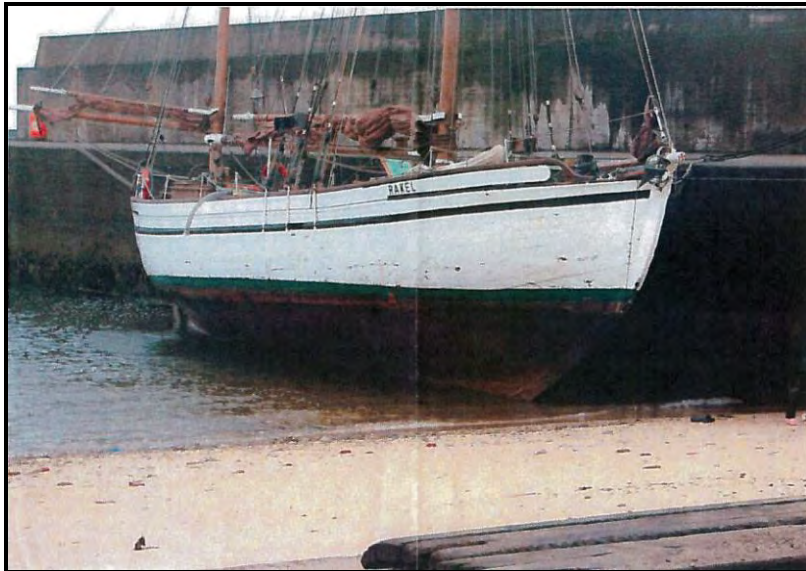
Figure 3: Controlled grounding in Heligoland

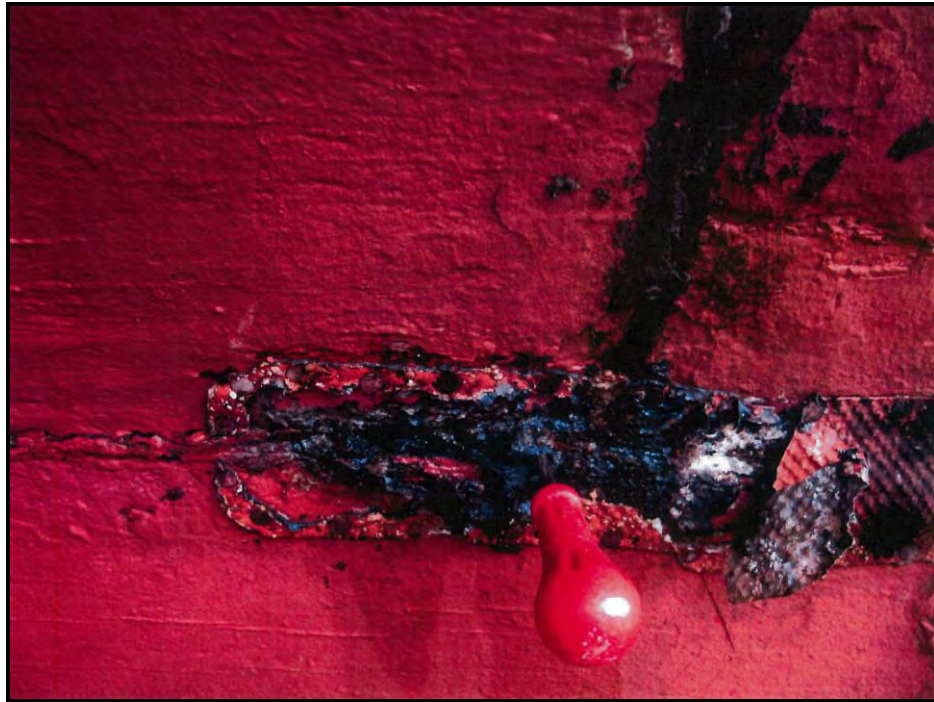
- 4.) All the longitudinal joints on the planking in the hull underbody were checked and re-caulked in places. Particularly large plank joints were covered and then treenailed with the application of lead in some areas amidships on the port side.
- 5.) In the area of the forepeak bilge, an old PU foam seal was removed and a damaged plank sealed properly.

Figure 7: Plank joints treenailed with the application of sheet metal

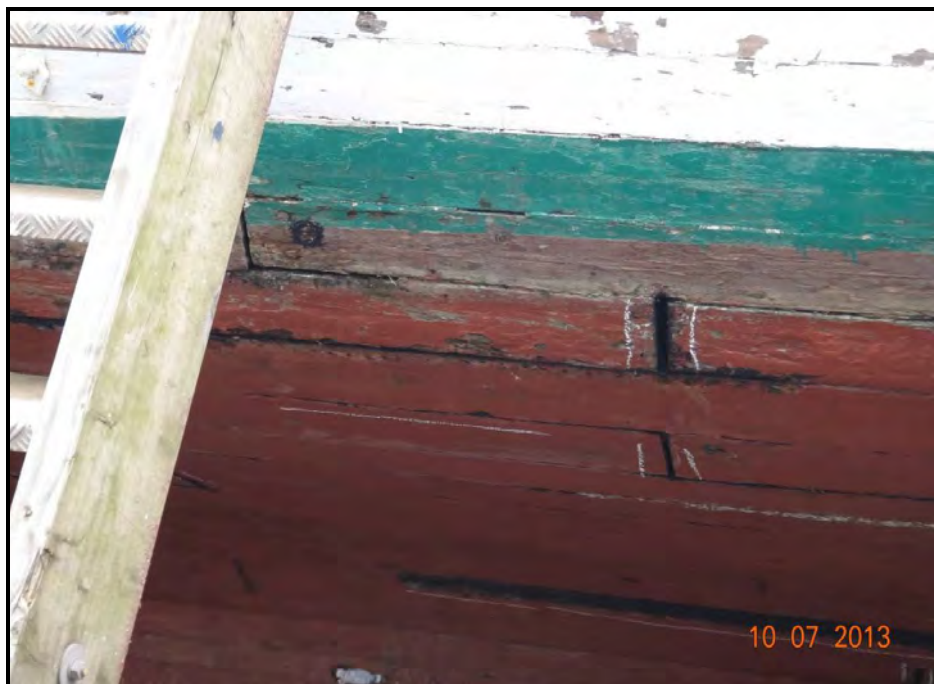
Figure 8: Plank joints

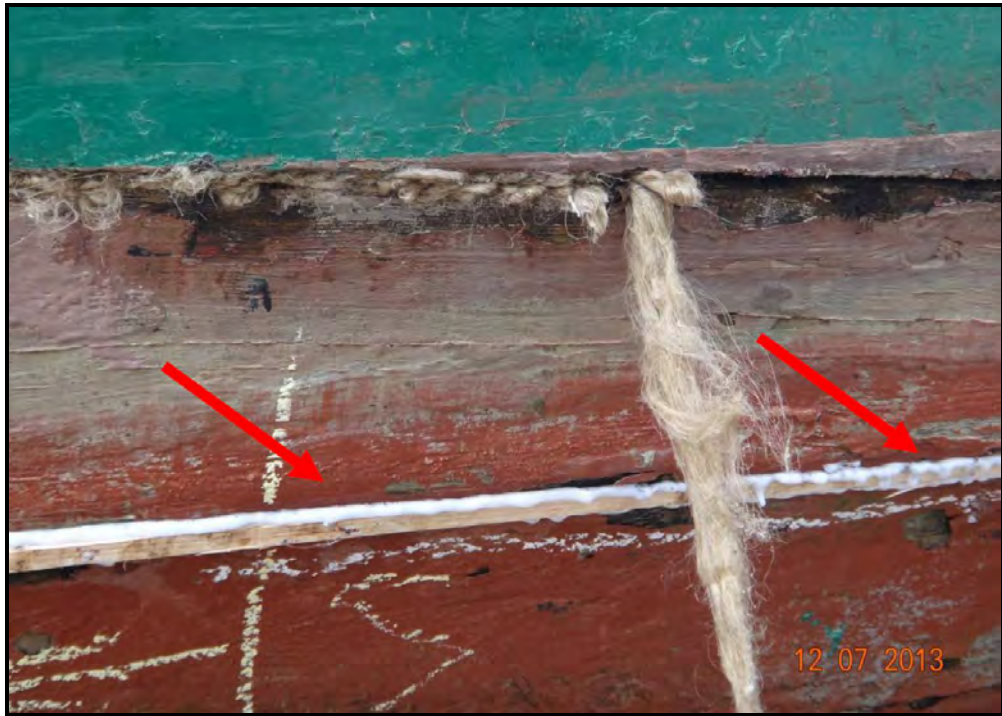
Figure 9: Bonded wood strips in longitudinal joints

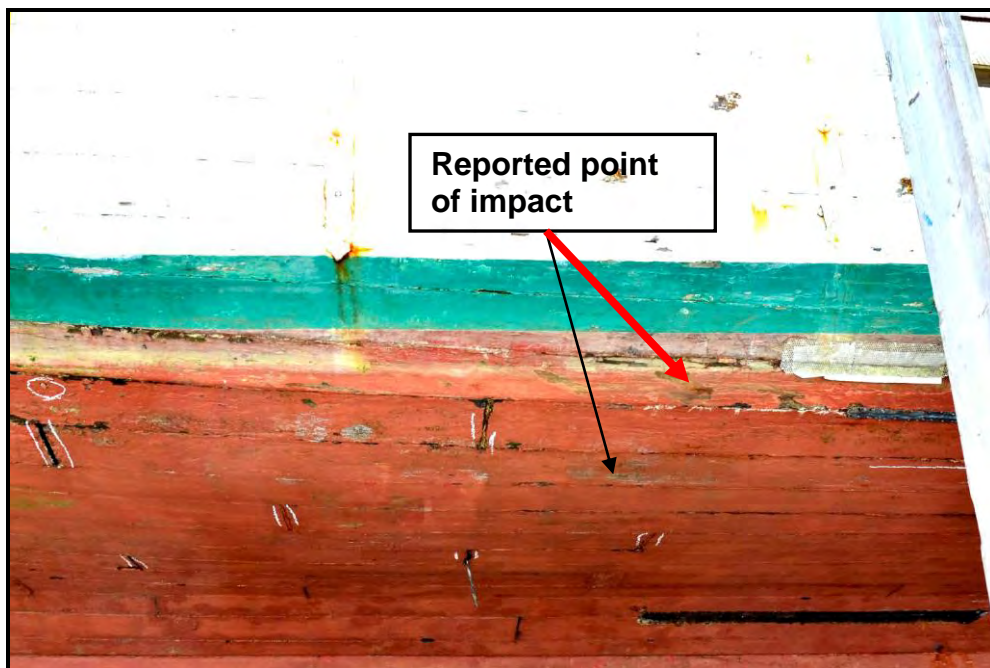
The expert acting on behalf of the underwriter indicates the point of impact just below the waterline (red arrows). This was treenailed with the application of sheet metal when the vessel was run aground in Heligoland and should be visible in the photo below in the vicinity of the longitudinal joint. According to information given by the owner, the point of impact with an unknown object should be the area visible two strakes lower (black arrow).

Figure 10: Details of the point of impact

The expert acting on behalf of the underwriter states that based on the new scuff marks found on the port side (see Fig. 10), it would be possible that a collision with flotsam occurred, which compressed the material enough to cause the underlying plank joint to burst open. However, this leakage of approximately 40 cm in length on the plank joint just below the waterline cannot have been the sole reason for not being able to pump out the water. The expert assumes that significant forces acted on the structure when sailing in swell at 7 Bft and that with probability bordering on certainty additional water could enter at the vertical plank joints, which on the slipway were open to up to 20 mm. The expert assumes that the RAKEL had lost her longitudinal strength and bases this on the fact that on the slipway the ends of the vessel were resting on the cradle and a gap was visible in the middle between cradle and keel rail (hogging).

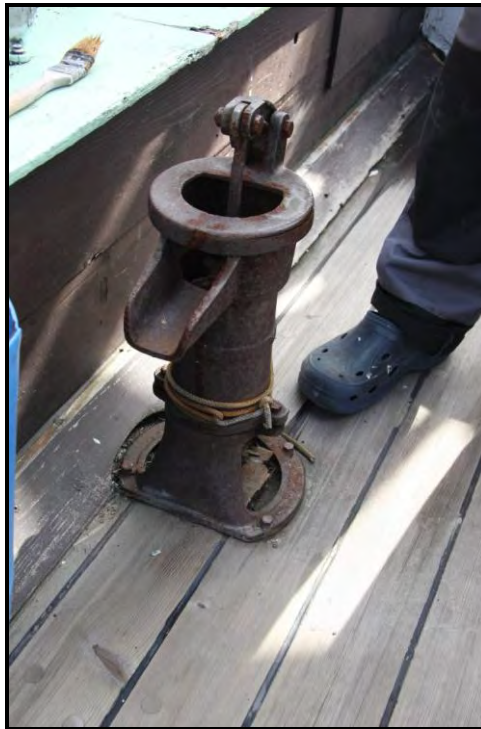
Figure 11: Hand pump

Simple hand pumps of this nature are very effective on fishing vessels because smaller particles in the bilge water do not affect the operation of the pump. The pump on board the RAKEL was not operational and had been taken out of service. The pump handle was no longer attached and the membrane had been replaced by a wooden block.

The permanently installed electrical pump in the engine room failed because of a technical fault and the hand pump mounted on deck had been taken out of service.

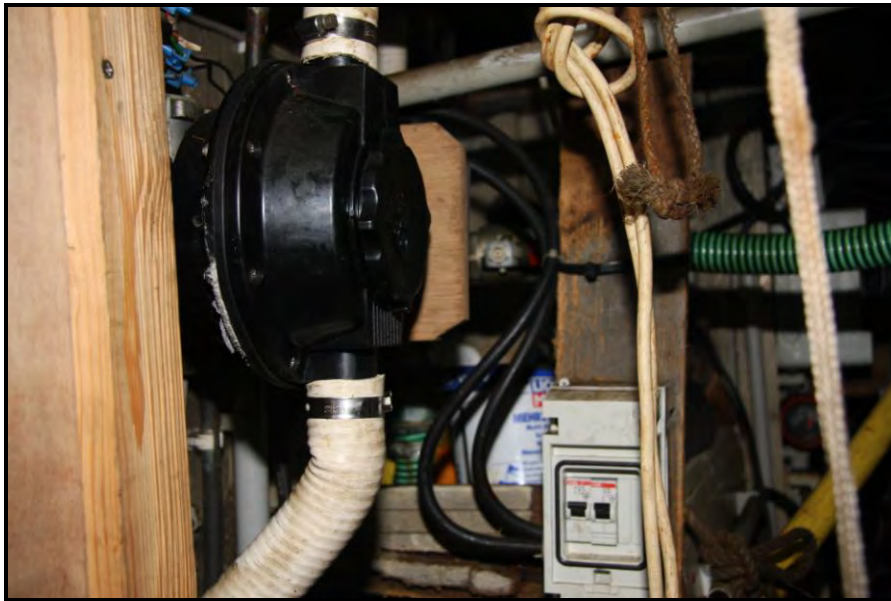
Figure 12: Electrical diaphragm pump

However, the pump on the bulkhead did not work because the bolt connecting the pump diaphragm to the handle had broken off.

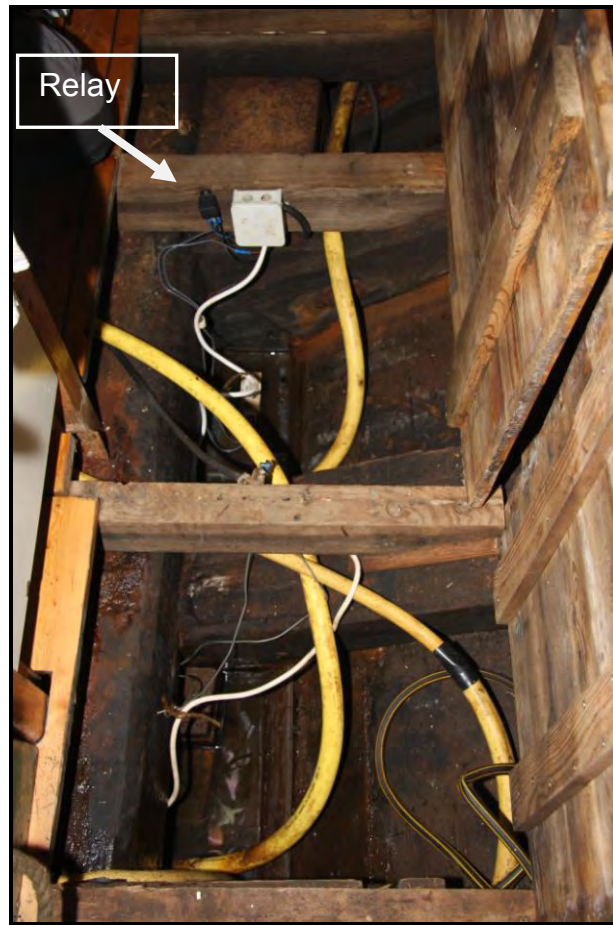
Figure 14: 12-volt pumps, hoses, and electric cables

According to information given by the owner, both pumps failed because the connections and a switching relay were immersed, thus producing a short circuit in the electric cables.

The wiring on the 12-volt yacht pumps beneath the bottom boards – or otherwise – does not conform to standard, meaning an electrical short circuit was to be expected. Use of the large number of 220-volt hardware store/household/garden pumps on board would have been able to stop the ingress of water. However, they could not be operated because the petrol-driven generator on deck failed after a short period because of an inadequate repair to the fuel tube.

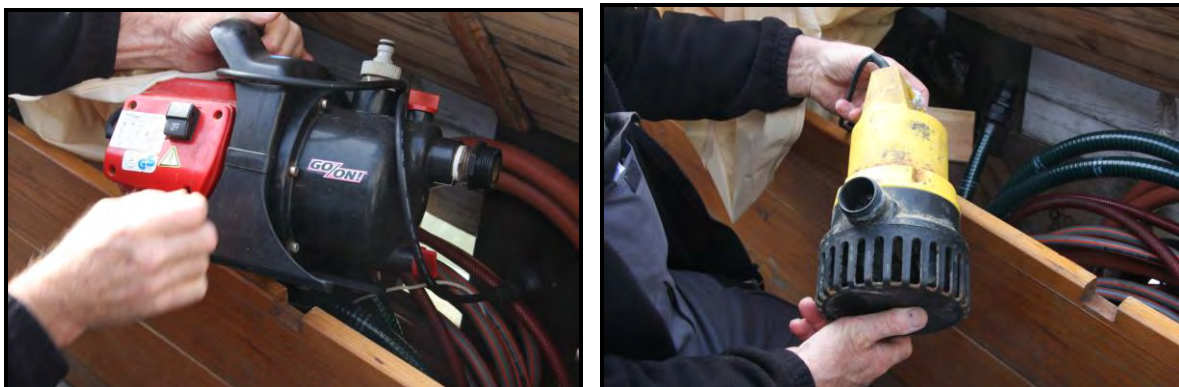
Figure 15: 220-volt household pumps

The three 220-volt pumps could not be used as the generator failed to run because a fuel hose had a kink in it. According to information given, the old porous fuel hose was replaced before the accident. The replacement hose installed was too long. This resulted in a kink in the hose during operation, thus interrupting the fuel supply.

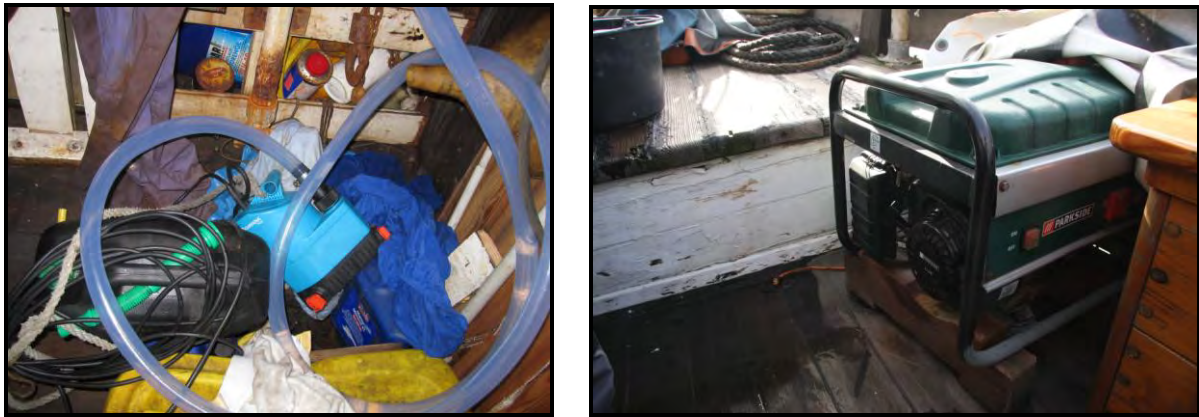
Figure 16: 220-volt garden pump and petrol-driven generator

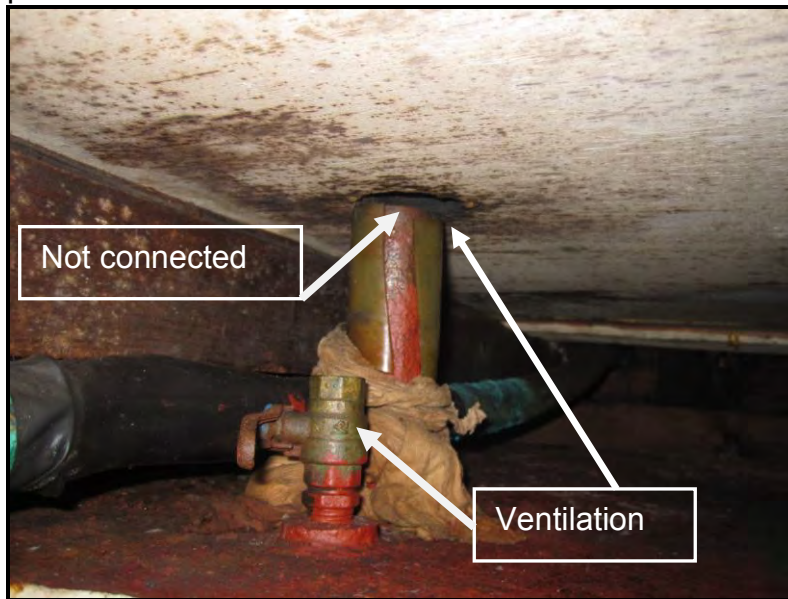
The exhaust pipe is not sufficiently insulated and the filling pipe for the diesel tanks located on the port and starboard side is not connected with the filler neck on deck:

Figure 23: Tank filling and ventilation

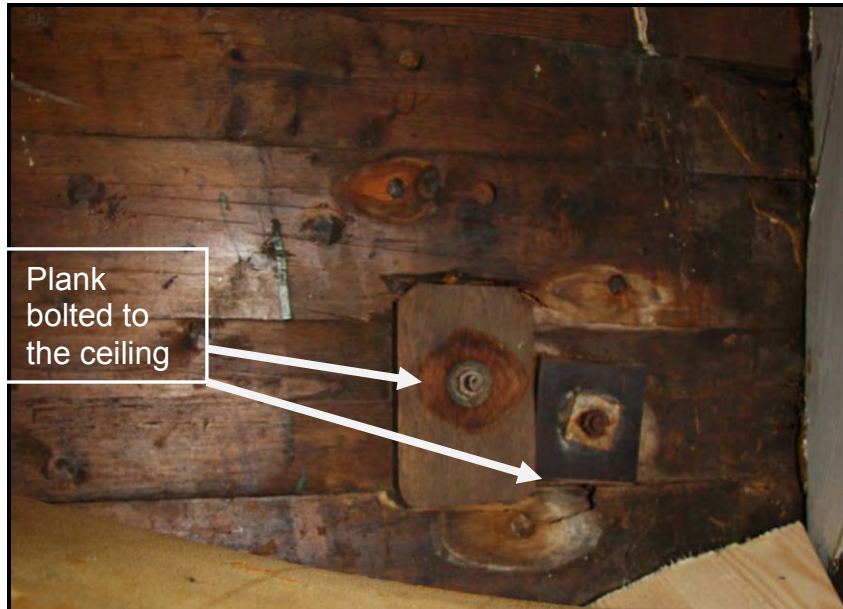
The BSU surveyed the hull when the vessel was afloat. The vessel has an inner ceiling almost throughout. The normal frame level should be 400 mm. The thickness of the planks and ceiling was not determined. The hood ends of the planking are bolted through the frames to the ceiling at several points. Here, additional wood and steel plates were placed below the nuts.

Figure 25: Bolted hood end

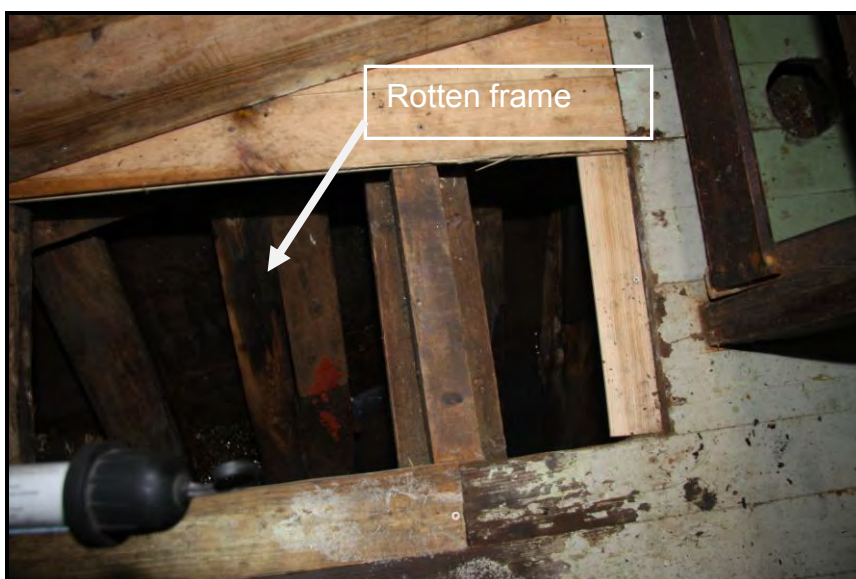
The vessel has no transverse bulkheads and the entire hull should be regarded as one unit. The area below the floor in the fore section, which was originally sealed using PU foam, was inspected. A rotten frame on the starboard side has been doubled using new frame pieces.

Figure 26: Frames in fore section

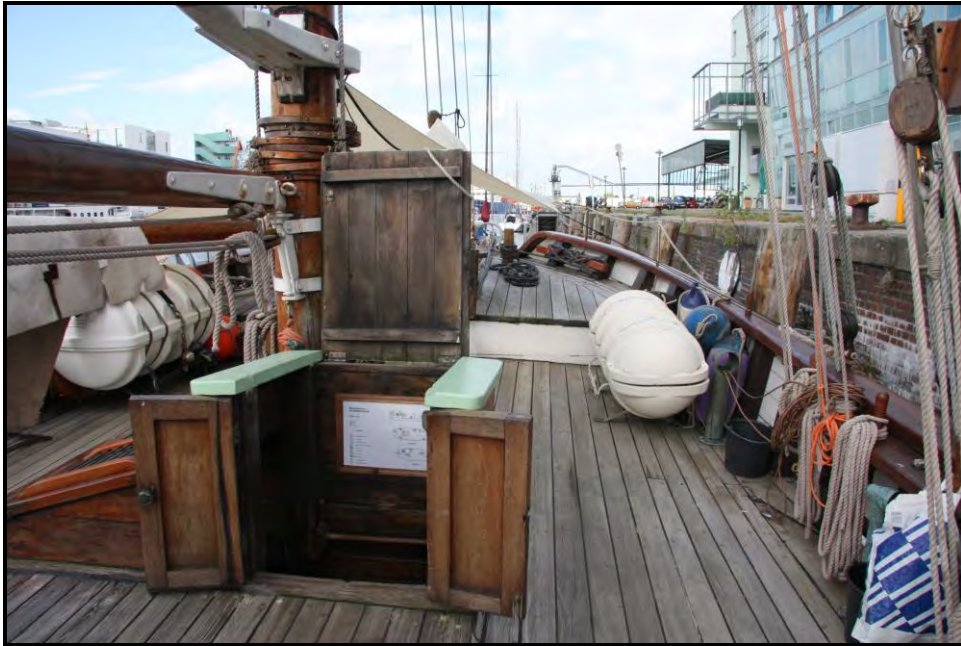
Inter alia, seaworthiness implies that fixed bulkheads with defined coaming heights⁶ are at access points to enclosed superstructure. The establishment of sufficient watertight integrity for the main companionway on the RAKEL was not possible because there was no coaming there whatsoever.

Figure 28: Main companionway amidships
