Bundesstelle für Seeunfalluntersuchung
Federal Bureau of Maritime Casualty Investigation
Federal Higher Authority subordinated to the Ministry of Transport
and Digital Infrastructure

Investigation Report 19/12

**Grounding
of the passenger ship DEUTSCHLAND in
Chile near the Italia Glacier
on 15 January 2012**

21 March 2014

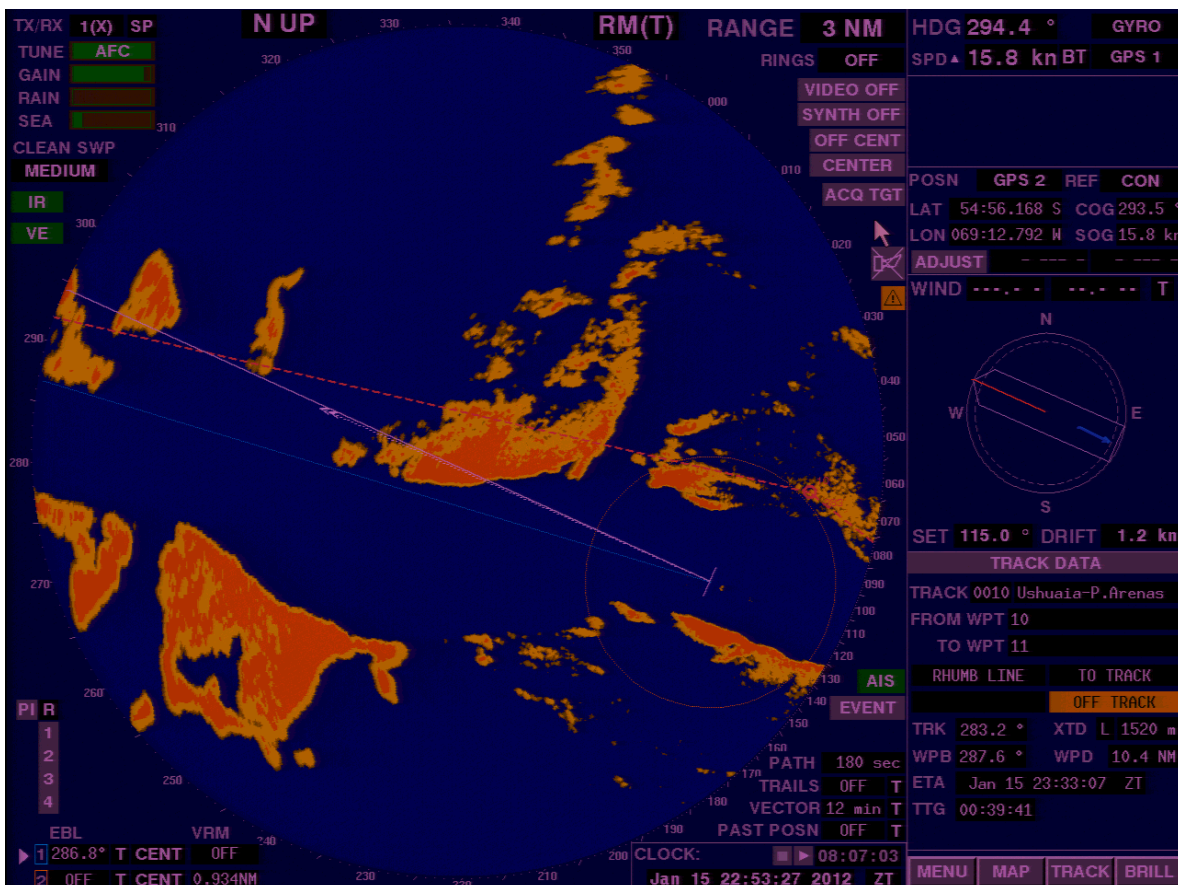
Figure 4: VDR recording of the radar image at 225327

A Rutter VDR-100 voyage data recorder (VDR) was on board. The data were backed up and made available to the BSU by the owner. Figure 4 shows the initial situation. At 225327, the DEUTSCHLAND is approaching the Italia Glacier at almost 16 kts. Her course over ground is 293°. The audio recording clarifies that the ship's command asks the pilot whether it would be possible to sail closer. The pilot confirms this immediately and reduces the speed. This can be seen in Figures 5 and 6 below.

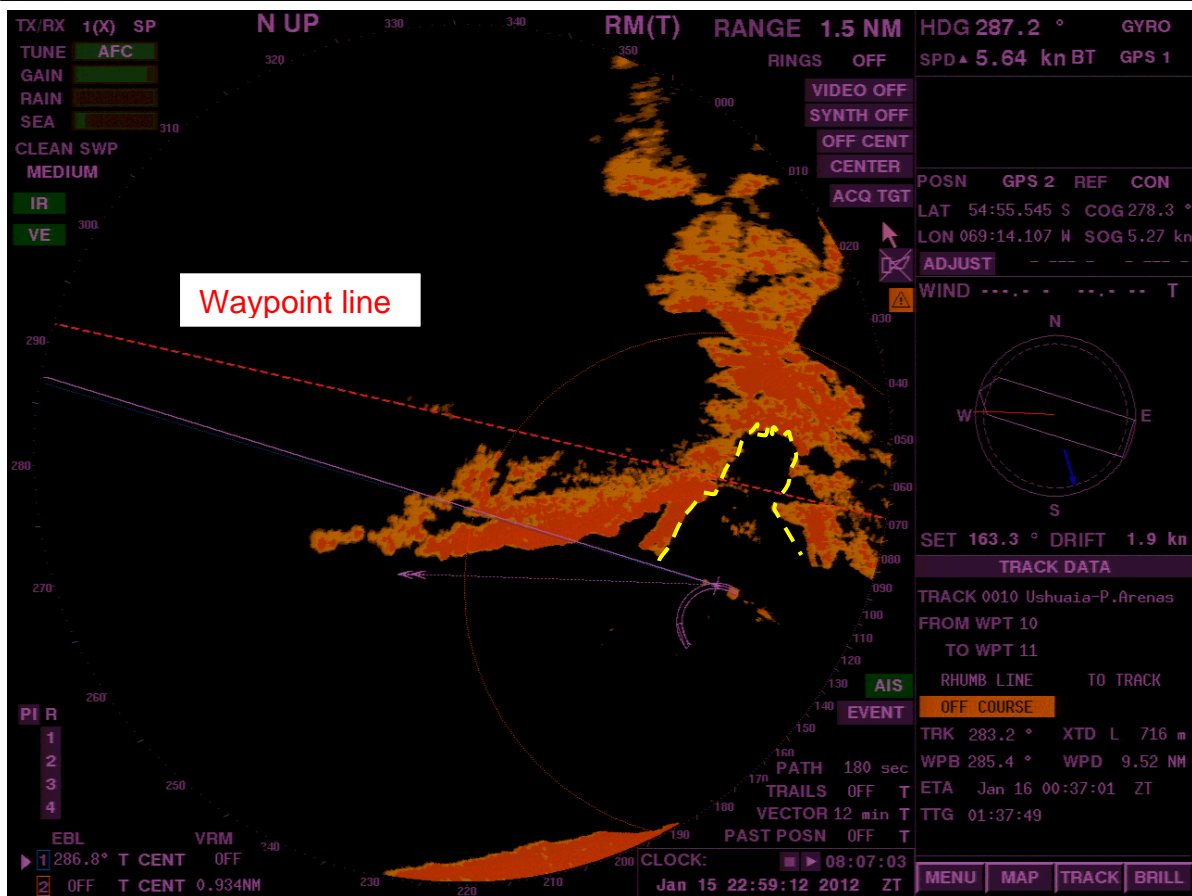
Figure 7: VDR recording of the radar image at 225912

Figure 7 shows the time at which the grounding incident occurred (225912). The ship was already returning to the middle of the fjord by means of a turn to port when she grounded on a submerged object.

It can also be seen very clearly on the radar images that the ice front has receded a long way into the interior (see yellow dotted line).

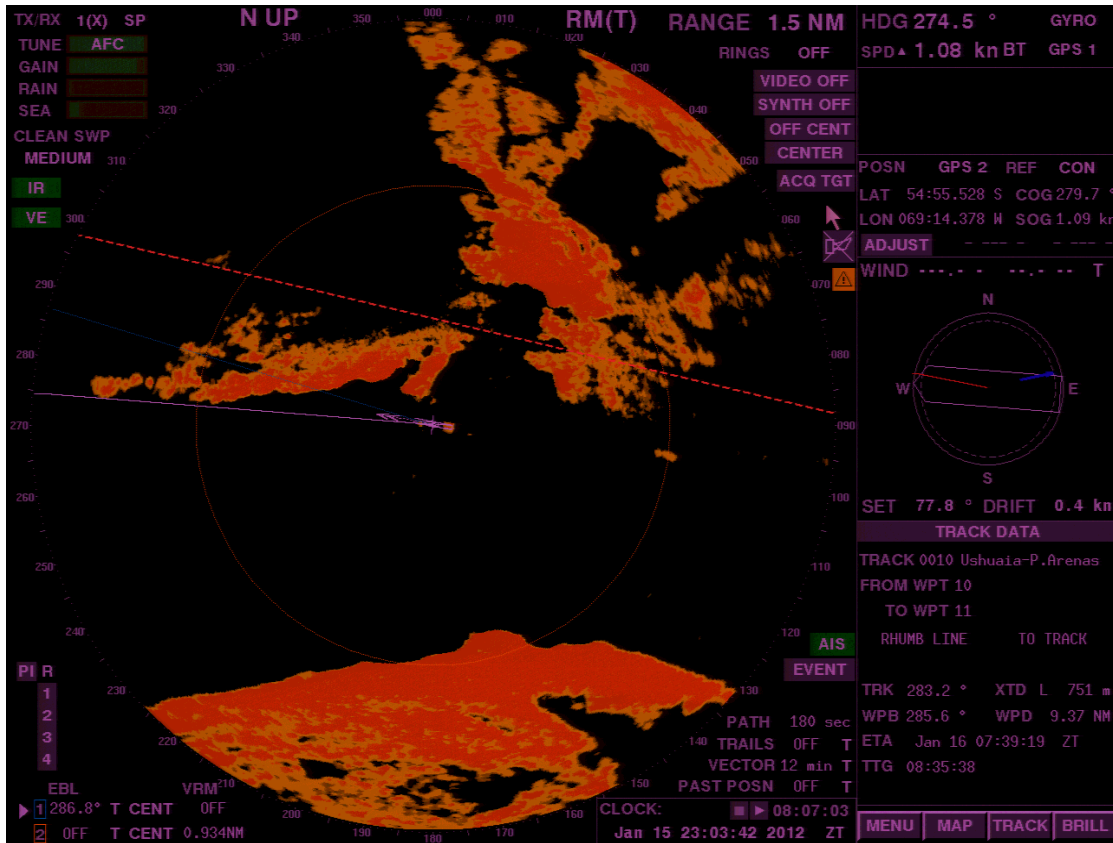
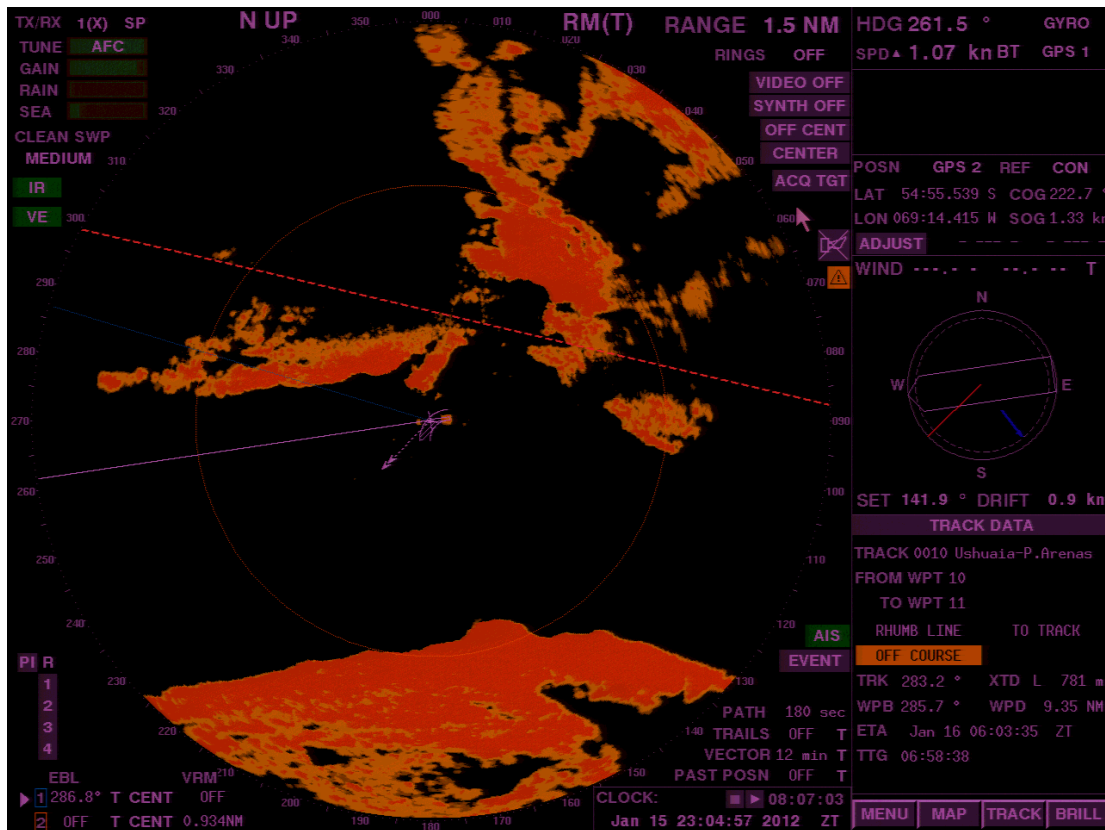
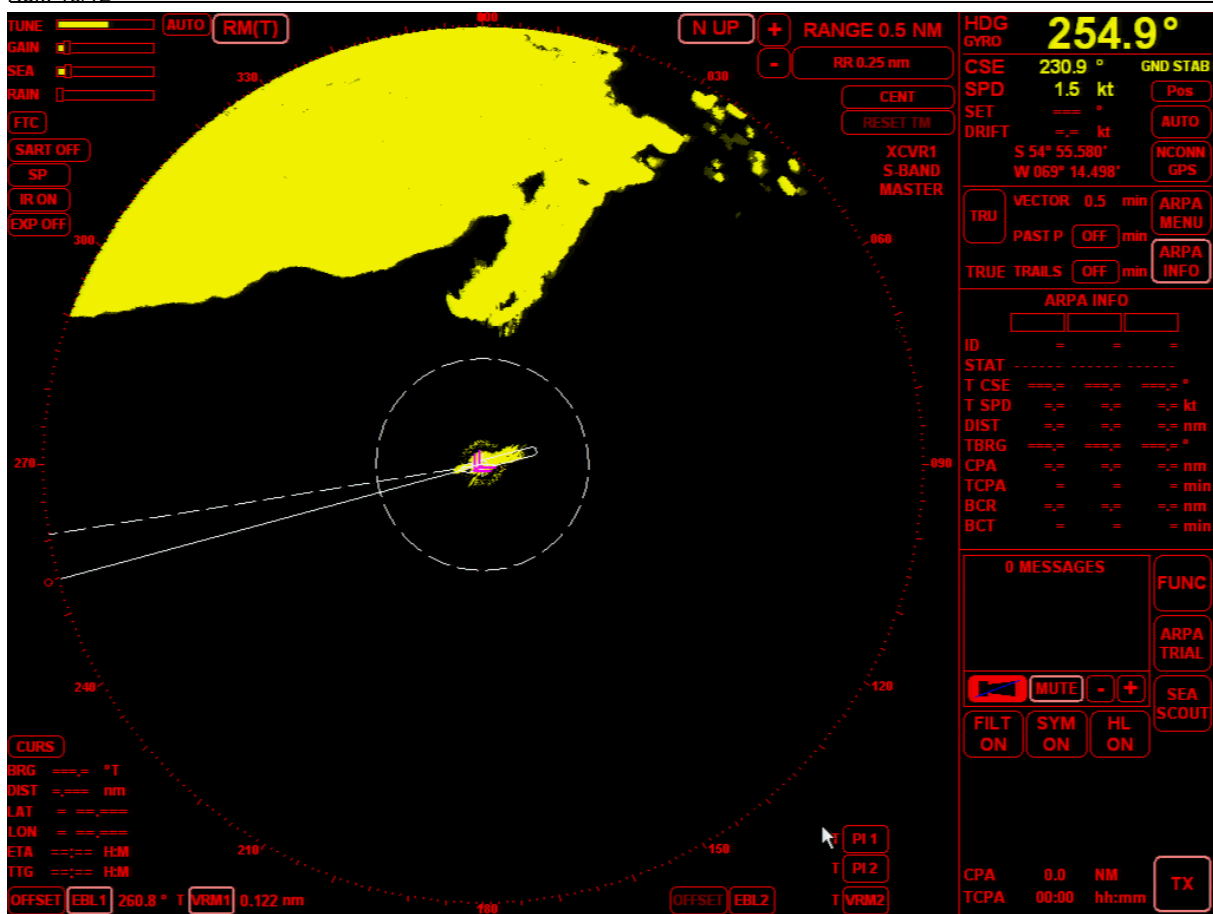
Figures 8 to 10 show how the DEUTSCHLAND slowly refloats and then sails in a westerly direction. Contrary to the statements that the ship's command and the pilot used the radar units, the recordings of the two radar units leave the impression that they were not used actively.

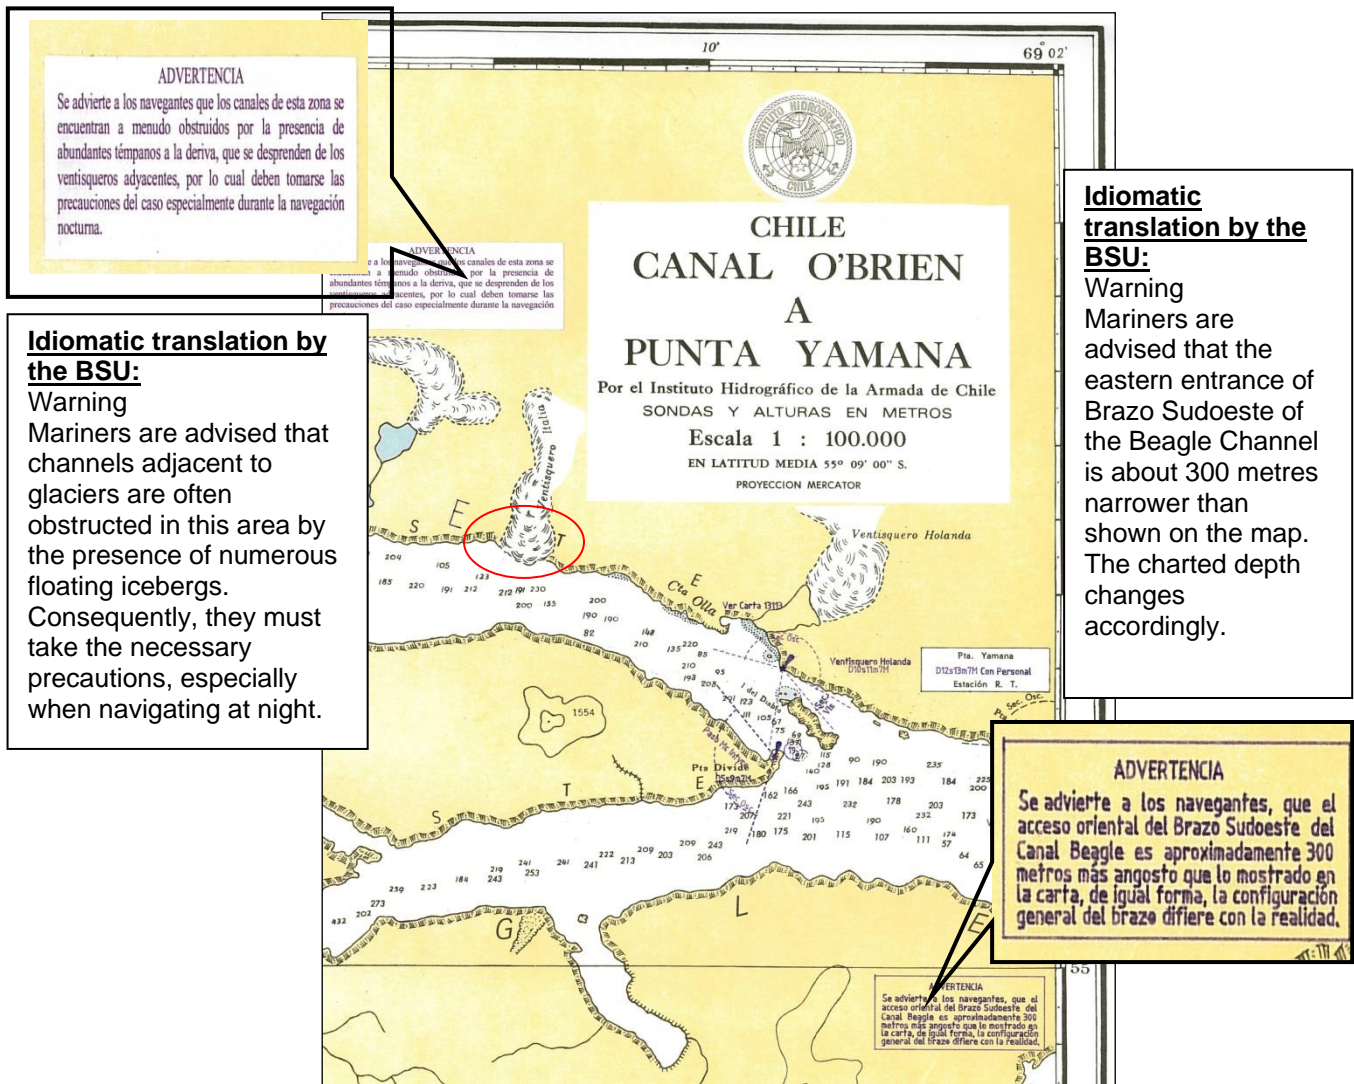
Figure 12: Warnings on the nautical chart in Spanish

Another important factor is that the chart is based on a local chart datum but this is not shown on the nautical chart. Consequently, GPS positions cannot be entered on this nautical chart because they cannot be corrected. Therefore, errors are inevitable. This chart is suitable only for terrestrial navigation (by means of radar or dioptré).

This would not be a problem if there were a corresponding warning on the chart in English. As can be seen in Figure 12, there are warnings on the chart but these are in Spanish. Moreover, even if an international ship's officer is able to understand them, the warnings are only of a general nature. There is no clear warning that this chart is based on a local datum. Furthermore, it cannot be converted to a WGS because no correction parameters are specified.

In a comparison between the paper chart (see red circle in Fig. 12) and the actual radar image (see yellow line in Fig. 7), it is clearly apparent that the ice front has melted and thus receded since the nautical chart was created.

The Federal Bureau of Maritime Casualty Investigation recommends that SHOA keep its nautical charts as current as possible. In particular, Nautical Chart SHOA 12700 should be revised as soon as possible. Even a statement (in English) that the chart is based on a local datum and thus not compatible with other WGSs would be helpful. Moreover, attention should be drawn to shallows, especially on the coastline of glaciers.

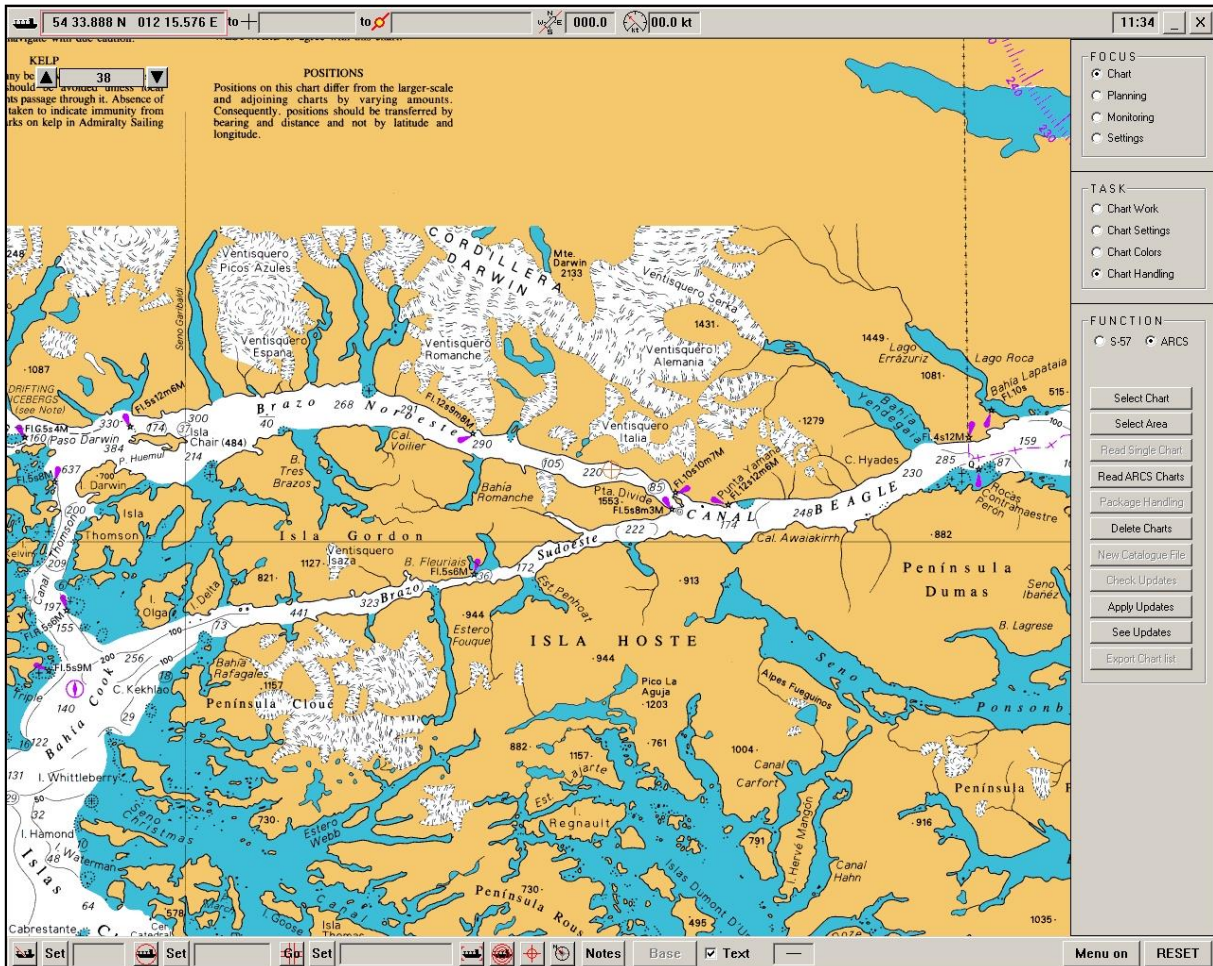
Figure 13: Raster chart – based on 12700

Figure 13 shows one of the available ARCS charts⁶. These are scanned images of the original paper charts. English warnings were inserted there; however, they also give no indication that this is a local datum. Nevertheless, it is noted that positions should be entered by bearing and distance rather than by latitude and longitude.

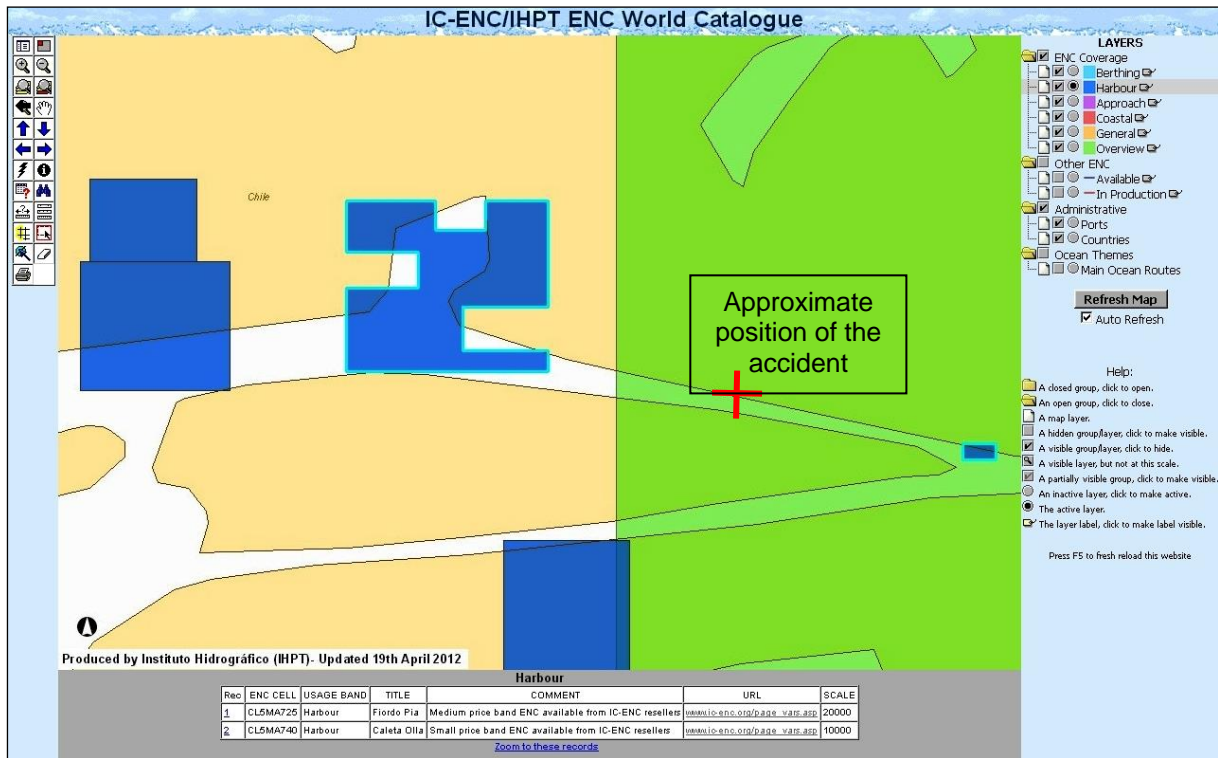
Figure 15: Detailed display with existing ENC data for the area of the accident

The scale used in Figure 15 shows more clearly that only an outline chart (in green) is digitised around the glacier. The blue areas are displayed on detailed nautical charts.
