Bundesstelle für Seeunfalluntersuchung
Federal Bureau of Maritime Casualty Investigation
Federal Higher Authority subordinated to the Ministry of Transport
and Digital Infrastructure

Summary
Investigation Report 250/11

**Collision between the CMV CCNI RIMAC
and CMV CSAV PETORCA on 21 June 2011
in the area of the approach to the port of
Yangshan**

31 March 2014

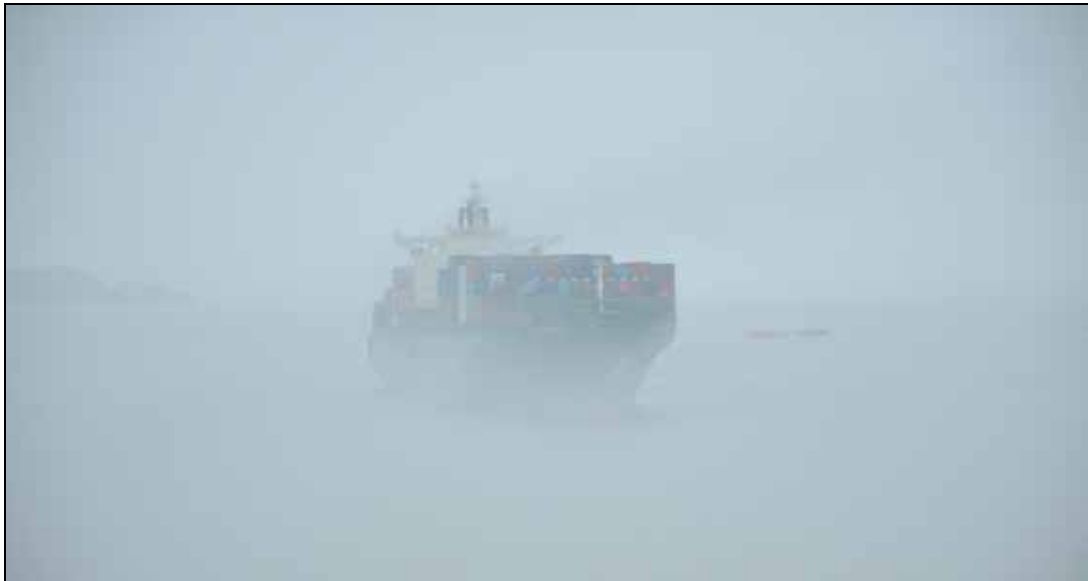
The digital photo below (**Fig. 6**) was kindly provided by the ship's command of the RIMAC and bears a timestamp set by the camera of 0634 (presumably CEST = 1234 LT). Accordingly, it would have been taken about 40 minutes after the accident. The photo illustrates the restricted visibility at the time of the accident. According to the S-VDR analysis, the distance between the two vessels is 0.6 nm at the time stated.

Figure 6: CSAV PETORCA seen from the CCNI RIMAC after the collision²¹

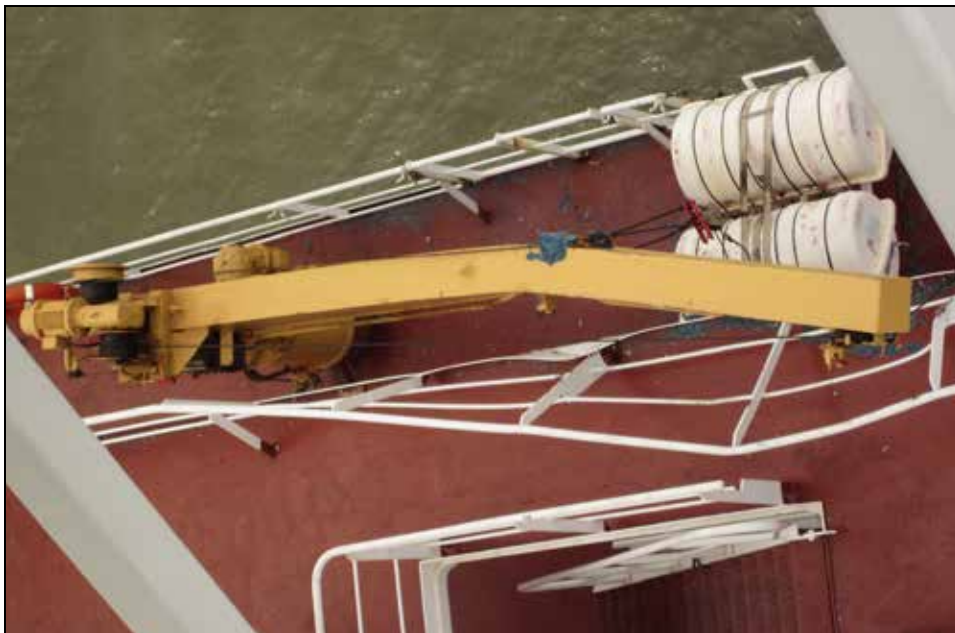
Initially, the bow of the PETORCA scraped along the superstructure on the port side of the RIMAC's aft section. The consequences of the accident in this area of the RIMAC are essentially limited to damage to the provision crane on the port side and a relatively small hole in the forward edge of the deckhouse (see **Figs. 7** and **8**).

Figure 7: Damage to the superstructure (provision crane) of the CCNI RIMAC

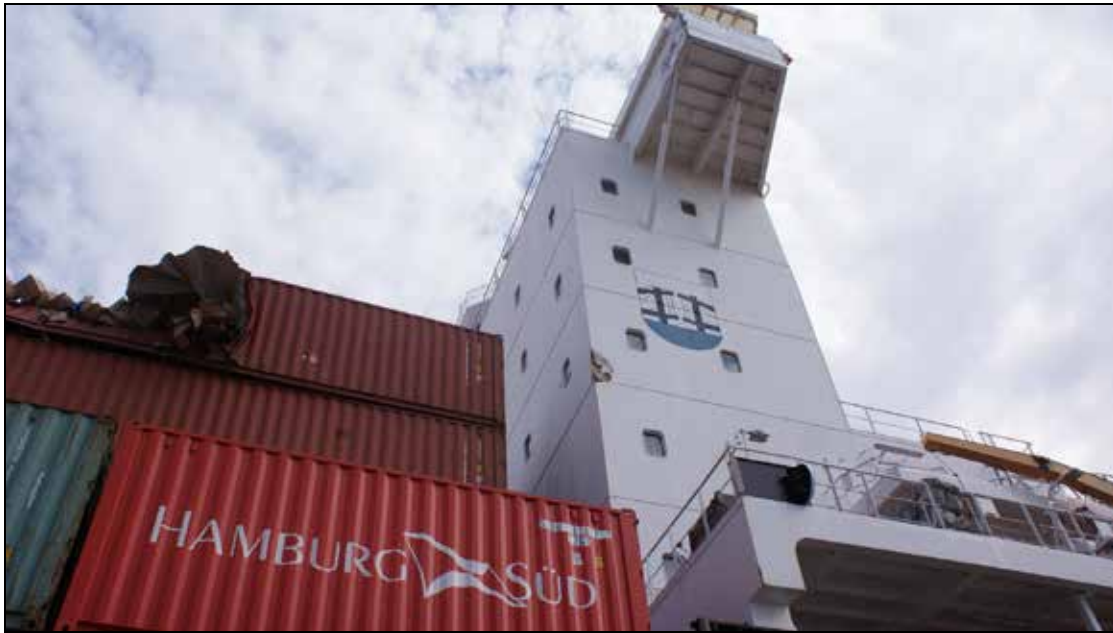
Figure 8: Damage to the superstructure of the CCNI RIMAC

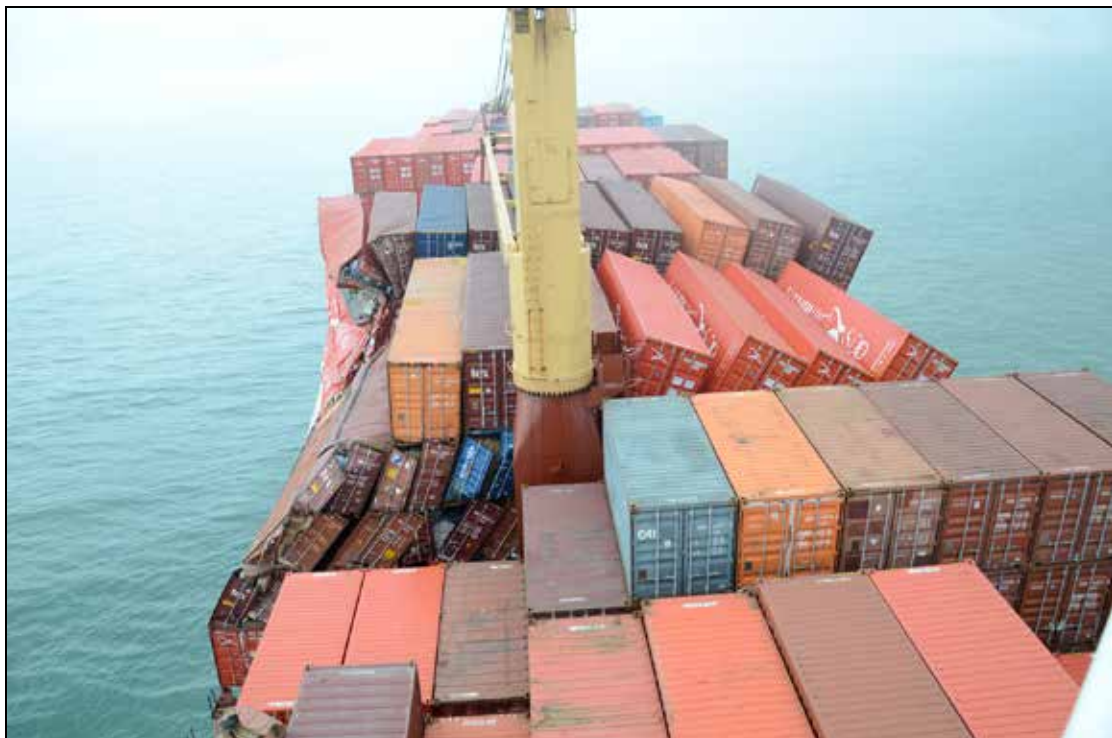
Several containers stowed on the outside of the container stacks situated directly in front of the superstructure were torn open or heavily deformed when the PETORCA scraped past them subsequently (**Fig. 9 f.**). A number of stacks in this area started to tilt across the entire breadth of the ship (**Fig. 11**), which resulted in 26 containers, situated mainly on her starboard side, falling overboard.

Figure 9: Damage to the deck cargo on the CCNI RIMAC (general view)

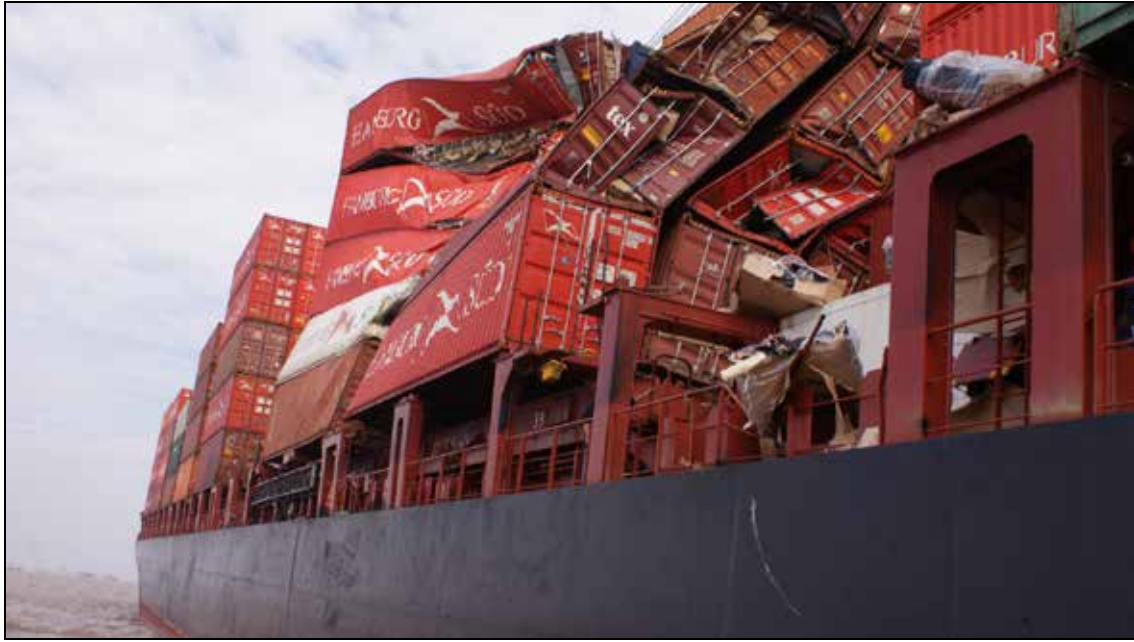
Figure 10: Damage to the deck cargo on the CCNI RIMAC (side view from port)

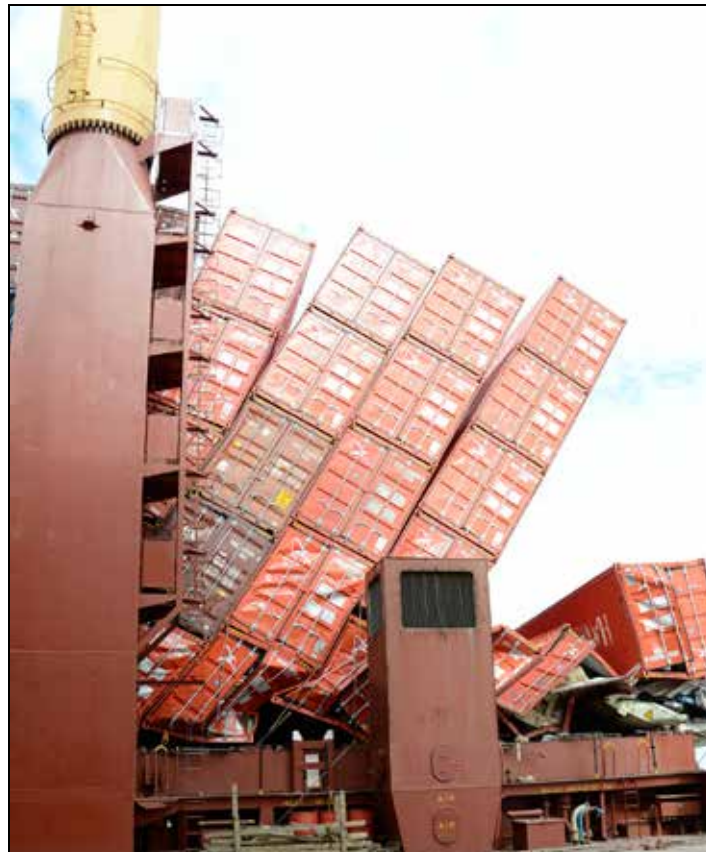
Figure 11: Tilted container stack (towards starboard) on the CCNI RIMAC²²

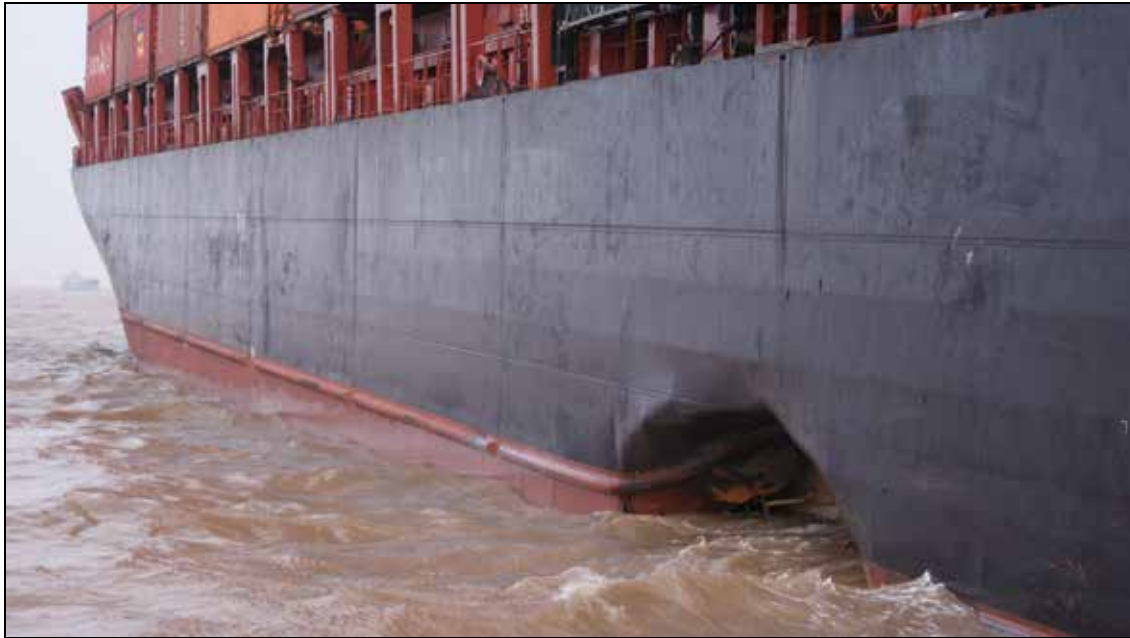
The PETORCA finally ploughed into the hull of the RIMAC level with the waterline with her bulbous bow and created a hole in a ballast tank and the adjacent wall of cargo hold 5 in the process (see **Fig. 12 f.**). The cargo hold then flooded to the height of the waterline with salt water.

Figure 12: Damage to the shell plating on the CCNI RIMAC

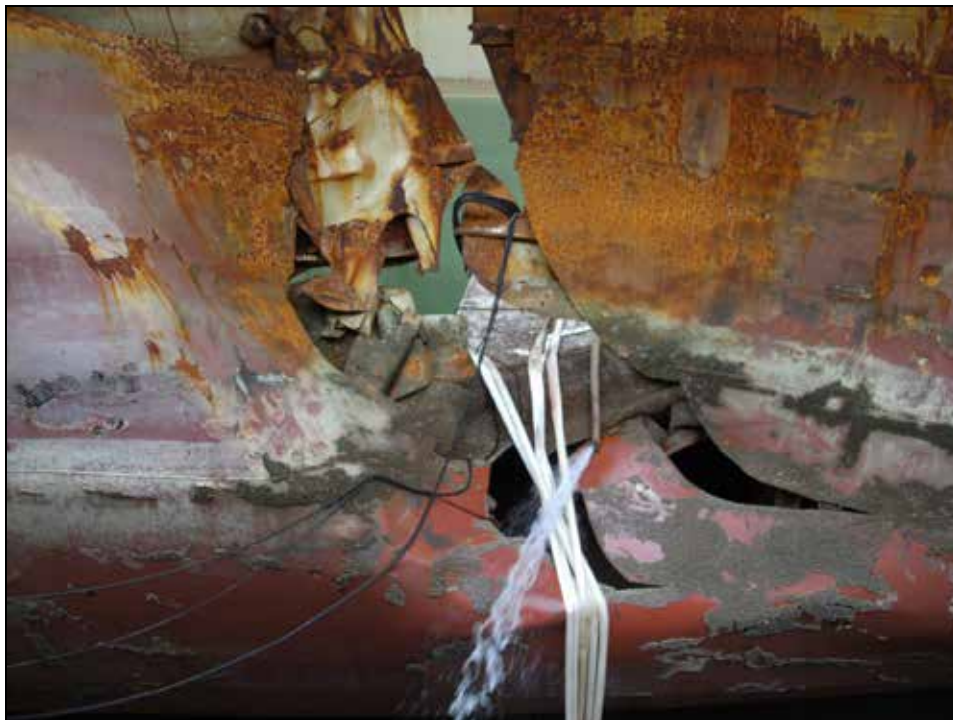
Figure 13: Damage to the shell plating on the CCNI RIMAC (close-up)

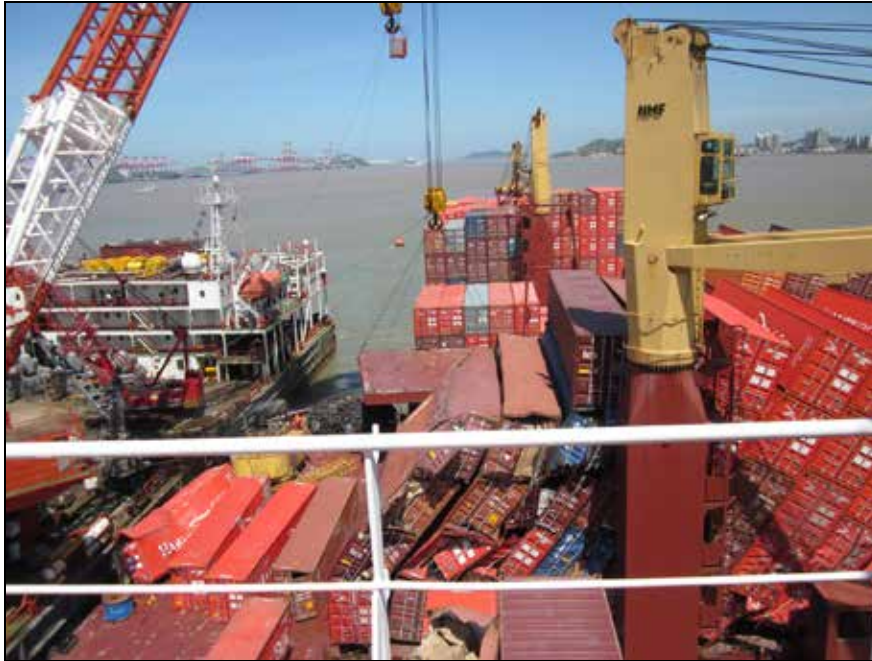
Figure 14: Deck cargo on the CCNI RIMAC being discharged in the roads of Yangshan

The crew of the RIMAC was temporarily evacuated from the vessel as a precaution. Moreover, a special team eliminated the ensuing hazardous situation by discharging the deck cargo stowed above cargo hold 5 and the four affected dangerous goods containers as a priority (see **Fig. 14 f.**).

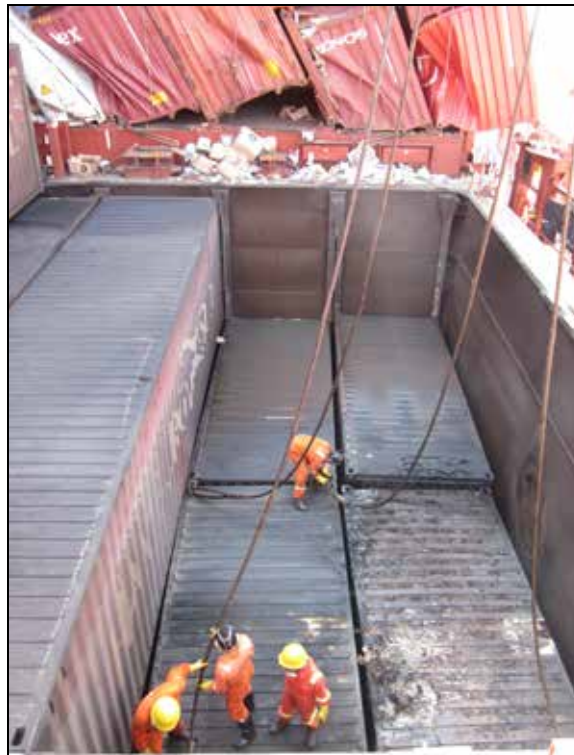
This reaction was between the flammable contents of at least one dangerous goods container stowed below deck and the salt water that had entered.

Figure 15: Elimination of the hazardous situation in cargo hold 5 of the CCNI RIMAC

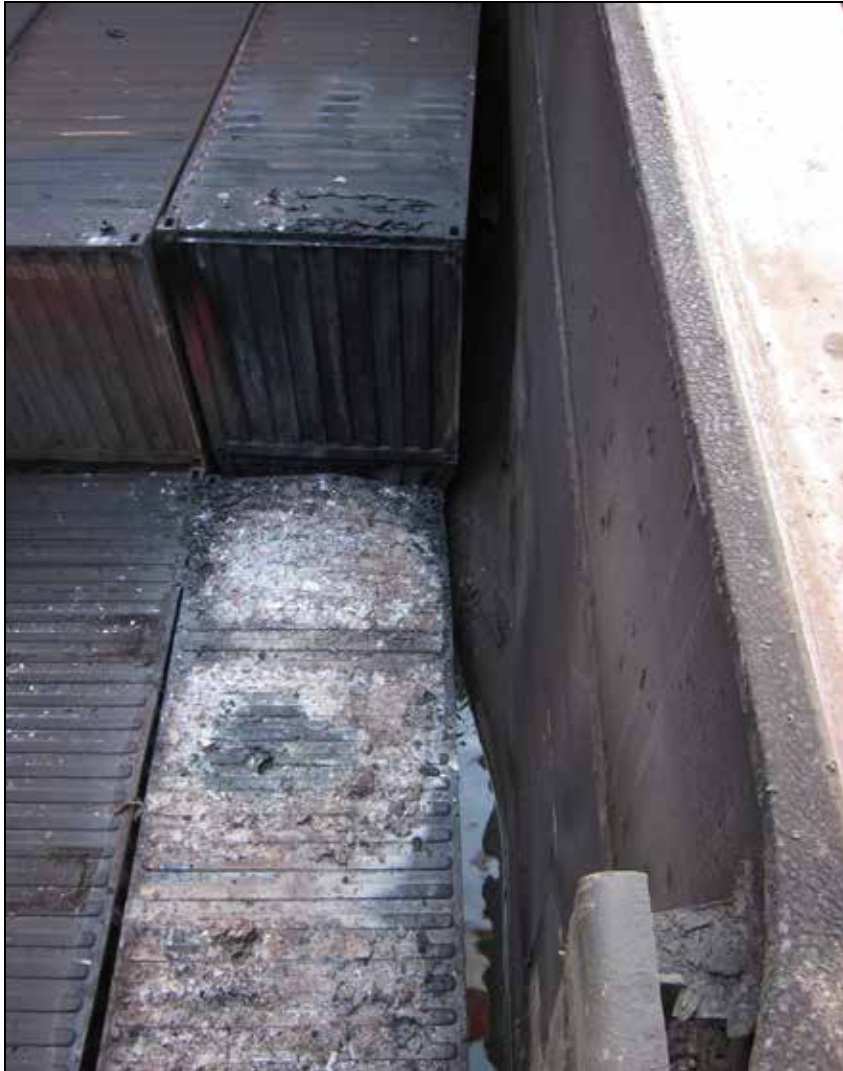
After the water ingress in the cargo hold, a chemical reaction followed by heat and smoke occurred during the next 24 hours in the roads of Yangshan.

Figure 16: Water ingress and evidence of heat development in cargo hold 5

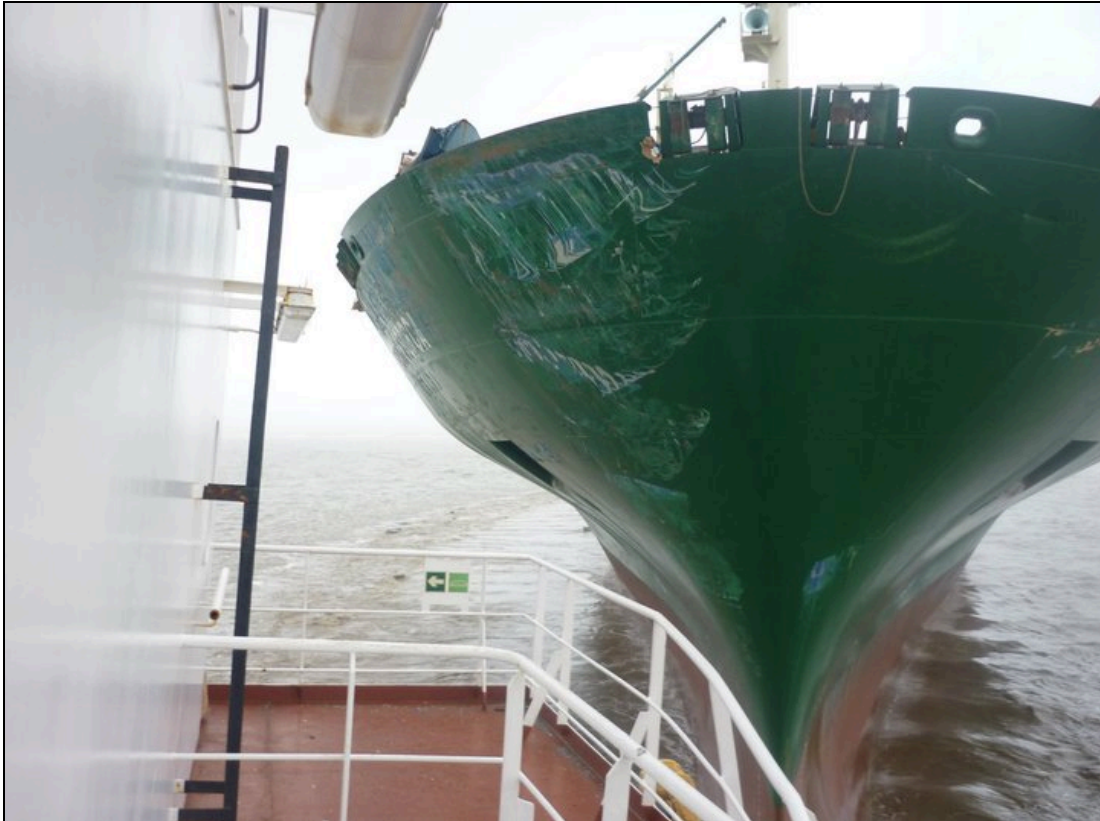
The damage to the PETORCA was limited to paint abrasions in the area of the bow (see **Fig. 17**) and a dent in the bulbous bow. Water ingress was not found in the course of sounding all the tanks and cavities open to consideration, which was carried out immediately.

Figure 17: Paint abrasions on the bow of the CSAV PETORCA²³

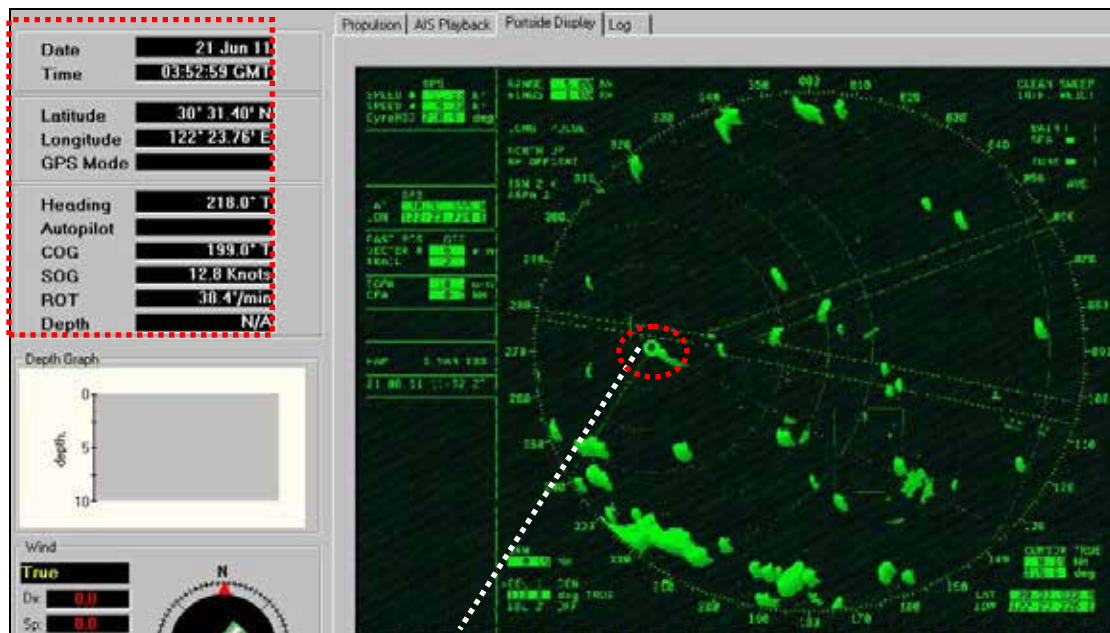
Figure 25: Starboard radar on the CCNI RIMAC at 115259 (S-VDR replay)

At about 115259 (see Fig. 25 below), the PETORCA's echo merges with the centre of the radar image (RIMAC).³³ The two vessels collide. The repeated distinct continuation of the turn to starboard in the RIMAC's heading line, as compared to Figure 24, proves

that the RIMAC tried to prevent the collision with the PETORCA until the very last minute by means of a hard to starboard manoeuvre.
