**Bundesstelle für Seeunfalluntersuchung**  
**Federal Bureau of Maritime Casualty Investigation**  
Federal Higher Authority subordinated to the Ministry of Transport  
and Digital Infrastructure

Investigation Report 255/12

**Very Serious Marine Casualty**

**Fire and explosion on board the  
MSC FLAMINIA on 14 July 2012  
in the Atlantic and the ensuing  
events**

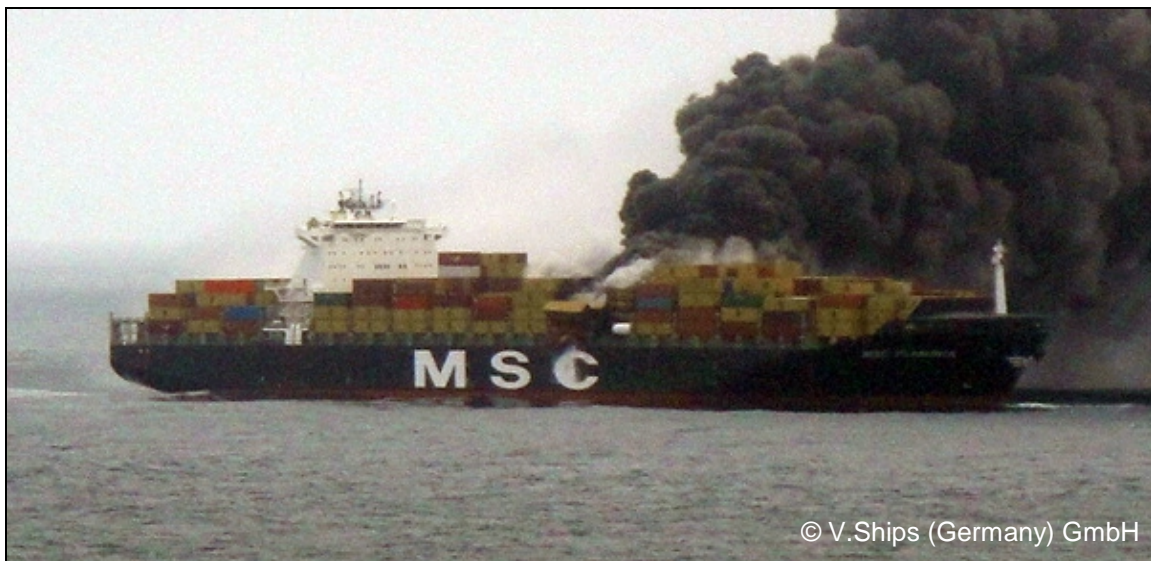
Figure 3: MSC FLAMINIA seen from the DS CROWN

At this point, two different smoke clouds could be seen (Figure 3) above the MSC FLAMINIA. One was black/grey in colour and seemed to come from the open flames above cargo hold 4. The other was light grey. It was located below the other cloud and was more fog-like in structure. It appeared to come from a source further below in cargo hold 4.

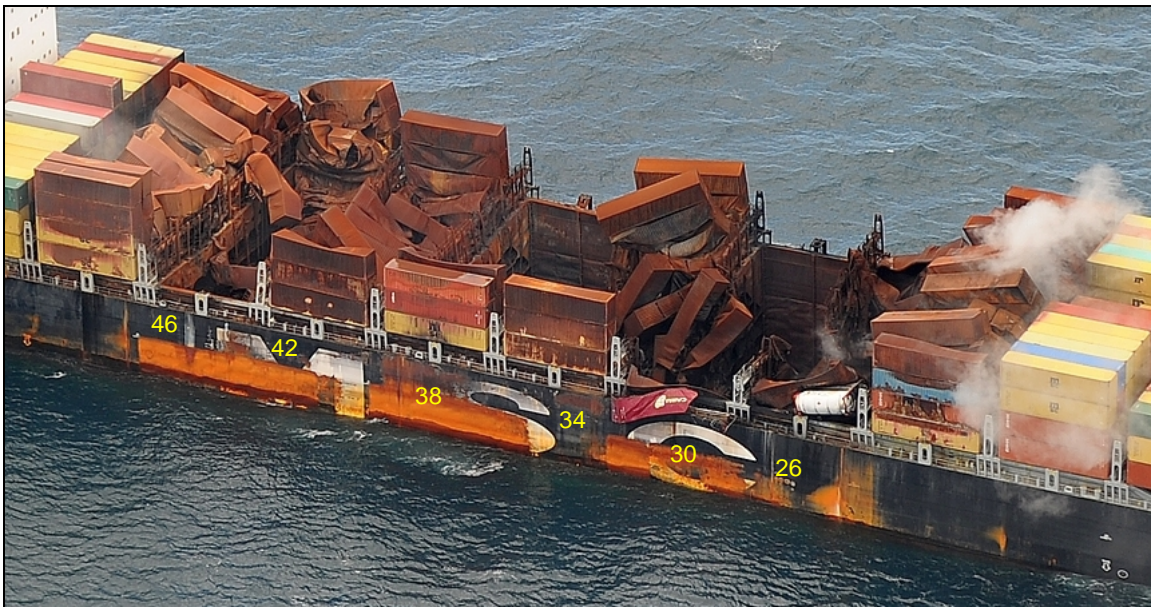
Figure 4: Starboard side of the MSC FLAMINIA

Due to the explosions and fire, the ship and the cargo in the area of cargo holds 3 to 7 were damaged to varying degrees. The ship's structure was significantly weakened in this area and needs to be replaced. Extinguishing water entered the bridge and rendered part of the electronic systems installed there unserviceable.

The containers in bays 26 to 46, where the hatch covers lost their structural strength due to the temperatures generated and fell into the cargo holds together with the containers on them, sustained very heavy damage.

Also due to the high temperatures generated, the watertight transverse bulkhead between cargo holds 4 and 5 was destroyed. The supporting transverse bulkheads between bays 26/30, 34/38, and 42/46 were destroyed or very heavily damaged.

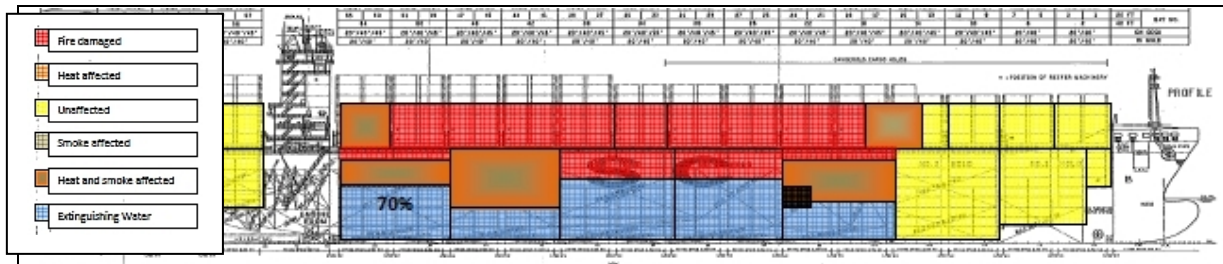
Figure 5: Areas affected by fire, smoke or water (SMIT, information as of 28/08/2012)

Due to the extinguishing work and cooling of the cargo and the ship, water was in all the cargo holds, except for cargo hold 2, at least temporarily. While entering Wilhelmshaven, there was water in cargo holds 1, 3, 4, 5, 6, and 7. This was several metres high and heavily contaminated in places. In addition, the salvor pumped extinguishing water into some of the ship's tanks. Inter alia, this was done to reduce the initial maximum draught from 19 m to 16 m for the entry into Wilhelmshaven and to counteract the initial 11° list.

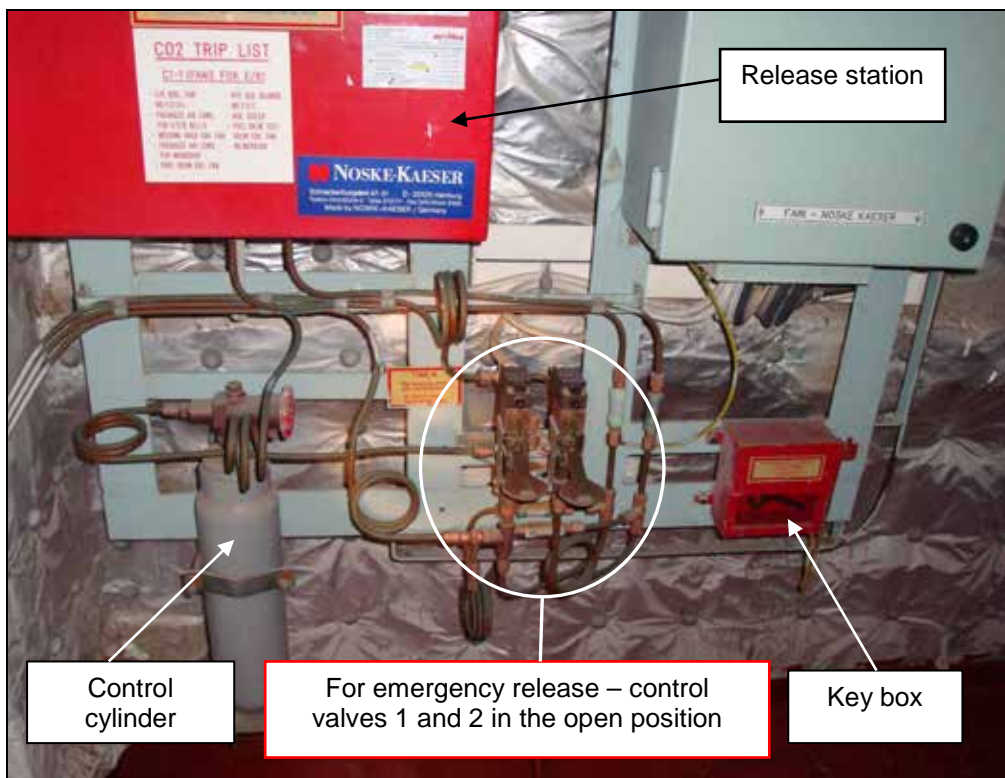
Figure 10: MSC FLAMINIA, release station in the CO<sub>2</sub> room, control valves, control cylinder, and key box

In contrast with this the investigators determined during the survey of the MSC FLAMINIA that the position of the pilot valves 1 and 2 for the emergency release deviated from the normal position, in other words, they were open (figure 10). Part of the emergency release of the engine room is the manual actuation of the control valves 1 and 2.

The fact that both valves seemed to have been activated manually, was initially interpreted by the investigators to that effect that it was an operating error of the crew. It was assumed, that the actuation of the pilot valves led to the activation of the electrical connections connected with them which in return triggered the alarm and shut down the ventilators. In contrast the vessel's operator advised the BSU in its statement supplied in December 2013 of the fact that an inspection of the releasing station in June 2013, carried out by the vessel's operator and Noske-Kaeser, revealed that an incorrect installation of pipes was the cause for the malfunction of the releasing station. Representatives of Noske-Kaeser confirmed this on inquiry of the BSU. Additionally it was made clear that in all likelihood the error already existed since the installation of the system. However, the error should have been detected with a proper acceptance of work. The error should also have been detected during regular inspections of the system.

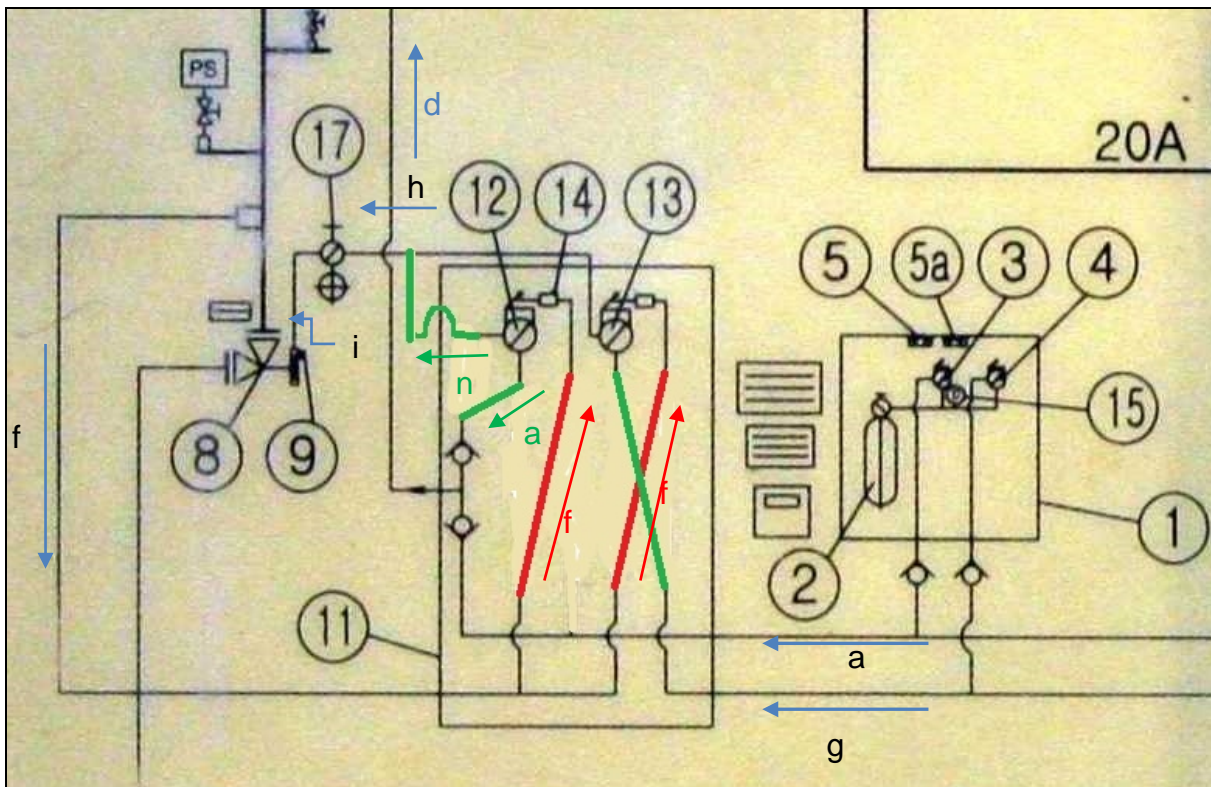
Figure 14: Piping schematic as assembled

Due to the incorrect assembly the pipes were connected like explained in figure 14. After opening the cylinders the CO<sub>2</sub> gas flew also into the 150A-pipe. The main valve was indeed closed but through the pipe (f) the full system pressure was also applied to the pneumatic pistons of the control valves 1 and 2. Thereby the control valves 1 and 2 were opened. Since there was no control pressure applied to the pipes [a] and [g], were neither further cylinders released nor the main valve to the engine room opened. Opening of the control valves only led to the triggering of the CO<sub>2</sub> alarm and the shutdown of the ventilators.

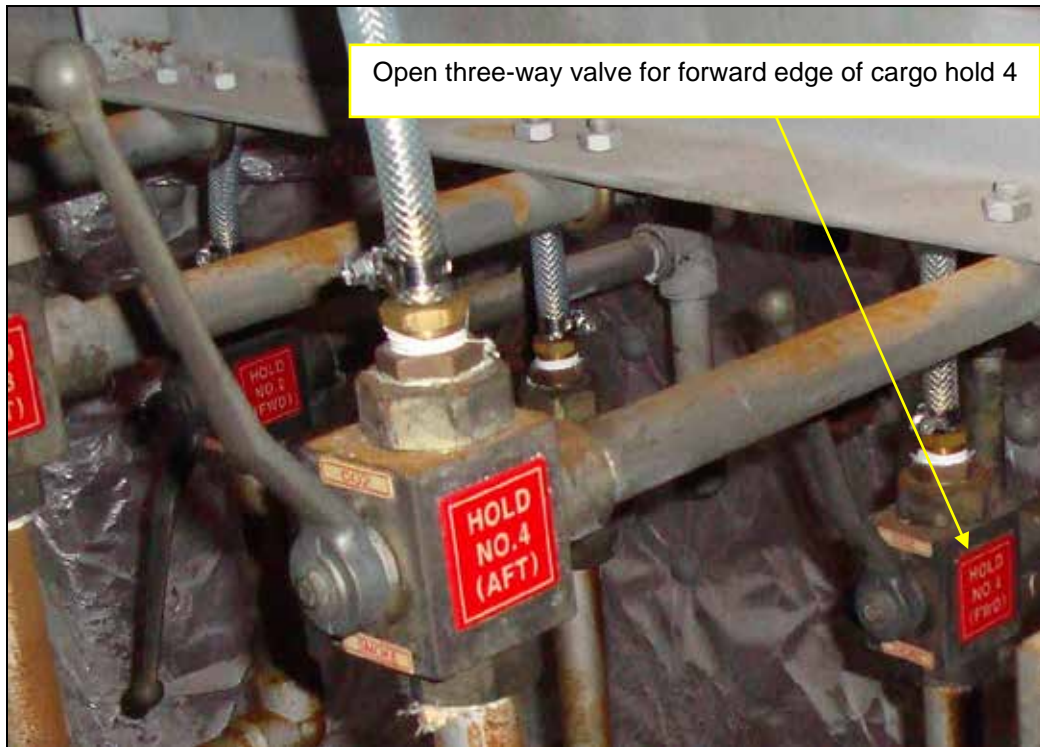
Figure 21: Open three-way valves for cargo hold 4

It should also be noted that the instructions in the CO<sub>2</sub> room described the procedure for the three-way valve as follows: "Fully down 3-way valve lever relating to the compartment fire." In fact, the lever on the MSC FLAMINIA had to be pulled upward. This also corresponded with the label on the valve itself (Figure 21).

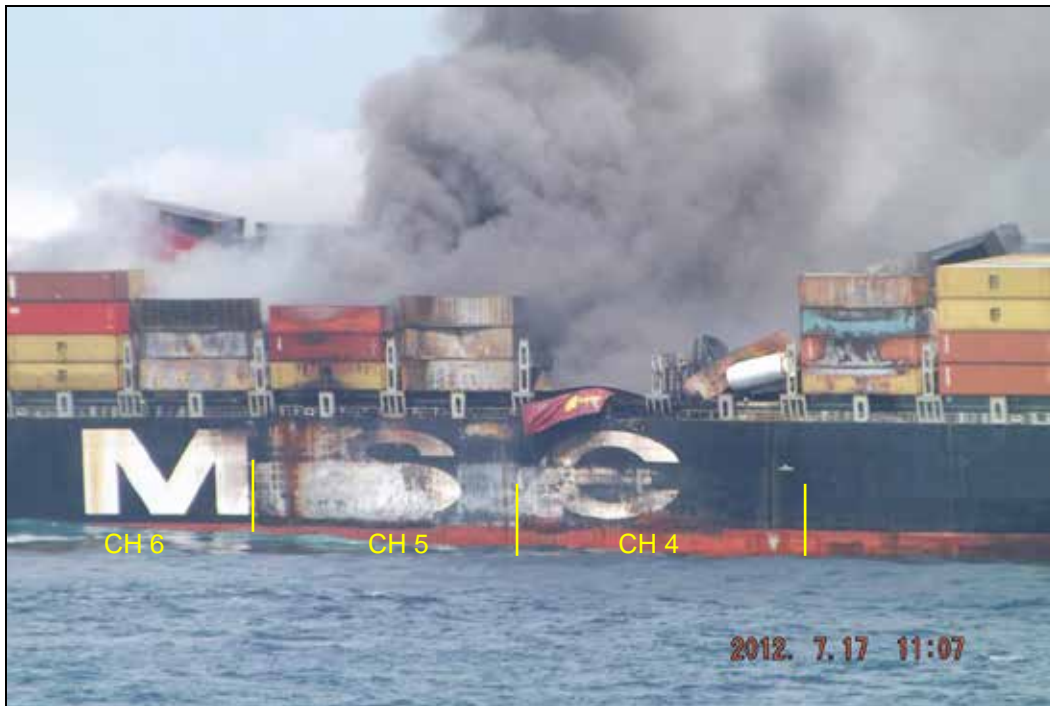
Figure 25: Progress of the fire on 17 July 2012

In Figure 25, it can be seen that the fire has spread as far as into cargo hold 5, at least. The shell plating of the ship is beginning to change colour at that position. The investigators assume that the ballast water tank located there was empty. This tank spans bays 31 to 39. The upper limit of the discolouration of the shell plating marks the transition to the passageway.

Furthermore, it should be noted that the containers located on deck in the area of cargo holds 3 and 6 are starting to collapse.

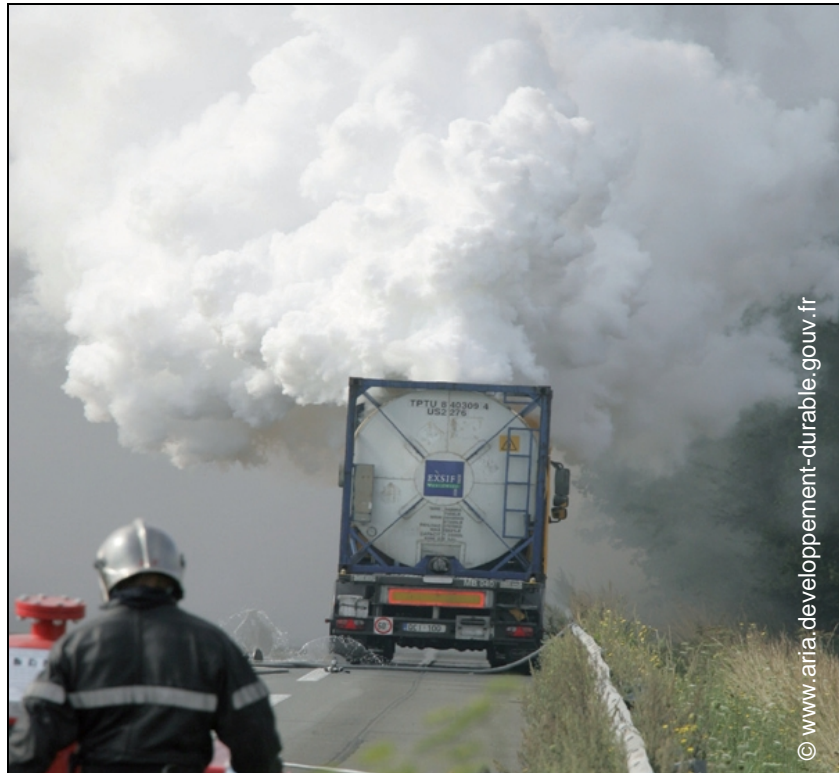
Figure 39: Ongoing polymerisation on a container in road transport

assumed that polymerisation occurred during the voyage. The resulting heat release of 350°C was then reportedly responsible for the fire. Moreover, the occurrence of white smoke is reportedly typical to polymerisation. He referred to past events with this substance<sup>62</sup> (see Figure 39). In the case of the events that are known, it should be noted that neither an explosion nor open flames have occurred.

In its statement concerning the draft report, Deltech informed the BSU that the incident described in figure 39 occurred after a transport time of 37 days. Thereby the containers were said to have stand in the sun in a port. By evaluating the incident the precautions taken by the manufacturer were optimized. Since then no abnormalities have reportedly been determined during transports to destinations in warm countries far away. The own temperature monitoring resulted in the fact that the temperatures in the containers remained within the limit value.
