Bundesstelle für Seeunfalluntersuchung
Federal Bureau of Maritime Casualty Investigation
Federal Higher Authority subordinated to the Ministry of Transport
and Digital Infrastructure

Investigation Report 289/12

Serious Marine Casualty

**Ground contact by the
oil tanker KATJA
in the River Jade
on 14 August 2012**

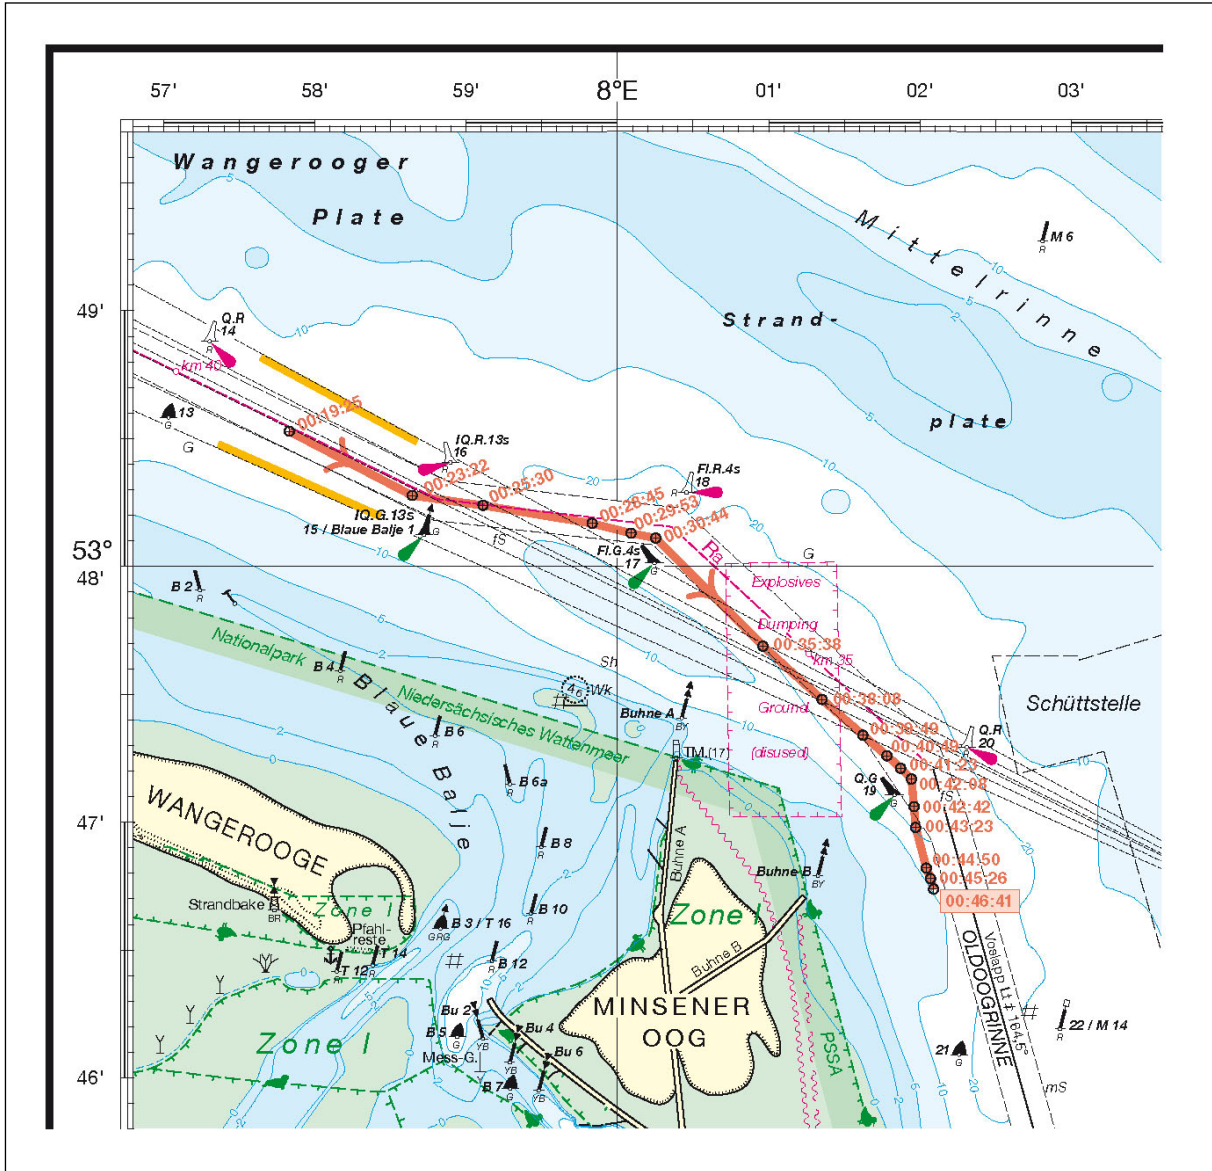
Figure 3: Course of the voyage taken by the KATJA

The KATJA passed pair of buoys 15/16 at 0023 on 14 August 2012. The ensuing course alterations at the next two pair of buoys were made to pass the Minsener Oog National Park area (see Figure 3).

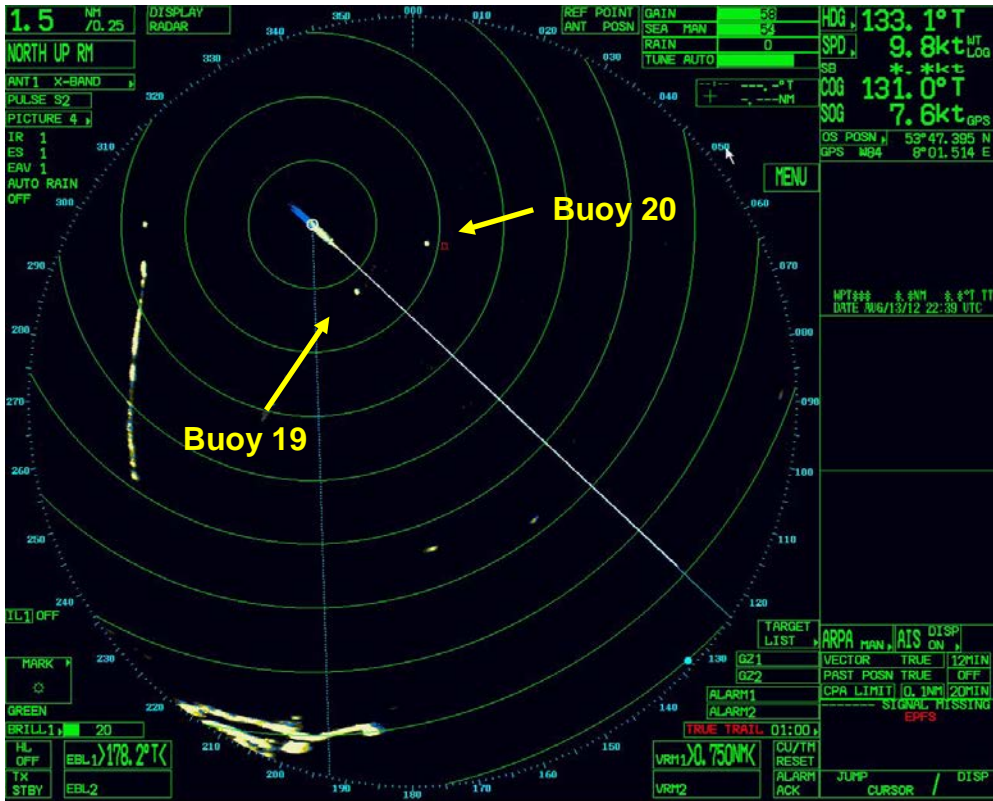
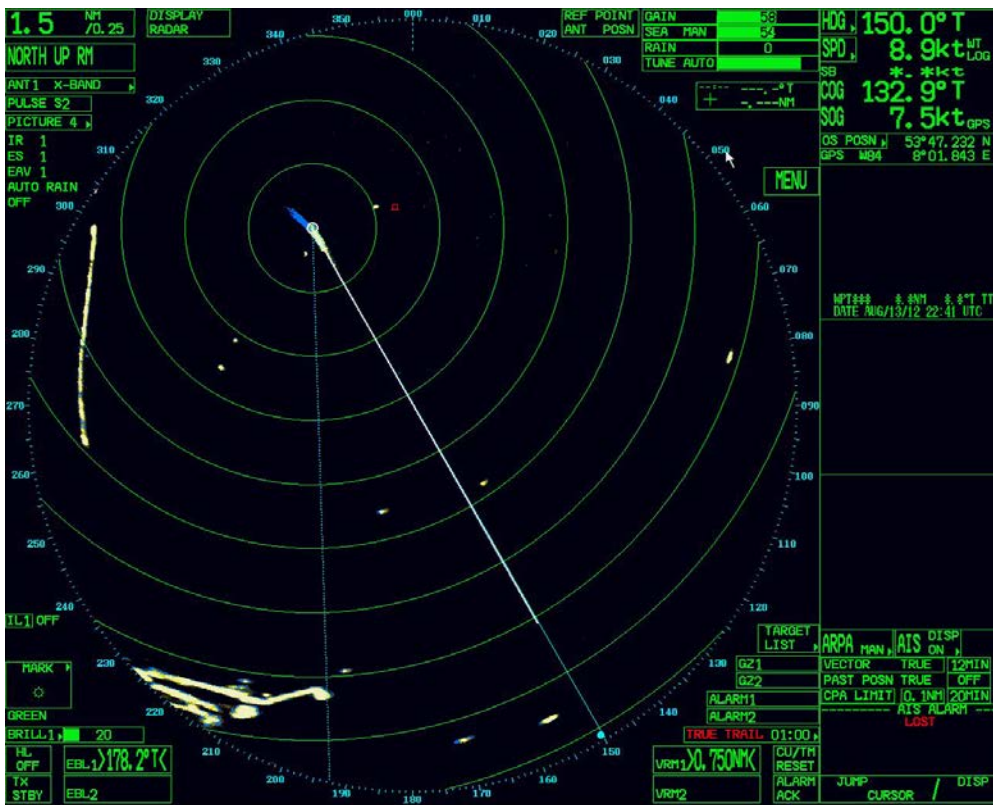
At 0040, some 250 m before the next course alteration at pair of buoys 19/20, the ebb current⁷ increasingly acted on the KATJA, which could only manage 7.5 kts

speed over ground and 9 kts speed through water despite proceeding at full speed ahead (see Figures 4 and 5).

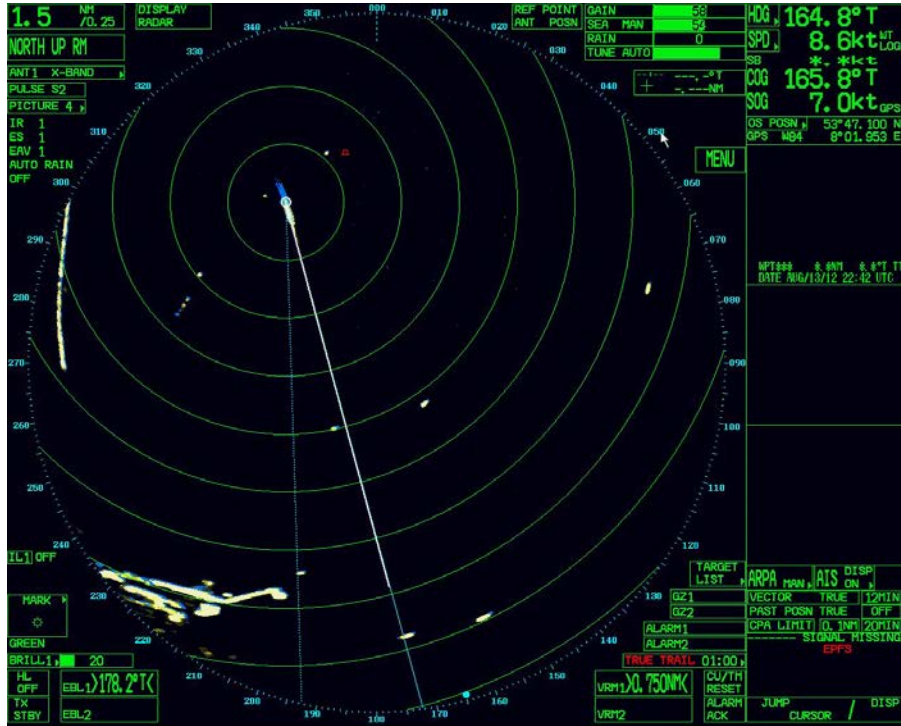
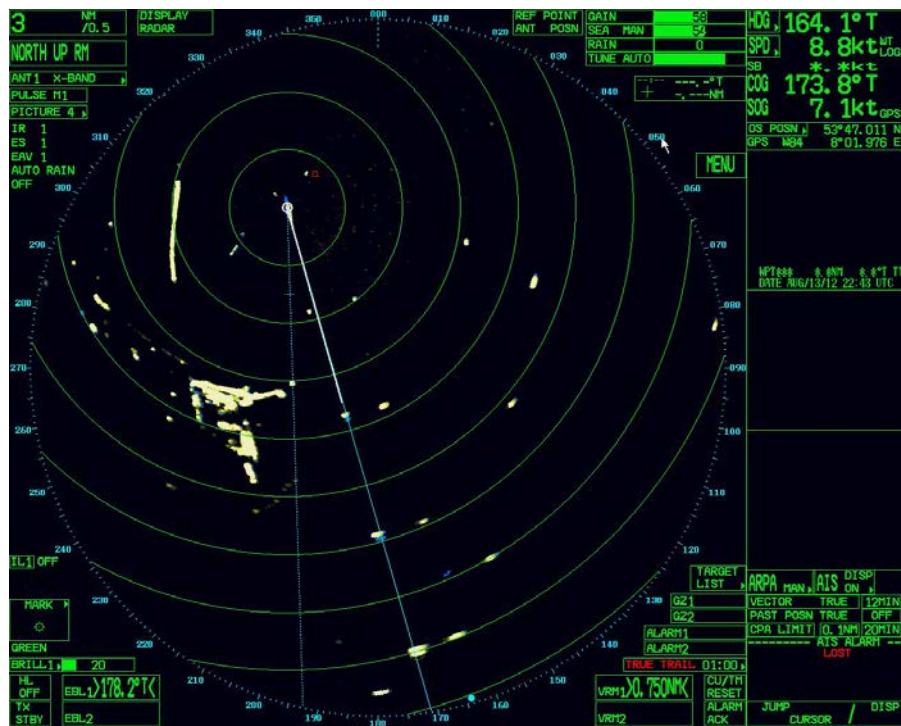
The shore-based radar pilot advised the sea pilot on VHF that after completing the course alteration (165°), the KATJA was approaching the western border of the dedicated corridor. At the same time, her tendency to set westward continued. The sea pilot ordered that the course be altered to 160° in response (see Spreadsheet 2). However, the tanker continued to be displaced considerably to starboard due to the ebb current (see Figures 6 and 7).

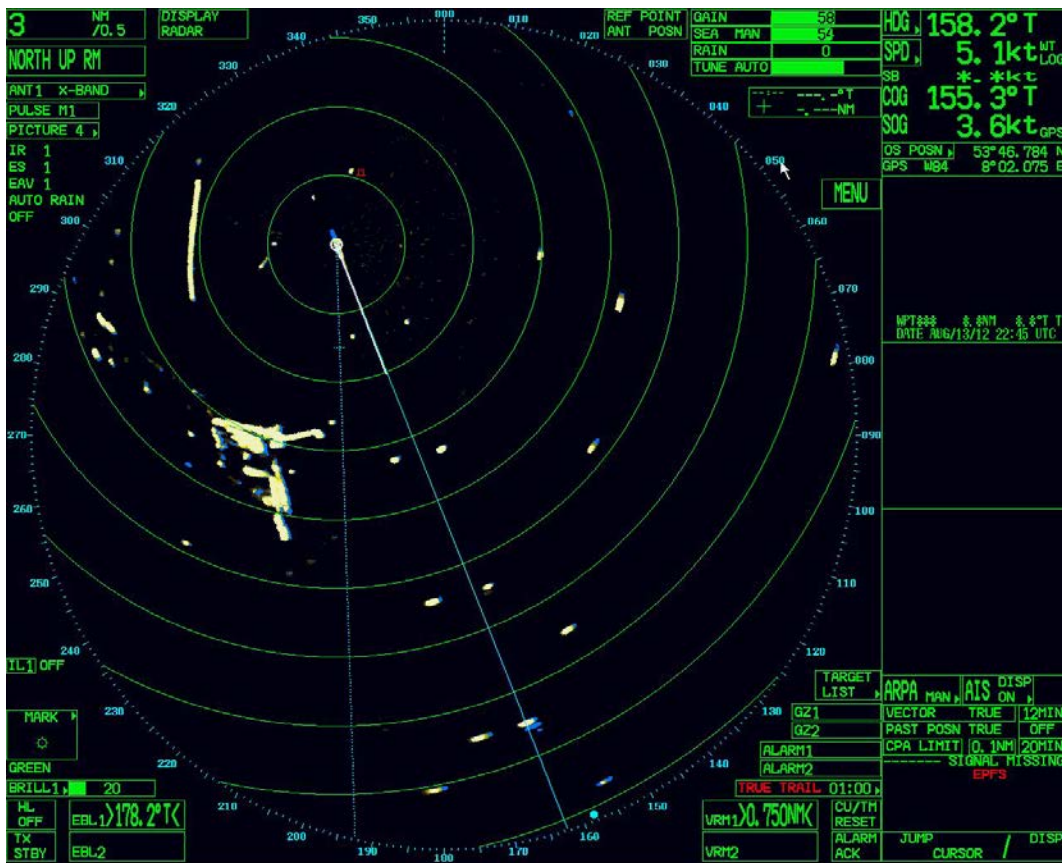
Figure 8: The KATJA's radar plot at 004525

At 0043, the KATJA was almost one beam outside the western corridor. Since sand regularly accumulates in the area to the east of Minsener Oog Island, the existing water depth outside the dedicated corridor was not sufficient for the KATJA's draught of 13.45 m. At 0045, the KATJA slowly propelled herself onto the ground (see Figure 8).

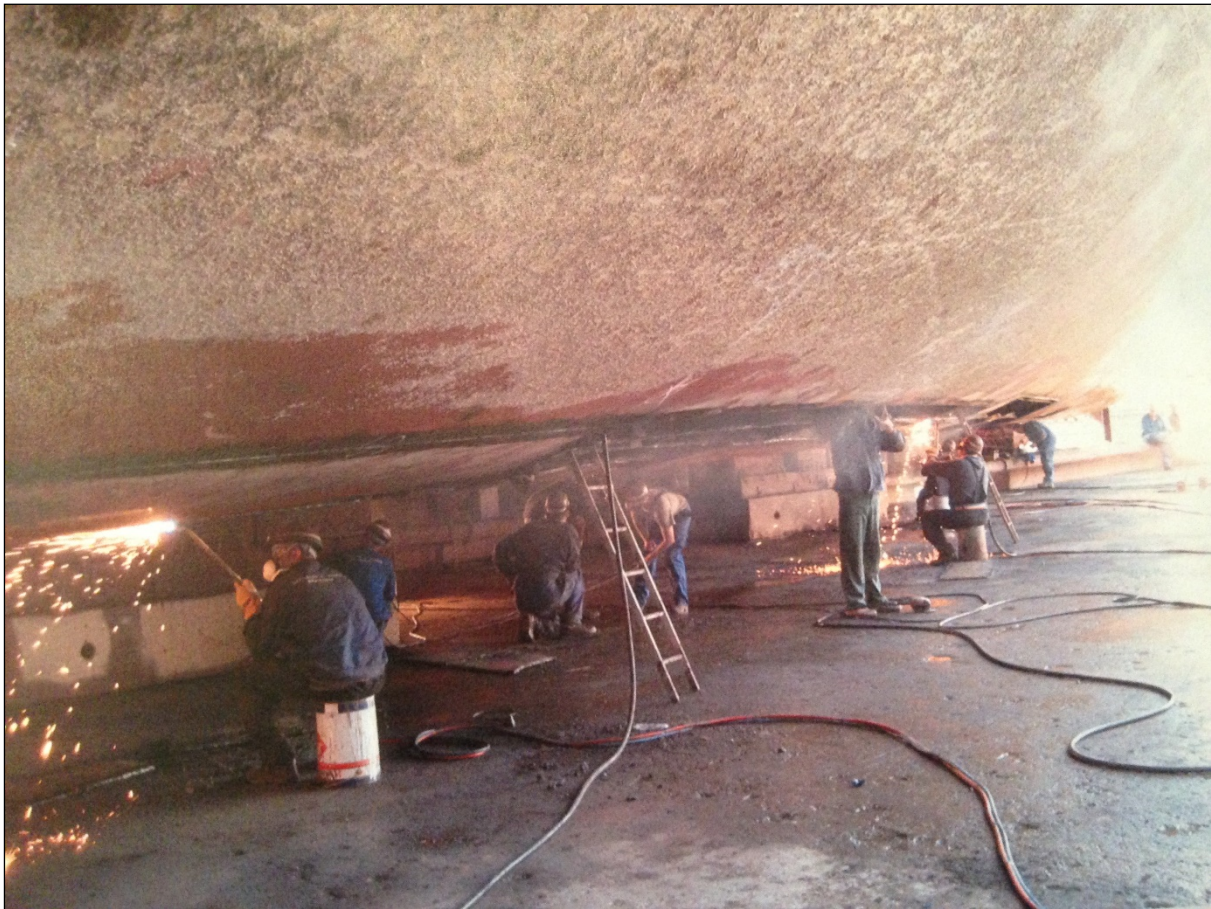
Figure 13: Repair work in the dry dock

The ground contact damaged the bottom of the ship. Web frames and longitudinals were deformed in places (level with Ballast Tank 1 on the starboard side, in particular). The KATJA was taken to a dry dock in Hamburg for the repair work (see Figure 13).

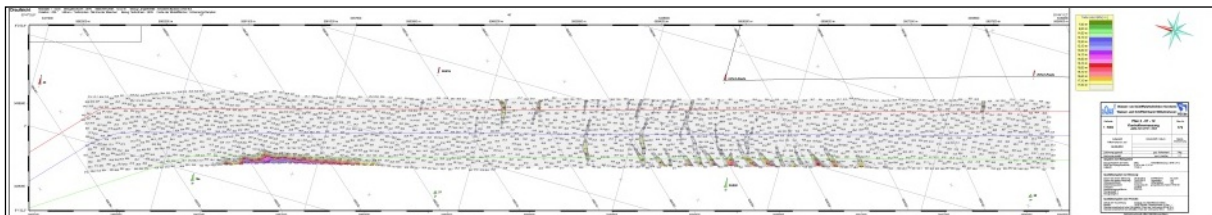
Figure 19: Sounding chart of 3 September 2012

The sounding chart of 3 September 2012 (see Figure 19) reportedly shows that actually an accumulation cannot always be removed completely or permanently, in spite of dredging in the interim. By all accounts, this is usually because sediment reportedly flows back at the 'cutting edge' immediately after dredging. Therefore, the dredger was reportedly in operation at the scene of the accident once again in mid-September. The amount of sediment that accumulates there is reportedly unpredictable, as it is heavily dependent on the weather, tide, and swell at the time.

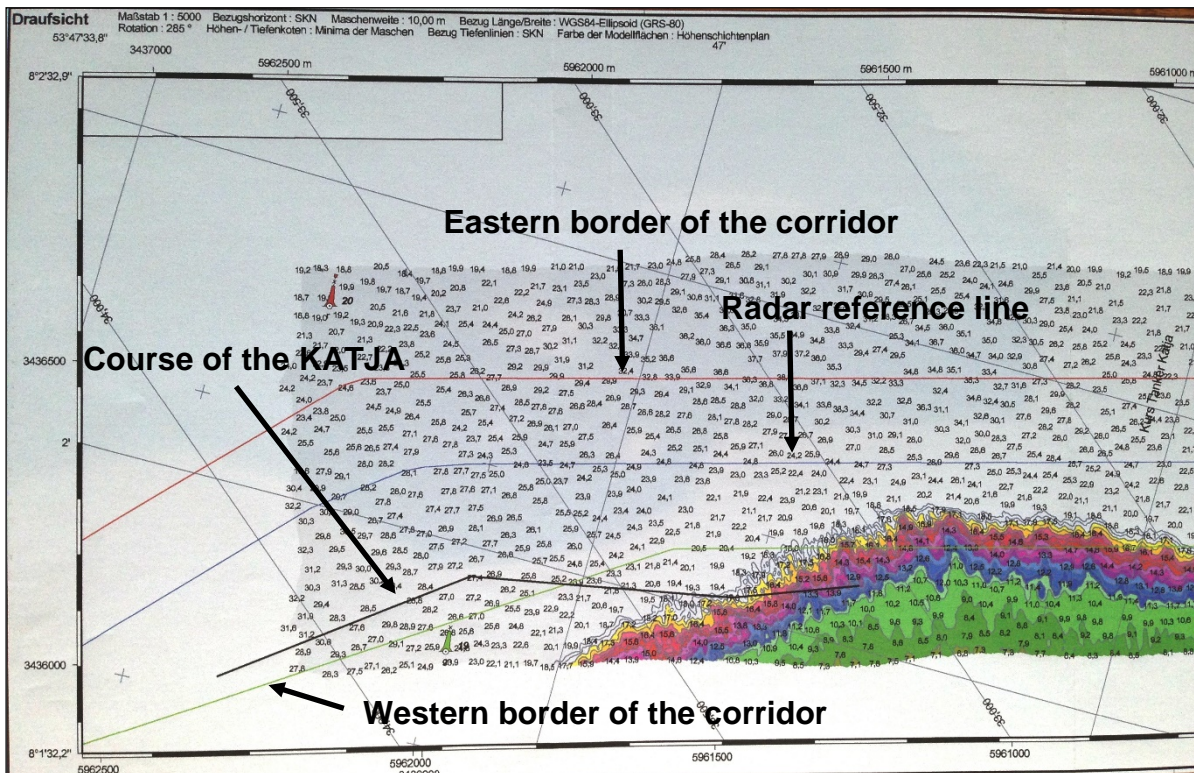
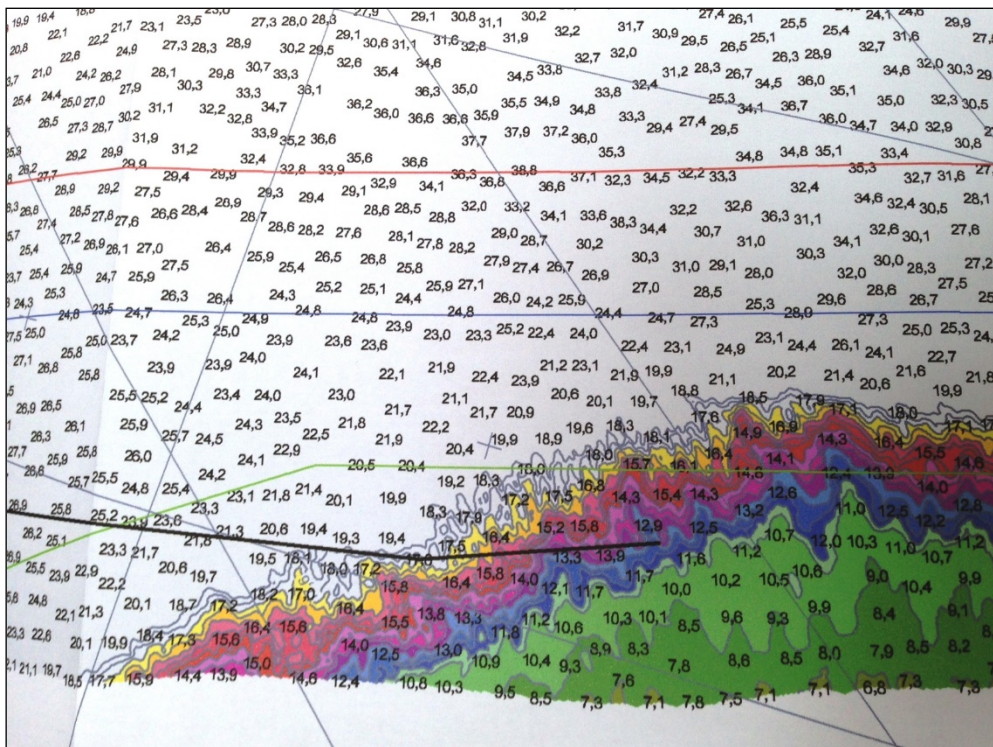
The last sounding up to the buoy line was made on 6 August 2012, i.e. shortly before the accident (see Figures 20 and 21: Chart excerpt from 8 August 2012 with the KATJA's course inserted).

According to the sounding chart, the depth of water outside the corridor was not sufficient for the draught of the KATJA (13.45 m). The black course line of the KATJA ends in an area for which depths of much less than 13 m are shown. It should be noted here that the chart only shows the depth conditions for the day the sounding was made, 6 August 2012, but not for the day of the accident.

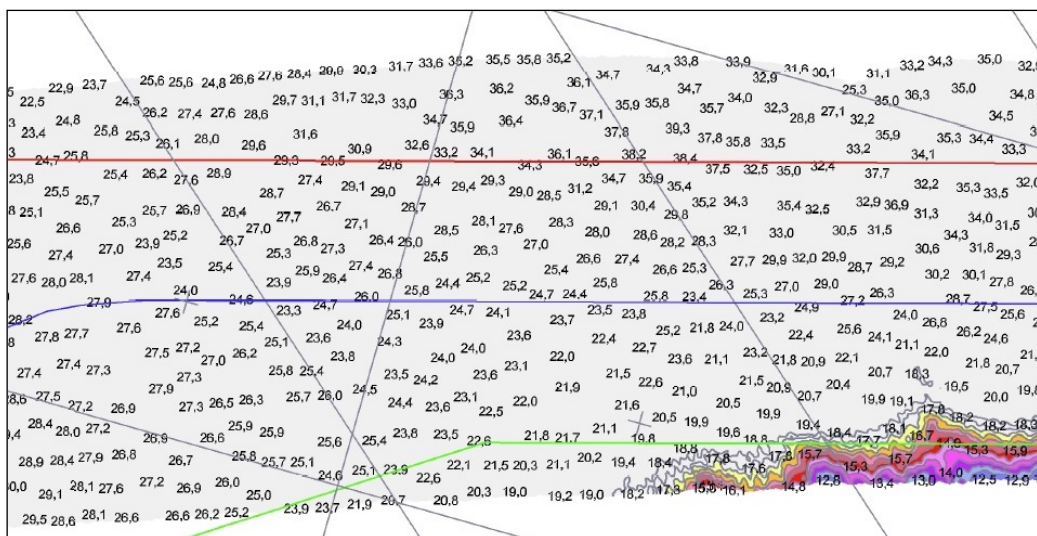
Figure 22: Details of the accident area, sounding chart of 4 September 2012

The first chart after the accident was created on 4 September 2012 (see Figure 22) after further dredging. Rather than the entire fairway to the buoy line, it only covers the dedicated corridor within the fairway.
