Investigation Report 342/13

Serious Marine Casualty

**Stability-related accident involving the MV ROSEBURG
in the Kieler Förde
on 5 November 2013**

20 October 2014

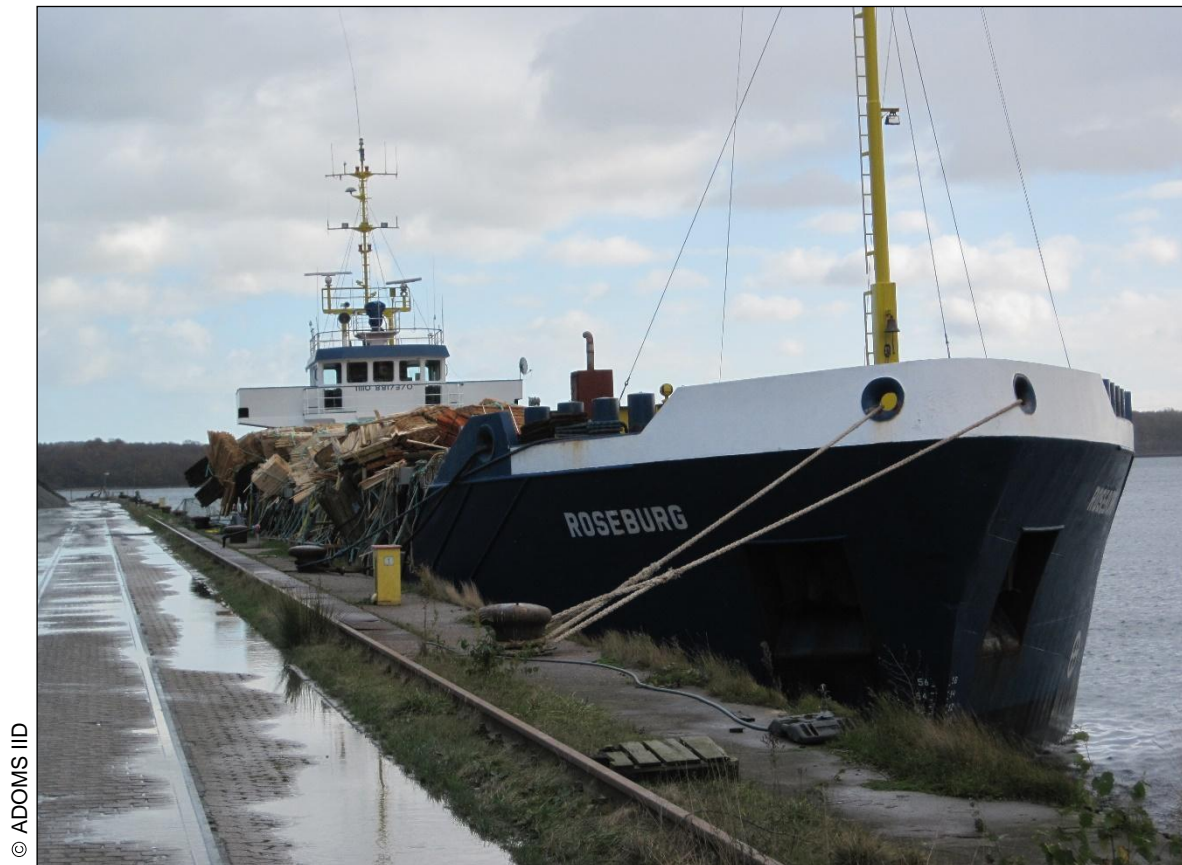
Figure 3: Damage photo 1

At the same time as the chief mate fell, numerous lashings on the deck cargo broke and about 75% of the cargo slid into the water.

Figures 3 to 7 illustrate the condition on the day after the accident.

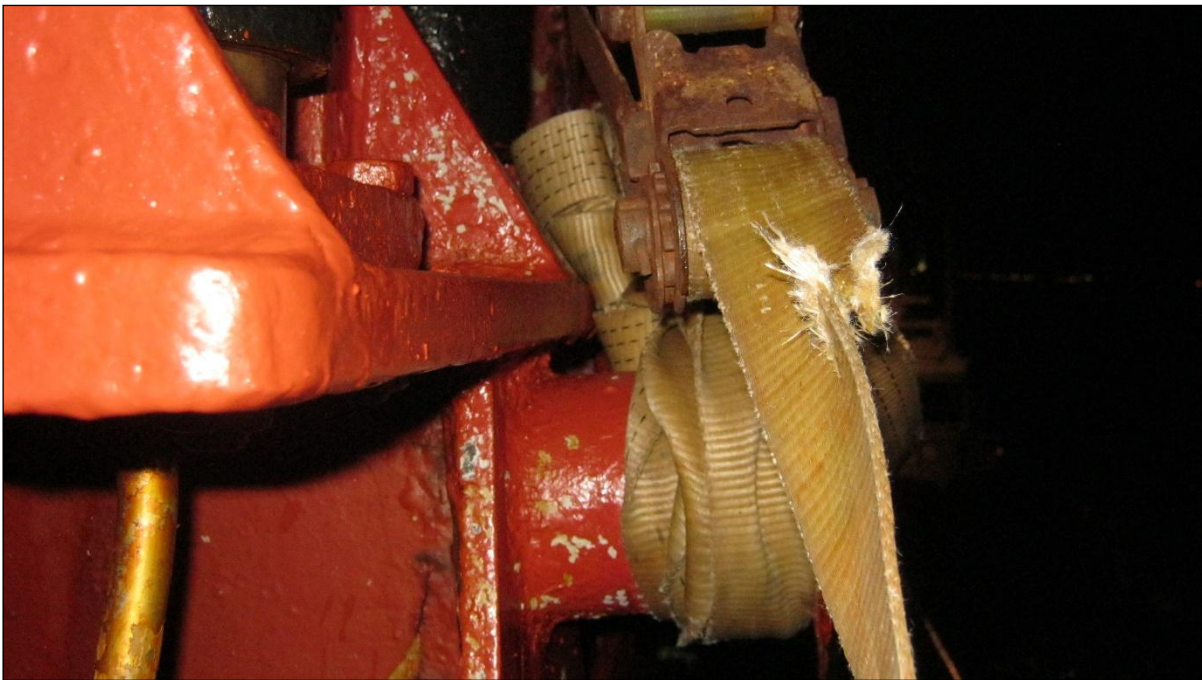
Figure 8: Knotted lashing strap

According to the Timber Cargo Securing Manual, 41 polyester straps with a breaking load of 15,000 kg should have been used on board the ship. However, during the survey shortly after the accident on 5 November 2013, the waterway police found only 18 straps with a breaking load of 20,000 kg and 17 with a breaking load of 5,000 kg. Of the former, six were only tied to the ship and not attached with a hook. In the case of the smaller straps, several older cuts and abrasions were found, meaning it can be assumed that these would not even have reached a breaking load of 5,000 kg.

The Federal Bureau of Maritime Casualty Investigation and ADOMS IID recommend that the ship's command of the MV ROSEBURG desist from taking risks and give absolute priority to the safety of the ship. This includes secure cargo and a sufficiently intact lashing system in accordance with requirements.

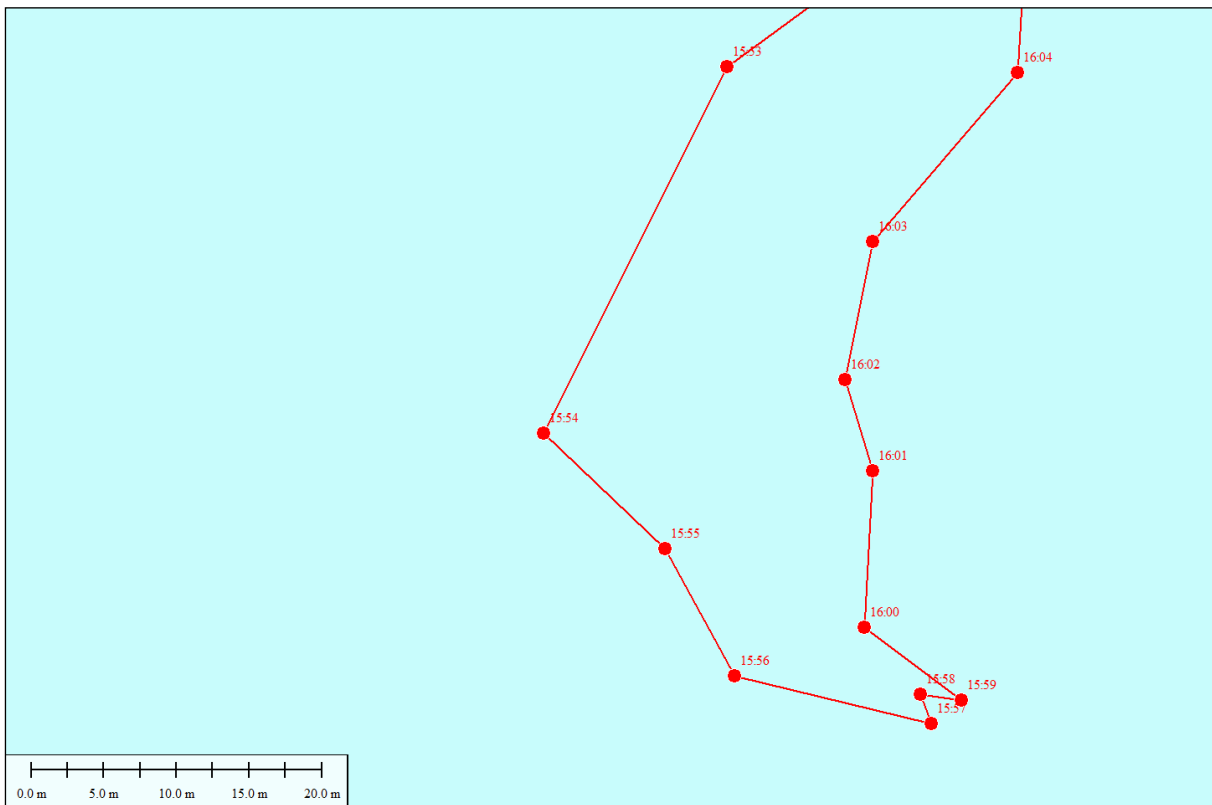
Figure 11: AIS data 3

Figure 10 shows the arrival at Kieler Förde . Figure 11 shows the anchor manoeuvre at the time of the accident, 1553 UTC (1653 LT).

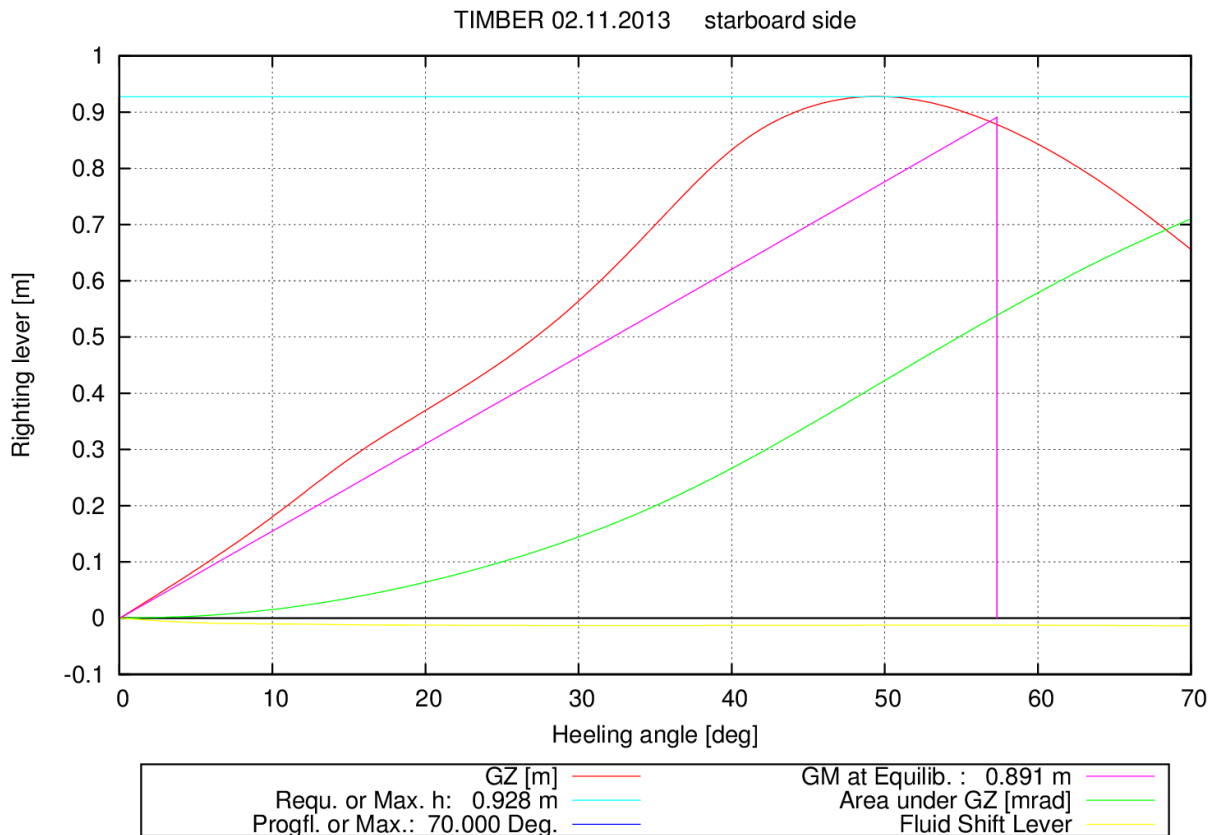
Figure 19: Righting lever arm curve for the condition on departure from Riga

The ship has a deadweight of 2,886 t on the shipboard computer's load case. This is below the permissible deadweight of 3,005 t. The associated righting lever arm curve is shown in Figure 19. The ship has adequate stability in this condition. Applicable intact stability criteria are complied with. According to the data on the shipboard computer and our own calculations, the draughts during the approach stood at 5.00

m aft and 4.90 m fore. Therefore, the mean draught was 4.95 m. Accordingly, the ship was just short of being overloaded because the maximum permissible draught would have been 4,953 m.

*It is conspicuous from the shipboard computer's data that the deck cargo is only specified with volume but not weight or centre of gravity. Moreover, the documents indicate that the deck cargo is included in the weight specified for the **cargo hold**. However, the corresponding **centre of gravity** was **not adjusted for the deck cargo**. The timber load's centre of gravity is quoted at 4.8 m in the load case. This cannot be correct because deck cargo was also stowed on the hatches. Therefore, the centre of gravity indicated for the cargo in the departure load case is definitely wrong.*

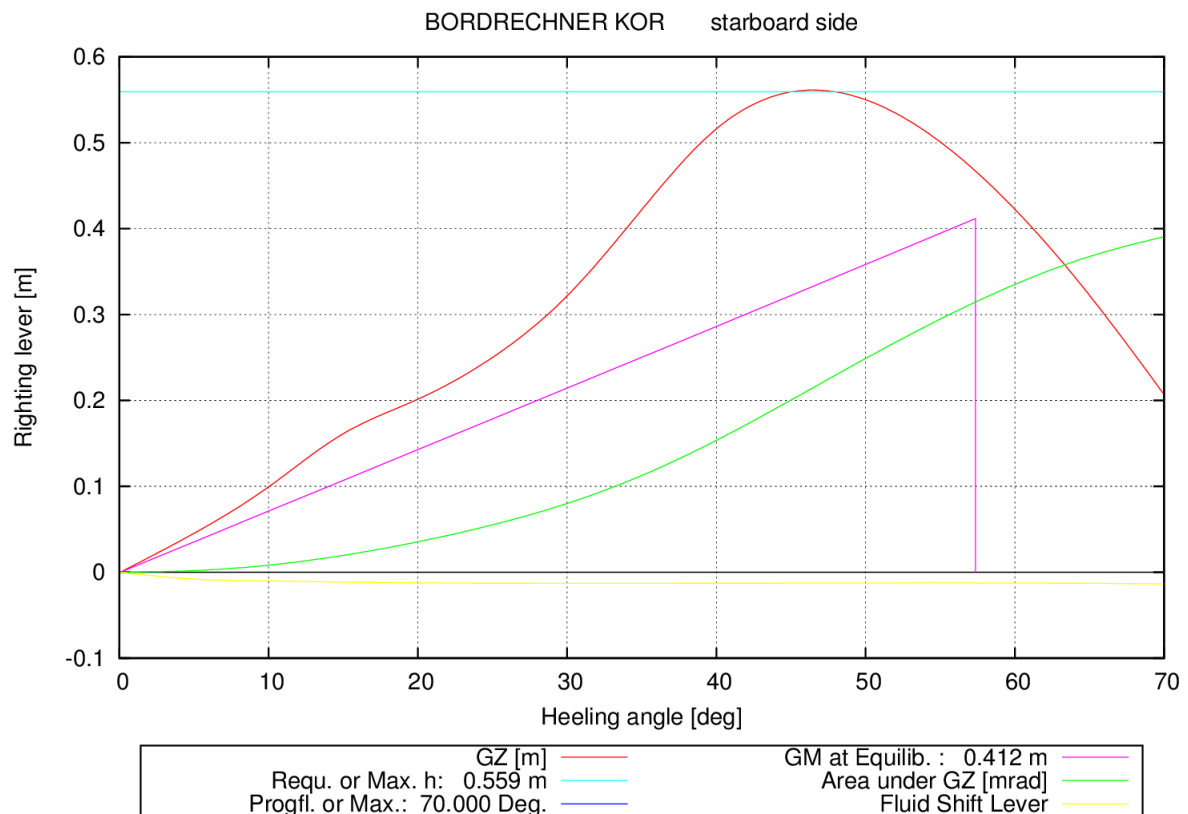
Figure 20: Righting lever arm curve for the condition on departure from Riga according to the shipboard computer's data on 2 November 2013 with the centre of gravity corrected for the deck cargo

Consequently, we made a new calculation with a revised centre of gravity for the timber cargo. Here, 1,845 t was first placed in the cargo hold and 300 t on deck. This reduces the ship's initial stability from 0.891 m to 0.412 m (see Figure 20 and Figure 21). According to our calculations, the ship still complies with the applicable intact stability criteria under these conditions (see Fig. 21).

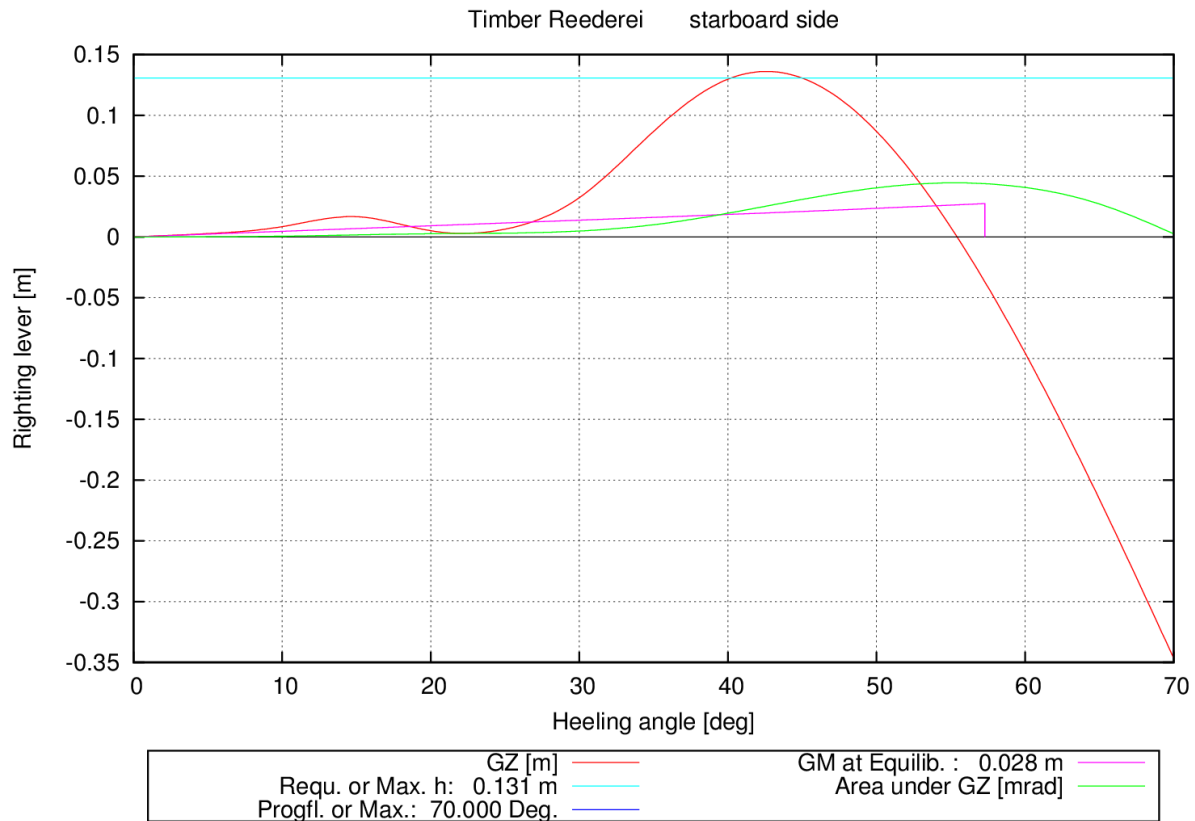
Figure 21: Righting lever arm curve for MV ROSEBURG's load case from Riga to Barrow Haven according to information given by the owner

It is apparent that another difference to the shipboard computer's load case is that the amount of ballast water is now only 250 t instead of 563 t previously. The difference in ballast water is missing in the double bottom tanks. The draughts in this load case are 5.18 m aft and 4.90 m fore. The mean draught is then 5.04 m. Technically, this means the ship would have been just overloaded.

However, the additional deck cargo and omission of ballast water have a serious impact on the stability, as shown in Fig. 21.

The applicable intact stability criteria are clearly no longer met for the ship at this load condition.

It is now highly likely that the stability condition as shown in Figure 21 led to the observed course of the accident: the ship just has a positive initial stability but only very low heeling moments lead to the first local maximum being exceeded, causing the onset of an equilibrium position of about 20°. If the deck cargo then starts to slide or goes overboard, then the ship would incline further. When a sufficient amount of deck cargo has gone overboard, the ship becomes more stable, partly rights herself again, and finally remains in an inclined position.

Therefore, due to the course of the accident, we take it as given that the ship must have had a stability condition that roughly corresponded with the condition specified by the owner. Otherwise, the course of the accident is not technically feasible. That also becomes clear from the remainder of the investigation.

It remains unclear why it was not noticed that the stability was definitely insufficient in the stability assessment of this condition by the owner.

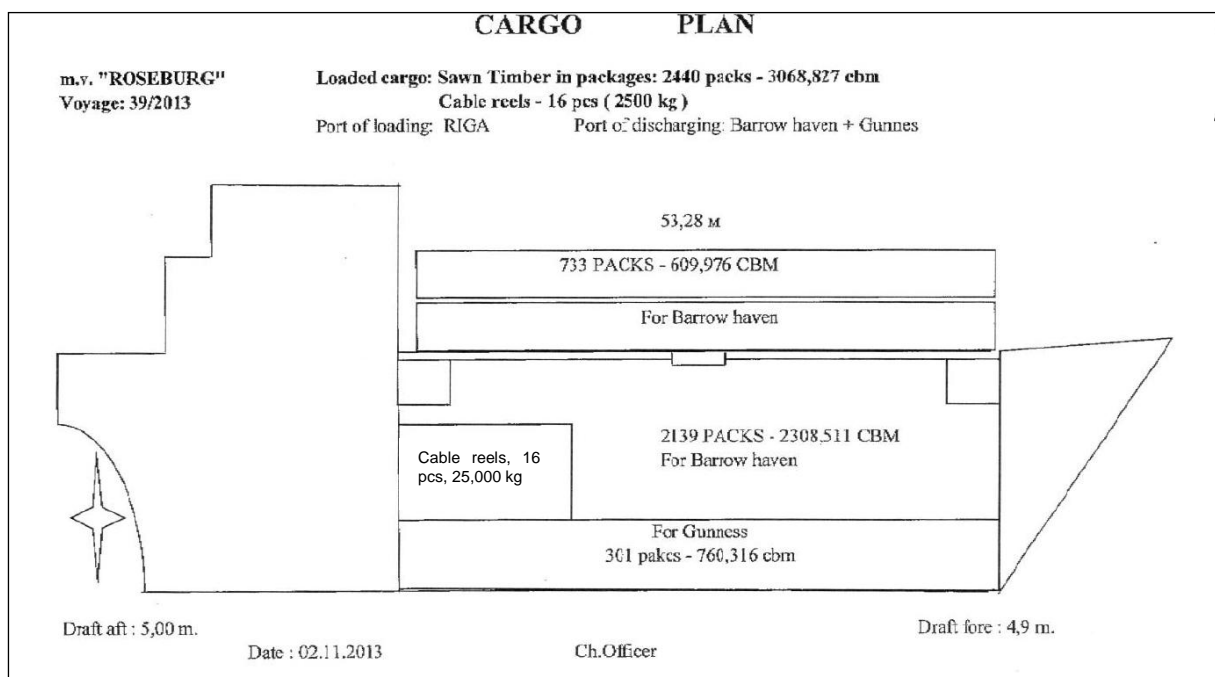
Figure 23: MV ROSEBURG's load plan during the voyage from Riga to Barrow Haven

Due to the inconsistencies concerning the timber cargo between the shipboard computer's data and that of the owner, application of the load plan is of crucial importance for the load condition of the ship. The load plan is shown in Figure 23. It may first be noted that a comparison of the load plan documents and data from the shipboard computer reveals no deviation between each other. The deck cargo is also already included in the data for the cargo in the hold here. As previously stated, this caused an incorrect centre of gravity to be considered when the ship departed.

Documentation from the BSU shows that the waterway police stated the cargo loss was about 700 packages of timber. No more than 75% of the cargo went overboard according to witness statements, however. It follows that the calculated minimum number of packages of timber carried on the deck would be at least 933. According to the load plan, it was only 733 packages, however. Furthermore, Sartori & Berger (the agency responsible) stated that timber weighing some 750-800 t was recovered from the water. Taking into account the fact that the timber recovered was saturated with water and thus about 1.7 times heavier than dry timber, the resulting loss of cargo is 440-470 t. If we now assume that the weight of the lost deck cargo is approximately 75%, the total deck cargo amounts to 587-626 t. The scale of these values corresponds with the weight of the deck load specified in the owner's load case (596 t).

From that and the above deliberations, it immediately follows that the load case printout from the shipboard computer cannot have taken the entire load of timber into account, as about 300 t, which the ship must have additionally carried on deck, is missing.

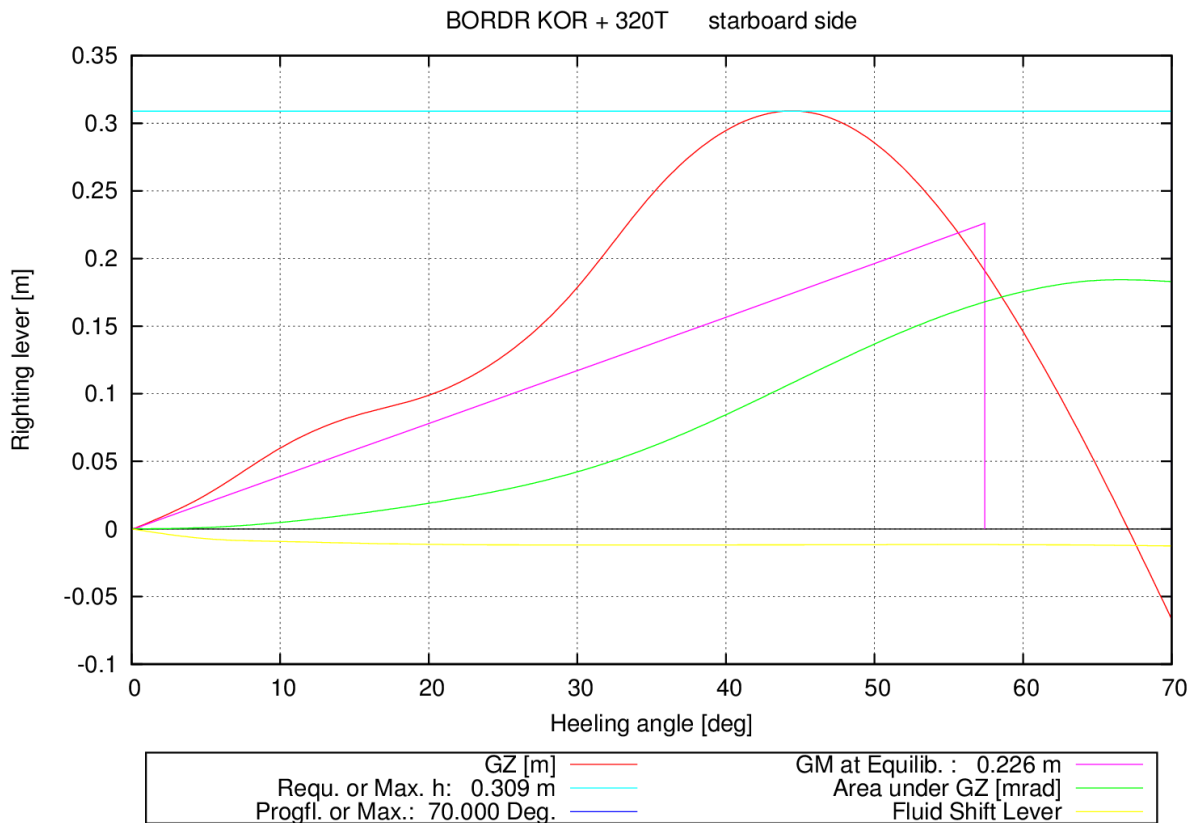
Figure 24: Righting lever arm curve for the condition on departure from Riga according to our calculations

Taking into consideration this cargo, the resulting deadweight is now 3,206 t. This means that the permissible deadweight of the ROSEBURG of 3,005 t was exceeded by 201 t in this load condition. Based on these factors, the ship was overloaded. The draughts would then be 5.524 m aft and 4.985 m forward, resulting in a mean draught of 5.255 m. The maximum permissible draught is only 4.953 m, however.

The associated righting lever arm curve is shown in Figure 24. In this condition, the applicable intact stability criteria are not complied with.

- the lever at 30° is 0.18 m instead of 0.20 m;
- the area up to 30° is only 43 mm rad instead of 55 mm rad, and
- the area up to 40° is only 85 mm rad instead of 90 mm rad.

Consequently, the ship **would not have been permitted to start** the voyage for reasons of stability.

The Federal Bureau of Maritime Casualty Investigation and ADOMS IID recommend that the ship's command of the MV ROSEBURG desist from taking risks and give absolute priority to the safety of the ship. This includes, in particular, sufficient ship stability.

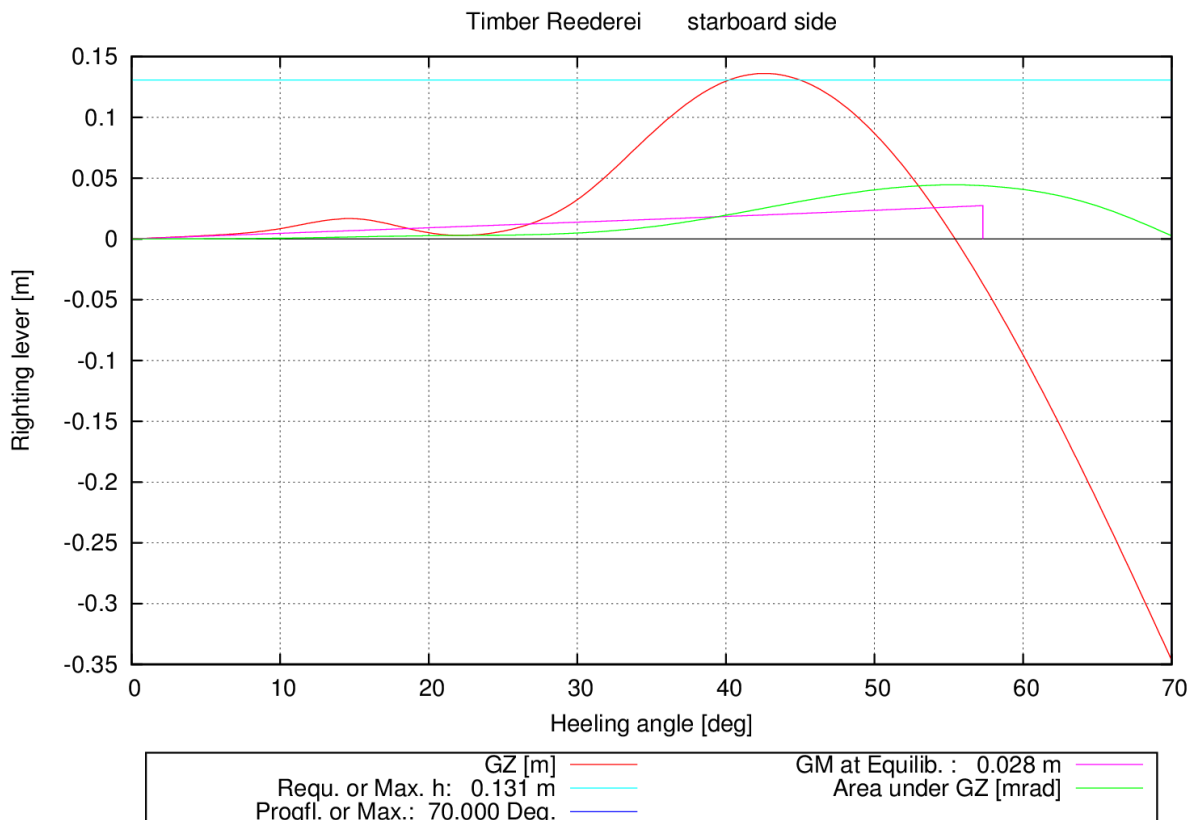
Figure 25: Righting lever arm curve for the probable accident condition

This shows that the ship has reached a limit in terms of stability. If there are no heeling moments, then the ship will be able to maintain an upright position. Minor heeling moments initially cause the ship to roll close to an upright position. Here, there is a maximum heeling moment when the ship rolls beyond the initially existing positive stability and then assumes a position of equilibrium at about 25°. In application of this stability condition, we determined this maximum moment by applying a heeling moment starting from the upright position. We then calculated the ship's rolling motion thus. The result is the maximum roll angle, the static end position, and the resulting maximum acceleration during the rolling motion.

The calculations clearly show that at the presumed stability condition the accident would definitely have unfolded in exactly the manner observed if a heeling moment of more than 28 mt had acted on the ship. We will continue by showing it is highly probable that such a moment actually occurred at the time of the accident.

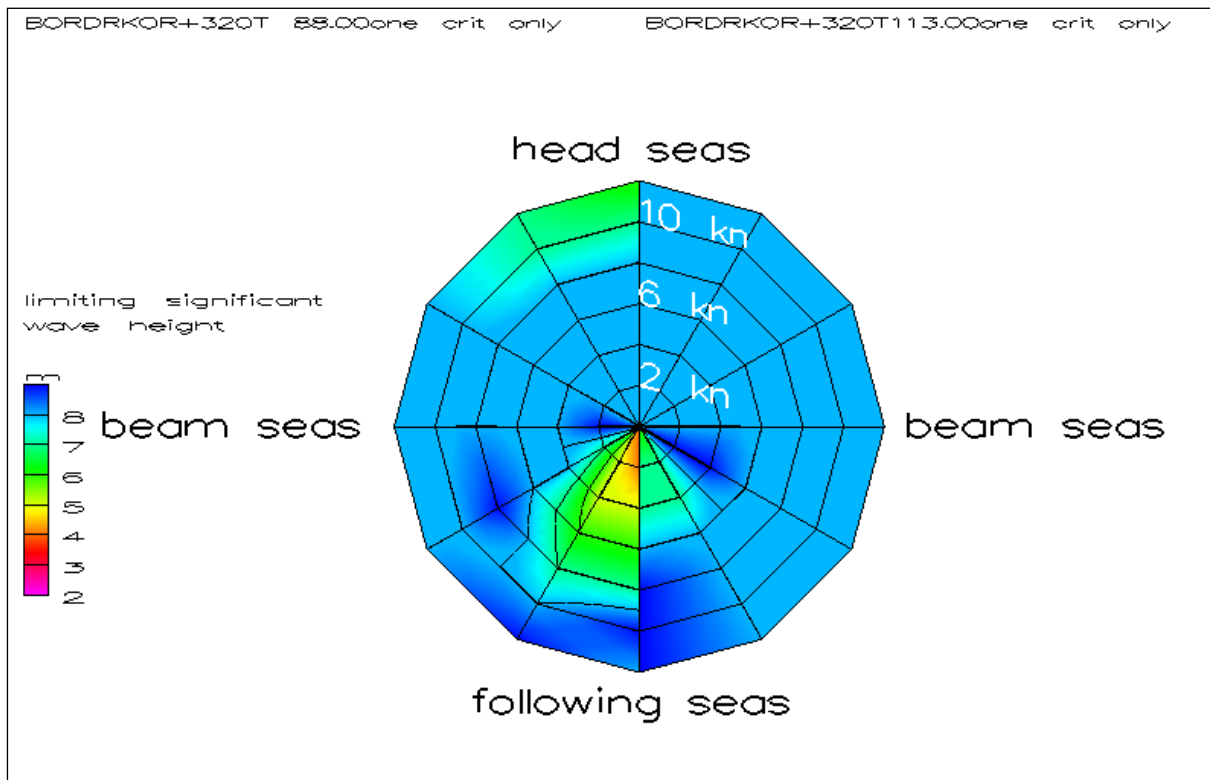
Figure 27: Polar coordinate diagram showing the significant wave heights necessary for reaching a transverse acceleration of 4.5 m/s^2 at significant periods of 7.5 s (left) and 8.5 s (right).

It can be seen that significant wave heights of at least 5 m would have had to occur to cause a loss of cargo. However, it is highly unlikely that these occurred during the voyage. This shows that the ship must have started the voyage with ballast water, as the ship would never have reached the Bay of Kiel without losing cargo in the accident condition.
