**Bundesstelle für Seeunfalluntersuchung**  
**Federal Bureau of Maritime Casualty Investigation**  
Federal Higher Authority subordinated to the Ministry of Transport  
and Digital Infrastructure

Summary  
Investigation Report 417/13

**Collision between the CMV CONMAR  
AVENUE and CMV MAERSK KALMAR on  
7 May 2013 on the Outer Weser**

31 July 2014

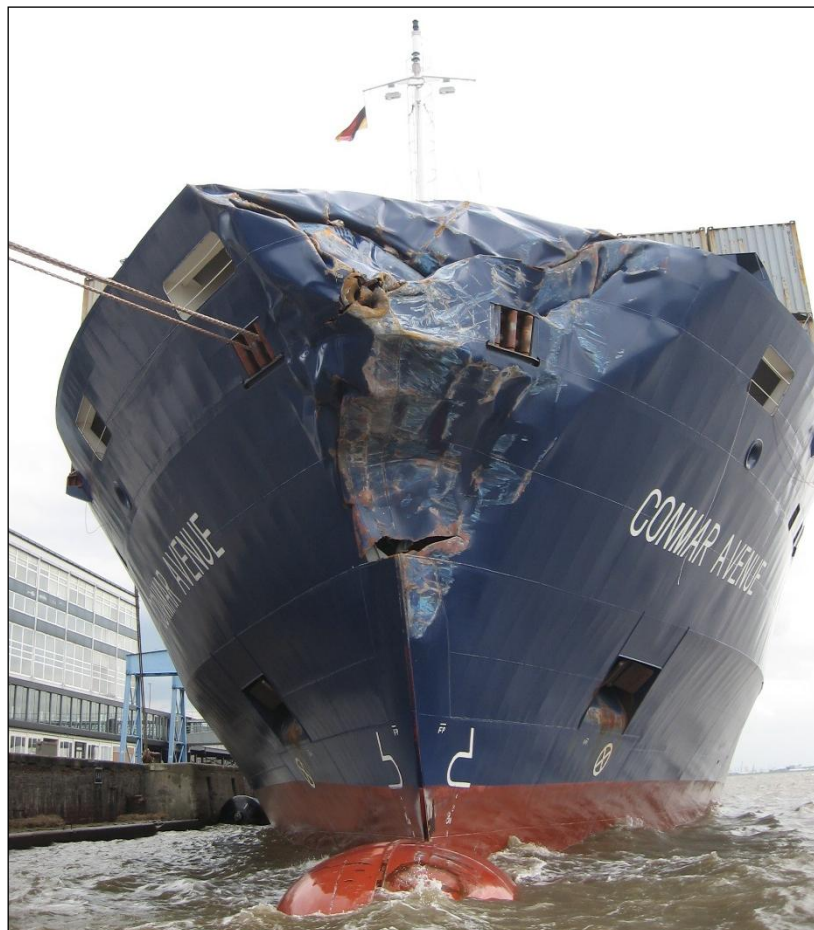
**Figure 12: Damage to the forecastle of the CMV CONMAR AVENUE**

During the collision, the port side of the CONMAR AVENUE's forecastle scraped along the starboard side of the MAERSK KALMAR's aft section. In the process, the stem of the CONMAR AVENUE was heavily deformed centrally and on the port side extensively. Moreover, it was torn in places well above the waterline. The bulbous bow of the ship was also affected (see **Figs. 12ff.**).

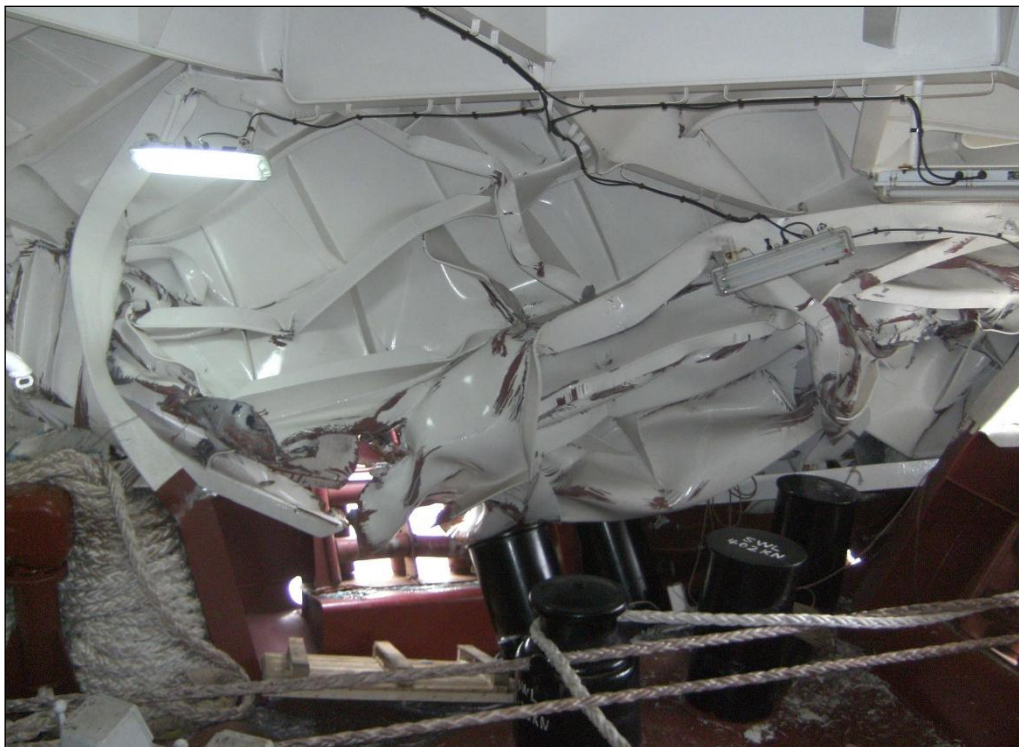
**Figure 14: Damage to the forward manoeuvring station on the CMV CONMAR AVENUE**

The heavy deformations on the stem also resulted in damage to the forward manoeuvring station – a number of bollards and guide rollers, in particular (see **Fig. 14**).

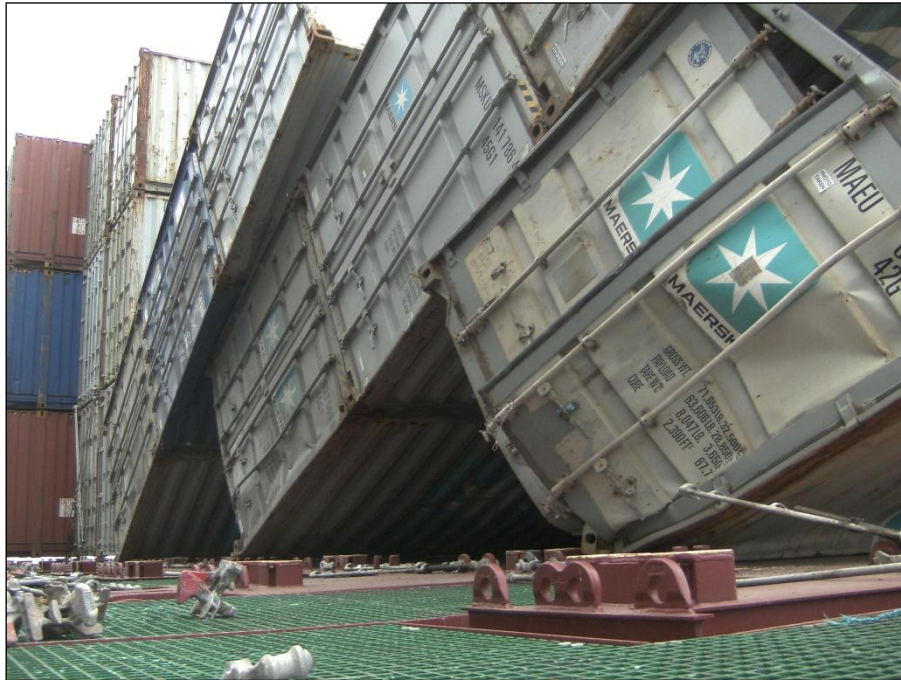
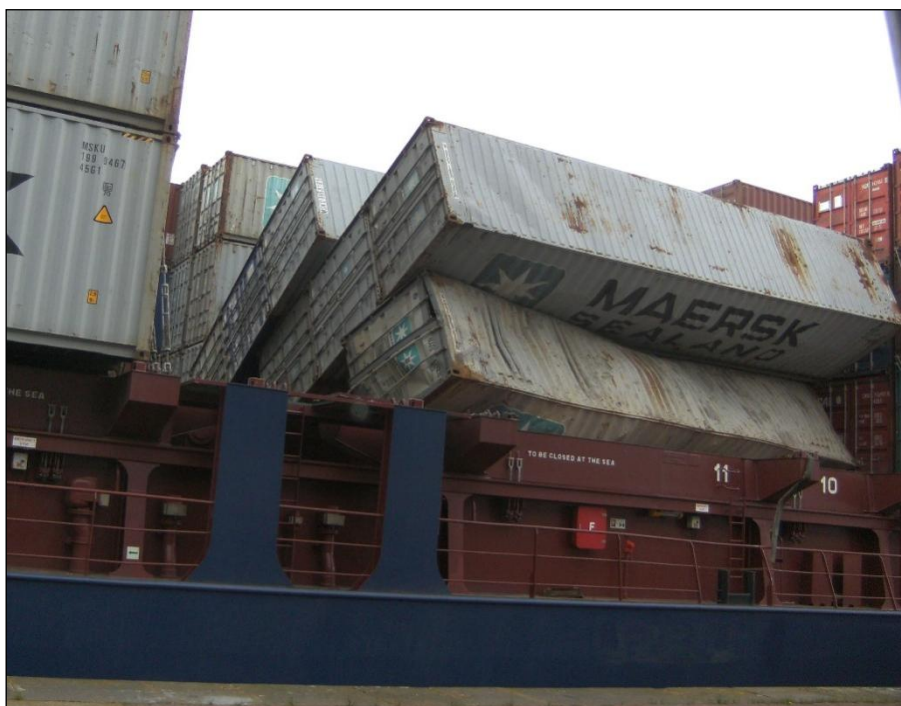
As a result of the collision, several container stacks on the deck of the CONMAR AVENUE tipped towards the starboard side (see **Figs.15 f.**). Altogether, 15 containers fell into the water. They did not contain any dangerous cargo and were filled mainly with wood or paper. Interrupted by breaks at night-time, it was possible to recover the containers from the Weser over a period of about 48 hours with the help of a floating crane and many support vessels.

**Figure 15: Topped deck cargo on the CMV CONMAR AVENUE (1)**

**Figure 16: Topped deck cargo on the CMV CONMAR AVENUE (2)**

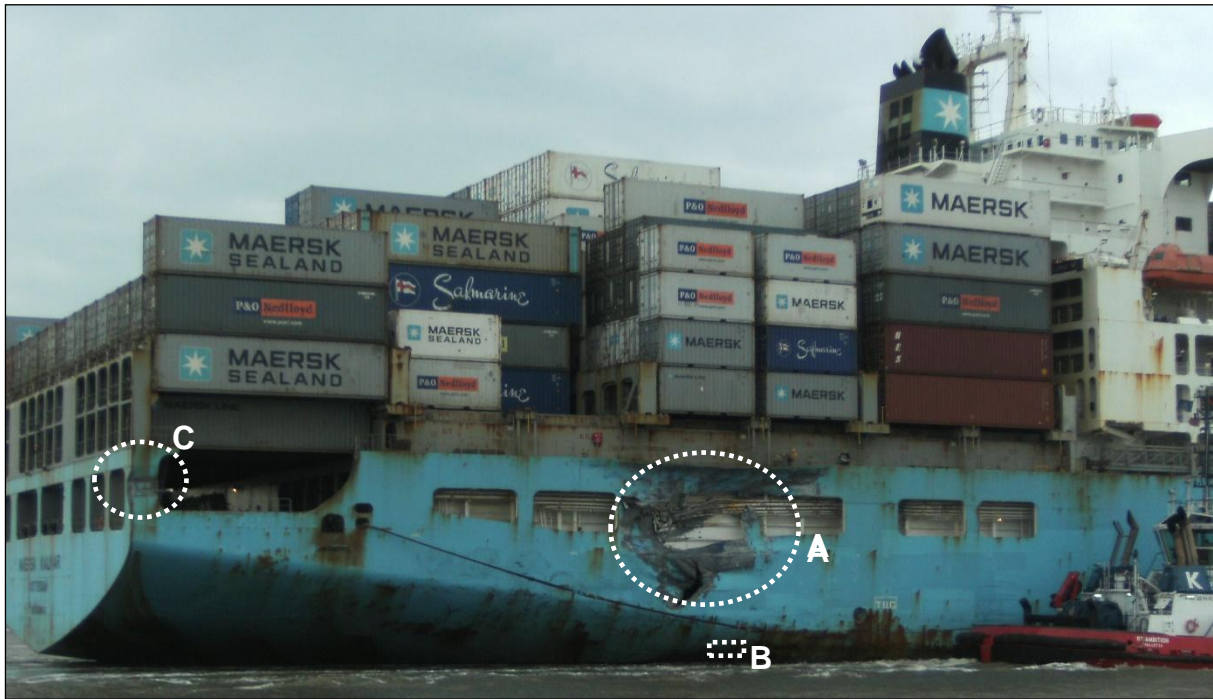
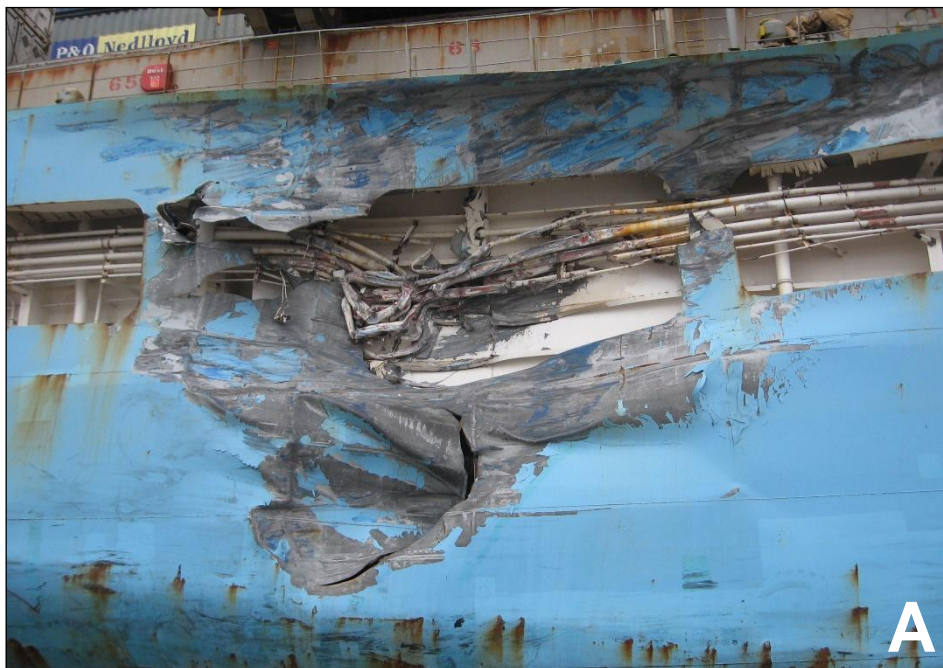
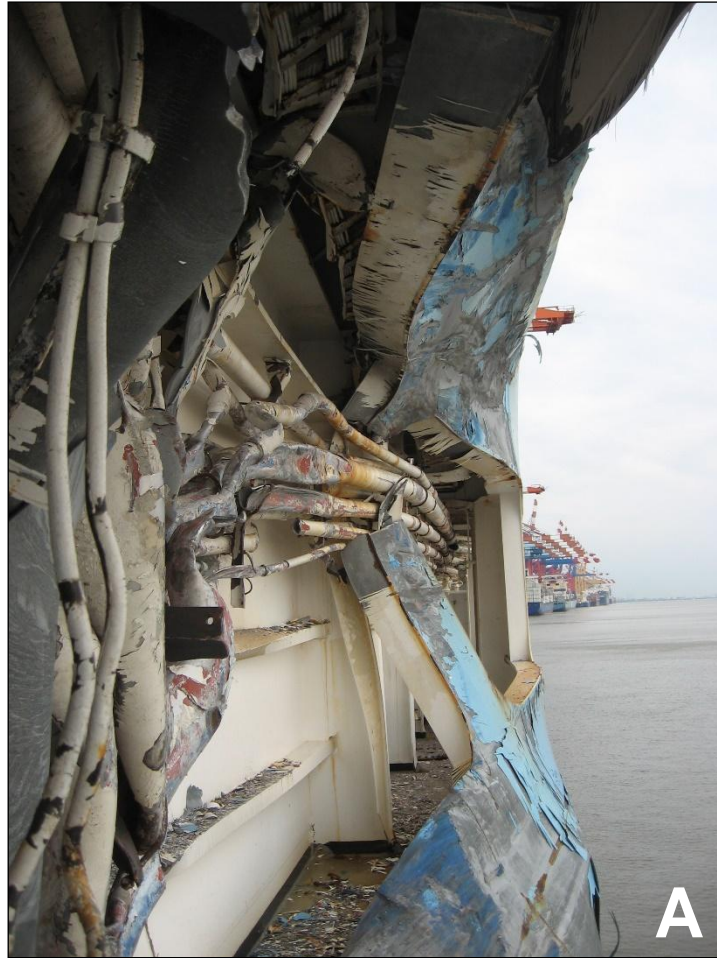
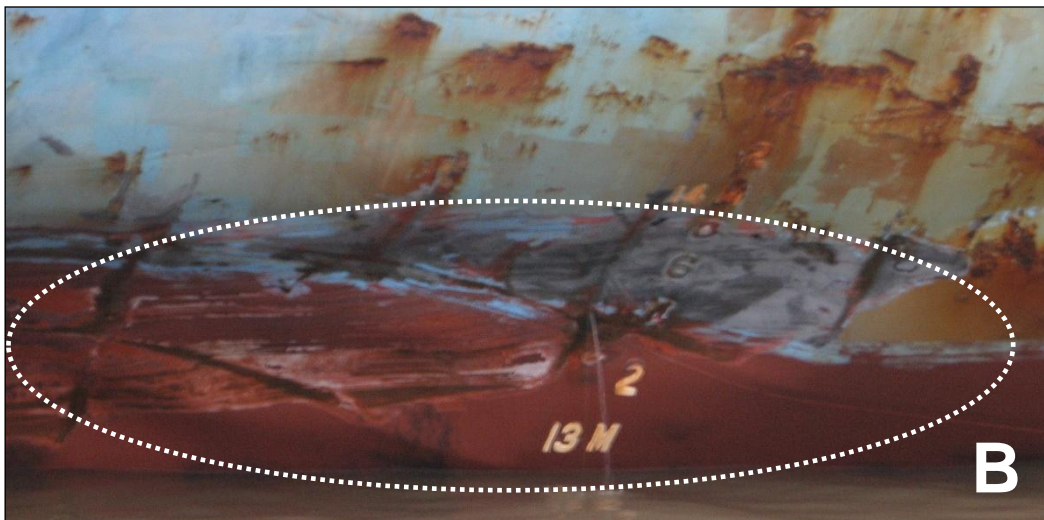
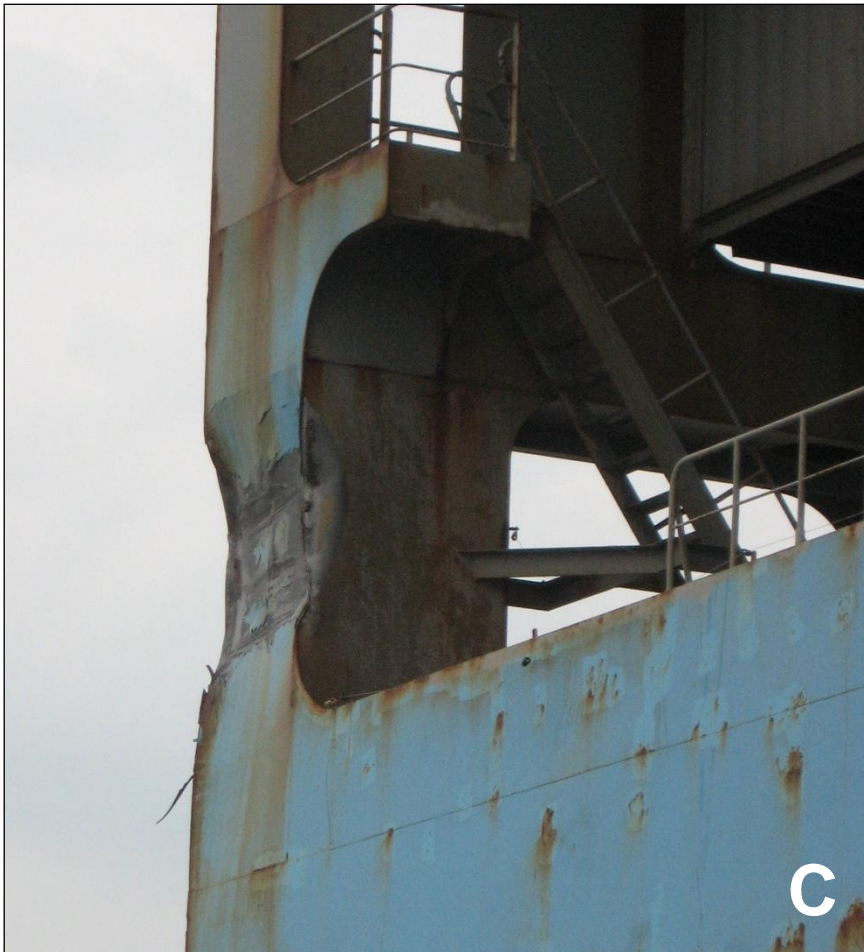
The hull wall on the starboard side of the MAERSK KALMAR's aft section was heavily deformed in the area of bay 63 well above the waterline extensively (A). In the same area, a tear of about 3.5 metres in length and almost horizontal formed just above the water line in the shell plating (B). Moreover, the foundation of the vertical container rail on the starboard aft edge of the ship was dented level with the main deck (C) –Figs. 17ff.

Figure 17: Damage to the aft section of the CMV MAERSK KALMAR – general view

Figure 18: Damage to the hull wall – close-up (1)

Figure 19: Damage to the hull wall – close-up (2)

Figure 20: Tear in the shell plating – close-up

**Figure 21: Damage to the cell guide foundation on the starboard side of the aft edge (close-up)**

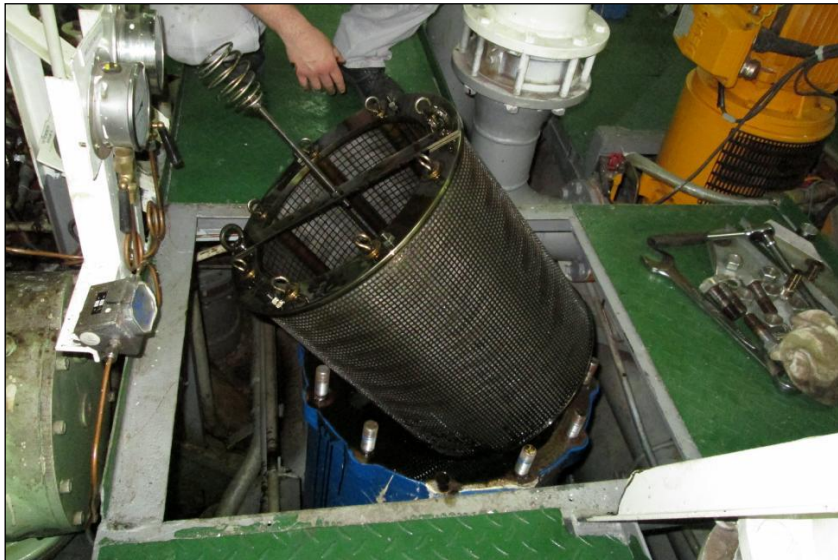
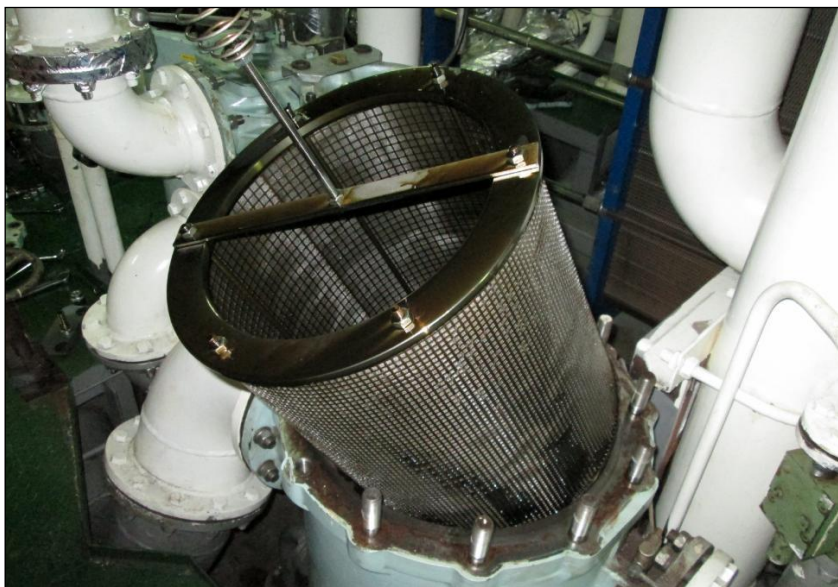
The suction filter on the primary active lubricating oil pump and the one on the standby pump were free of contamination, damage, and other abnormalities. Both filters were absolutely clean (see **Figs. 29f.**) and could be reinstalled immediately after the inspection.

**Figure 29: Suction filter on the primary active lubricating oil pump**

**Figure 30: Suction filter on the standby pump**

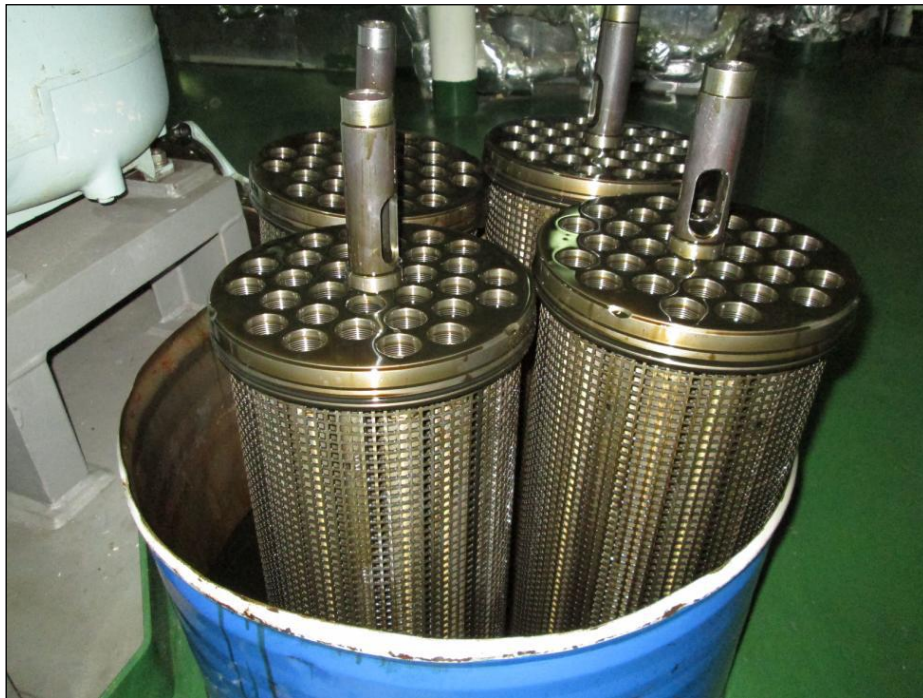
**Figure 31: Automatic backwash filter**

The four filter inserts on the automatic backwash filter (see **Fig. 31**) exhibited no contamination or other irregularities. The filter itself underwent functional testing successfully. The engine was also tested for a drop in oil pressure during a purge. As

*expected, this was not the case. Therefore, this filter can be ruled out as the cause of the loss of oil pressure.*

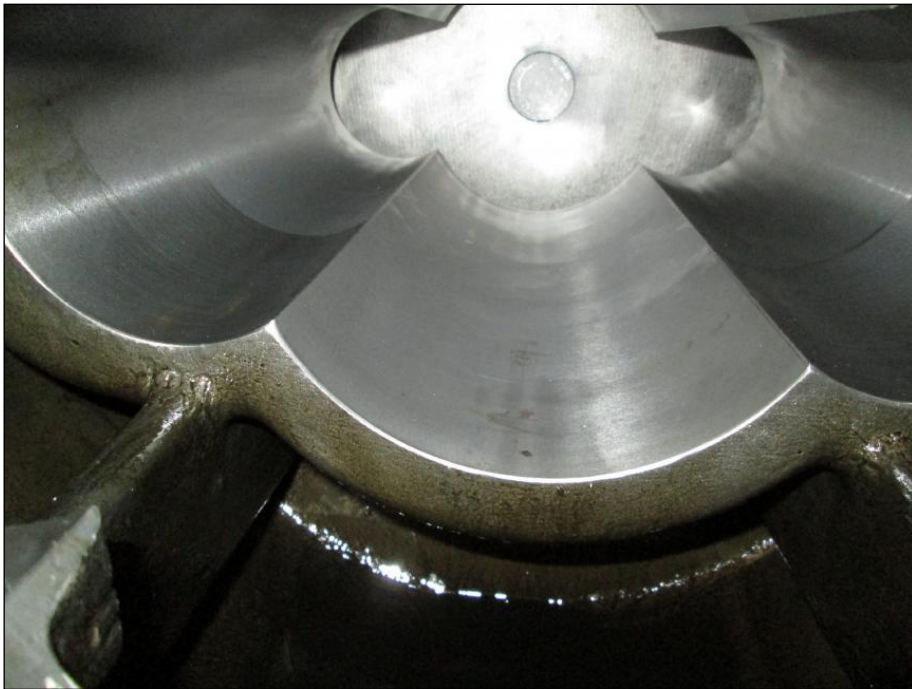
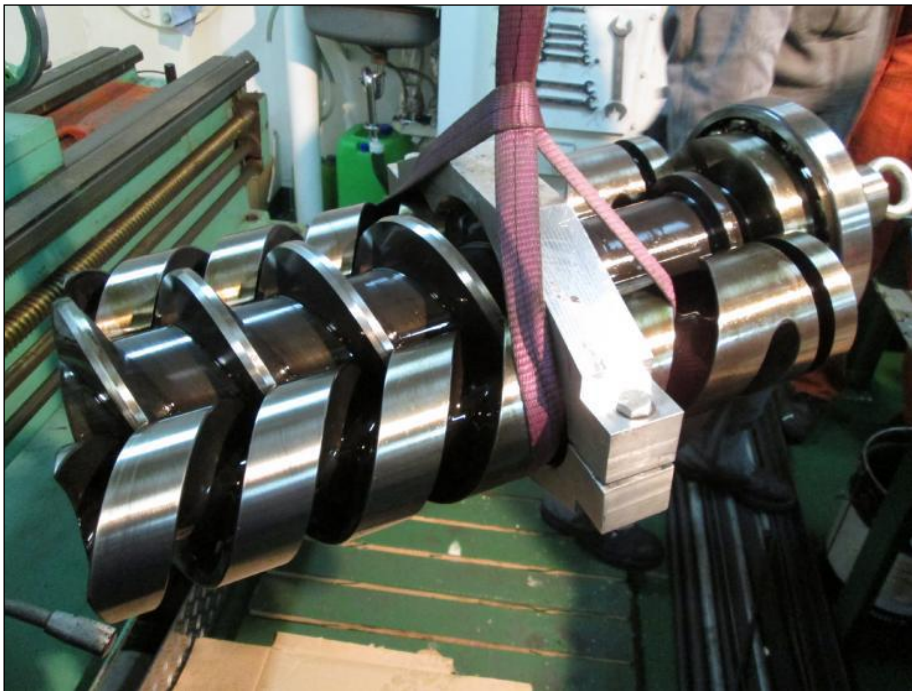
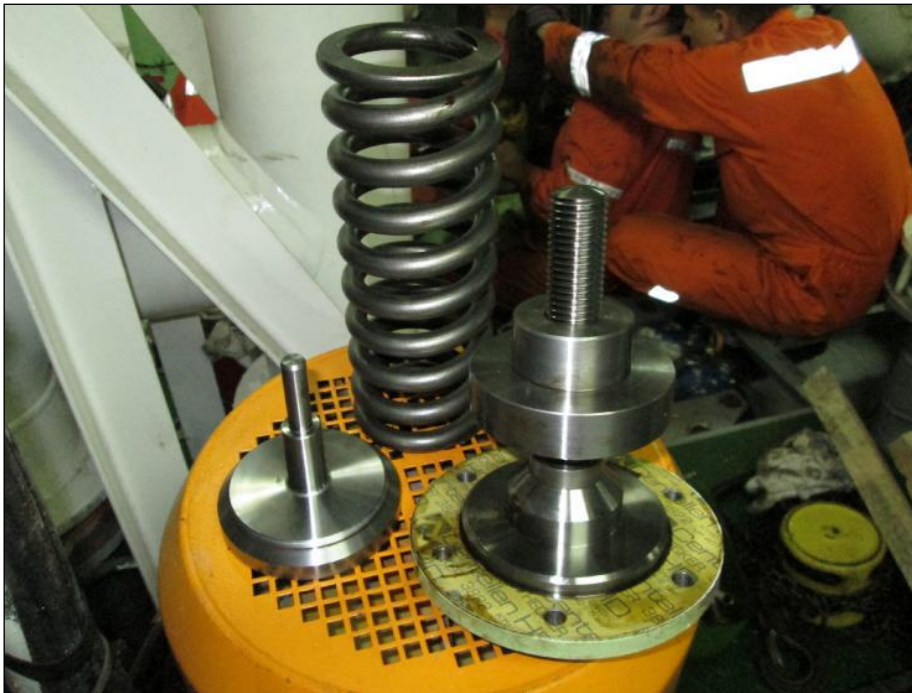
*The primary active lubricating oil pump was removed and disassembled to its individual parts in the workshop to determine whether the spindles or body were damaged or worn to a dimensional limit (see **Figs. 32f.**). The overflow valve (safety valve) was disassembled and checked at the same time (**Fig. 34**). Neither the pump spindles and body nor the components of the safety valve exhibited any abnormalities.*

**Figure 32: Pump body after removing the spindles**

**Figure 33: Pump spindles after disassembly**

**Figure 34: Pump safety valve after disassembly**

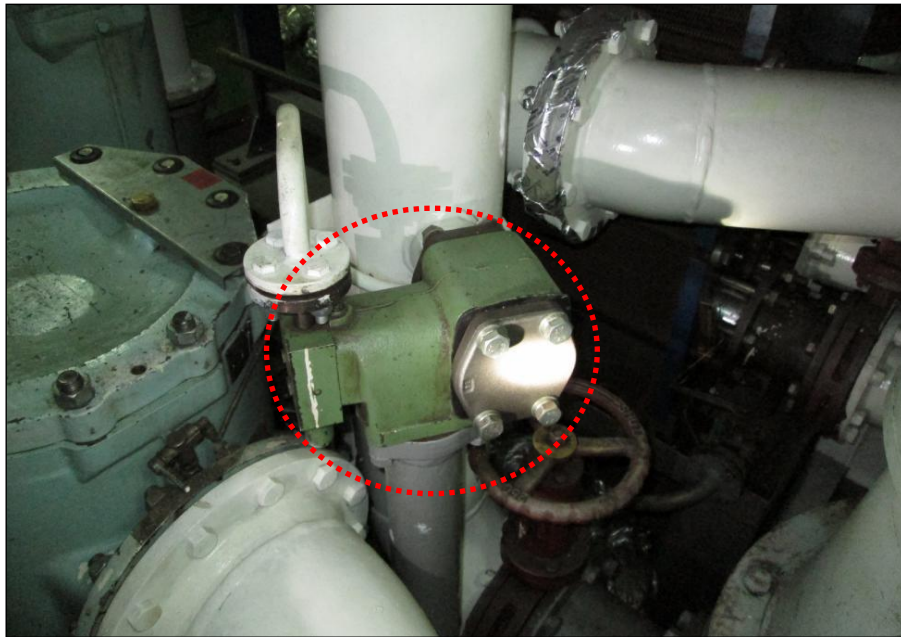
**Figure 35: Pressure control valve when installed**

*The pressure control valve (see **Fig. 35**) is located on the main line between the pumps and oil cooler. A pilot valve is used to control the valve. This pilot valve is set to the required pressure once by means of spring tension when the ship is put into service and does not require further adjustment after that. The adjusting mechanism is protected against unintentional alterations by a protective cap. This pressure control valve is completely maintenance-free during periods of ship operation.*

As a result of the course of events leading up to and during the accident, the owner of the CONMAR AVENUE searched for the fault extensively and took the precaution of replacing the pressure control valve in the safety management system. Moreover, it emphasised the clear instruction already in place that the officer in charge of the engineering watch is required to inform the officer in charge of the navigational watch immediately if operating conditions arise that could cause the main engine to fail.

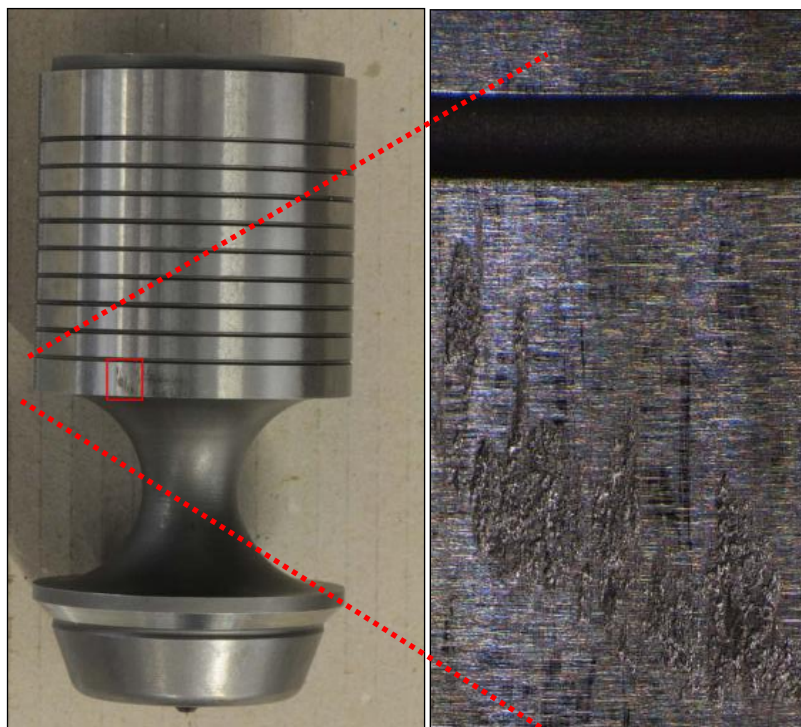
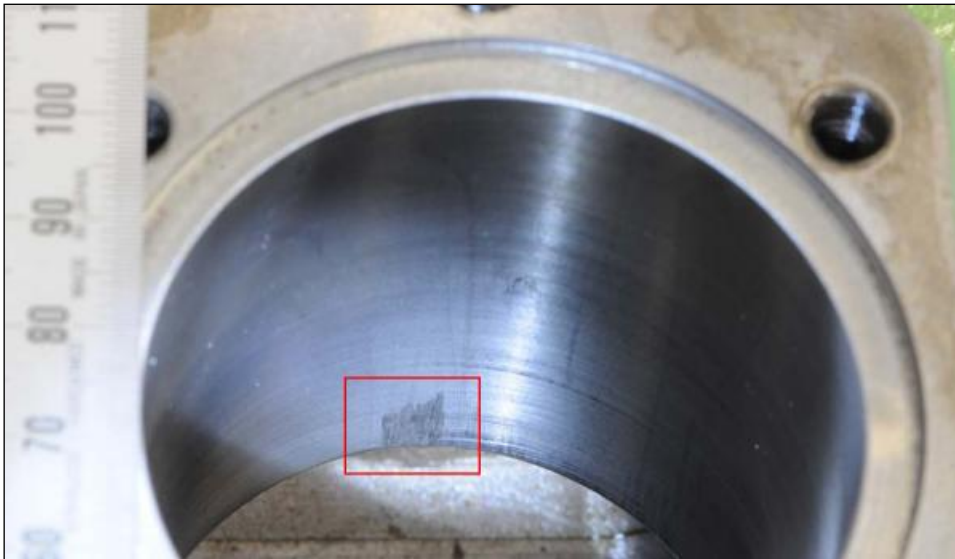
*After the removal of the pressure control valve, so-called seizure marks were found on the discharge piston and in the body (see **Fig. 36**). This implies that the valve was possibly blocked when in a fully open condition, enabling a disproportionately large amount of lubricating oil to flow back into the circulating tank. This assumption is underpinned by the fact that small foreign matter/contaminants were found in the valve.*

**Figure 36: Discharge pistons with seizure marks**

**Figure 37: Seizure mark in the valve body**

*To test whether the drop in oil pressure could have been caused by the piston seizing in a fully open position, the pressure control valve was assembled so that the discharge piston was blocked in a fully open position. After the standby pump was switched on, a significantly lower oil pressure was found than in the case of a functioning pressure control valve. The drop in pressure was about 0.7 bar when the oil was relatively cold and would have been even greater had the oil been at operating temperature.*
