Bundesstelle für Seeunfalluntersuchung
Federal Bureau of Maritime Casualty Investigation
Federal Higher Authority subordinated to the Ministry of Transport,
Building and Urban Development

Summary Investigation Report 53/13

Collision in the Brunsbüttel siding
between the CMV HERM KIEPE and CMV
EMPIRE
on 2 March 2013

18 December 2013

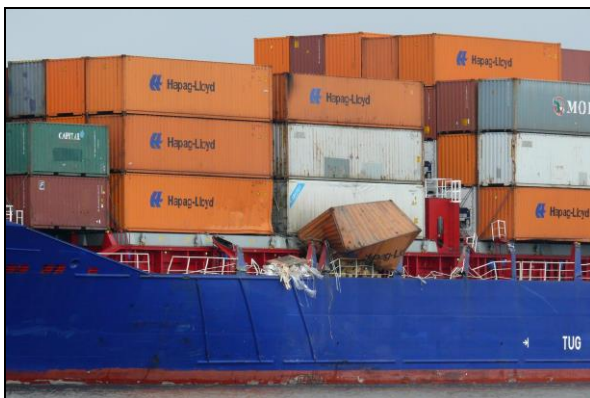
The damage sustained by the ships was relatively minor. The forward port bulwark on the EMPIRE and the bow on the HERM KIEPE were pressed in. Both vessels could manoeuvre under their own steam and continue their voyages.

Figure 4: Damage to the EMPIRE

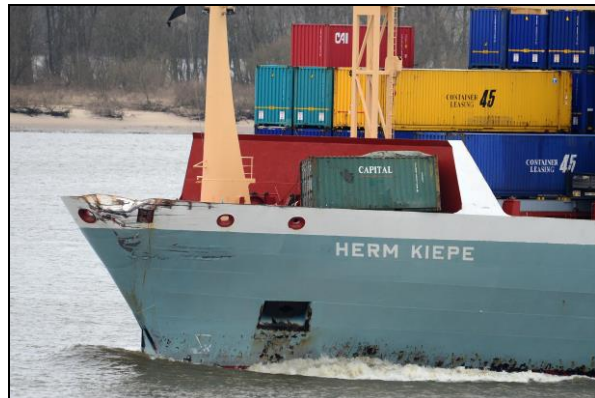
Figure 5: Damage to the HERM KIEPE

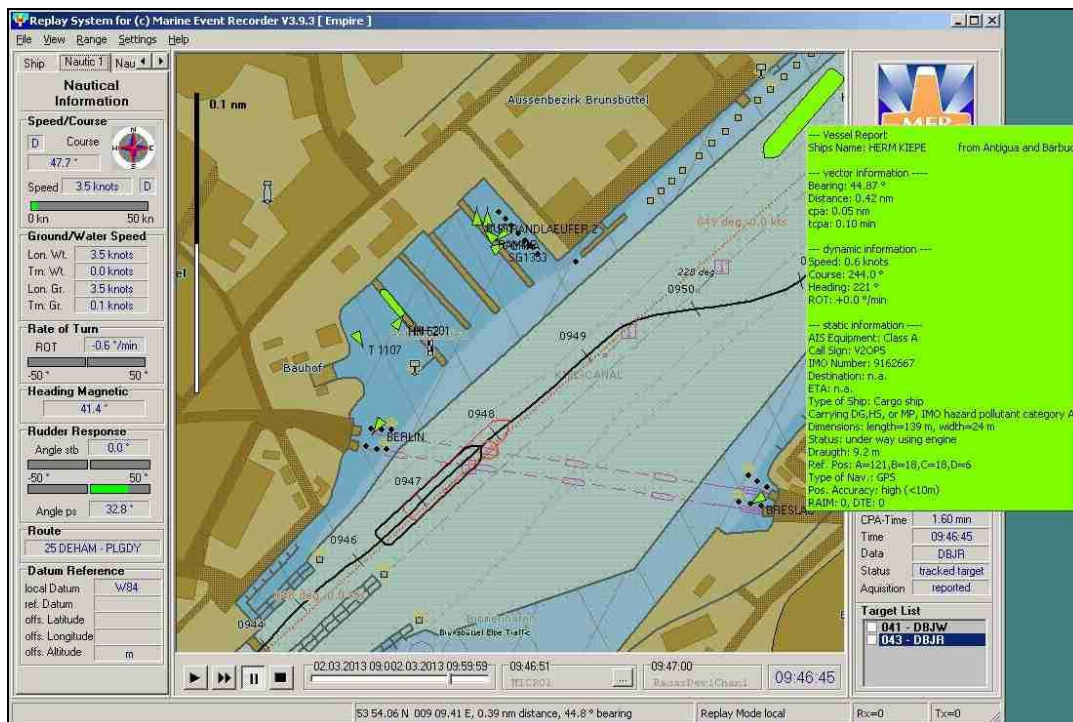
First, the course of the accident after the EMPIRE departed the Große Nordschleuse can be seen. Here, the AIS data of the HERM KIEPE is also displayed (green). The EMPIRE's course made good is marked in one-minute intervals. Unlike the VDR, the AIS data are not recorded by the second, but based on the speed of the vessels, i.e. at intervals of three minutes at speeds of 3 kts or lower, and 10 seconds at speeds of 0 to 14 kts or 3.3 seconds if the course is altered. Reference A-D marks the antenna position of the HERM KIEPE's AIS signal. The distances and bearings relate to the EMPIRE and the antenna position of the AIS signal level with her superstructure. At 104645, the EMPIRE's bow is on the so-called stop line, approximately north-east of the plotted ferry crossings. Her speed stands at 3.5 kts. Until that point, she may not be overtaken by any other vessel. The HERM KIEPE is almost parallel to the dolphins and moving at 0.6 kts. She is required to keep to the north of the leading line of the middle guiding rack's signal masts until the stop line. The antenna distance between the two vessels is 0.42 nm.

Figure 6: VDR of the EMPIRE at 104645

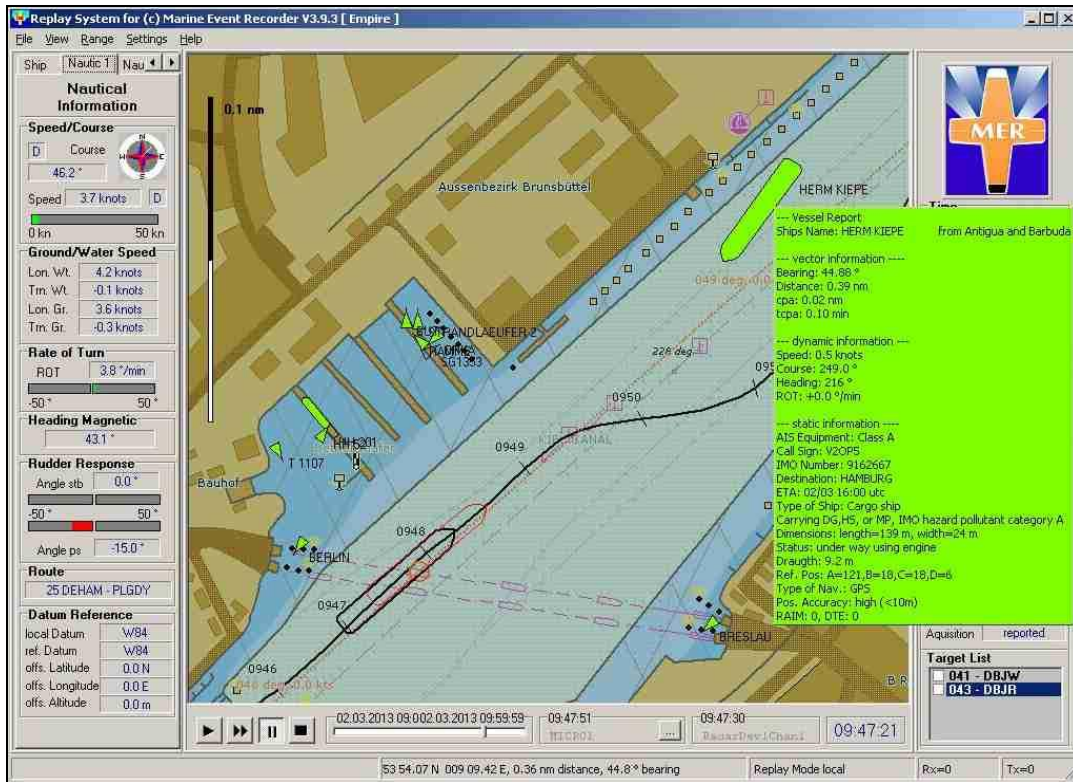
Figure 7: VDR of the EMPIRE at 104721

At 104721, the EMPIRE is located to the north in line with the signal masts of the middle guiding rack's. Her speed stands at 3.7 kts. The HERM KIEPE turns further to port at a speed of 0.5 kts and on a course of 249°. The parallel course to the dolphins would be 228°.

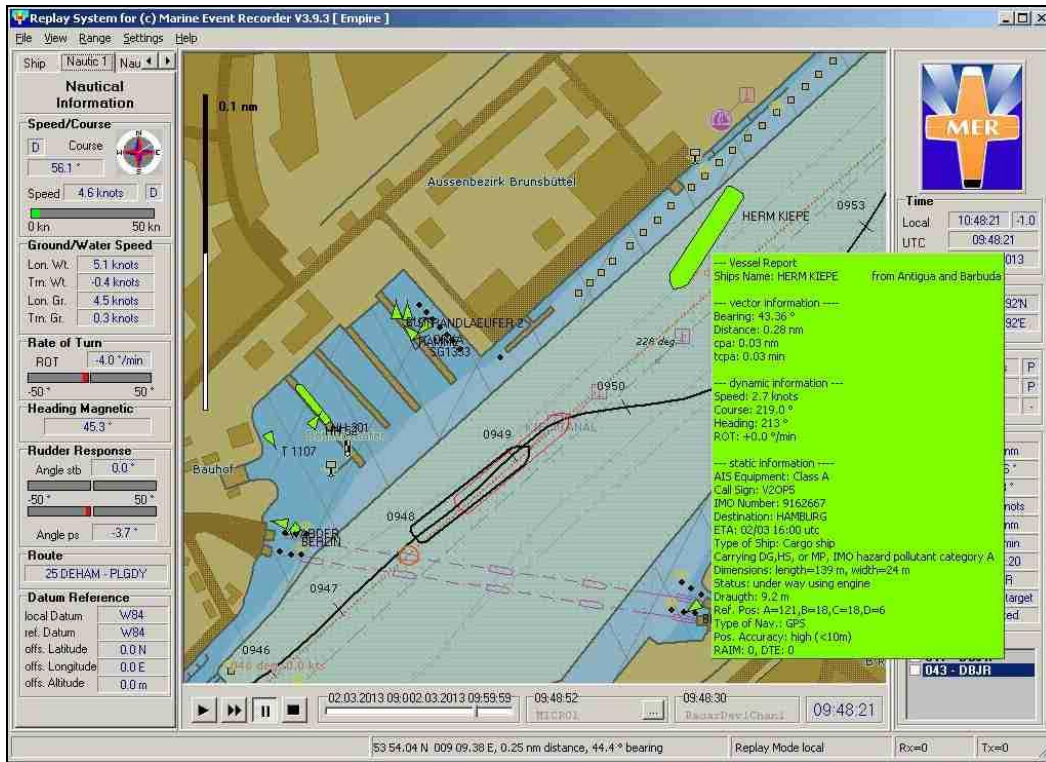
Figure 8: VDR of the EMPIRE at 104821

At 104821, the EMPIRE is still north of the leading line of the signal masts and turns slowly to starboard at a speed of 5 kts; the HERM KIEPE turns further to port, now on a course of 219° and at a speed of 2.7 kts. The collision is looming and unavoidable.

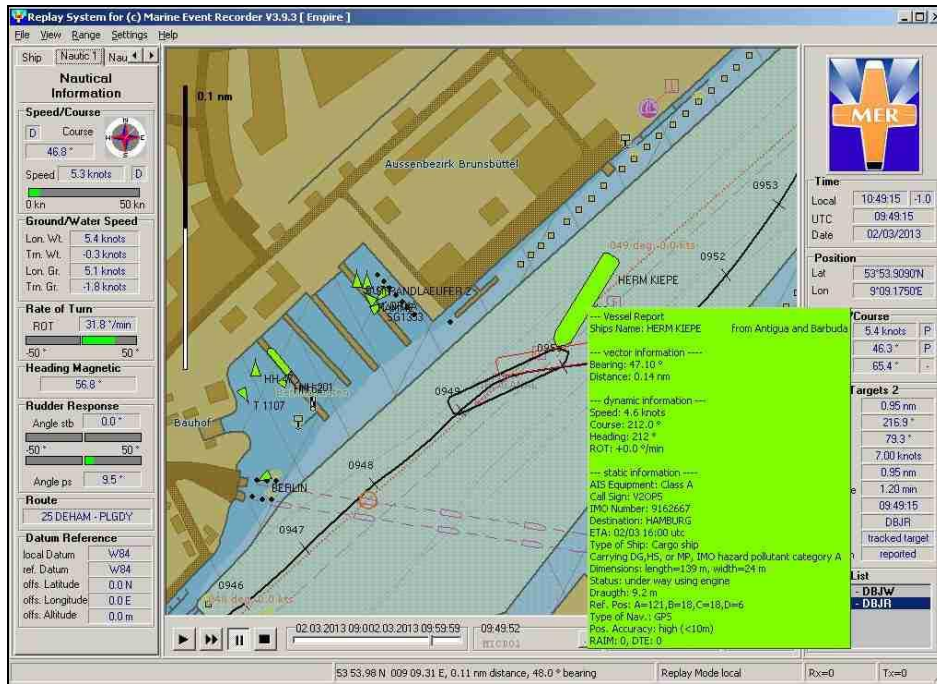
Figure 10: VDR of the EMPIRE at 104915

The two vessels collide at 104915. The HERM KIEPE strikes the port side of the EMPIRE's forecastle head-on. The EMPIRE is still north of the leading line of the signal masts.

The two ships finally collided with the bow on the leading line (see Fig. 10). Here, the speed of the EMPIRE stood at 5.3 kts and that of the HERM KIEPE 4.4 kts according to the VDR recordings. Four containers on the forecastle of the EMPIRE were lost. Three containers fell overboard and the fourth landed on the HERM KIEPE's forecastle. After the collision, the ships remained manoeuvrable and could proceed to the allocated berths. A tug assisted the EMPIRE.

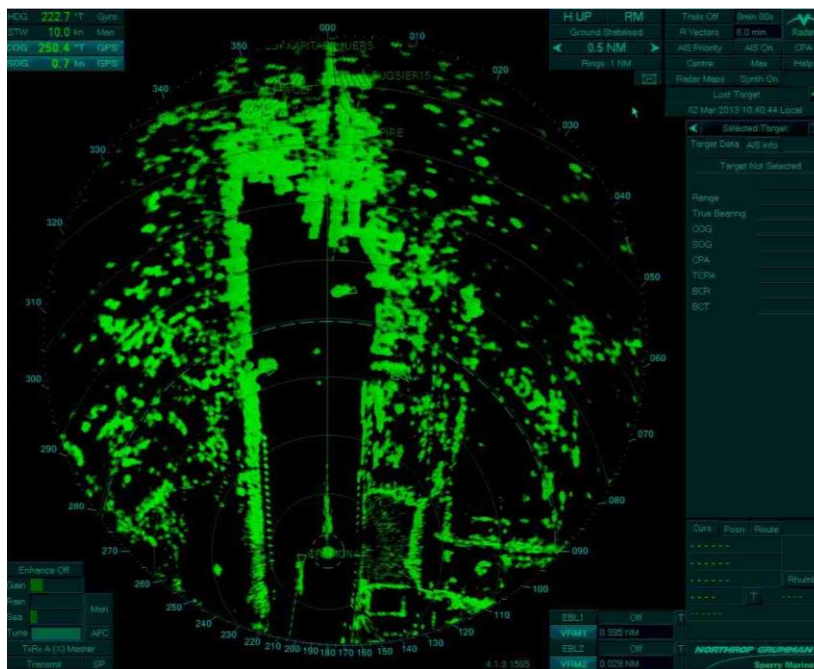
The following radar images are recordings of the HERM KIEPE. At 104044, the CREMONA passes the stern of the HERM KIEPE. In this situation, the HERM KIEPE moves to port. The heading (HDG) is 222.7° and the speed over ground 0.7 kts. The KLENODEN and EMPIRE are still in the lock.

Figure 11: Radar image of the HERM KIEPE at 104044

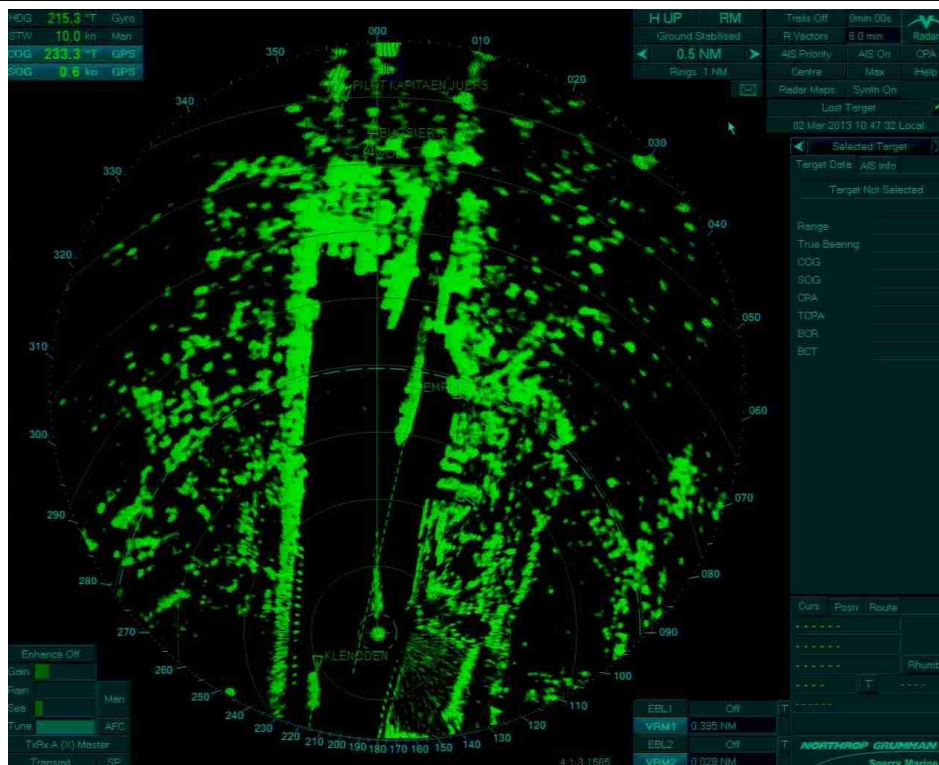
Figure 12: Radar image of the HERM KIEPE at 104732

The KLENODEN had passed the stern of the HERM KIEPE at 104732. At the same time, the HERM KIEPE continues to turn to port on a HDG of 215.3° and at a speed of 0.6 kts. The EMPIRE leaves the guiding racks of the Große Nordschleuse and is almost in line with the lock's lateral guiding racks.

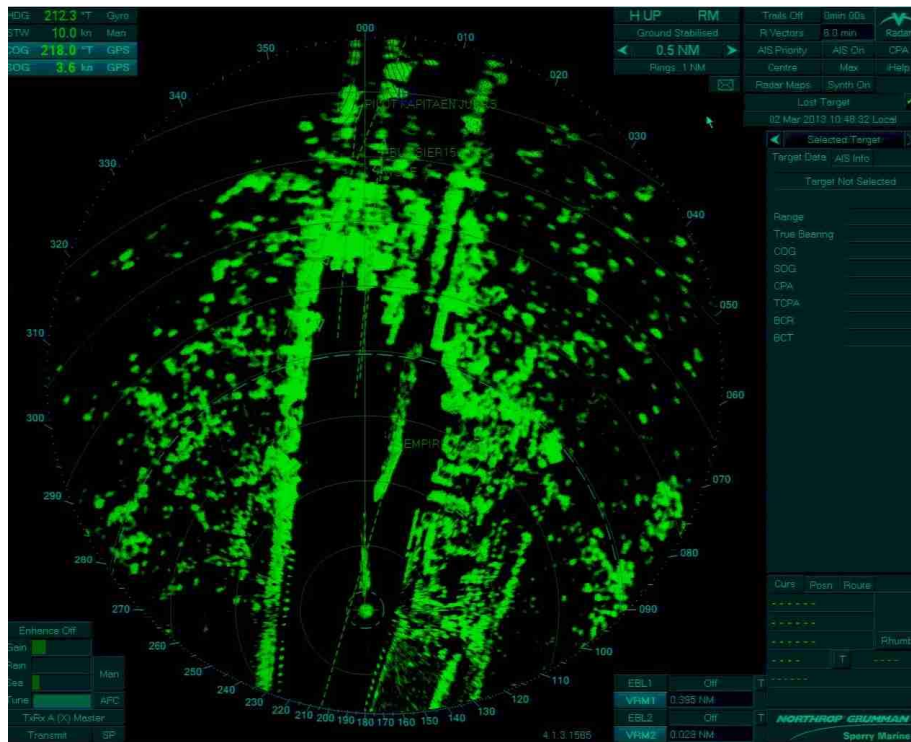
Figure 14: Radar image of the HERM KIEPE at 104832

The HERM KIEPE turns further to port on a HDG of 212.3° and at a speed of 3.6 kts; the EMPIRE is still on the northern side. The collision is looming.

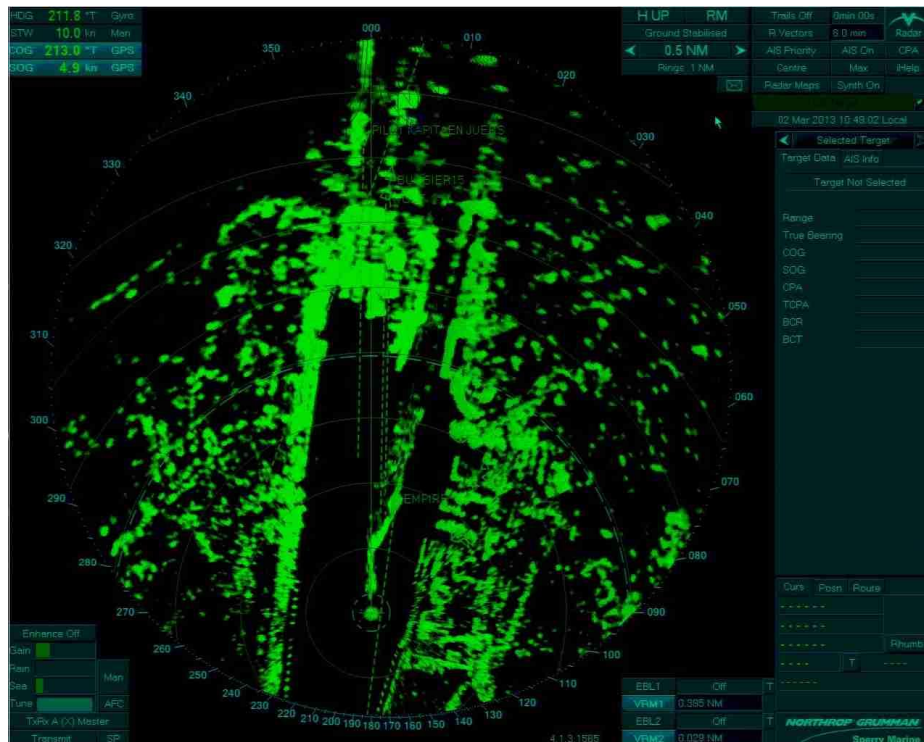
Figure 15: Radar image of the HERM KIEPE at 104902

At 104902, the two vessels collide and scrape past each other. The following images are generated by the ship-handling simulator based on AIS data and show the

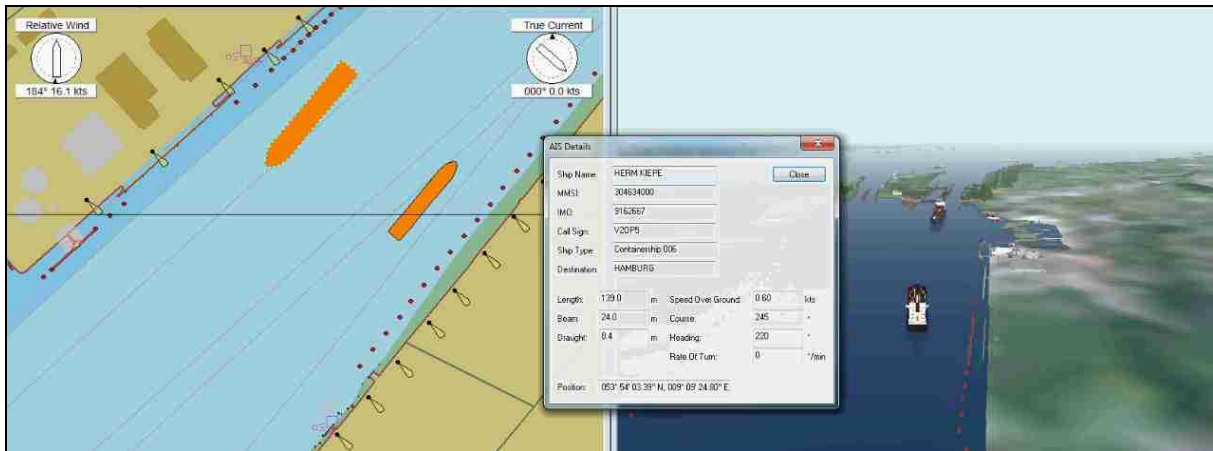
Figure 16: Simulator at 104653

At 104653, the KLENODEN passes the HERM KIEPE as the EMPIRE is just leaving the lock.

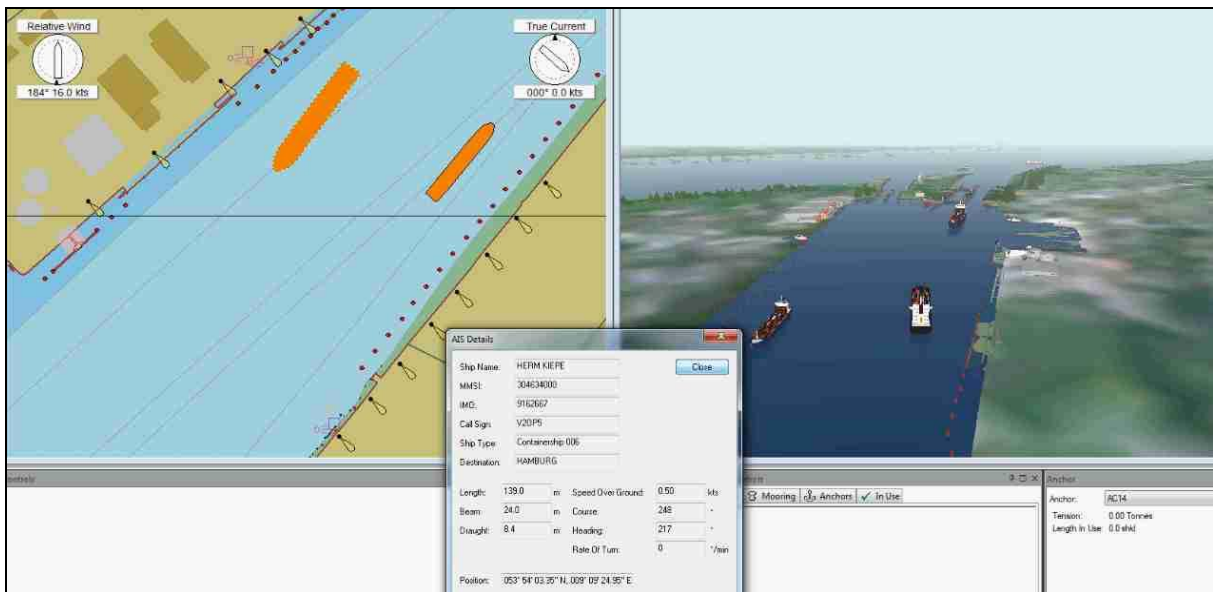
Figure 17: Simulator at 104710

During the passage, the KLENODEN and the HERM KIEPE can be seen making movements to port.

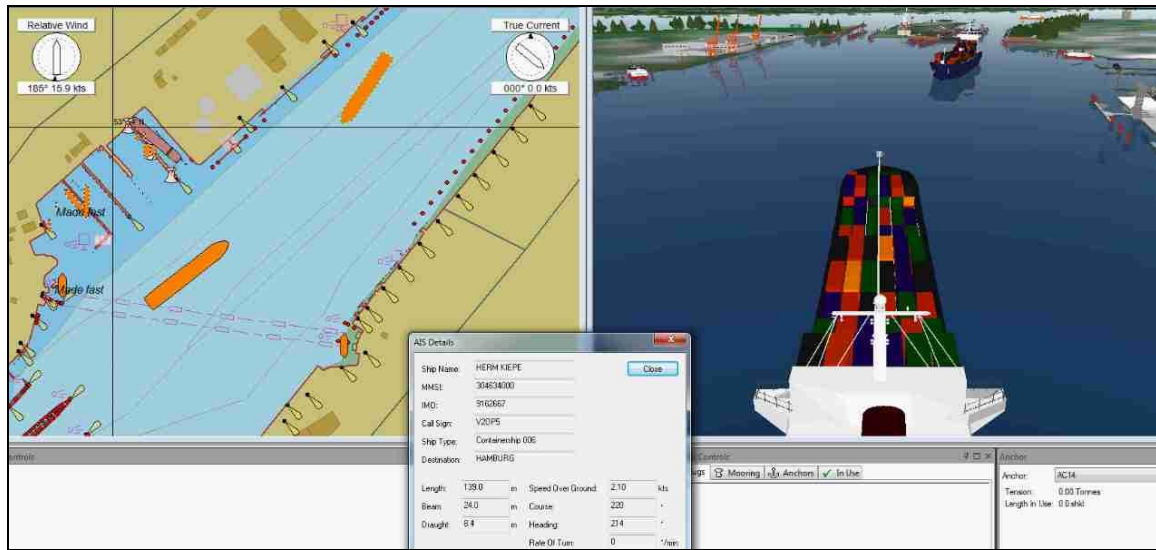
Figure 18: Simulator at 104815

The HERM KIEPE turns further to port and the EMPIRE slightly to starboard.

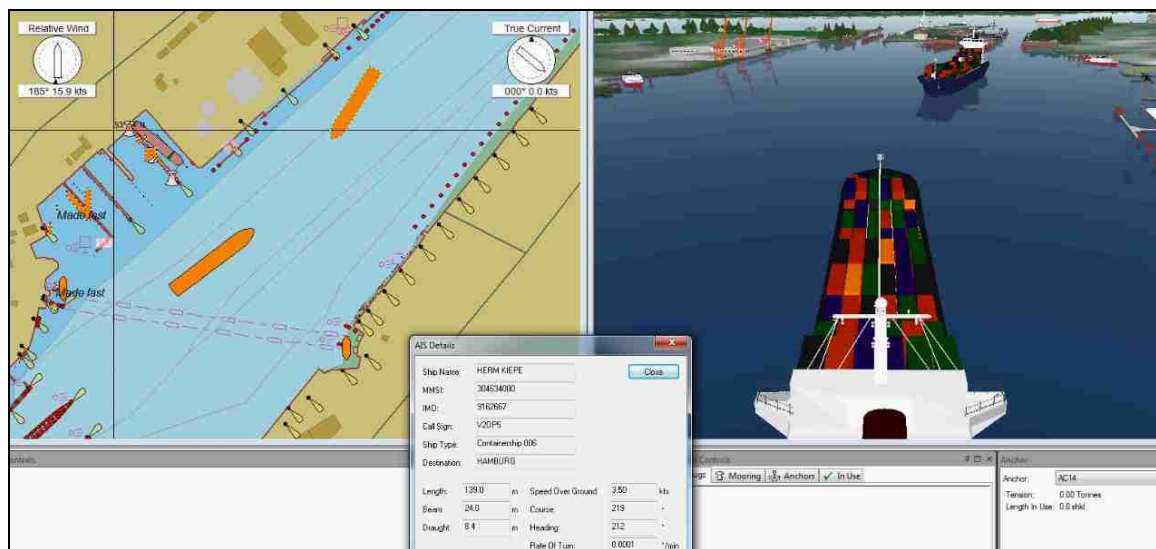
Figure 19: Simulator at 104835

The HERM KIEPE's turn to port cannot be stopped. The HERM KIEPE turns further towards the middle of the canal and the EMPIRE. The EMPIRE turns slowly to starboard and is still north of the middle guiding racks.

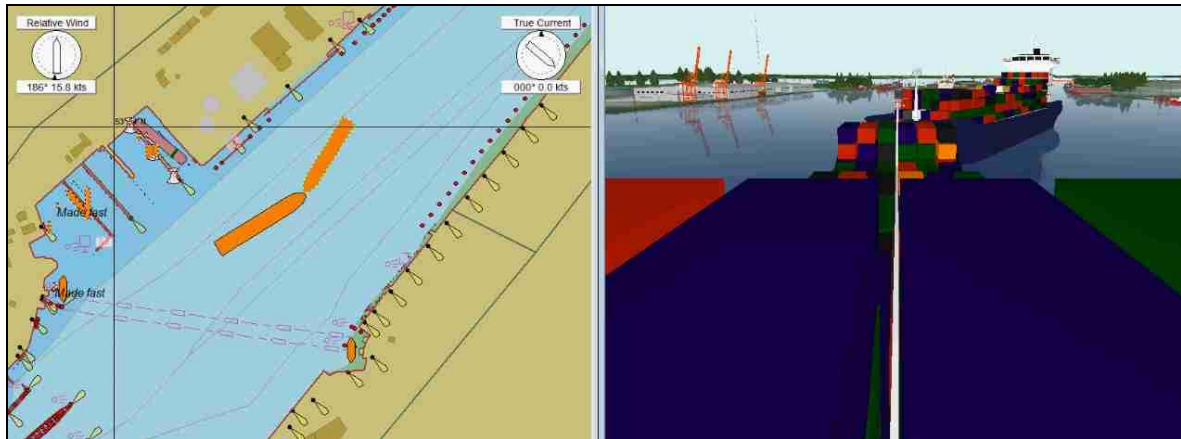
Figure 20: Simulator at 104915

The two vessels collide. The forecastles are in line with the middle guiding racks.

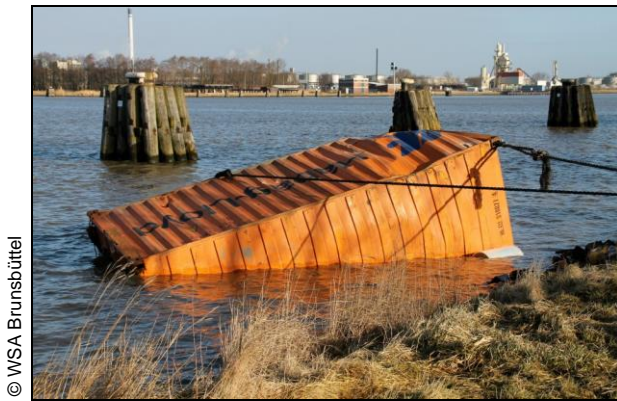
Figure 21: Container that fell overboard

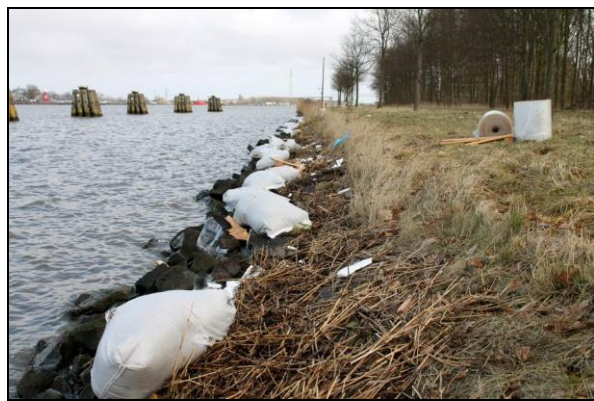
Figure 22: Flotsam, cargo damage

There were no injuries and no pollutants escaped. It was possible to salvage the containers that were floating/partially submerged in the water using equipment from the WSV. The Kiel Canal was closed for that purpose. Due to the risk analysis on the space requirement of shipping initiated by the Directorate-General for Waterways and Shipping, which is to include extensive hydrodynamic studies and towing tests, the BSU is abstaining from issuing additional safety recommendations regarding management of the Kiel Canal for the time being.
